**CHURCH FARM, EAST WING, SHRAWLEY,
WORCESTERSHIRE**

HISTORIC BUILDING RECORDING

Fieldwork Reference No.: WSM47405

November 2012

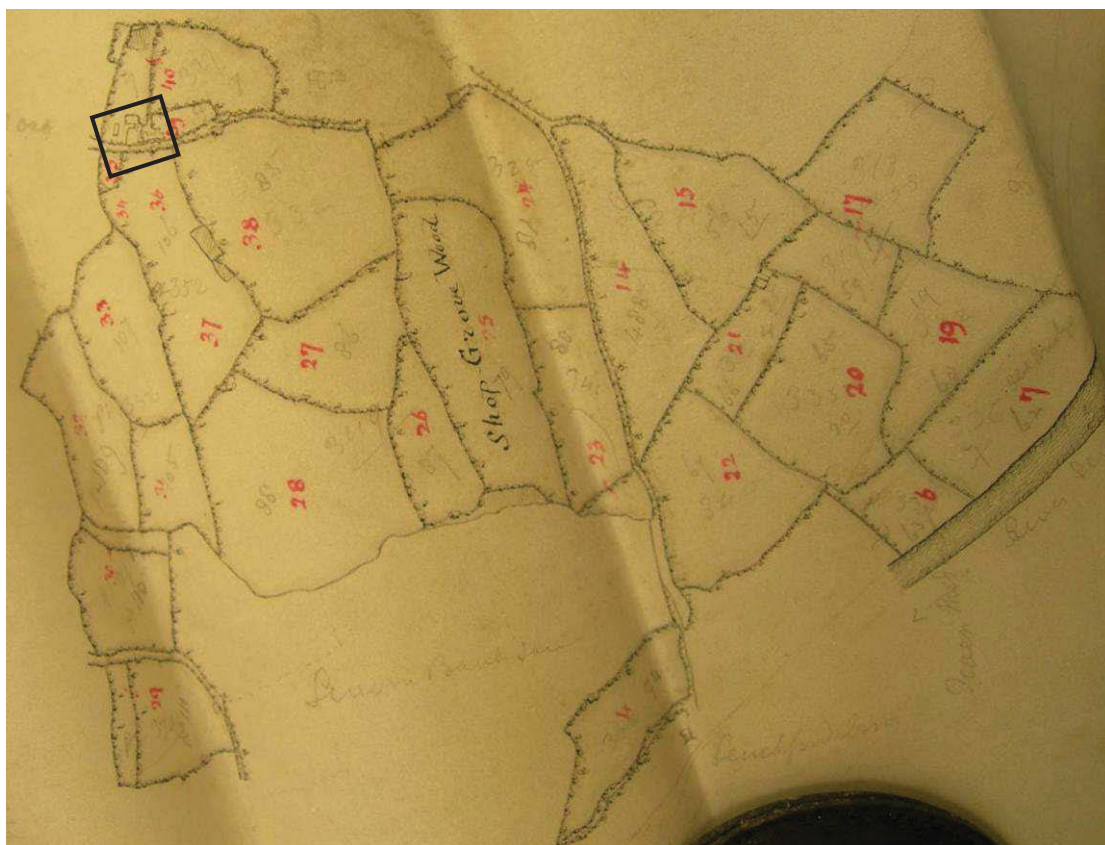
Image 1: Plan of Church House Farm, c.1805

The first map to show details of the farm dates from about 1805 (7335/47(ii)). It is included in a bundle of miscellaneous Shrawley documents which include a ground plan and watercolour of Wood House and a survey dating from 1544-5 of the manor assigned to Catherine Parr. None of the other documents appear to be related to the plan of Church Farm and it is not known why it was drawn or who commissioned it.

The plan is a small scale plan on parchment which is labelled "Plan of the Church House Farm Shrawley". A pencil note on the map dates it to "about 1805" and a note in red in one corner indicates that "The numbers in Red Ink correspond with the numbers in the map made in 1821 by W. Womack". The area shown is presumably land that formed part of the farm. It includes a few fields to the north of Church Lane and a large area to the south that extends eastwards as far as the River Severn. The different land parcels are numbered with at least two sets of numbers in pencil and one in red ink.

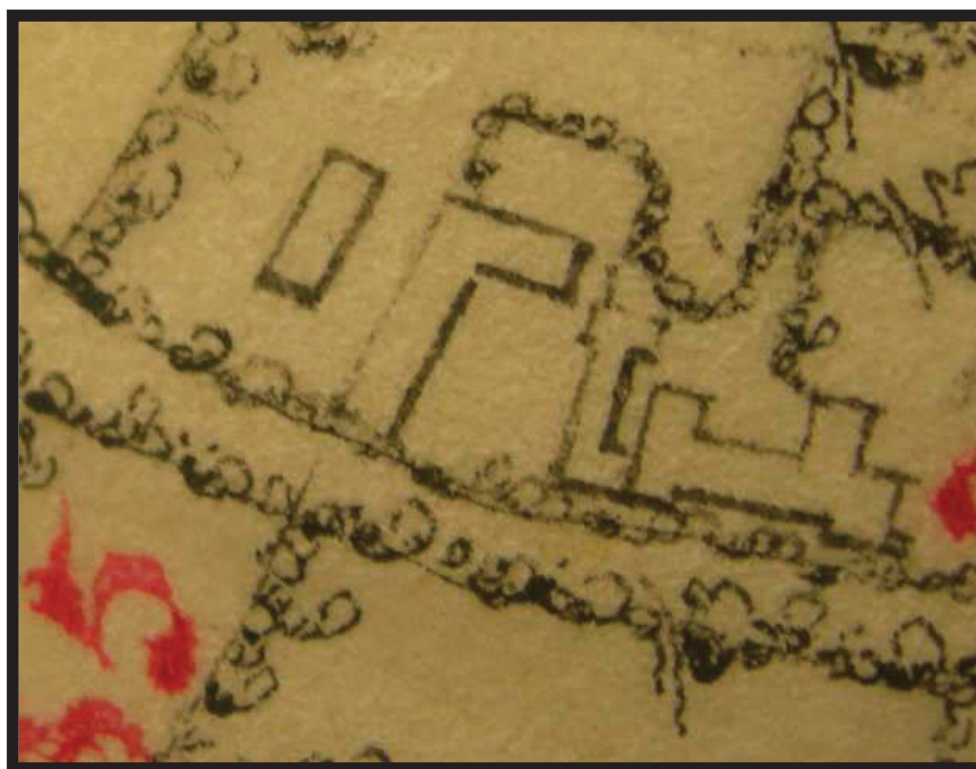
Image 2: Plan of Church House Farm, c.1805 (detail)

The plan of the farm buildings (Image 2) shows the barns and outbuildings to the west and the farm house. The farm buildings are ranged along the north, west and east sides of a large yard with a separate building in the field to the west. The farmhouse appears to be longer from east to west when compared with later plans. A range across the west end of the building forms a cross-wing. A wing projecting from the north side of the building should correspond to the present east wing. Another block on the south east corner does not correspond to features on later maps. The plan of the house is an extremely small and its proportions may be incorrect. It is possible that the block shown on the south east corner could represent a walled garden or yard, rather than part of the house.

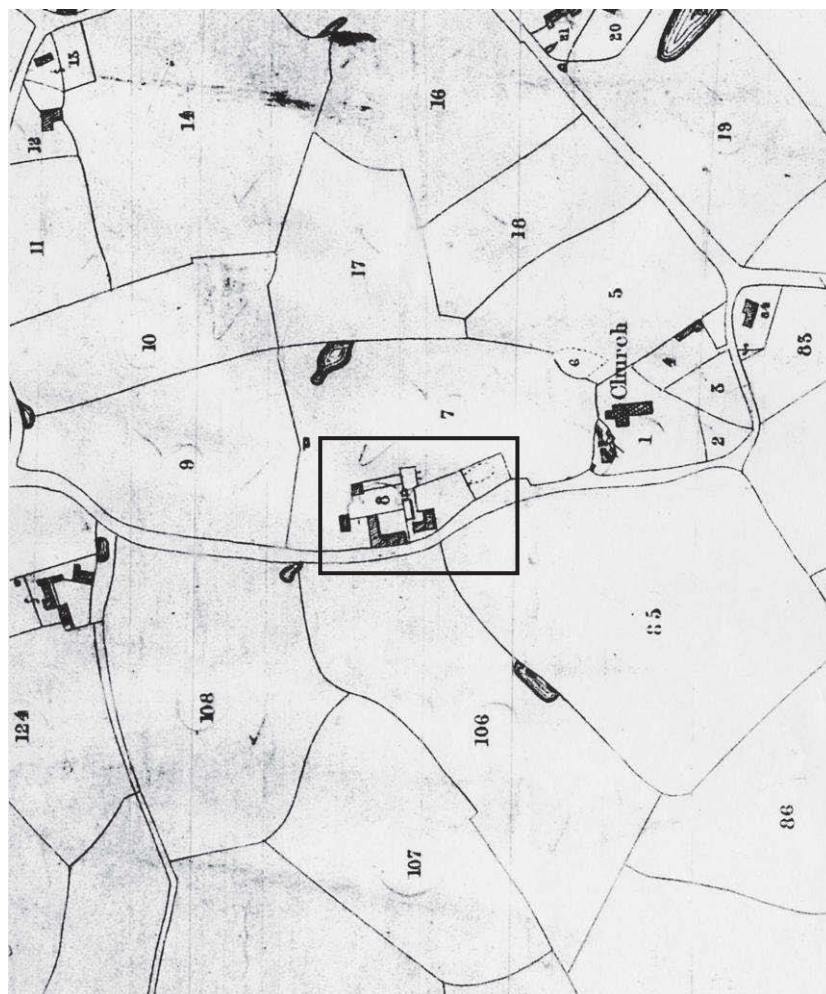
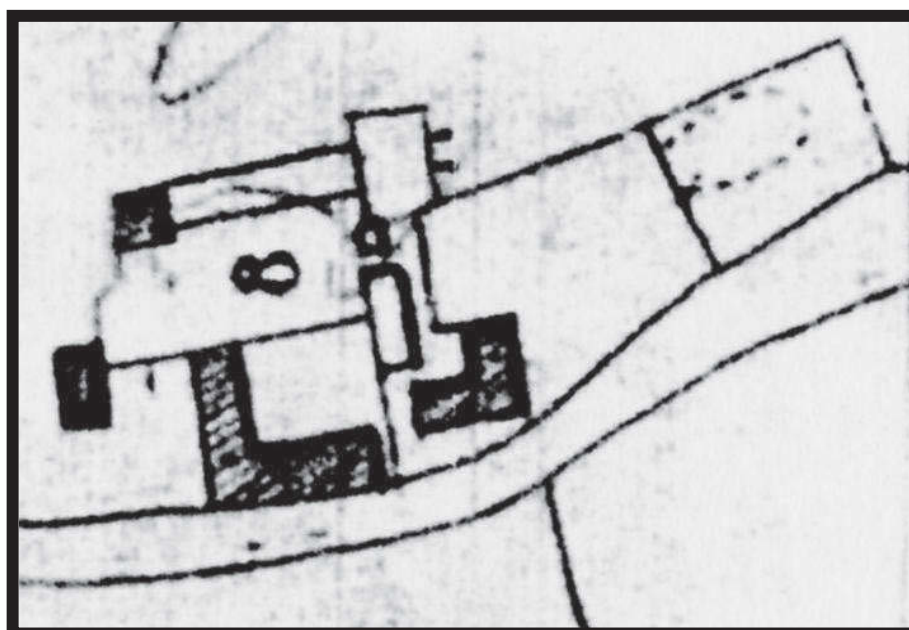
This plan shows considerable changes from the earlier plan. The farm buildings on the north and east side of the yard next to Church Lane had been removed leaving the large barn on the west side of the yard. A new range of buildings closed the south side of the yard. The plan also shows additional enclosed areas or yards extending to the north and north east of the original yard. The changes indicate development and investment in the farm at this time. It is possible that the rearrangement of the yard areas reflect changes in the economy of the farm, possibly related to animal husbandry. The plan of the farmhouse at this time appears as a simple L-shape, corresponding to the south west and east ranges.

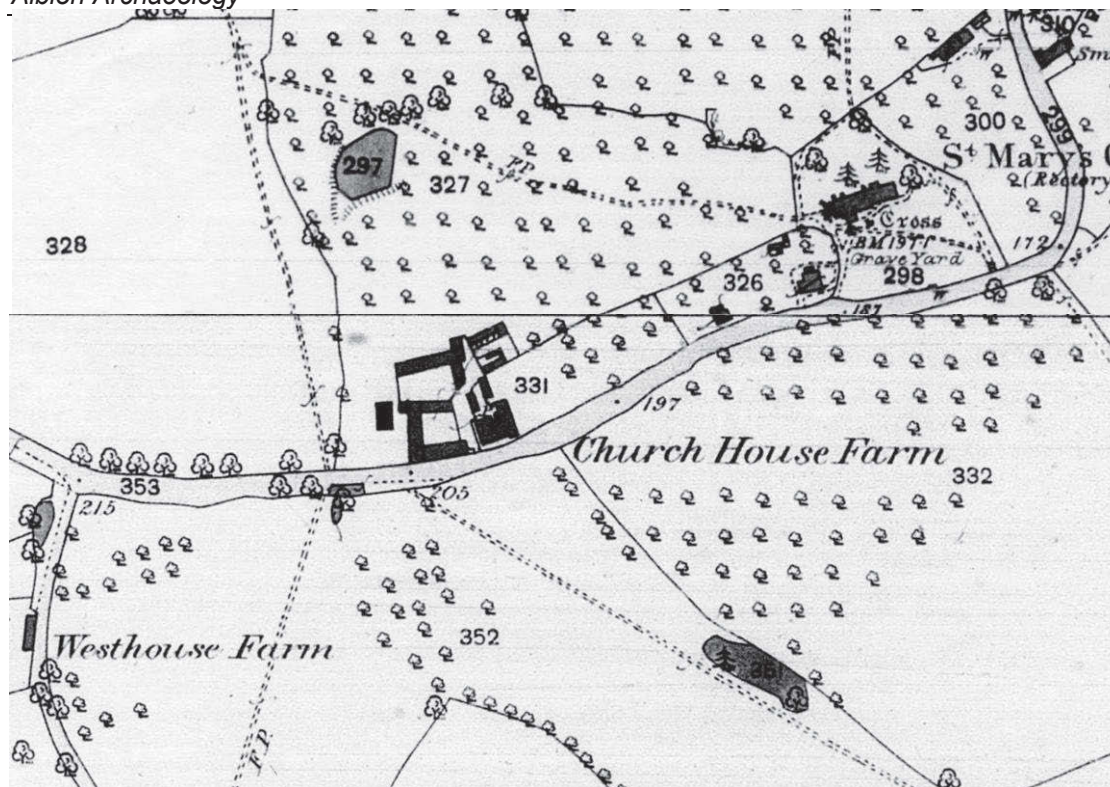
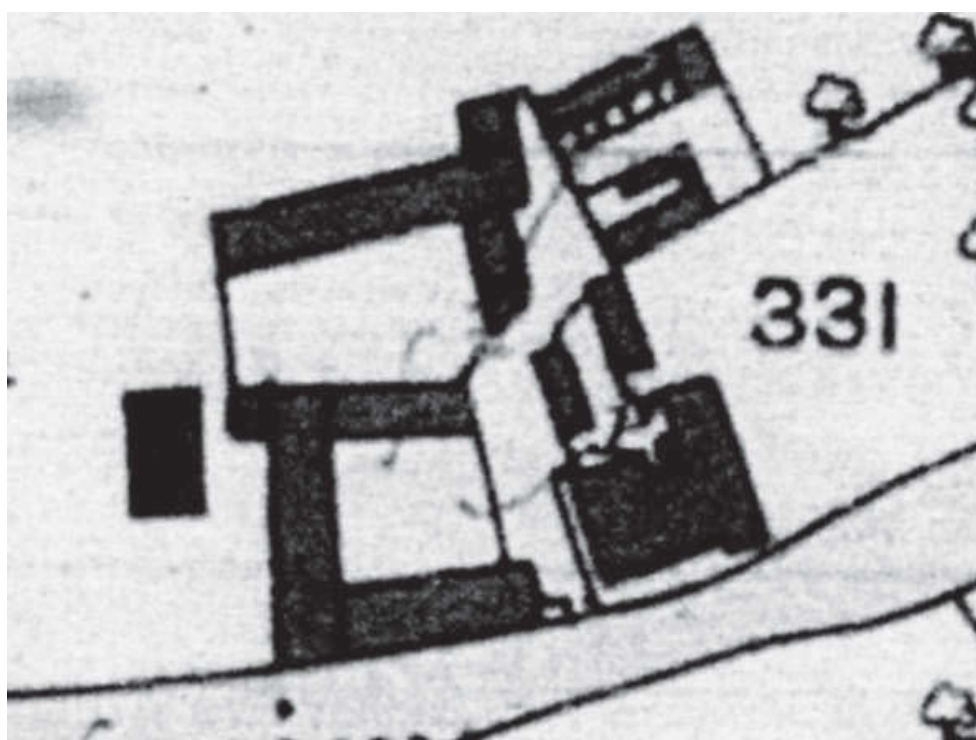
This map shows the land to the north and south of the farm as large orchards. More buildings are shown around the existing yards to the west of the farmhouse and further outbuildings and a yard with what appears to be a piggery has been constructed to the north of to the house. The plan of the farmhouse appears identical to the modern plan with the exception of the northern half of the lobby on the west side of the east range, which appears to be a modern addition.

All of the external building work was carried out using a similar brick laid in Flemish stretcher bond suggesting that it forms part of a single phase of construction. Flemish stretcher bond appears to have first been used in central England where some examples have been found in buildings dating from the sixteenth to the eighteenth century, however the great majority date from the nineteenth (Brian 1975). The same type of brickwork was used in outbuildings located immediately north of the farmhouse (Image 47). These are not shown on the tithe map on 1839 (Image 4) but appear on the Ordnance Survey map of 1884 (Image 6) dating this phase of construction to the later nineteenth century.

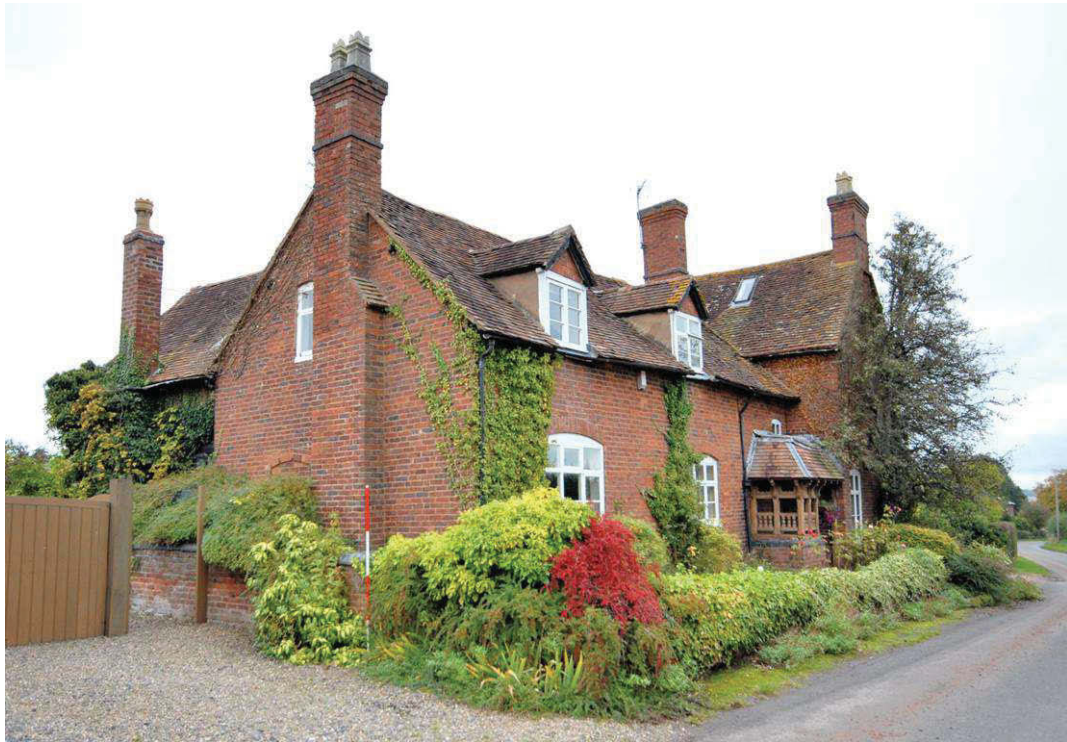
Image 7: Farmhouse from the south west

The south west range has one and half storeys in two bays. This elevation contains two ground floor windows, the main south entrance to the building, a small first floor window and two first floor dormers. The ground floor window openings have segmental brick arches with wooden window frames divided by two mullions, a transom and a glazing bar below. The main entrance is covered by a porch consisting of a low brick wall with an ornate open timber framework supporting a tiled roof. Above the porch a small two light window under a segmental brick arch lights a small first floor roof space. The first floor dormers have tiled gabled roofs with shaped barge boards, brick gables and rendered cheeks. The tiled gabled roof of the south west range has chimneys located towards its eastern end and on the west gable. These have a band of blue brick mid-way up and a corbelled out cap.

The brickwork on this side of the south west range consists of red brick with some dark purplish blue over-fired bricks. The bonding used is a mixed garden bond (rows of alternate header-stretcher separated by courses of stretchers) in the area above the windows with more random bonding in the lower part of the wall.

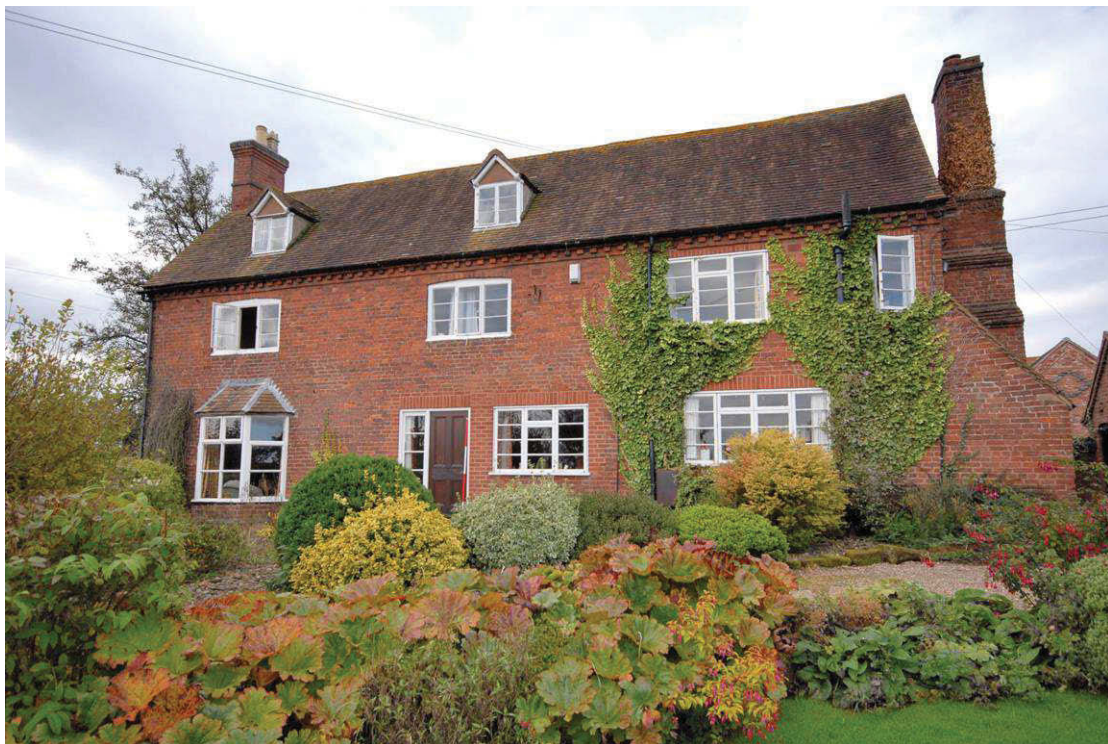
Image 8: Farmhouse from the east

On the ground floor the southern bay contains a canted bay window with a tiled roof. The central bay has a modern door and a three light window with flat soldier arches over both. The eastern bay has a modern four light window with a flat soldier arch. On the first floor the south and central bays have three light windows with segmental brick arches. These windows have not been replaced in the modern period. They have wooden frames with a central metal framed casement hung on external pintle hinges. They also retain external iron window stays attached to the window sill. The two first floor windows in the northern bay are modern replacements with flat soldier arches. These windows were inserted to accommodate the insertion of a small bathroom at the north end of the range and probably replaced a single window matching those in the bays to the south. The attic storey has two small dormer windows in the south and central bays. The dormers have tiled gabled roofs and leaded cheeks. These two light dormers each have an iron framed hinged casement on pintles with an external window stay.

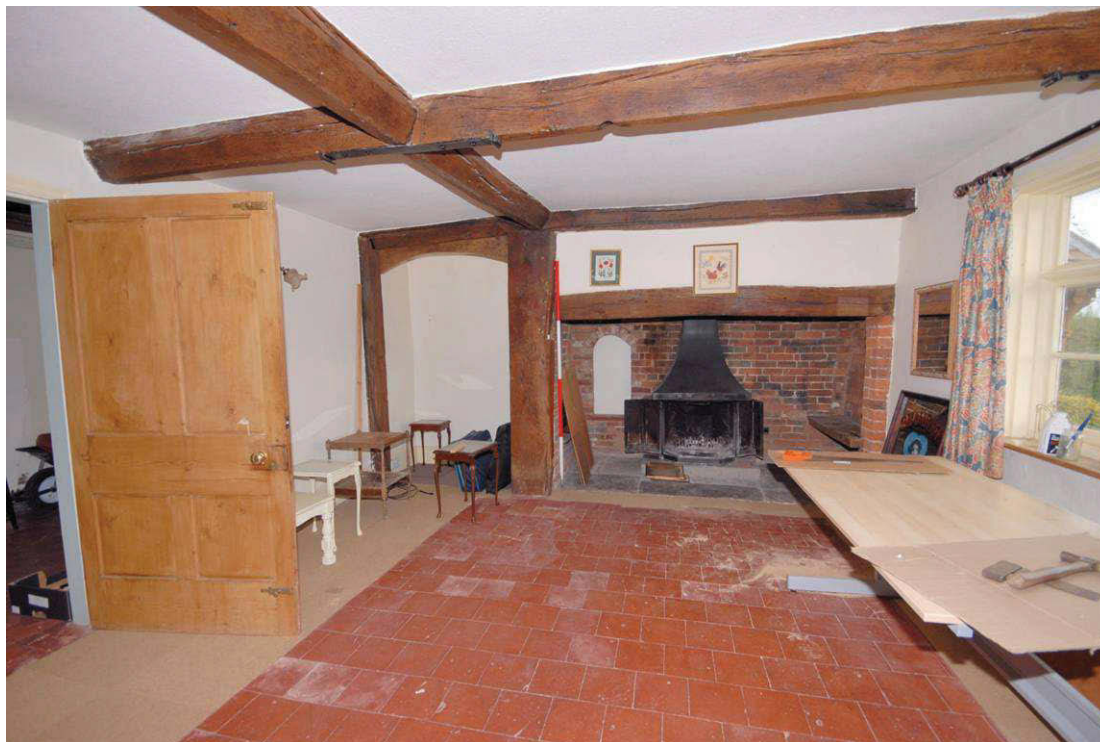
Image 15: Ground floor room 4
Looking east towards fireplace

A heavy post at the east end of the room joined to the transverse beam above with a pegged tenon and therefore appears to form an integral part of the frame. The post has three peg holes and large infilled mortise for a missing timber in its south side.

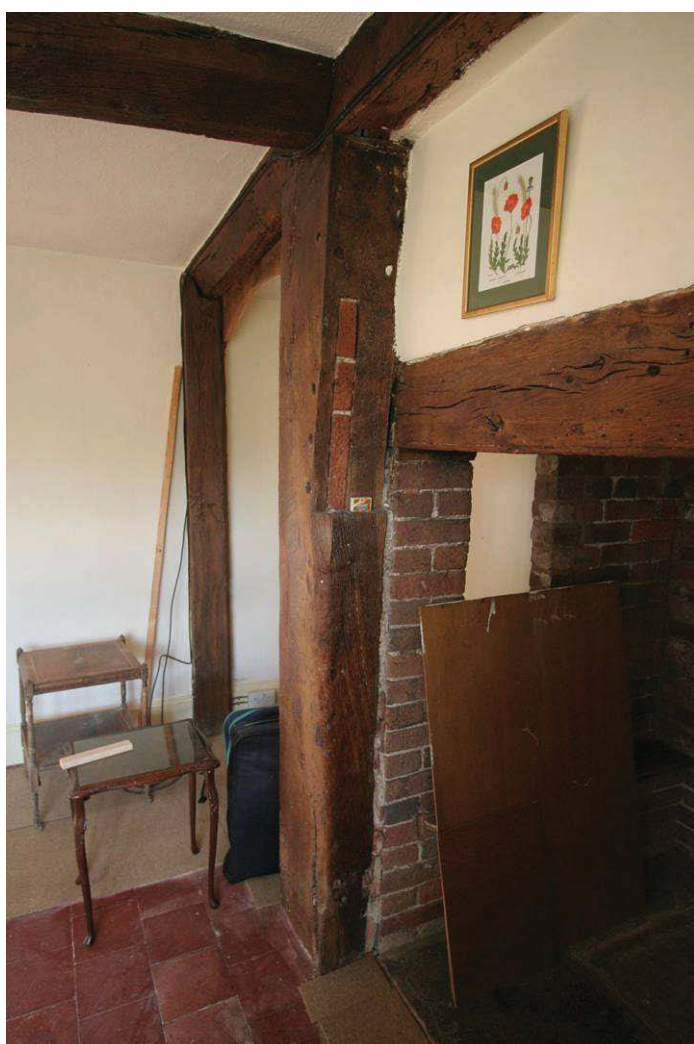
Image 16: Ground floor room 4:
detail of fireplace

The area in the south east corner is filled with a large inglenook fireplace. This contains some evidence of recent repairs or alterations. The brickwork in the sides has been reworked, particularly the pier on the left hand side. The bressumer has a shallow moulding along its bottom edge and peg holes for a possible mantelshelf on the front. It is likely that the existing fireplace post-dates the original construction of this part of the house, the bressumer is not connected to the timber frame in front which has an empty mortise for an earlier beam in this location.

Shows post with redundant mortise (filled with brick) for a possible earlier bressumer. Existing bressumer and brick fireplace visible immediately behind

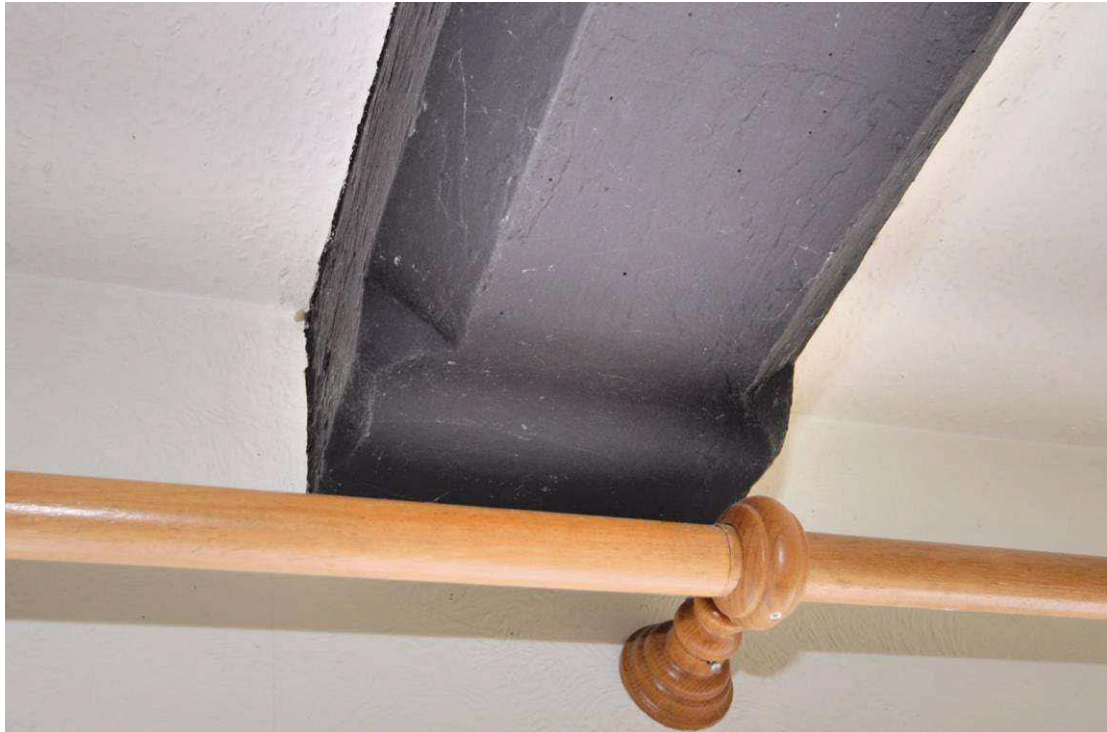
Image 26: First floor: detail of stop on chamfered beam
Western end of the beam which is visible in the corridor adjacent to room 1

26). The western stop is visible in the adjacent corridor. The beam here contrasts with the plain beams found in rooms 2 and 3 on this floor probably indicating a higher status function for this room.
