LUTON - DUNSTABLE BUSWAY BEDFORDSHIRE

STRUCTURAL RECORDING

Document: 2010/71

23 September 2010

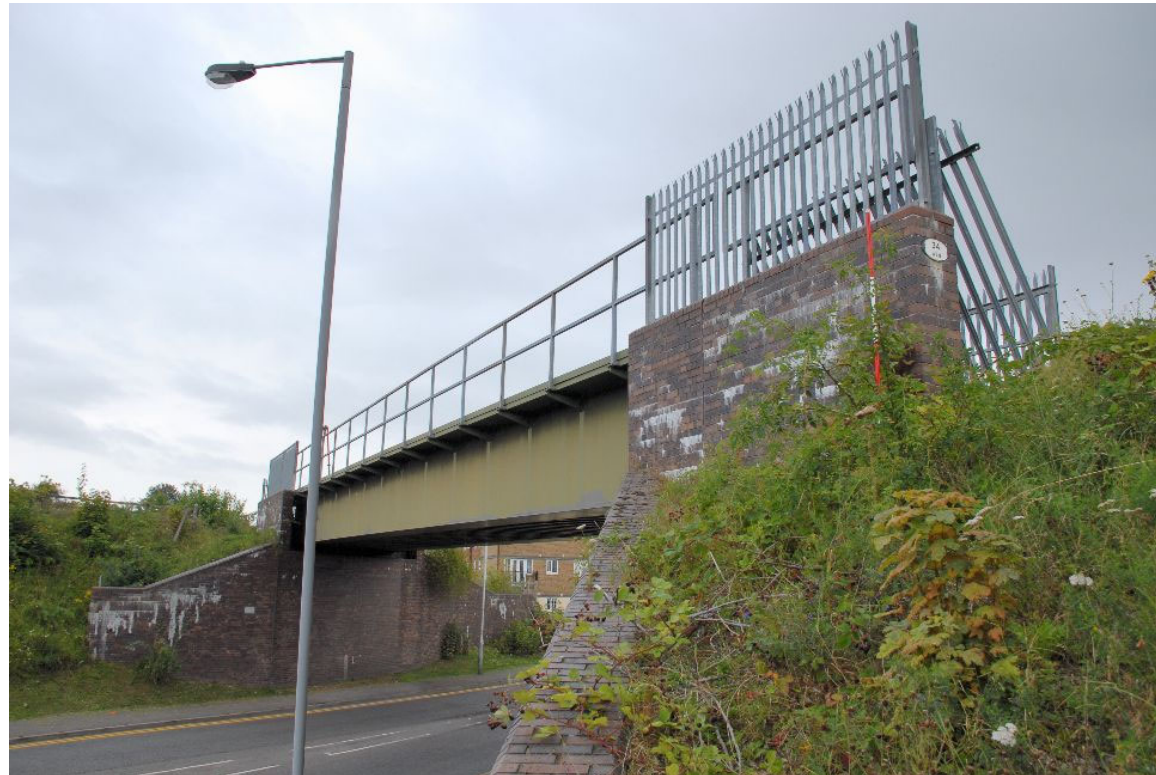
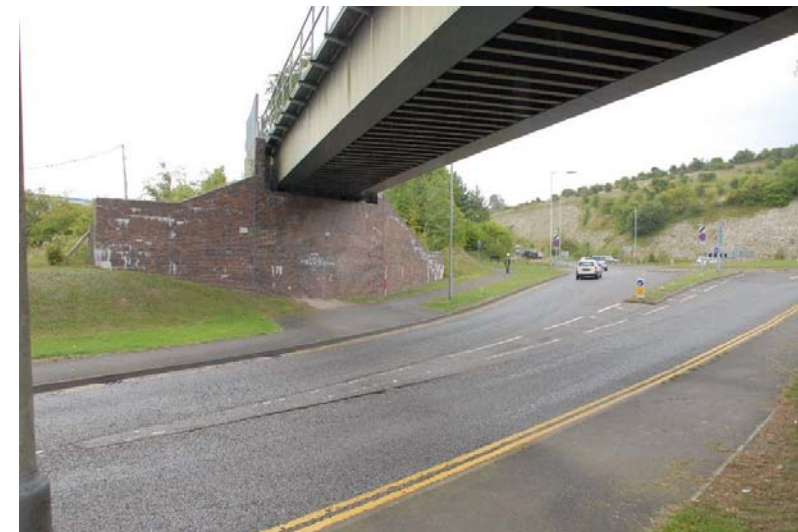
Plate 2 (a, b, c, d):
Bridge 34 – Skimpot road.

Bridge 34 spans Skimpot Lane, Dunstable and originally consisted of cast iron girders on abutments, wing walls and a parapet made of brick (Figures 5a and 5b). The original girders were riveted. It is possible that they were replaced at a later stage by a simple steel girder, as the girder in the photograph (Figure 5b) are clearly different to the illustrated riveted girder in Figure 5a. The photograph 5b must have been taken during maintenance and repair works on the bridge.

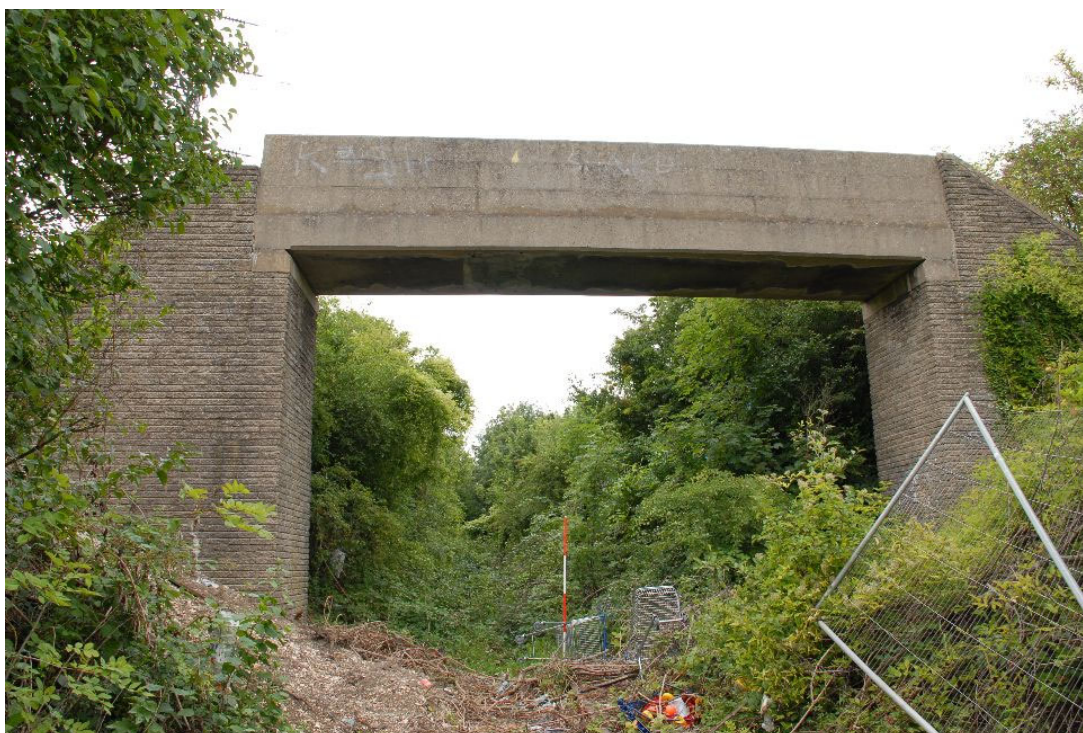
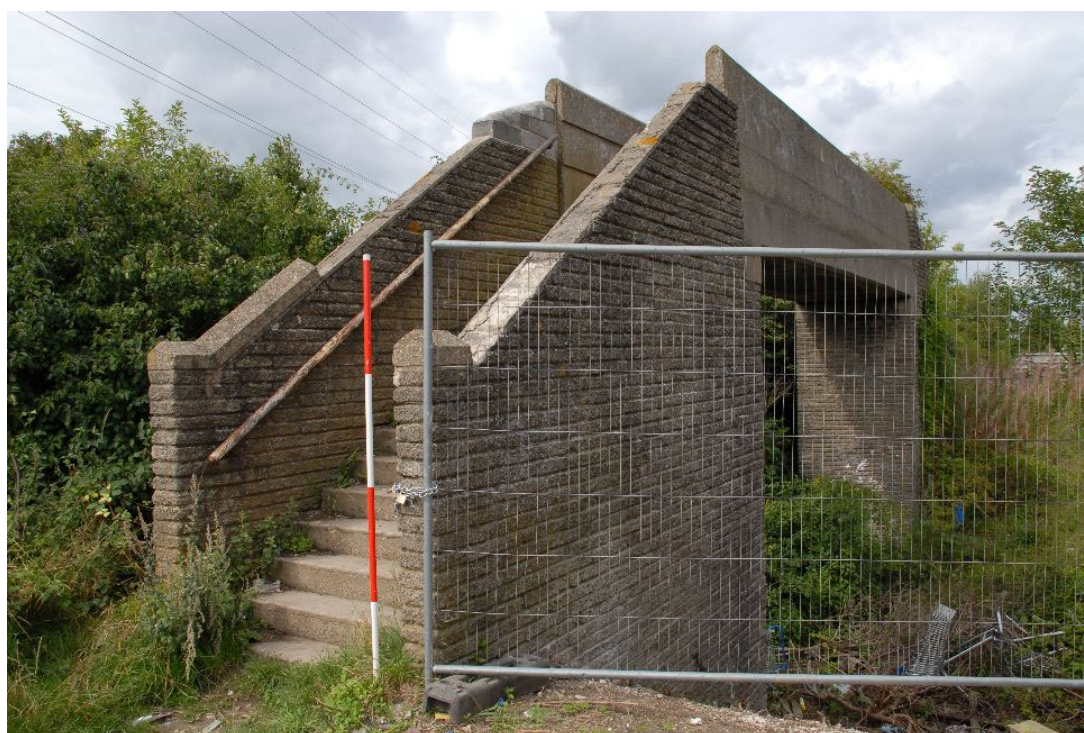
The parapets either side of the steps leading up to the footbridge have smoothed saddleback concrete coping and a simple tubular steel handrail. Much of the coping has been broken away and in one area, at the top of the steps, repaired with concrete breeze blocks.

Plate 3: Bradley Road footbridge. East-facing elevations.
Cross ref with Figure 6.

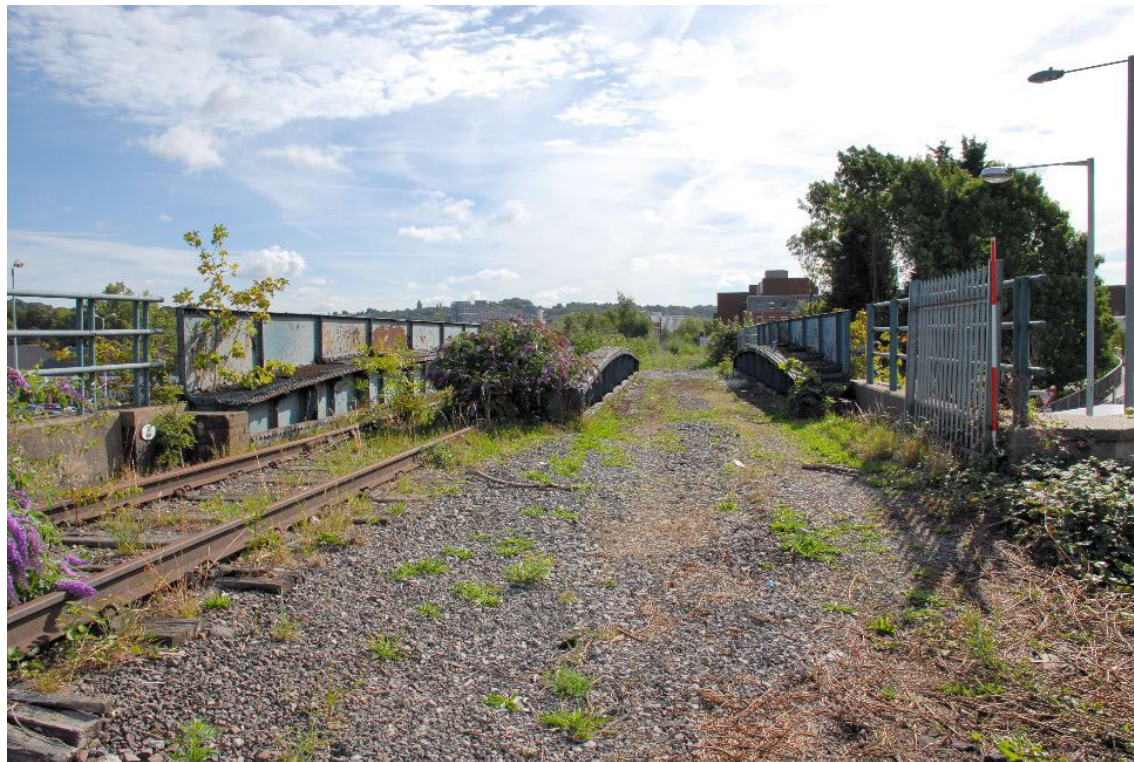
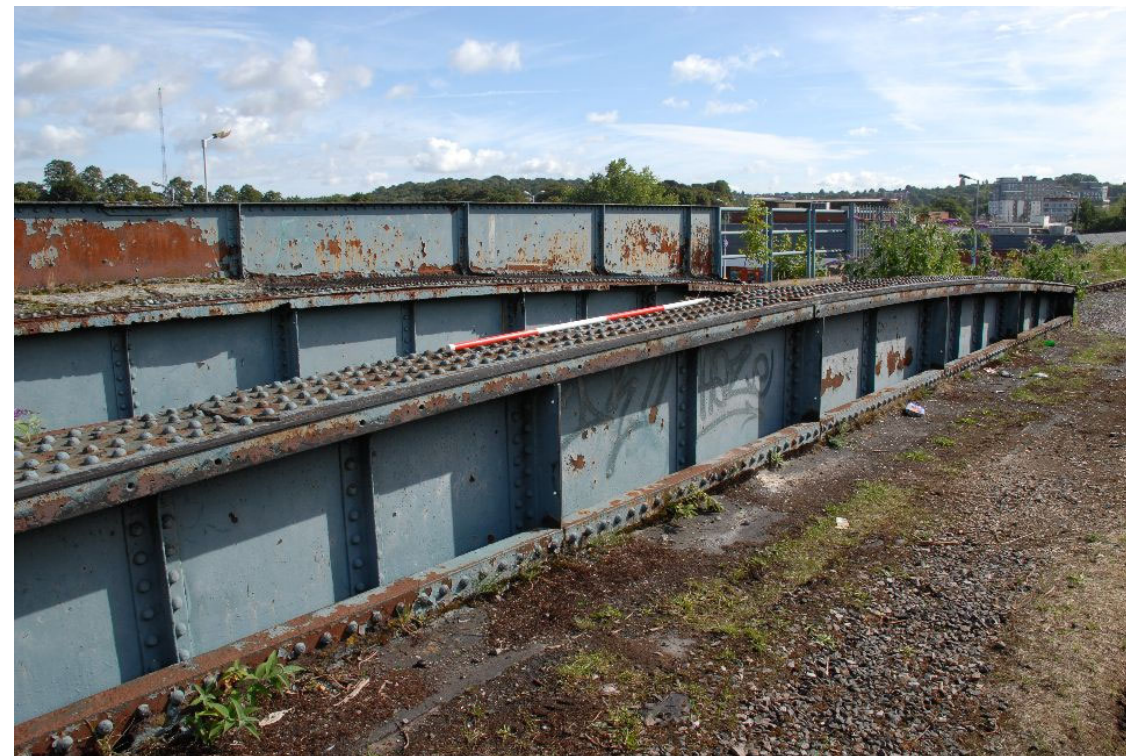
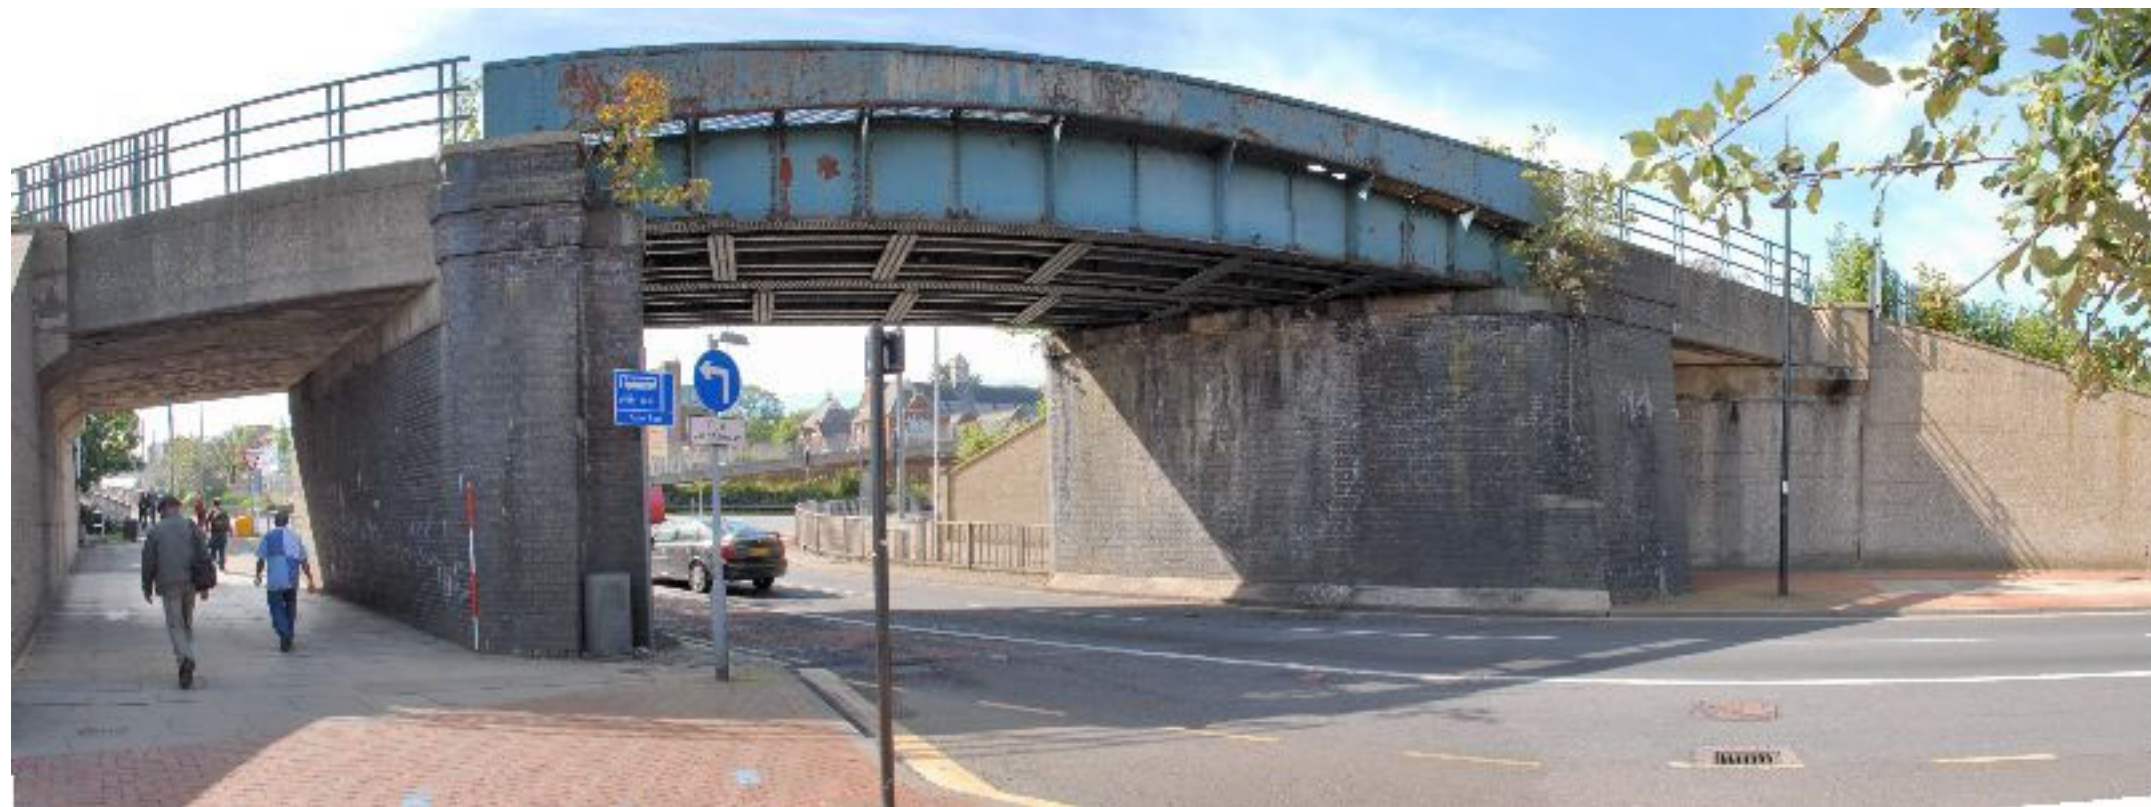
Plate 6 (a, b, c):
Bridge 31, Dunstable Road, Luton.

Bridge number		21
Location		Dunstable Road, Luton
Date		1898 – extended 1961
Plans	Current	3104119.TIF, 3104120.TIF
	Original	3104121.TIF, 3104122.TIF
Photo refs		6096-6137
Figure refs in this report		Figure 9, Plate 6
Construction		Brick piers, concrete abutments, steel superstructure.
Conditions		Partially overgrown but accessible. Bad repair.

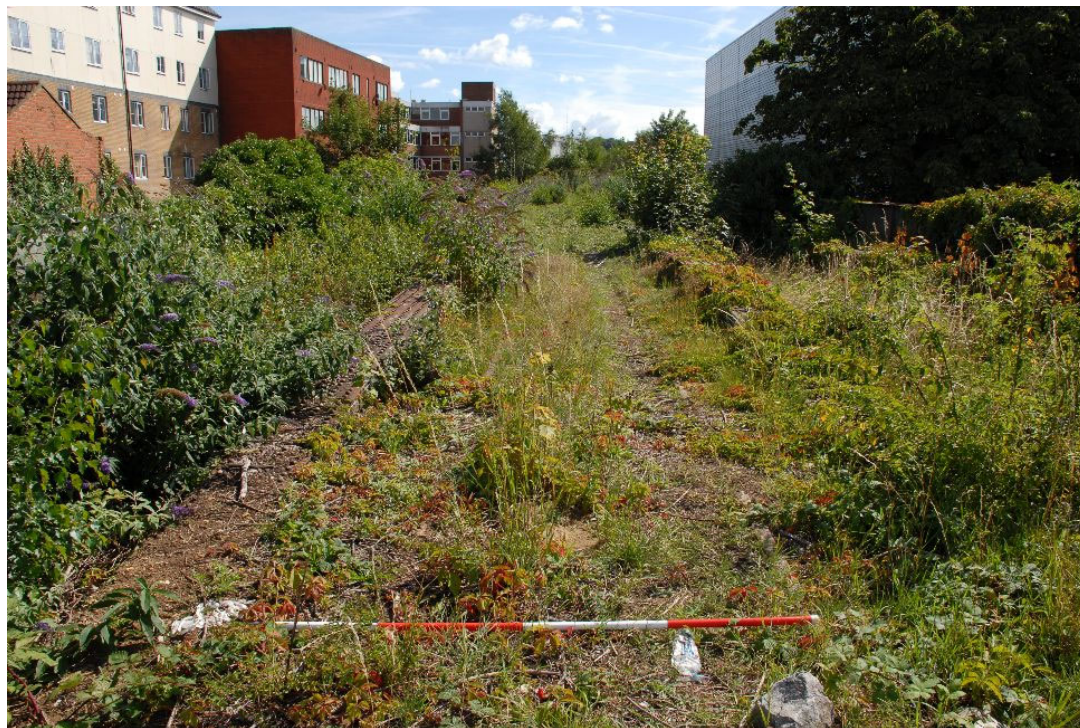
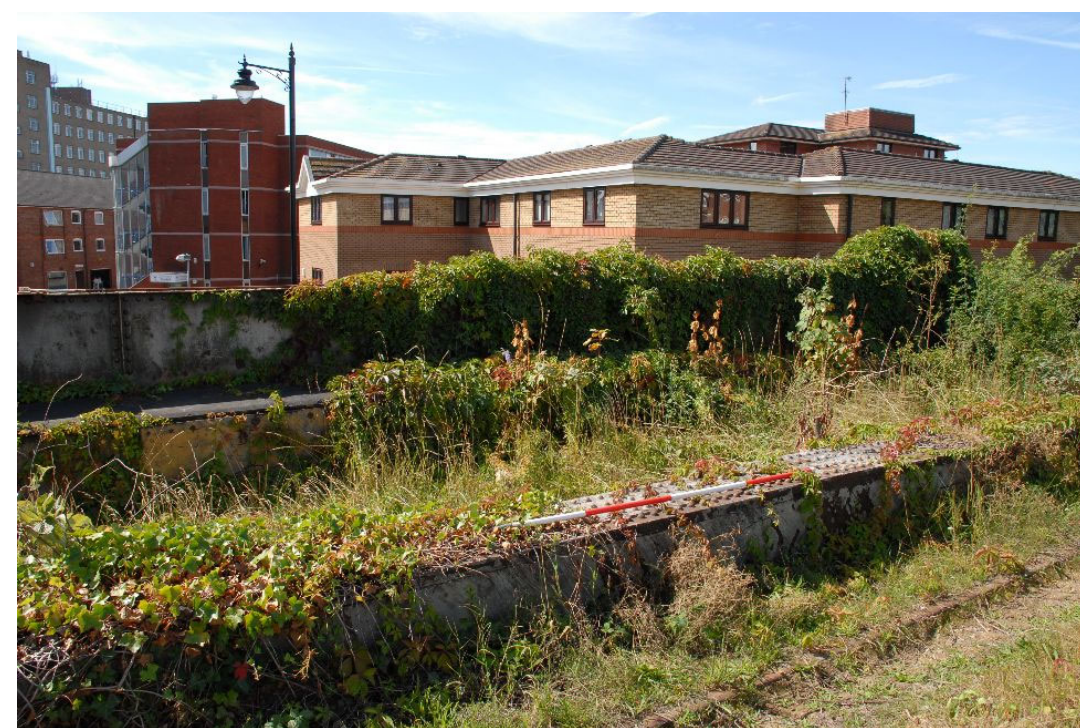
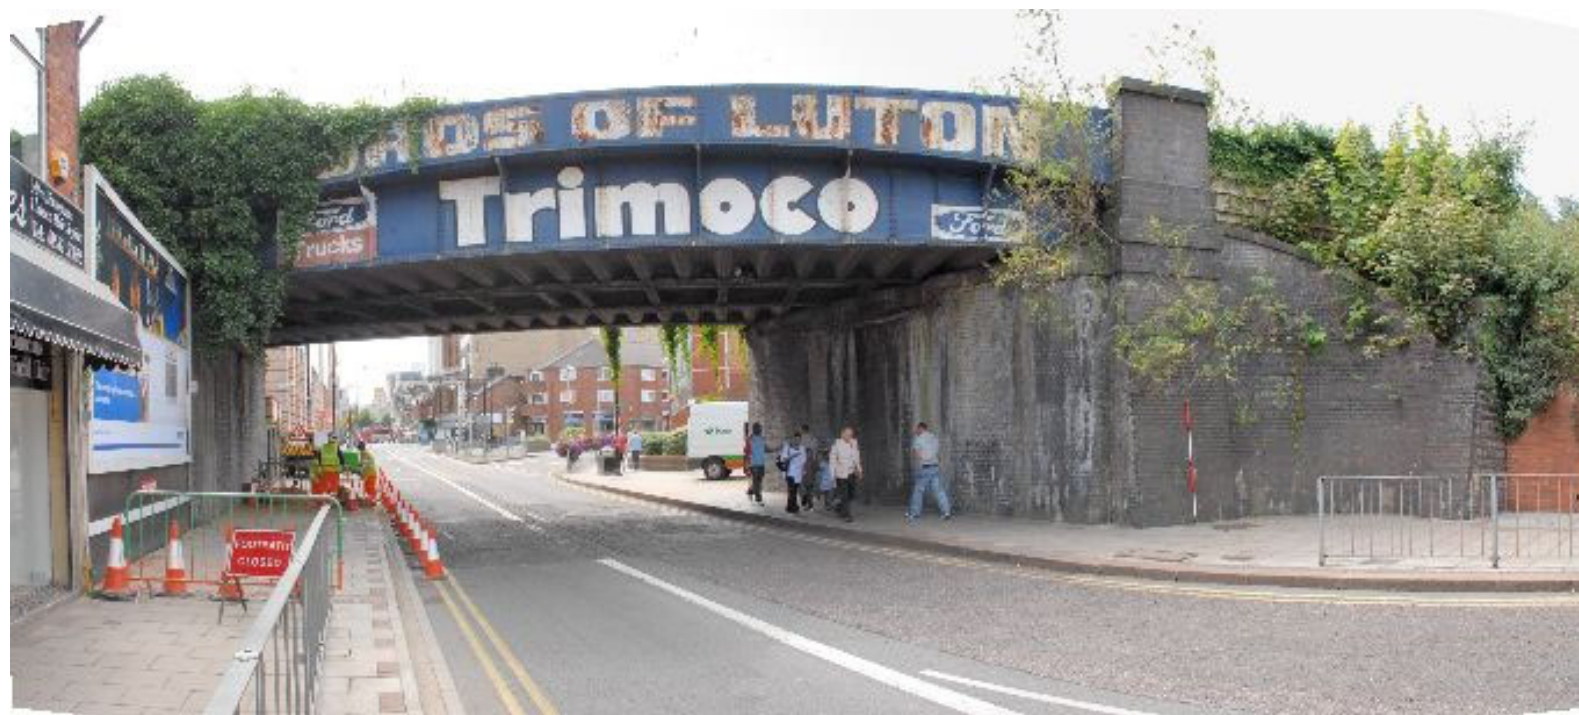
Plate 8 (a, b, c, d):
Bridge 30 – New Bedford Road, Luton.

use as the single permanent way after the double line was no longer required, was repaired with new steel girders and new concrete deck slabs, leading to a raise in the rail bed by about 2".

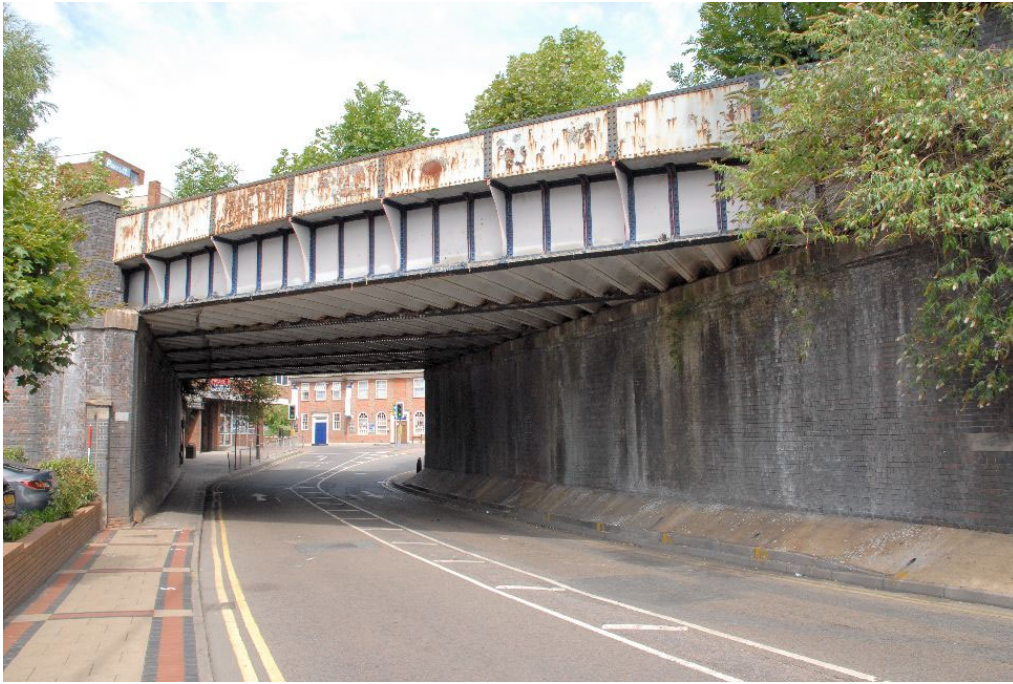
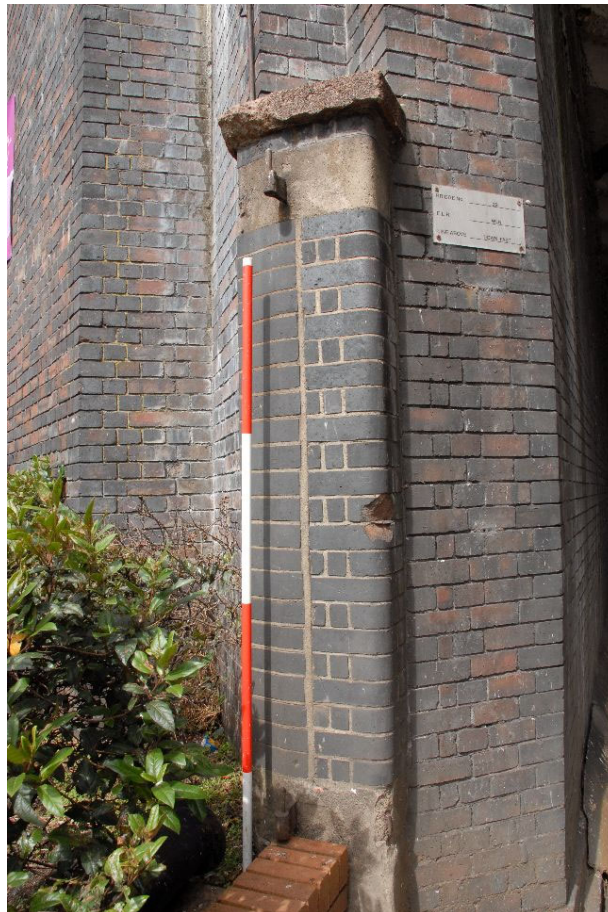
Bridge 29 was considerably widened in 1898 when the Luton – Dunstable line was partially extended to two tracks (section 2.2). The Guildford Street bridge was altered not only to take the two tracks but three sidings as well, making it the widest bridge in Luton (Woodward 1994, 20). It seems likely that whatever remained of the older, narrow bridge must have been almost completely replaced by the new wider structure.

Plate 9: Bridge 29 – Guildford Street, Luton.
South-facing elevation (top); detail of gate at south-facing elevation (bottom).

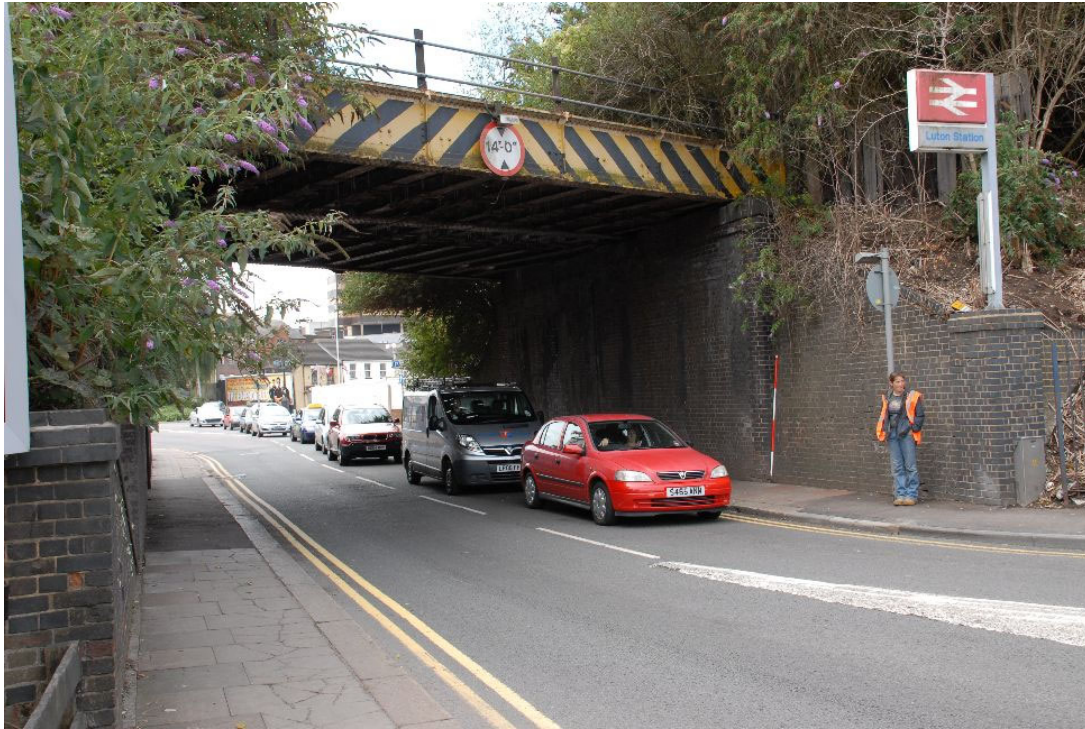
The bridge consists of brick abutments and has a simple riveted steel girder span with steel cross girders and a two-bar steel handrail. It is painted with black and yellow diagonal hazard lines as it has a low clearance of 14'0".

Plate 10: Bridge at Church Street, Luton.
North-facing elevation (top); bridge railway bed (bottom left), underside
of bridge with drain pipe removed (bottom right).

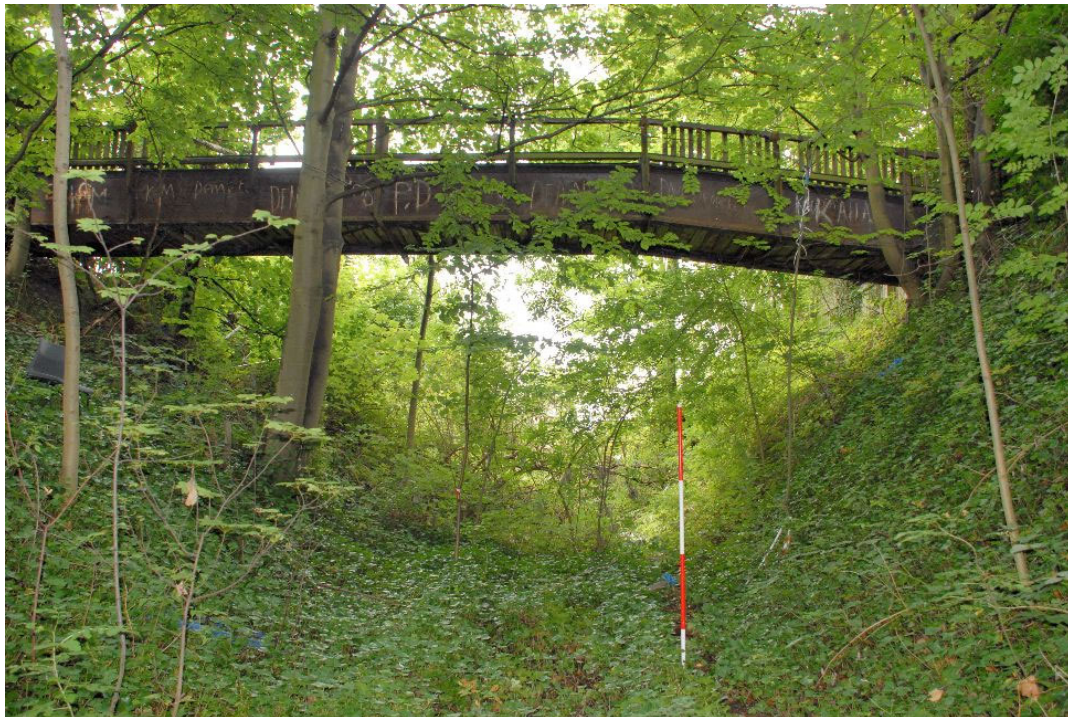
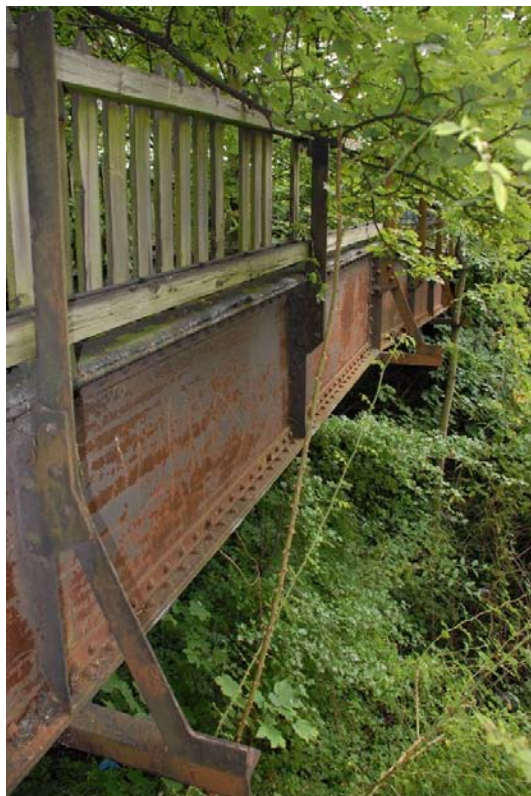
The bridge span consisted of two main, riveted steel-plate girders with isolated thin steel cross beams which provided a frame for the timber decking of the bridge. The bridge parapet was made up of simple timber “garden fence” construction which is of a recent date. The bridge is in a dilapidated condition and many of the upright pointed planks of the timber parapet have been torn off and lie scattered across the bridge deck.

Plate 13: Second footbridge to the east of Crawley Green Bridge. West-facing elevation

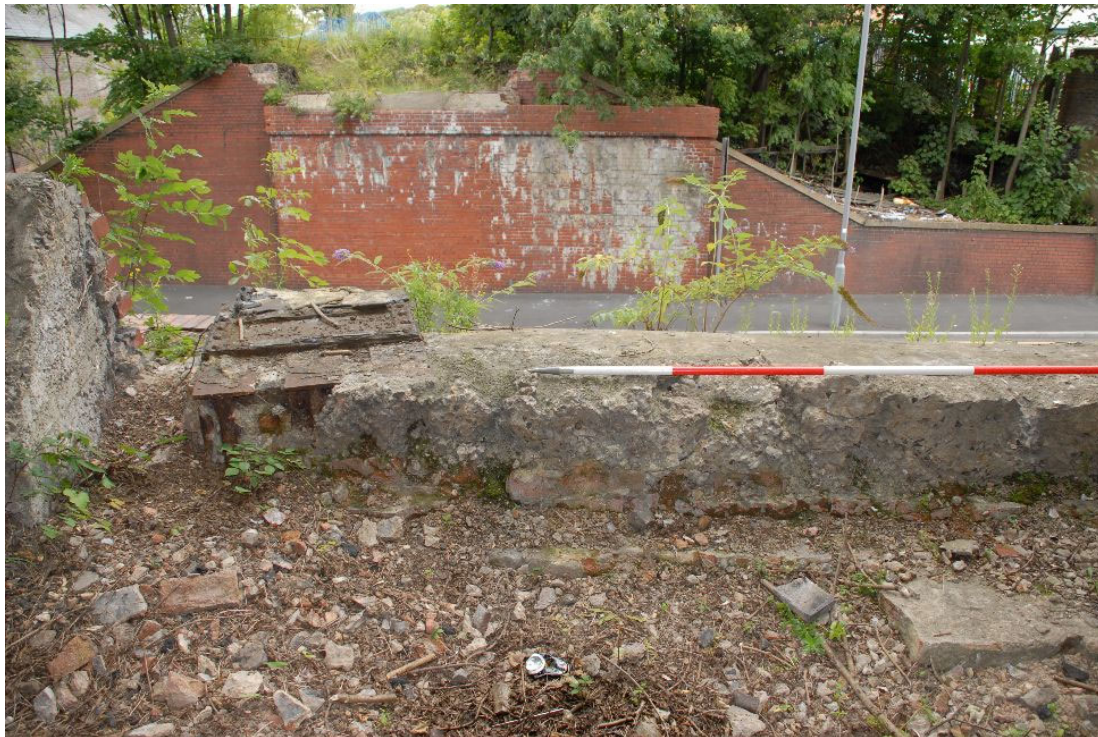
The bridge at Kimpton Road was removed in the 1960s, allegedly to provide better access to the Vauxhall motor works as its headroom was too low to allow large lorries to pass underneath it (Pat Byrne pers comm). What survives are the brick abutments either side of the road, the broken-out tops of which have been secured with concrete. Riveted steel pads that supported the removed steel spans are still in place.

Plate 15: Remains of demolished bridge over Kimpton Road, Luton.
Looking north-west

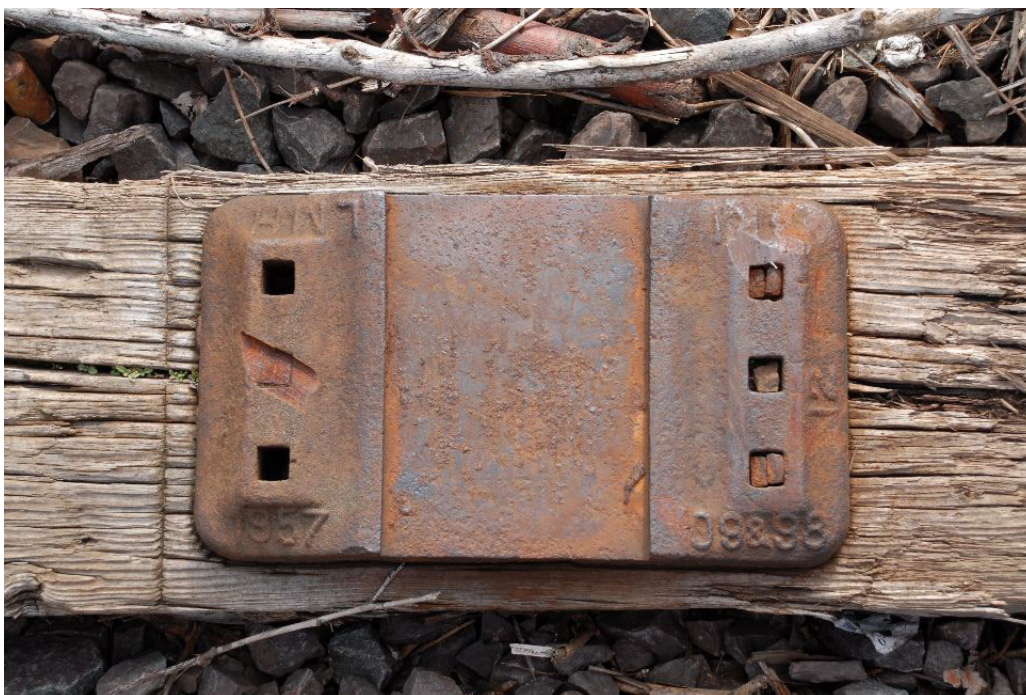
Most of the track between Luton and Dunstable dates from the early to mid 20th century. Track chairs bearing dates from 1957 onwards have been recorded along the line (Plate 19). As railtracks have to continuously maintained and replaced it cannot be expected that any older sections of track could have survived.

Plate 19: Track chair with a date of 1957

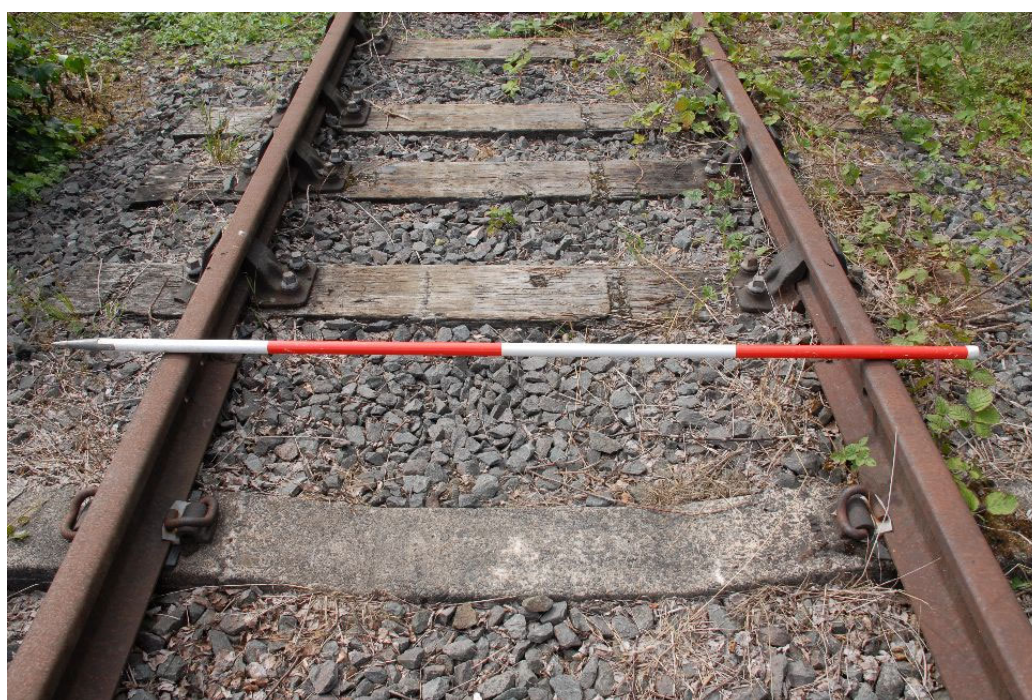
Even after the line was closed for passenger traffic in 1965 the line was being adapted for goods traffic and sections repaired and replaced. Traffic to the cement works actually increased in the late 1960s and new wagons, capable of holding much heavier loads began to appear. For some time 100-ton oil wagons were using the route between Luton and Dunstable and in order to carry their load a section of the track near Blows Down and also along Luton Town football ground, was replaced with heavy duty concrete sleepers (Plate 20) (Woodward 2008).

Plate 20: Change from wooden to concrete sleepers
