**CHESTNUT COTTAGE AND BARNs  
COMMON STREET  
RAVENSTONE**

**HISTORIC BUILDING RECORDING**

Document: 2014/133

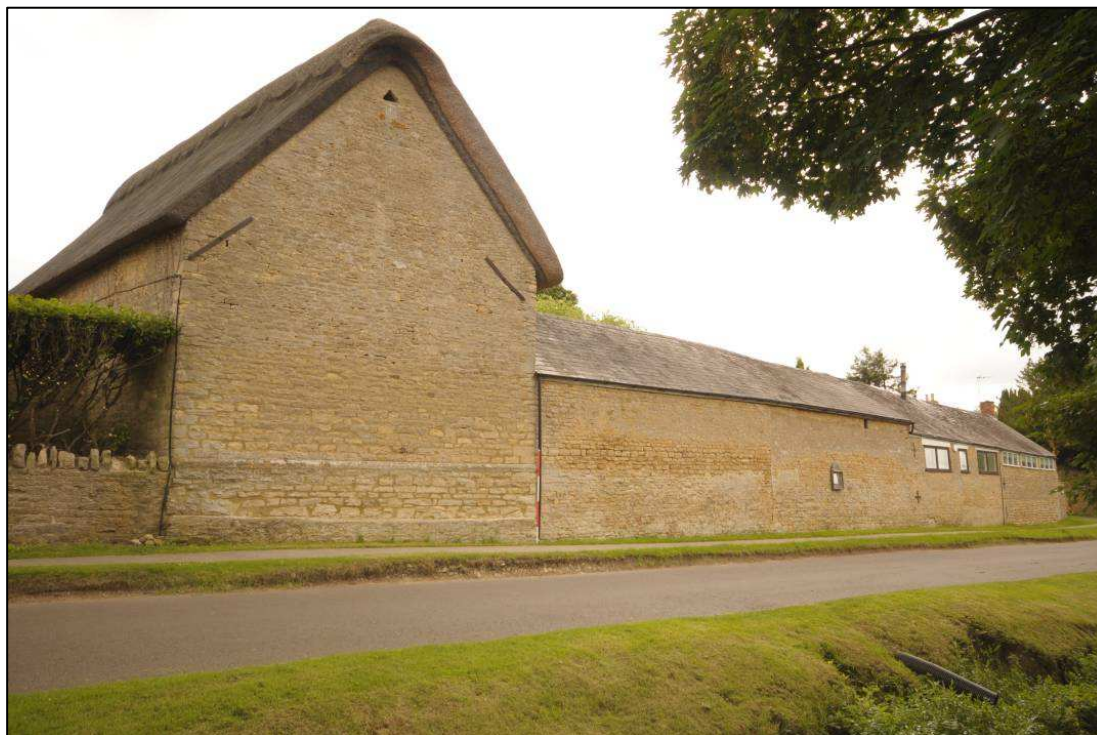
The walls forming the western elevation are in coursed limestone rubble (image 1). Separate sections of masonry correspond to the stable/tack room and the shelter shed. Straight joins mark the point where the shelter shed abuts the north range and

Image 1: West range and west end of barn seen from street

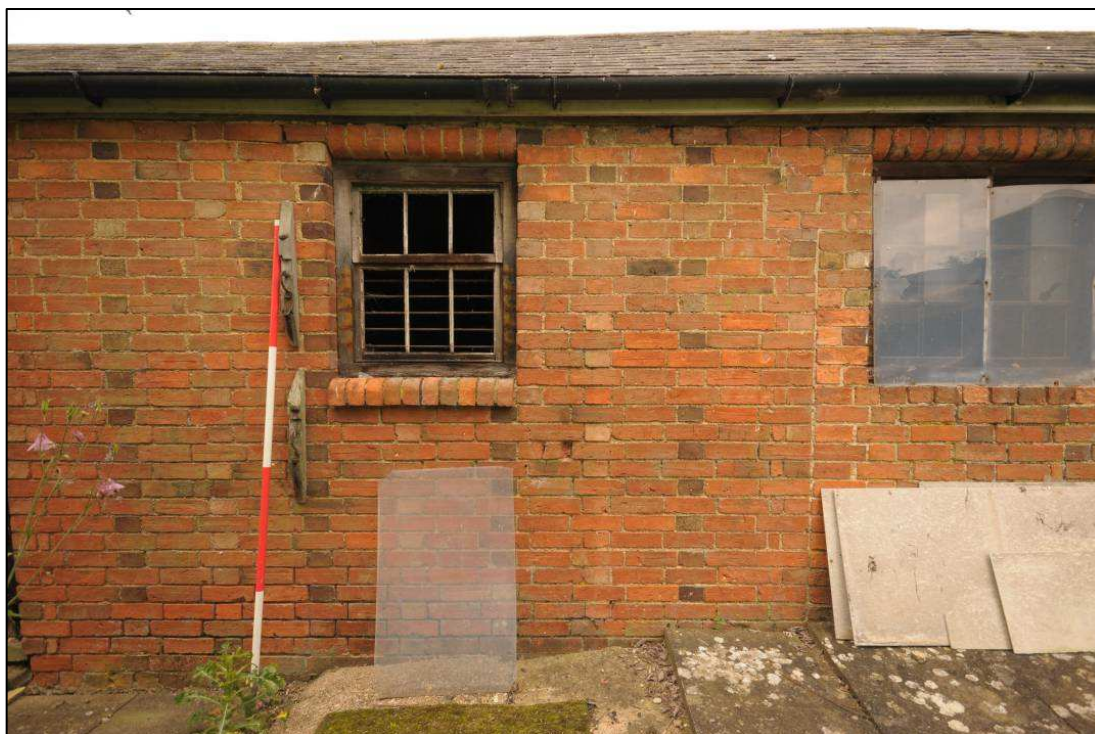
The brickwork for the stable and the tack room are separated by a straight join (image 7). Regular bonding and closers to the south of the join contrast with more irregular brickwork to the north, indicating that the brickwork of the tack room is a later addition. The tack room has three-light window with two timber mullions and a central opening casement. The brickwork adjacent to the right-hand side of the window contains a straight join, possibly connected with the construction of the window.

Image 7: West range: showing east wall of stable and tack room (shows straight joint between brickwork of stable and tack room on the right)

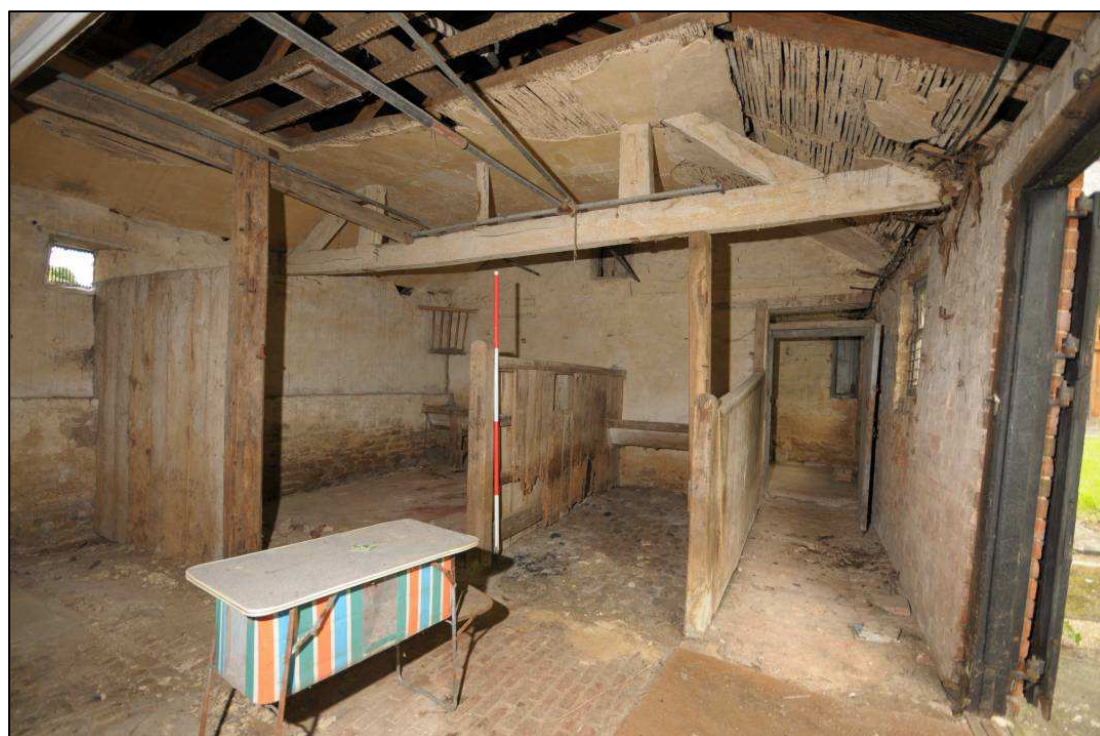
A three-bay roof is supported by two queen post trusses (images 8 and 9). The remains of a lath and plaster ceiling remain over the northern bay. It is attached to the underside of the Queen-post strainer beams with sloping soffit sections at the east and west sides of the room. Surviving joists in the central bay and the plastered soffit which extends along the whole west side of the stable indicate the ceiling formerly extended across all three bays.

Image 8: West range: Interior of stable looking north-west

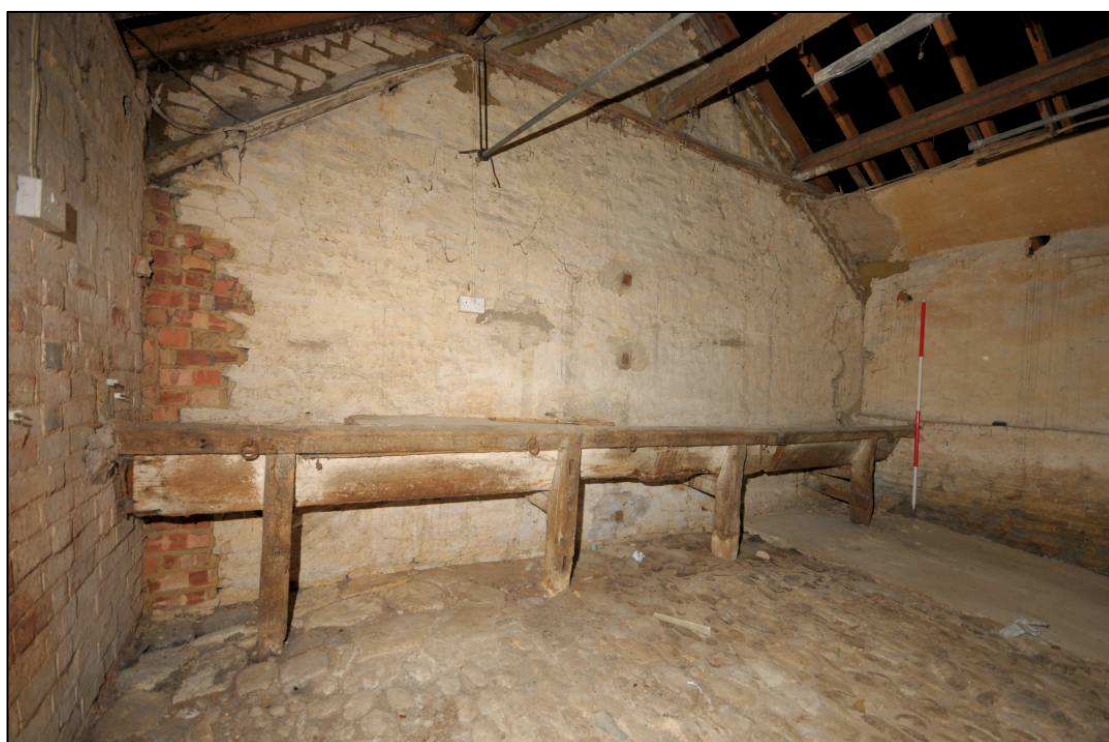
Modern repairs or additions to the building comprise concrete repairs or replacement in parts of the floor. A section of the south wall has been repaired with Fletton brick at its east end (image 10).

Image 10: West range: Interior of stable looking south-west

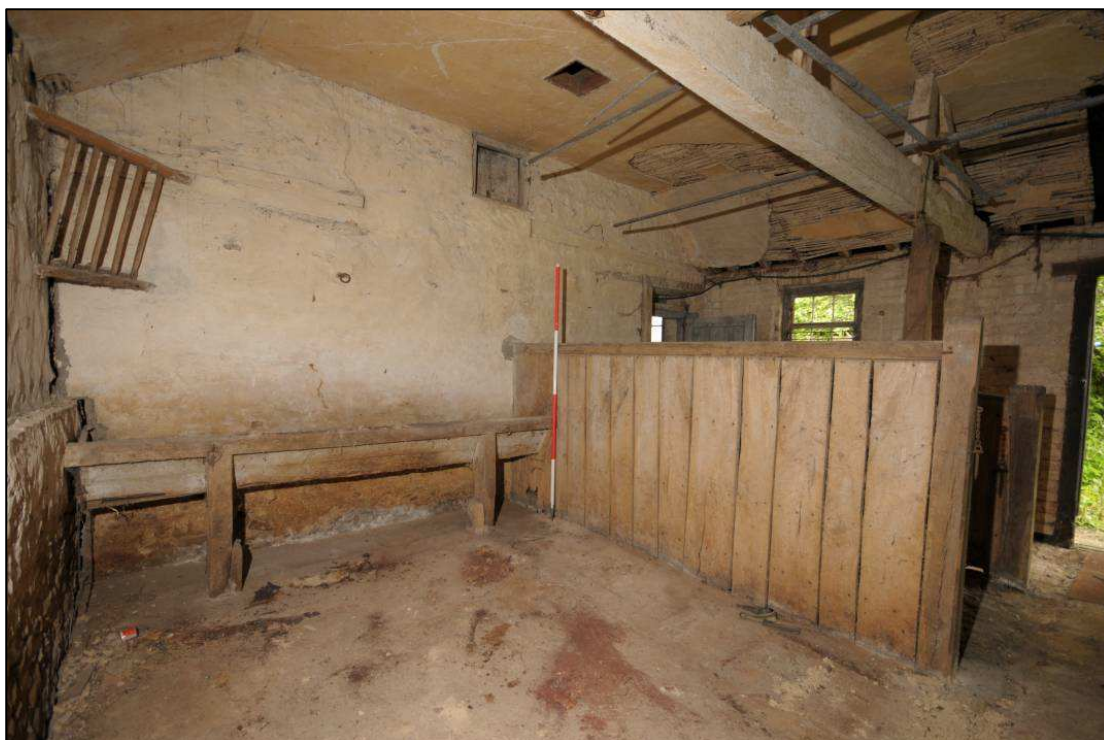
The south side of the stable is open. Three stall dividers in the north of the stable are used to form a 1.5m wide stall towards the east side of the stable and an approximately square area in the north-west corner. Both sides of the easternmost stall divider and the eastern side of the adjacent divider are covered in vertical tongue and groove boards which are planed and have a beaded moulding on one edge. The remainder have rough sawn vertical boards. Hinge pintles and a staple fitted to the posts on the ends of the stall dividers indicate that a gate was fitted to form a loose box in the north-west corner of the room.

Image 11: West range: Interior of stable looking north-east  
(Loose box with feed trough and hay rack)

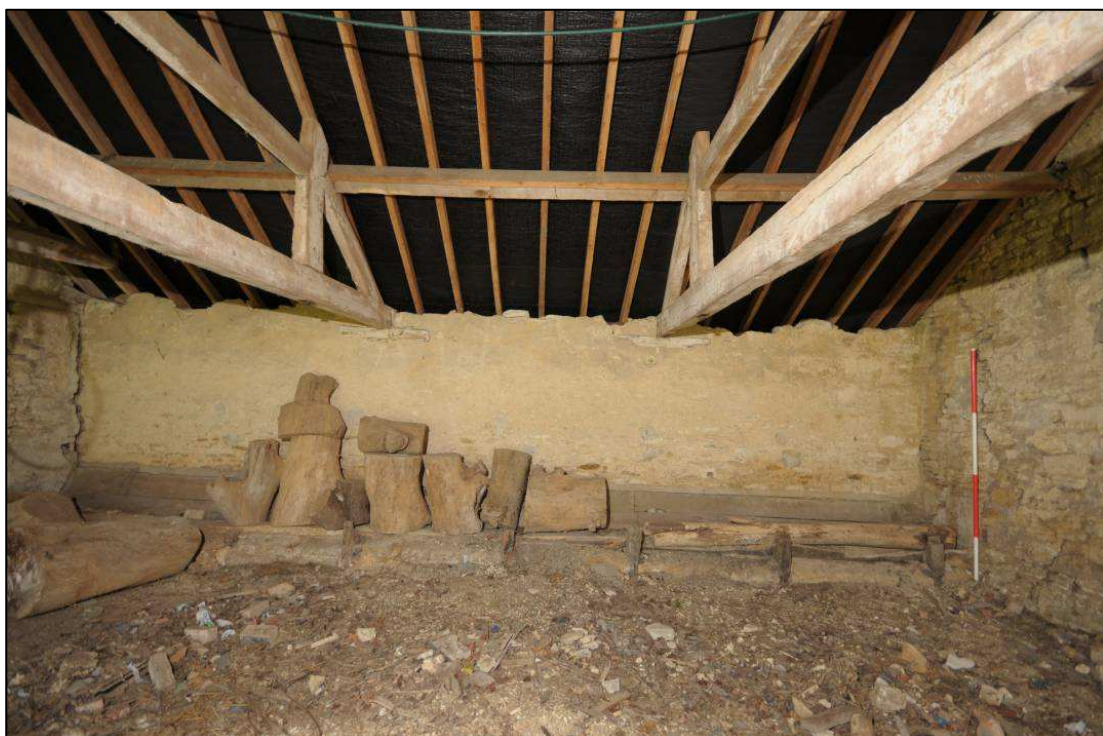
The remains of feed trough extend along the west wall (images 22 and 23). The base of the trough is set just above floor level with a fillet of cement across the gap. The front of the trough was supported by seven posts; however the lining and rail are missing.

Image 22: West range: Shelter shed, west wall

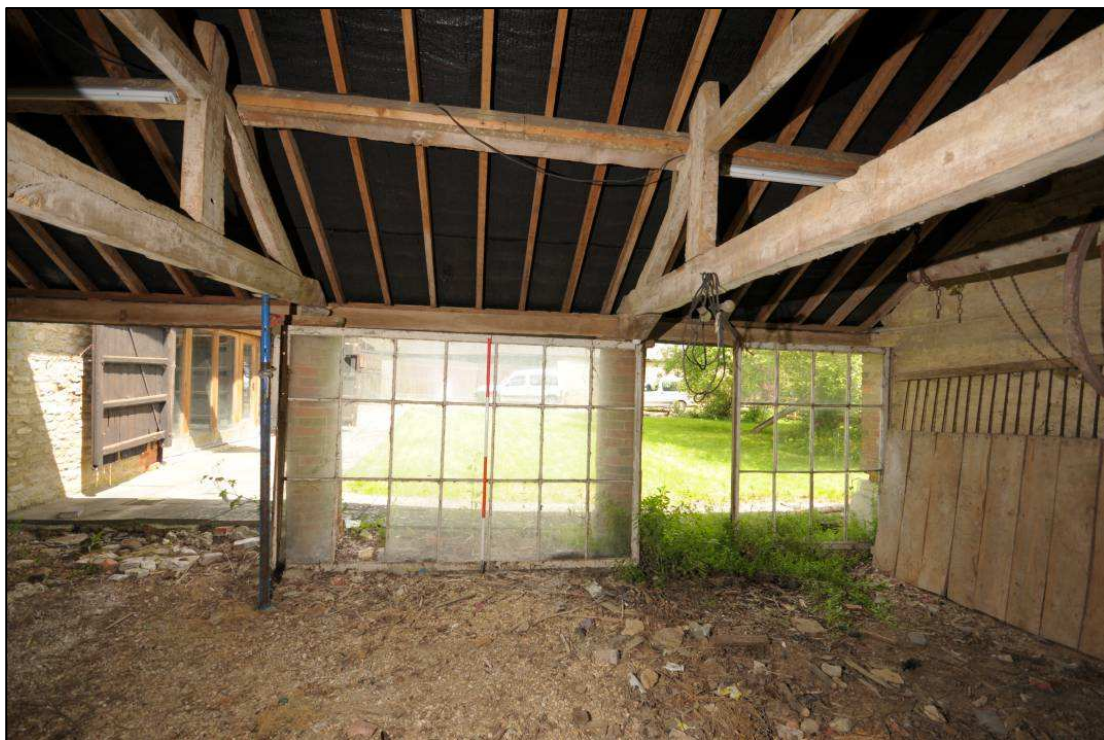
The three-bay roof is supported by queen post trusses matching those in the rest of the western range (images 25 and 26). The wood retains traces of white wash. The upper part of the roof (the common rafters and ridge plate) is a modern replacement.

Image 25: West range: Shelter shed, east side

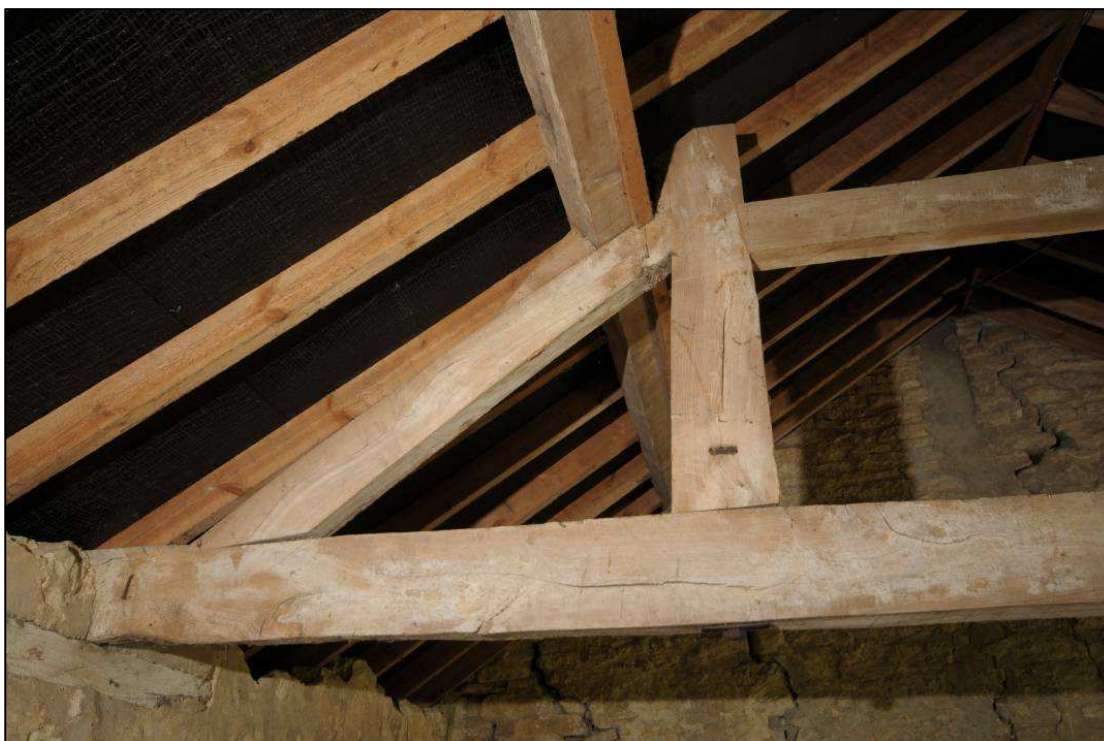
Image 26: West range: Shelter shed, detail of queen post roof truss

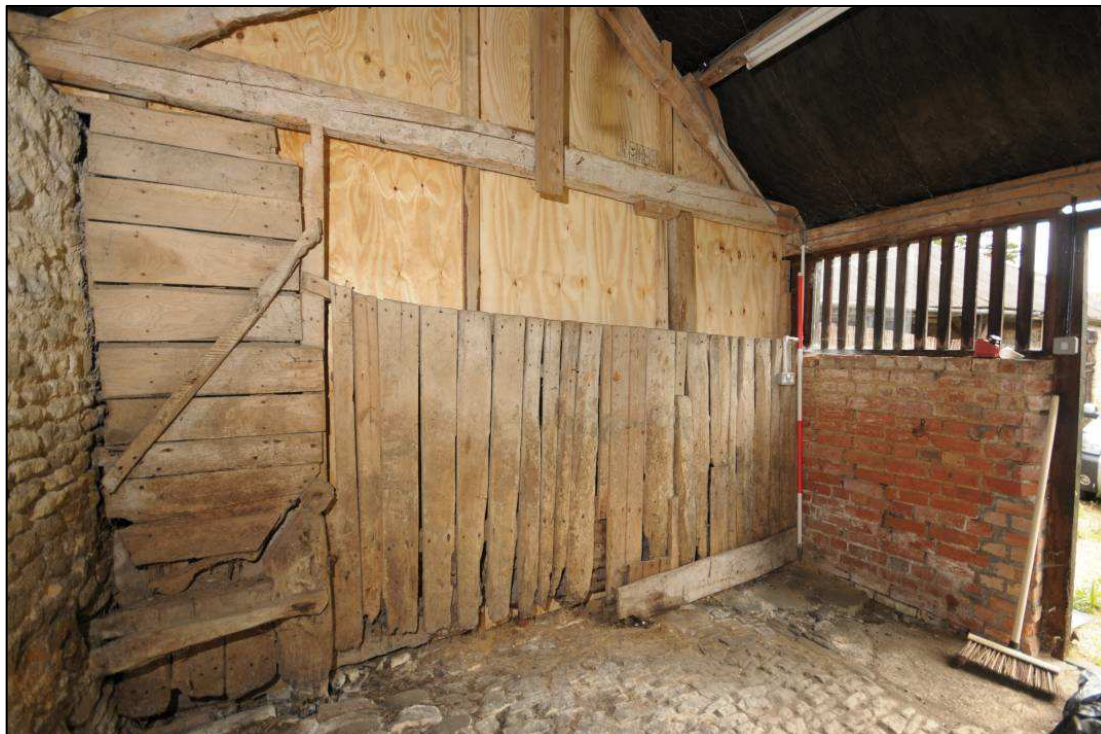
Image 36: North range: Stable, looking south-east

(Remains of feeding trough visible at lower left-hand side)

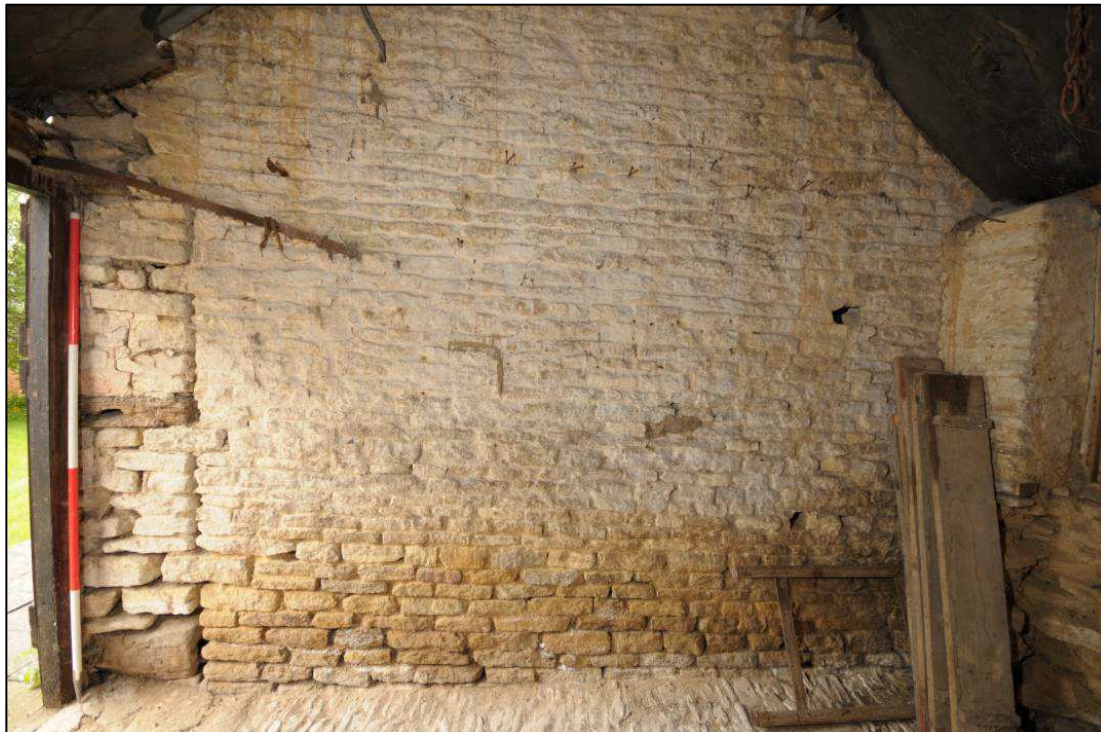
Image 38: North range: Stable, west wall

(Straight join visible towards left-hand side of wall)
