**WOOD BURCOTE MANOR FARM
PLOTS 3 & 4
WOODBURCOTE
NORTHAMPTONSHIRE
HISTORIC BUILDING RECORDING**

Document: 2015/51
Version: 1.0
April 2015

Albion Archaeology Project Code: WB2558
Northamptonshire Archaeological Resource Centre entry number: ENN107938
Oasis reference: albionar1-210391

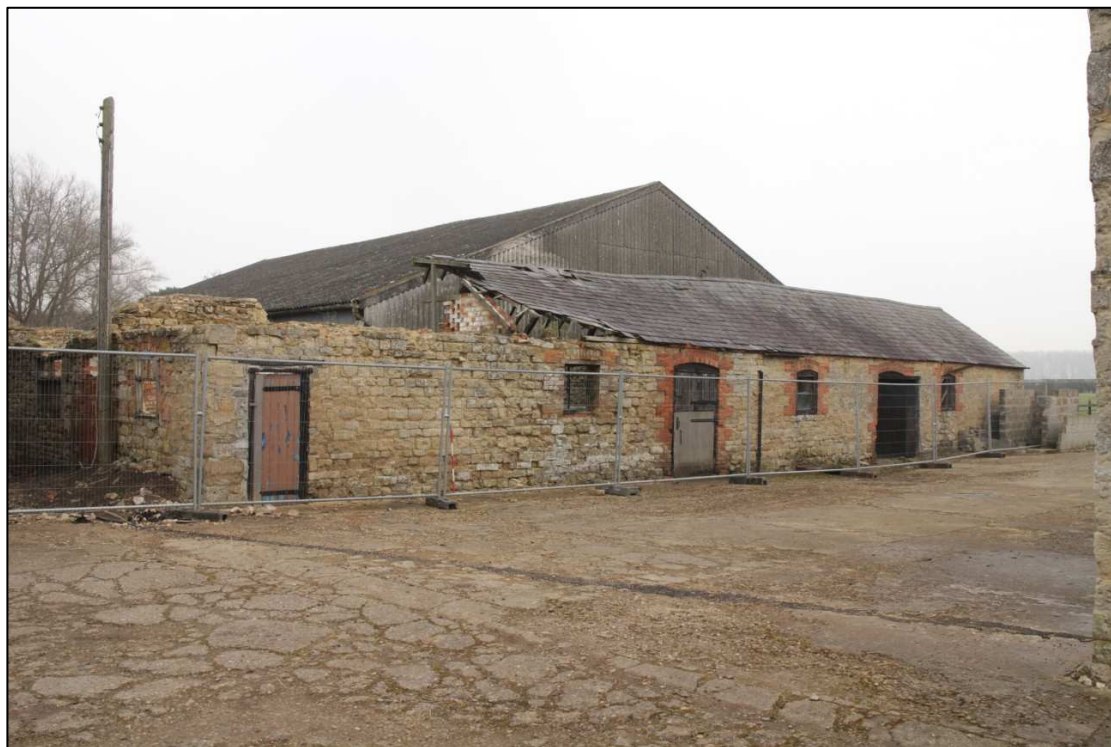
Image 5: West range, exterior elevation

This range is divided internally into three sections C1, C2 and C3 (Figure 3). The exterior walls are in limestone *c.*0.5m thick with brick dressings to the openings (Image 5). The interior is divided by three transverse partition walls. These are in plain red brick laid in Flemish garden wall bond. The northern and southern partition walls have single thickness panels at the top with gaps between adjacent bricks for ventilation (Image 7).

Looking south-east

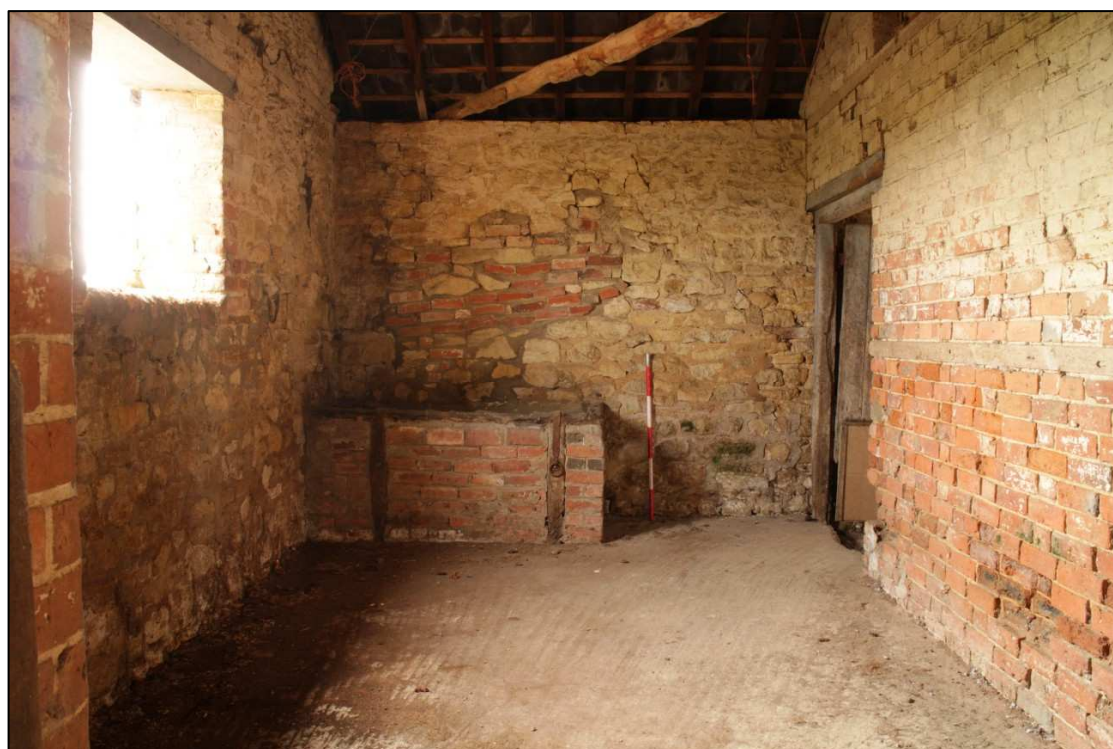
Image 6: West range, C1

C1 is situated at the southern end of the west range (Image 6). It measures 4.7m east-west and 3m north-south. The brick wall forming the north side of the compartment is in Flemish garden wall bond.

Interior, looking west showing feed trough in south-west corner and brick partition wall to the right

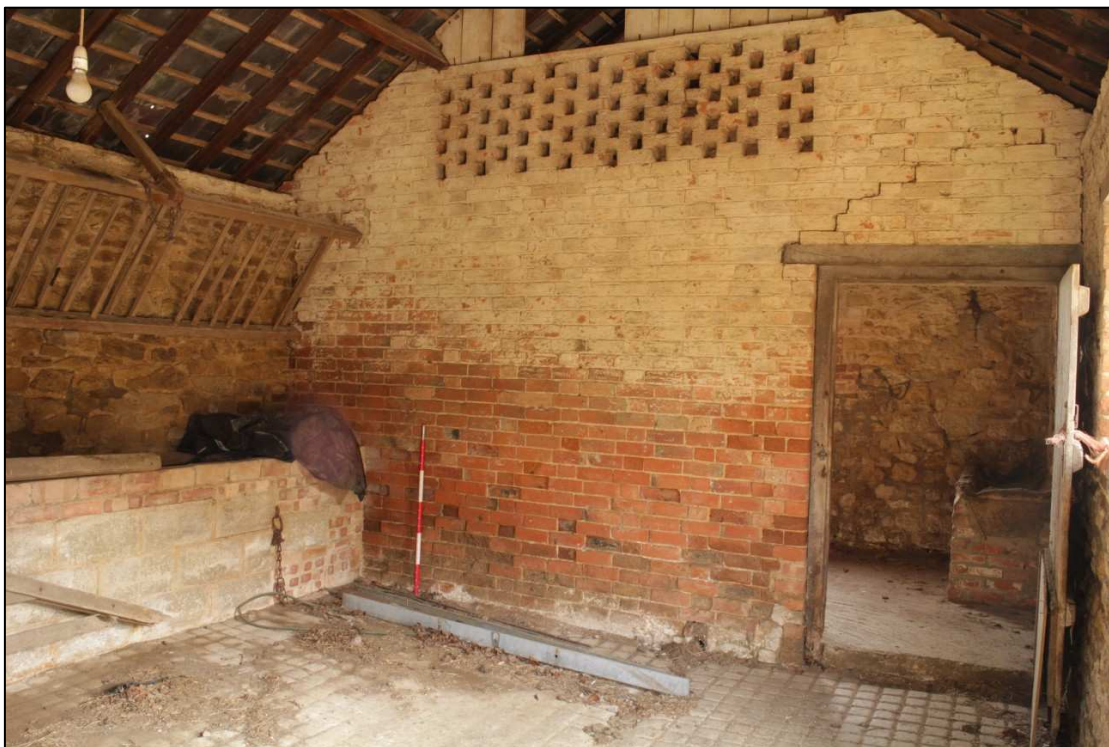
Image 7: West range, C2

A feed trough and wooden hay-rack extend along the whole eastern side of the compartment (Image 7). The feed trough is constructed from a mixture of concrete blocks and machine-made brick.

Looking south-east, showing south wall with ventilation holes and feed trough and hay rack on east wall

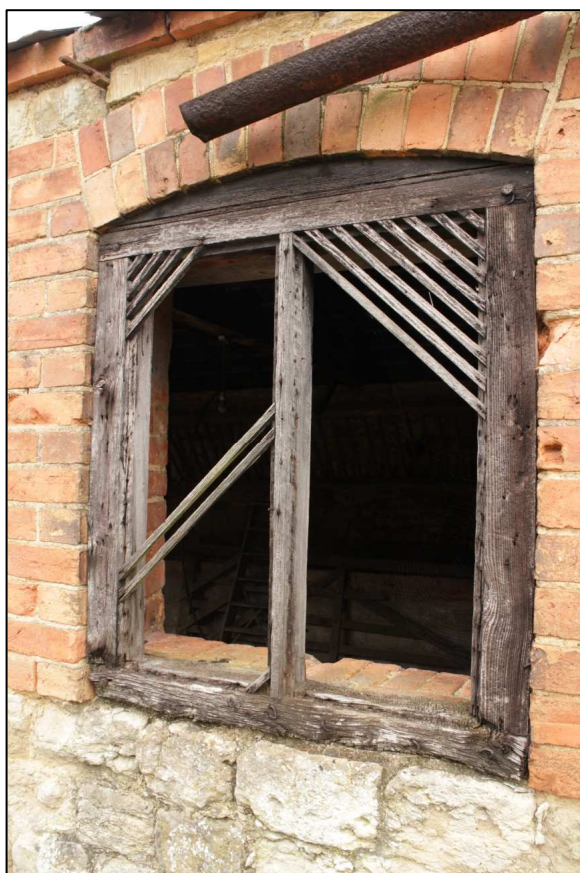
Image 8: West range, C2:
Window detail

A window in the southern part of the west wall has a plain timber frame and central mullion with diagonally arranged thin wooden slats nailed into an external rebate (Image 8).

Slatted window in west elevation

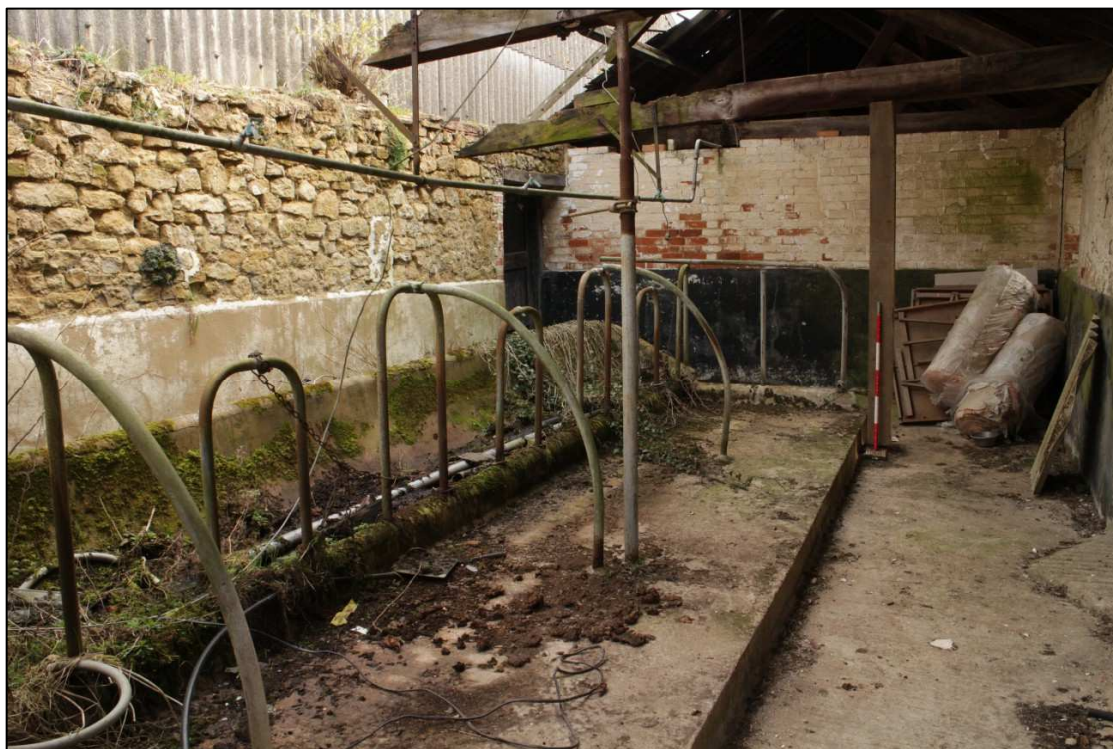
Image 9: West range: C3

The roof is supported by two king-post trusses as described in the in general description of this range (Section 3.3). Here the eastern half of the roof has decayed and the remaining western half is supported on props.

Looking south-east, showing 20th century feed trough and stalls

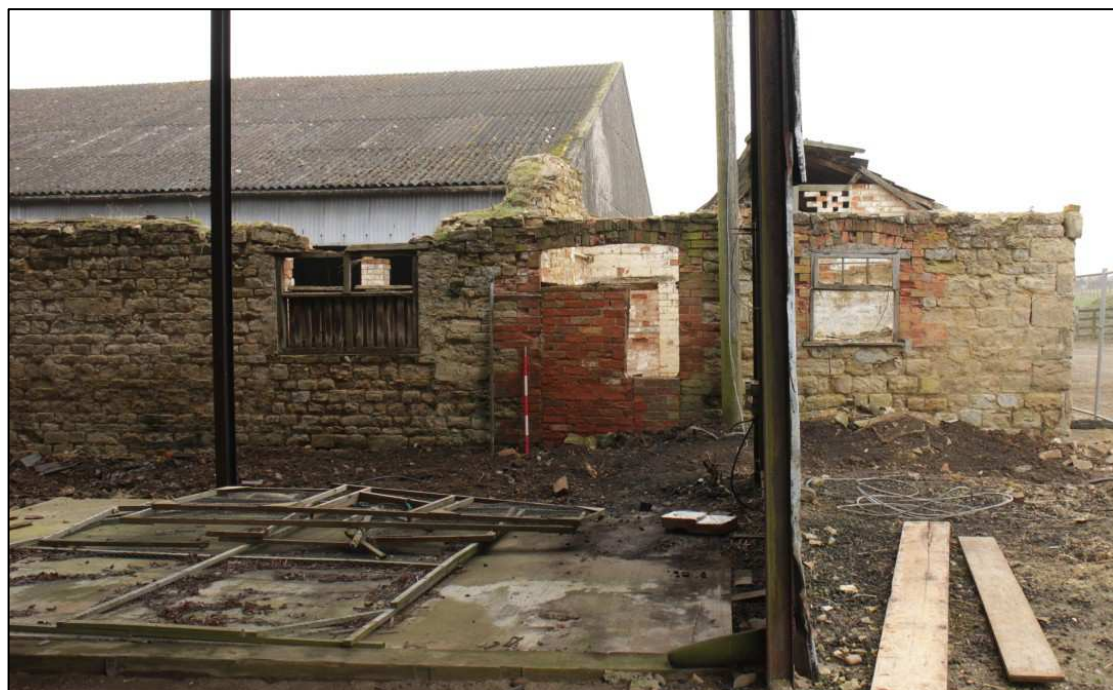
Image 10: North range, C4 & C5: Exterior view of north elevation

There are external door openings in the north and west walls and an internal opening in the west wall. The external opening in the north wall has been blocked with brick (Image 10). The blocking is in two sections. A narrow strip against the western jamb suggests that the doorway was initially narrowed before it was completely blocked with additional brickwork. In contrast to all of the other external doors, the door in the west wall has a plain opening with no brick quoins. Irregularities in the limestone masonry around this door suggest that it is a later insertion, possibly as a replacement for the blocked north door.

Shows door in C4 with brick blocking and windows in C4 and C5

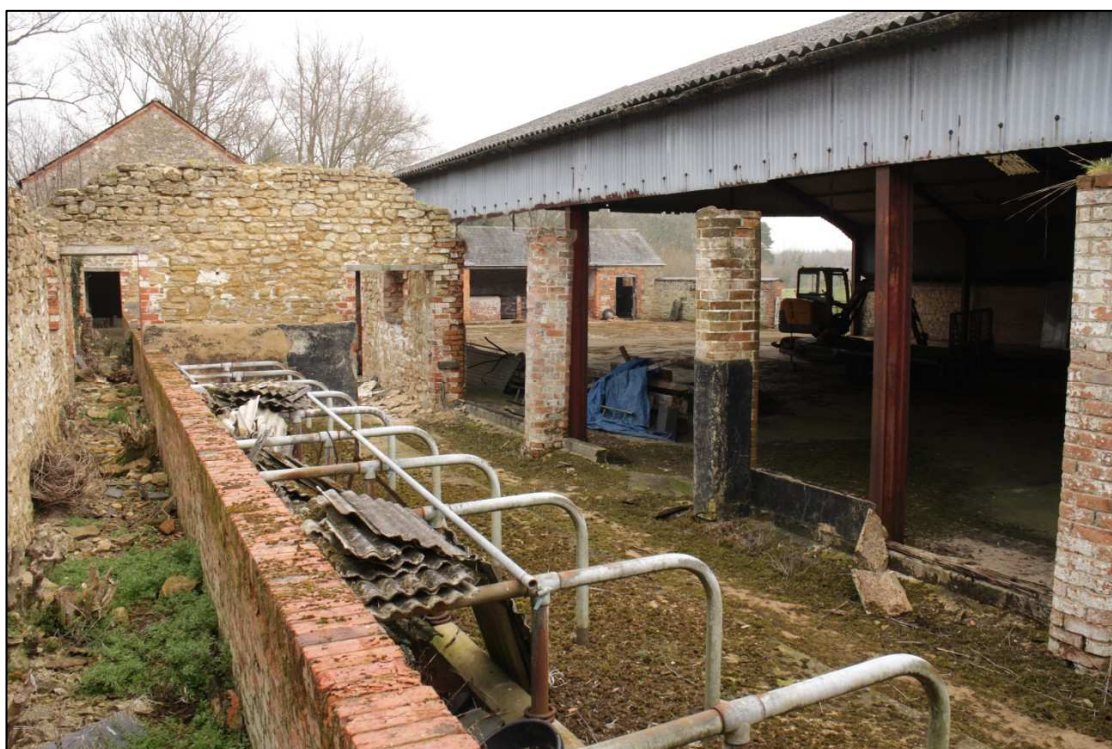
Image 11: North range: C5: Interior, looking south-east
Shows brick pillars of original open front and 20th century stalls

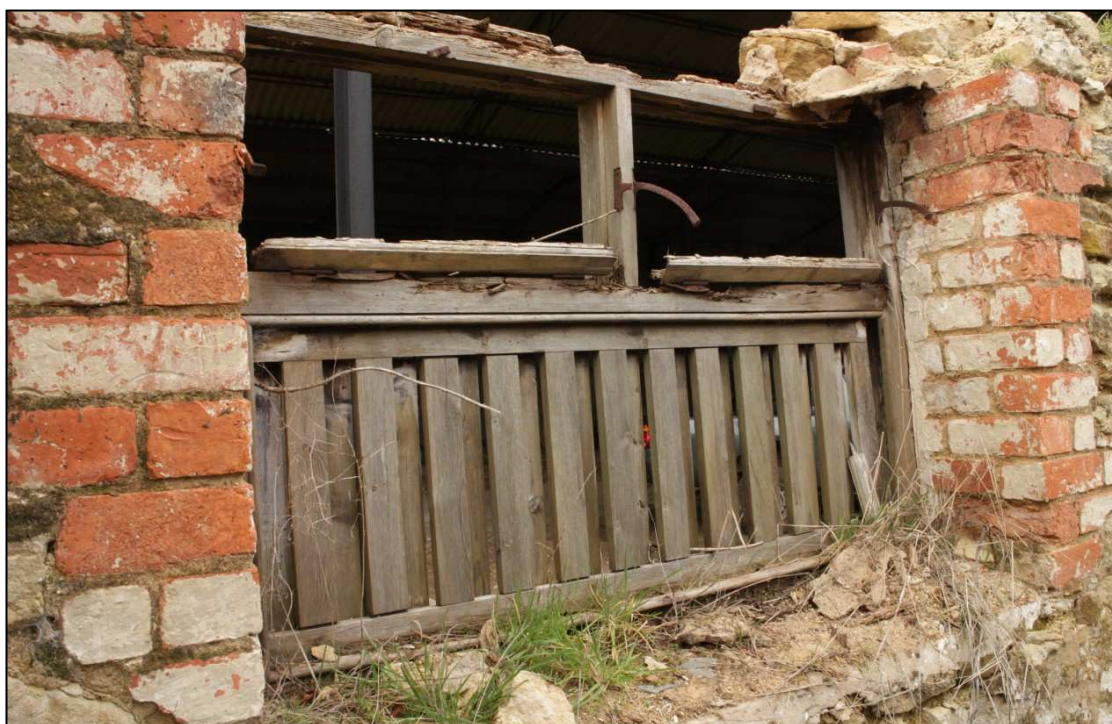
Image 12: North range: C5: Window detail

Shows interior view of window in north wall with 'hit and miss' vent in lower part
and hinged hopper windows above

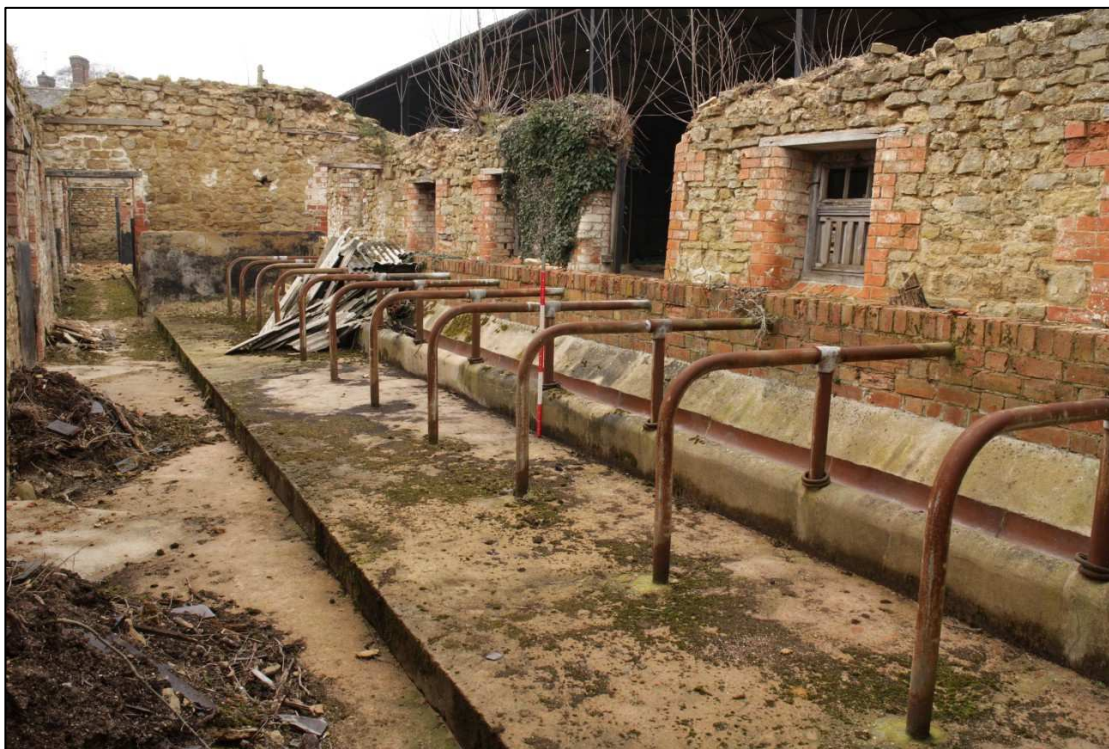
Image 13: North range: C6: Interior looking north-west

C6 contains a 20th century feed trough and stalls matching those in C5 (Image 13 & 14).

Shows north wall and west cross-wall and 20th century stalls and feed trough

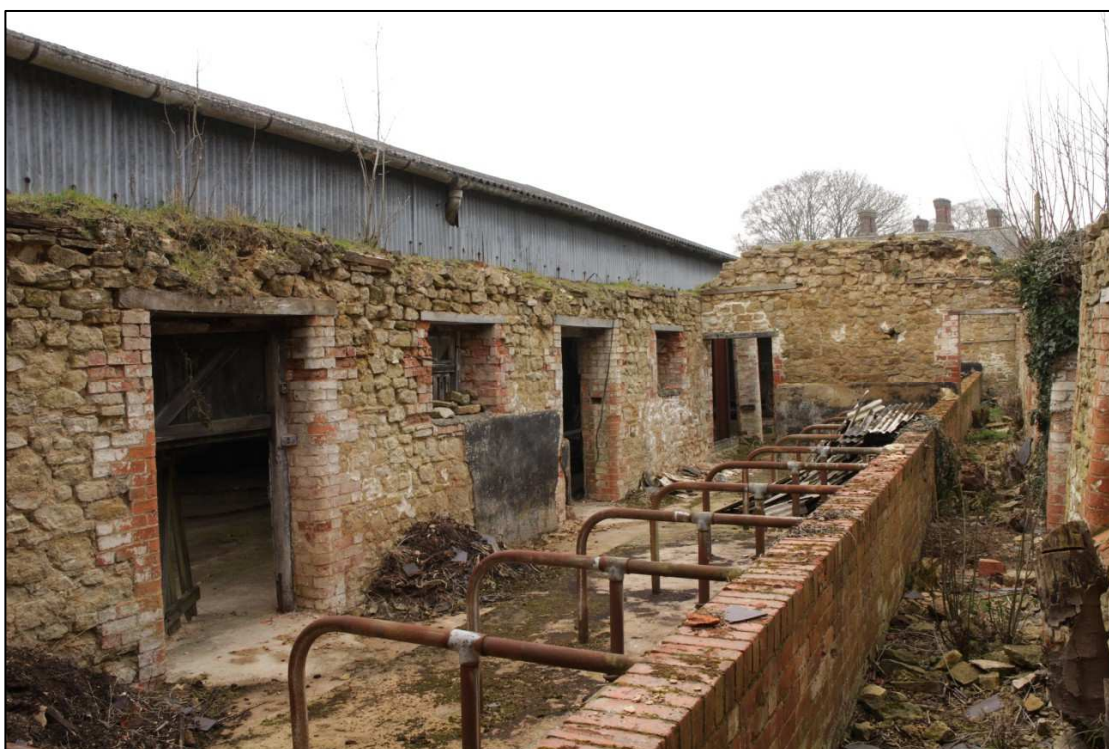
Image 14: North range: C6: Interior looking south-west

Shows openings in south wall onto yard and 20th stalls

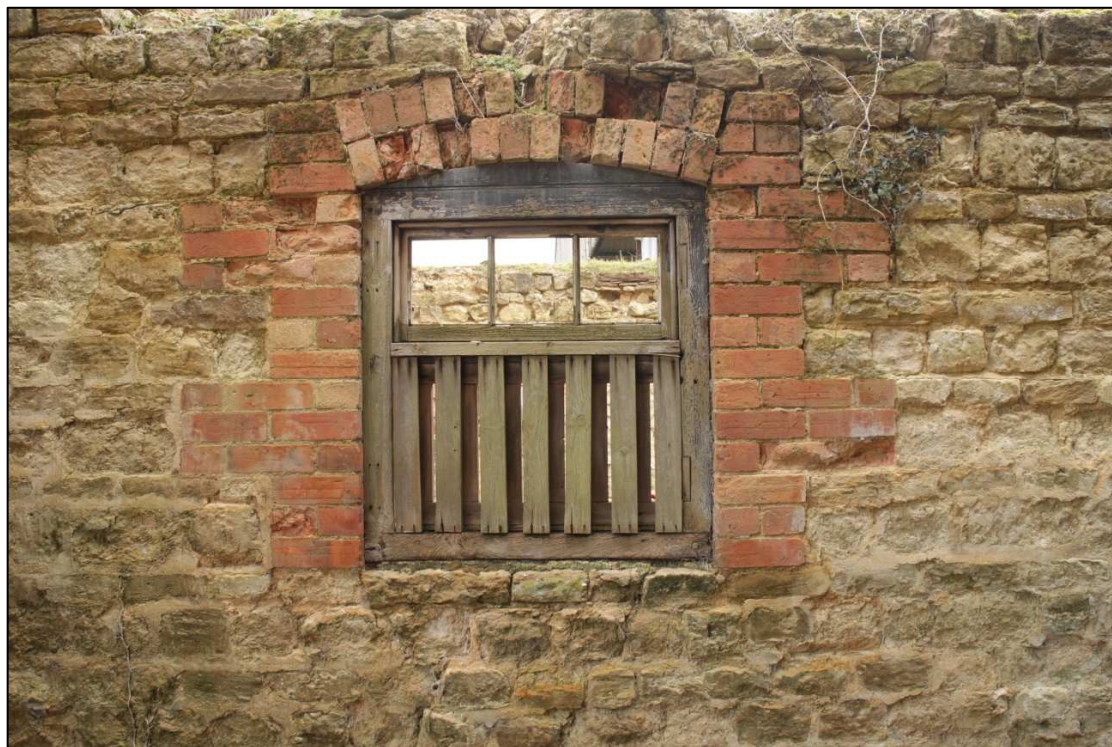
Image 15: North range: C6: Exterior window detail: north wall
Shows slatted section in lower part and horizontal hinged light above

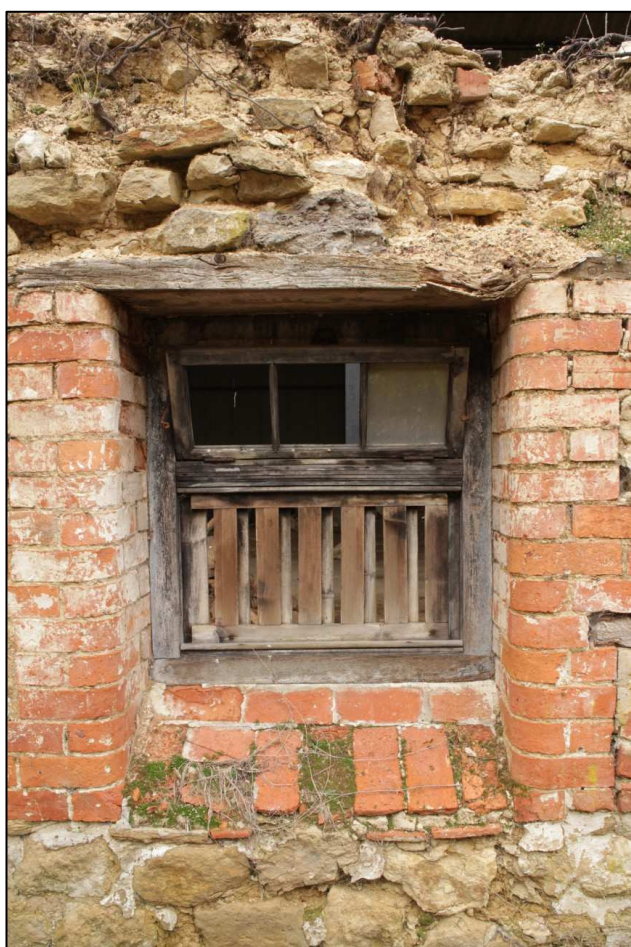
Image 16: North range: C6:
Interior window detail: north wall
Shows bullnose bricks on the sides
of the opening and tile dressing to
sloping section below

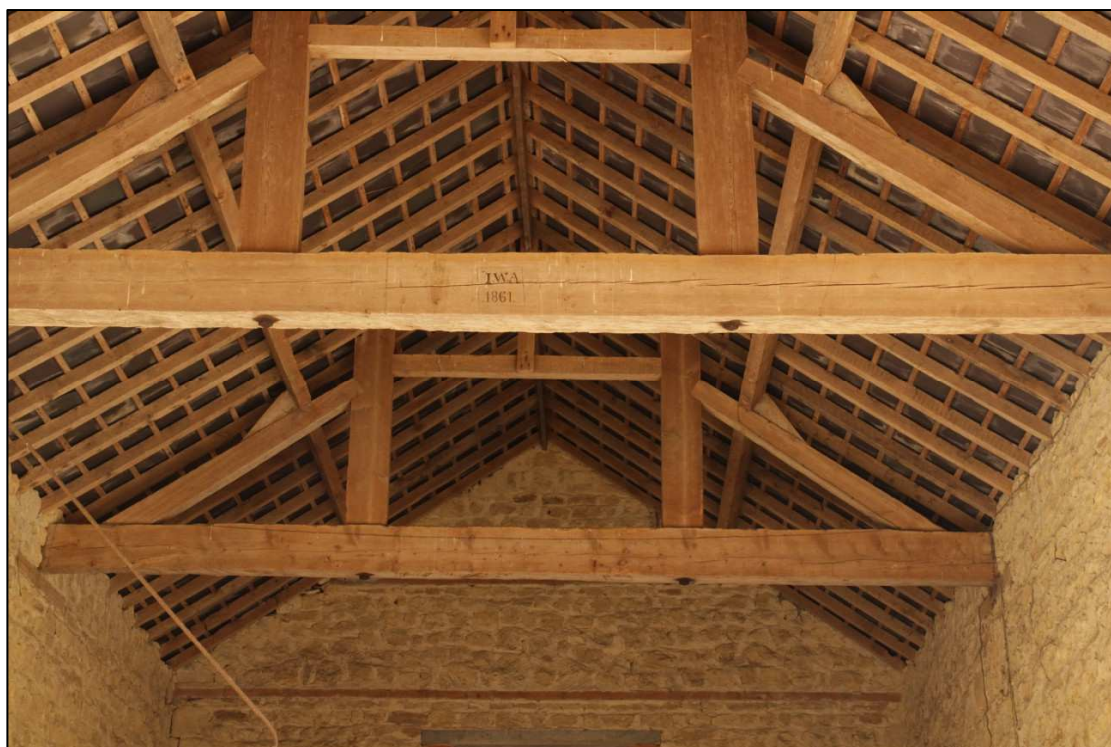
Image 22: North range: C7 Barn: Interior showing roof

View looking east. Date and initials are just visible on centre of nearest tie-beam

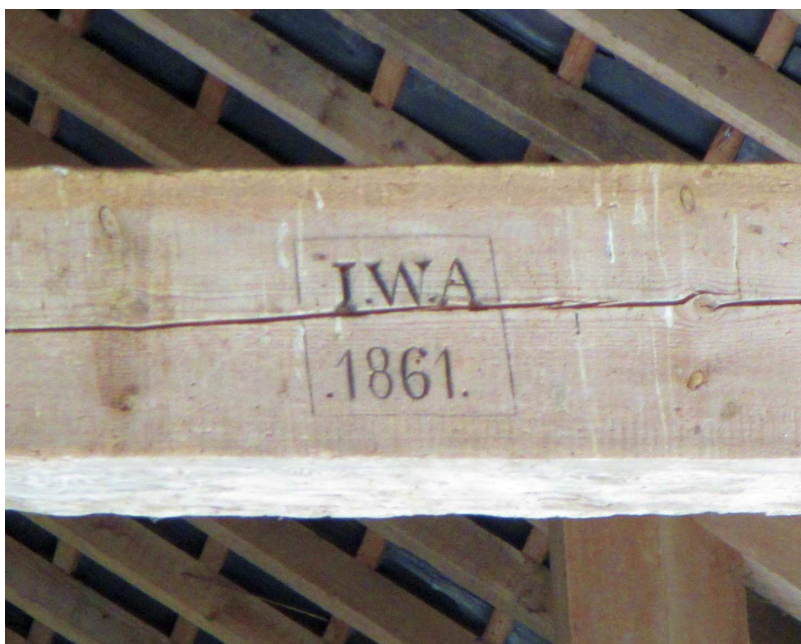
Image 23: North range: C7 Barn: Detail of date and initials

The date of 1861 is inscribed into a tie-beam in the barn (Image 23). Other dateable features of the building are consistent with this date. King-post roofs with an iron rod as the king-post were described as a recent introduction in 1850 and surveys of farm buildings in Norfolk and Staffordshire noted its use in buildings dating from after 1865 (Peters 1988, 29-30).

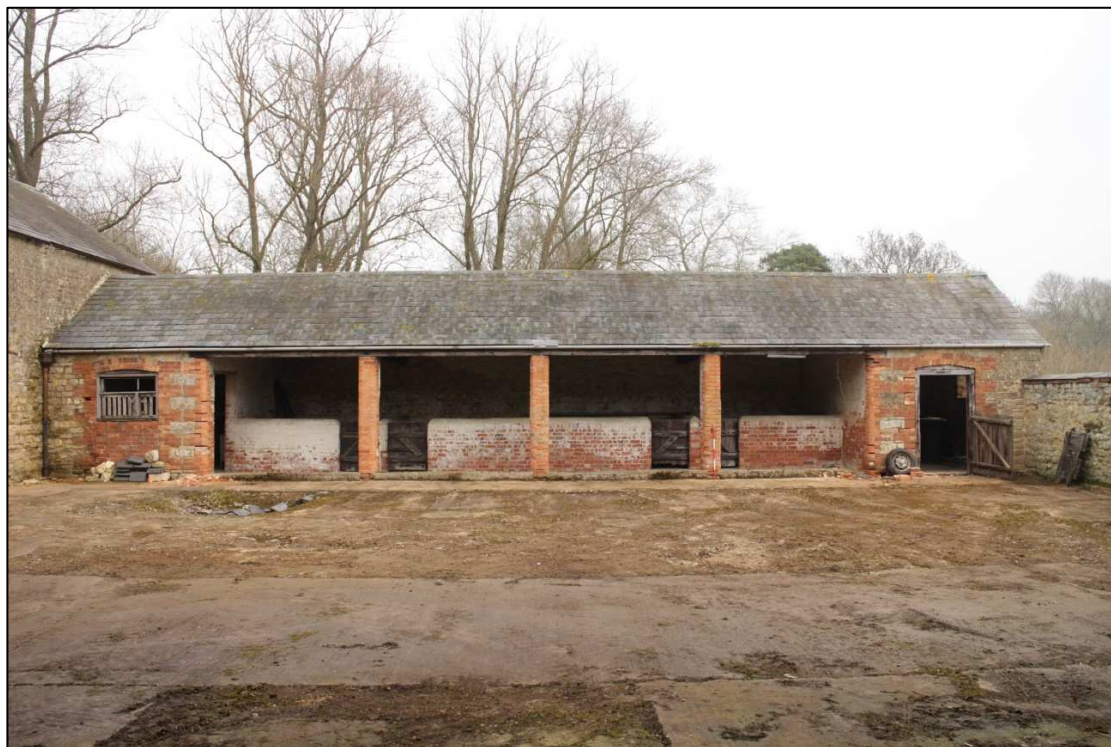
Image 27: East range: West side

View shows open-fronted section containing pigsties and compartments at either end. The northern compartment originally had a doorway that has been partially in-filled with brick to form a window opening.

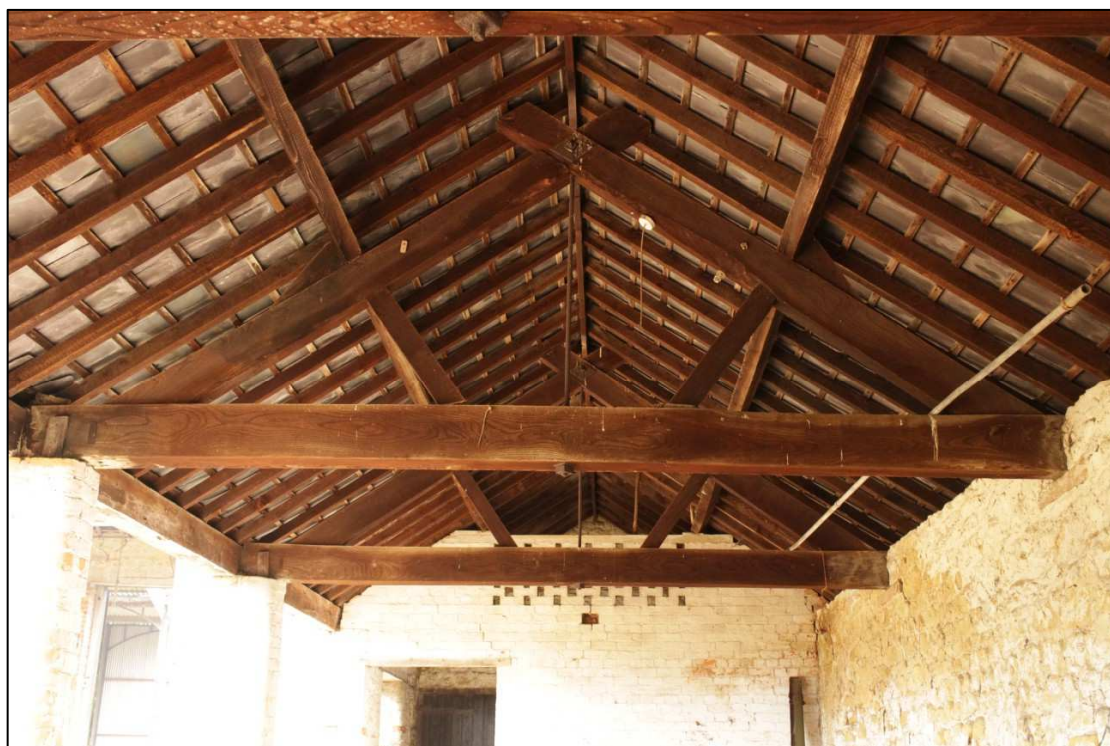
Image 28: East range: Roof structure

The roof is supported by king-post roof trusses with an iron rod in place of the king-post (Image 28 shows an example in the east range). Towards the apex the principle rafters are crossed in a halved joint. The halved joint has lozenge shaped reinforcing plates screwed to either face and is through bolted. The iron rod is threaded at its base and fixed with a square nut. The top is presumably looped around the bolt which passes though the rafters. Short struts link the tie-beam with the rafters.

View looking north. Shows crossed principle rafters with a bolted fixing and iron stay in place of king-post

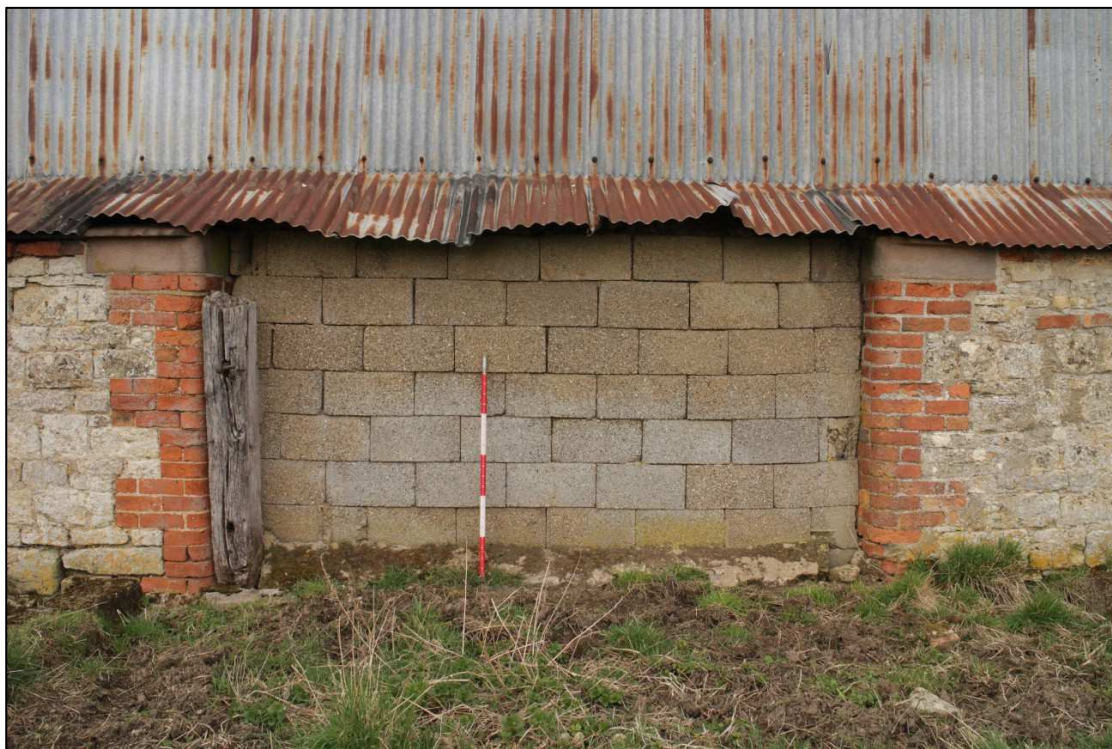
Image 31: Yard wall: Detail of western opening

Exterior view of blocked western gateway, looking north with corrugated sheets on south side of modern building which fills this end of the yard

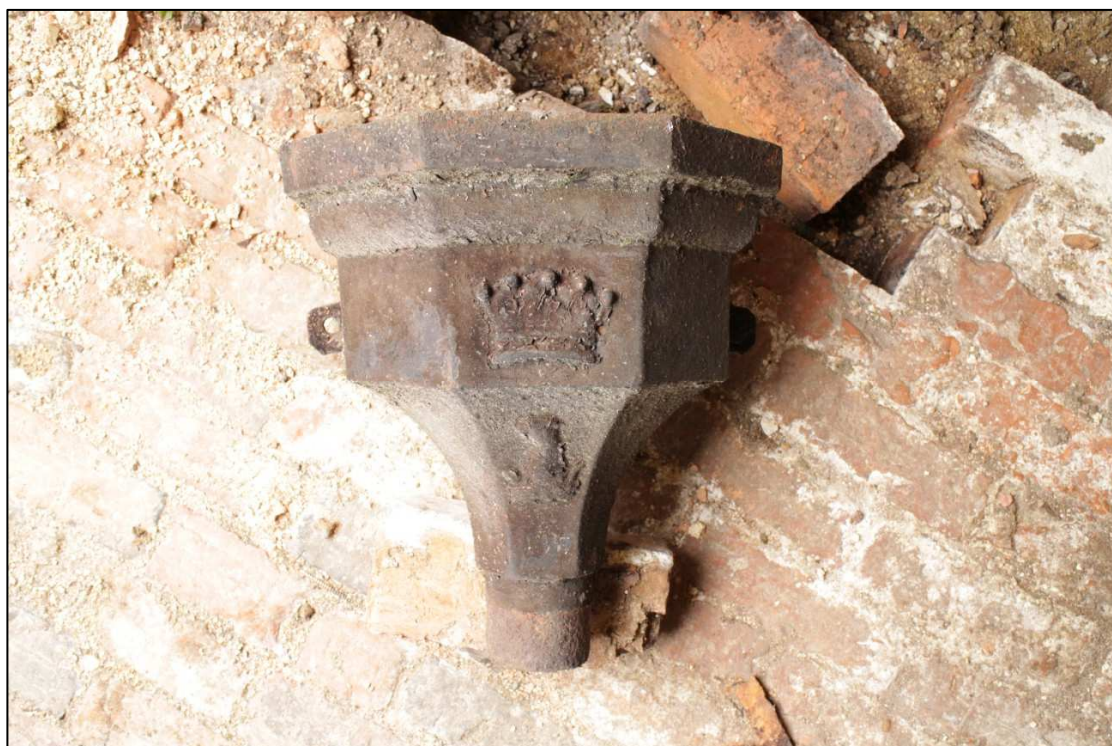
Image 32: Detail of rainwater head

Cast iron rainwater heads survive *in situ* on the barn and on the east range and loose at the time of the survey in C10 (Image 32). These are decorated with a crown and the Fermour-Hesketh family crest, the owners of Easton Neston Estate.

Showing crown and Fermour-Hesketh crest below
