**BASSMEAD MANOR  
STAPLOE  
BEDFORDSHIRE**

**HISTORIC BUILDING RECORDING**

Document: 2013/73  
Version: 1.0

Issue date: 29th May 2015

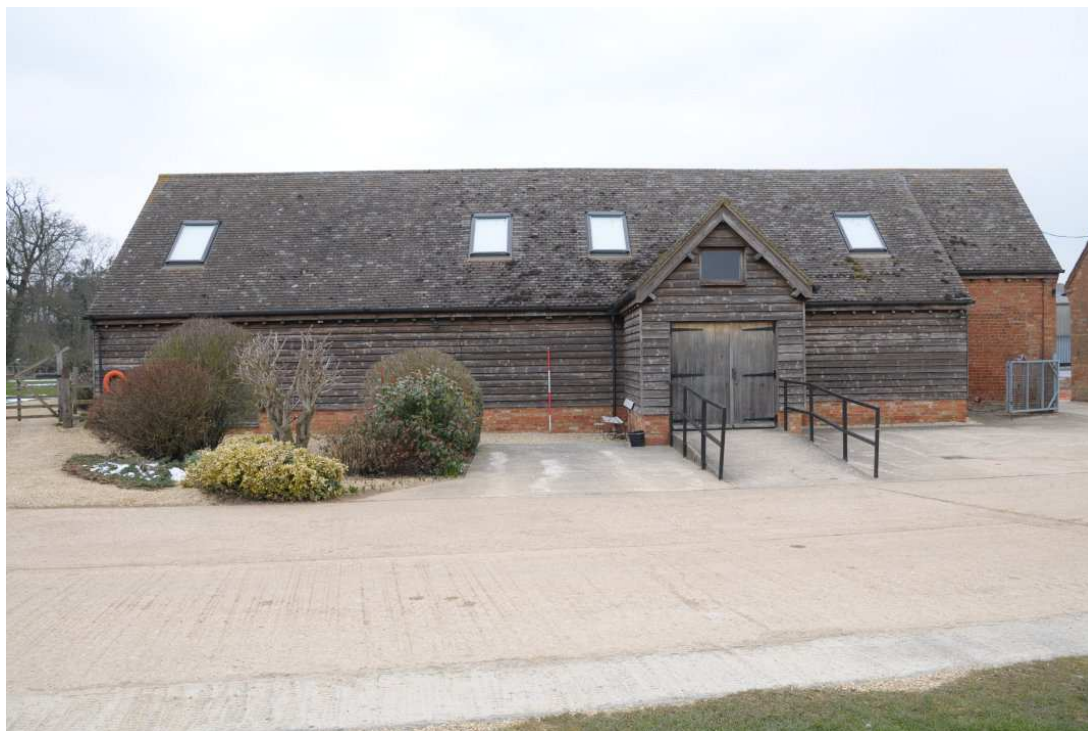
**Image 1:** Bean Barn, south elevation

Shows modern porch and roof lights (scale 2m)

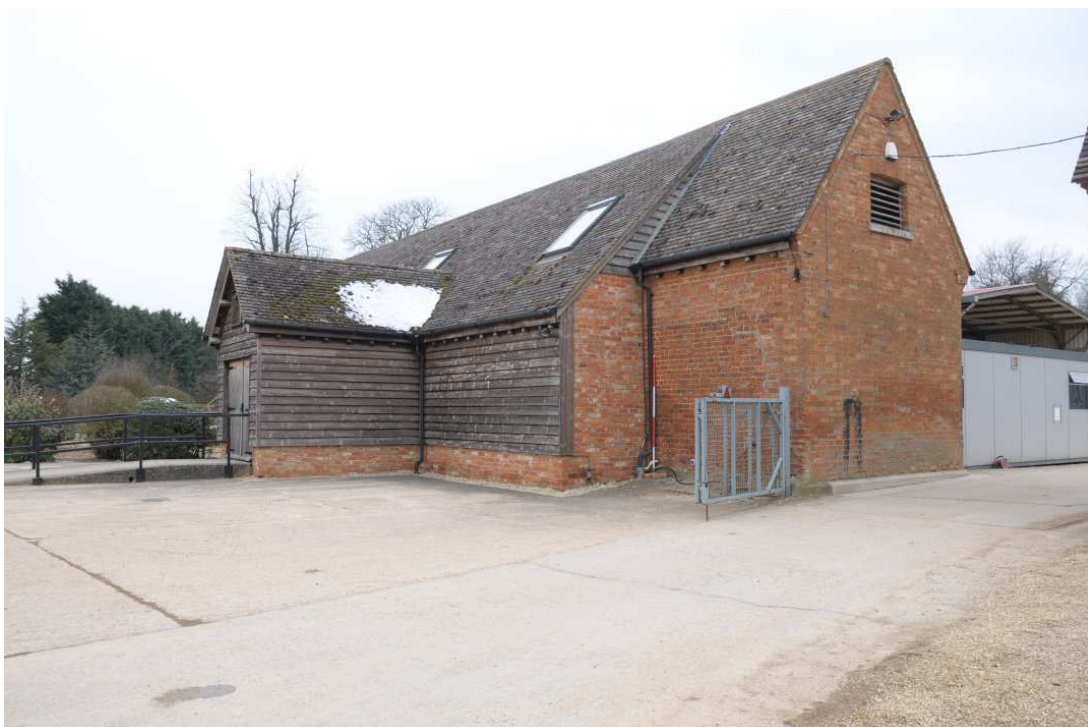
**Image 2:** Bean Barn, exterior from south-east

Shows modern porch added to south aisle and brick end bay  
(scale 2m)

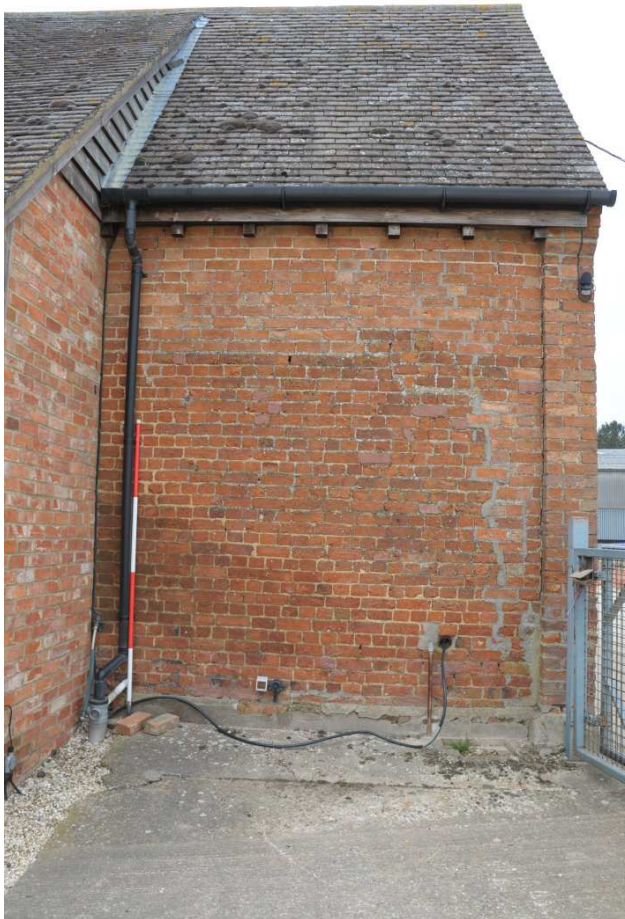
**Image 3:** Bean Barn, south elevation of brick end bay

The brick-built bay at the east end of the barn incorporates some earlier brickwork in the lower two-thirds of the south elevation (Image 3). This consists of a brick plinth and English bond brickwork in red bricks measuring 220mm x 105mm x 65mm. The earlier brickwork abuts the later masonry in an irregular, nearly vertical join close to the east end of the wall. A crack between the two sections of brickwork has been repaired with cement and four bricks have been cut-in across the crack at intervals to form a stitch repair.

Shows red brick in English bond forming lower part of wall with lighter brick above and in the pilaster strip on the south-east corner (scale 2m)

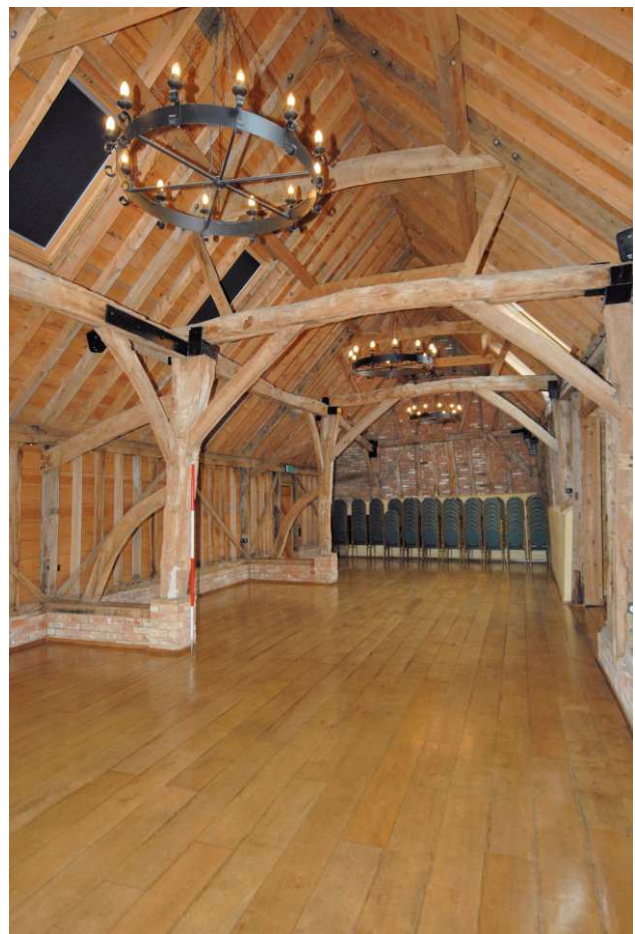
**Image 4:** Bean Barn, interior looking west

View shows south aisle and modern roof structure (scale 2m)

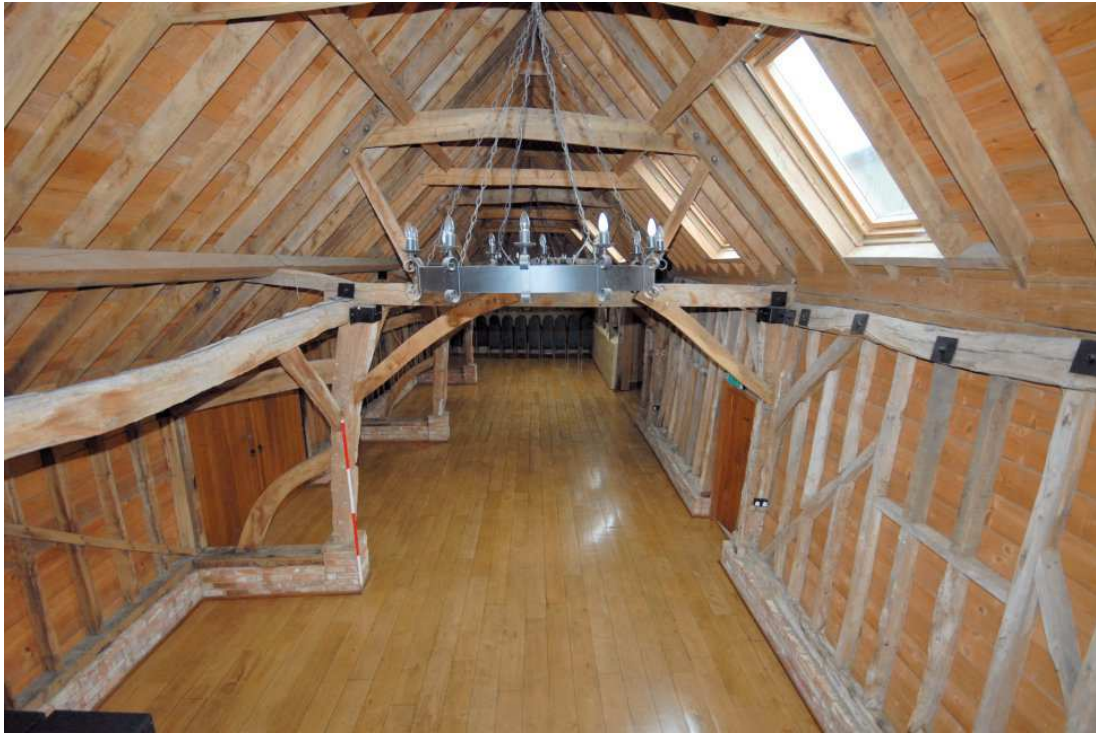
**Image 5:** Bean Barn from first floor of brick end bay

The roof is a modern (late 20th-century) construction above the level of the tie-beams (Image 5). It is made with machine-sawn softwood assembled with bolted lap joints and scarf joints. A traditional form of construction has been used, with clasped purlins supported by collar beams and raking struts rising from the tie-beams to just below the level of the purlins. The apex uses a more modern form, with common rafters fixed to a ridge plank. A gap between the rafters and the arcade plate shows that the roof has been raised above its original level on this side, presumably to increase headroom in the south aisle.

View shows the south aisle and the north wall with primary bracing (scale 2m)

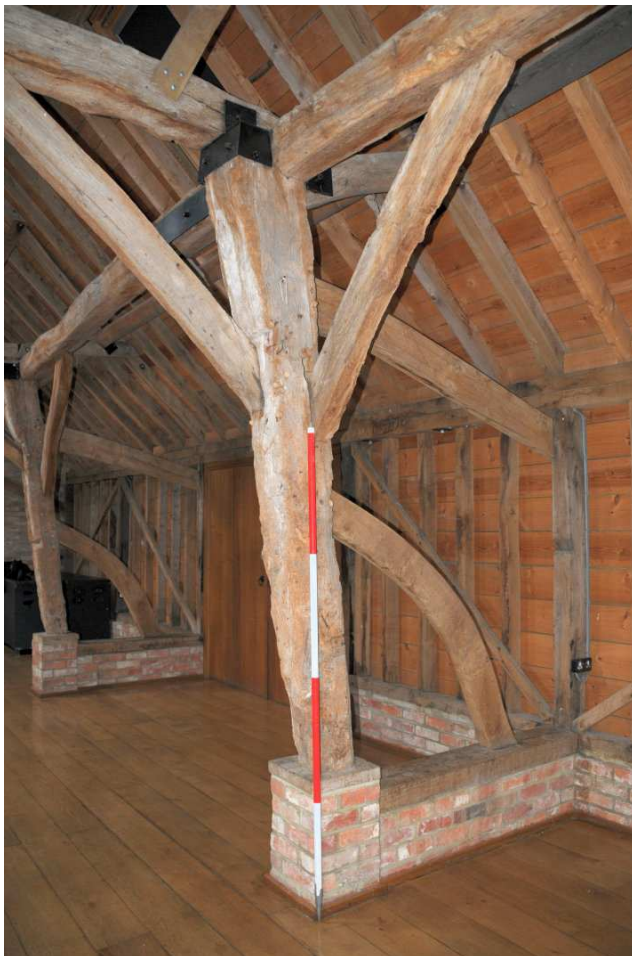
**Image 6:** Bean Barn, south aisle

The south aisle was rebuilt during the modern restoration of the barn. In the process the height of the aisle was increased. The wall along the south side of the aisle is a modern timber construction. It stands on a low sill-wall of re-used brick and consists of close-set studs with long diagonal braces that run across the interior face of the studs.

Shows aisle post and braces to the aisle plate and tie beam with modern braces at the rear of the post in the south aisle (scale 2m)

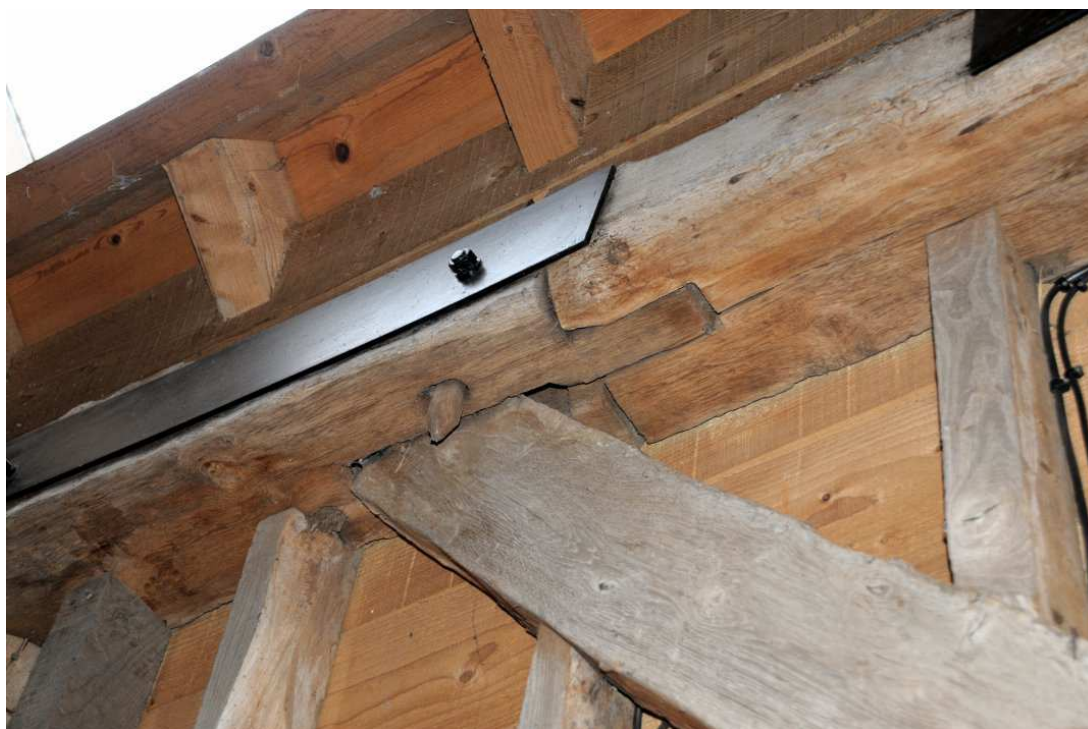
**Image 7:** Bean Barn, scarf joint in north aisle plate

Showing the underside of an edge-halved scarf located towards the east end of bay 3

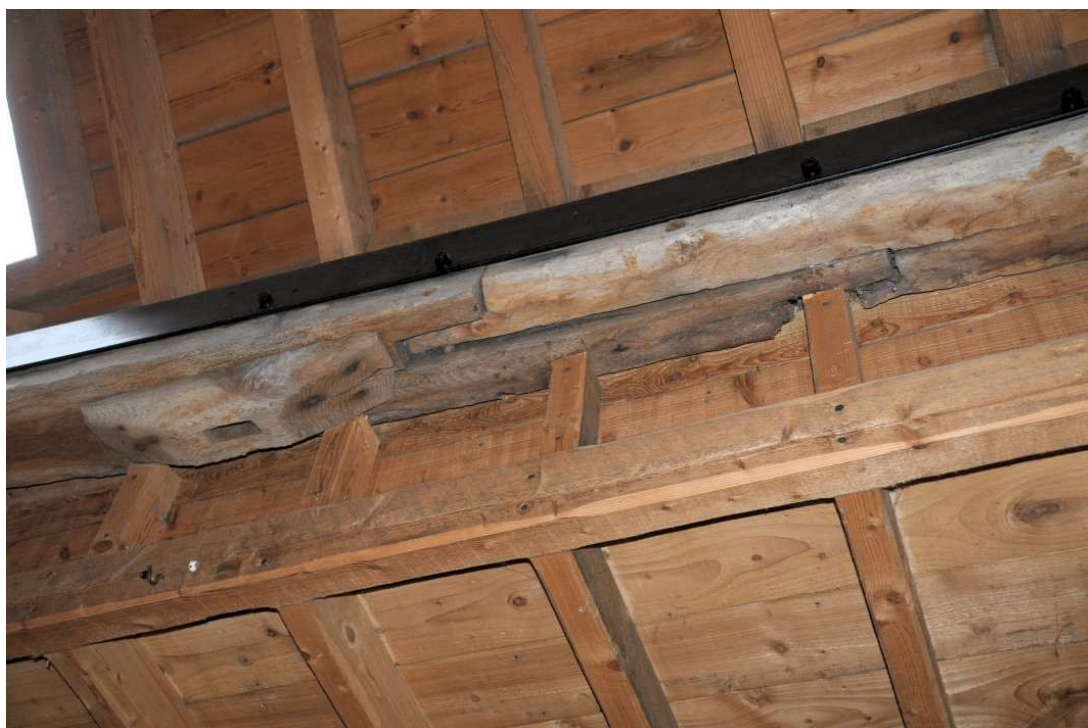
**Image 8:** Bean Barn, scarf joint in north aisle plate

The aisle plate is made up of at least three parts with two visible scarf joins. In bay 3 it is edge-halved with bridled abutments with two additional pegs inserted vertically through the central part of the scarf (Image 7). In bay two the scarf join is face halved with bladed abutments (Image 8).

View showing the underside of a face-halved scarf joint in bay 2

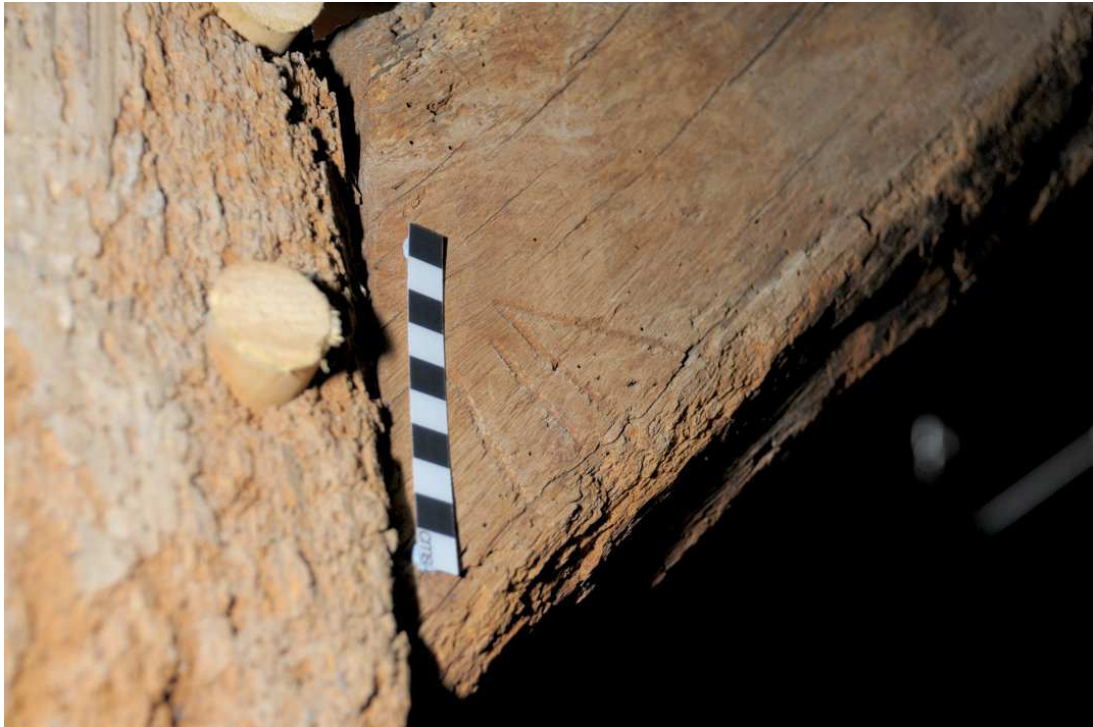
**Image 9:** Bean Barn, assembly mark

The braces beneath the aisle plate carry assembly marks (Image 9). Incised Roman numerals on the rear (outer) face at the lower end of each brace run from I to VII, starting at the western end of the barn. Nothing is visible on the easternmost brace, but the surface of this timber is heavily eroded.

Detail view of assembly mark at lower end of brace (scale 10cm)

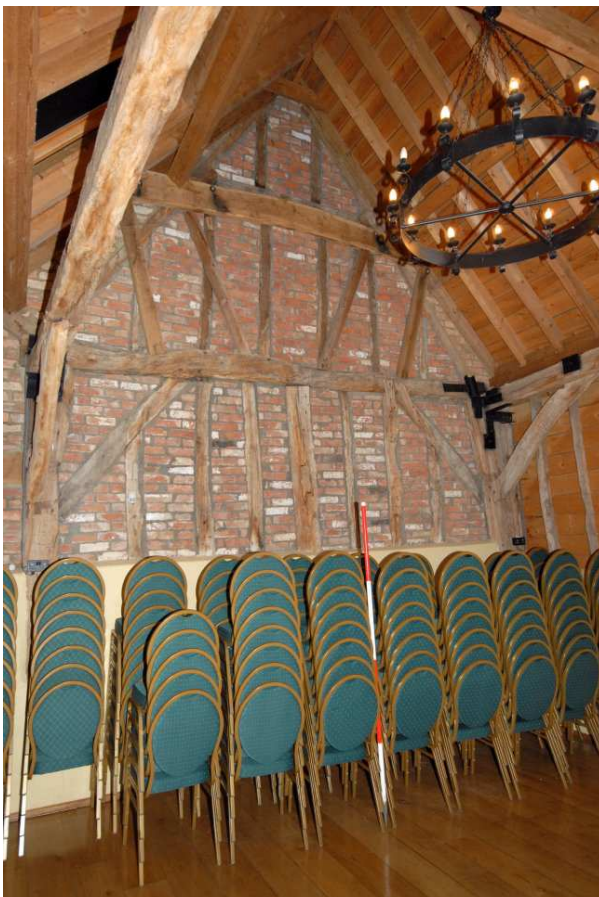
**Image 10:** Bean Barn, west end

Additional modern timbers have been added to form angled supports for the modern replacement roof structure.

West end wall showing original frame with brick filling and additional raking struts and collar beam supporting modern roof (scale 2m)

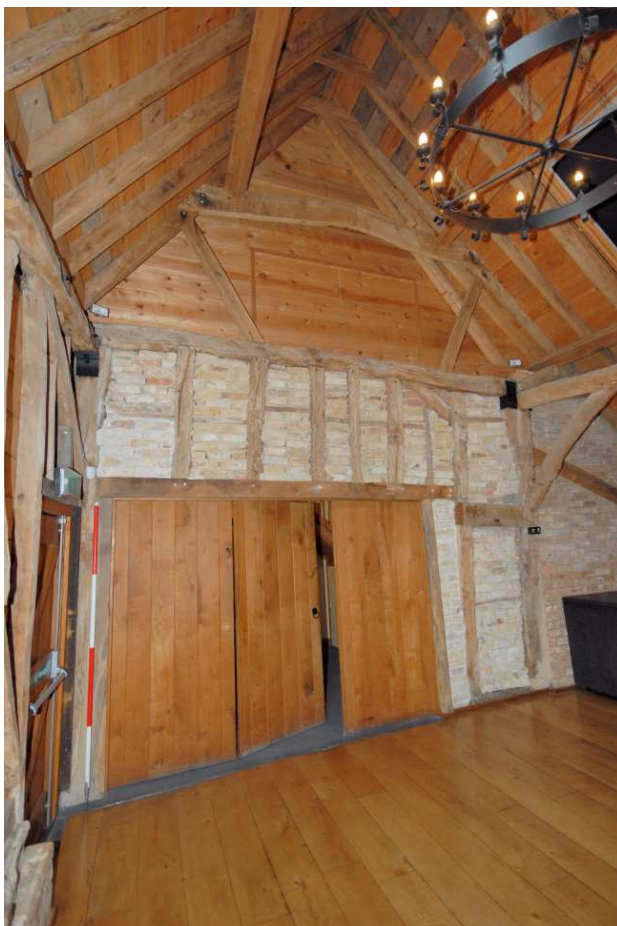
**Image 11:** Bean Barn, east end

The position of the post in this wall could indicate the south-west corner of a former building attached to the east end of the barn that has since been replaced by the present brick structure.

East end wall showing frame with brick infilling between modern doorway and roof structure (scale 2m)

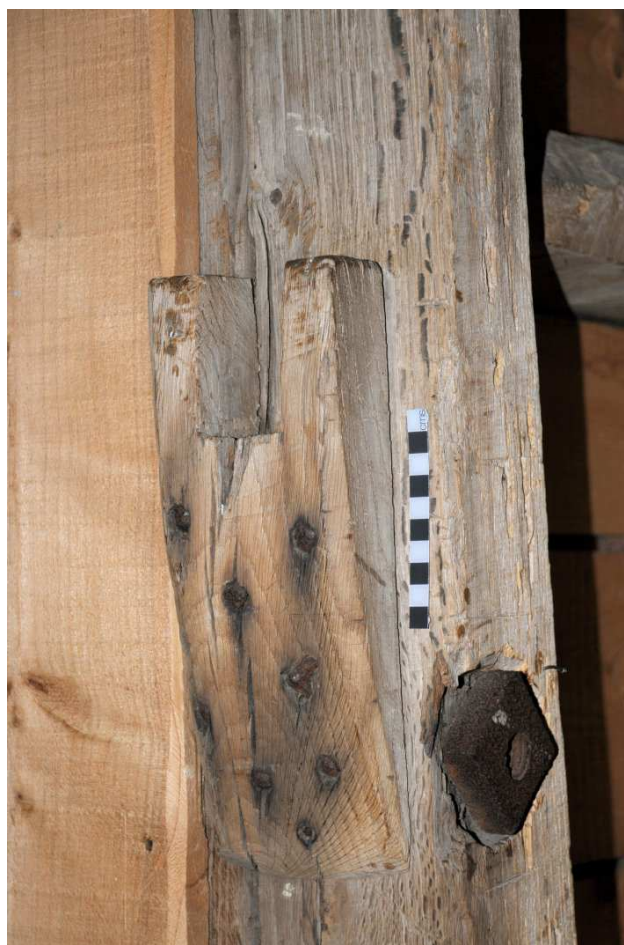
**Image 12:** Bean Barn, east jamb of north door

Detail view of wooden bracket nailed to door jamb (scale 10cm)

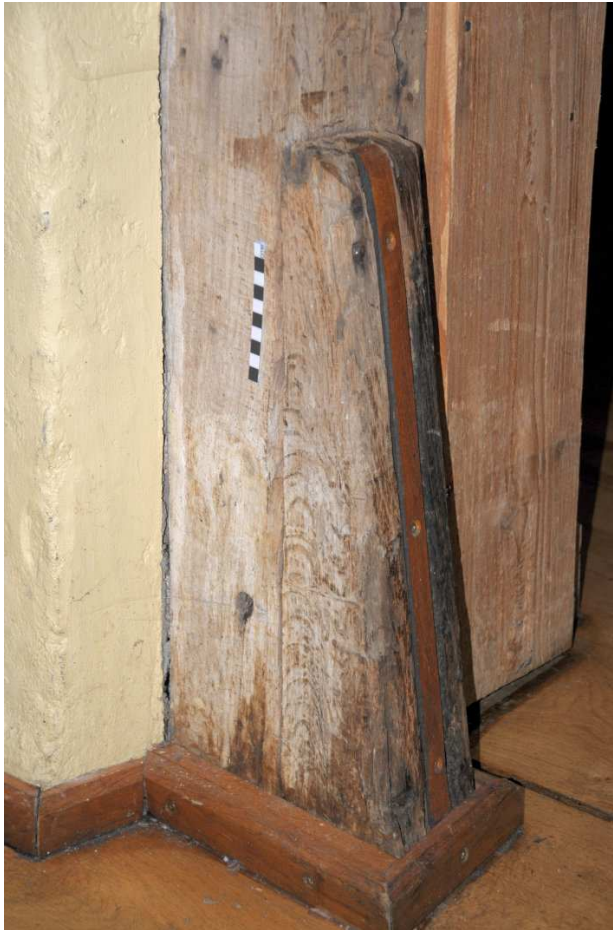
**Image 13:** Bean Barn, west jamb of north door

Detail showing fitting attached to door jamb. The vertical slot (now infilled with wood) was designed to support a set of horizontal boards, to form a temporary barrier called a lift (scale 10 cm)

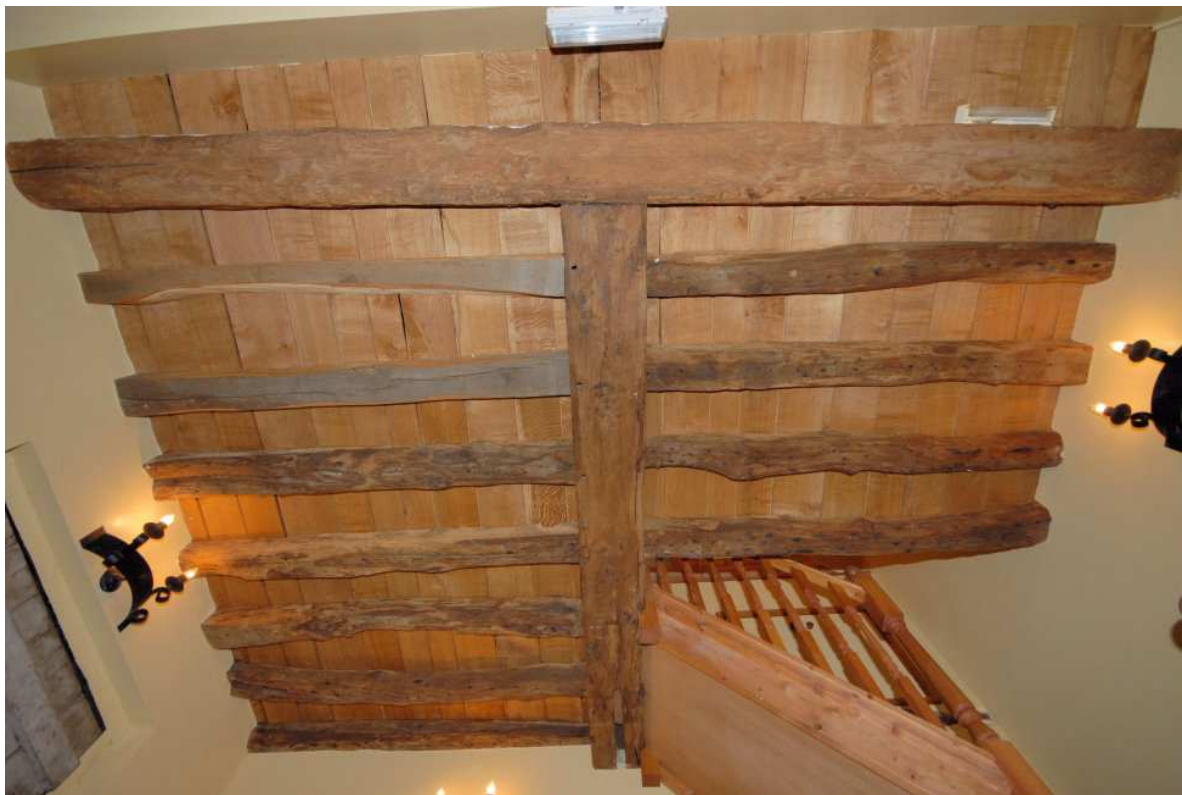
**Image 14:** Bean Barn, ground floor of brick end bay

View looking upwards at framing of floor

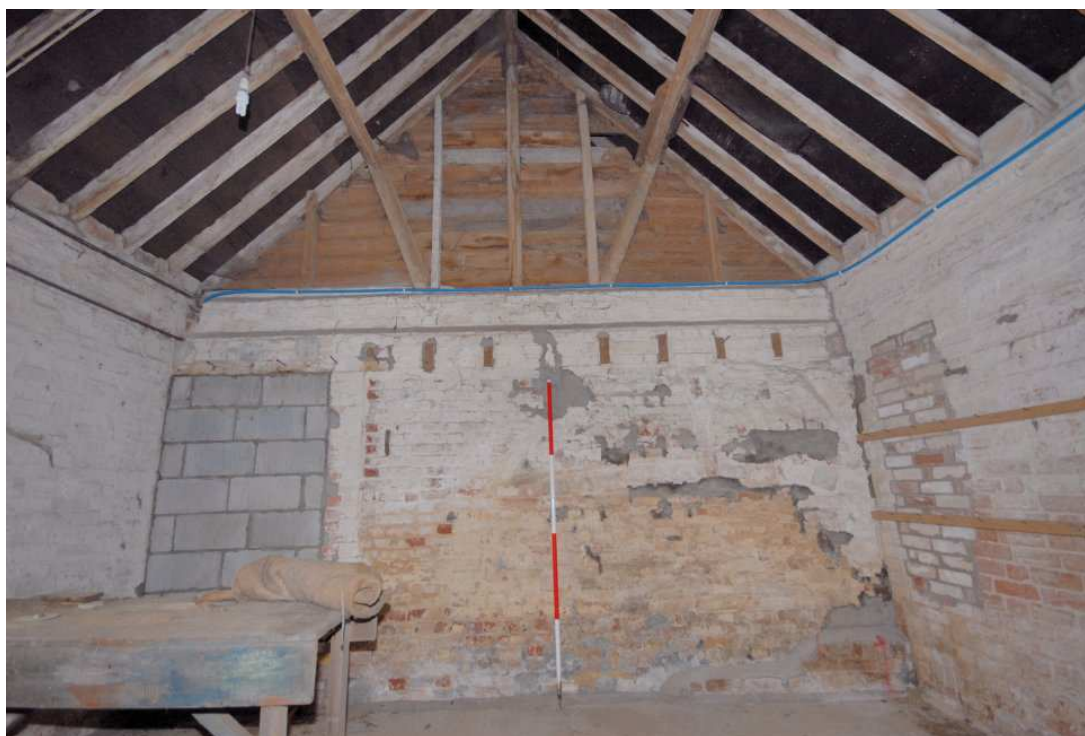
**Image 22:** Long Barn C2, east wall

View looking east showing blocked door in north side of wall, irregular area of brickwork and cut-off joists in upper part of wall (scale 2m)

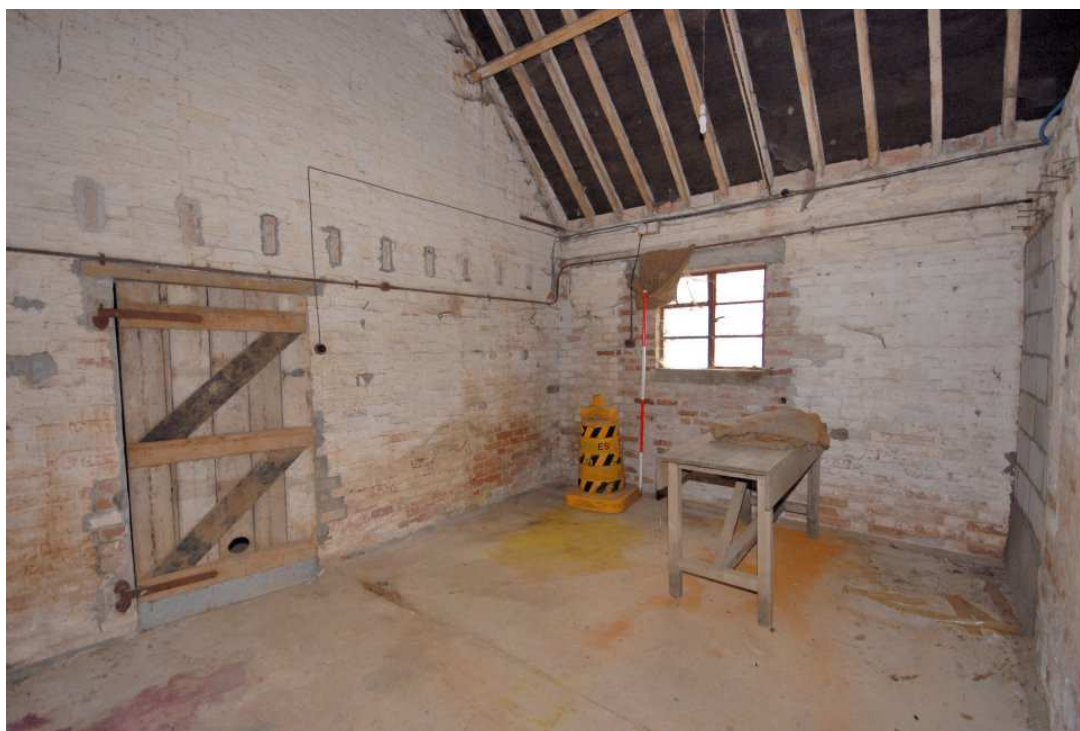
**Image 23:** Long Barn C2, looking north-west

Shows metal-framed window inserted into larger opening in north wall  
(scale 2m)

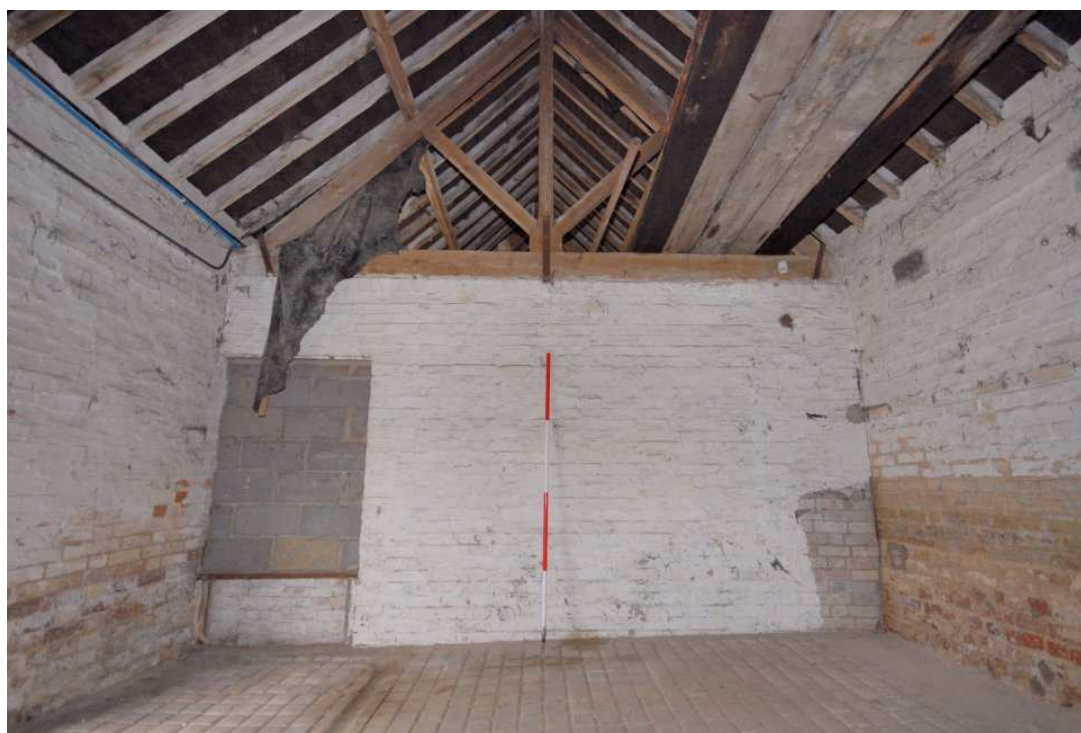
**Image 24:** Long Barn C3, east wall

View looking east showing blocked door to 3 and whitewash 'shadow' of feed  
trough against south wall (scale 2m)

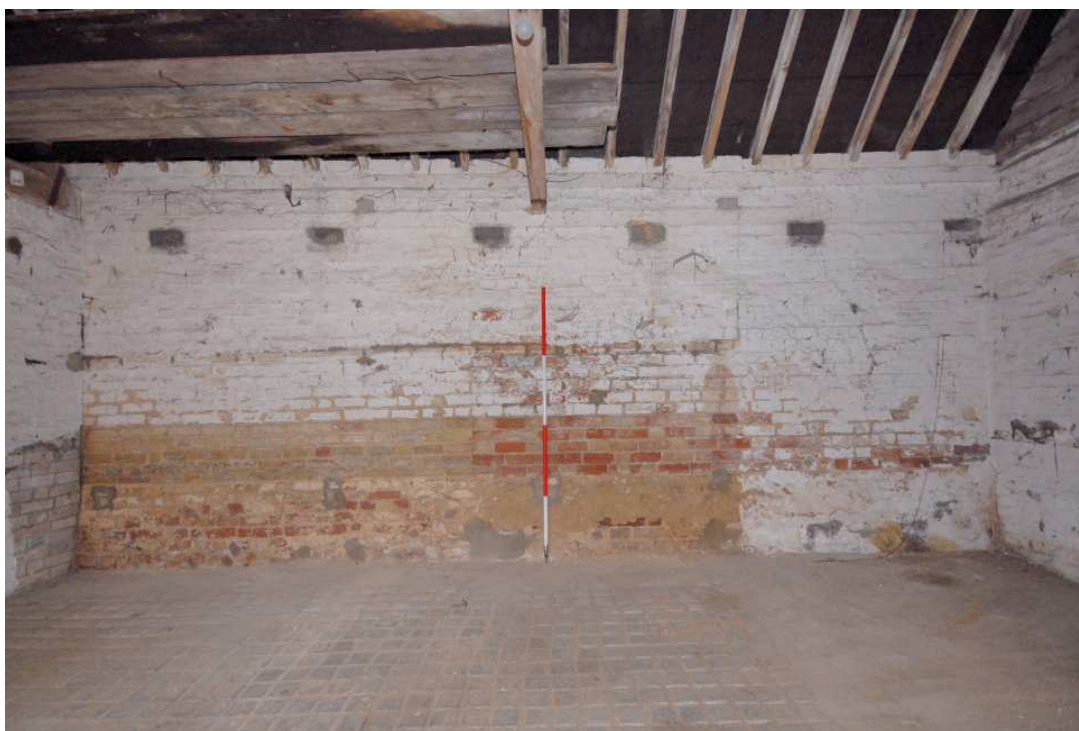
**Image 25:** Long Barn C3, south wall

View looking south showing 'shadow' left by feed trough against south wall and vents in upper part of wall (scale 2m)

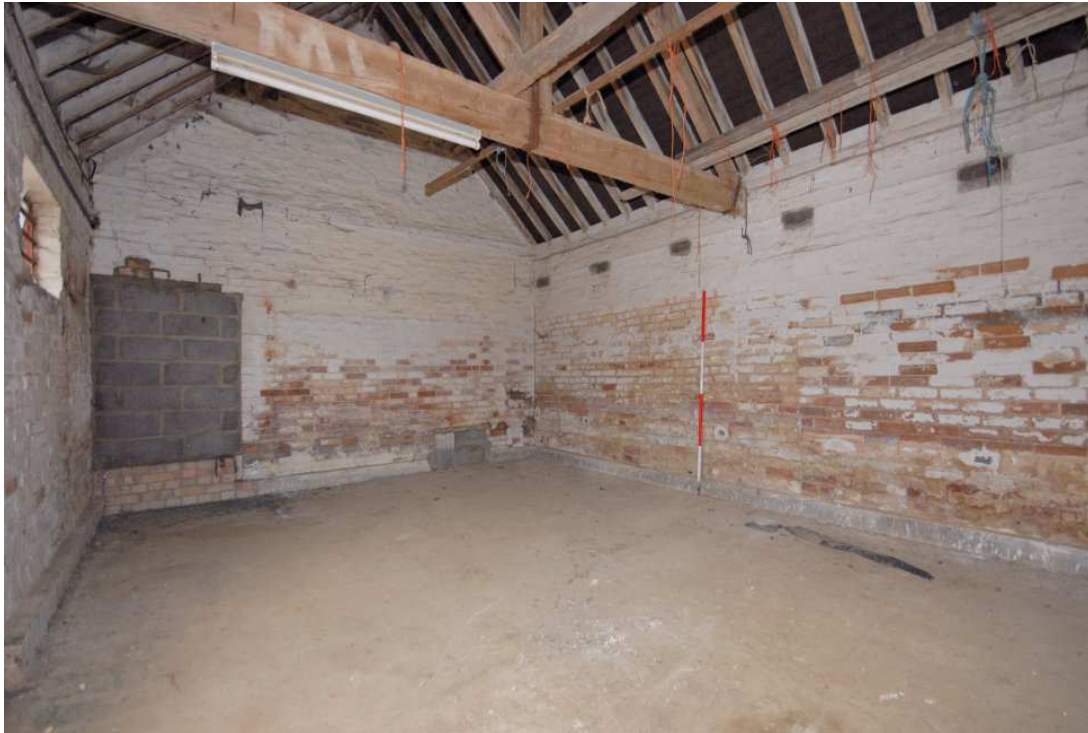
**Image 27:** Long Barn C4, looking south-east

Showing blocked door to 5, concrete shelf at base of wall for sack drying floor and vents in south wall (scale 2m)

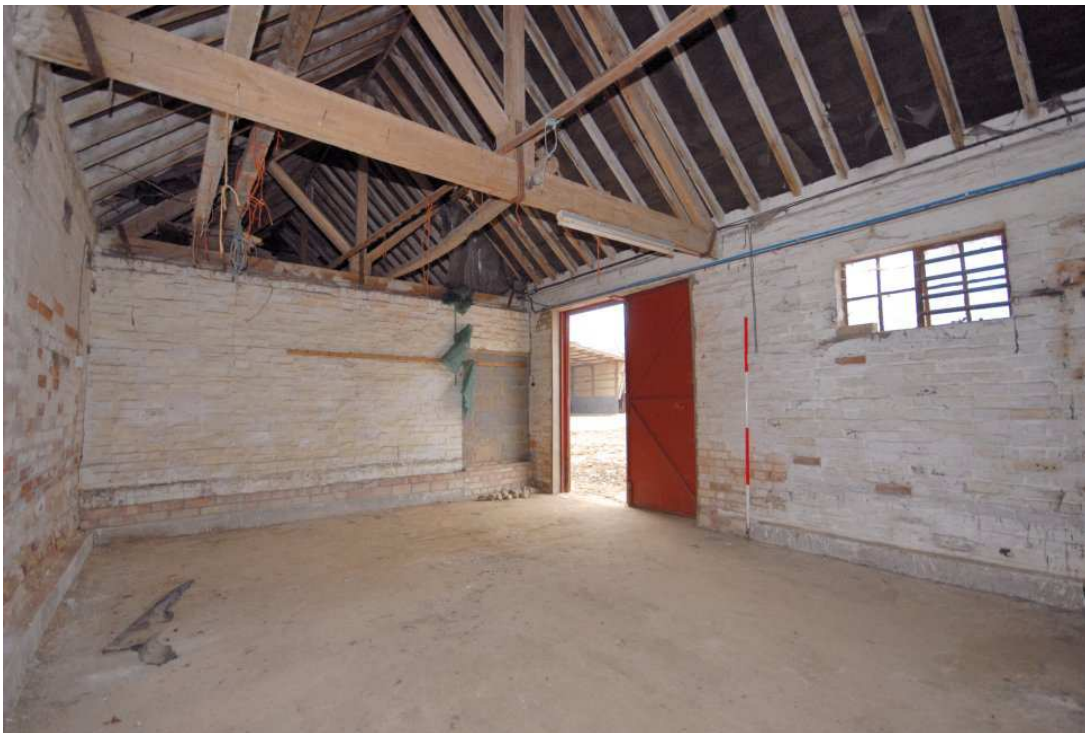
**Image 28:** Long Barn C4, looking north-west

Showing modern double door opening in the corner and blocked former opening with metal-framed window to the right (scale 2m)

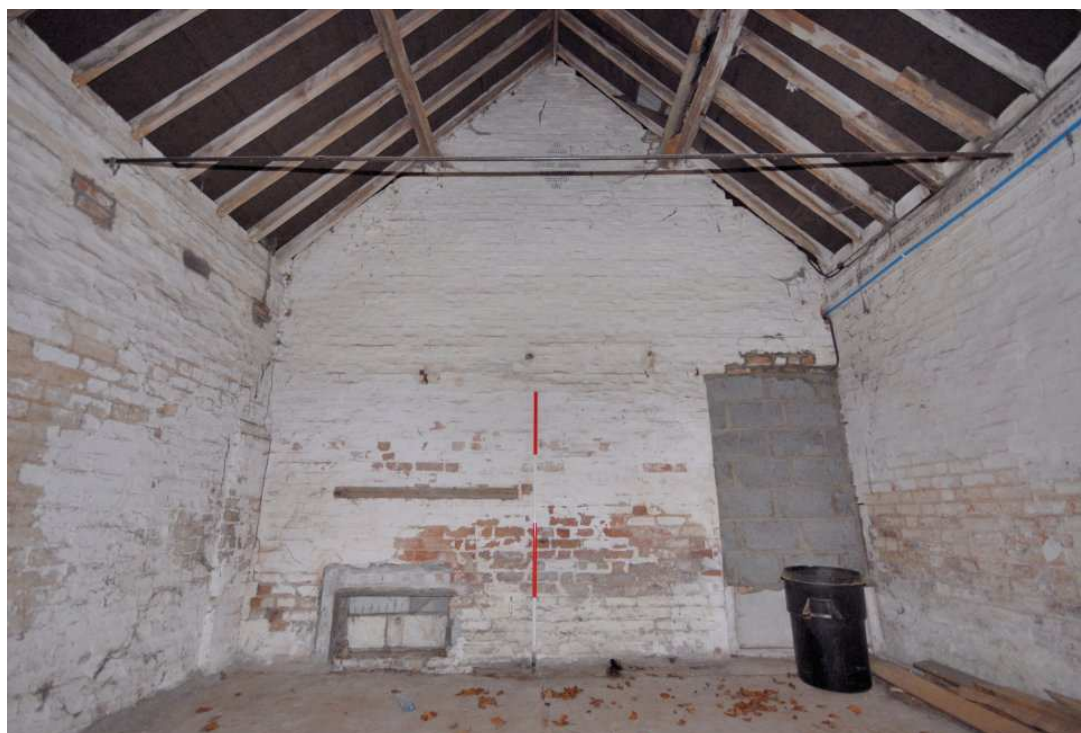
**Image 30:** Long Barn C5, west wall

Showing blocked door to 4 and blocked low-level vent (scale 2m)

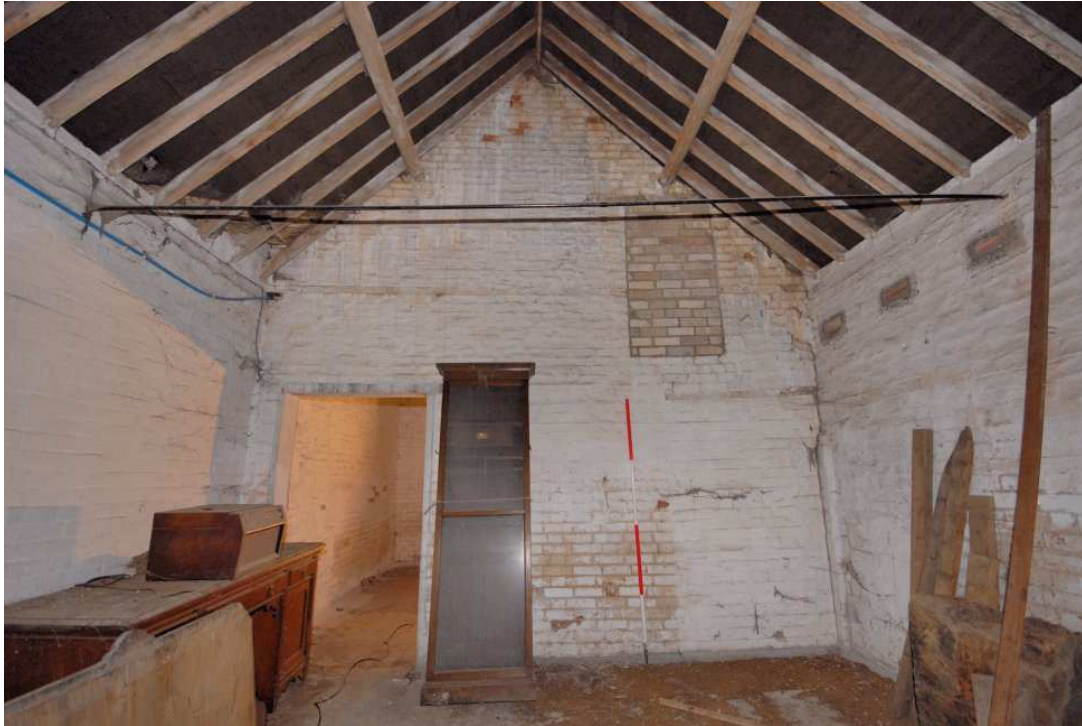
**Image 31:** Long Barn C5, east wall

Showing blocked first floor door. This wall abuts the south wall (at the right of the photograph) in a straight join where it meets the pilaster strip (scale 2m).

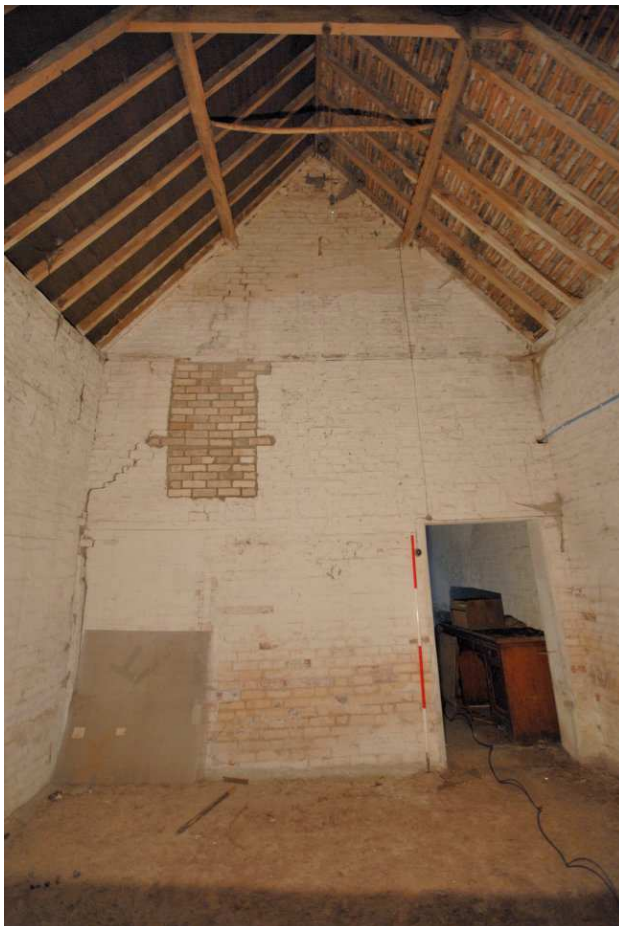
**Image 32:** Long Barn 6, west wall

Showing blocked first floor door  
(scale 2m)
