**BARNS OFF EDENS LANE
CARLTON
BEDFORDSHIRE**

HISTORIC BUILDING RECORDING

Document: 2015/114
Version: 1.0
11th September 2015

Project: EL2692
Bedford Museum Accession Number: BEDFM 2015.52
Oasis reference: albionar1-215336

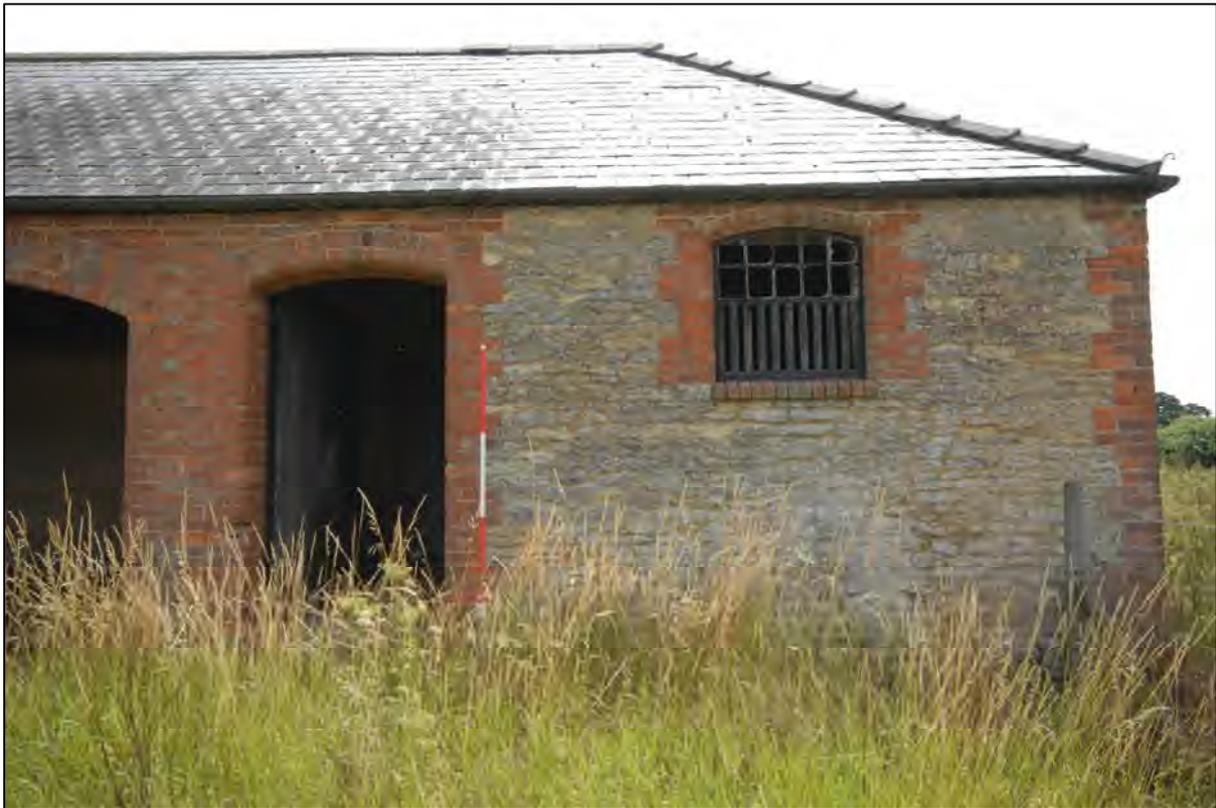
Image 1: Eastern end of north range showing construction details

Walls are constructed either of brick or coursed limestone rubble with brick dressings (Image 1). All of the outward-facing walls around the exterior of the farmyard are in limestone. Almost all of the internal dividing walls are in brick.

Shows limestone rubble with brick dressings and shallow brick arches to openings

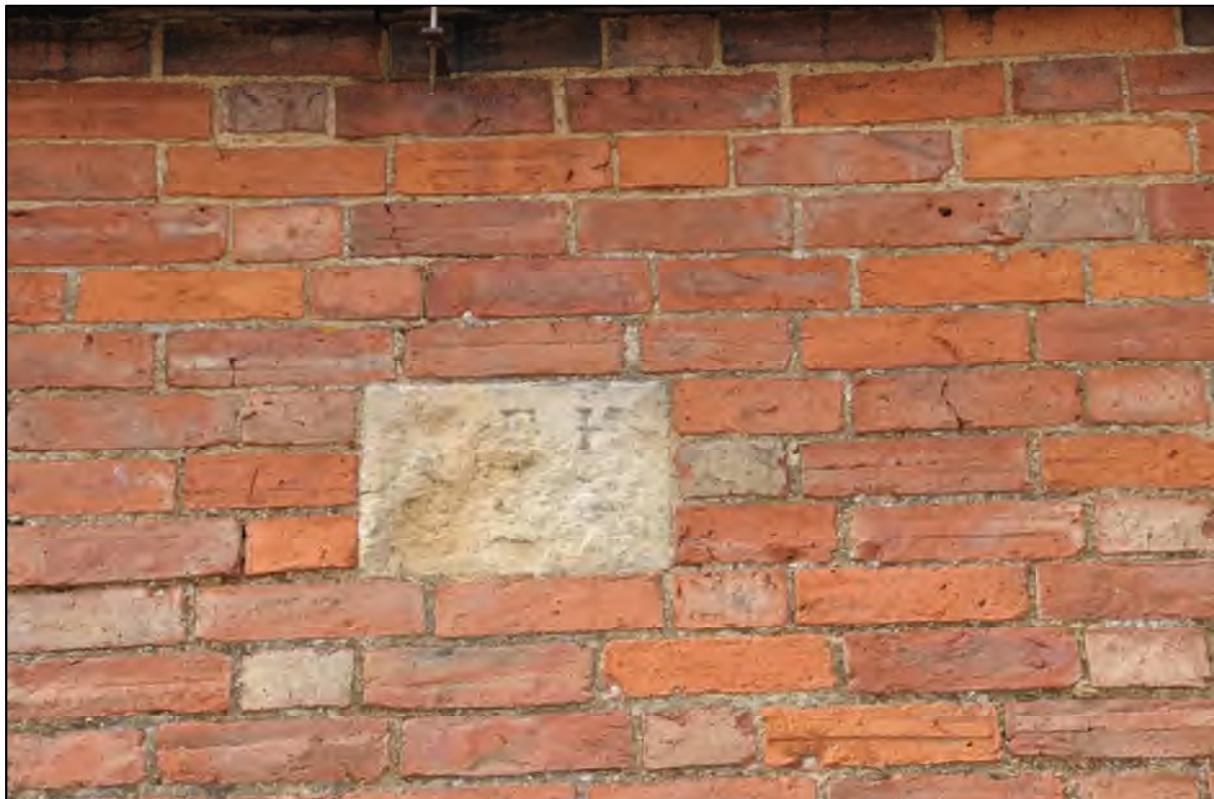
Image 2: Brickwork in south wall of north range

The brick is a handmade red brick with fairly regular dimensions (225mm x 110mm x 65mm) (Image 2). The bricks include some yellowish and light blue-grey over-fired examples. Bricks with a yellow vitrified exterior are particularly noticeable as headers in the south wall of the barn in the north range. The bricks have longitudinal pressure marks and occasional longitudinal or diagonal kiss marks. Special bricks consist of corner chamfer and bullnose bricks. The brickwork is laid in Flemish garden wall bond, also known as Sussex bond, which has three stretchers to one header. Some irregularity is evident in the brick bond. Brick dressings consist of triple brick quoins at the openings and corners of the limestone walls and three courses of brick with a central dogtooth course on the verge at the gable ends (Image 3).

Shows use of Flemish garden wall bond and weathered date stone

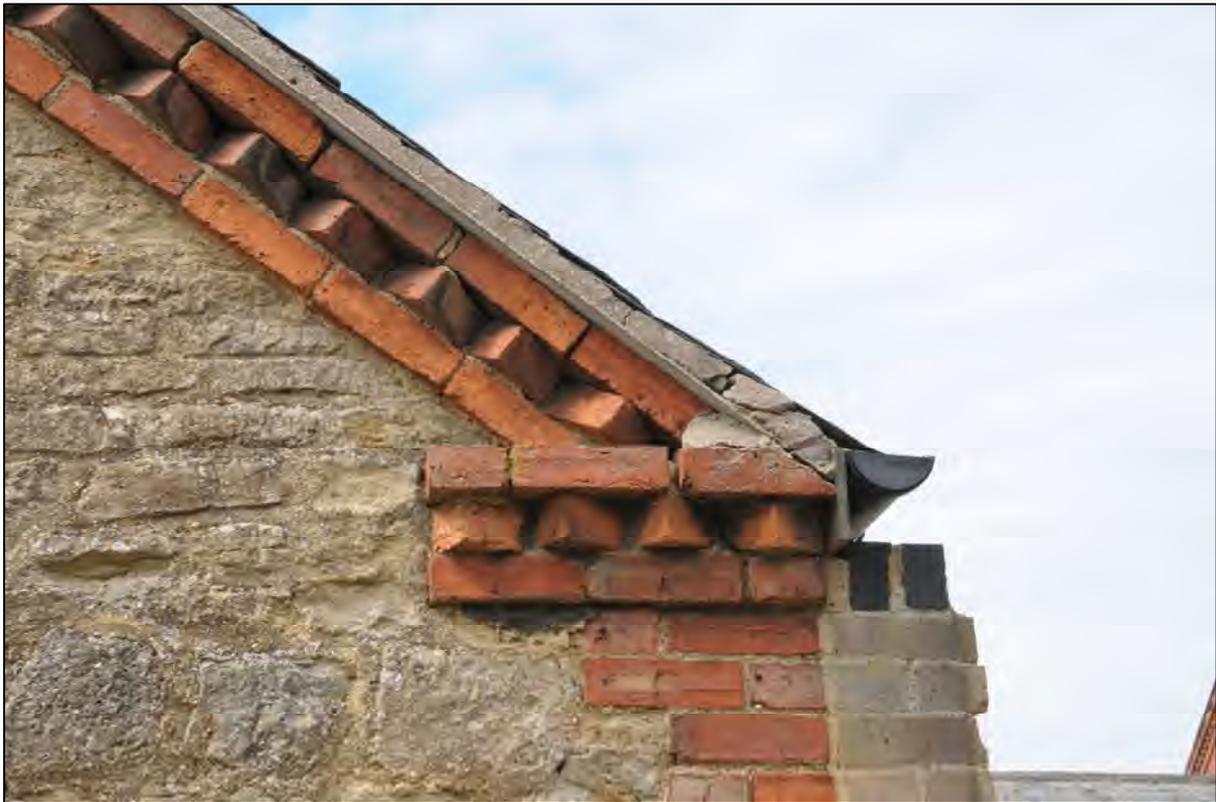
Image 3: Brickwork on south gable end of west range
Shows dogtooth detail used on gable ends

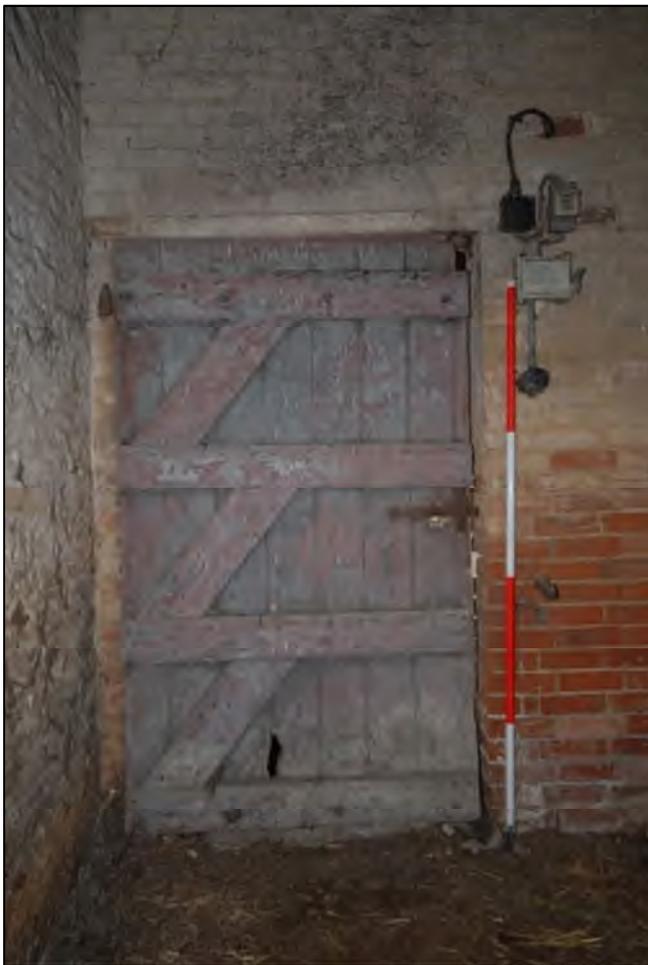
The doors consist of ledged-and-braced doors with short diagonal braces (Image 4). The hinged doors are fitted with strap hinges on pintles. Two large doorways in the north elevation are fitted with sliding doors hung with rollers on rails above the openings (Image 5). Evidence for smaller, internal sliding doors survives in the east range where iron rails remain over some of the blocked door openings.

Image 4: Typical door construction
Ledged and braced door with four ledges
and short braces on the hinge side of the
door

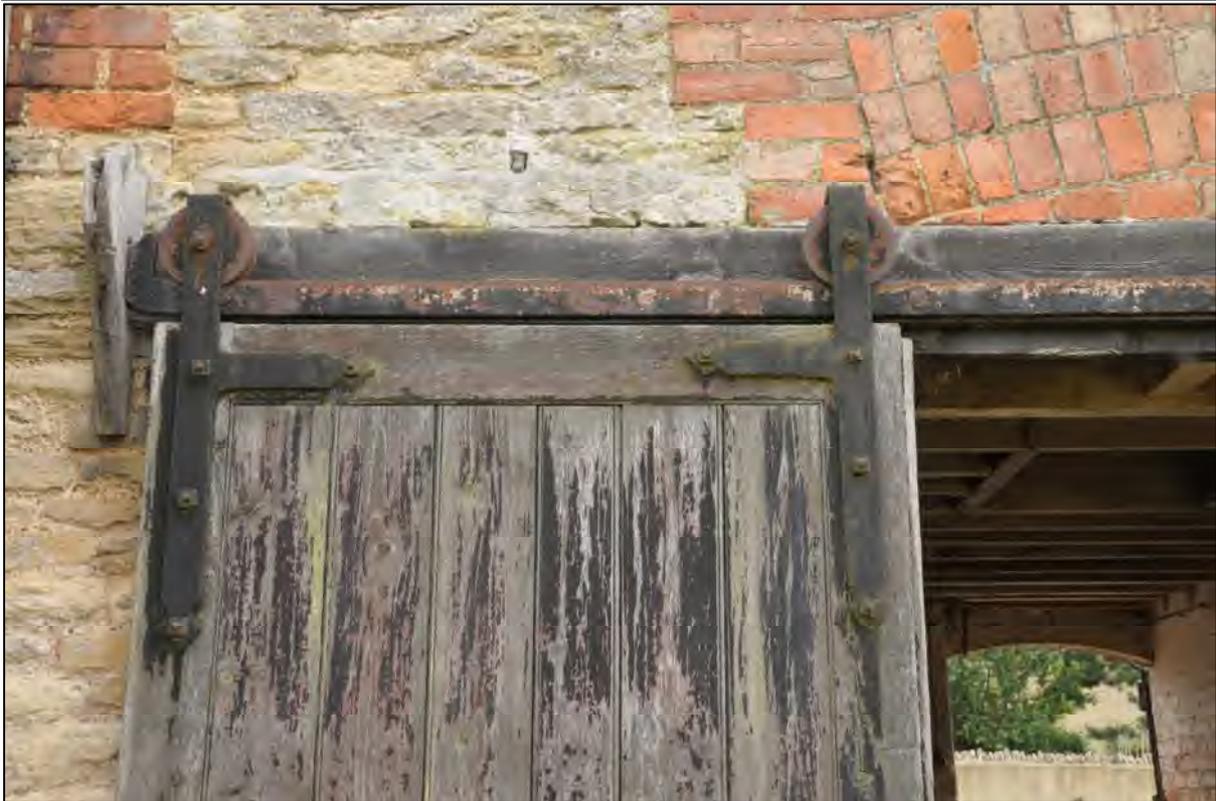
The large sliding doors in the north elevation are suspended from rollers that run on a rail fixed above the door (Image 5). T-shaped iron straps fixing the rollers to the doors have shaped terminals matching those found on the strap hinges.

Image 5: Exterior sliding door on the north range
Shows fittings of the door to compartment C4

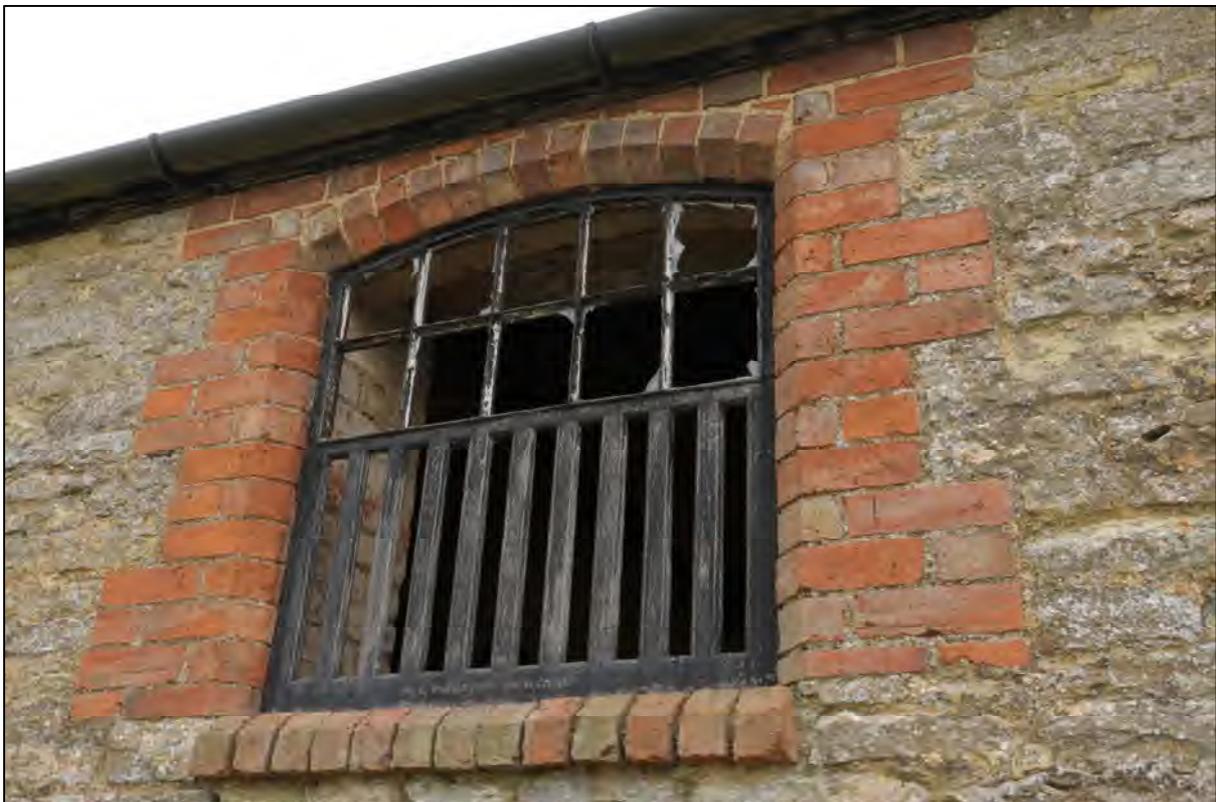
Image 6: Cast iron window in the north range

Window to compartment C2 has glazed upper part and slatted lower part with cast maker's name along lower edge (E L MOULTON BEDFORD)

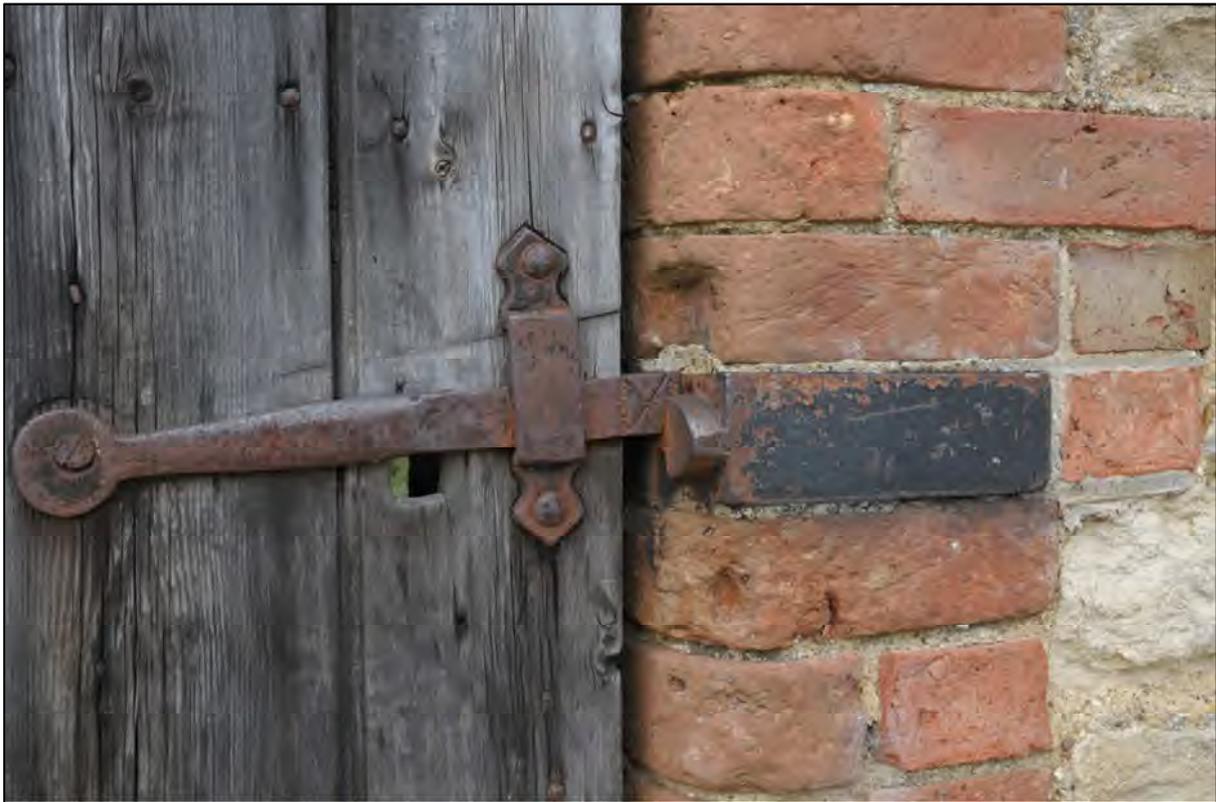
Image 7: Cast iron latch fastener and iron latch

Shows latch fastener built into brickwork and standard form of latch used

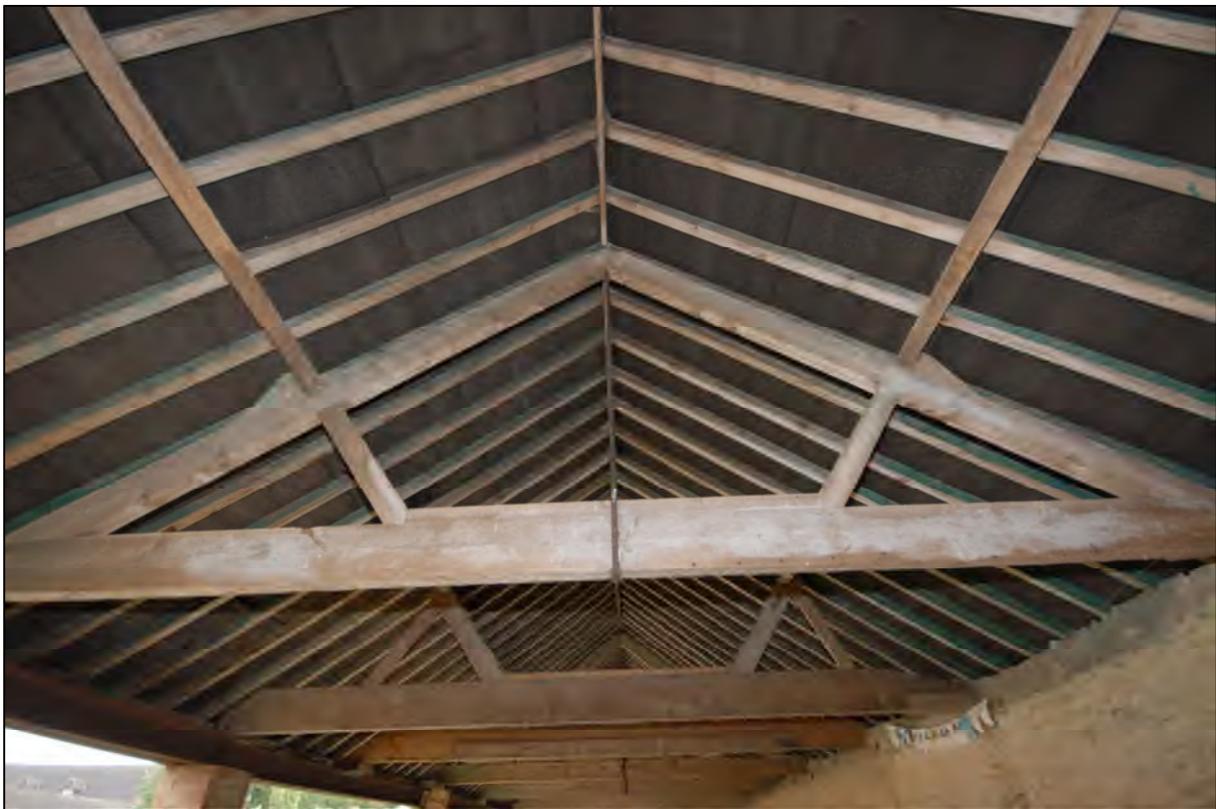
Image 8: Roof over compartment C1

The roof is of machine-sawn softwood. Throughout the buildings the roof trusses, with the exception of some modern replacements, are of the same pattern (Image 8) — king post trusses with an iron rod as the king post. A loop at the lower end of the rod passes around the tie-beam. At the lower end the rafters are notched into the tie-beam and at the top they meet in a mitred joint with a metal plate over the top of the joint. The king post rod is bolted through the metal plate. There is a single raking strut on each side. Some of the wood retains traces of marking out in pencil.

Shows the type of king post roof trusses which are used throughout the building

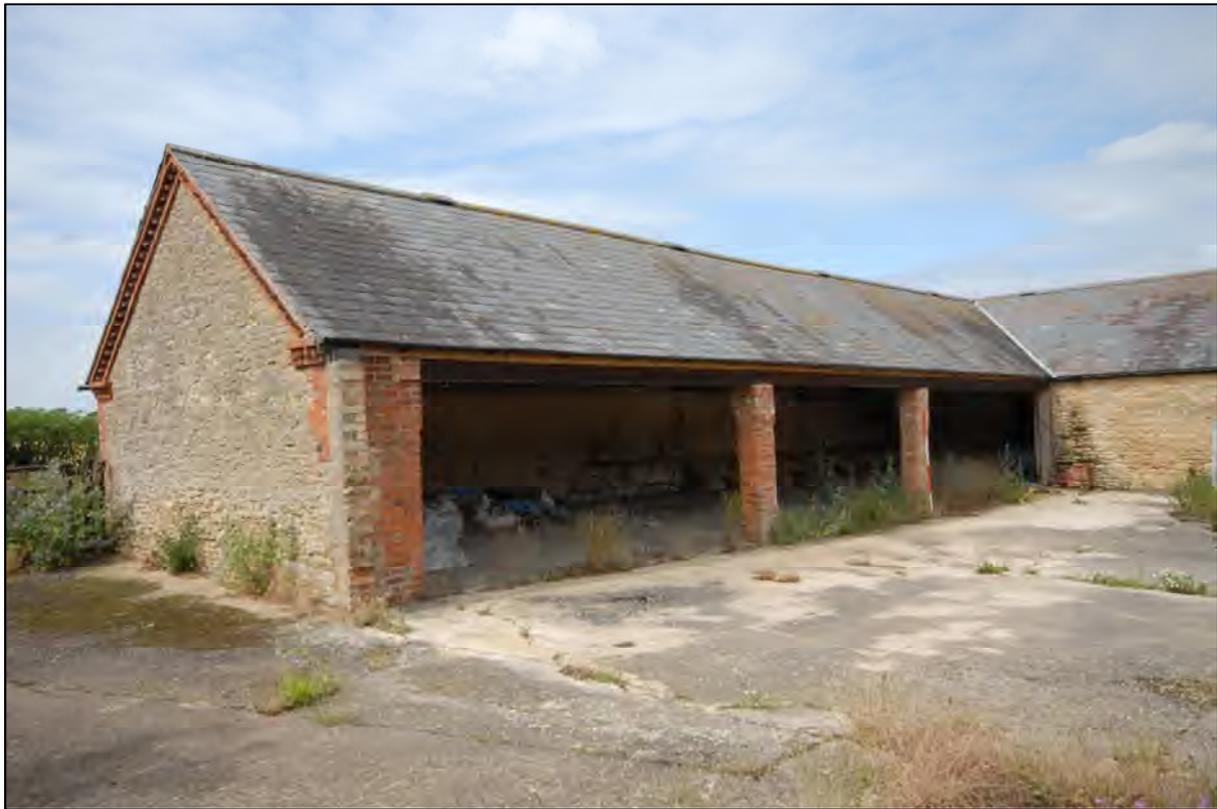
Image 9: Exterior of west range from the south-east
Showing open fronted shelter shed C1 facing the farmyard

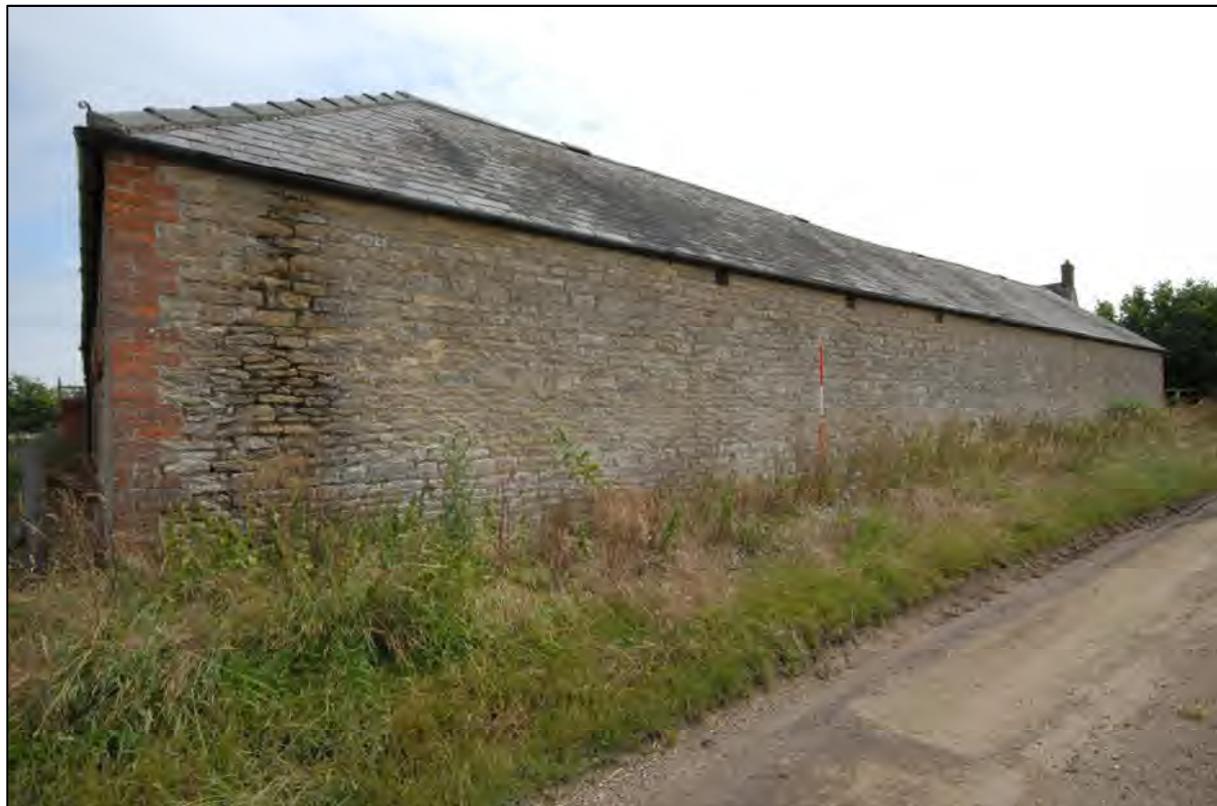
Image 10: Exterior of west range from the north-west
Showing hipped roof at north end and blank limestone wall facing roadside

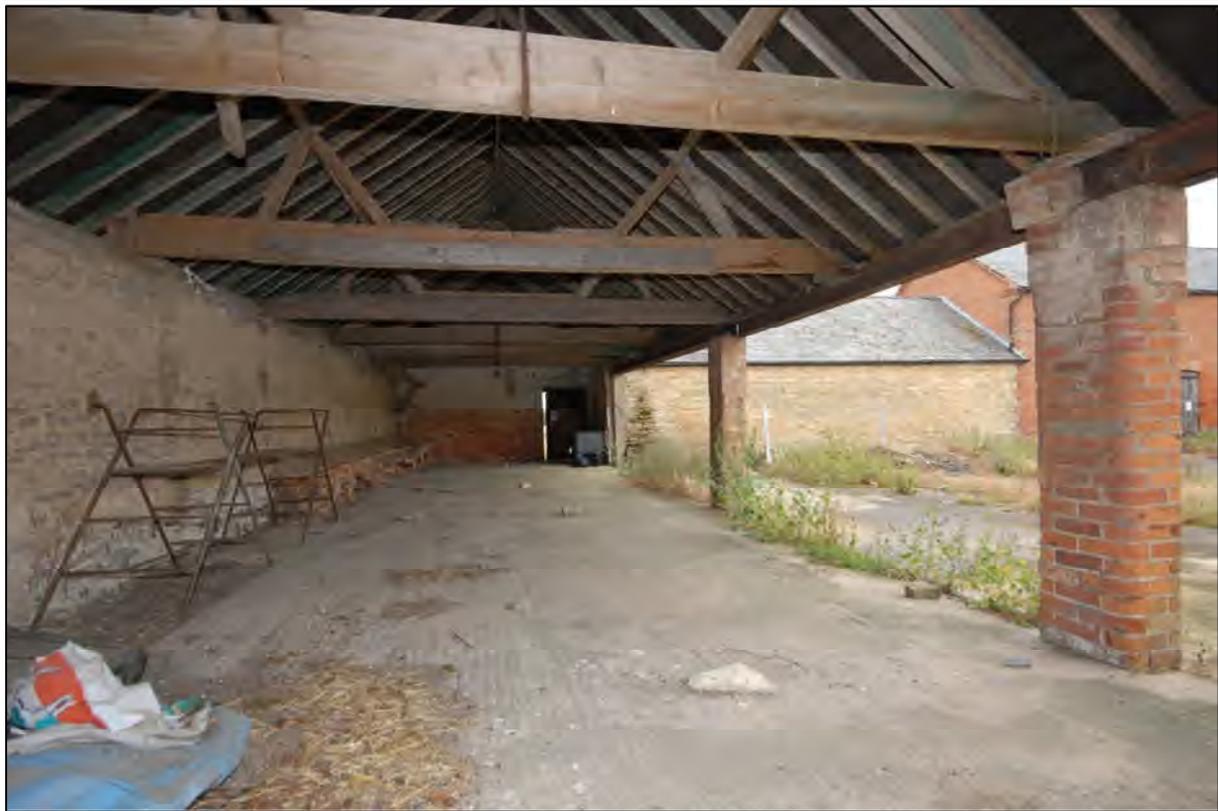
Image 11: Compartment C1, view looking north

It is clear that the open front of this compartment was modified during the 20th century with the insertion of RSJ lintels and a modern brick pier. It is likely that in the original arrangement there would have been six brick piers with either wooden lintels or brick arches in the openings.

Showing eastern side supported by two brick piers and steel beams at the eaves

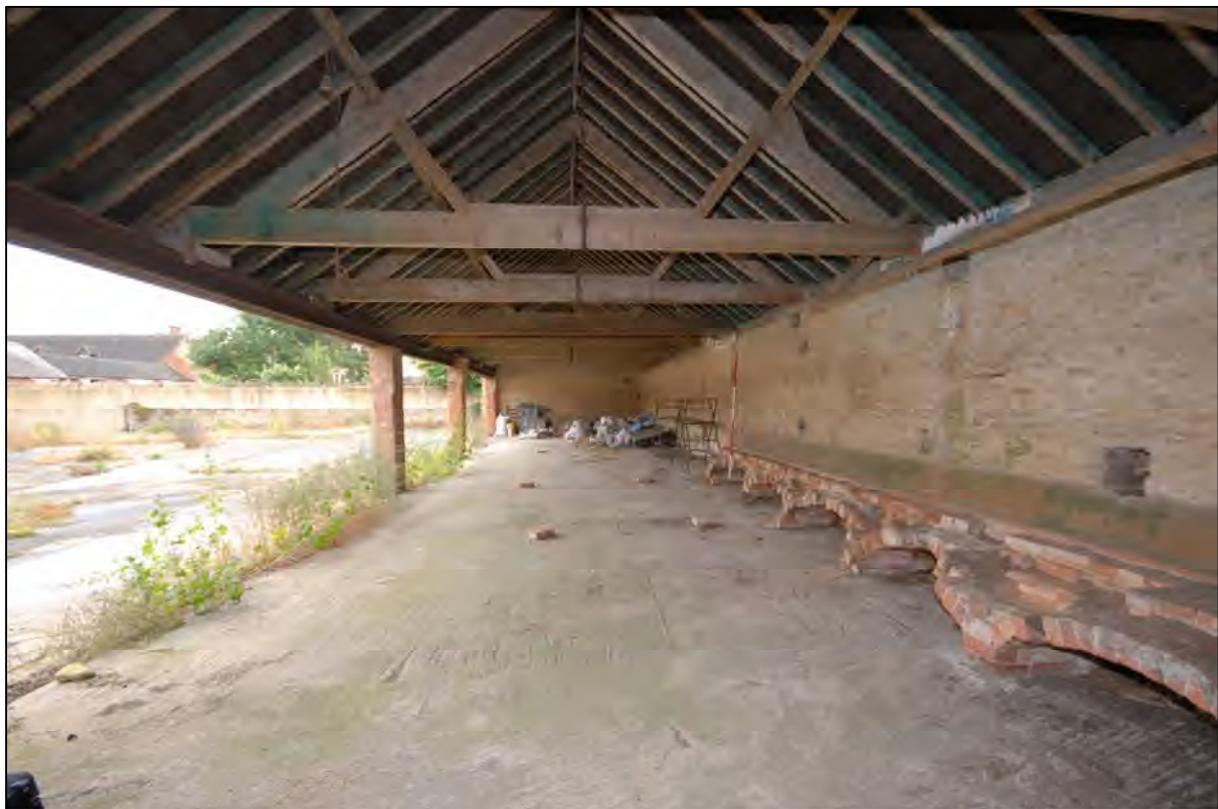
Image 12: Compartment C1, view looking south

Showing roof trusses and brick-built trough along northern section of back wall

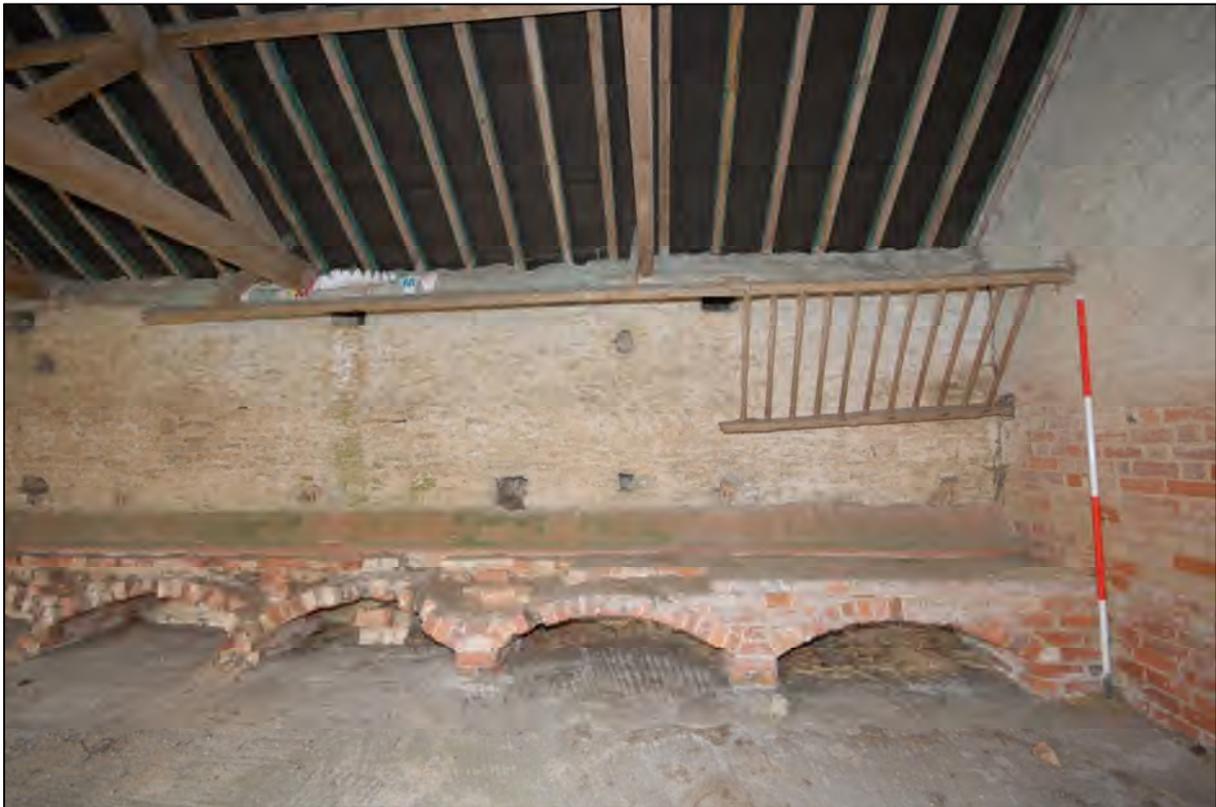
Fittings in this compartment comprise the remains of a brick feed trough and a wooden manger against the back wall in the northern part of the compartment. The trough is supported on six brick arches and measures 770mm wide and 9.4m long (Images 12 and 13). It is lined with large unglazed brick paviments or tiles. Only its northernmost section survives substantially intact. The wooden manger is attached to the tie-beams above and only its northern end survives intact (Image 13).

Image 13: Compartment C1, detail of brick trough and hay rack
Shows remains of wooden hay rack and brick trough at north end of C1

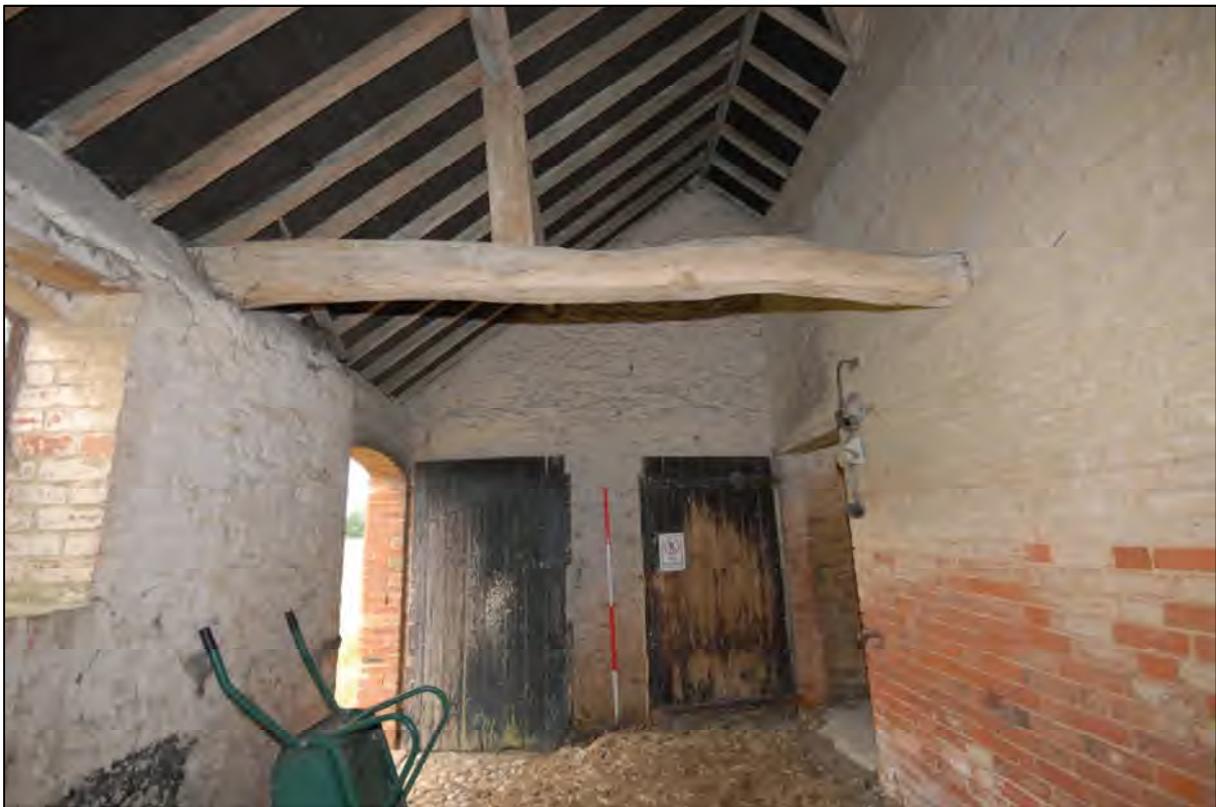
Image 14: Compartment C2, view looking east
Showing exterior door in north wall and interior door to C1 at right

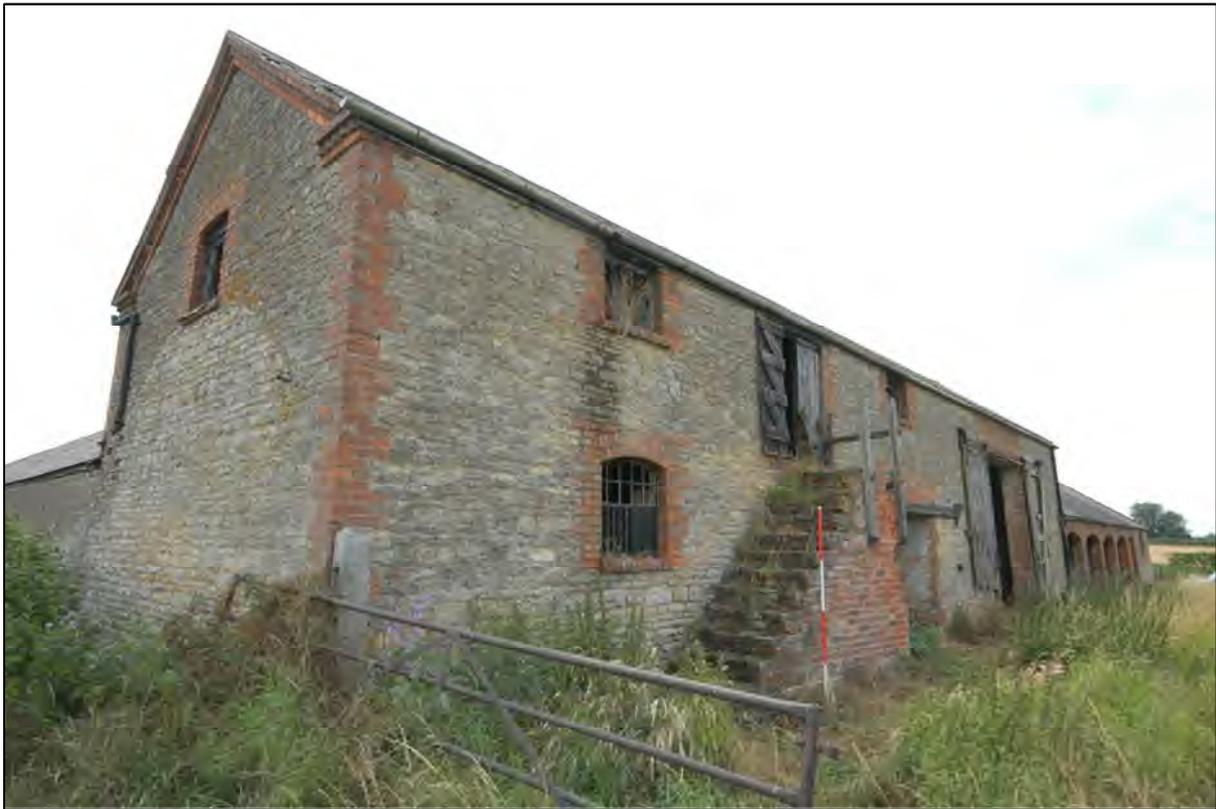
Image 15: Exterior view of north range, looking south-west
Showing two-storied section (C5, C6 and C7) in foreground

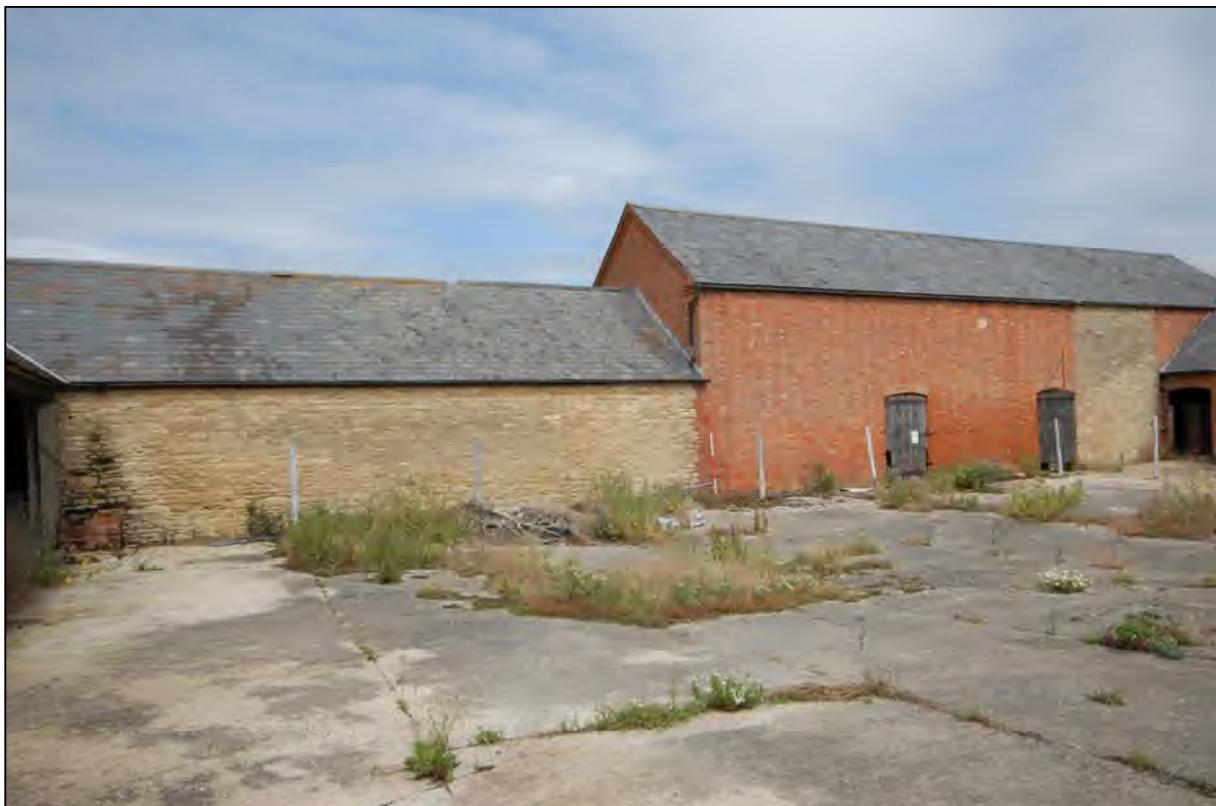
Image 16: Exterior view of north range, looking south-west

View from farmyard showing limestone and brick construction. The brick wall at mid-right is the south wall of barn C4 with a date stone visible near the top (Image 2).

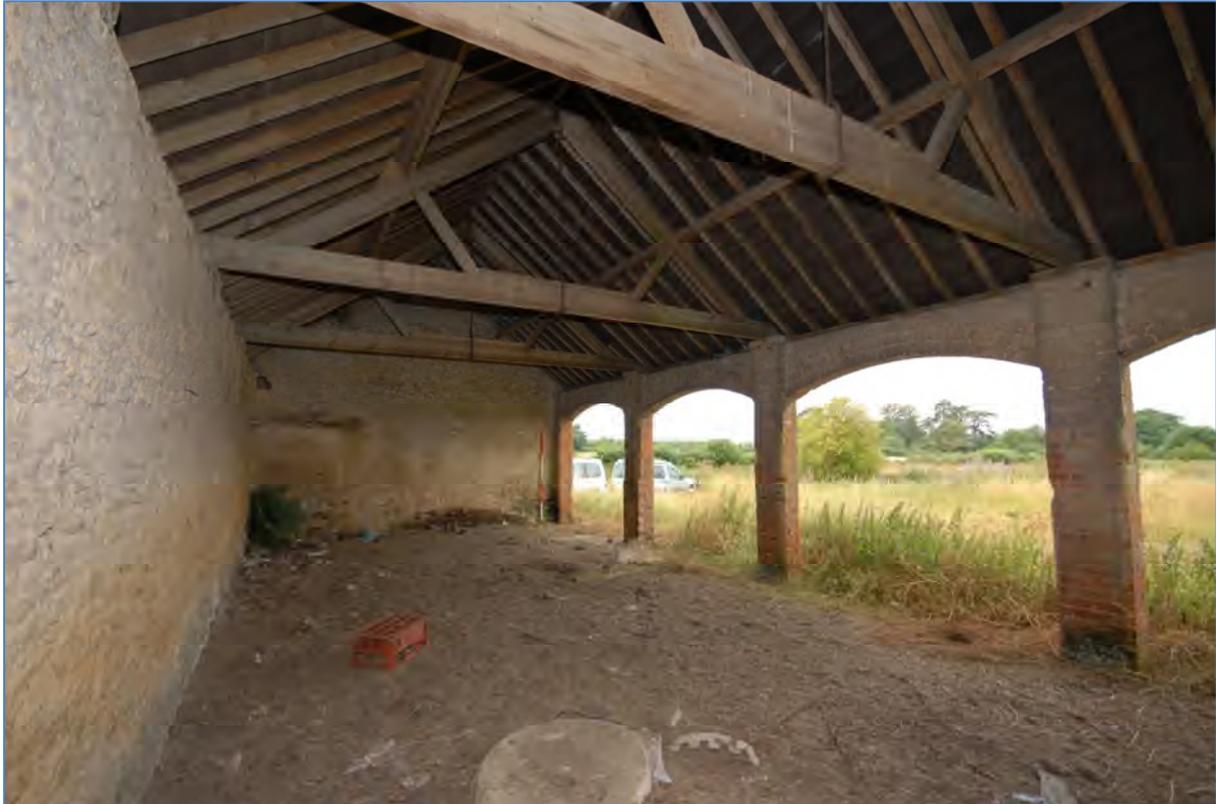
Image 17: Exterior view of north range, looking south-west
Showing brick piers and arches supporting open side to the north

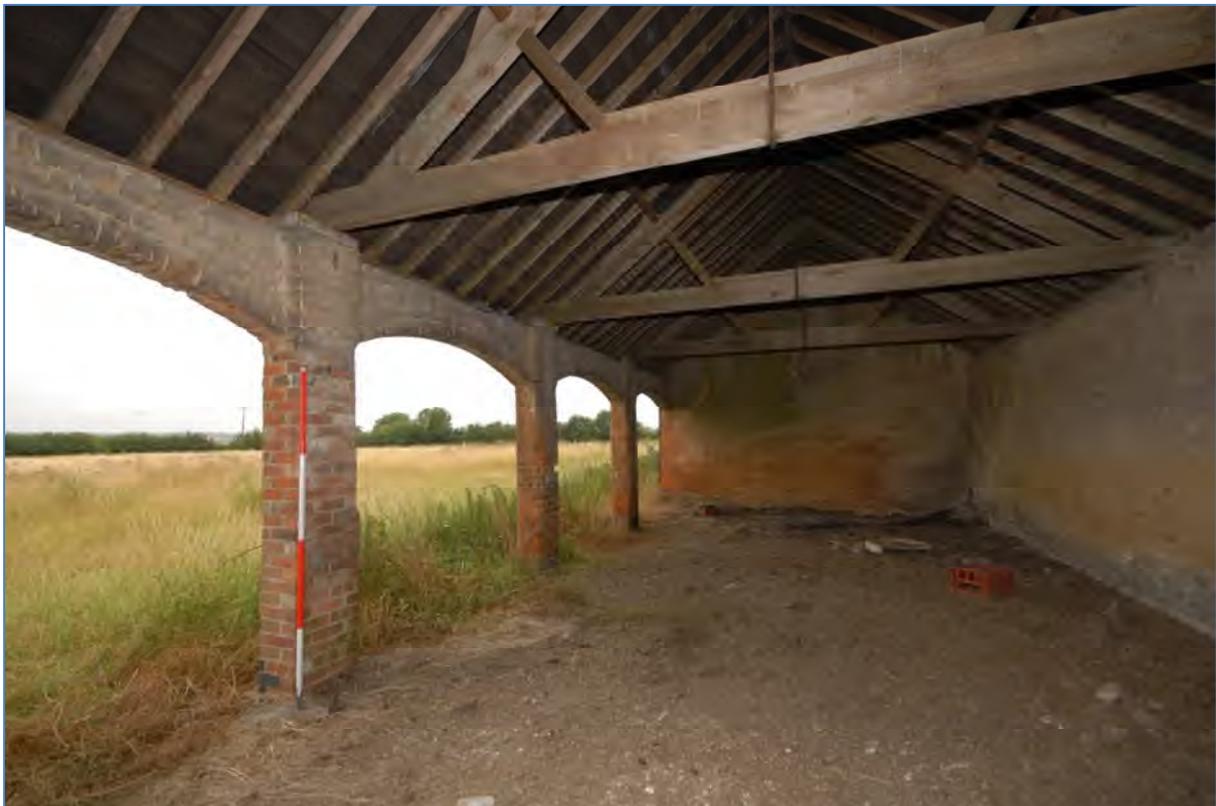
Image 18: Compartment C3, view looking east
Showing brick piers and arches supporting open side to the north

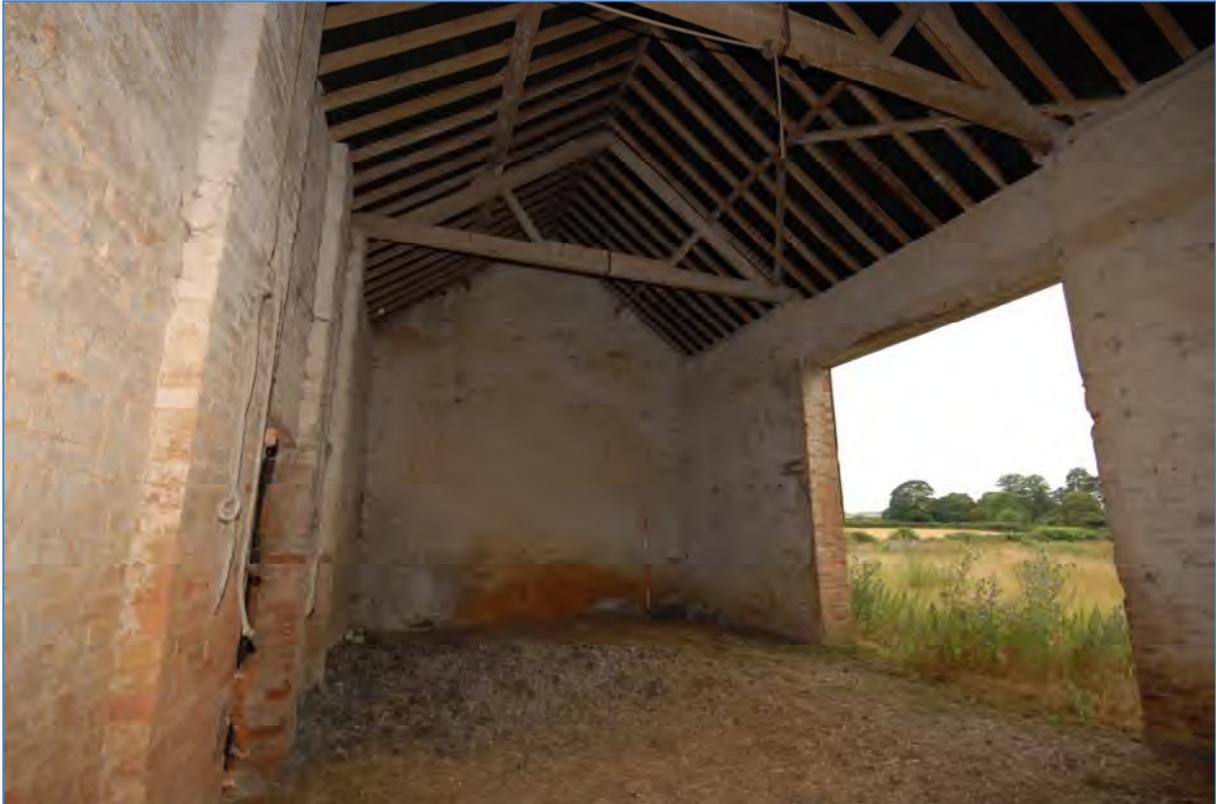
Image 19: Compartment C4, view looking west

Showing full-height door opening in north wall and diagonal braces in roof structure

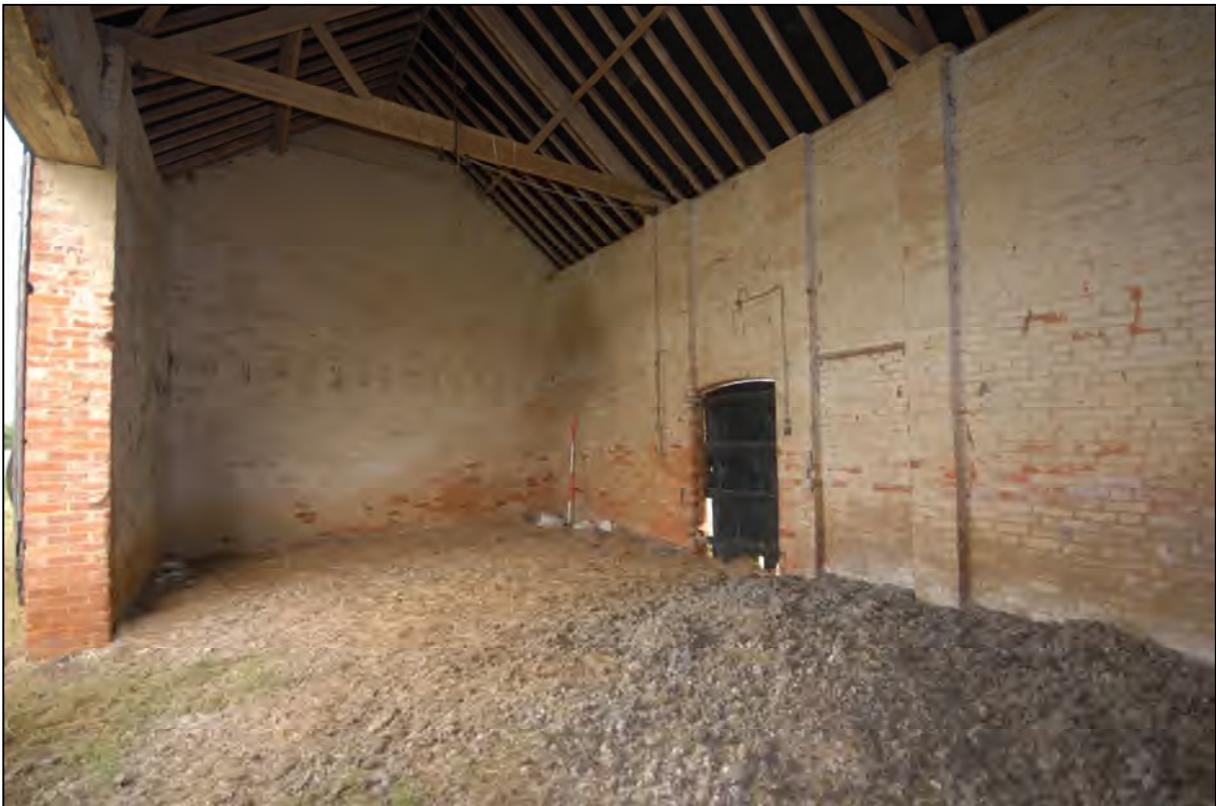
Image 20: Compartment C4, view looking east

Showing brick southern wall with pilaster strips and single door

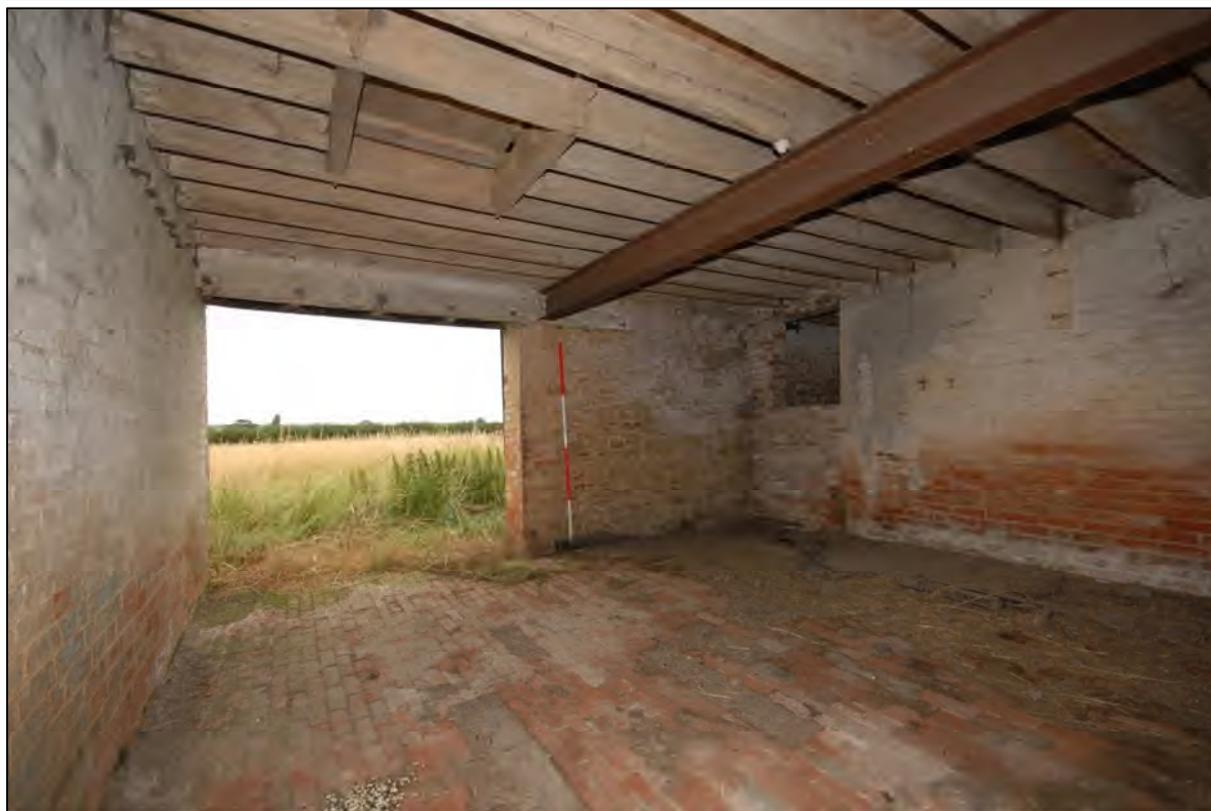
Image 21: Compartment C5, view looking north-east

Showing north doorway, first floor trap door and partly blocked opening in east wall

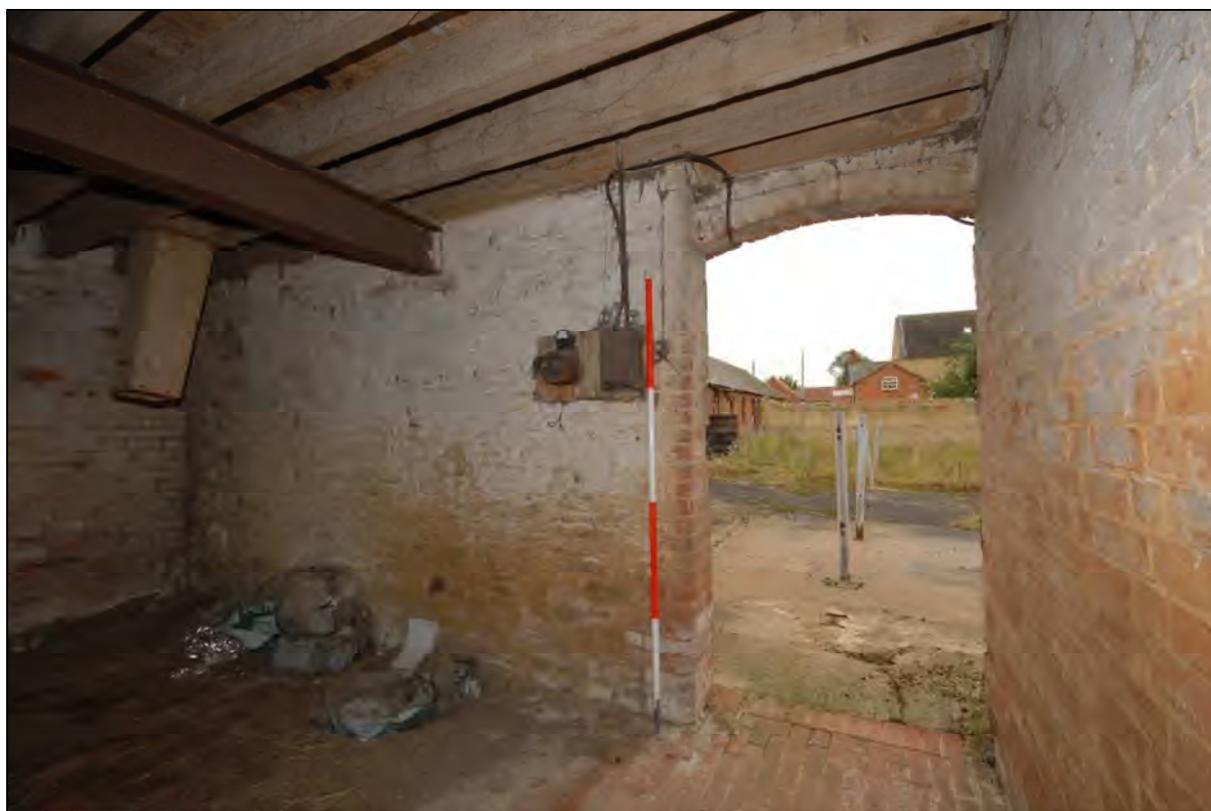
Image 22: Compartment C5, view looking south

Showing doorway to farmyard and wooden chute from first floor at left-hand side of image
