**BARNS OFF EDENS LANE
CARLTON
BEDFORDSHIRE**

HISTORIC BUILDING RECORDING

Document: 2015/114
Version: 1.0
11th September 2015

Project: EL2692
Bedford Museum Accession Number: BEDFM 2015.52
Oasis reference: albionar1-215336

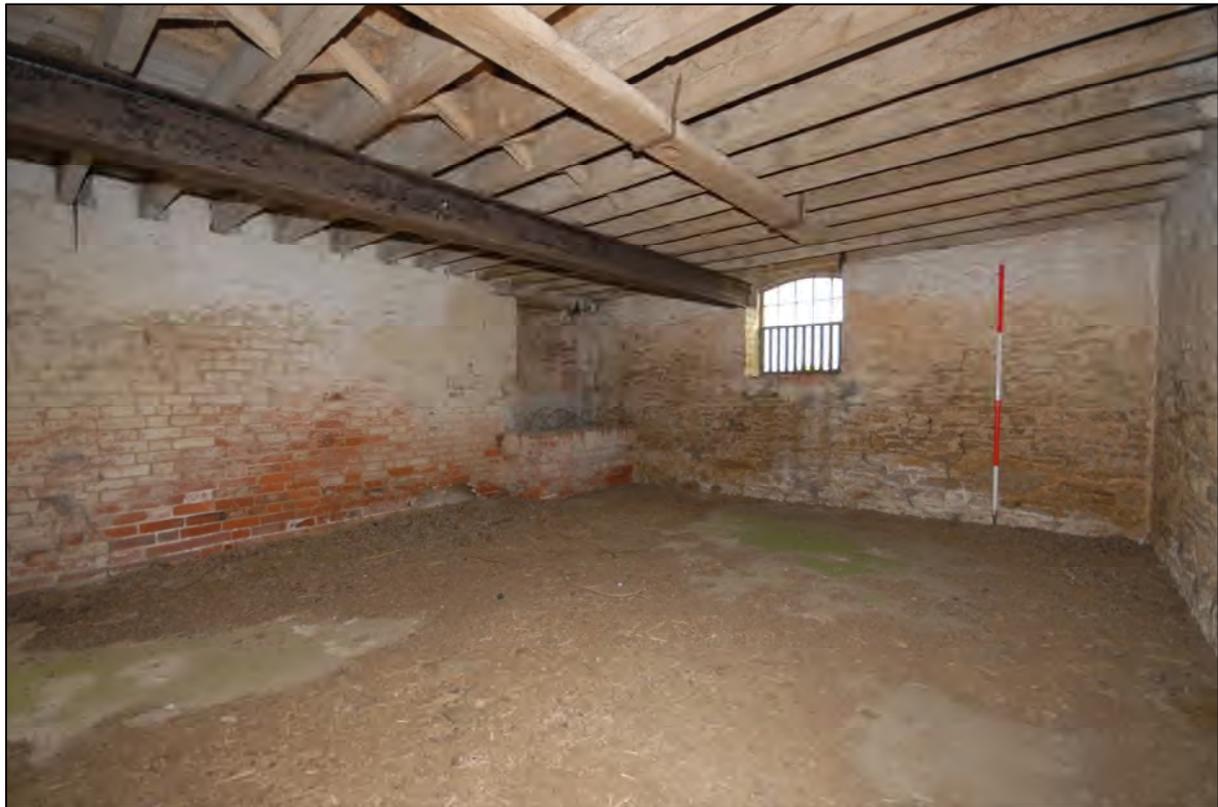
Image 23: Compartment C6, view looking north-west

Showing partly blocked opening in west wall, feed trough and cast iron window in north wall

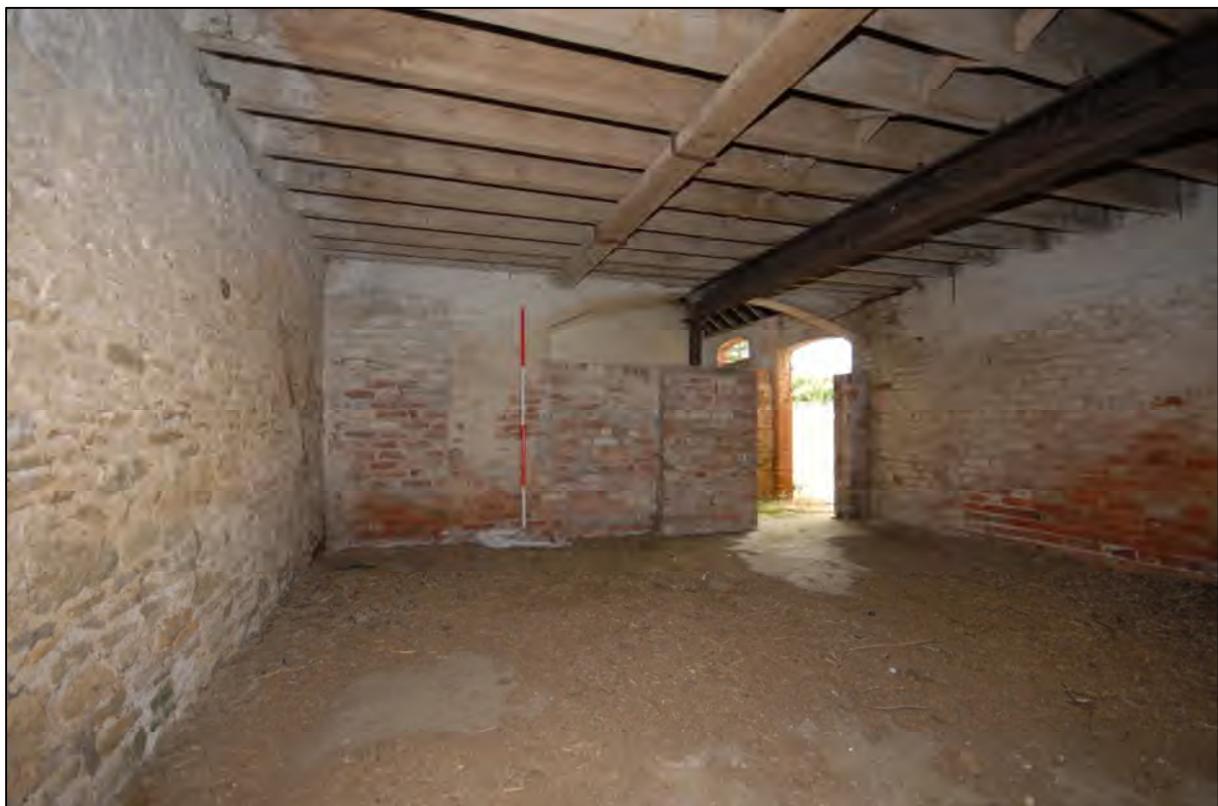
Image 24: Compartment C6, view looking south

Showing blocked door and partly blocked opening in south wall. An inserted steel beam, herringbone strutting and support for possible stall dividers is visible at ceiling level.

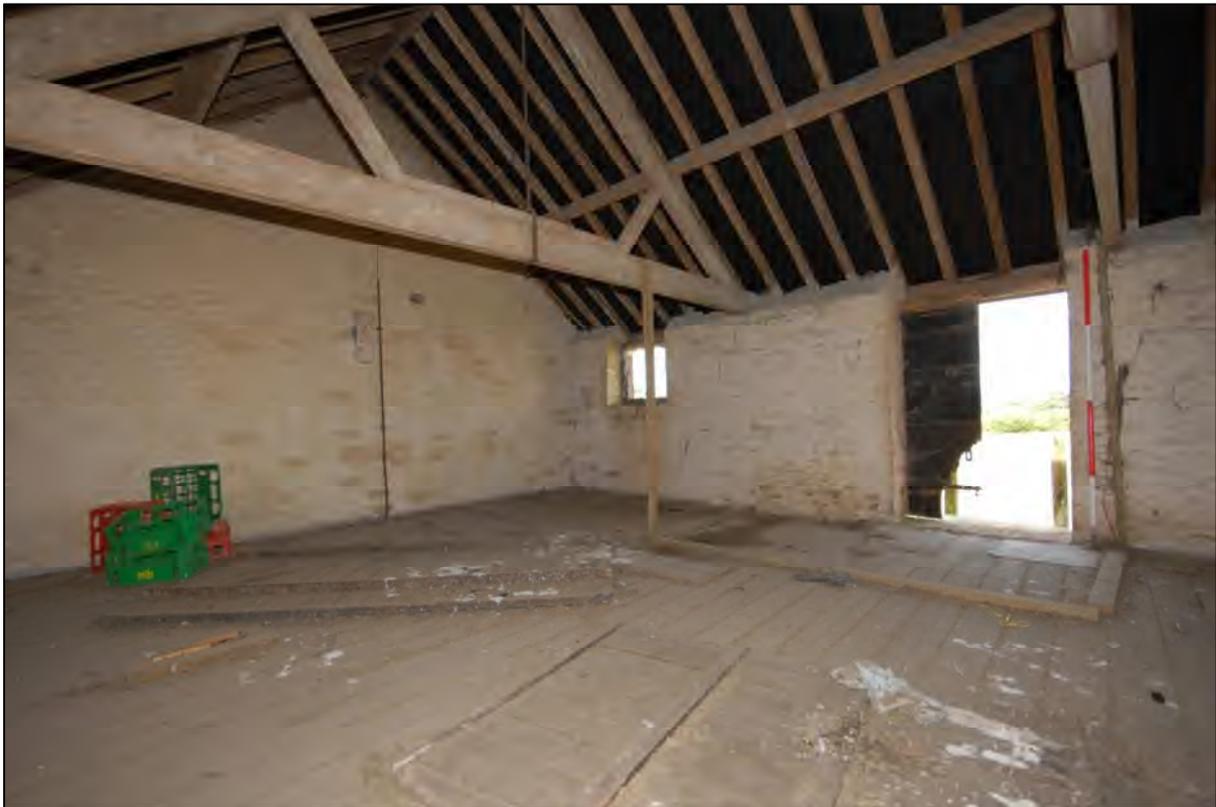
Image 25: Compartment C7, view looking north-west

Showing double door and window in north wall. A trap door is located close to the west wall.

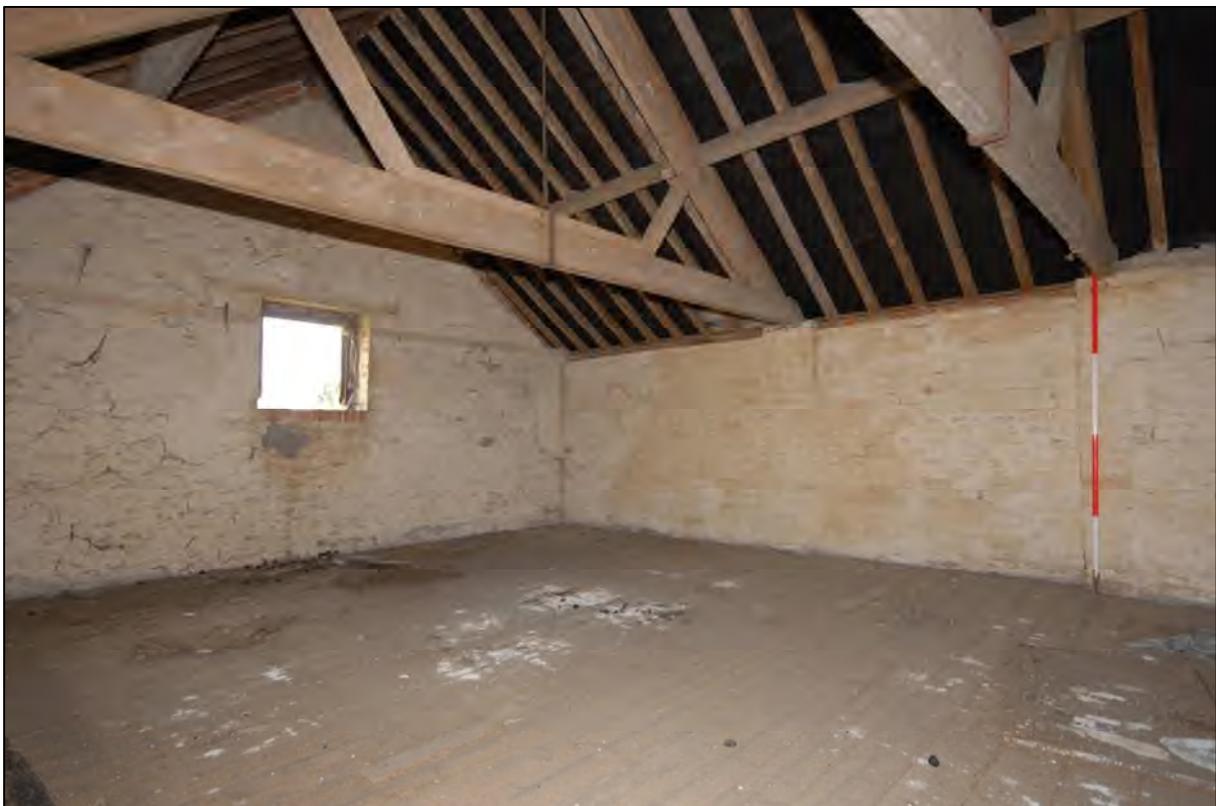
Image 26: Compartment C6, view looking south-east

Showing window in west gable end and mixed brick and stone construction in south wall

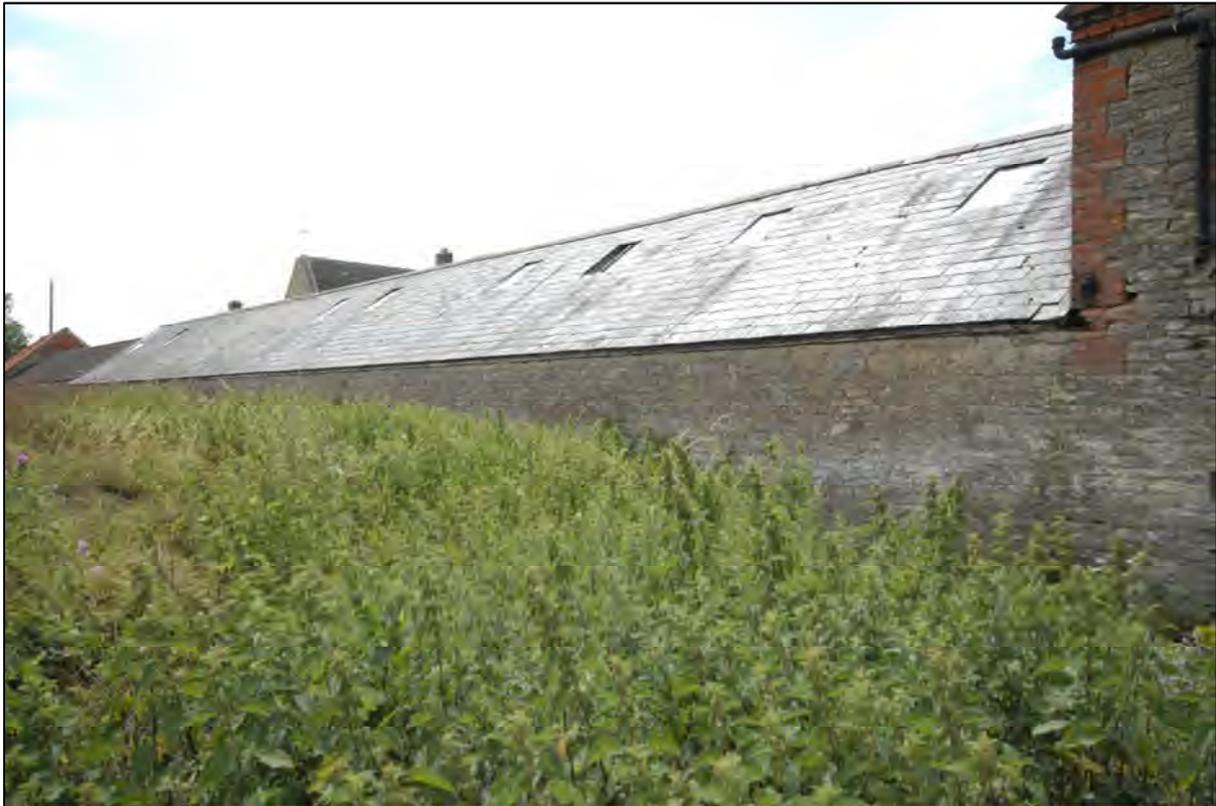
Image 27: Exterior view of east range, looking south-west
Showing the outward-facing east elevation

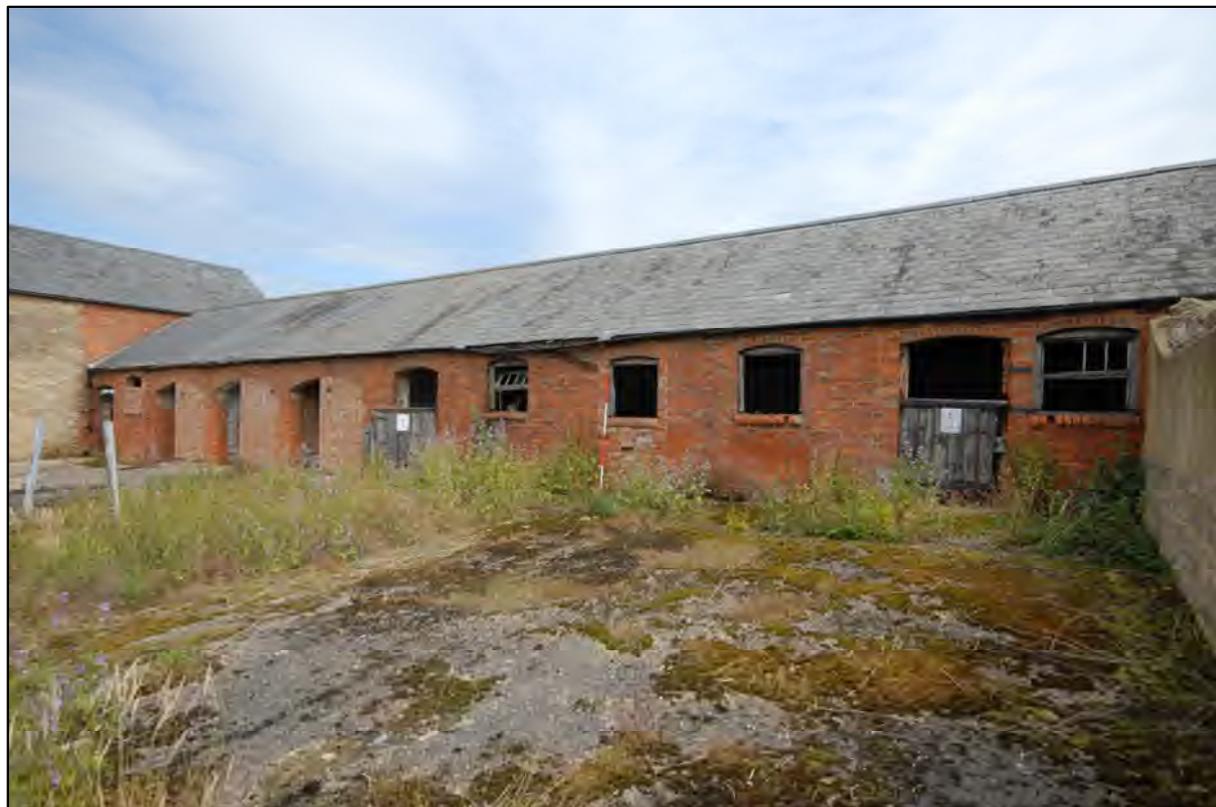
Image 28: Exterior view of east range, looking north-east
Showing the west elevation facing the farmyard

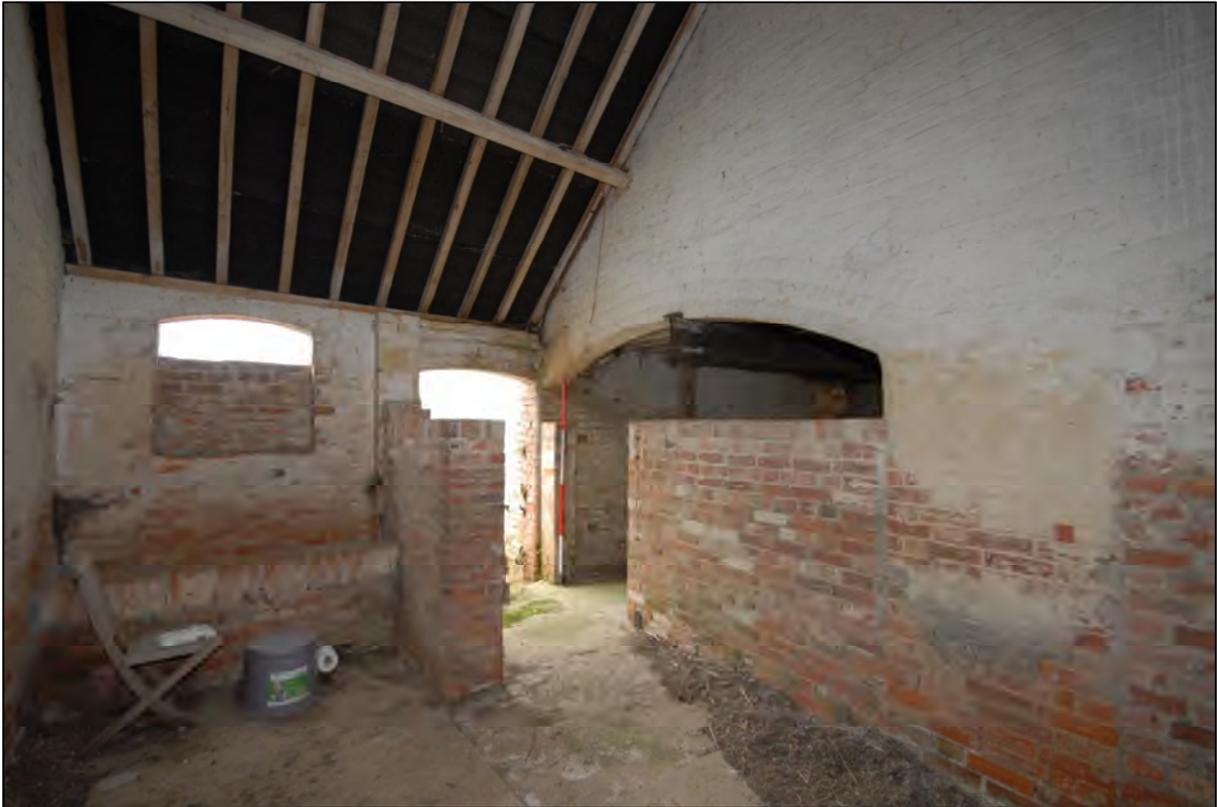
Image 29: Compartment C8, view looking west

Towards the right-hand side a grey mark on the wall indicates the former location of the end of a trough between the wide arch and a blocked door opening.

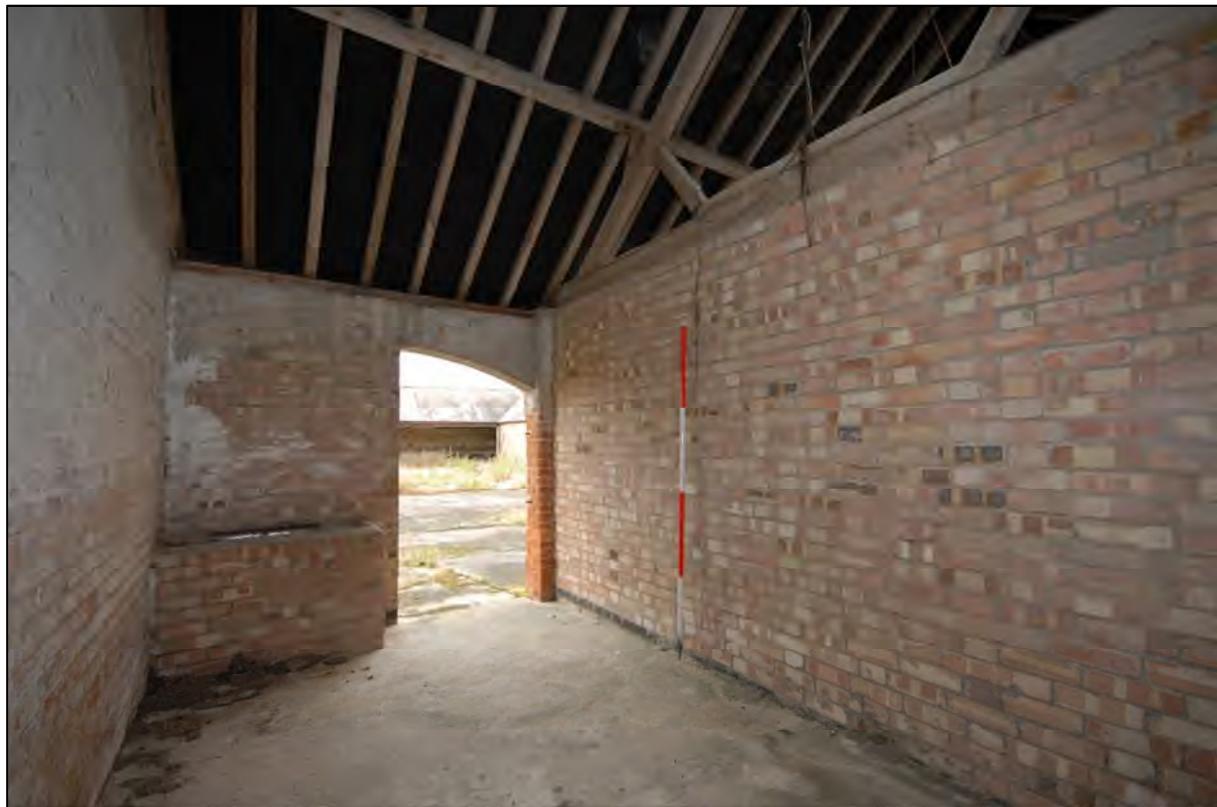
Image 30: Compartment C9, view looking west

Showing inserted brick partition wall to right and partially blocked arched opening in west wall

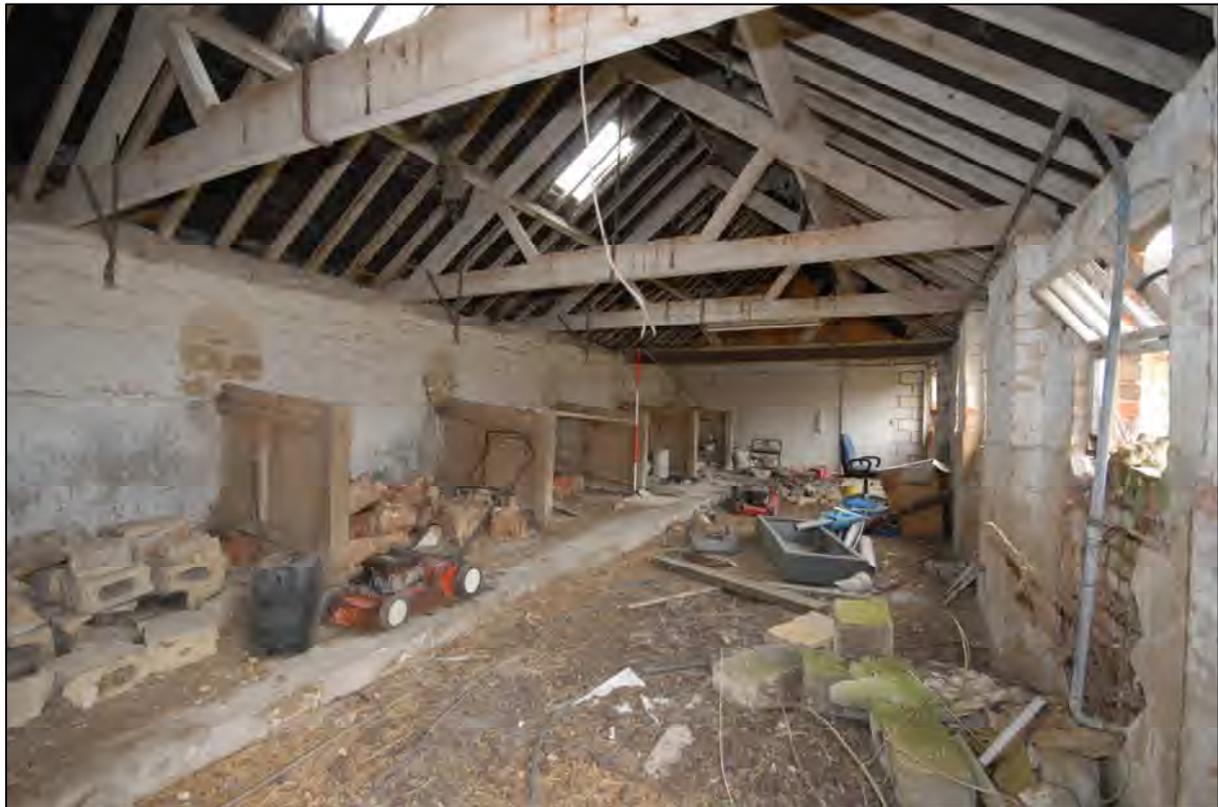
Image 31: Compartment C10, view looking south

Showing concrete platform with wooden stalls along east wall

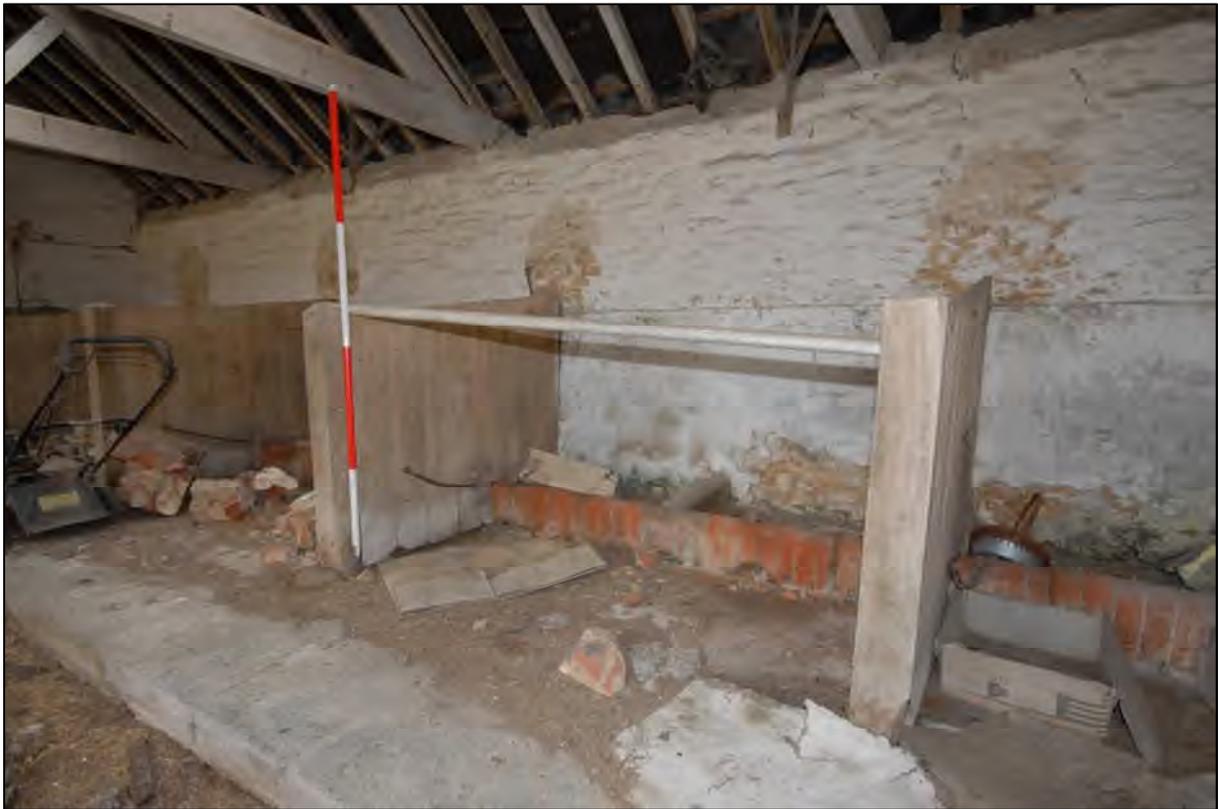
Image 33: Compartment C10, showing stalls and feed trough

Showing raised concrete platform with brick feed trough and wooden stall dividers
