34 BEDFORD ROAD
WILSTEAD
BEDFORDSHIRE

HISTORIC BUILDING RECORDING

Document: 2016/38
Version: 1.0
2016

Project: BR2723
Bedford Museum Accession Number: BEDFM 2015.71
Oasis reference: albionar1-224764

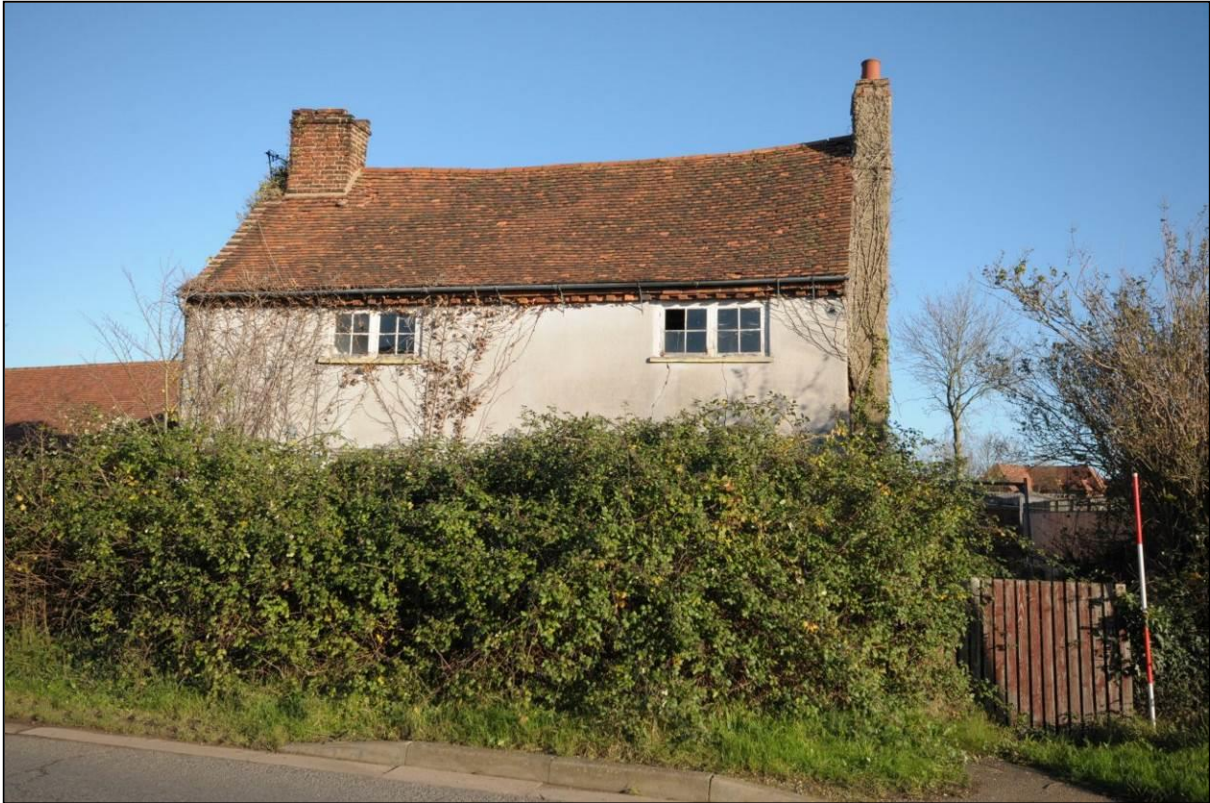
Image 1: Front elevation

The walls are covered with a cement render with a smooth finish on the front elevation (Images 1, 3 and 4) and small pebbles on the other elevations (Images 2, 5, 6 and 7). The brick is partly exposed where the render has failed, particularly on the south-west corner of the main range (Image 5). On this corner the front wall meets the end wall in a straight join and the front has bowed out slightly, opening the join. The bricks used in the two walls appear very similar in terms of size, colour and texture. Those in the end wall are slightly thinner (c. 5mm) and have been bonded with thicker mortar joins.

Shows north-west front of the main range

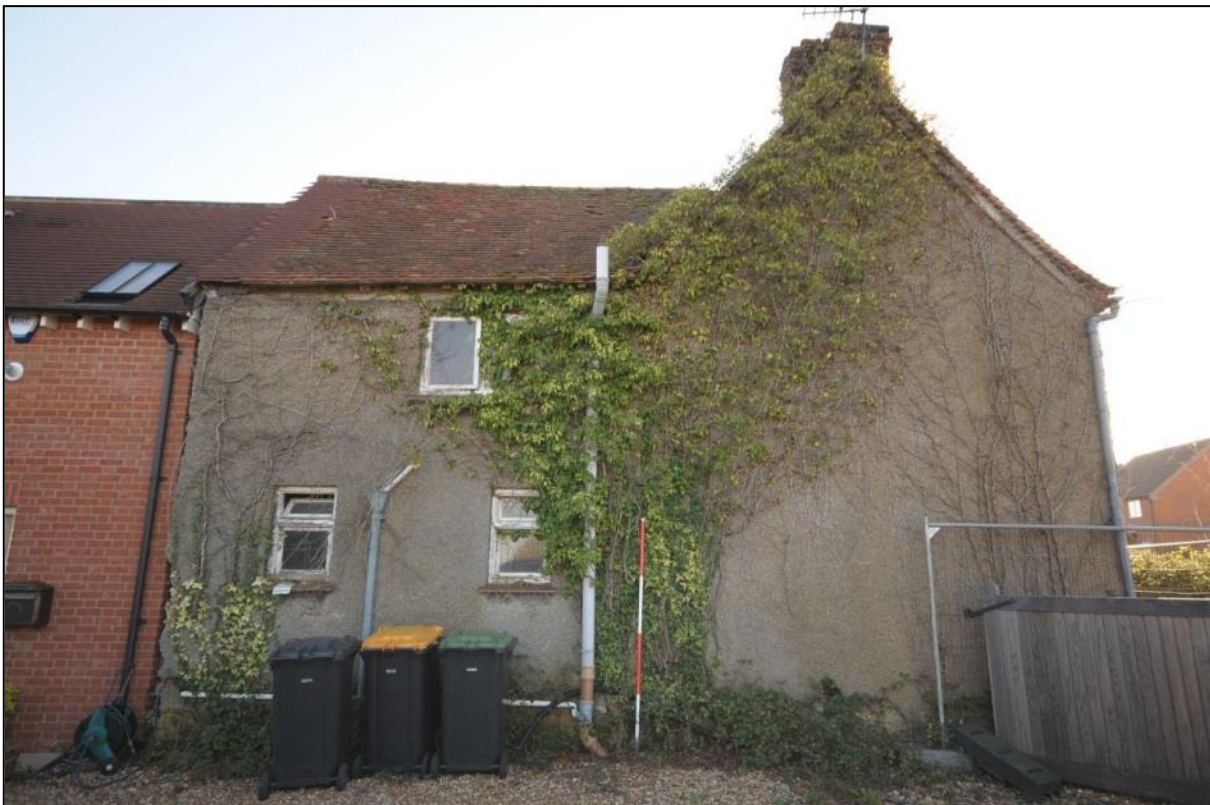
Image 2: North-east end elevation

Shows the gable end of the main range at right and the side of the rear wing to the left (Scale 2m)

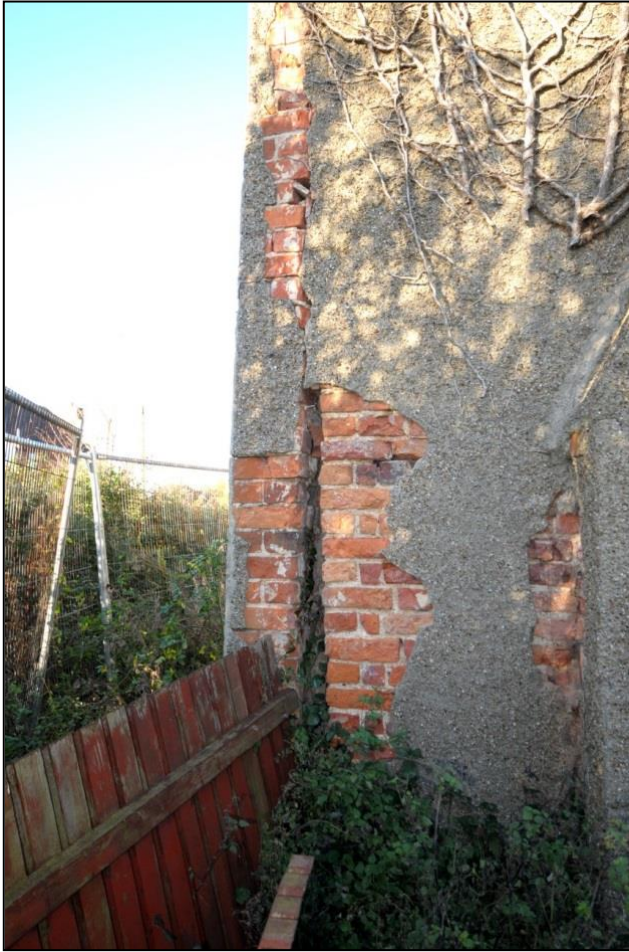
Image 5: Detail of south-west corner of building

Shows brickwork in the front elevation (left) meeting the south-west end wall in a straight join

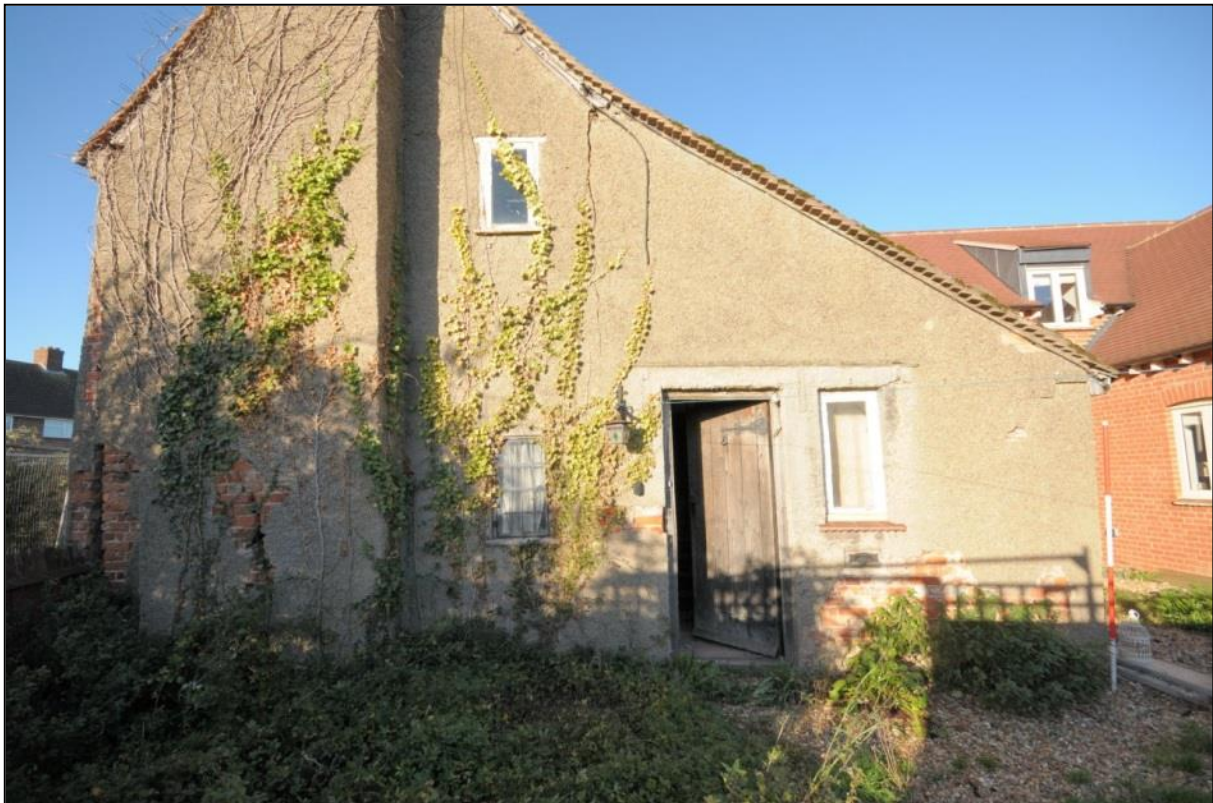
Image 6: South-west end elevation

Shows main range at left and the outshot to the right (Scale 2m)

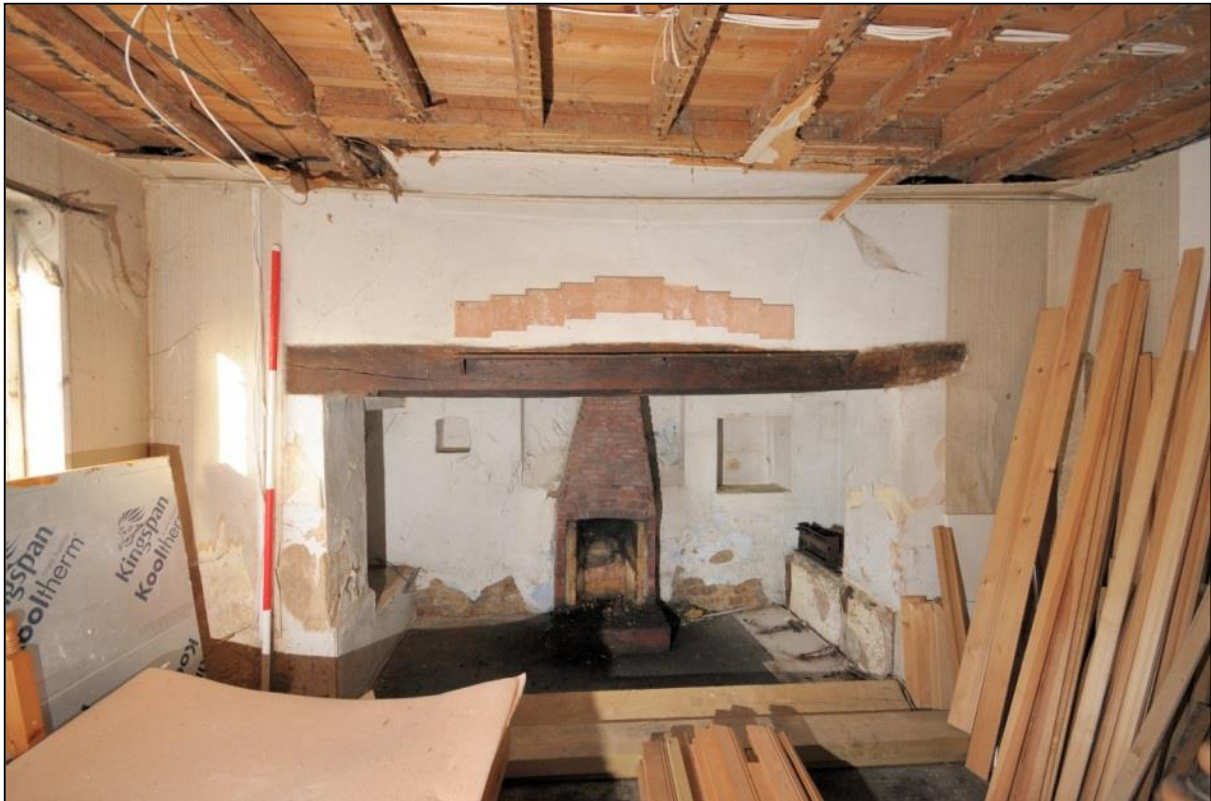
Image 9: Room G1, looking north-east

The north-east side of the room is occupied by an inglenook fireplace (Images 8 and 9). Above the opening is a plain chamfered bressumer with a stop towards its left-hand end. The stop has been damaged by being partly sawn away, but what remains appears to part of a scroll or ogee stop.

Shows inglenook fireplace (Scale 2m)

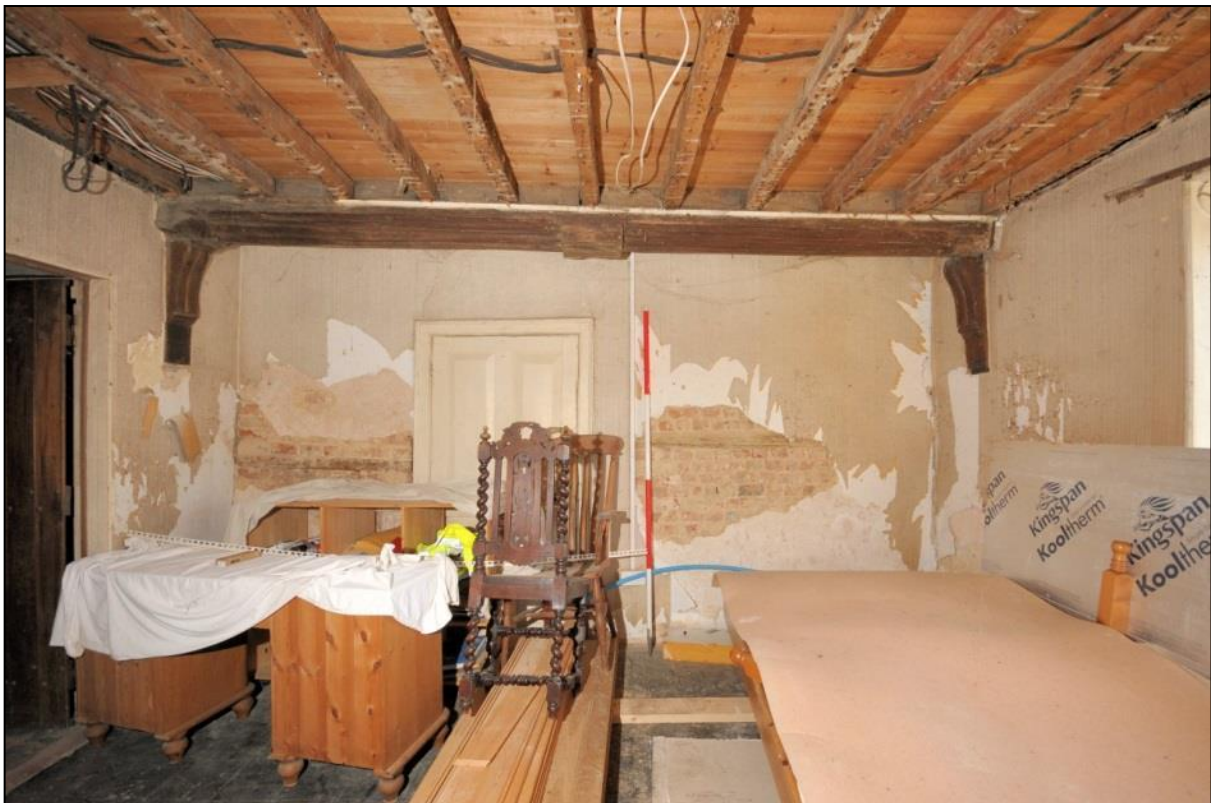
Image 10: Room G1, looking south-west

Shows inserted beam and four-panel door to room G2 (Scale 2m)

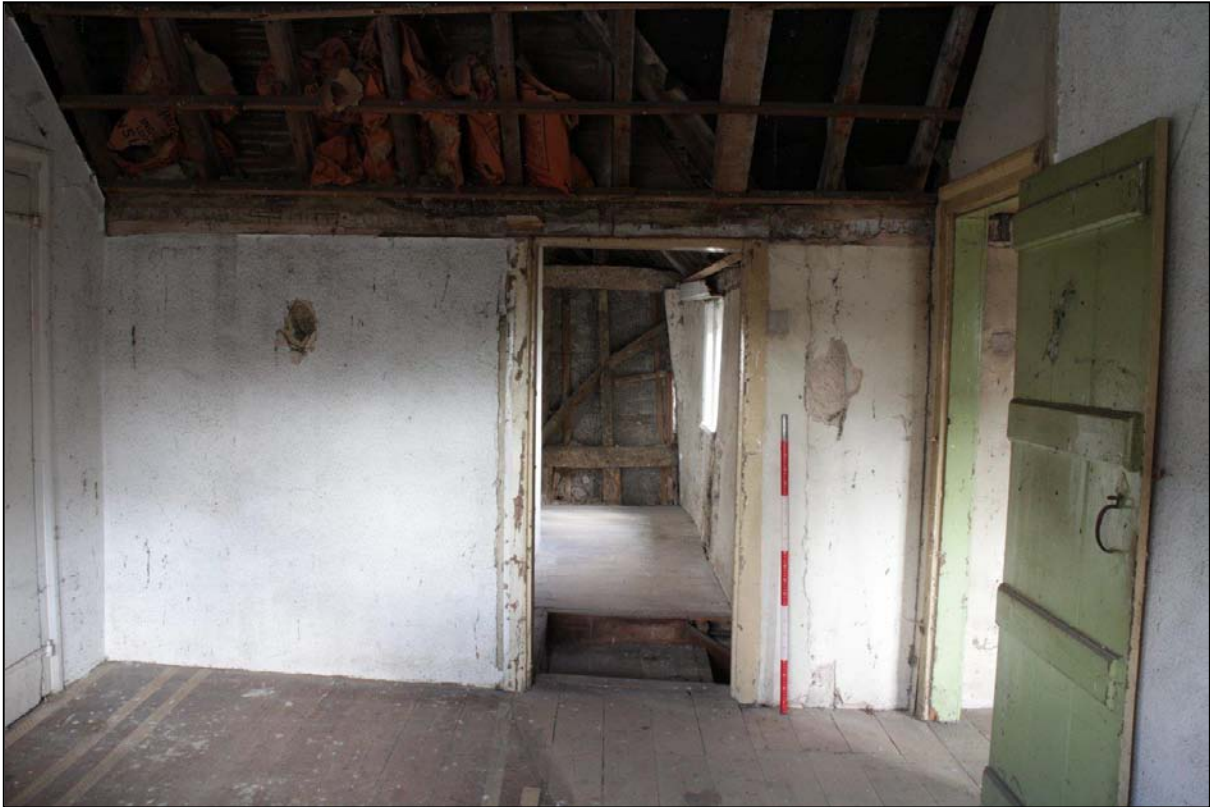
Image 17: Room F1, looking south-east

The south-east wall is timber-framed. To the right of the door the wall-paper is missing, revealing a full-height stud pegged into the wall plate at the top (Image 17). Other pegs in the wall plate in this and the adjacent room (F2) indicate the location of other studs in the rear wall of the main range. A small section of the rear/exterior side of this wall was visible above the ceiling in room G4. The timber framing consists of studs at intervals of c. 600mm with wattle and daub infill. The wattles are woven in a diagonal pattern which was also used in the south-west gable of the roof (Images 34 and 35). Inside the room, above the door, a scarf joint is visible in the wall plate. This appeared to be a face halved with under-squinted abutments. Only one end of the scarf was visible. On the face of the wall plate it showed as a vertical join and on the upper surface one abutment was visible with a 45 degree under-squinted end.

Shows door to rear wing with door to F2 to the right. (Scale 1m)

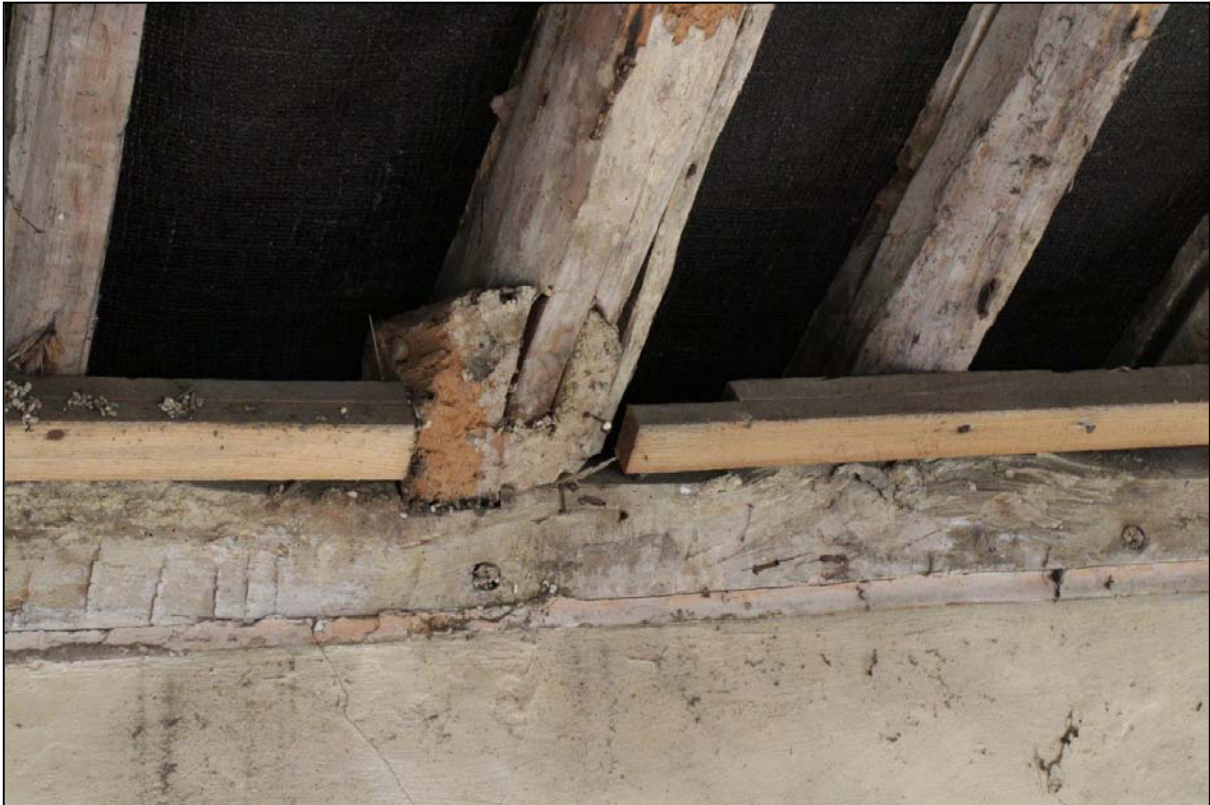
Image 29: Room F2, detail of tie beam and wall plate

Shows the south-east wall plate with peg holes for studs and the cut-off end of a tie-beam in the centre of the image

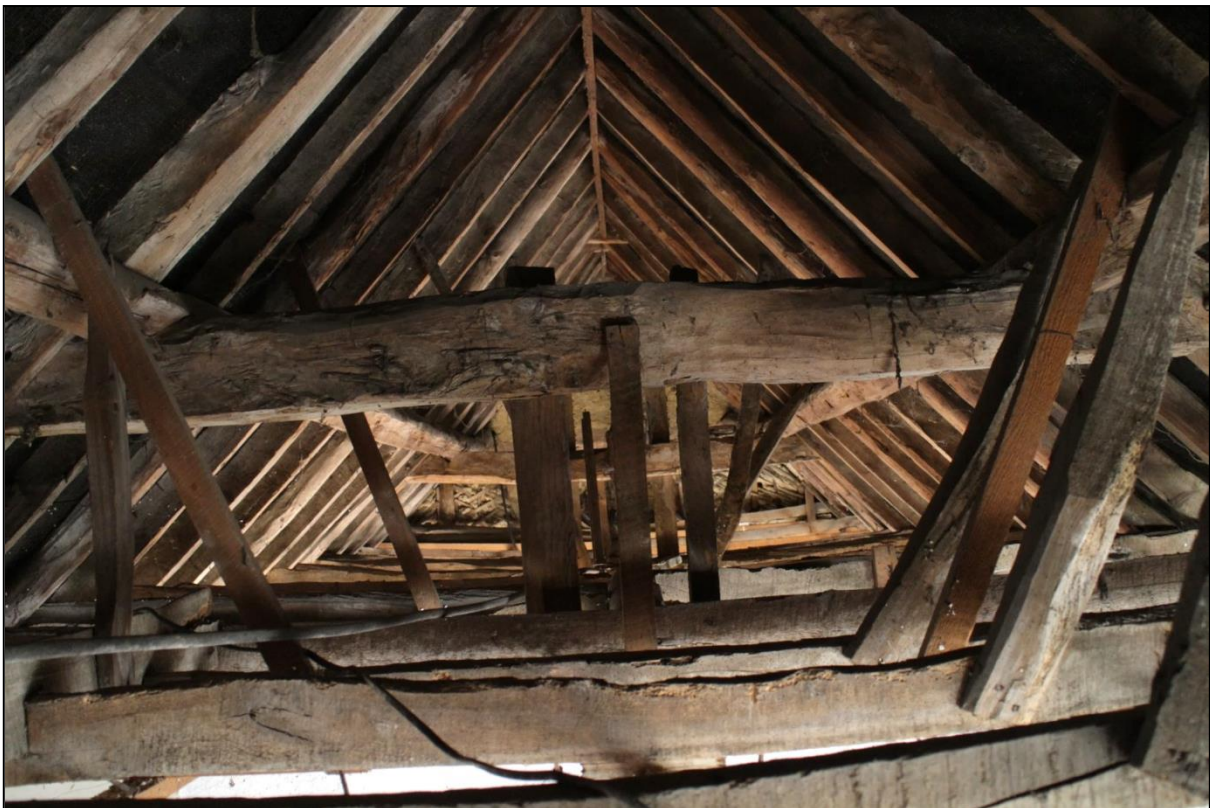
Image 30: Roof over main range, looking south-west

Shows clasped purlin construction with joists for ceiling below

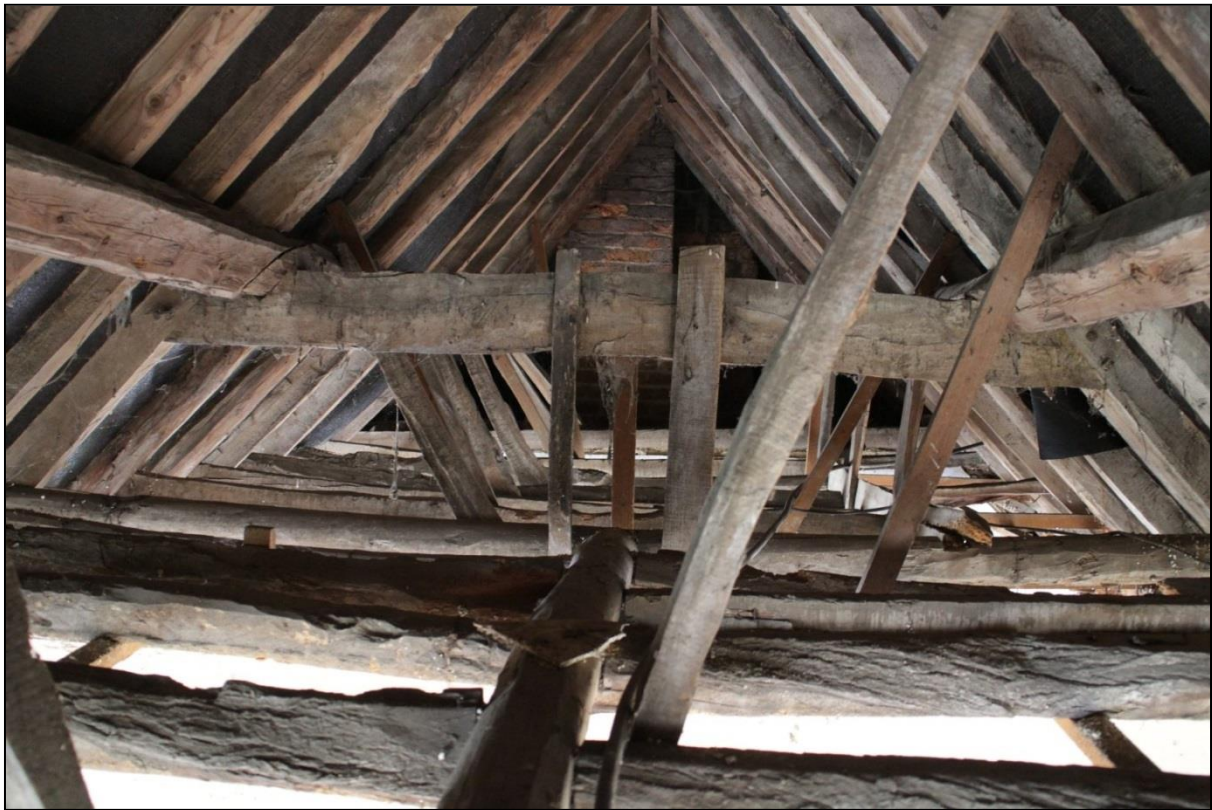
Image 31: Roof over main range, looking north-east

Shows clasped purlin construction with joists and spine beam for ceiling below

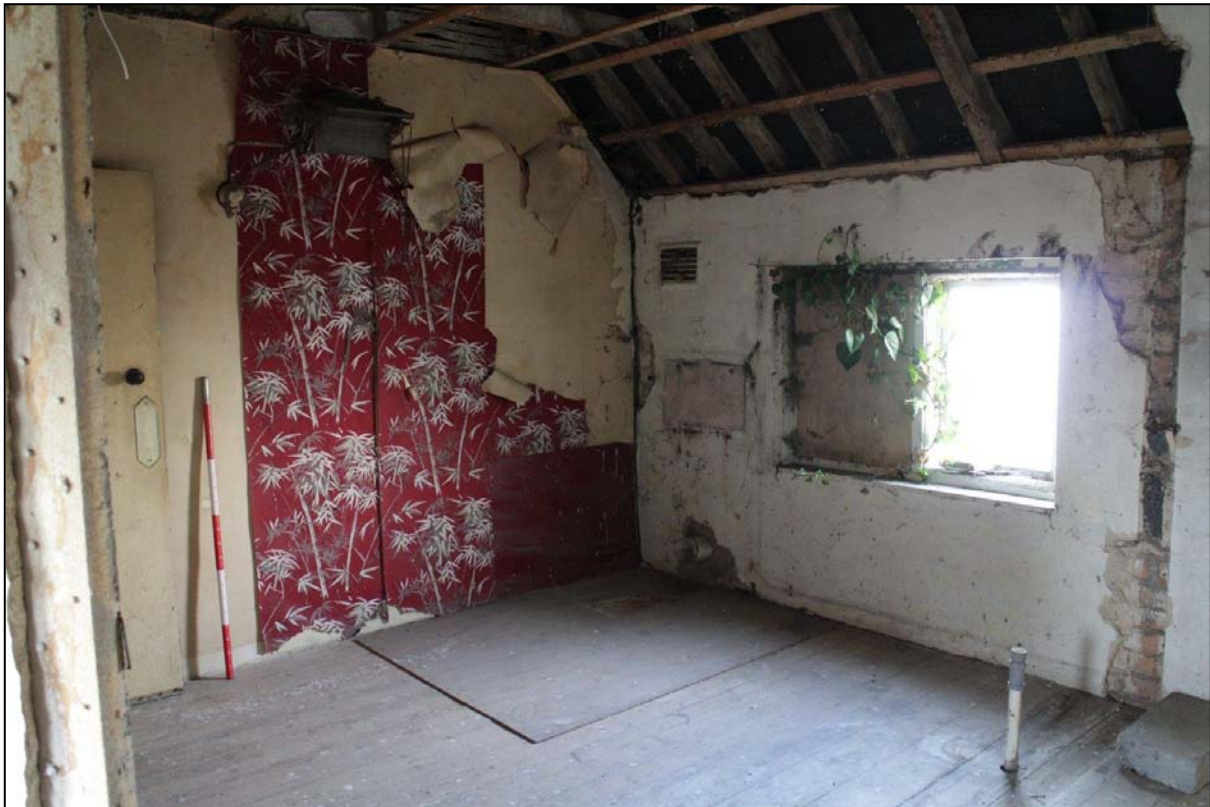
Image 39: Room F3, looking north

Shows wall scar from removed modern internal partition at right (Scale 1m)

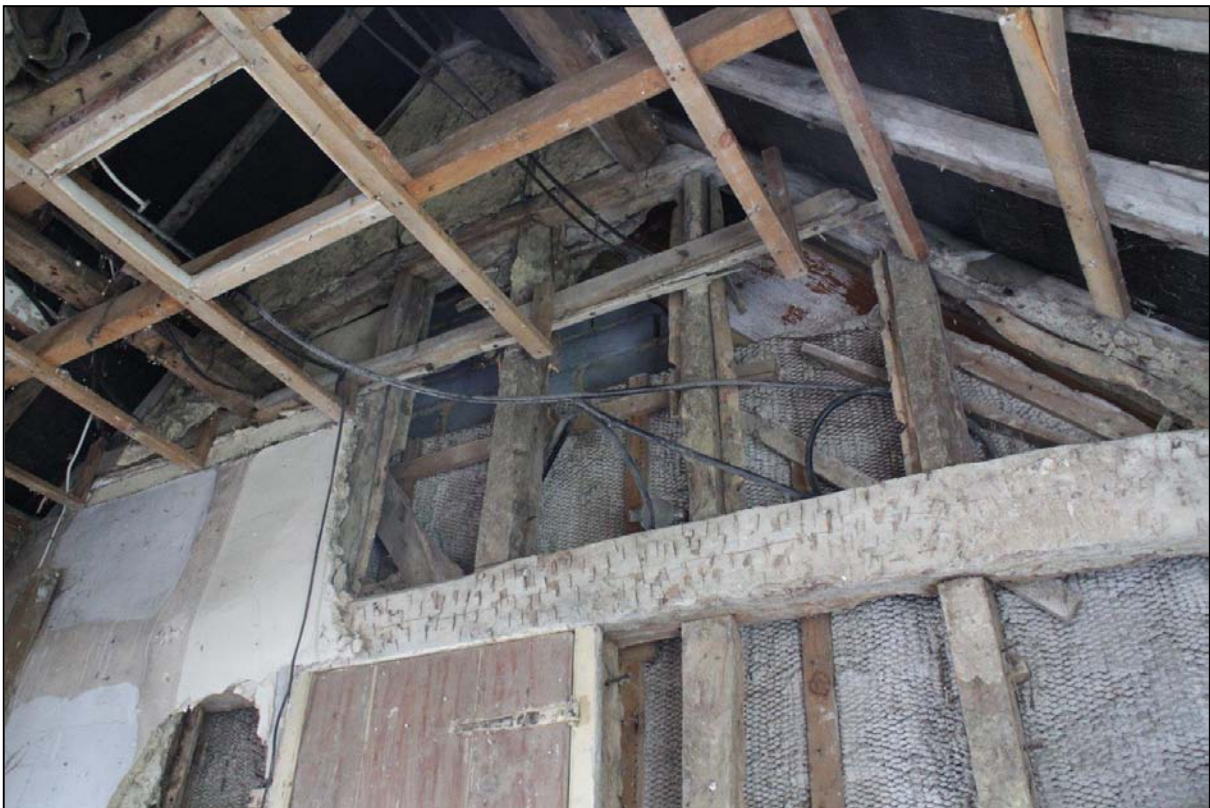
Image 42: Room F3, detail of frame in south-east wall

Shows tie-beam with studs and collar beam in the gable above with remnants of wattle and daub infill above the collar

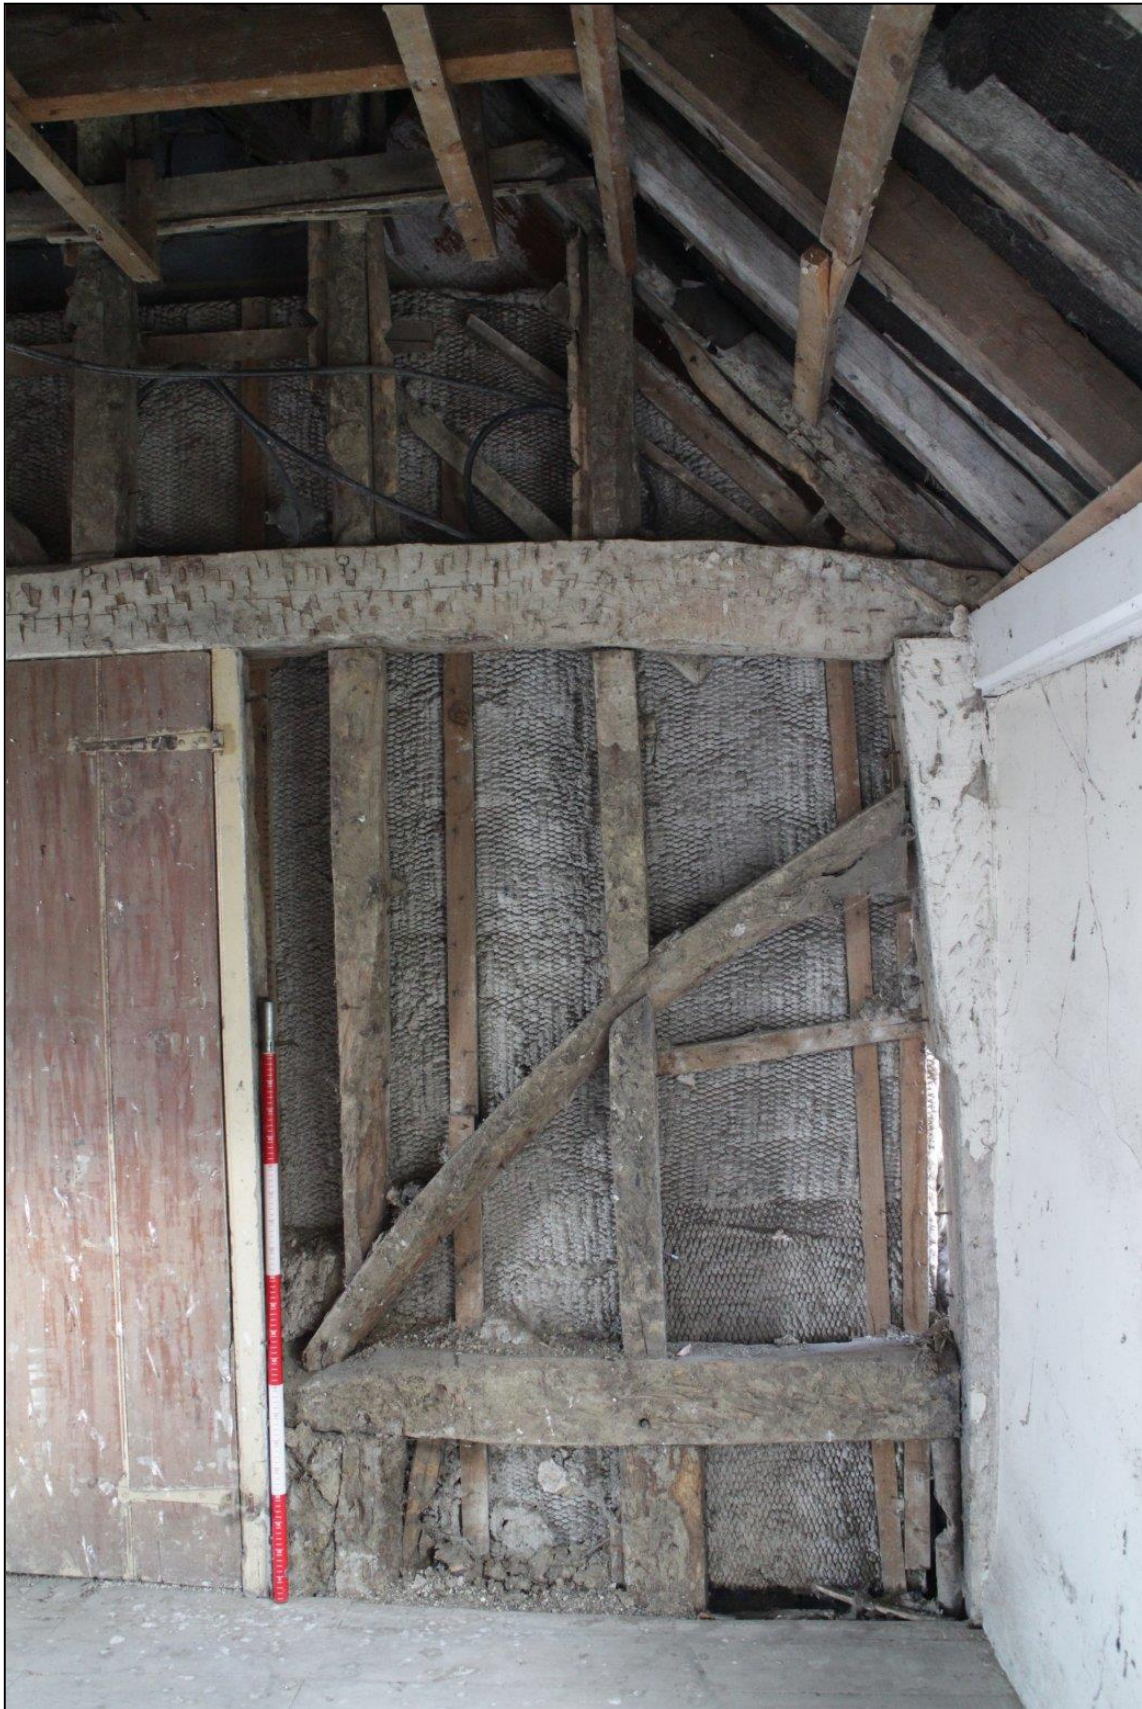
Image 43: Room F3, detail of frame in south-east wall

Shows rail c.400mm above the floor with heavy studs below the rail and light studs with principal bracing above the rail (Scale 1m)
