**LYNCH FARM  
KENSORTH  
BEDFORDSHIRE**

**HISTORIC BUILDING RECORDING**

Document: 2016/16  
Version: 1.2  
22nd February 2016

Project: LF2106  
Luton Museum: Entry No. LTNMG 1168  
Oasis reference: albionar1-230307

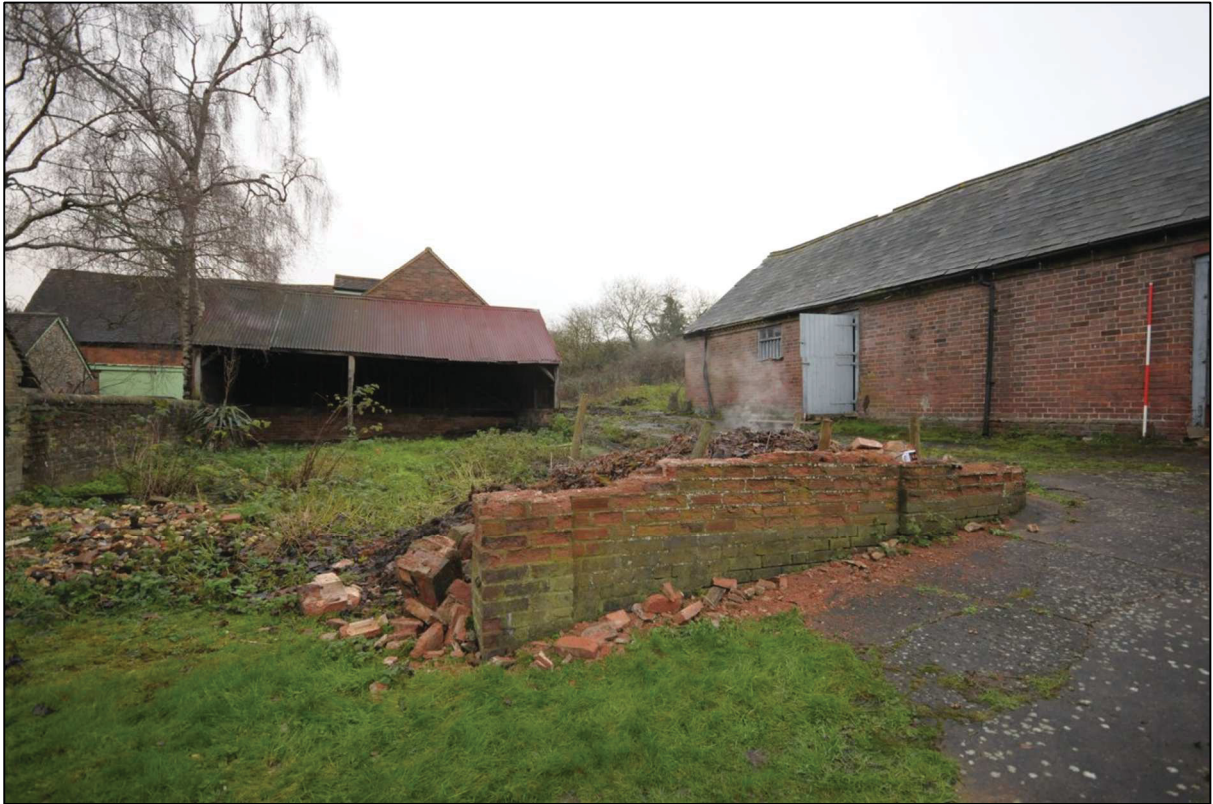
**Image 3:** General view showing stockyard wall

Shows wall at south-east corner of former stockyard in foreground with the upper part of the wall rebuilt in Fletton brick (Scale 2m)

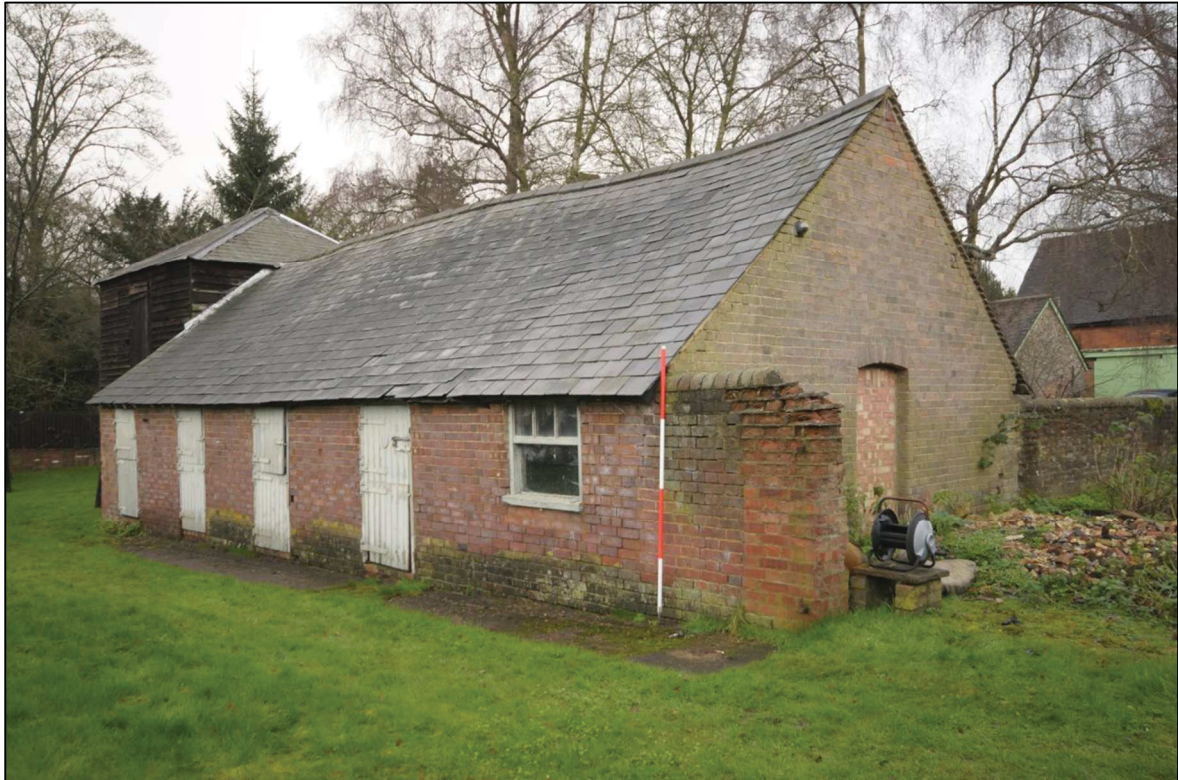
**Image 4:** Barn 1, general view looking west

Shows blocked door in north-east end wall and section of stockyard wall attached to eastern corner of building (Scale 2m)

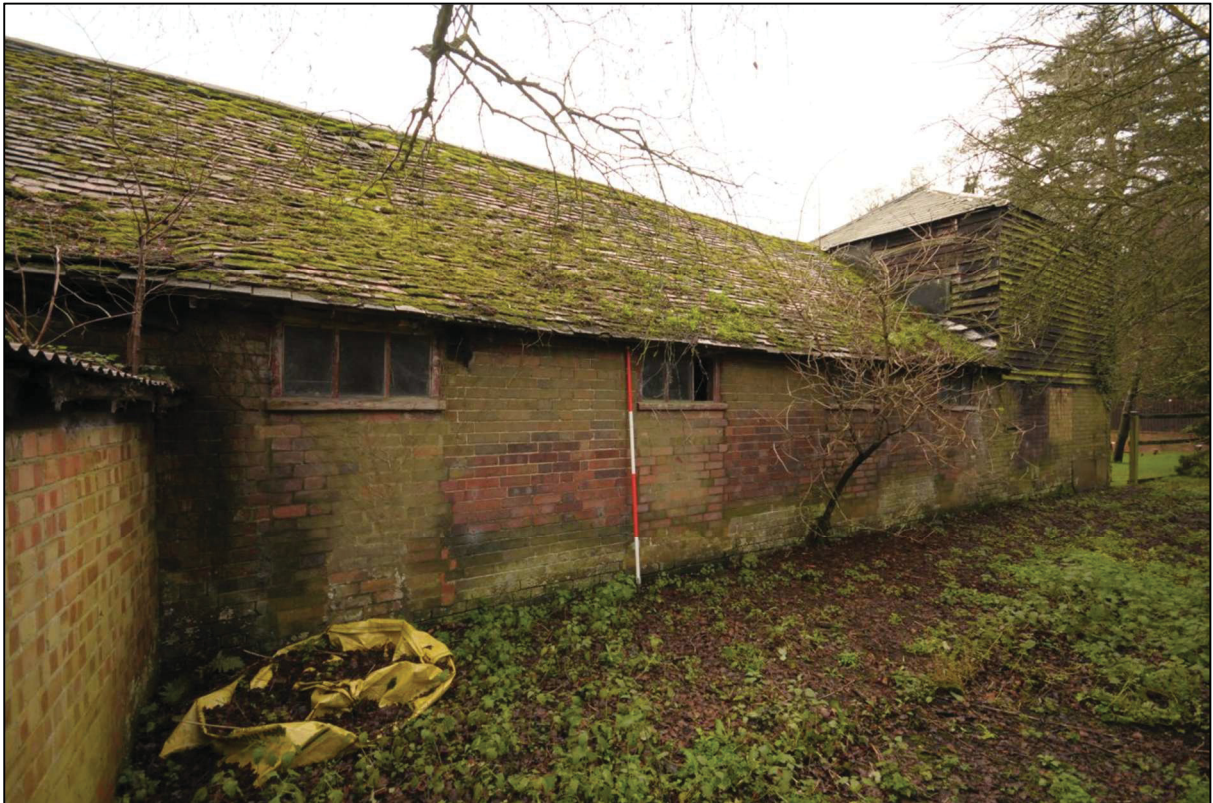
below (Image 7). The sides of these openings show the same characteristics noted for the openings in the south-east wall, with closers next to the upper part of the opening and they appear to have been cut-in in the lower part.

**Image 7:** Barn 1, north-west (rear) elevation, looking south  
Shows blocked door openings with inserted windows in rear wall

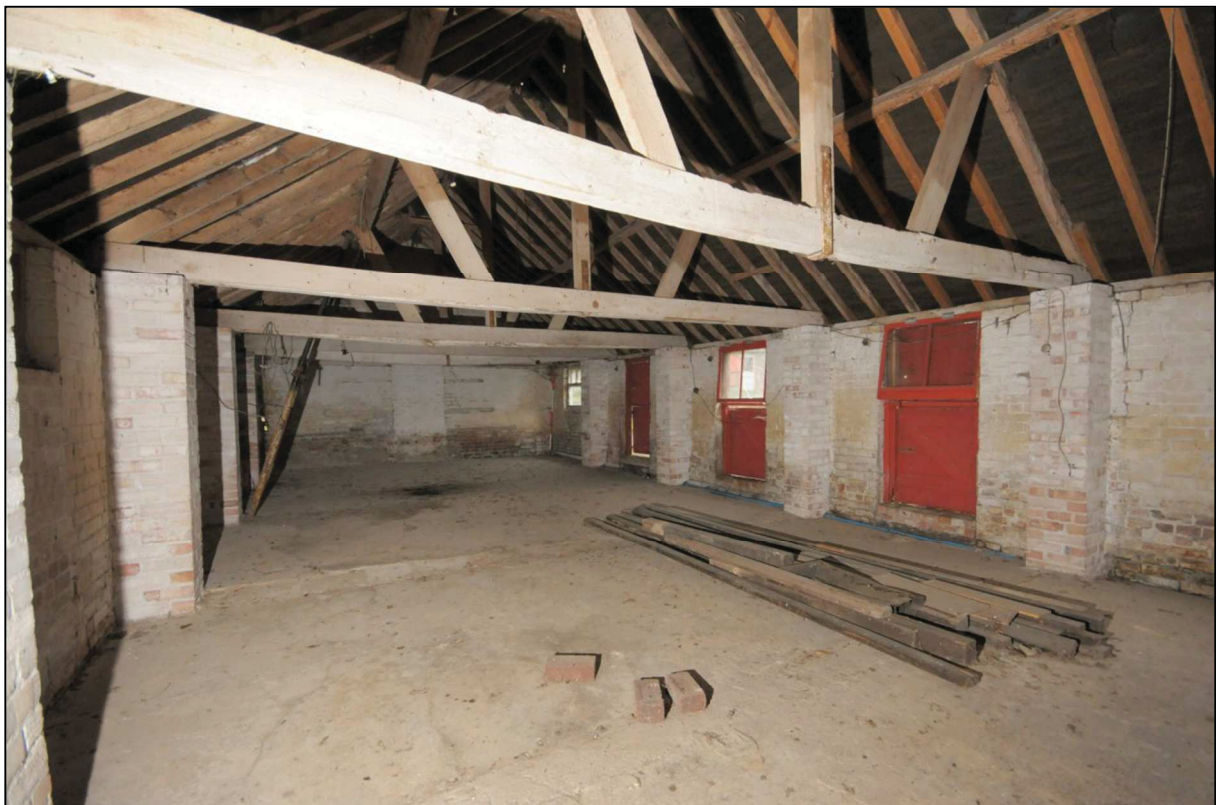
The roof is supported by four trusses (Image 8). These have kingposts but lack the principal rafters that support the purlins in a regular kingpost roof. Instead, the struts on either side of the kingpost directly support the purlins. The kingposts are fixed at the base with iron straps around the tie beams. The lightweight construction has proved insufficient for the span. The northernmost tiebeam is bowed; the next one is broken and the spread of the roof has caused part of the northern side wall to move outwards. Brick piers have been inserted below the ends of the tie beams to support the roof and walls (Images 8 and 9). The piers are in Fletton brick and include some textured types, which were produced from the mid-20th century onwards.

**Image 8:** Barn 1 interior, main compartment, looking north-east  
Shows inserted brick piers below the ends of the tie beams

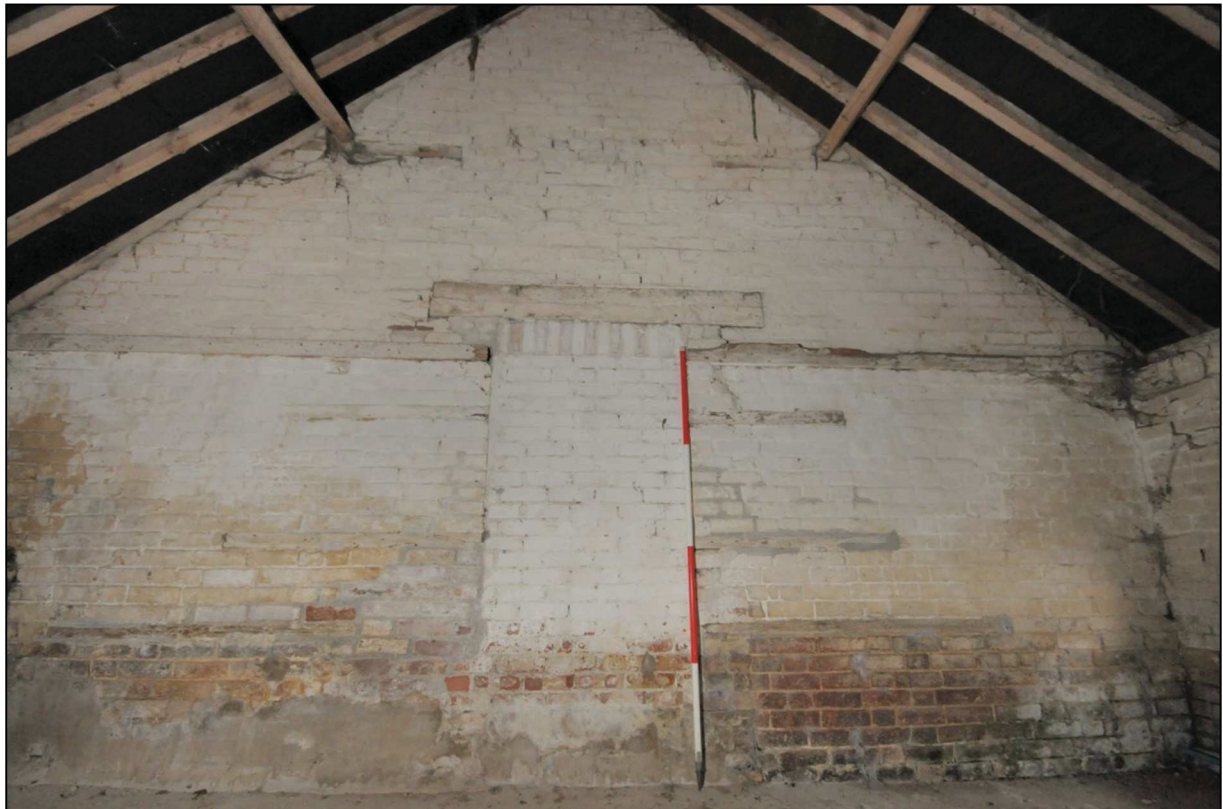
**Image 10:** Barn 1 interior, main compartment, showing north-east end wall

Shows blocked door with timber built into the wall on either side (Scale 2m)

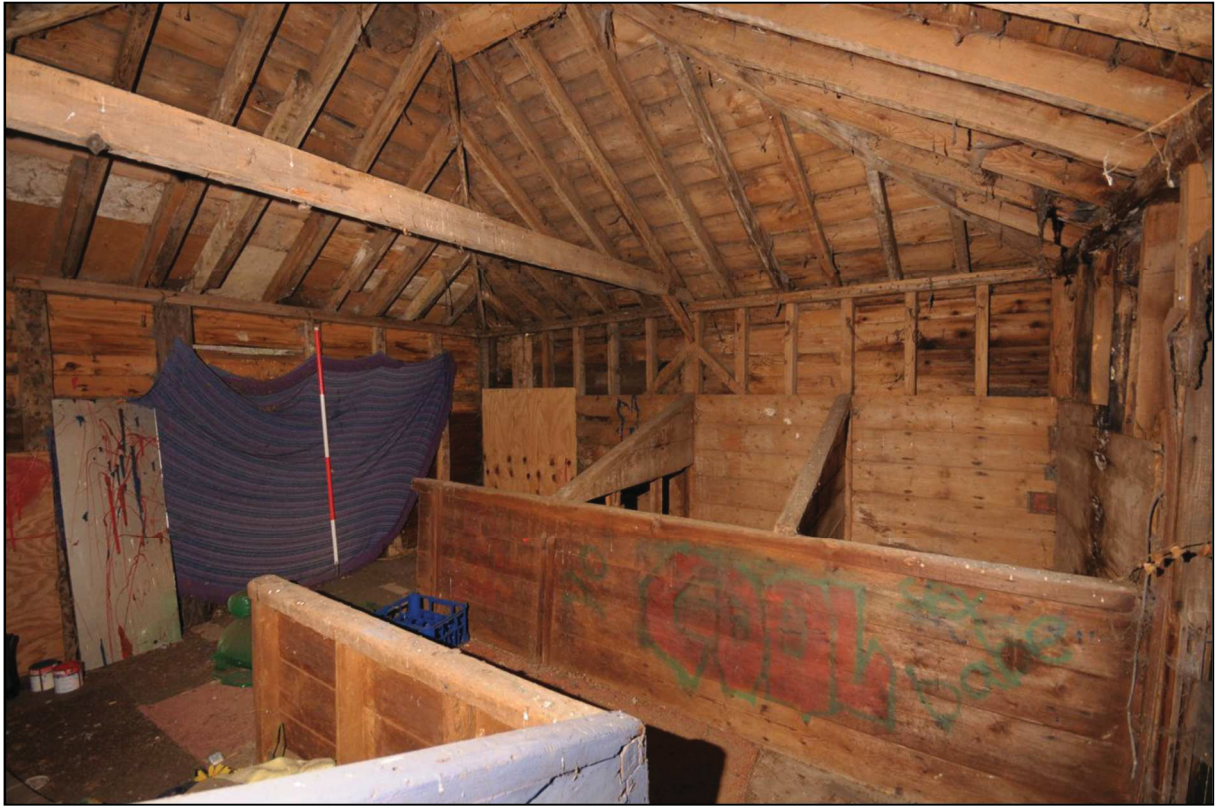
**Image 15:** Barn 1 interior, granary, looking north

Shows grain bins in foreground and replaced north-west wall to the left (2m scale)

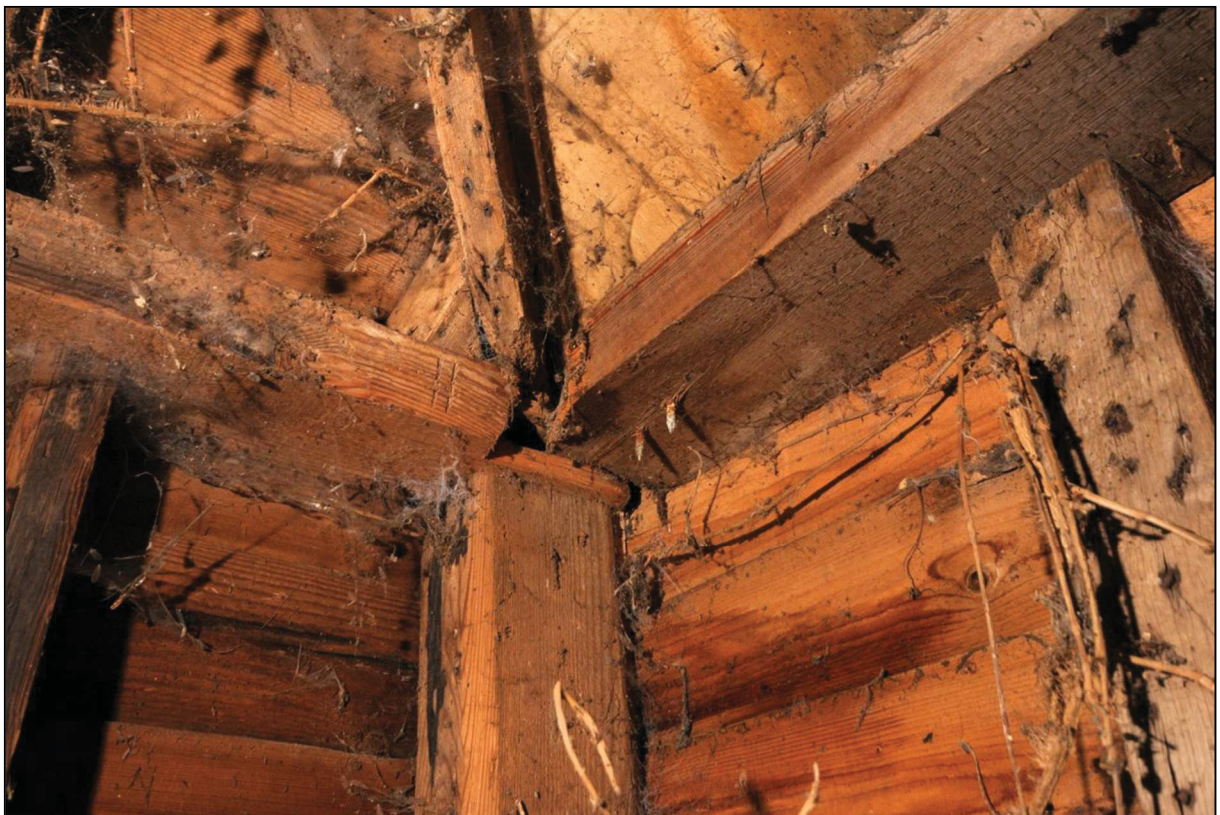
**Image 18:** Barn 1 interior, detail of west corner of granary

The south-west wall has been replaced using re-used timber for the wall plate, central post and studs. The wall plate has not been tenoned into the adjacent (original) wall plates but has been roughly cut-in.

Shows assembly mark (II) in end of south-west wall plate at left of centre. Also shows crudely inserted wall plate in the rebuilt north-west wall in the right half of the image.

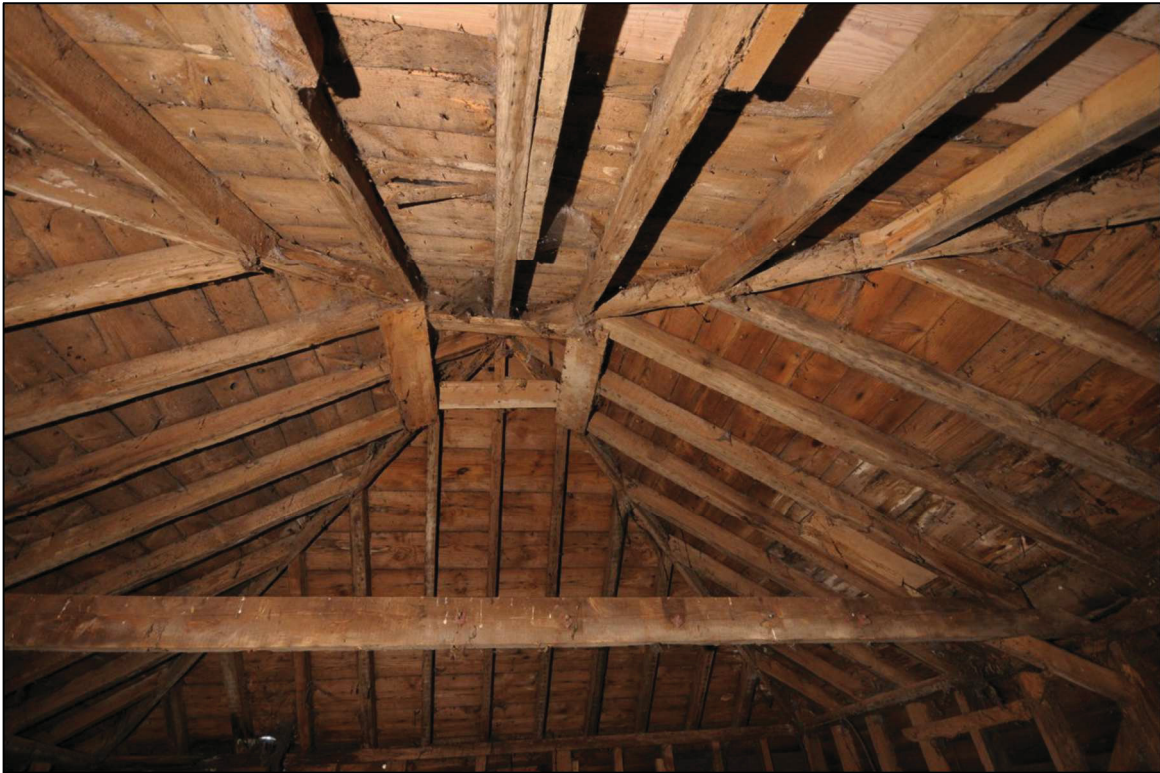
**Image 19:** Barn 1, granary roof, looking south-east

The rafters in the north-west edge of the roof (at the top of image) are doubled where the roof and wall on this side of the granary have been repaired

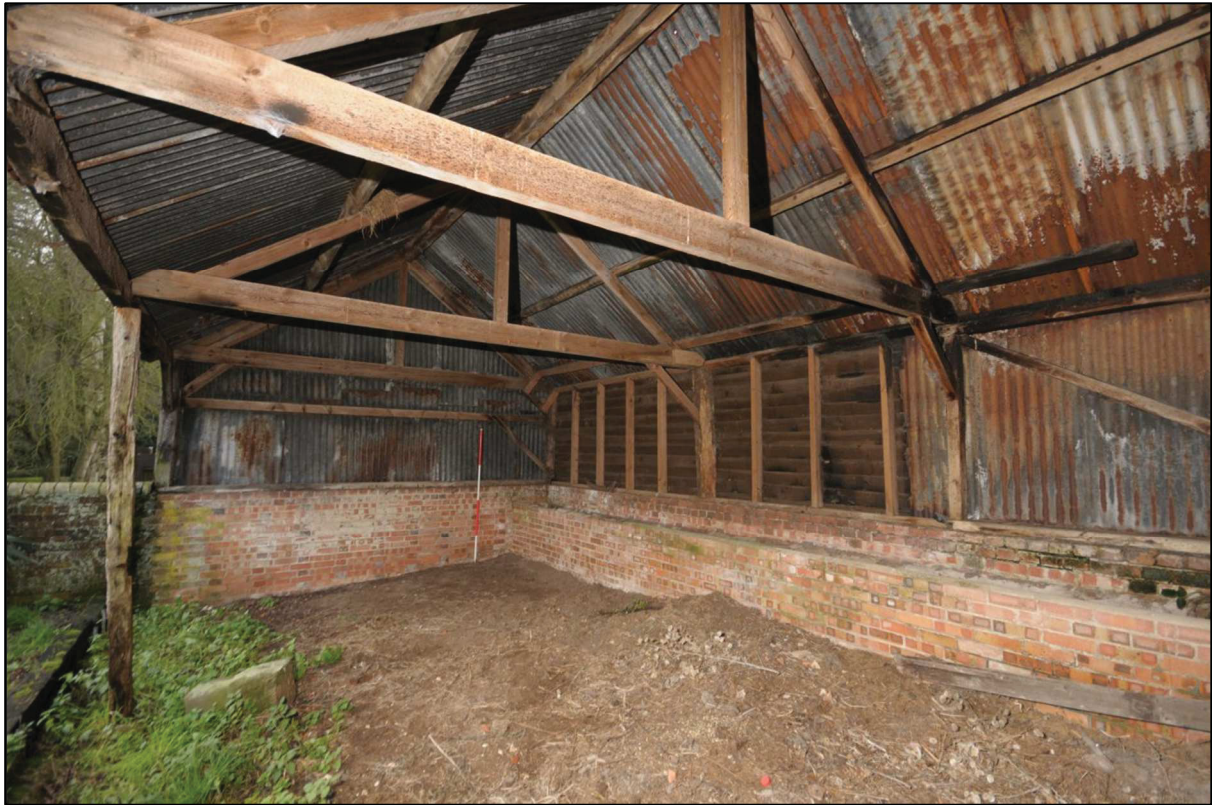
**Image 21:** Barn 2 interior, looking west

Shows modern timber studs in rear wall and brick feeding trough (Scale 2m)

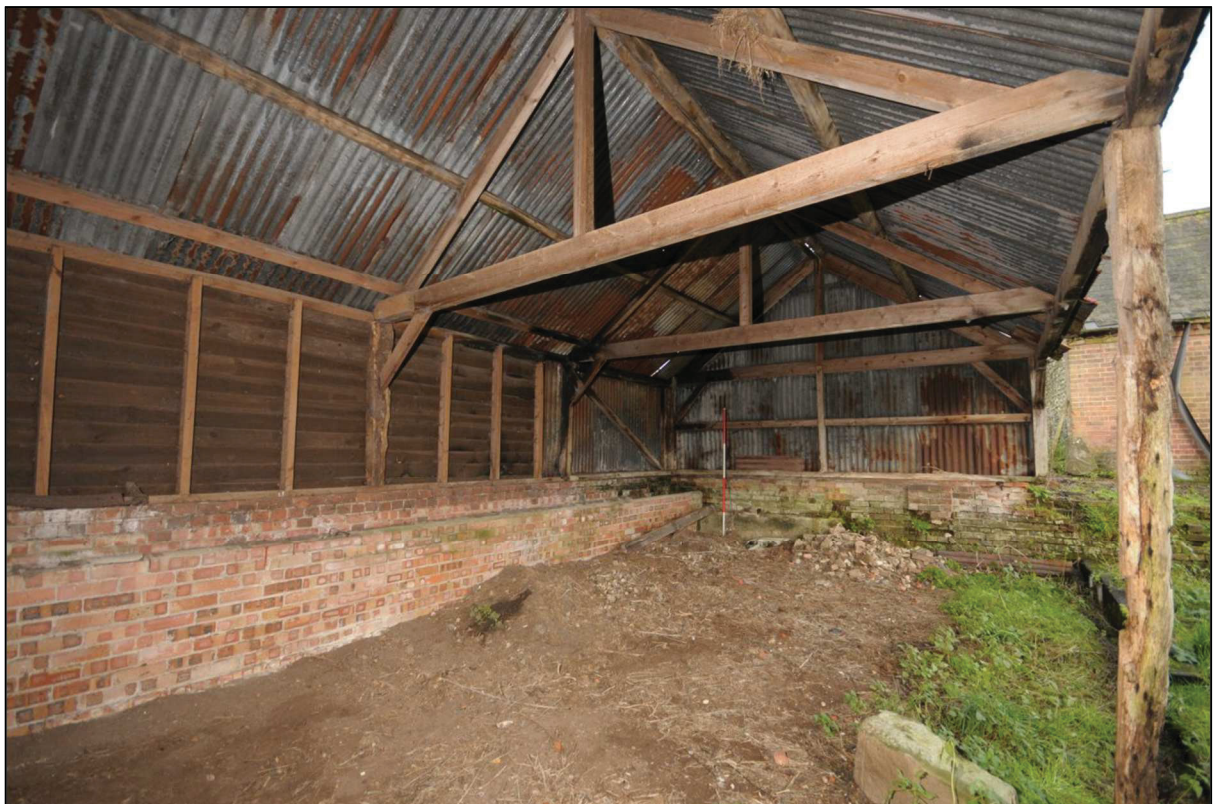
**Image 22:** Barn 2 interior, looking north-east

Shows modern timber studs in rear wall and brick feeding trough (Scale 2m)

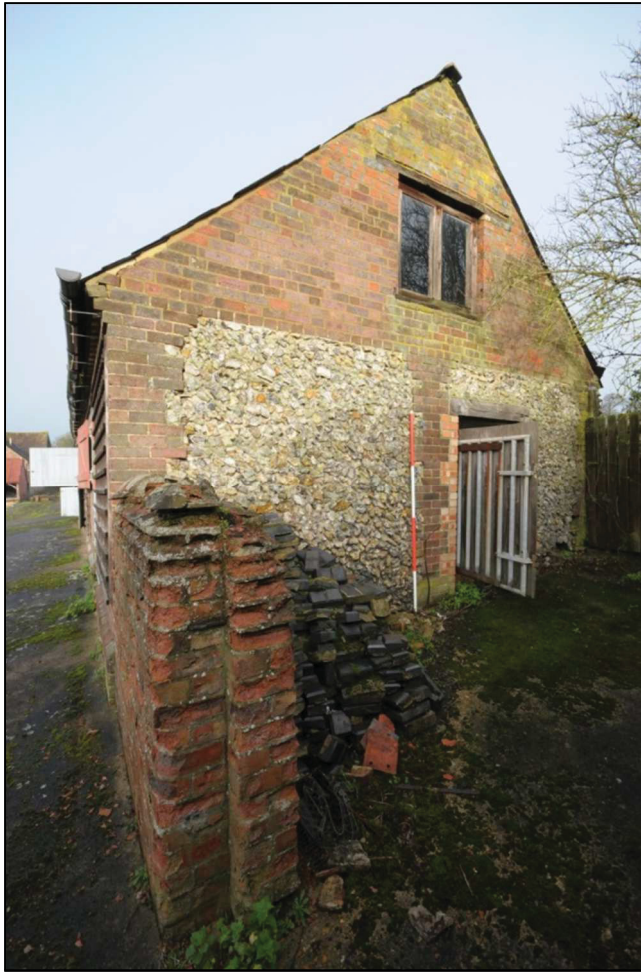
**Image 27:** Barn 3, south-east end, looking north

Shows flint panels in lower part of wall with inserted door opening in right-hand side (Scale 2m)

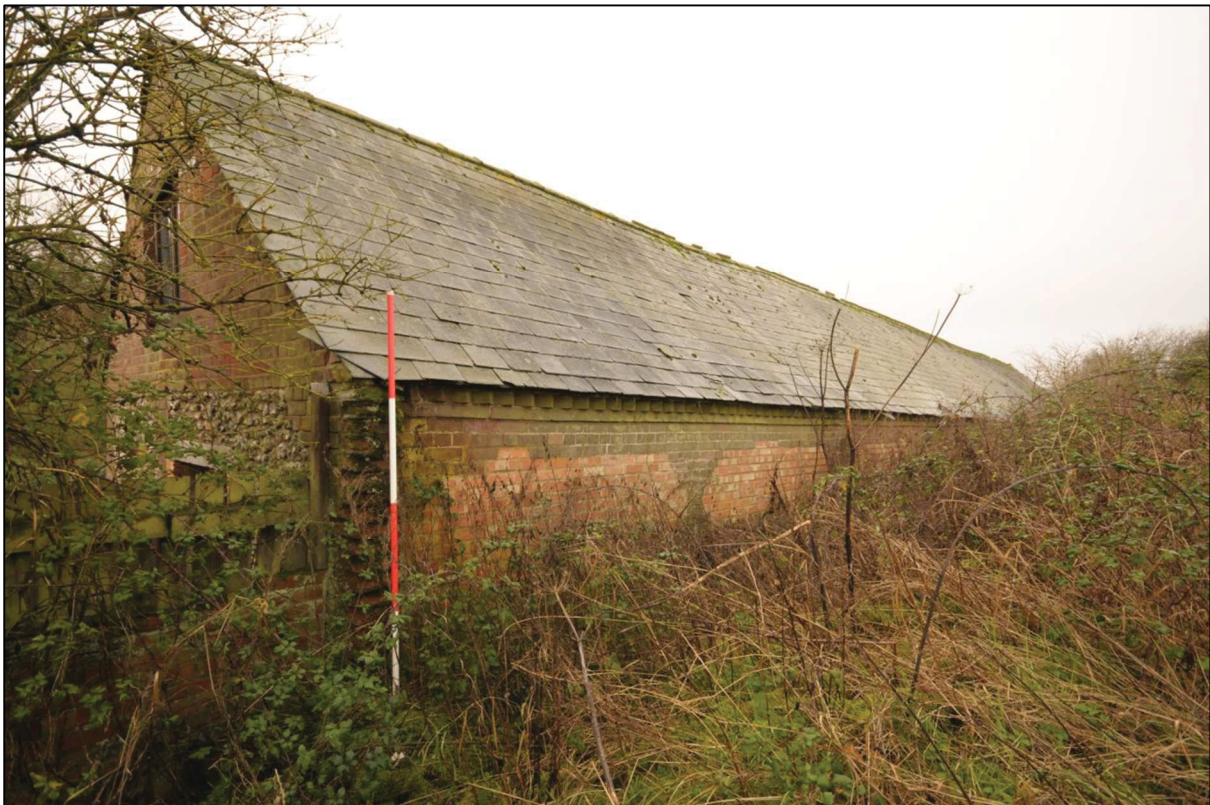
**Image 28:** Barn 3, rear wall, looking west

The wall at the south-east end of the compartment is described in the previous section. The rear wall consists of brick dressings with panels of infill. The irregularly laid infill consists of brick headers with smaller numbers of brick paviours and flint nodules. The brick and infill in three of the panels located in the northern half of the compartment have been entirely replaced in Fletton brick.

Shows light coloured modern brick used to replace infill in rear wall (Scale 2m)

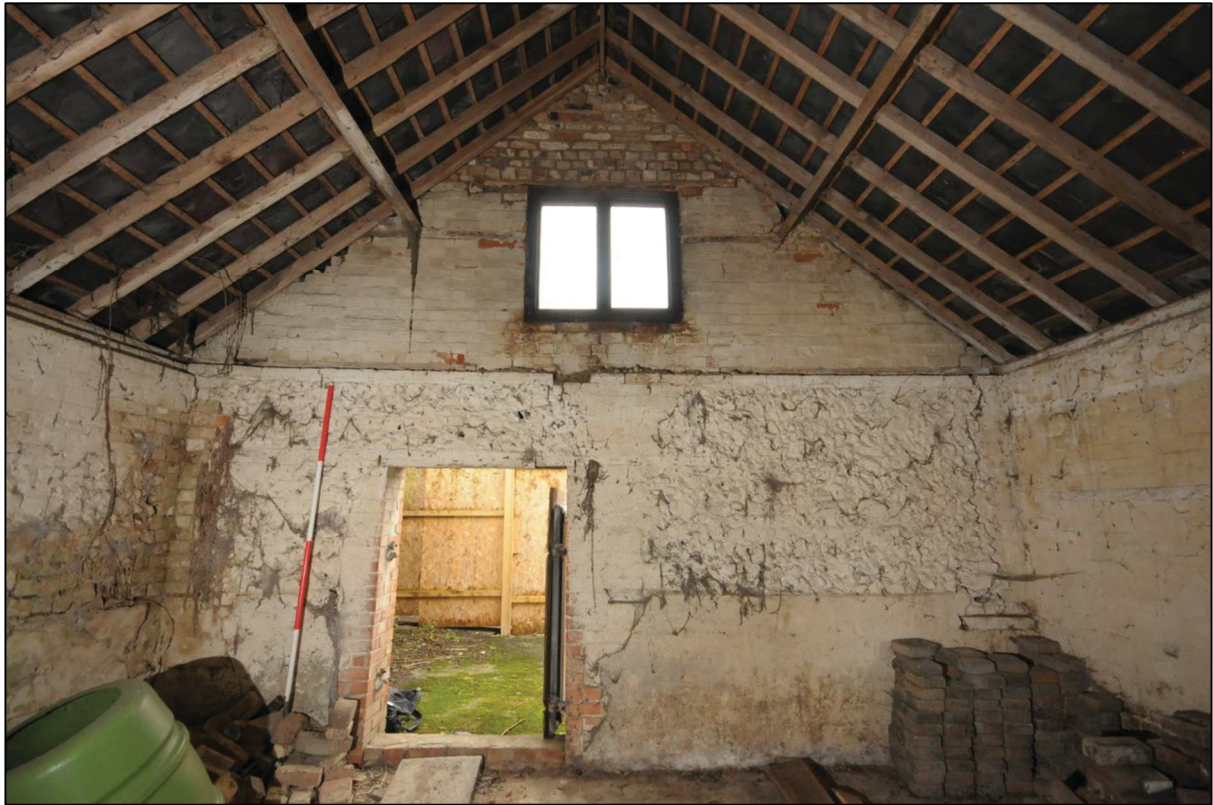
**Image 29:** Barn 3 interior, south-east wall

Shows modern inserted doorway and flint infill in wall with render over lower part (Scale 2m)

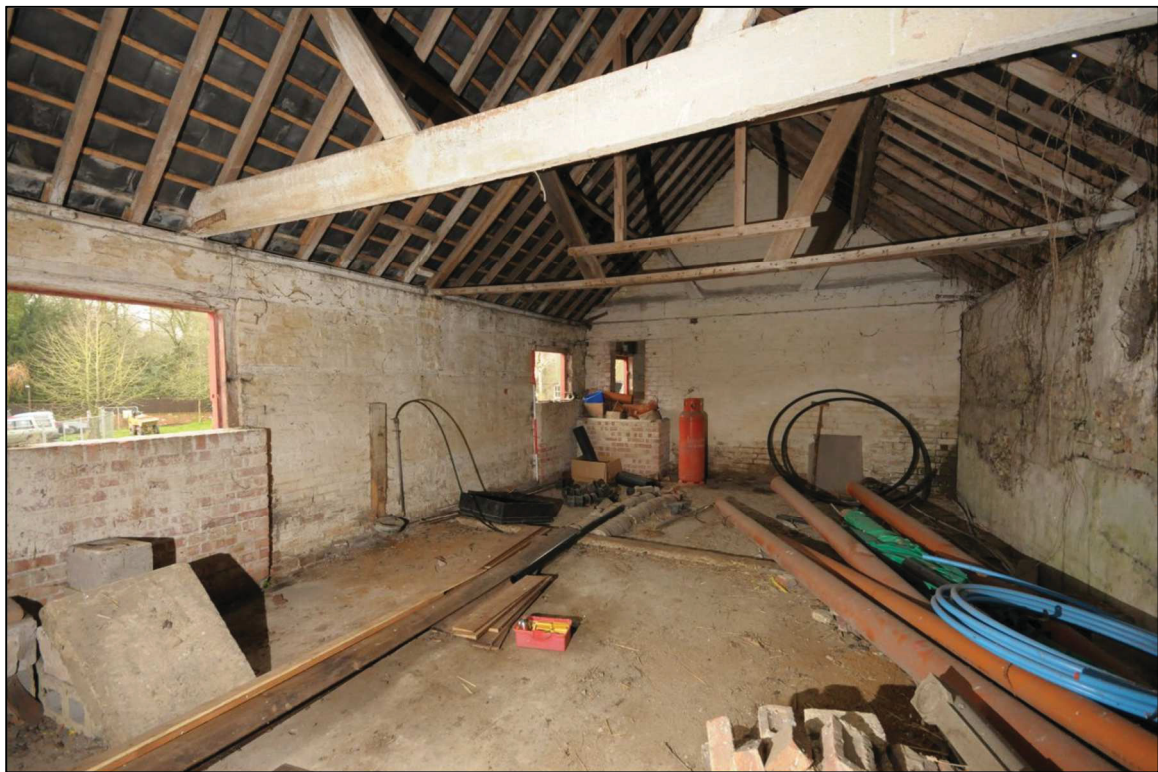
**Image 30:** Barn 3 interior, south-east compartment, looking north-west

A single roof truss in the mid part of this compartment differs from all of the others in Barn 3 and appears to be a modern replacement of one of the earlier trusses. A long plank laid flat forms the tie beam and two purlin struts appear to be reused from the earlier truss. Between the struts a frame made from square-sectioned timber forms a door opening. The truss indicates the location of a former partition which is also marked on the floor by a narrow raised strip of concrete in the concrete floor.

Shows partially blocked doors in south-west wall at left and inserted roof truss behind an original roof truss in the upper foreground

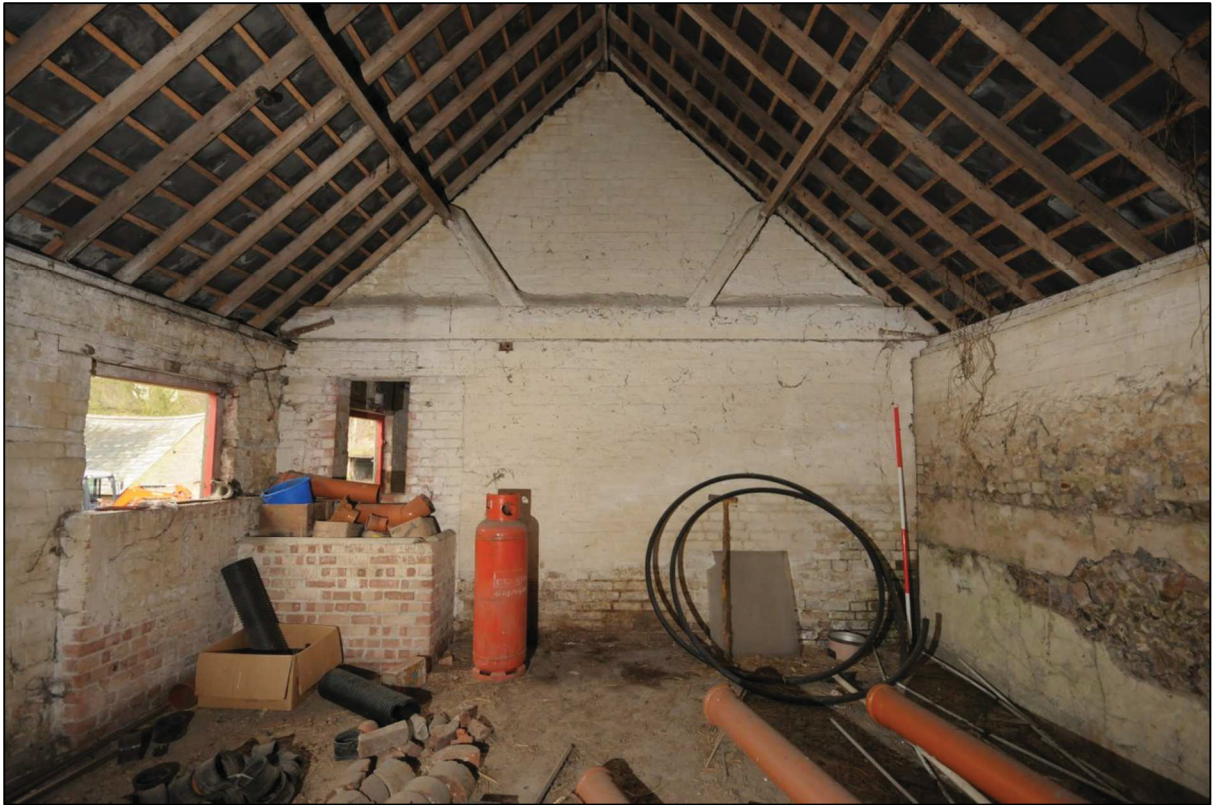
**Image 31:** Barn 3 interior, south-east compartment, looking north-west

Evidence for the construction sequence indicates that the internal dividing wall was inserted after the rest of the building, including the feed trough, had been completed. It meets both the rear wall and feed trough in a straight join and the roof truss at this position would have not been needed if the partition wall had already been present. It is possible that the dividing wall was built immediately after the completion of the rest of the building or it may have replaced a timber partition.

Shows dividing wall with a partially blocked opening and brick trough at left (Scale 2m)

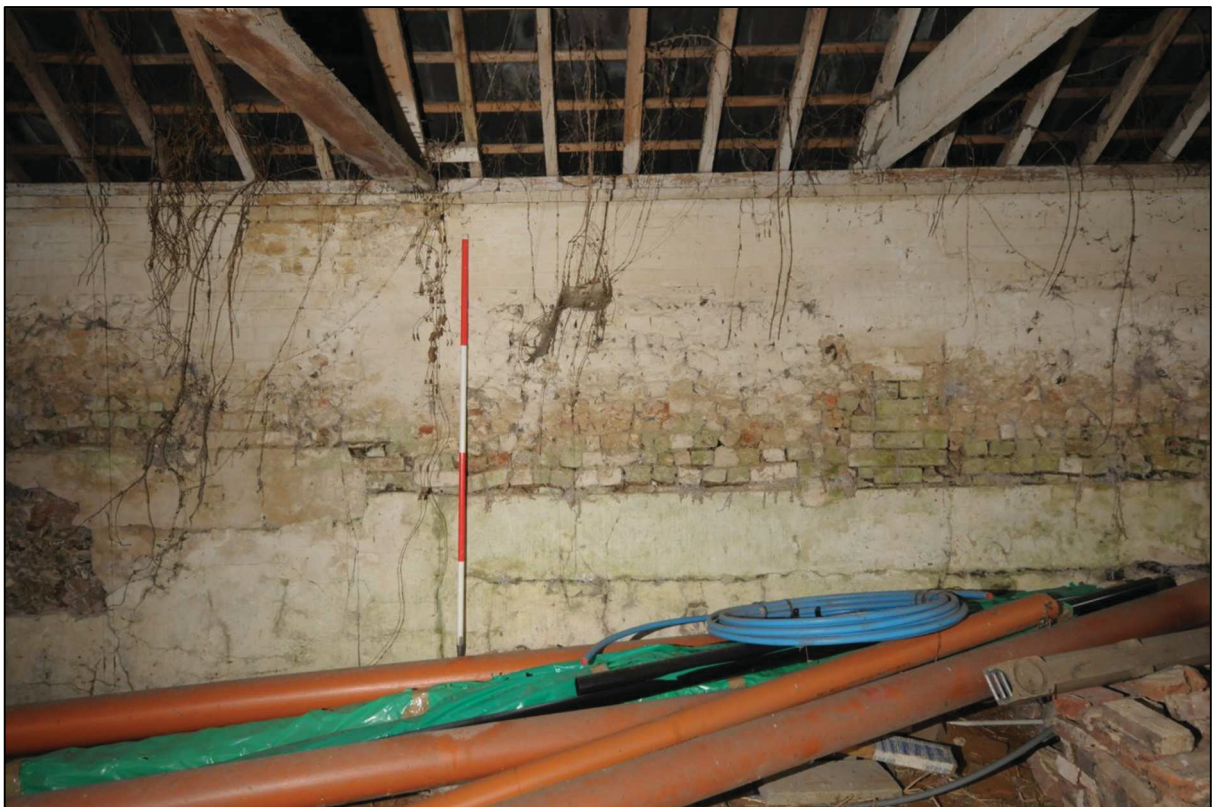
**Image 32:** Barn 3 interior, rear wall of south-east compartment

Shows wall roughly infilled with header bricks (Scale 2m)

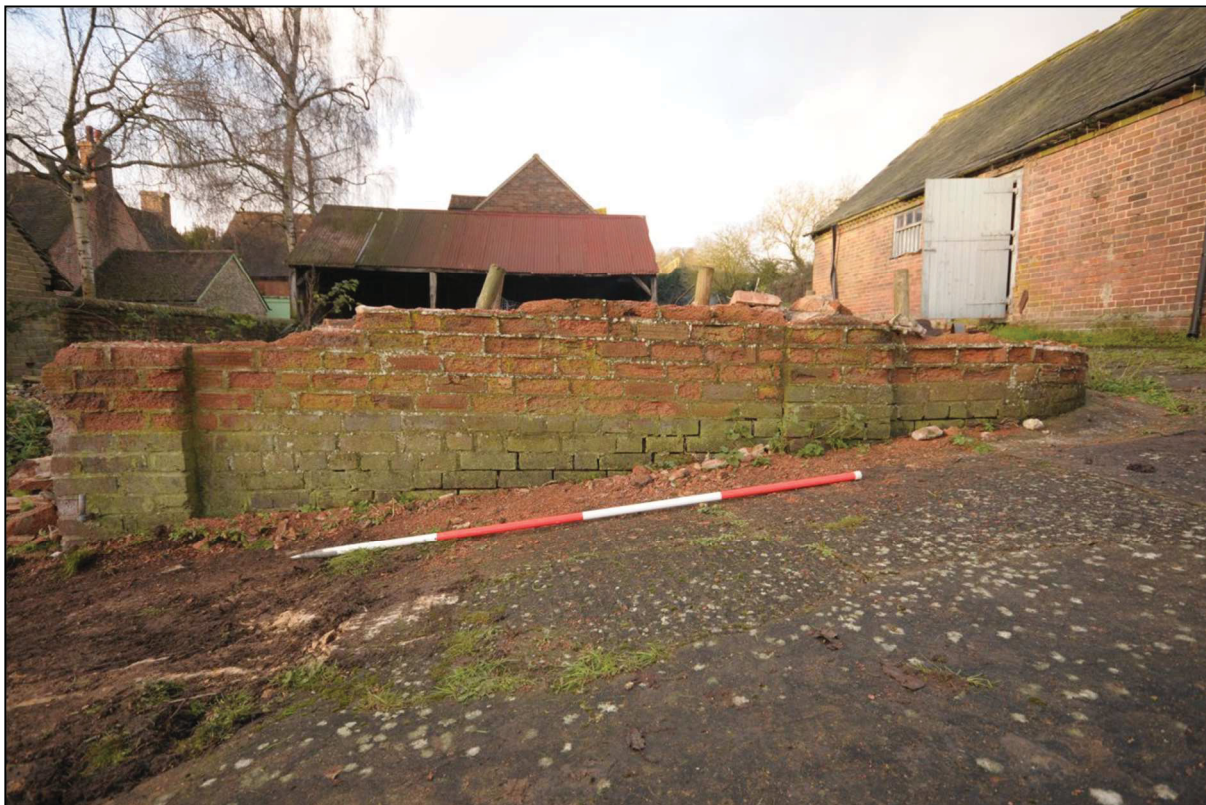
**Image 37:** Stockyard wall, eastern corner, looking north-west

Some parts of the wall have been repaired or rebuilt using Fletton rustics/textured brick, a type in use from the mid-20th century. The earlier bricks are similar throughout, *c.* 225mm x 115mm x 70mm and mid-red in colour with occasional darker, purplish examples. Where the upper surface of the brick is exposed in the wall along the north-east side of the yard, they have a shallow frog.

Shows wall with upper part rebuilt in Fletton brick (Scale 2m)
