LAND ADJACENT TO
51 HIGH STREET
ROXTON
BEDFORDSHIRE

HISTORIC BUILDING RECORDING

Project: HSR2574
Museum accession no.: BEDFM 2015.04
OASIS no.: albionar1-241452

Document: 2015/125
Version: 1.0

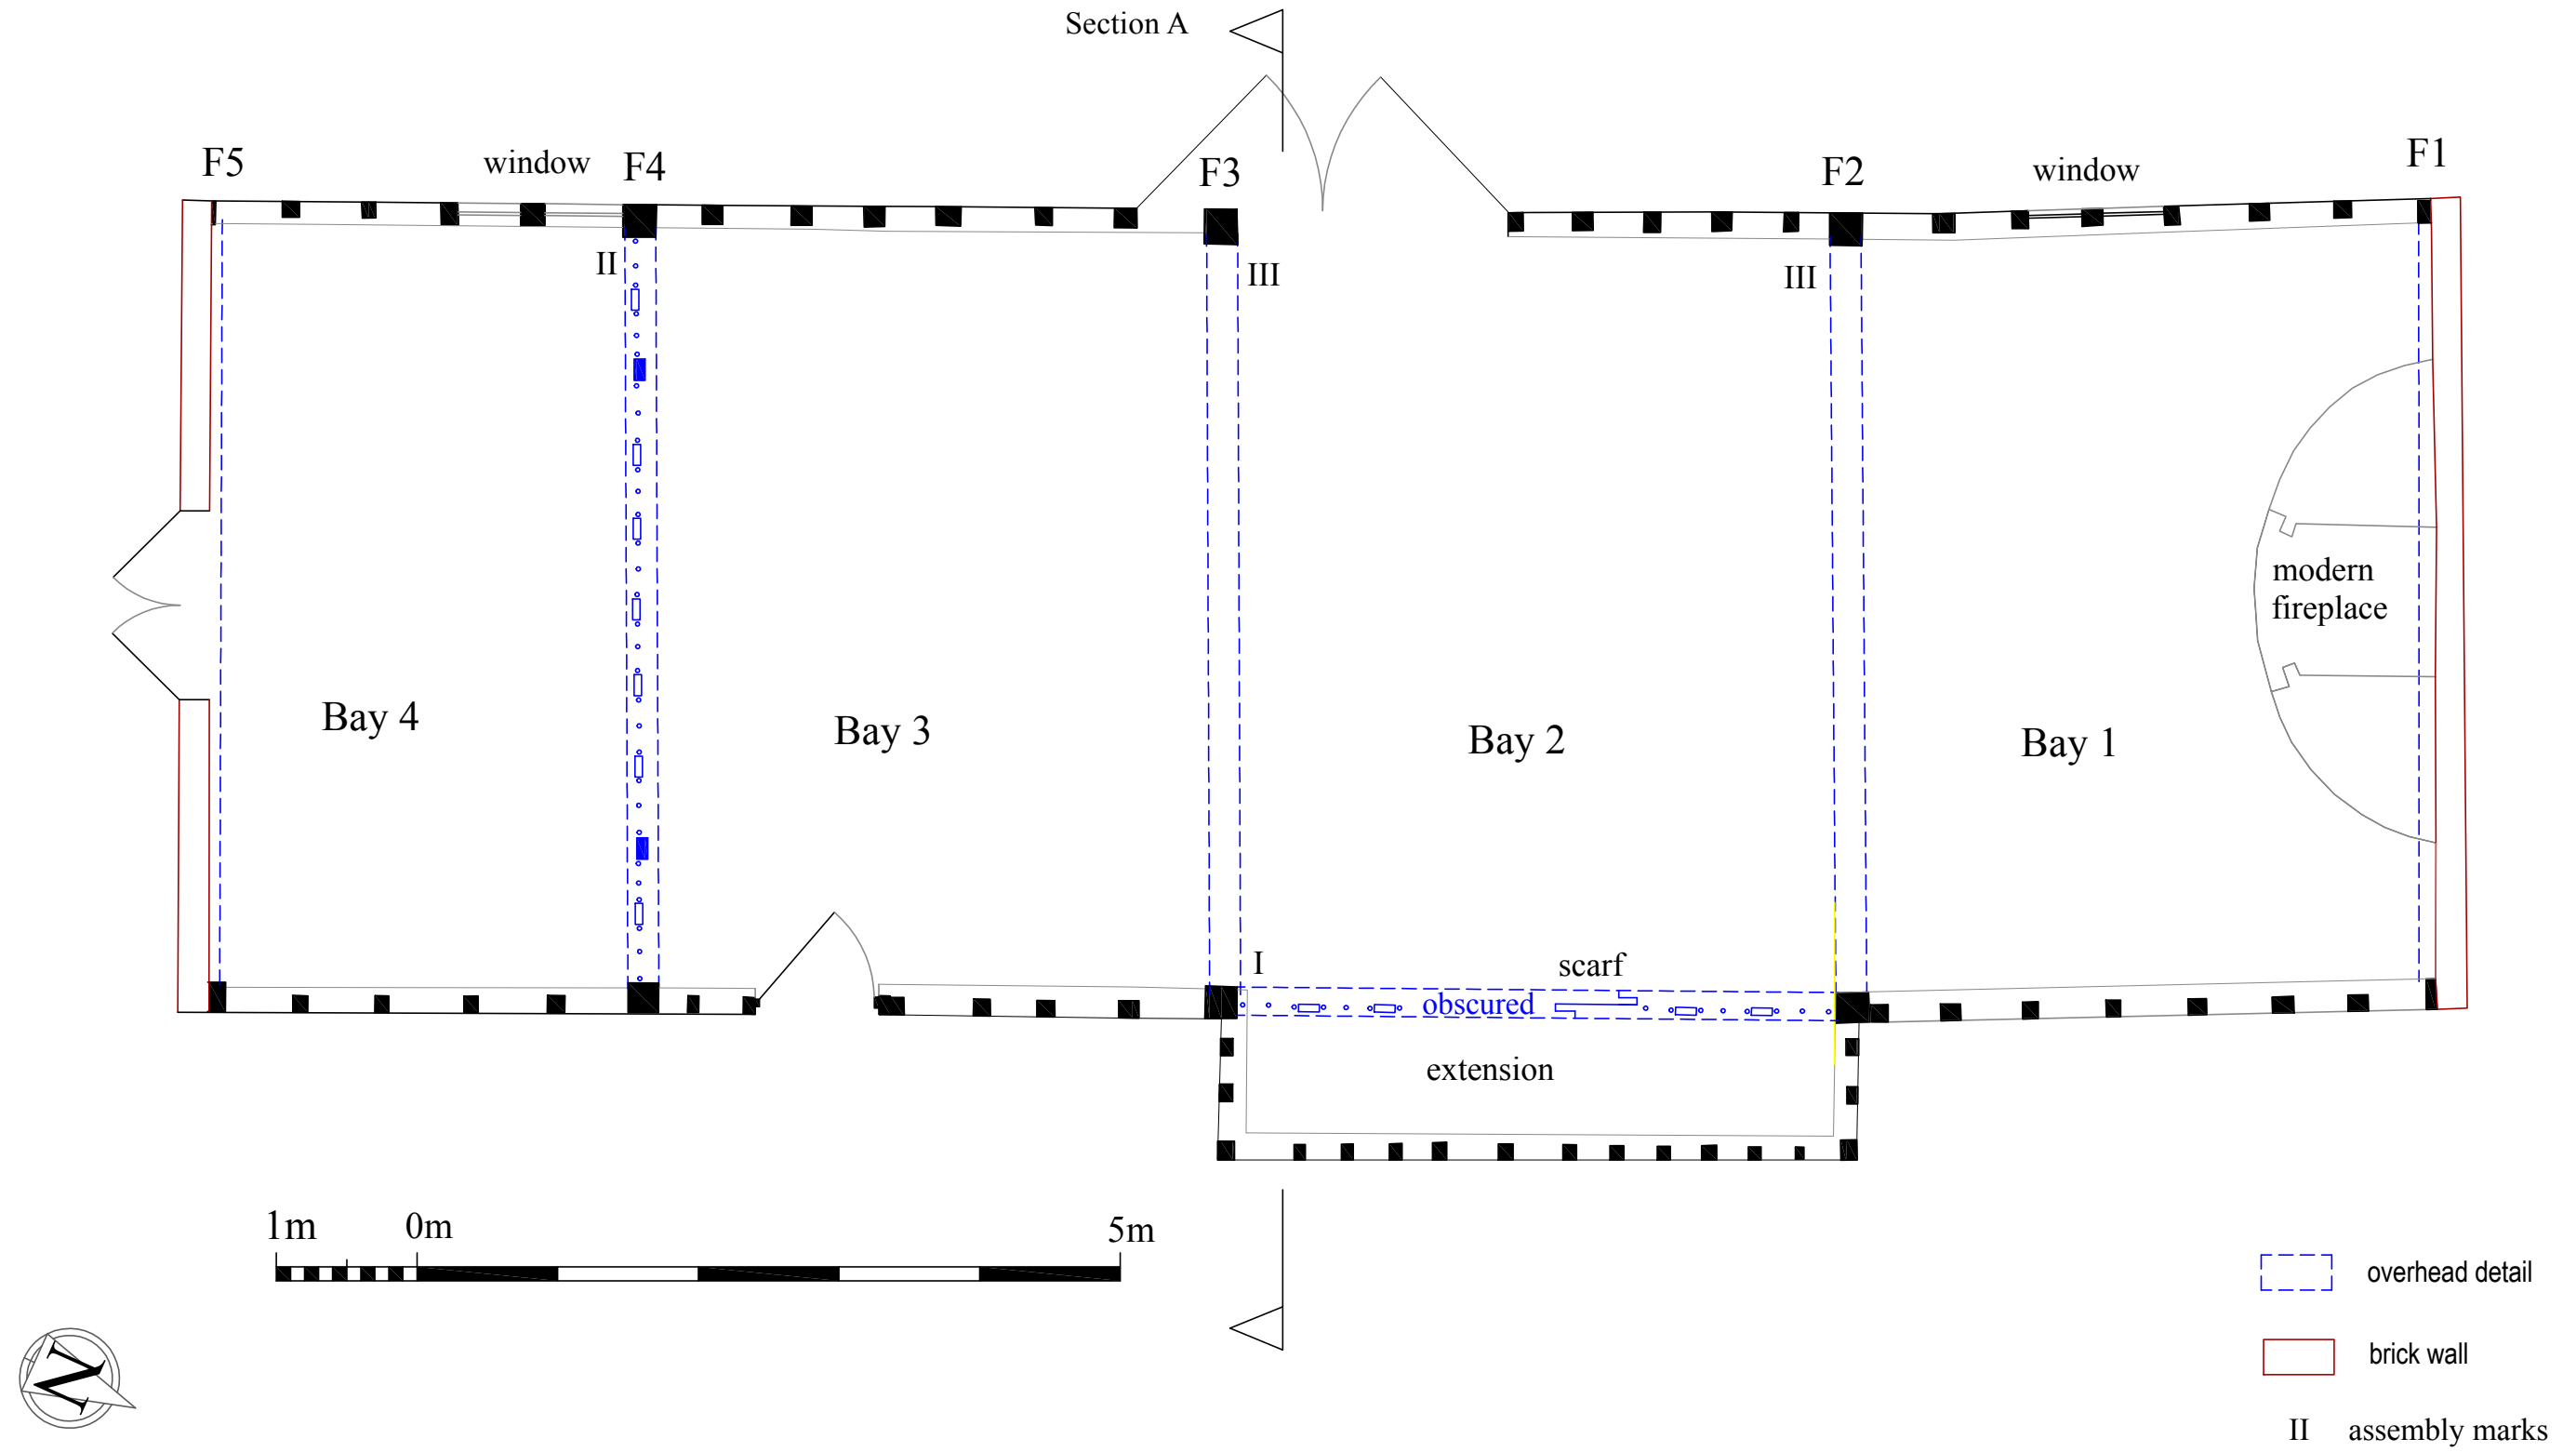
Figure 3: Barn, plan

Assembly marks in the form of knife-cut Roman numerals are visible on the north face of Frame 3 and the south face of Frame 4 (Figure 3). They are cut towards the ends of the tie-beams and in matching pairs on the lower part of the brace and post.

They appear to be used to 'side' the frames, I on the east side and II on the west (Image 9). Frame 2 carries a possible assembly mark on the south face of the west post. This is different in character to the other marks and consists of three, relatively widely spaced parallel marks. The location of the assembly marks are noted in plan on Figure 3.

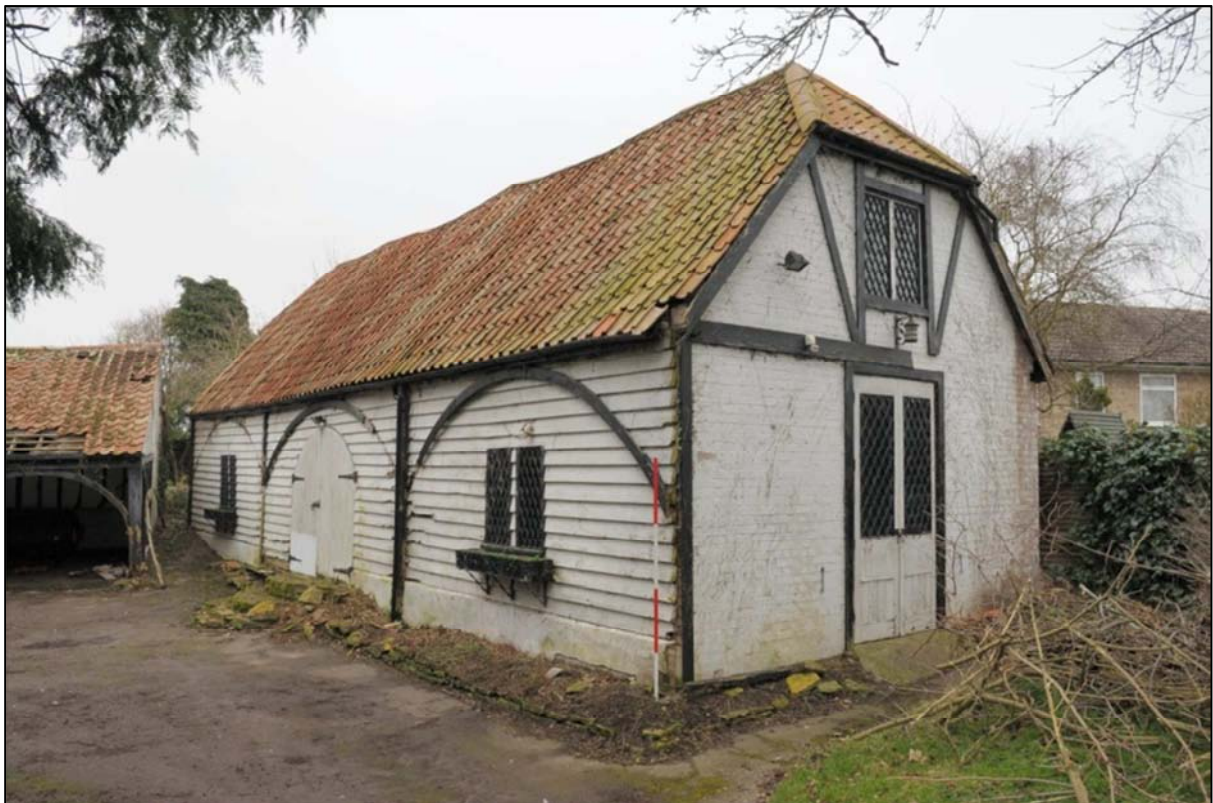
Image 2: Barn, showing west front and south end wall

The south end wall is in Fletton brick in English bond, painted white and with applied timber 'framing' attached to the brickwork (Image 2). It contains a glazed double door and a window in the gable above.

Shows modern brickwork in end wall and applied timbers (Scale 2m)

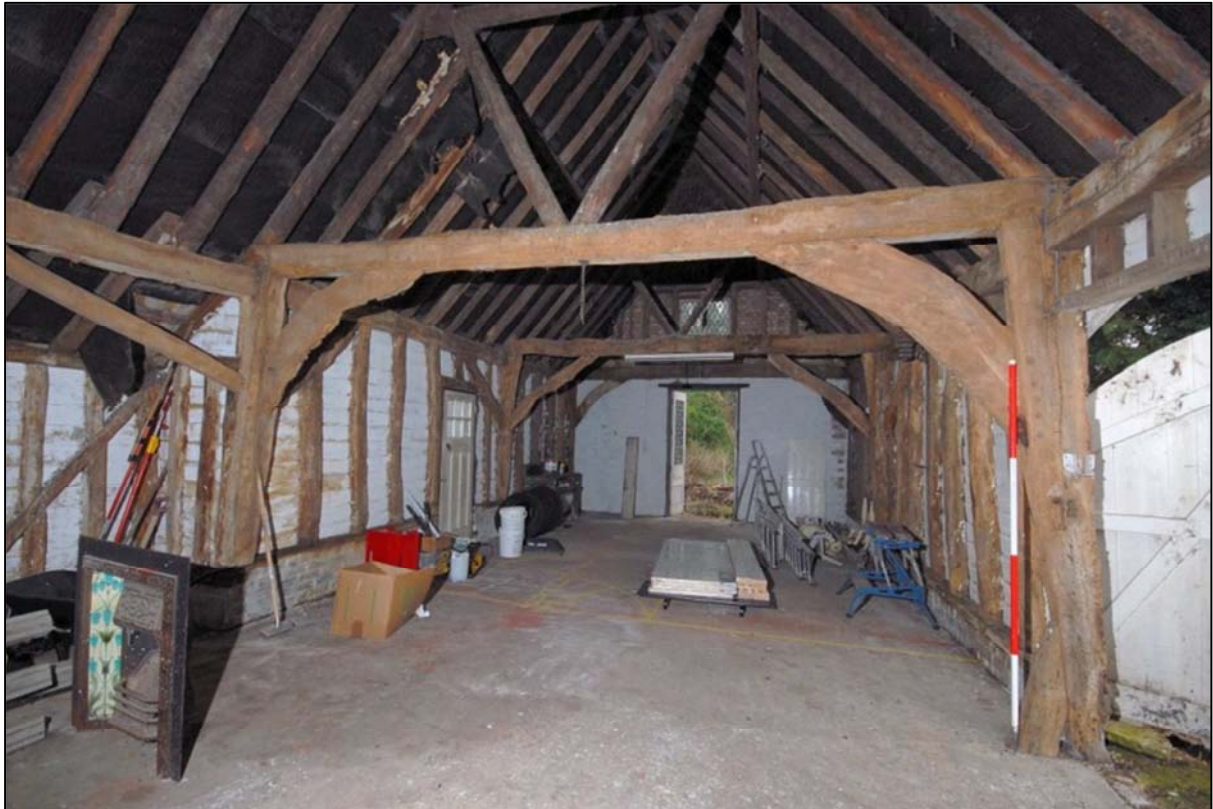
Image 3: Barn interior, looking south from Bay 2

The transverse frames of the primary structure (Frames 1 to 4) have posts with expanded jowls and straight tie-beams. The braces in Frames 2 and 3 are deep and slightly curved with long mortises fixed with 4 or 5 pegs (Figure 4). Those in the original end walls in Frames 1 and 4 are thinner and made from irregular waney timber.

Shows deep, curved braces in south side of Bay 2 (Scale 2m)

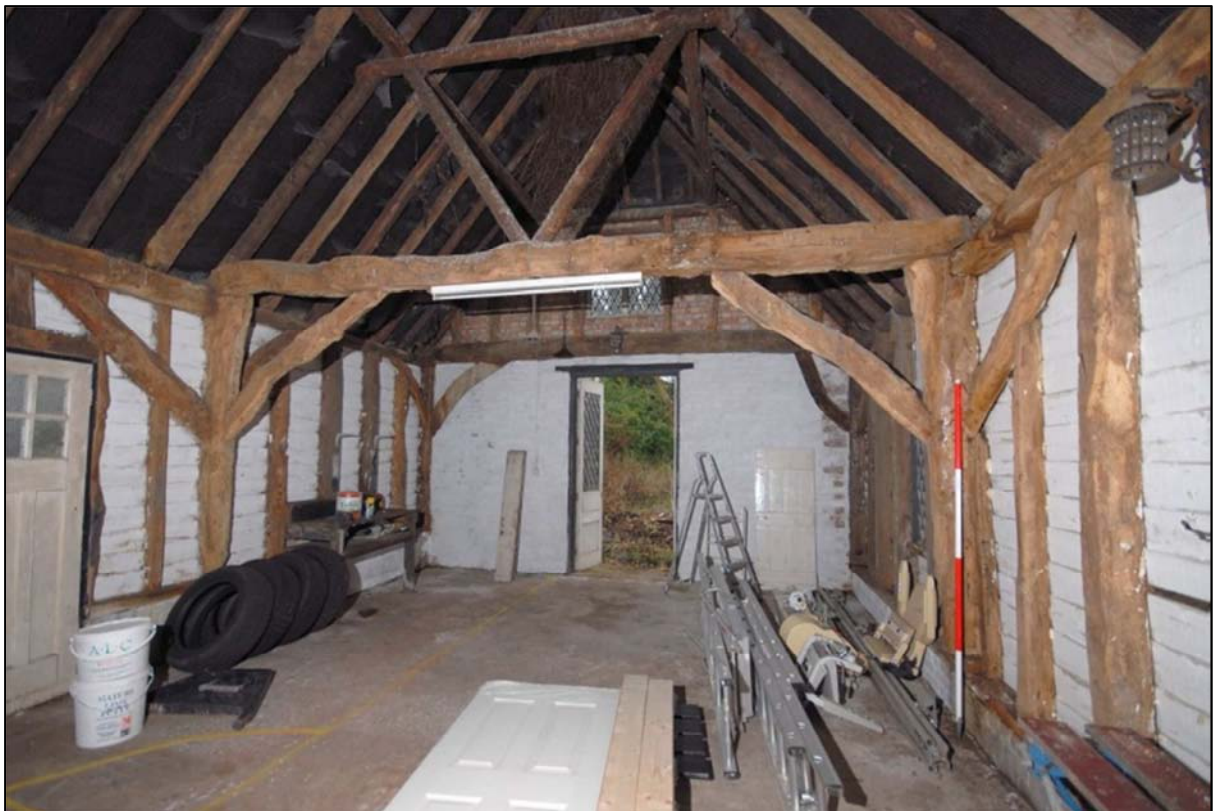
Image 4: Barn interior, looking south from Bay 3

Shows thin braces in south side of Bay 3 (Scale 2m)

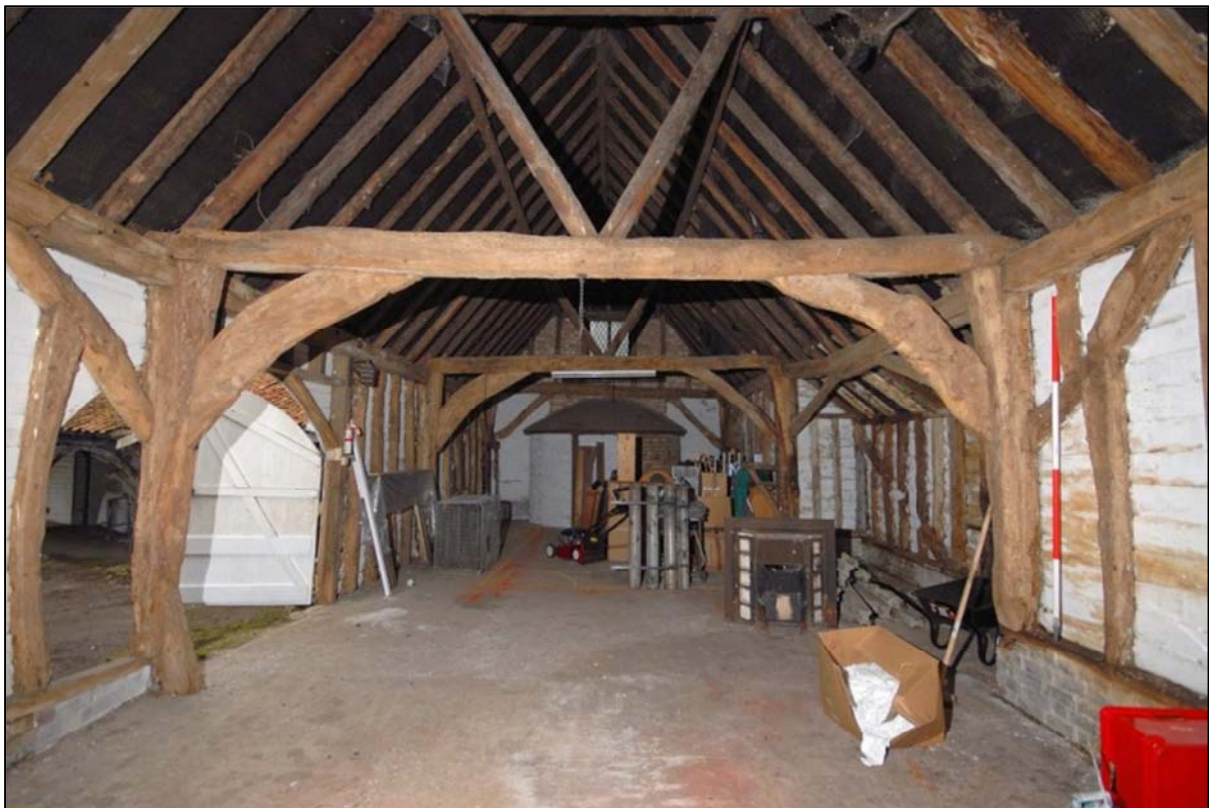
Image 6: Barn interior, looking north from Bay 3

The door opening in the west side of Bay 2 is a later insertion. Machine-sawn softwood forms the framing above and on the north side of the opening. This opening is likely to have replaced one located centrally in Bay 2; however, the replacement of the wall plate in this bay has removed any evidence for the original arrangement.

Shows door opening in west side of Bay 2 and shallow extension in east side (Scale 2m)

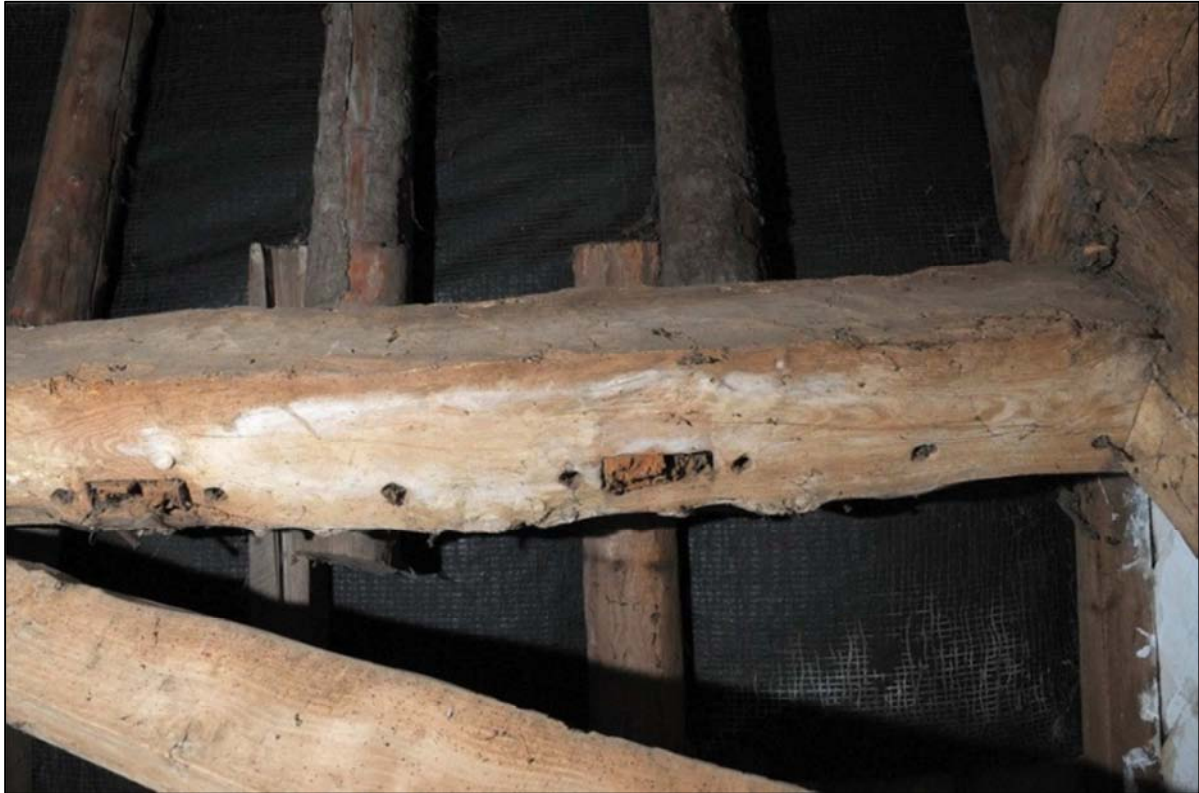
Image 7: Barn interior, underside of wall plate in east side of Bay 2

Evidence for a wattle infill survives in the primary structure. This consists of augured stave holes in the wall plates and notches in the sides of the studs (Image 7). The location of the stave holes are indicated in Figures 4 and 5. An arrangement of three rows of paired horizontal ledgers is indicated by notches grouped in twos at the top, middle and base of the studs. No stave holes or notches were found in the west walls of Bays 1 and 2 where the wall has been subject to later repair.

Shows mortise holes where the wall has been removed and stave holes for wattle and daub

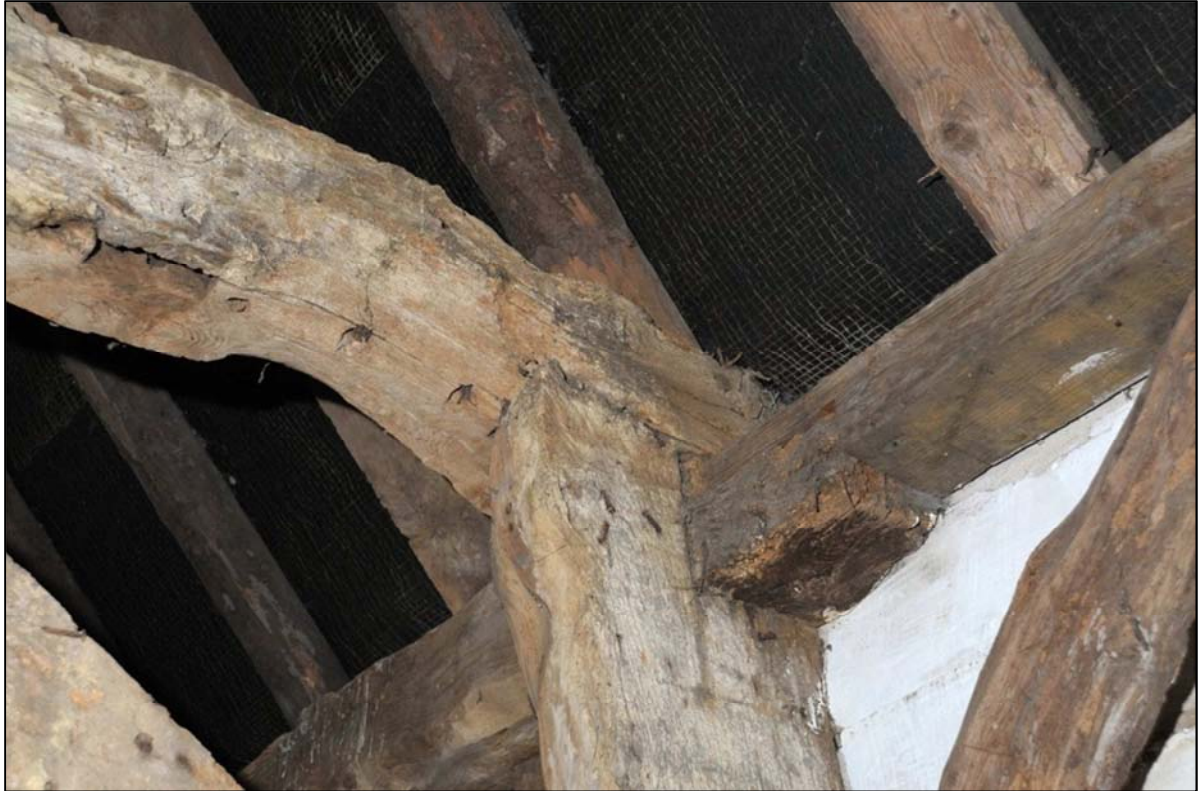
Image 8: Barn interior, south side of Frame 4, east wall

Stave holes and mortise in underside of the tie-beam indicate location of original south end wall of barn. The wall plate visible at the right is part of the Bay 4 extension.

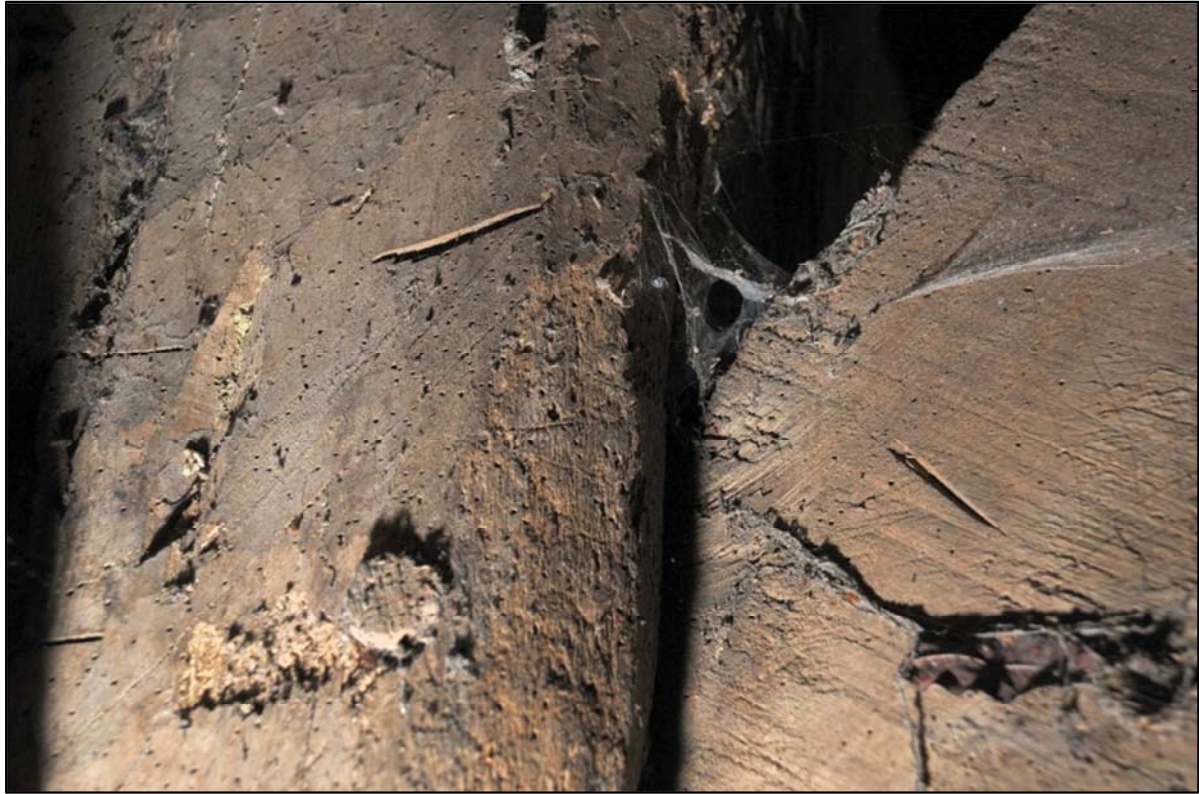
Image 9: Barn interior, assembly marks

Assembly marks on the post and brace on the north face of the east side of Frame 3

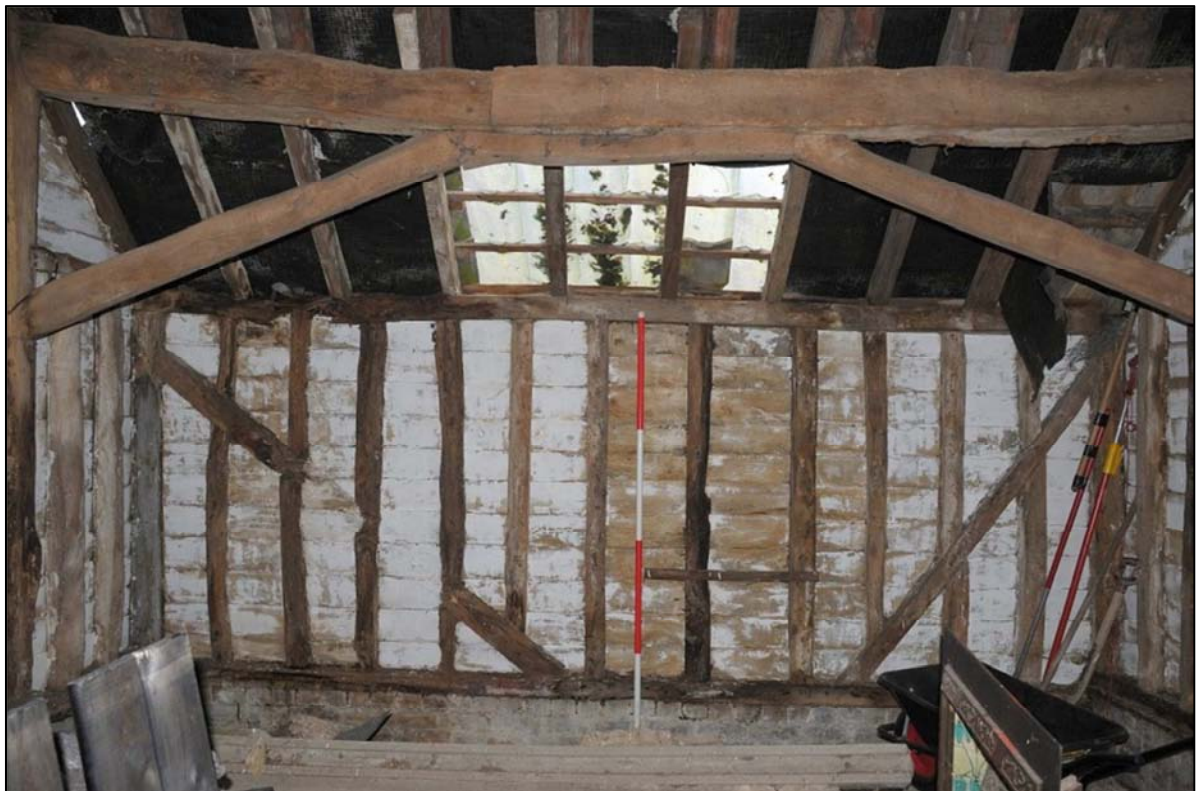
Image 10: Barn interior, extension on east side of Bay 2

A small extension stands on the east side of the central bay, increasing the width of this bay by 1m (Image 10). The wall stands on a low sill wall and is framed with lightweight studs with primary bracing. It is clad externally with weatherboard. The pantile roof is a cat-slide extension of the main roof and includes a panel (3x3) of glass pantiles. The form of construction suggests a probable 19th-century date for the extension.

Shows primary bracing and closely set studs

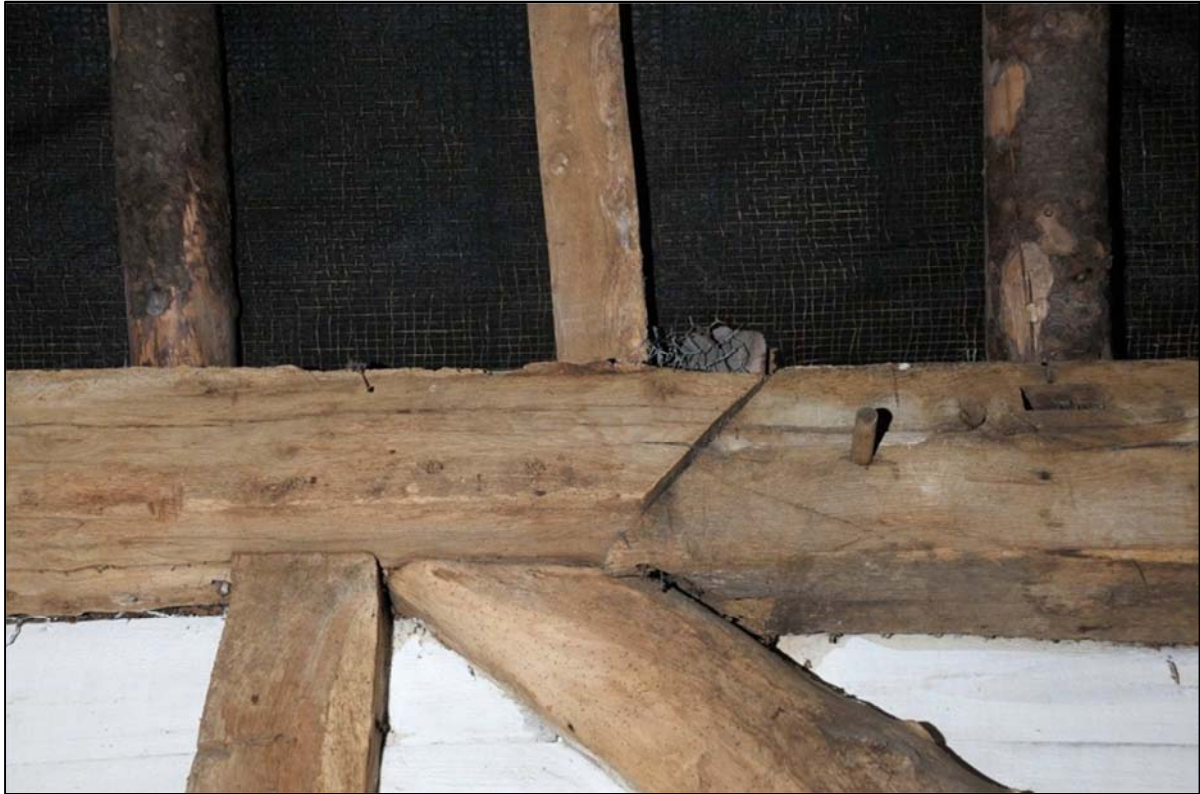
Image 11: Barn interior, repaired wall plate in west wall

The wall in the west side of Bay 1 and Bay 2 has been replaced at some time. Here the studs are not mortised into the wall plate and the wall plate is made from reused timber with closely set empty mortise holes in the side of the plate (Images 11 and 12). The plate is joined with a face-halved and bladed scarf. The scarf is set on its side compared to the usual arrangement and is fixed with bolts instead of the more usual pegs.

Shows splayed scarf joint with re-used timber used for the wall plate at right

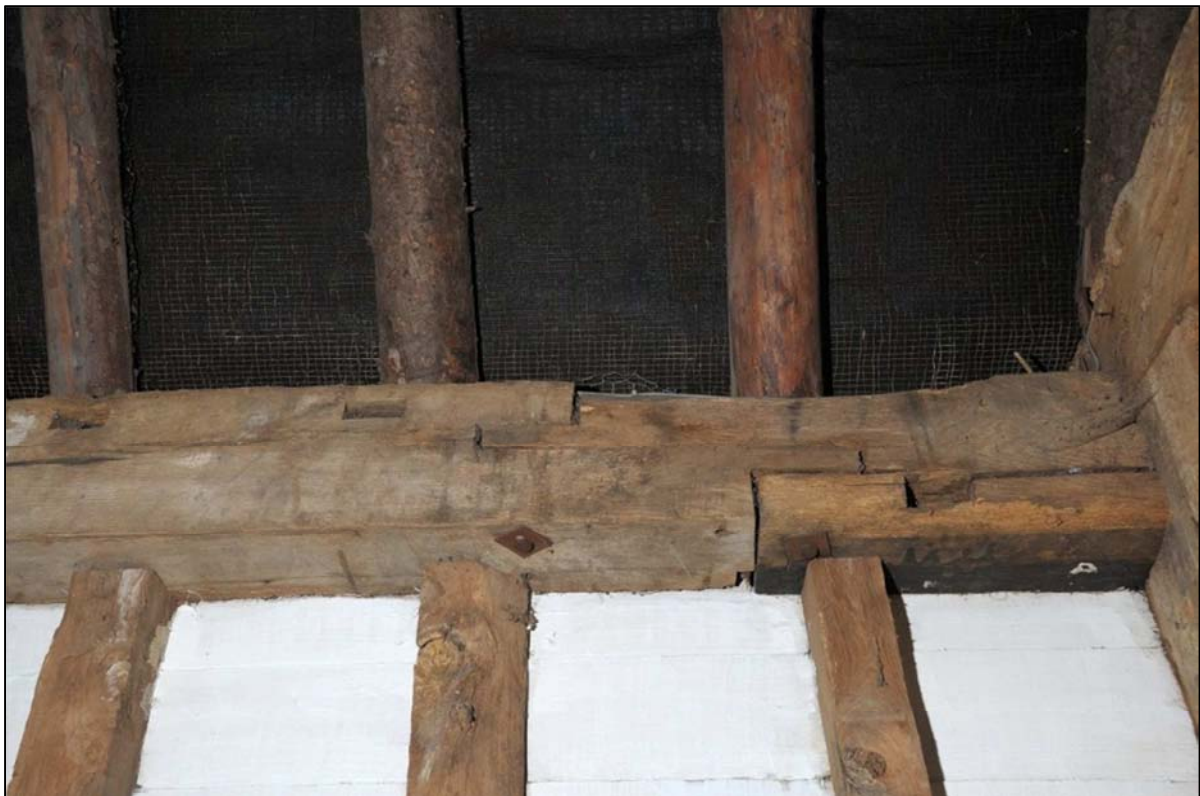
Image 12: Barn interior, repaired wall plate in west wall

Shows halved and bladed scarf joint with bolted fixings in Bay 2

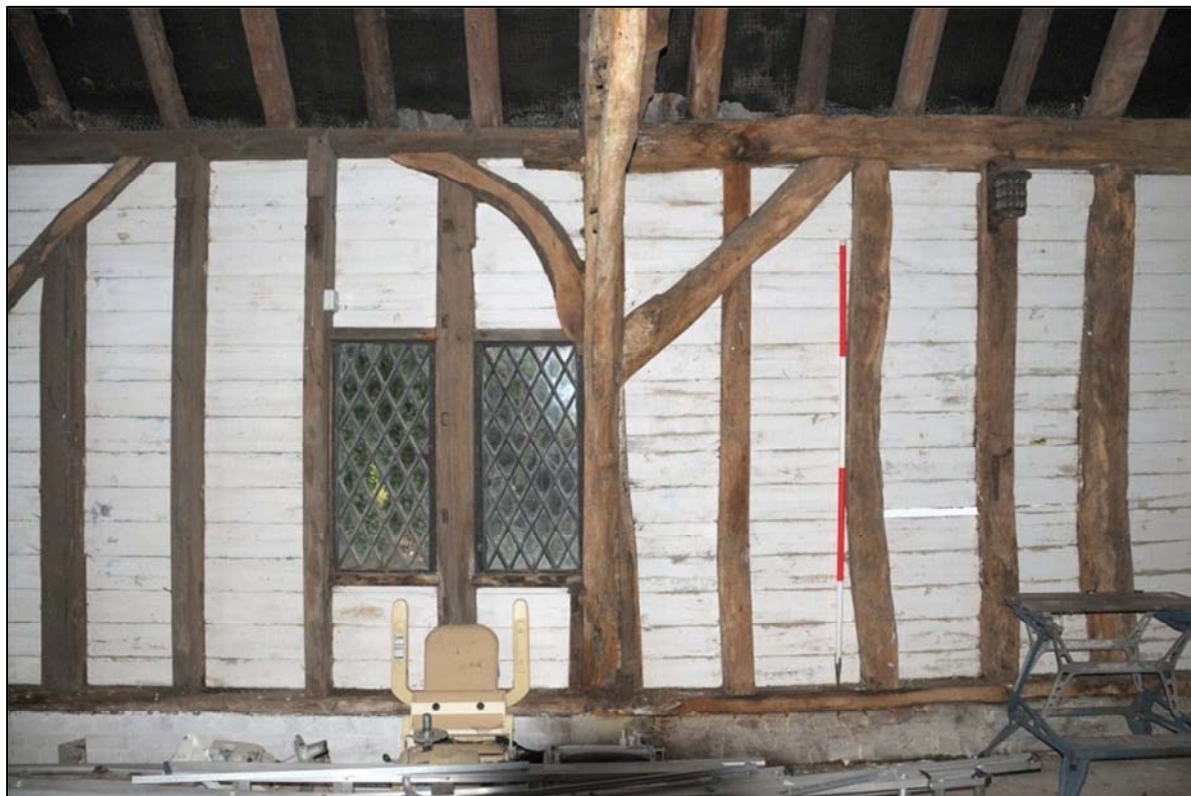
Image 13: Barn interior, west wall at Frame 4

The south end of the barn, Bay 4, is a later addition to the building (Image 13). This bay is shorter than those of the primary structure at 3.1m long. Much of the timber is machine-sawn softwood, including the wall plates. The studs are made from reused timber with mortise holes. In the west wall the braces are cut from roundwood with the bark partly remaining.

Shows primary wall construction in Bay 3 (right) and later extension (Bay 4) to the left (Scale 2m)

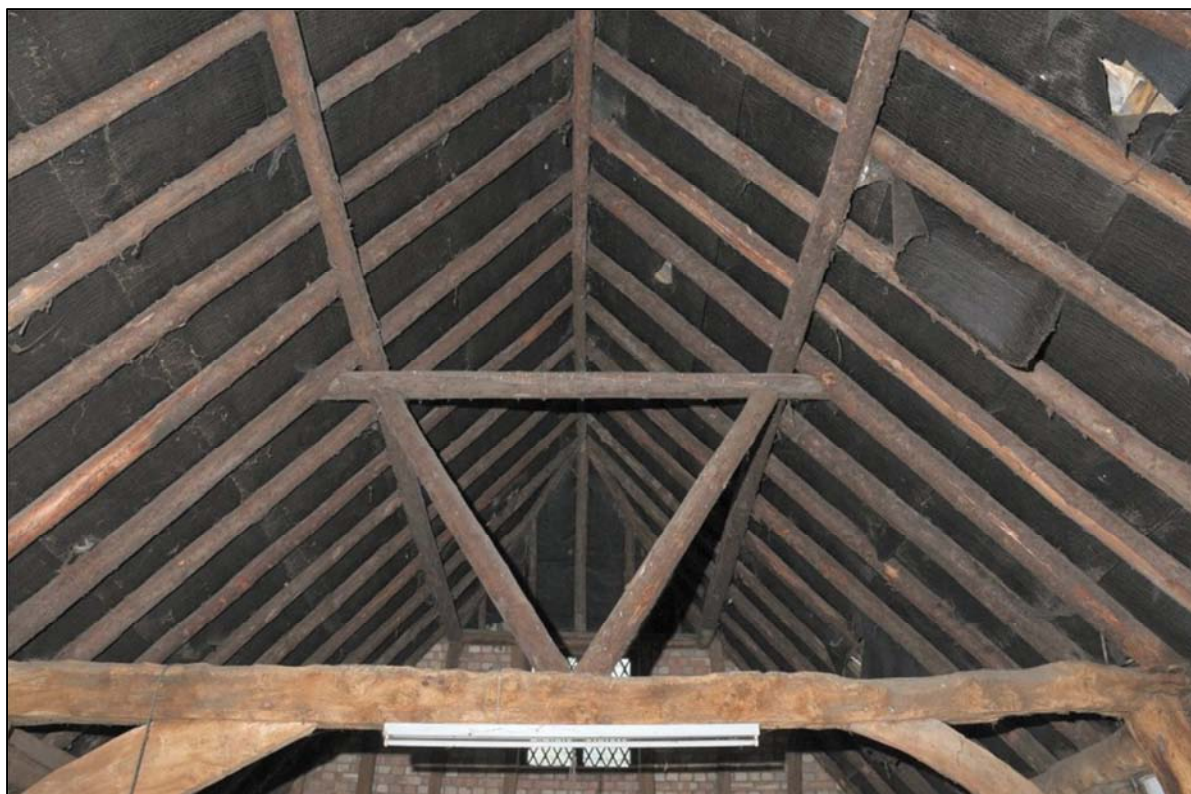
Image 14: Barn interior, roof structure

The roof has been renewed. It is of nailed construction using mostly small-section roundwood with intact bark and some machine-sawn timber.

Shows rebuilt roof with nailed roundwood pole construction

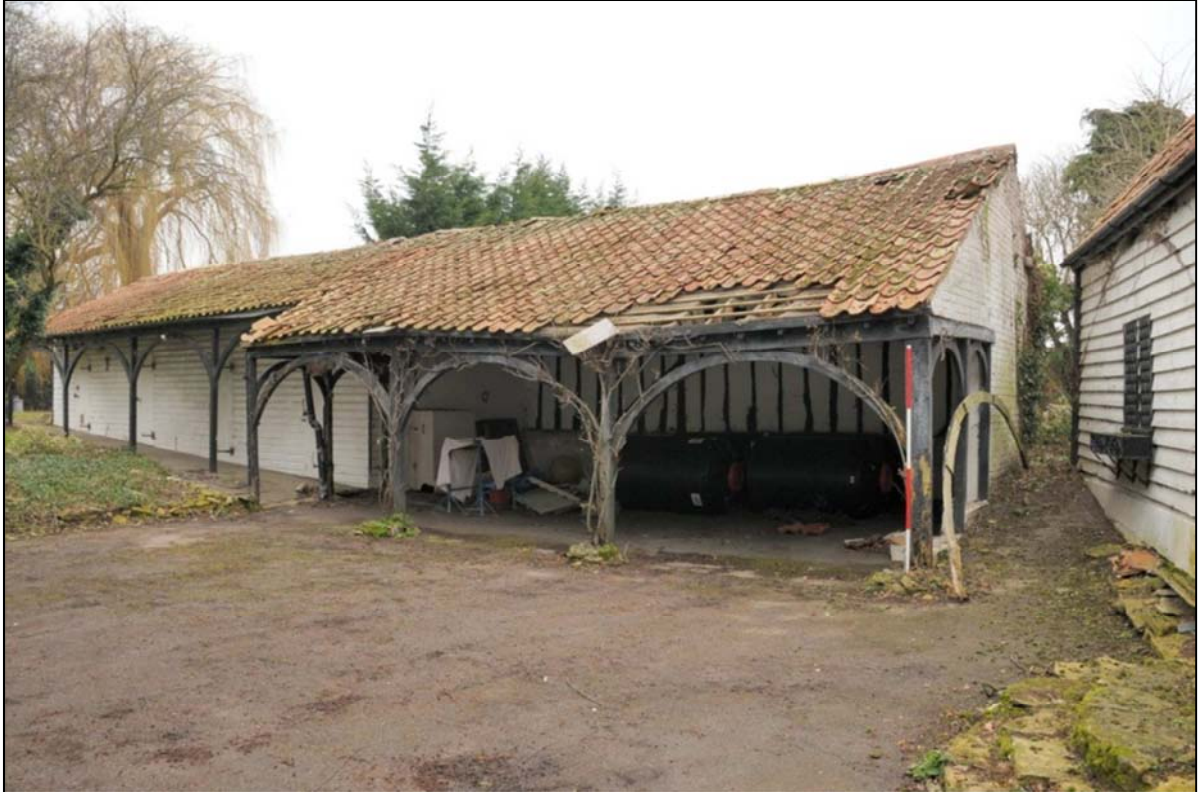
Image 15: Stables, south elevation, looking north-west

Shows modern extended south front and timber frame visible in rear wall of compartment C1

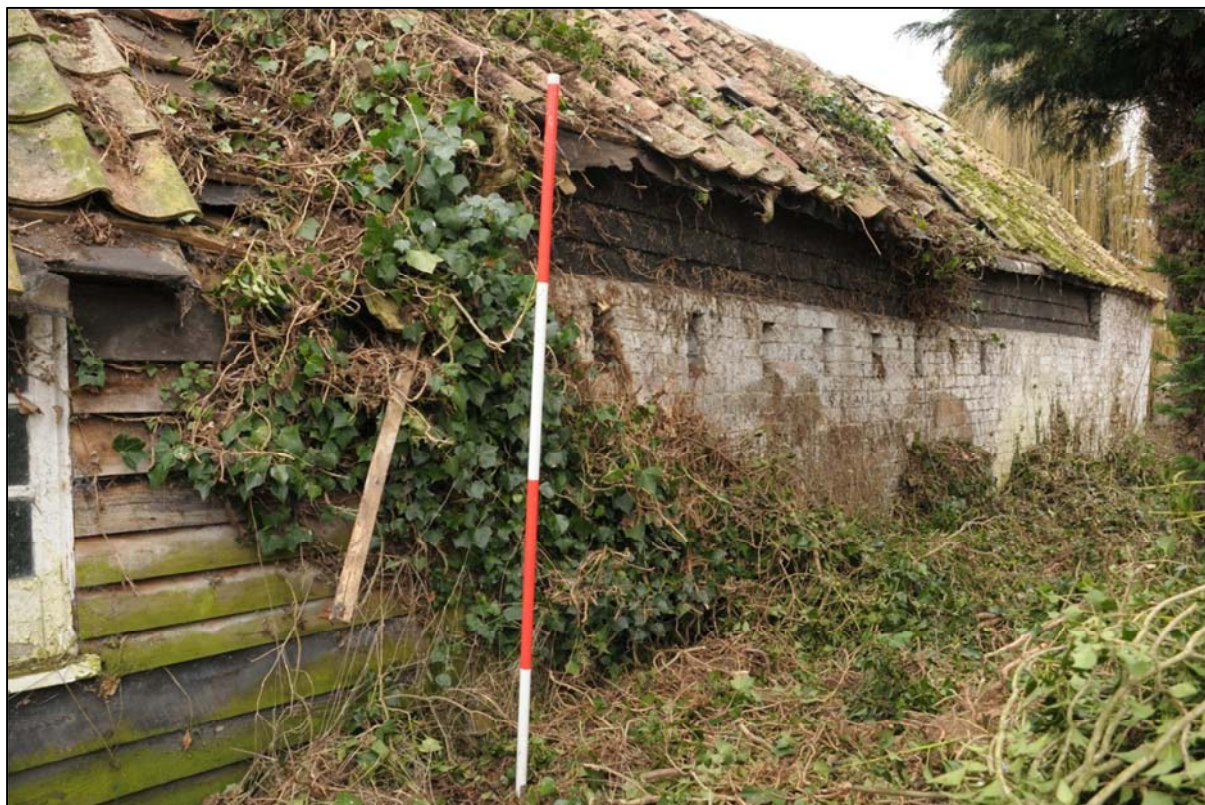
Image 17: Stables, north elevation, looking south-west

Shows change from weatherboard to brick with ventilation holes in top of brickwork (Scale 2m)

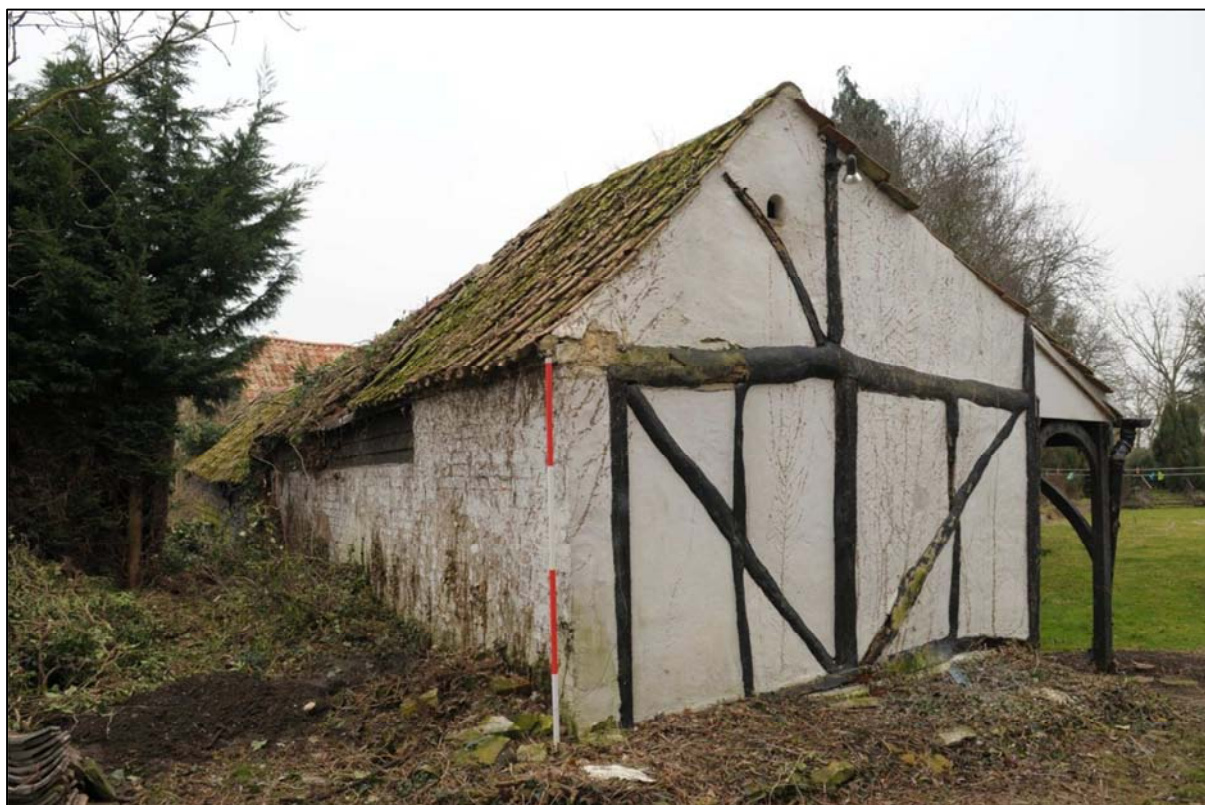
Image 18: Stables, west end wall, looking south-east

Shows brick rear wall to left and rendered end wall at right with applied timbers (Scale 2m)

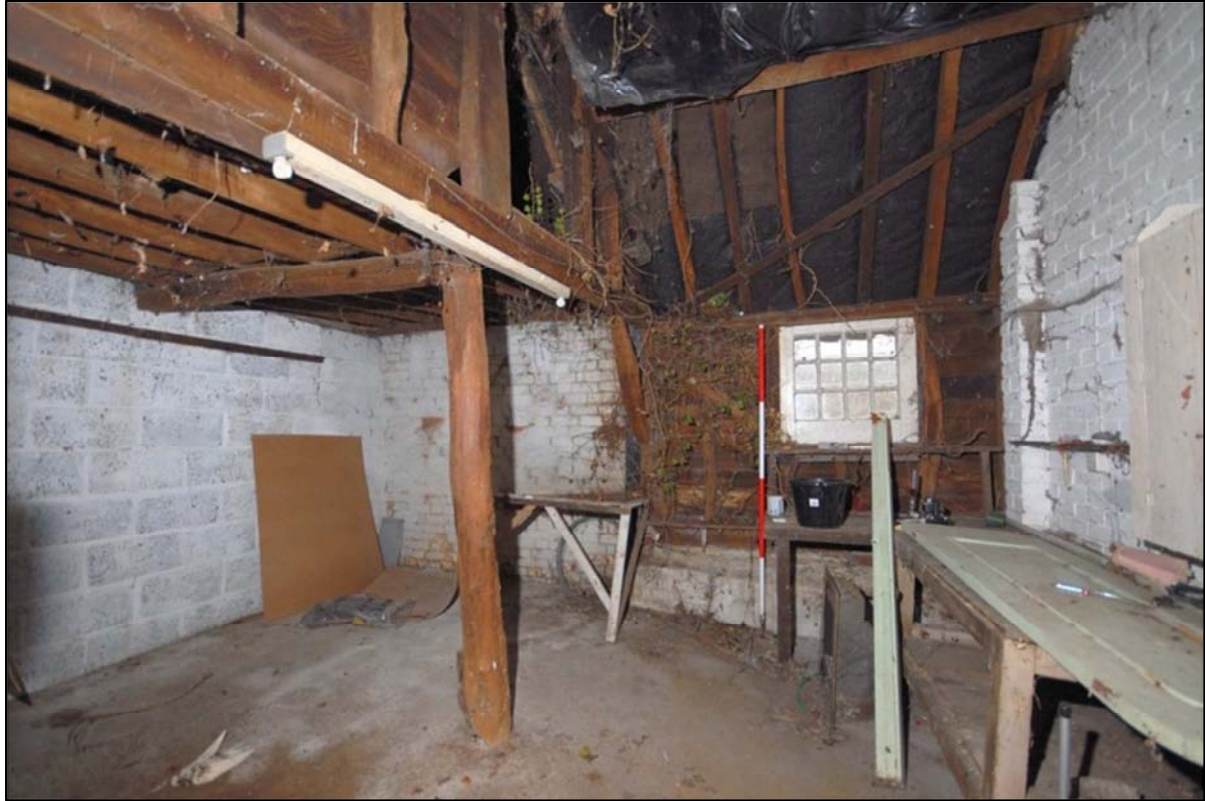
Image 19: Stables interior, compartment C2, looking north

Shows change from timber to brick in rear wall and end wall of loft at left (Scale 2m)

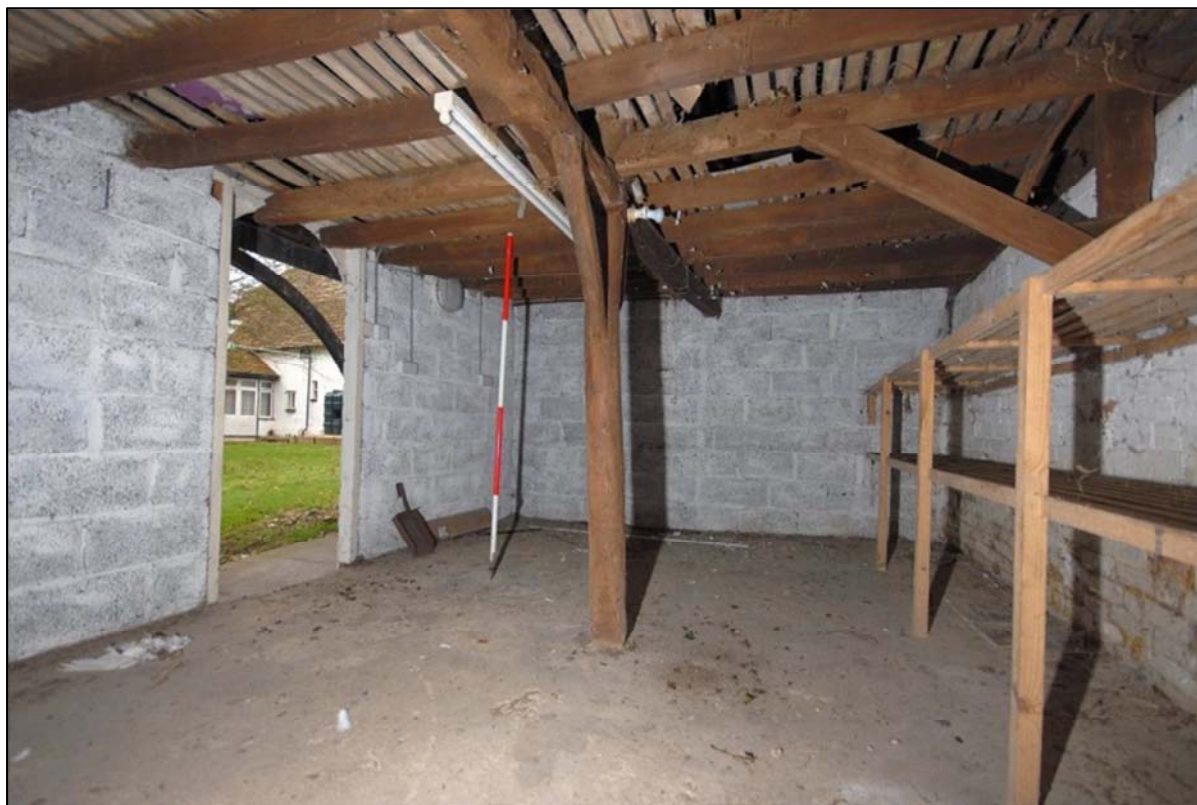
Image 22: Stables interior, compartment C3, looking west

Shows longitudinal beam supporting joists and slatted loft floor (Scale 2m)

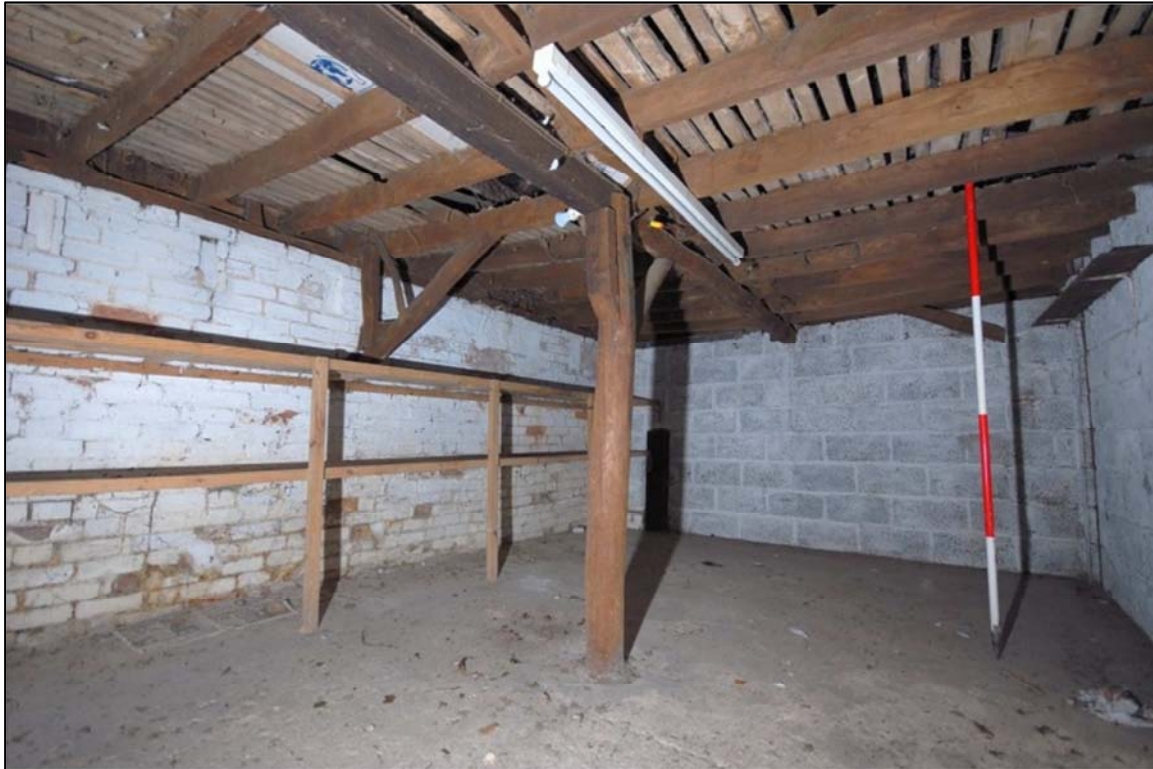
Image 23: Stables interior, compartment C3, looking east

Shows slatted loft floor and blocked vent holes at top of rear wall to the left (Scale 2m)
