**BARN AT 63-65 HIGH STREET
STAGSDEN
BEDFORDSHIRE**

HISTORIC BUILDING RECORDING

Document: 2016/217
Version: 1.0
January 2017

Project: HSS3007
Bedford Museum Accession Number: BEDFM 2016.93
Oasis reference: albionar1-270814

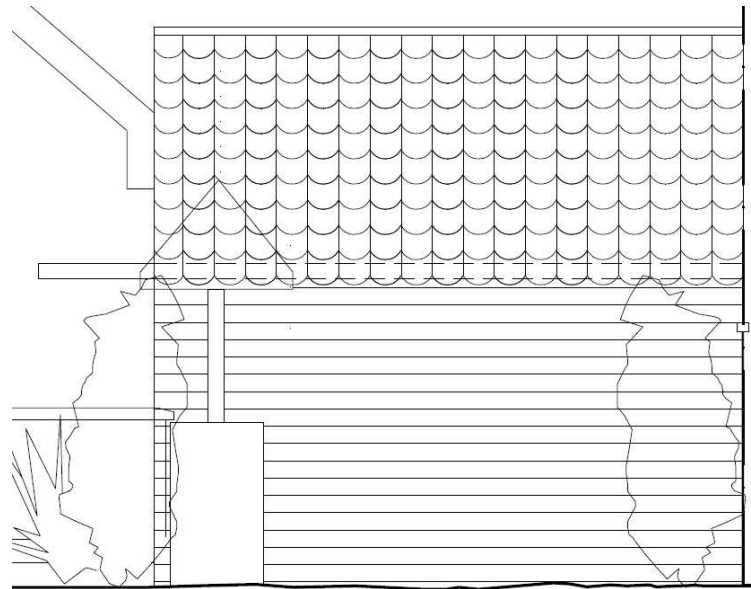
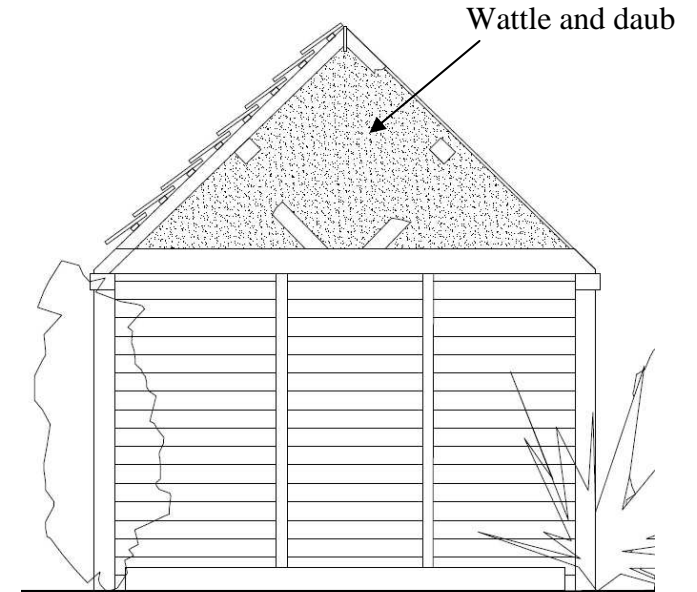
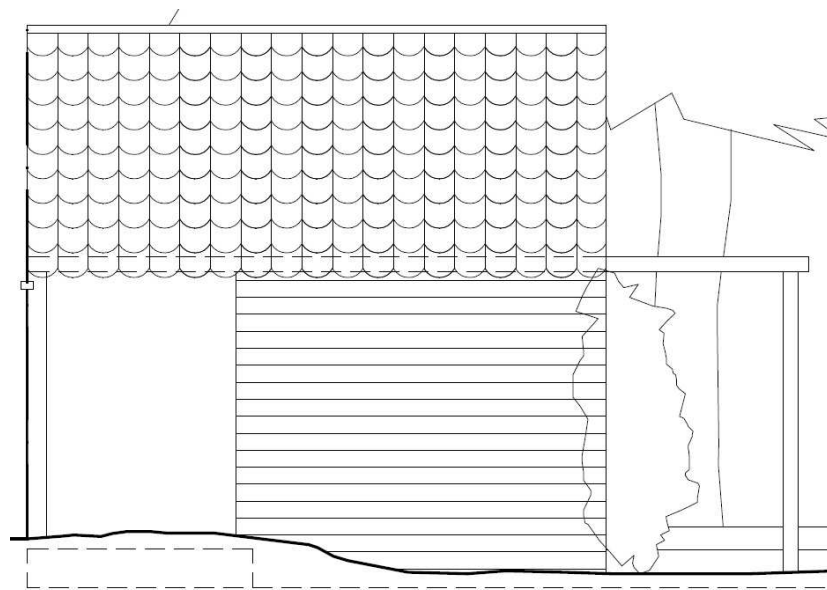
Figure 6: Architects survey of barn
Shows barn before start of building works

Architects plans dated June 2015 show the remaining northern half of the barn as it was prior to the start of the present building works (Figure 6). The drawings show the east and west side walls clad in weatherboard. A structural report prepared for the planning application indicates that the east elevation was of wattle and daub construction. An opening at the north end of the west side formed the access to the building. The north end wall contained two plank-and-batten doors, a metal-framed window with the remaining parts of the lower wall and gable covered by weatherboard cladding.

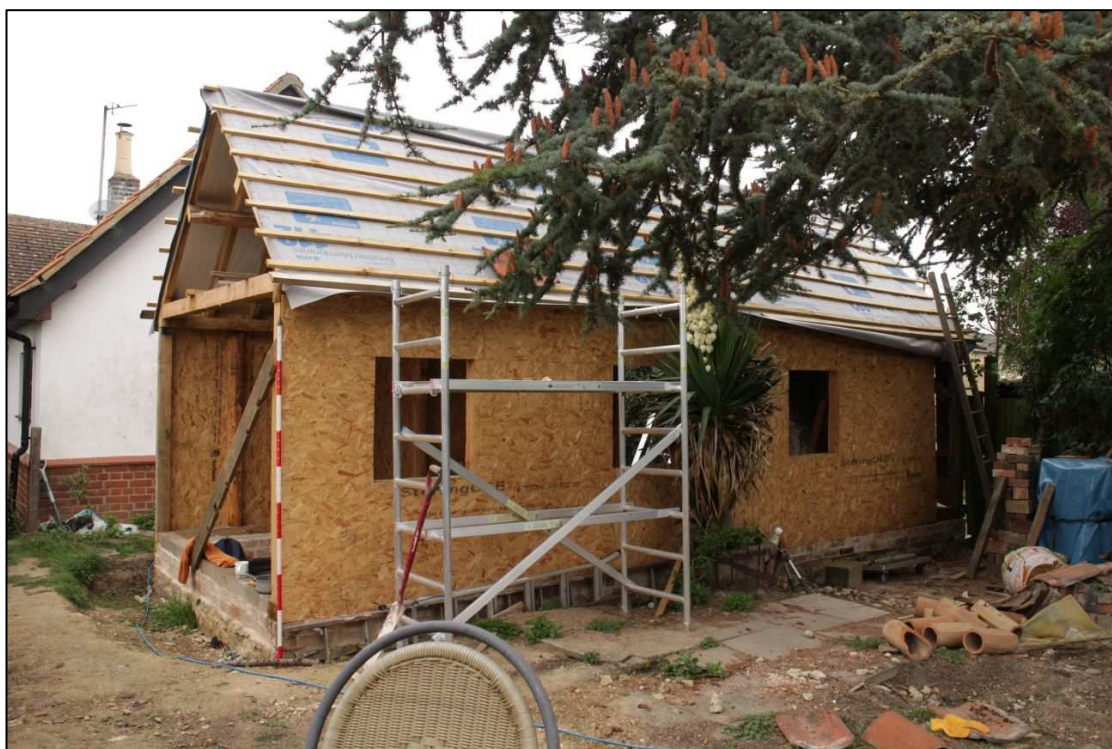
Image 1: Exterior of barn, looking north-west

The original barn had been dismantled and the process of rebuilding was at an advanced stage when the work was suspended until recording had been carried out (Images 1 & 2). The new building is 7.4m long and 3m wide. It is constructed on the same footprint as the original building but with new foundations and a sill wall made with reused limestone and bricks. Those parts of the frame which were found to be structurally sound have been incorporated into the new structure, reusing them in the original arrangement. The rest of the frame has been constructed in modern timber using traditional carpentry joints with pegged fixings.

Shows partially rebuilt barn with house in background (scale 2m)

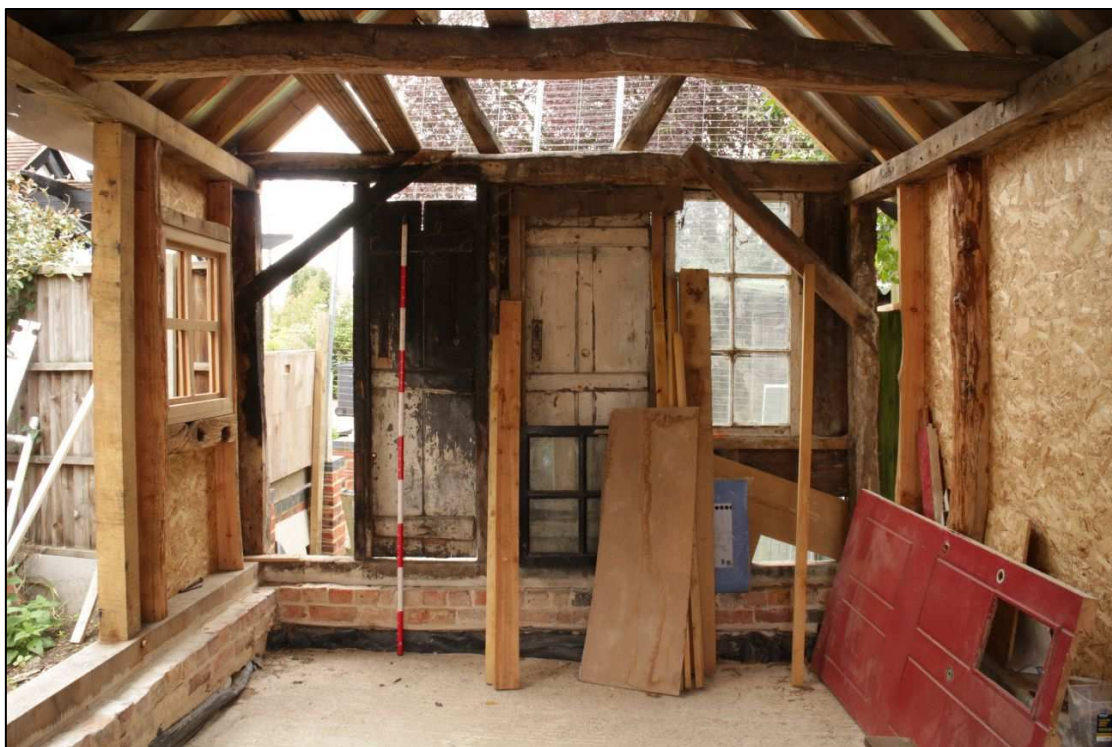
Image 3: Interior detail of north wall

The two corner posts in the end wall at the north of the barn are c.125mm square (Image 3). These are plain posts without jowls (expanded ends) or upstands to support the junction with the tiebeam and wall plate. Two straight, plank-like braces attached to the inside face of the north wall have the appearance of makeshift reinforcements but were clearly present when the building was damaged by fire in the 1990s as the scorch marks on the eastern brace match those on the tiebeam to which it is nailed.

At the time of the survey the north wall was relatively unchanged from its condition prior to reconstruction and still contained the two plank-and-batten doors and the metal framed window (Image 3).

Shows wall with original sill beam, tiebeam and reused doors and window
(scale 2m)

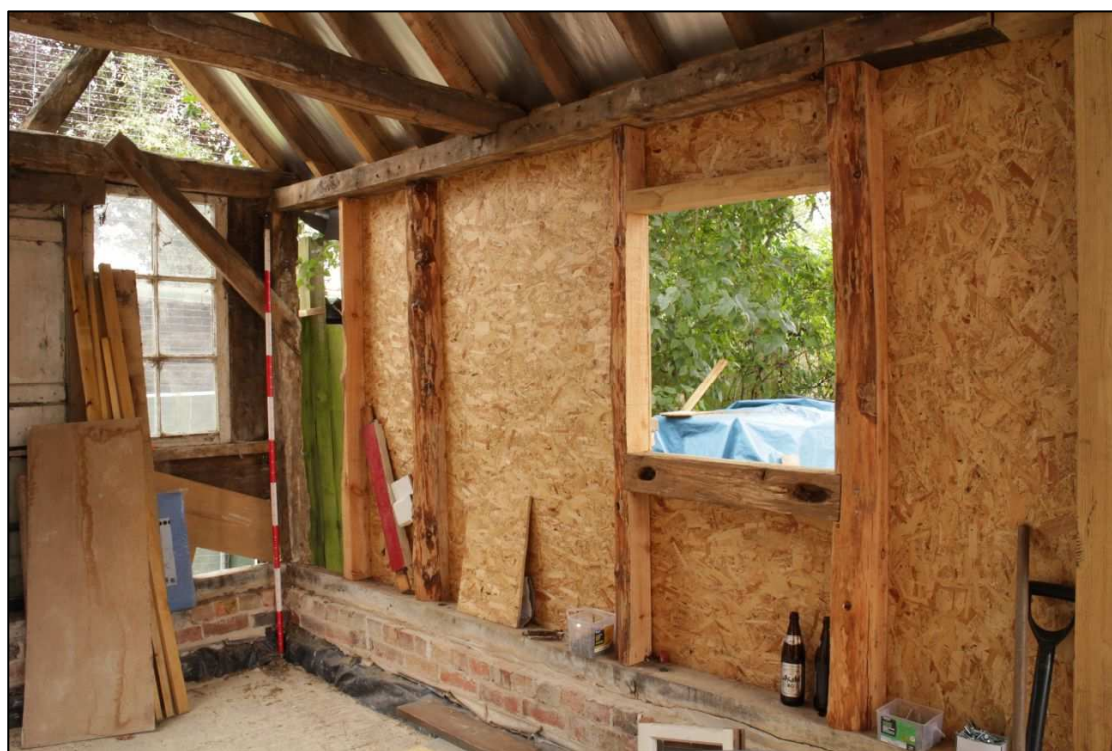
Image 4: Interior, showing northern end of east wall

The original sill beams are c.150mm wide and 100mm deep (Image 4). The surviving sections in the north and east walls meet in a halved join at the north-west corner of the building. The sill in the east wall is halved at its southern end where it is joined to the new timber.

The original wall plate in the east wall is c.150mm wide and 100mm deep (Image 4).

Looking north-east showing original sill beam and wall plate in this part of east wall
(scale 2m)

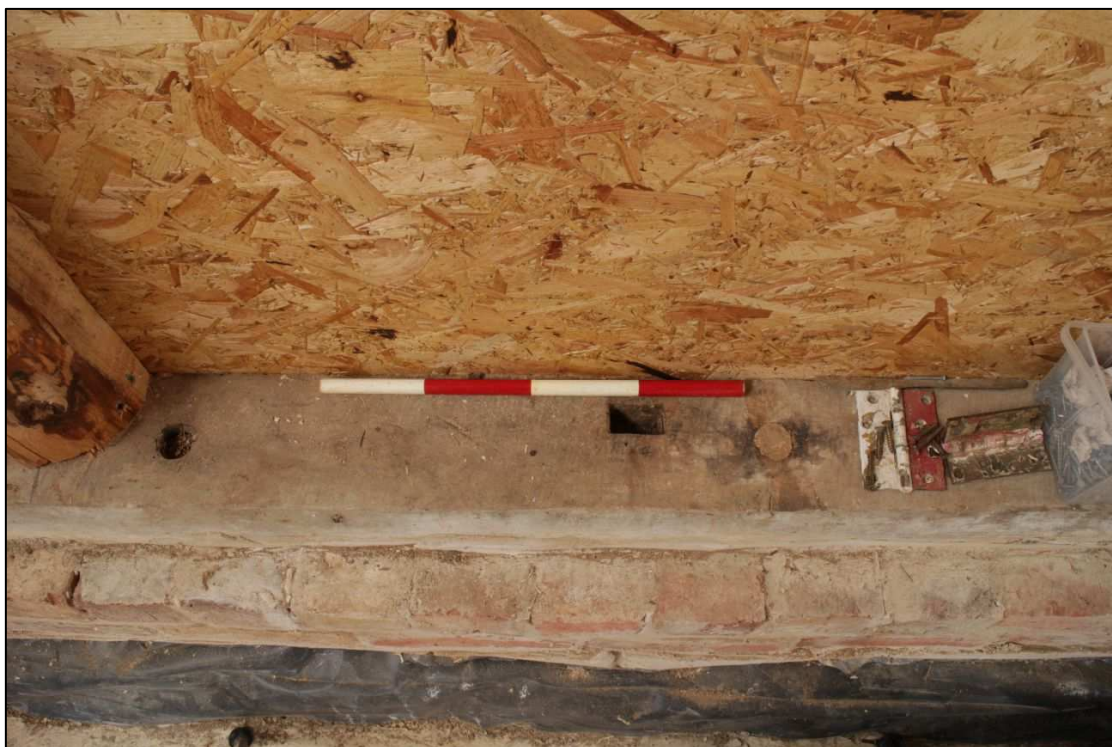
Image 5: Sill beam in east wall

Matching patterns of staff holes in the sill beam and the wall plate indicate the former presence of wattle and daub infill in the east wall (Images 5 & 6). Similar evidence in the north wall consisted of two staff holes identified in the sill beam. Some staves remained on site, presumably recovered from partition at the central truss (Images 7 & 8). These were c.1.74m long, up to 70mm in diameter and reduced to c.40mm at the ends to fit the staff holes. The staves have mottled or stripped appearance where they were stained by the daub infill.

Shows stave holes and mortise at base of east wall, located to left of window opening visible in Image 4 (scale 40cm)

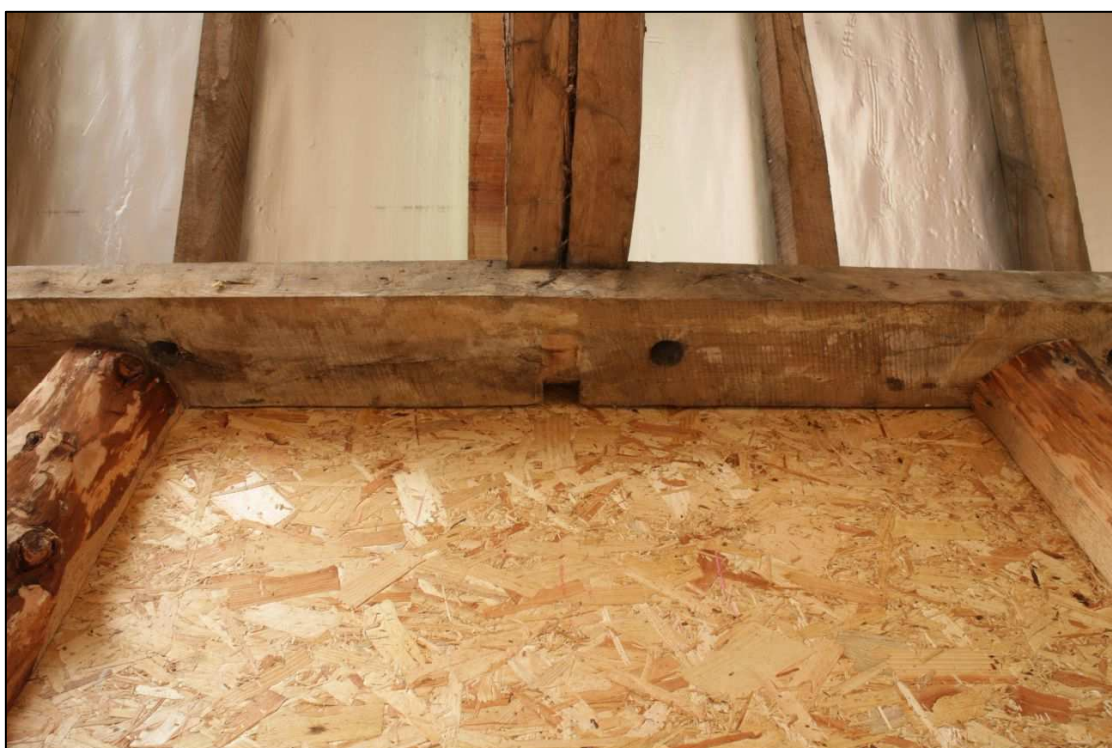
Image 6: Wall plate in east wall

Corresponding stave and mortise holes located directly above those shown in Image 5

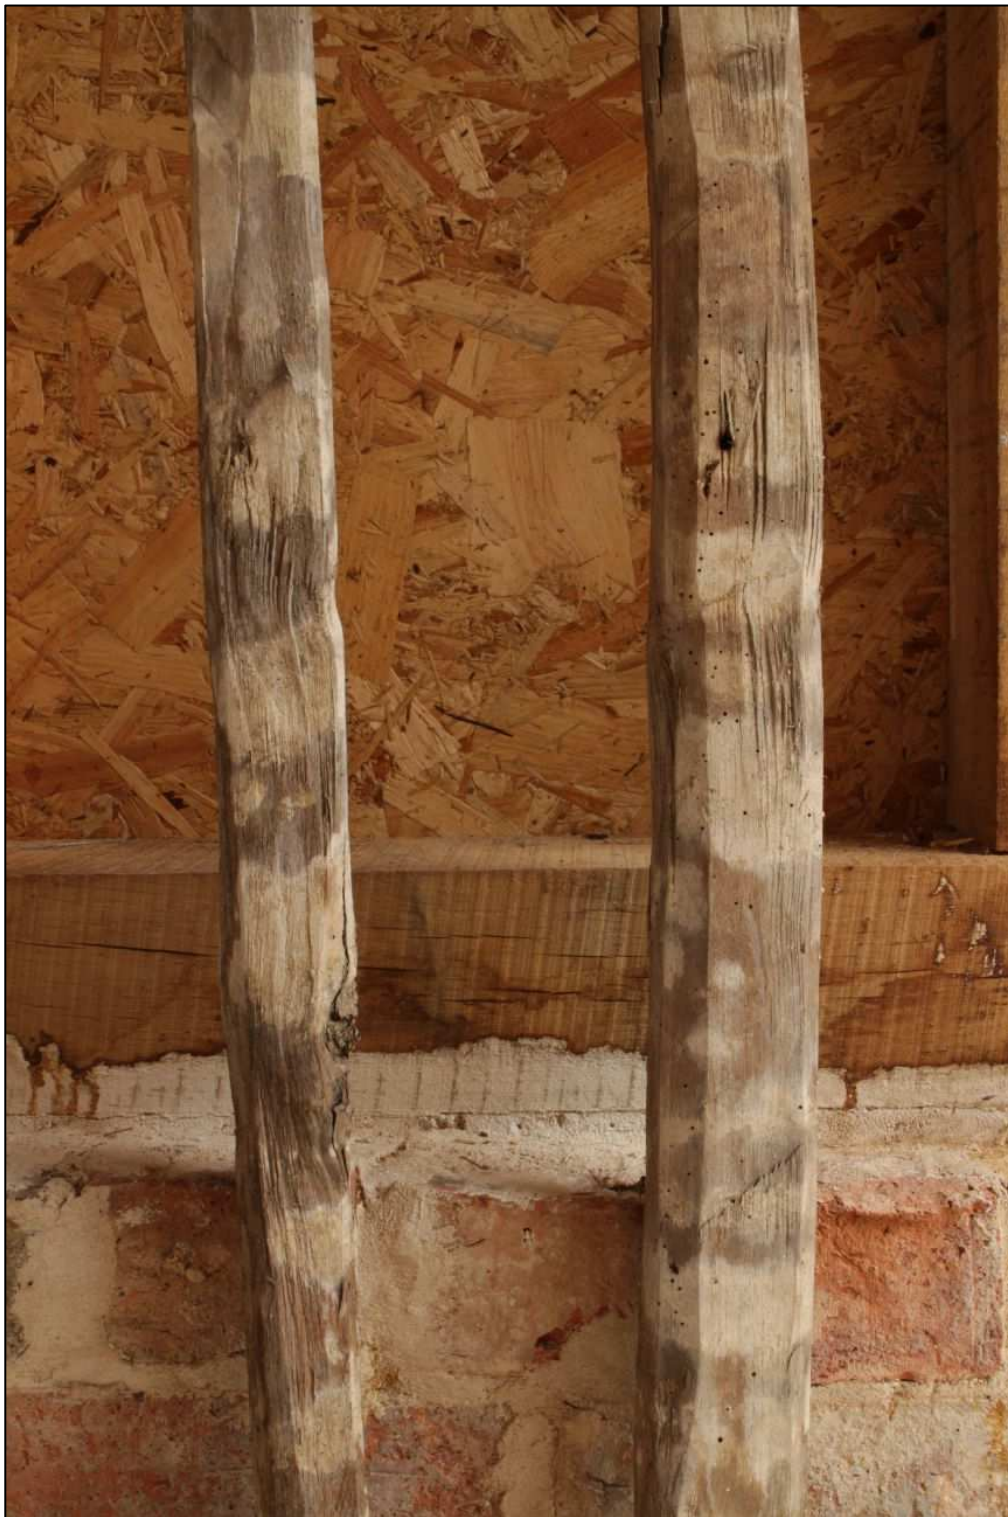
Image 8: Detail of staves

Detail of the two staves shown in Image 7

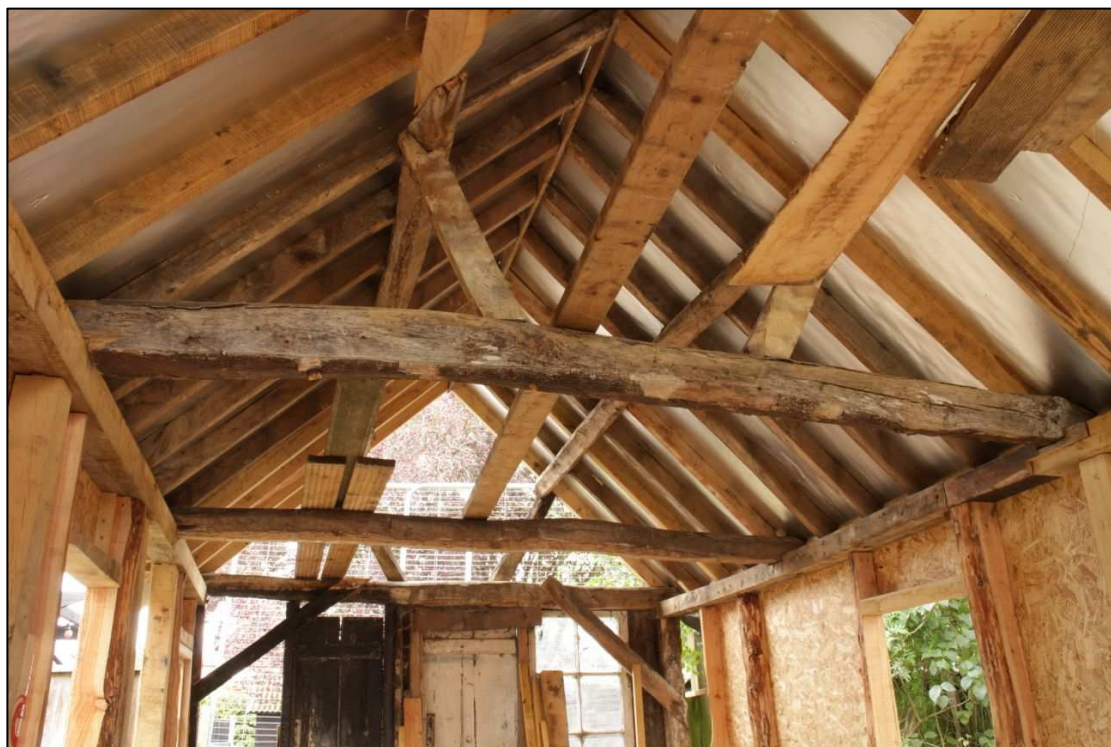
Image 9: Roof structure viewed looking northwards

Image shows the three original tiebeams in the northern half of the barn with raking braces at central tiebeam (nearest) and north tiebeam.

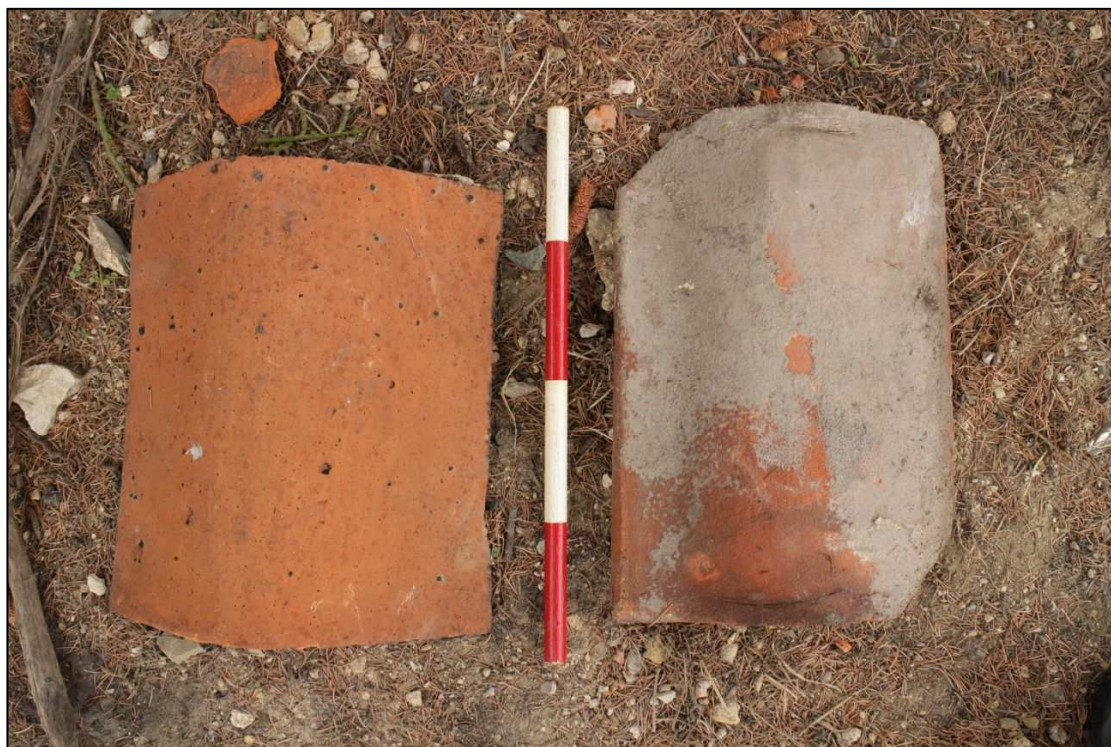
Image 10: Roof tiles

The tiles retained from the roof consist of red clay pantiles c.375mm long and red clay hogback ridge tiles (Image 10).

Image shows ridge tile (left) and pantile (scale 40cm)

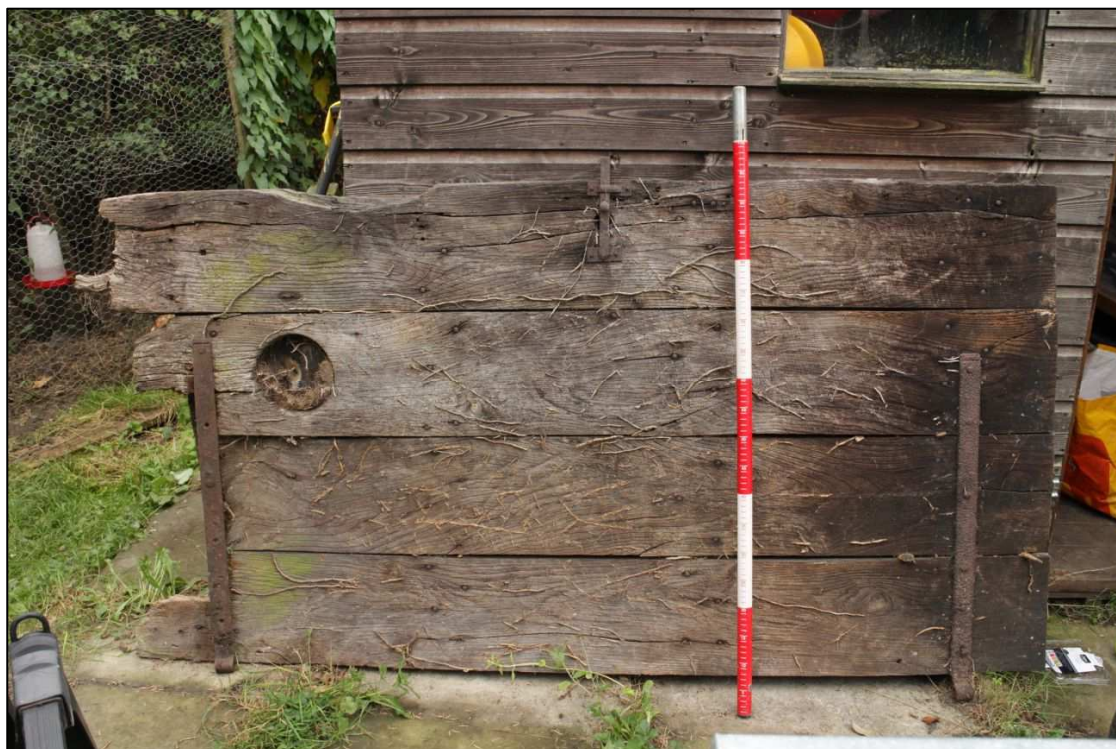
Image 11: Reused plank and batten door

Plank and batten door on plain strap hinges with circular cat hole

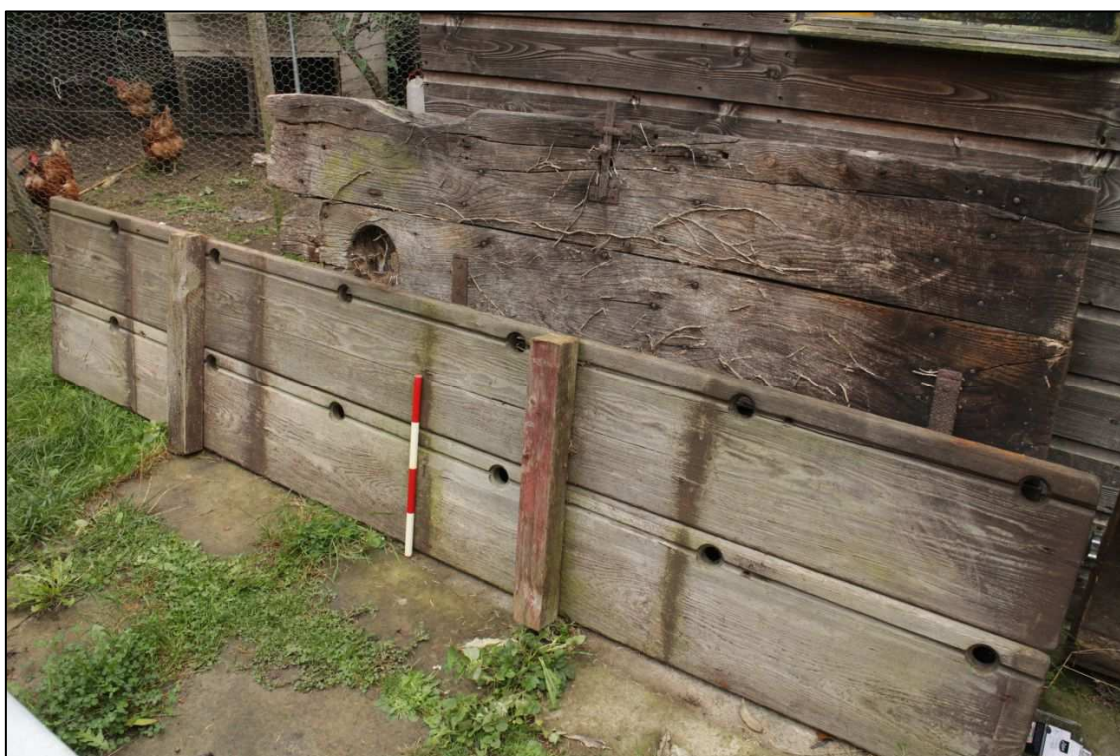
Image 12: Re-used school bench tops

After the demolition of the south half of the barn the south end was formed by a partition on the line of the former central truss. Above the tiebeam this consisted of wattle and daub formed from horizontal wattles woven around the raking braces and (three?) vertical staves and covered with yellowish clay daub. The partition below the tiebeam was formed from horizontal planks supported by two vertical battens and four staves. The staves were inserted into circular stave-holes in the underside of the tiebeam and are likely to be the remains of an earlier wattle and daub partition. The planks used to make the partition reused material which included old school desks, identifiable by holes for inkwells (Image 12).

Shows two school bench tops fixed with timber battens to form part of former central dividing wall. Four vertical marks show where the boards lay against the staves in this wall (scale 40cm)
