**RUTTERS FARM  
OLD MILTON ROAD  
THURLEIGH  
BEDFORDSHIRE**

**ARCHAEOLOGICAL MONITORING  
AND  
HISTORIC BUILDING RECORDING**

Document: 2015/14  
Version: 1.1

Issue date: 24th March 2015

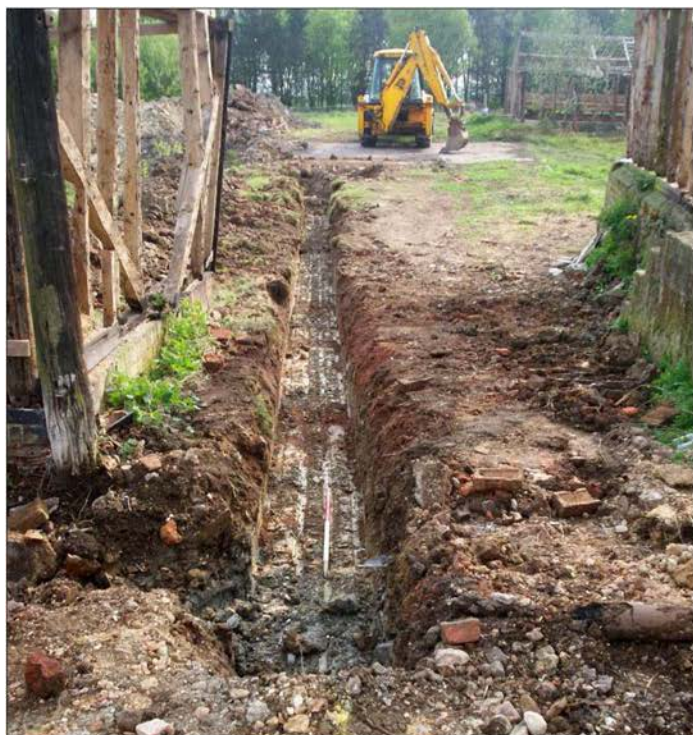
**Photograph 1:** Trench south of Barn 5, looking east

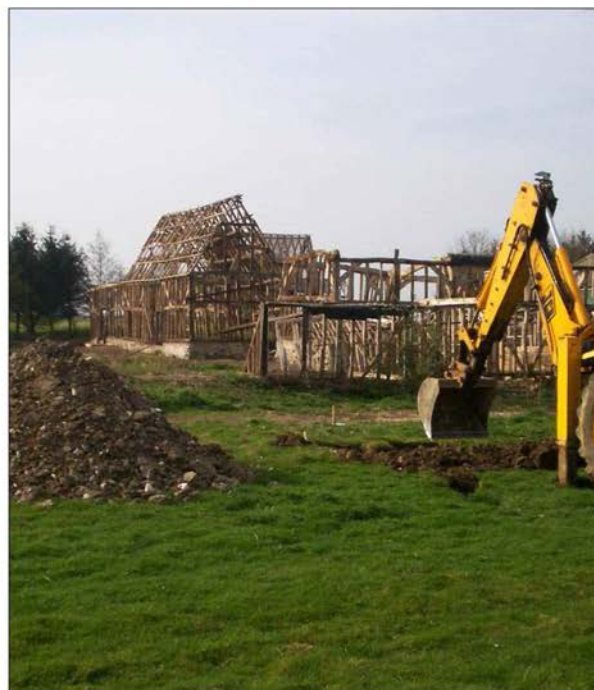
**Photograph 2:** Excavation of pit in northernmost trench, looking south-west

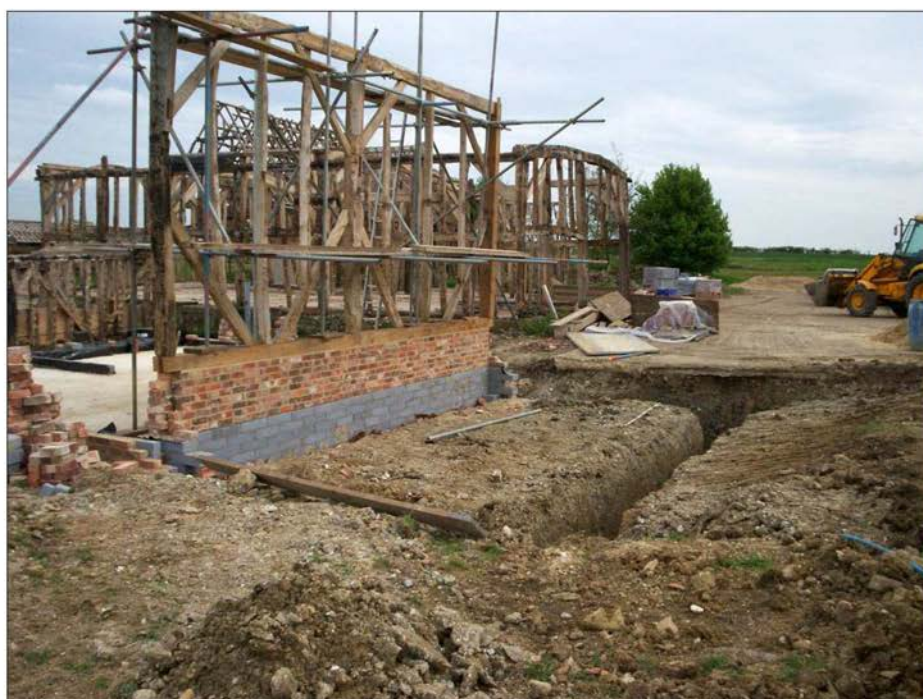
**Photograph 3:** Trenches at western end of Barn 4, looking south

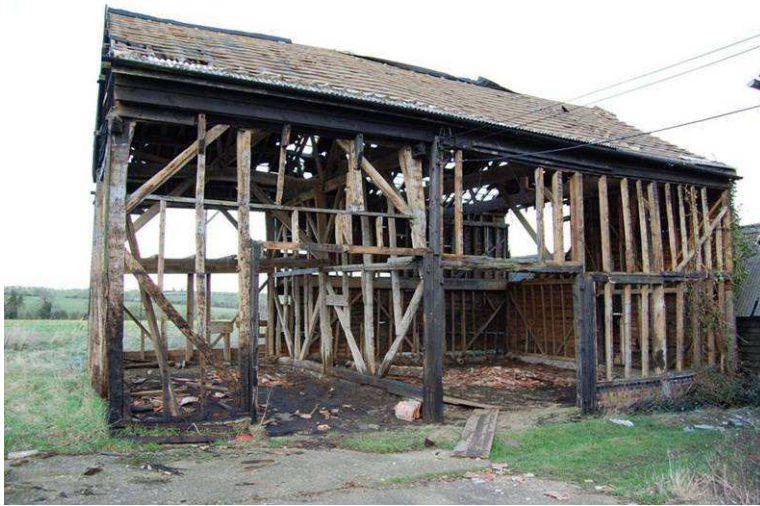
Barn 4 is an oak and softwood-framed building, partially clad in weatherboard and sitting on a low brick plinth (Fig. 7). At the time of the survey the roof covering and much of the cladding had been removed. The barn had also suffered from some fire damage. As Rogers notes, the barn is of unusual construction and proportions being tall and wide for its length and with a relatively low pitched roof (2004).

**Figure 7:** Barn 4: southern elevation

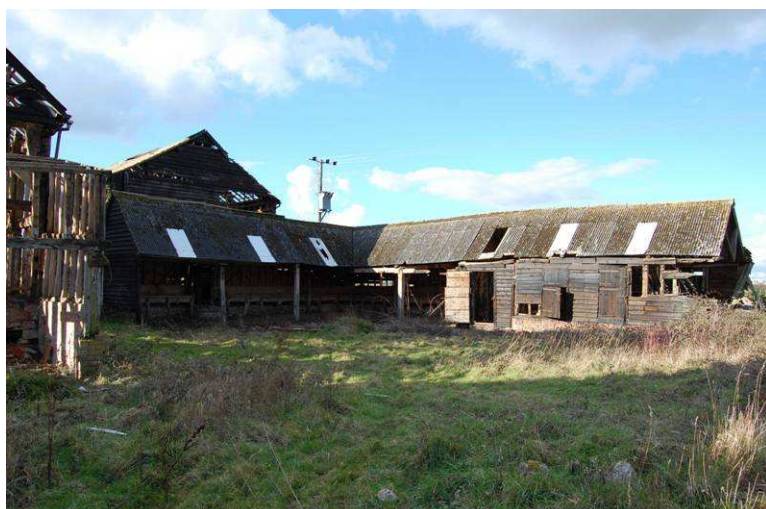
easternmost gable end has collapsed and the roof has been replaced in recent times.

**Figure 8:** Barn 5 view towards north-west

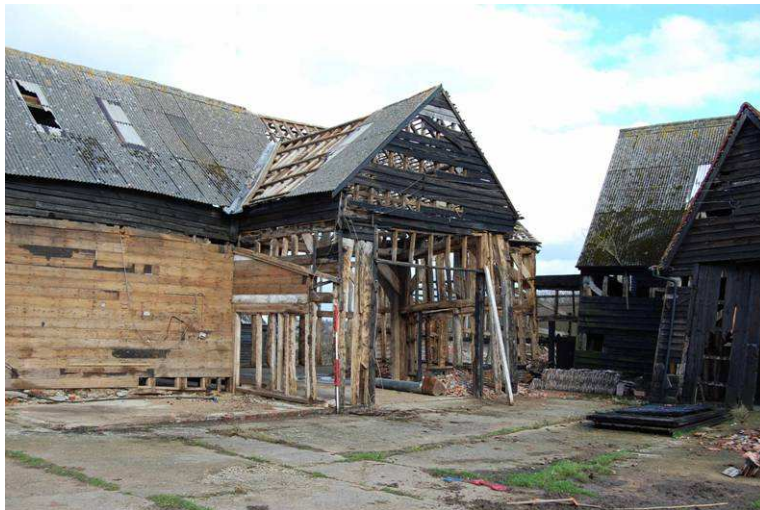
**Figure 11:** Barn 6:  
southern elevation

Although the barn is reasonably complete, it has had a number of more recent alterations including double doors inserted in western gable end. Internally there is brick-lined pit and grain hopper at the western end. A number of timbers are missing or have been repaired with modern insertions.

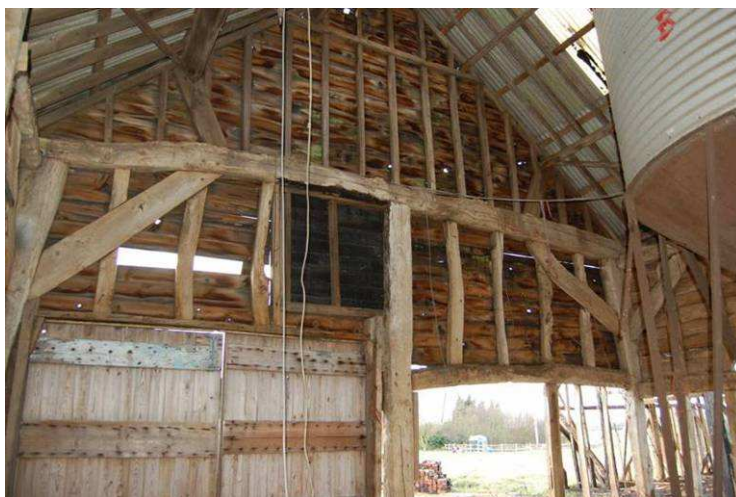
**Figure 12:** Barn 6: western  
gable end

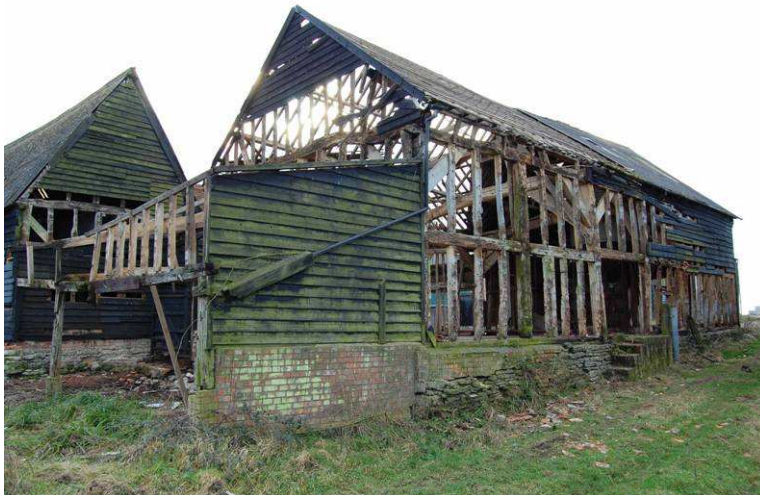
**Figure 16:** Barns 6 and 8: view towards south-west

Barn 8 is a lean-to against the eastern wall of Barn 6. Little of the structure remains other than the frame and its northern side wall sitting on a brick plinth (Fig. 16). The machine-sawn timbers are indicative of a 19th-century date. A shed in the angle between the porch and the external wall of westernmost bay had been demolished at the time of the survey; only its concrete base remained.

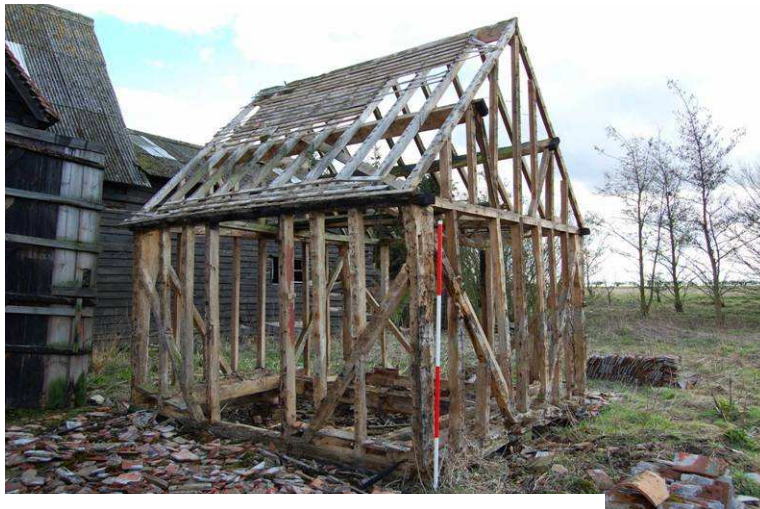
Barn 7 is a small oak-framed building with a door in its northern elevation. At the time of the survey the weatherboarding and roofing material had been removed. Ground clearance and the removal of the weatherboarding revealed that the building stood on small brick piers, not seen at the time of Rogers' survey (2004).

**Figure 17:** Barn 7

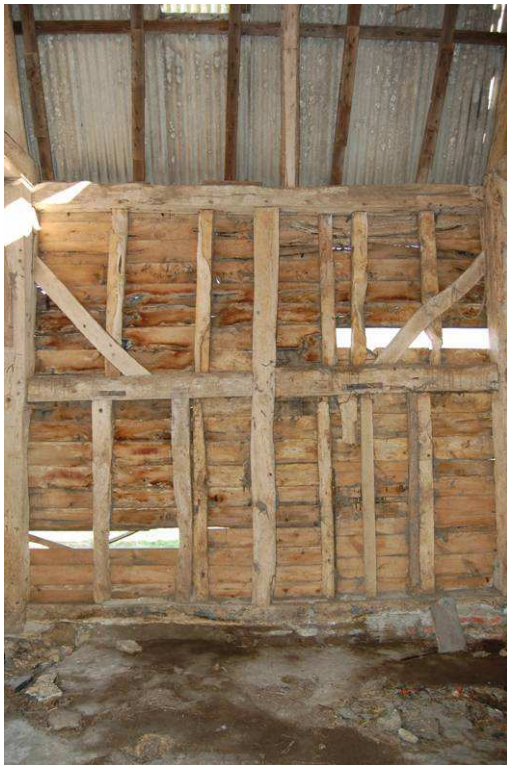
The main posts in this barn have gently swept jowls and there are full height mid posts and a mid rail all constructed from hewn studs. The wall plates are joined using side-halved scarf joints with bridled abutments. Many of the timbers show evidence of re-use. The re-used timbers are domestic in character, suggesting that they are timbers from an earlier house that once stood nearby. The re-used timbers show evidence for stave holes, as well as redundant mortices.

**Figure 19:** Barn 9: section of east wall showing scarf joint in wall plate and re-used timbers

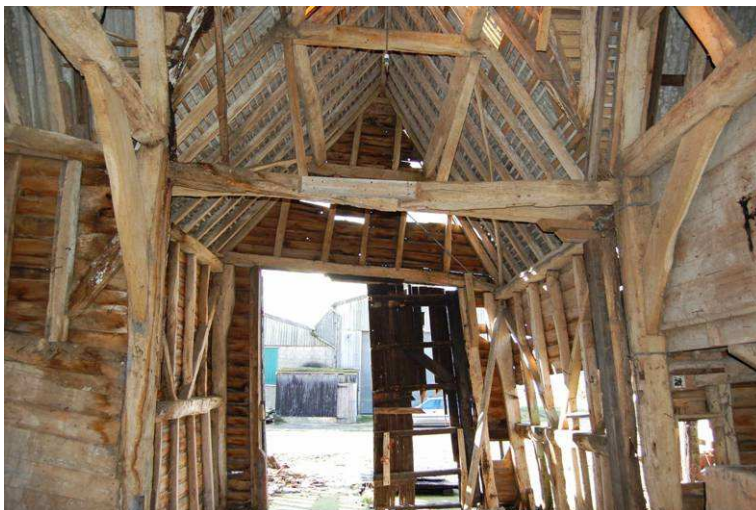
The porch is not integral to the barn and at the time of the survey was at risk of collapse. It is not clear whether the porch was added, or re-built at a later date. There is some indication that the mid rail may have been removed to insert a porch; however, the posts adjacent to the porch are re-used timbers and it is not clear whether the empty mortices are simply associated with a previous use.

**Figure 21:** Barn 9: internal view of porch

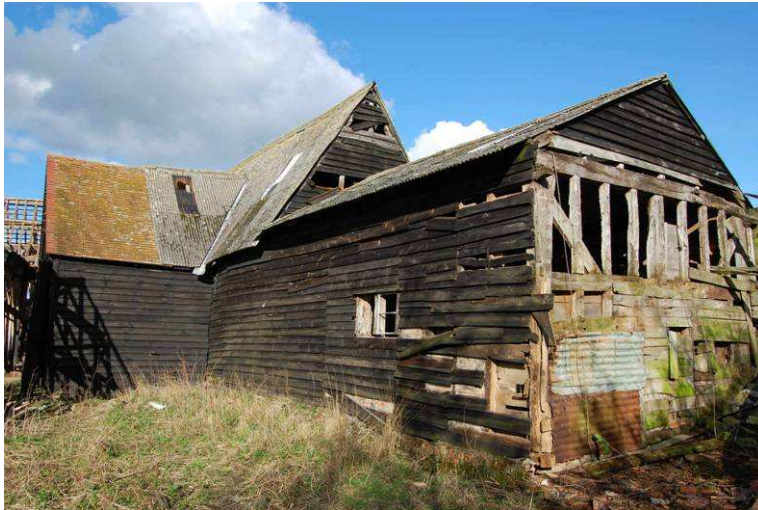
Barn 10 is a two-bay structure sharing the southern wall of Barn 9. Although the ridge height is much lower than the adjacent barn, this is a replacement roof and does not, therefore, represent the level of the original roof.

**Figure 22:** Barns 9 and 10: view towards north-east

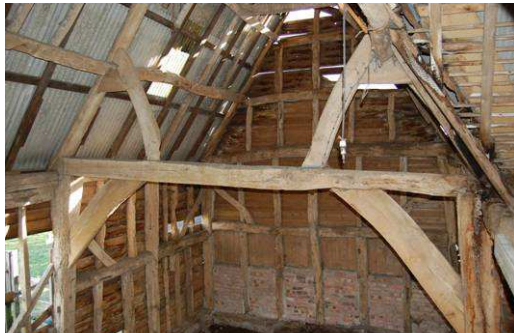
**Figure 25:** Barn 9: southern wall,  
shared with Barn 10, 'shadow'  
marking apex of Barn 10 roof can be  
seen in end wall

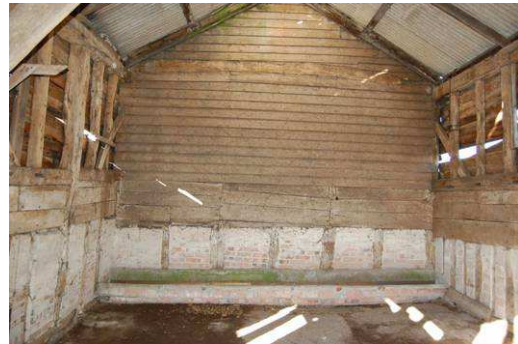
**Figure 26:** Barn 10: northern  
wall, shared with Barn 9, scarf  
joint in north-east corner

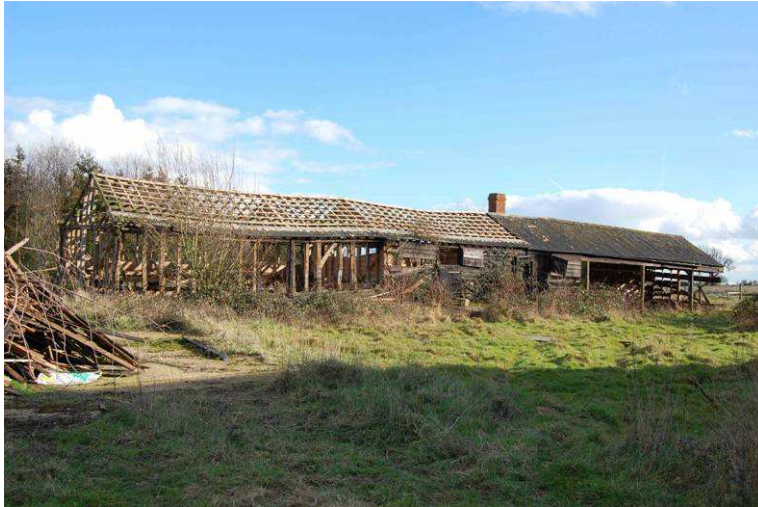
The building is partially clad with bitumen-coated weatherboarding, although most of this had been removed at the time of the survey.

**Figure 27:** Barns 13 and 14: view towards south-east

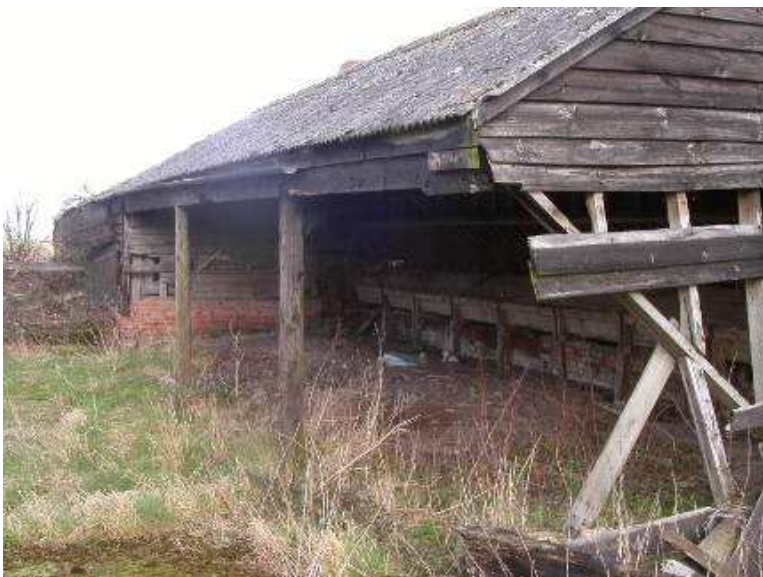
The open stock shed at the southern end (Barn 13) has a manger along its eastern wall and at the time of the survey was in a poor stage of repair, with most of the gable end collapsed.

**Figure 28:** Barn 13: view towards north-east

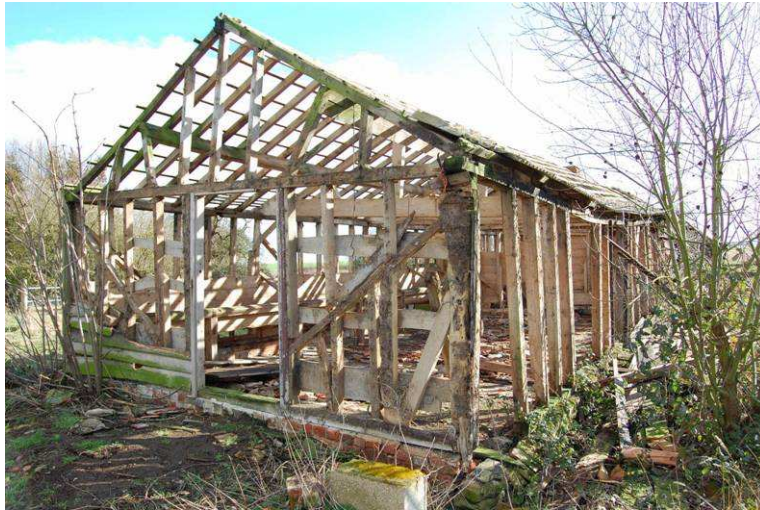
At the northern end Barn 14 had been divided into a number of compartments. The northern three bays comprised a cattle shed, probably for over-wintering stock. Most of the cladding had been removed meaning that the only parts remaining were the timber frame, elements of the internal boarding and a manger running along the eastern wall. There was evidence for an inserted door frame in the northern gable end.

**Figure 29:** Barn 14:  
enclosed stock shed at  
northern end
