**GLATTON HALL, GLATTON WAYS
GLATTON, HUNTINGDON**

**DESK-BASED ASSESSMENT
AND
HISTORIC BUILDING RECORD**

Report no: 2018/124

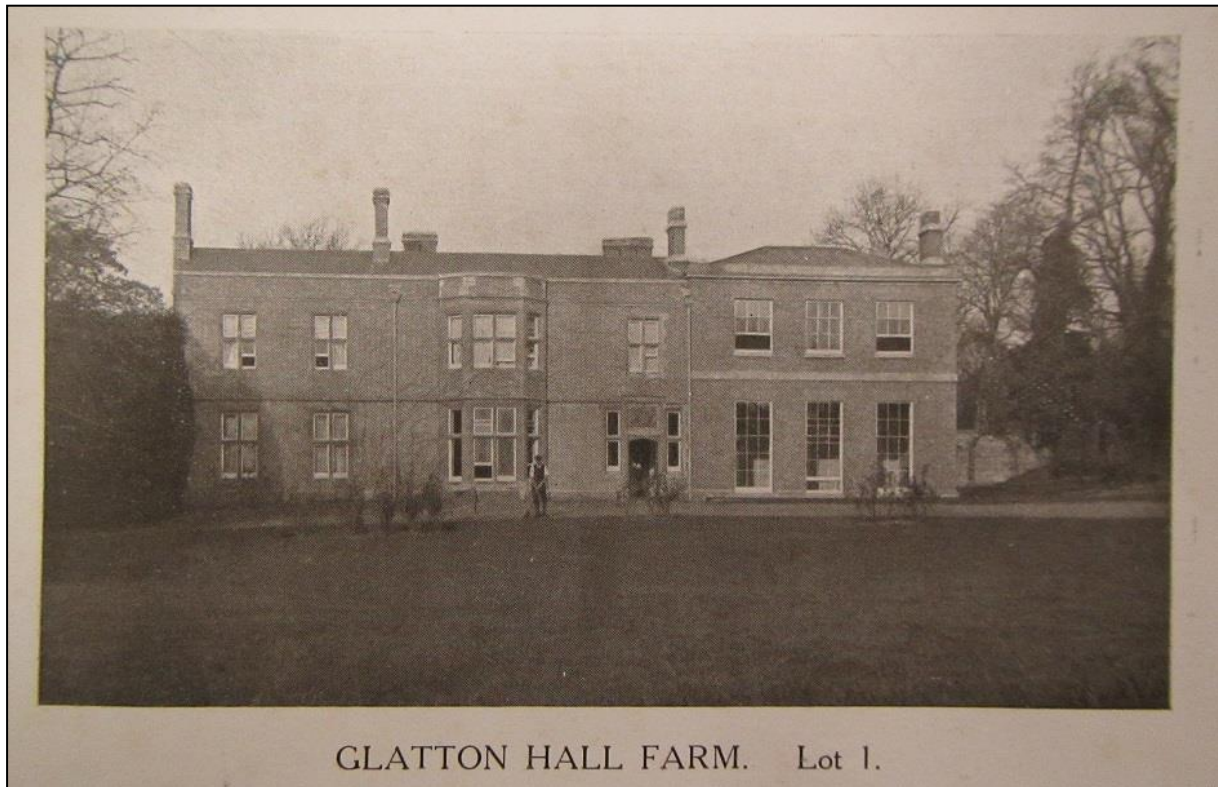
Historic photographs (Image 1) show a three-bay brick-built section at the east end of the main range. This section was replaced during the 20th century, possibly following a fire. This part of the building would appear to correspond to the drawing room in the 1918 sales particulars where it is described as measuring 30ft by 20ft and lit by three long windows. The overall appearance of this part of the building with a low pitch, hipped roof and long sash windows extended almost to ground level suggest a probable early 19th century construction date.

Image 1: Photograph of Glatton Hall from 1918 sales particulars
Image shows south front of house (Huntingdonshire archives ref: R45/1/13)

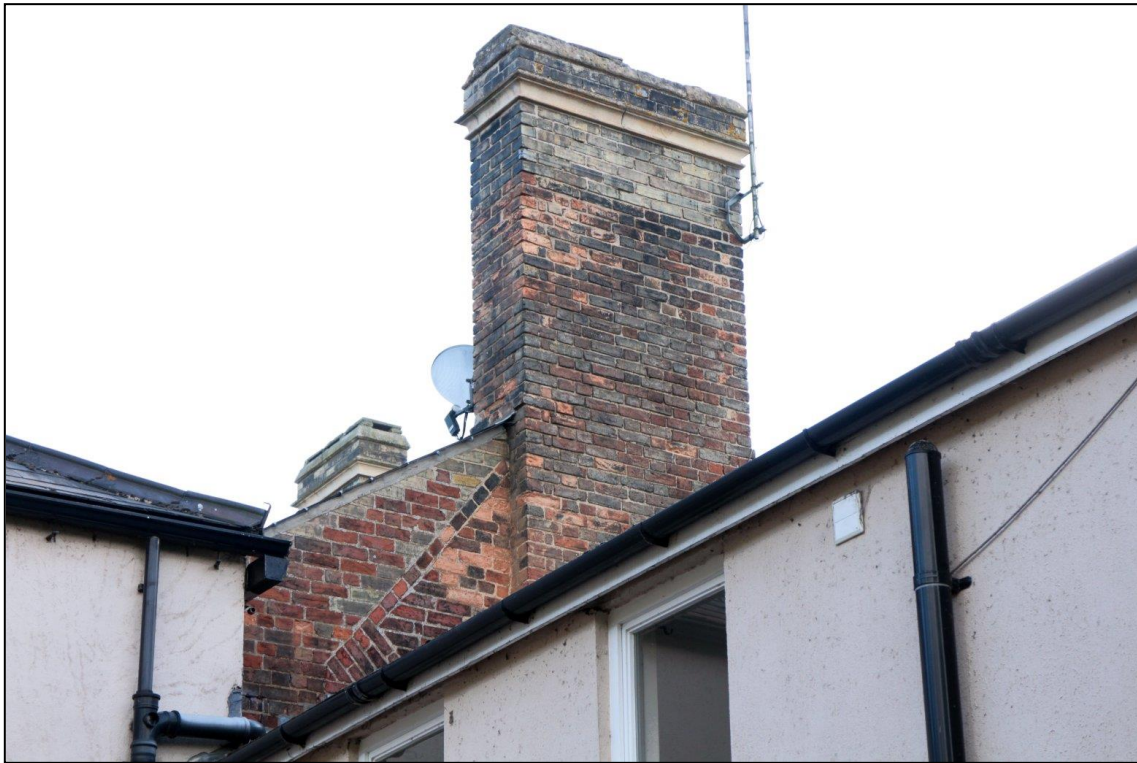
Image 11: Chimney and gable detail

Chimney and gable end of roof above north end of bedroom 26, viewed from north-east.
Image shows change in brick in gable wall indicating change in roof angle.

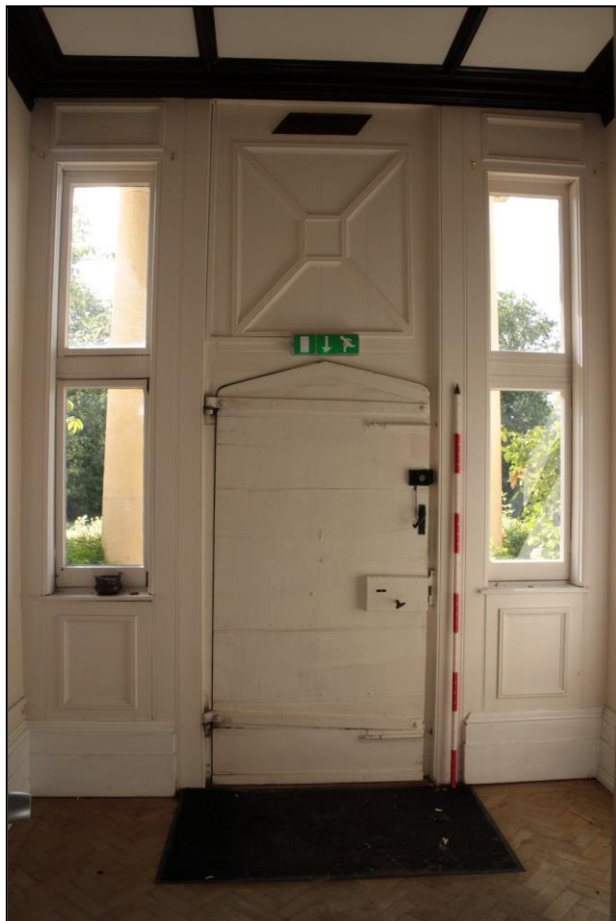
Image 12: Lobby

Looking south showing inner face of door.
Note lozenge shaped date plaque above door;
see below for detailed image (scale 2m)

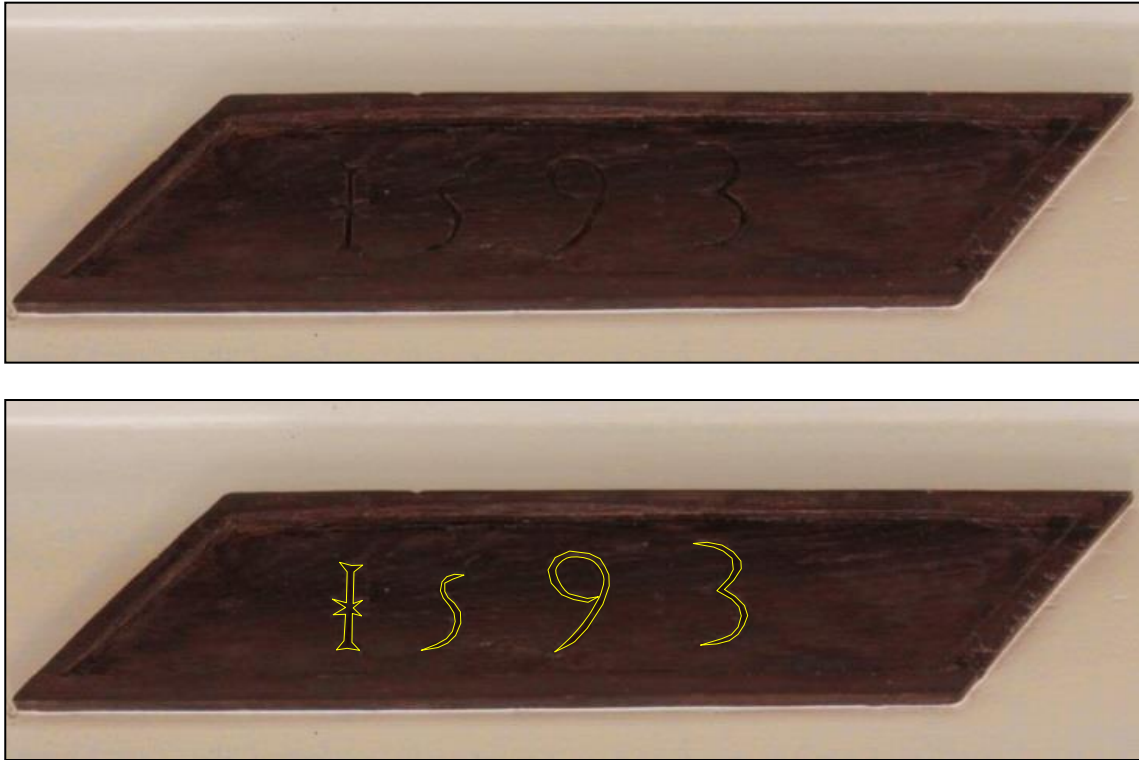
Image 13: Lobby; detail of carved date plaque

Lozenge shaped wooden plaque carved with the date 1593, highlighted in yellow in the lower image.

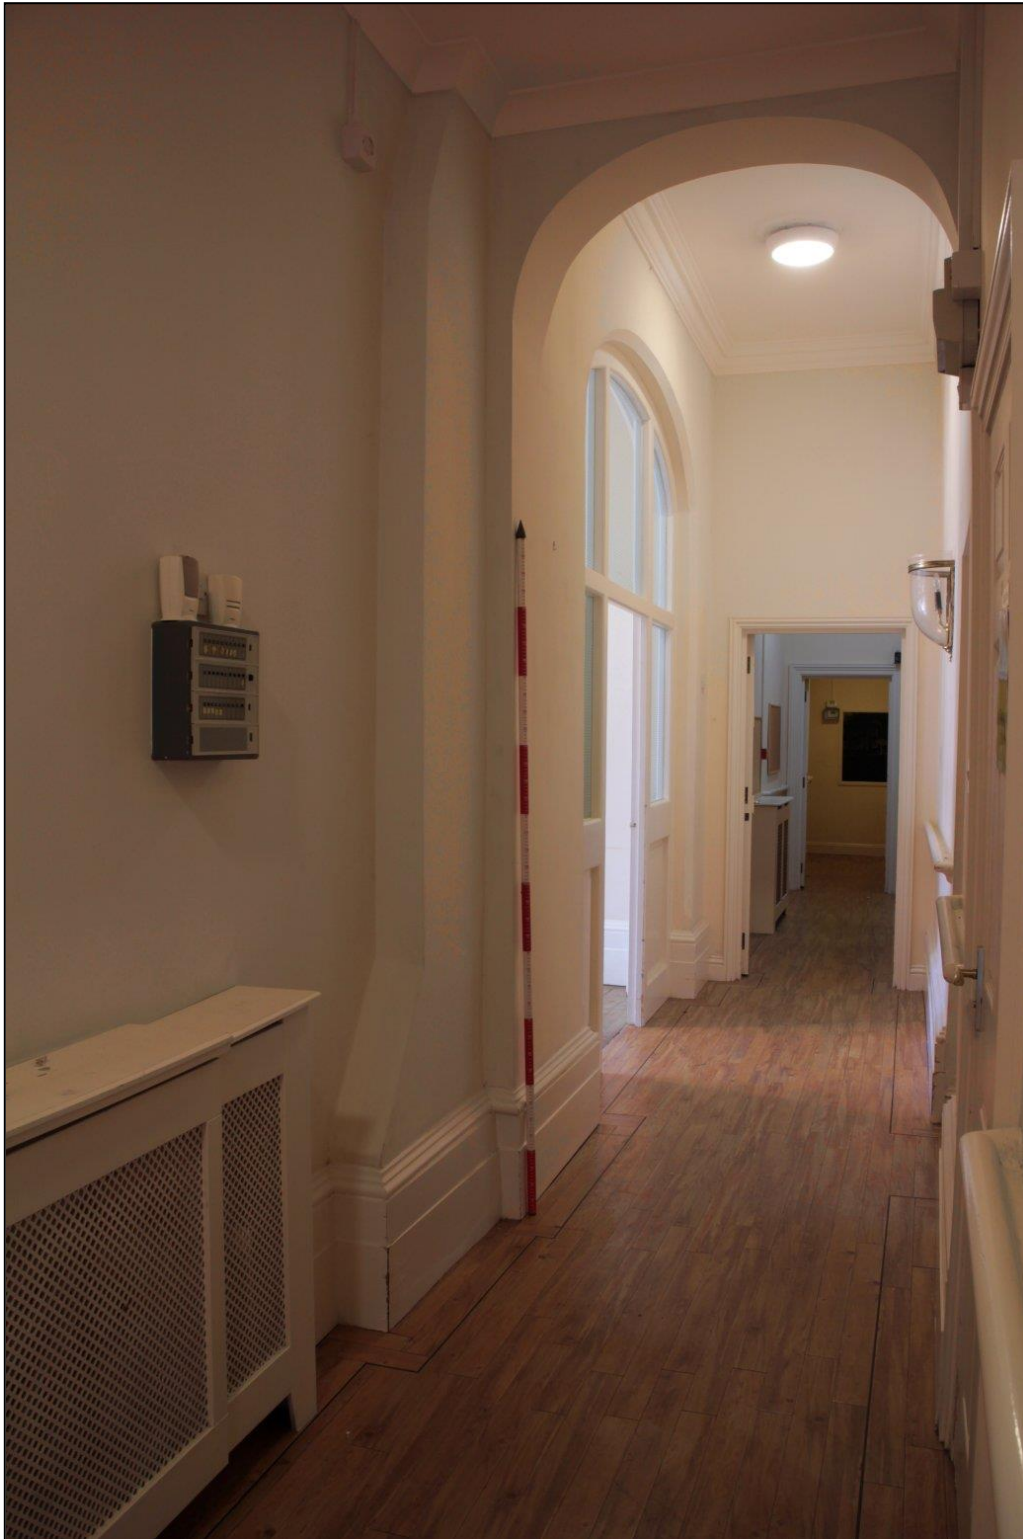
Image 17: Ground floor corridor

View looking west along corridor with arched opening to lobby on left. Shows thickened section of wall to the left of the photographic scale

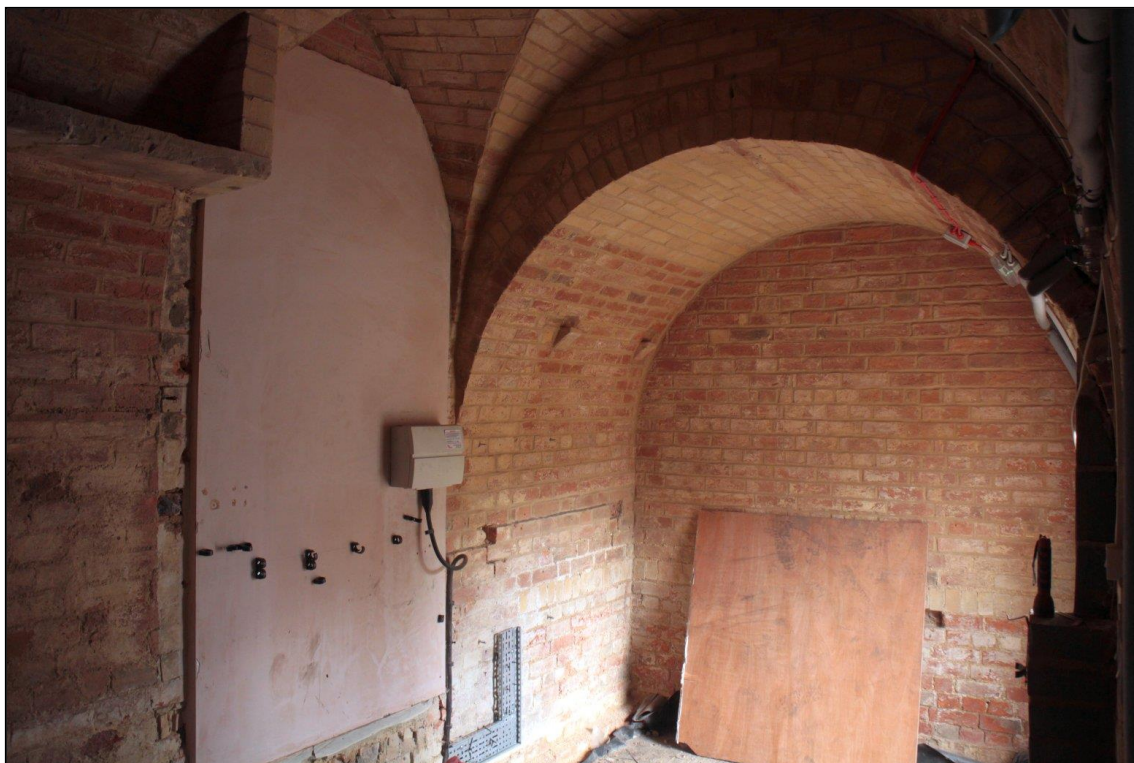
Image 22: Plant Room

Looking south-east with location of blocked doorway covered by plaster at left of image

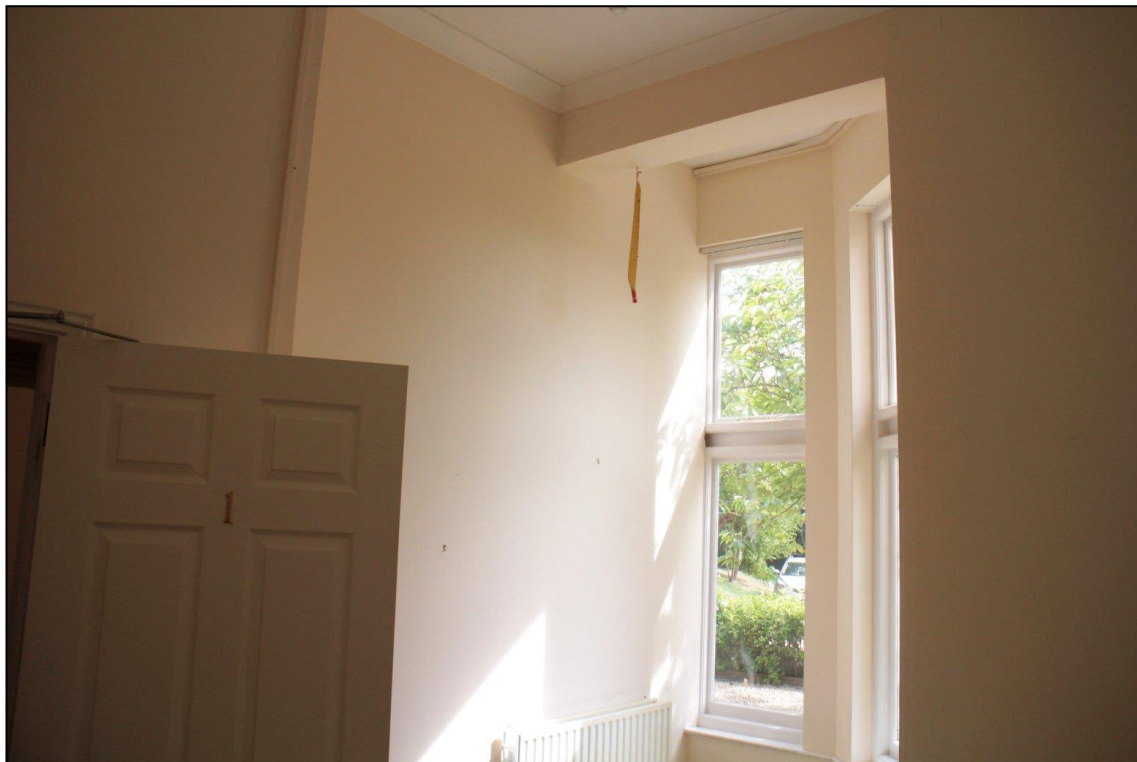
Image 27: Bedroom 1

Looking south-east showing bay window divided by modern stud wall

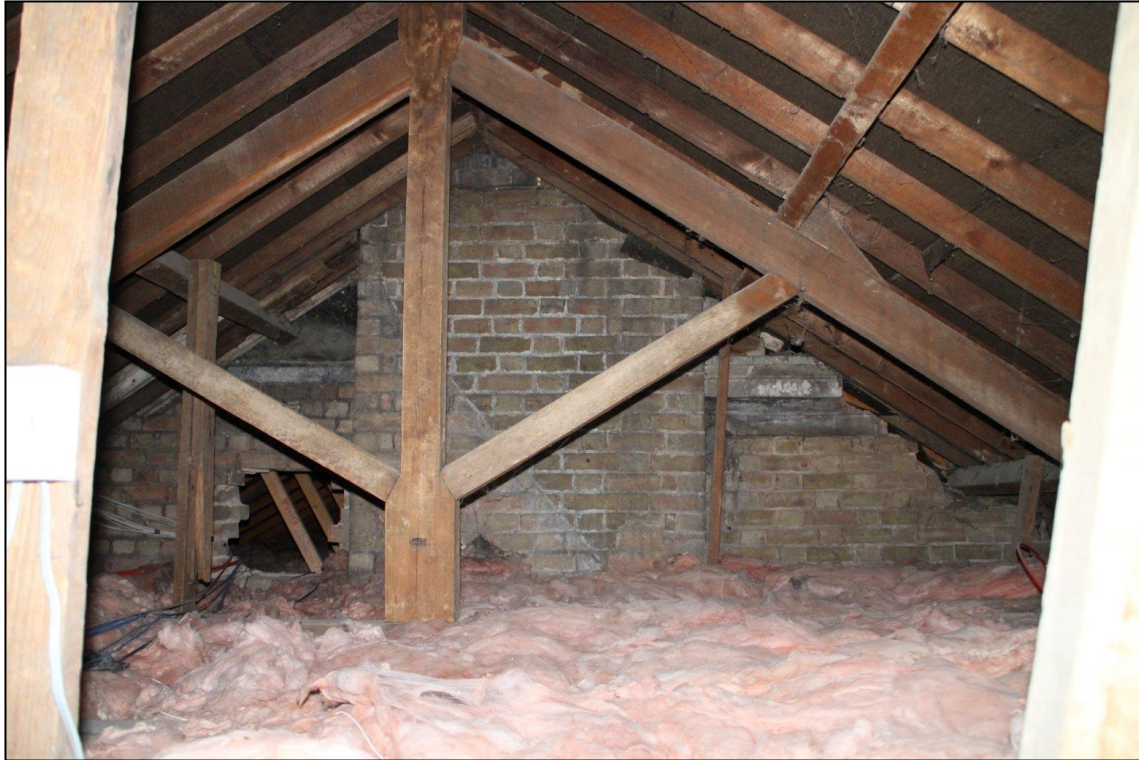
Image 29: Roof space above bedrooms 6, 7 and 8

Looking east from hatch in ceiling of Bedroom 7, showing kingpost roof truss in front of the chimney for the fireplace in Bedroom 8. Modern roof trusses in the roof above bedrooms 9, 10 and 11 can be seen through a hole in the wall to the left of the chimney

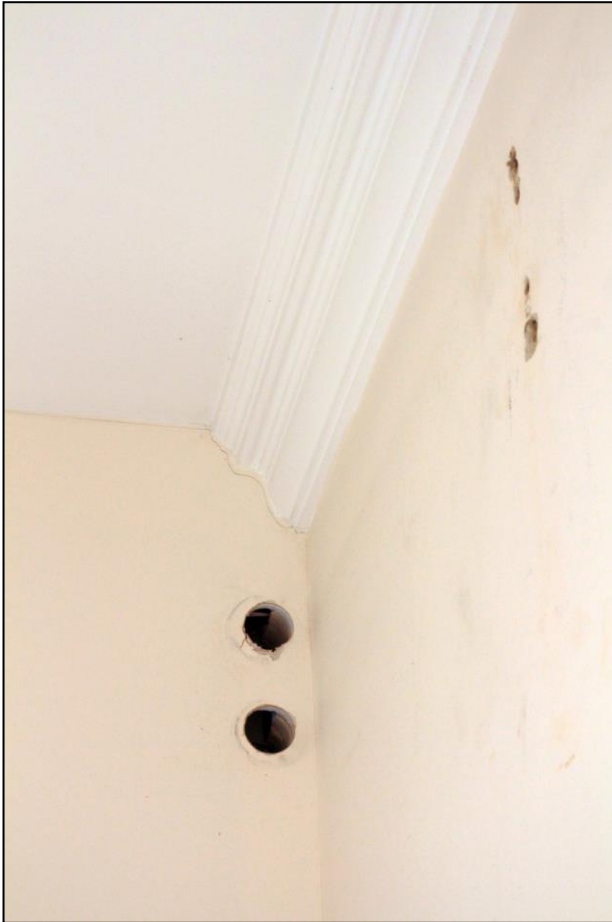
Image 36: Corridor adjacent to rooms 16 and 17

Looking west showing the cornice moulding abutted by an inserted plasterboard partition where the west end of the corridor was separated to form a store

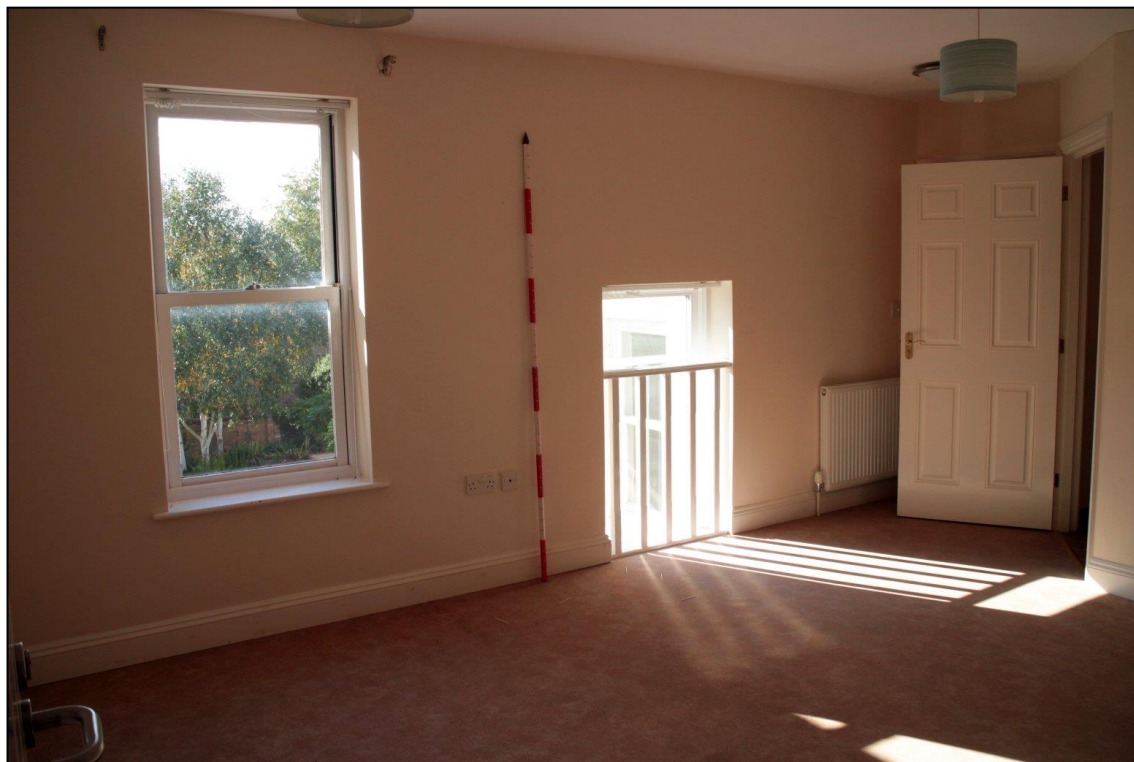
Image 40: Bedroom 26

View looking north-west from doorway towards west wall of room. Image shows windows at different heights, suggesting former staircase in this area

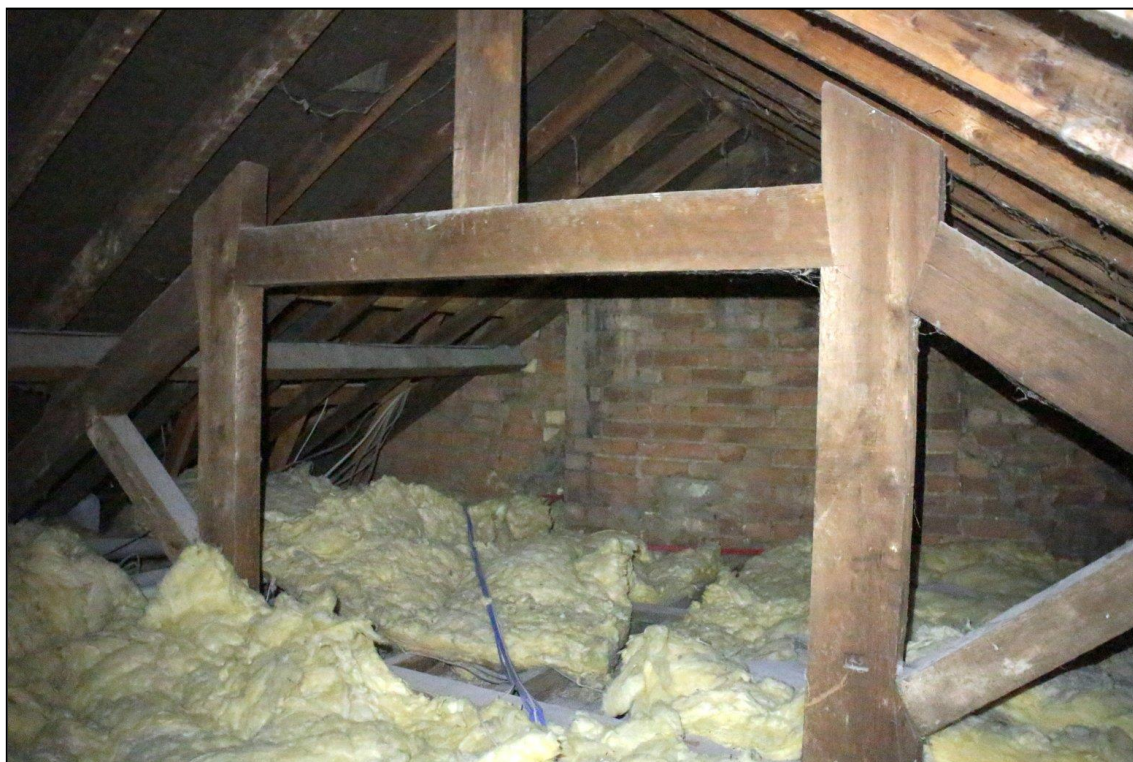
Image 41: Roof space above bedroom 26

Looking north-west from hatch in ceiling of corridor to east of bedroom 26. Image shows queenpost roof truss with a chimney in the background.

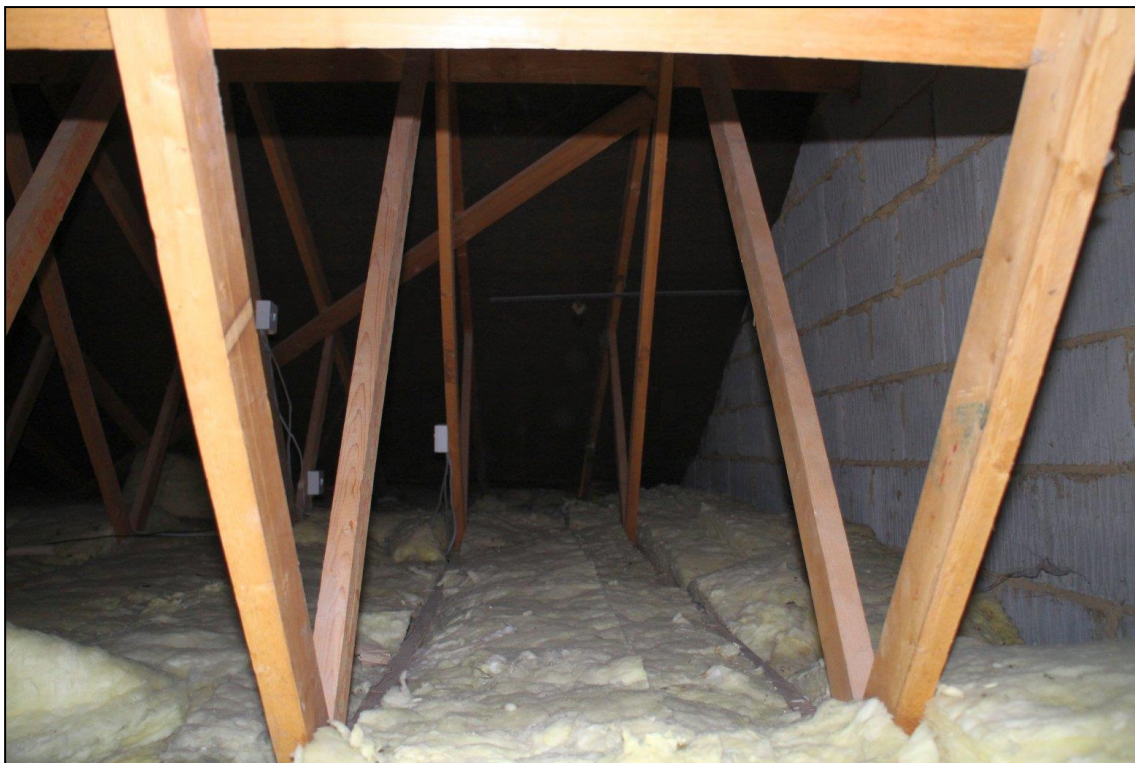
Image 43: Roof space above bathroom and bedrooms 12 and 13
Looking north from hatch in bathroom ceiling showing modern trussed roof and blockwork
in gable wall at east end of front range
