## ST. MARY'S CHURCH PIRTON, HERTFORDSHIRE

### PROGRAMME OF ARCHAEOLOGICAL TEST PITTING

Albion Archaeology Project No: MVP939

Report No: 2004/29

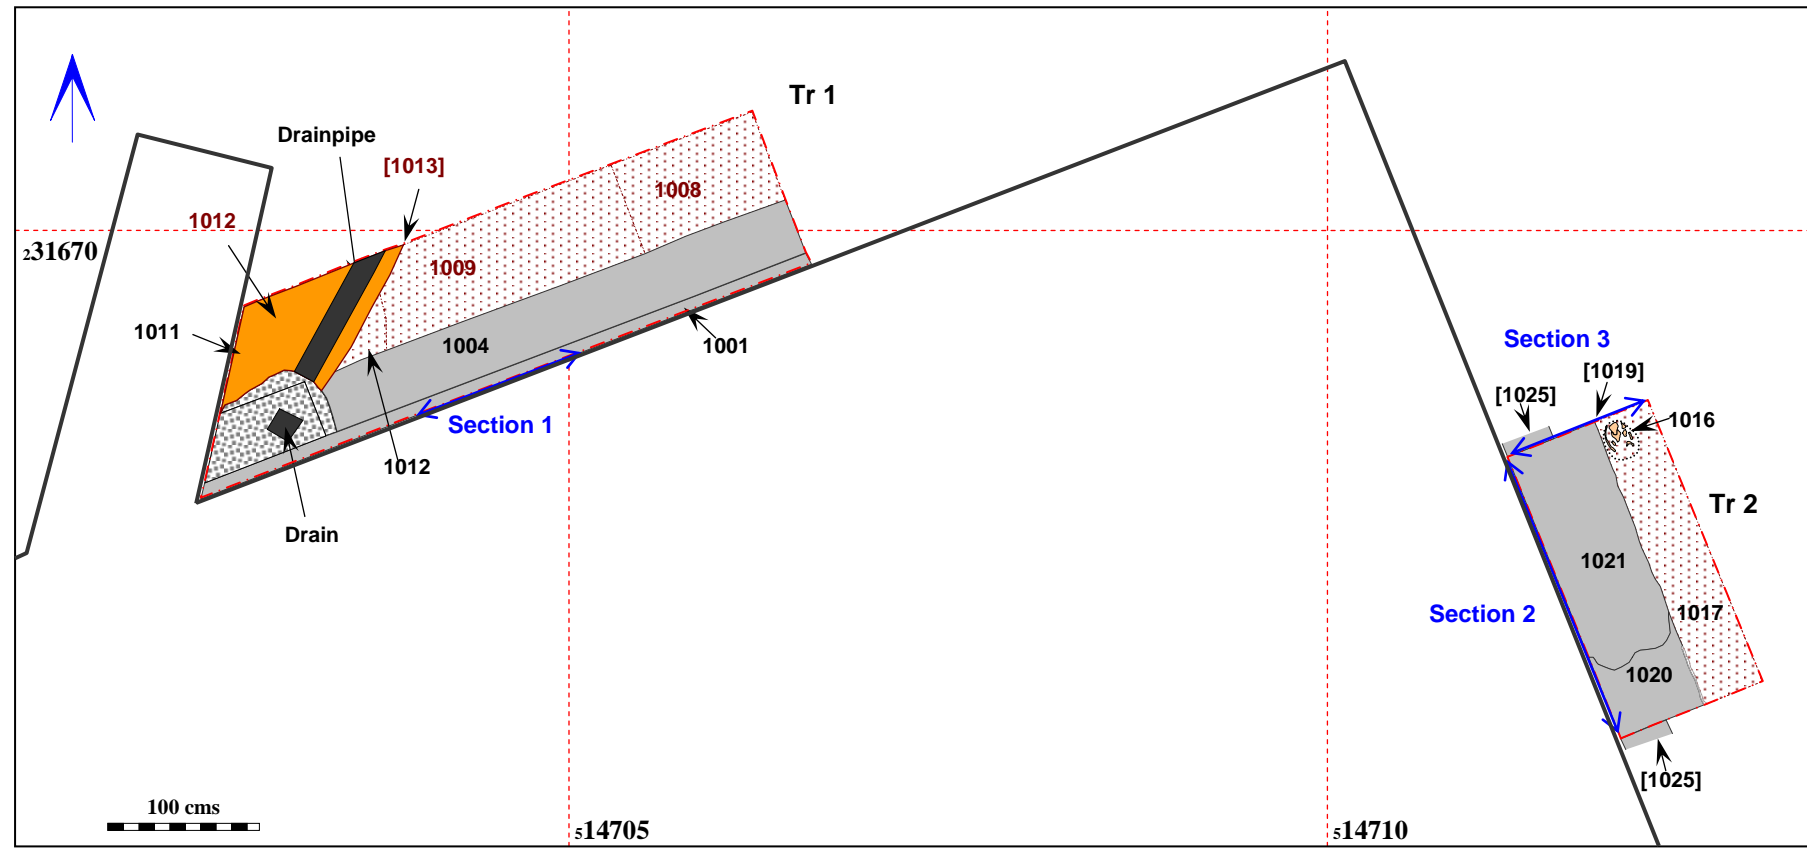
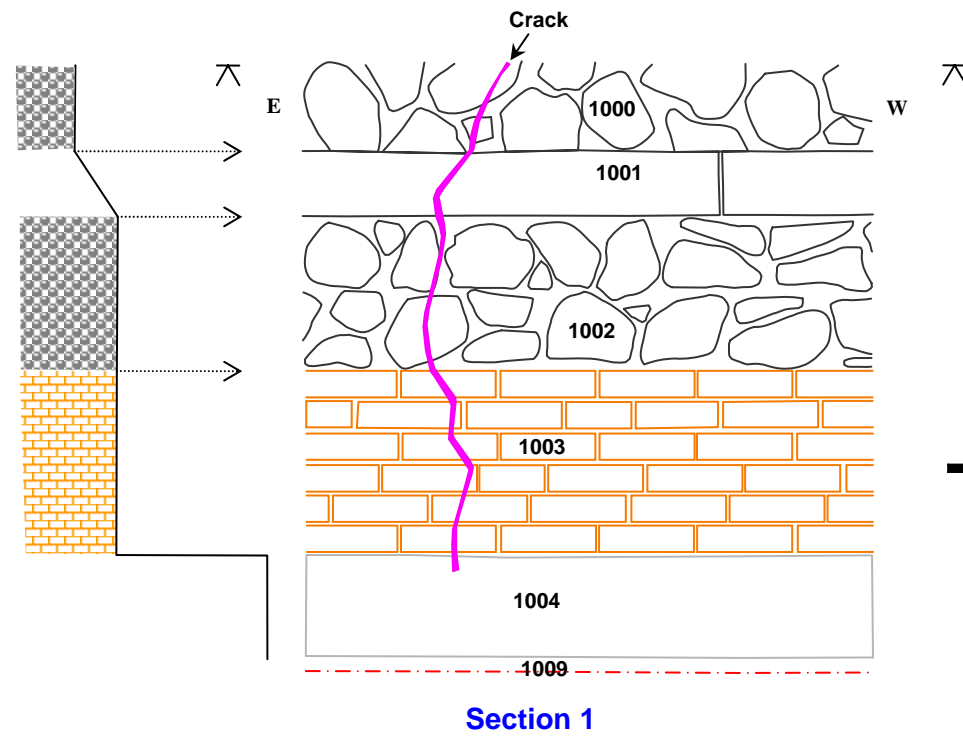
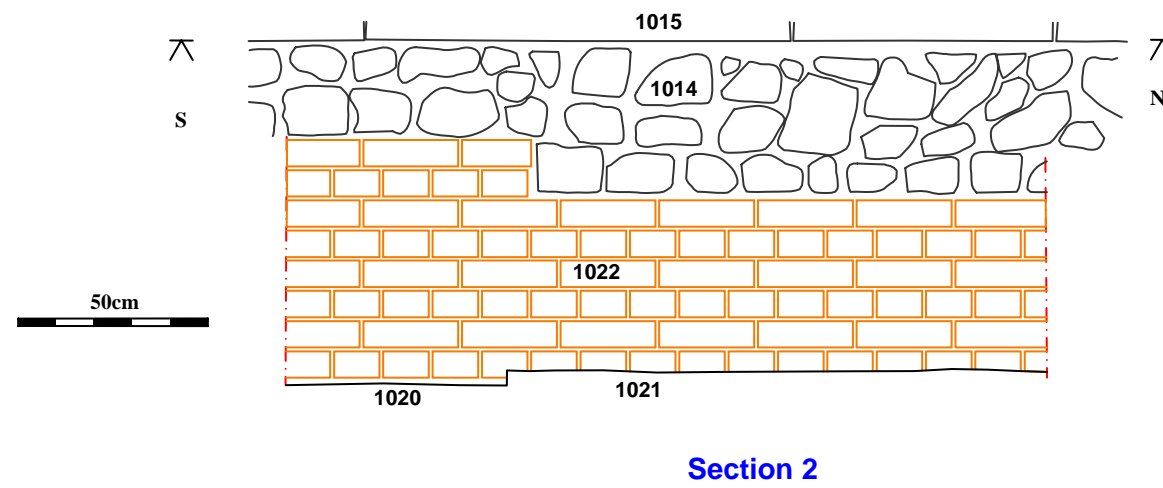
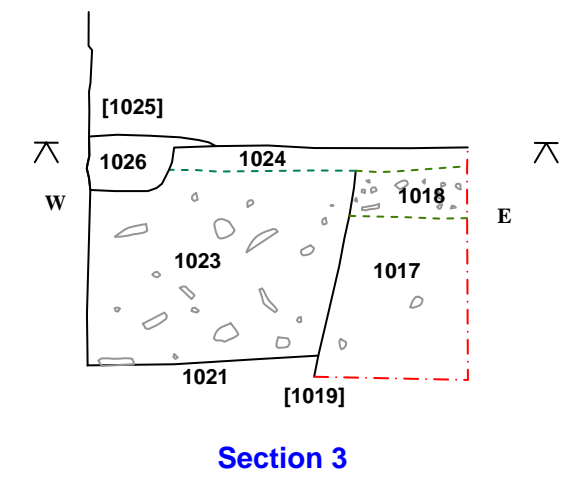
Figure 2: Test Pits 1 and 2

In November / December 2003 one test pit (3.50m E-W, 1.00m N-S, 0.80m deep) was excavated against the north wall of the chancel (at the junction of the chancel and the east wall of the former north transept) directly below the single window in this wall (Figures 1 and 2). A second test pit (2.00m N-S, 1.00m E-W, 0.65m deep) was excavated in February 2004 against the east wall of the chancel, again directly below the single window in this wall. Its purpose was to determine whether or not the foundations of this wall were similar to those observed in the first test pit.

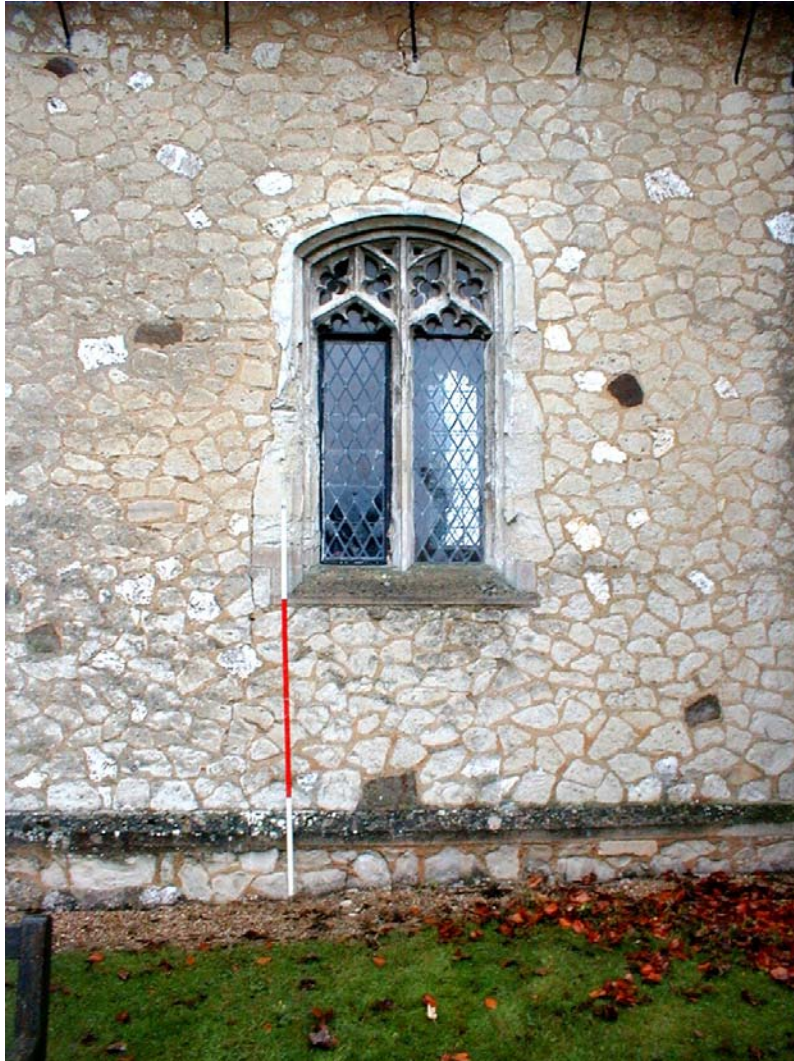
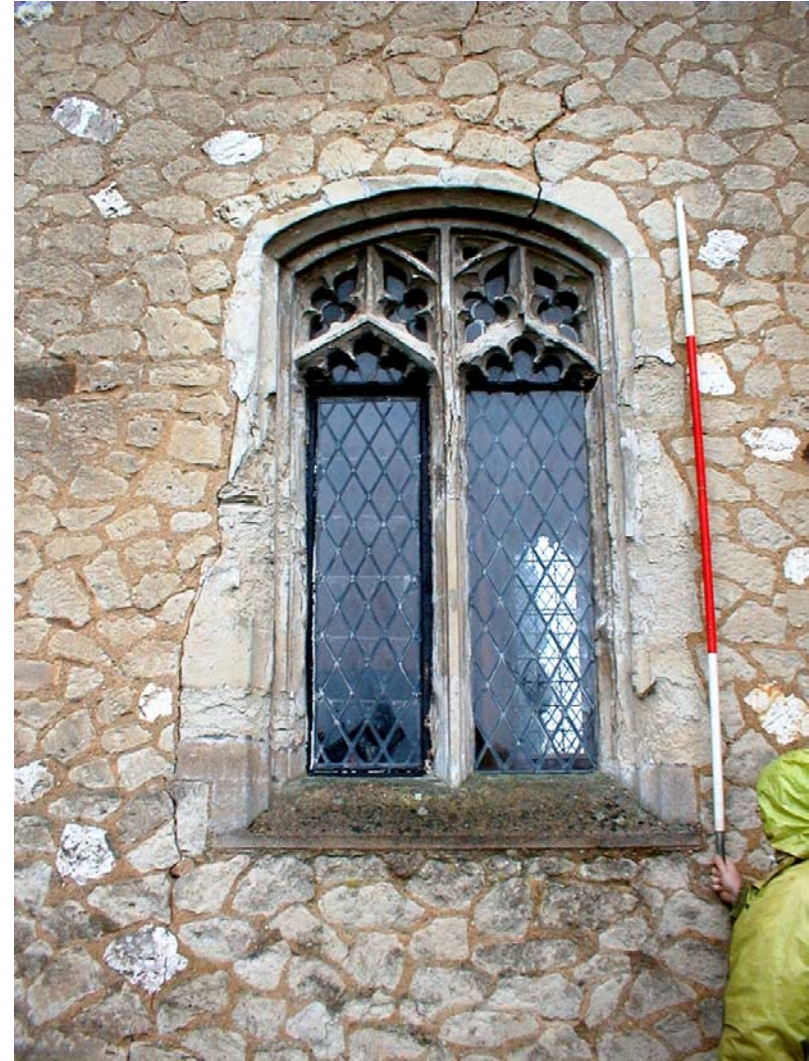
Subsidence/foundation movement at St Mary's Church, Pirton has resulted in damage to the north side of the chancel. This consists of substantial cracking in the wall from roof to floor, the window arch, elements of the stone frame of the window, and the floor itself. The Diocesan Archaeological Advisor, Adrian Havercroft, stipulated that limited archaeological work should be undertaken in advance of any engineering works to repair the wall or foundations. The aim of the work was to provide sufficient information to allow assessment of the archaeological impact of any engineering works. These requirements were detailed in a brief.<sup>1</sup> Albion Archaeology was invited by the project architect, Mike Dale, acting on behalf of the Parochial Church Council, to undertake the evaluation. The small nature of the project meant that a formal Project Design was not required.<sup>2</sup>

The crack in the north wall of the chancel ran through the angled bricks, through the clunch- and brickwork and even penetrated (although did not completely split) the foundation pad (Figures 2-4).

**Figure 3:** Photographs illustrating exterior damage to north wall of chancel (2m scale).

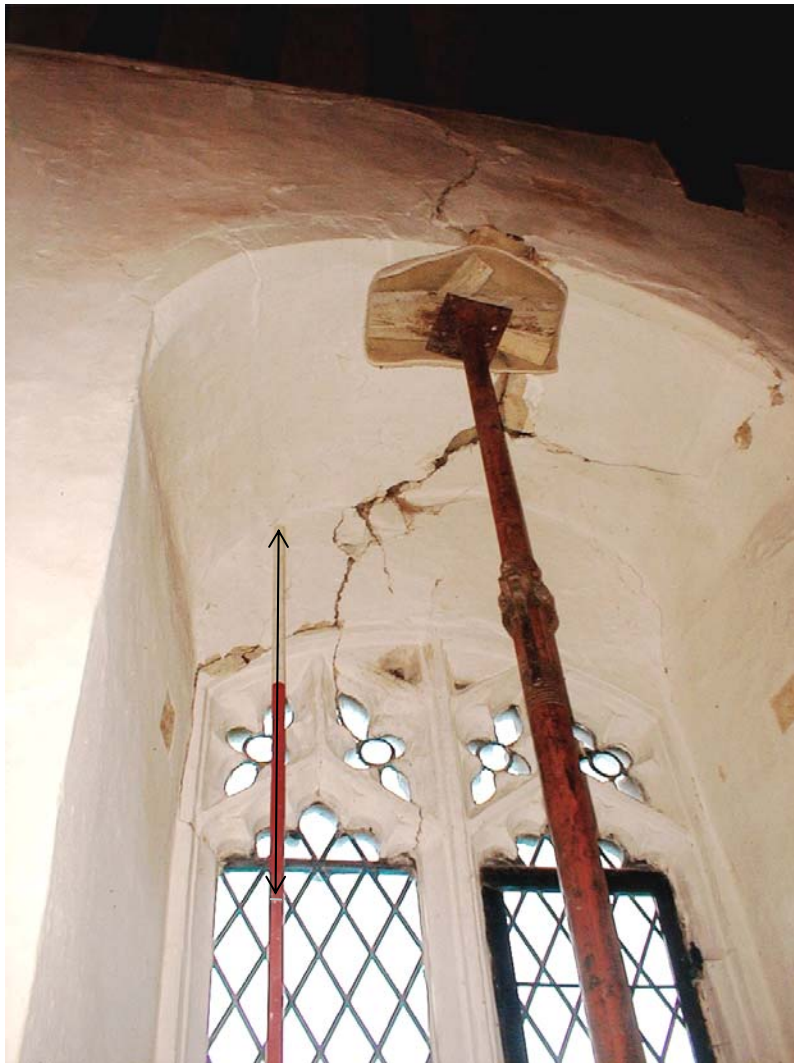
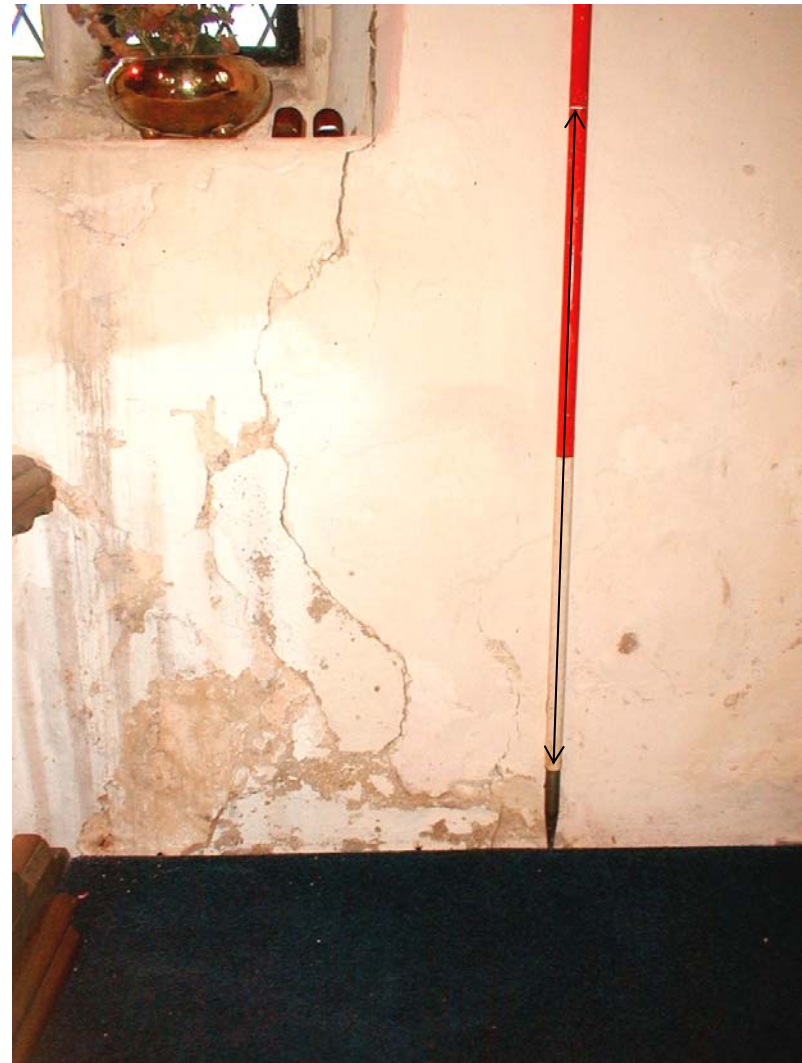
**Figure 4:** Photographs illustrating interior damage to north wall of chancel (arrowed lines = 1.00m).

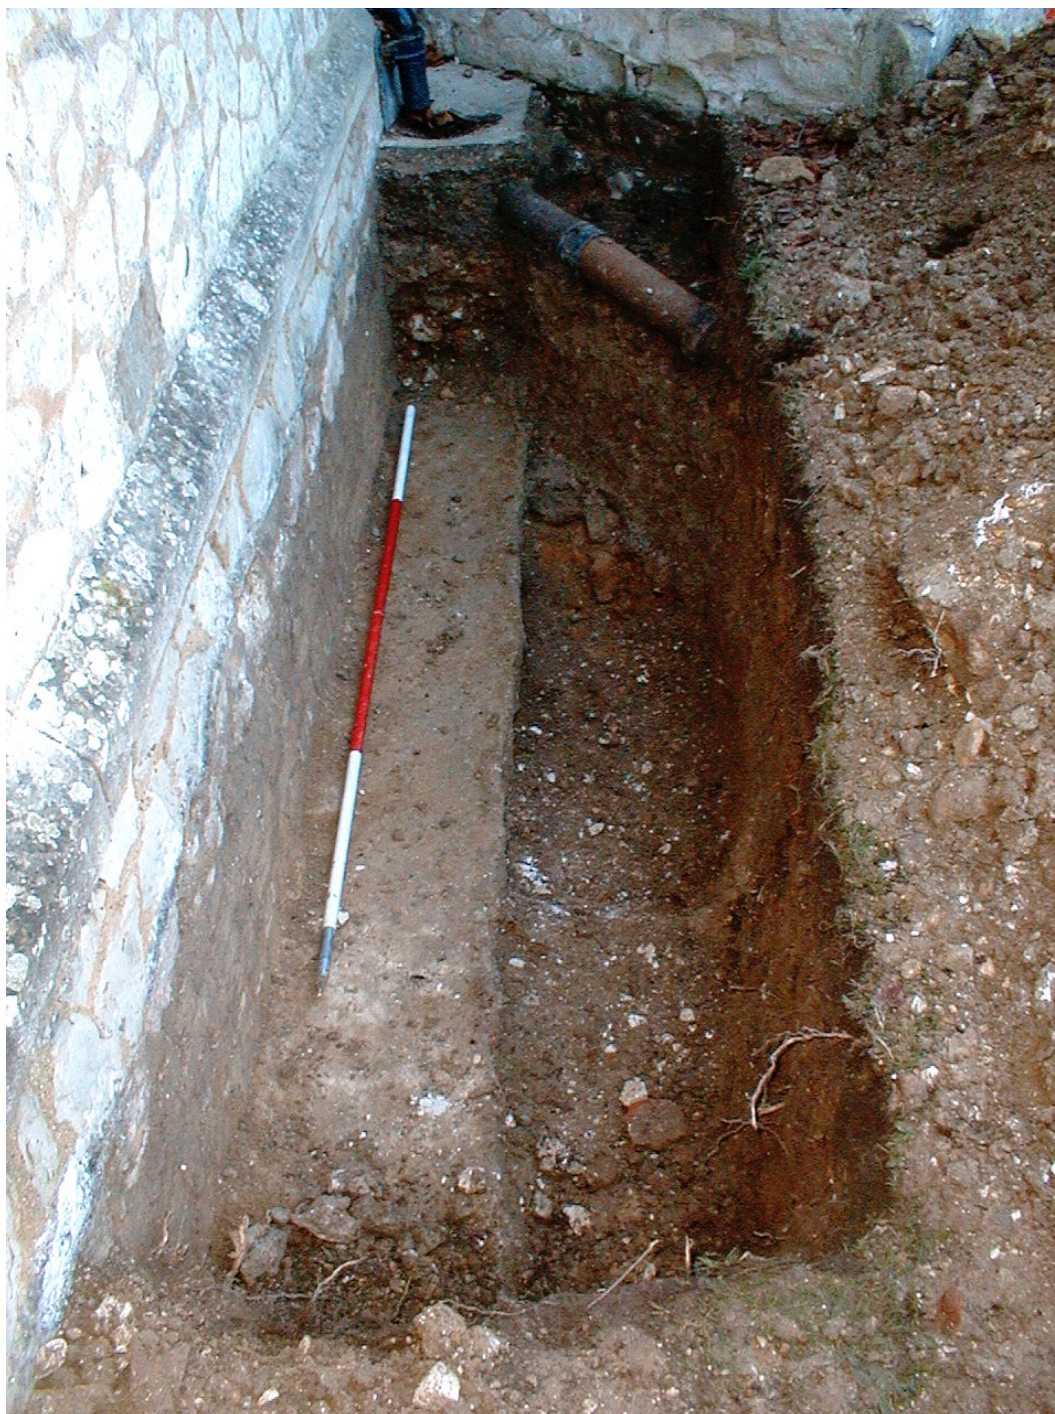
At c.0.40m above current ground level a single course of bricks (context 1001) was laid head to head, bonded to the original clunch face of the wall (context 1000) (Figures 2, 3 and 5). These dark grey bricks were 1.38m long and 0.17m tall and bonded with a hard, dark grey mortar, typically 0.01m thick. They were angled to be flush with the original wall at their top end but 0.11m proud of the wall at their bottom end. Below this 'step out' from the original face of the chancel wall, created by these bricks, was what appeared to be a face of clunch stonework (1002). This section of wall was c. 0.45m tall, running from directly under the angled facing bricks to just below current ground level. Utilising the same type of clunch, in the same rough hewn style (cut to the same size, typically 0.17m x 0.18m) and laid in a similar random, uncoursed pattern, this section of wall appeared to be a facing to the original wall and was clearly designed to be in keeping with it. It even used similar sandy, limestone, orange mortar (of a variable thickness, but typically 0.03m). It was, however, a little more regular – the stones were actually laid in two rough courses, not in the completely random pattern of the original clunch wall.

Below ground level the construction of the wall changed. The above ground section of *faux* clunch wall sat on, and was bonded to, a foundation of modern, neatly squared, rectangular, fired clay bricks (1003). These bricks were 0.23m long and 0.06m tall, yellow in colour and laid in a regular, stretcher bond with a 0.01m thick, slightly friable, yellow, limestone-based mortar. This section of the wall was six courses tall (c. 0.50m) and sat on a poured concrete/conglomerate foundation pad, which was 0.27m thick and projected 0.40m beyond the brickwork (Figure 5).

**Figure 5:** Test Pit 1 (looking north).

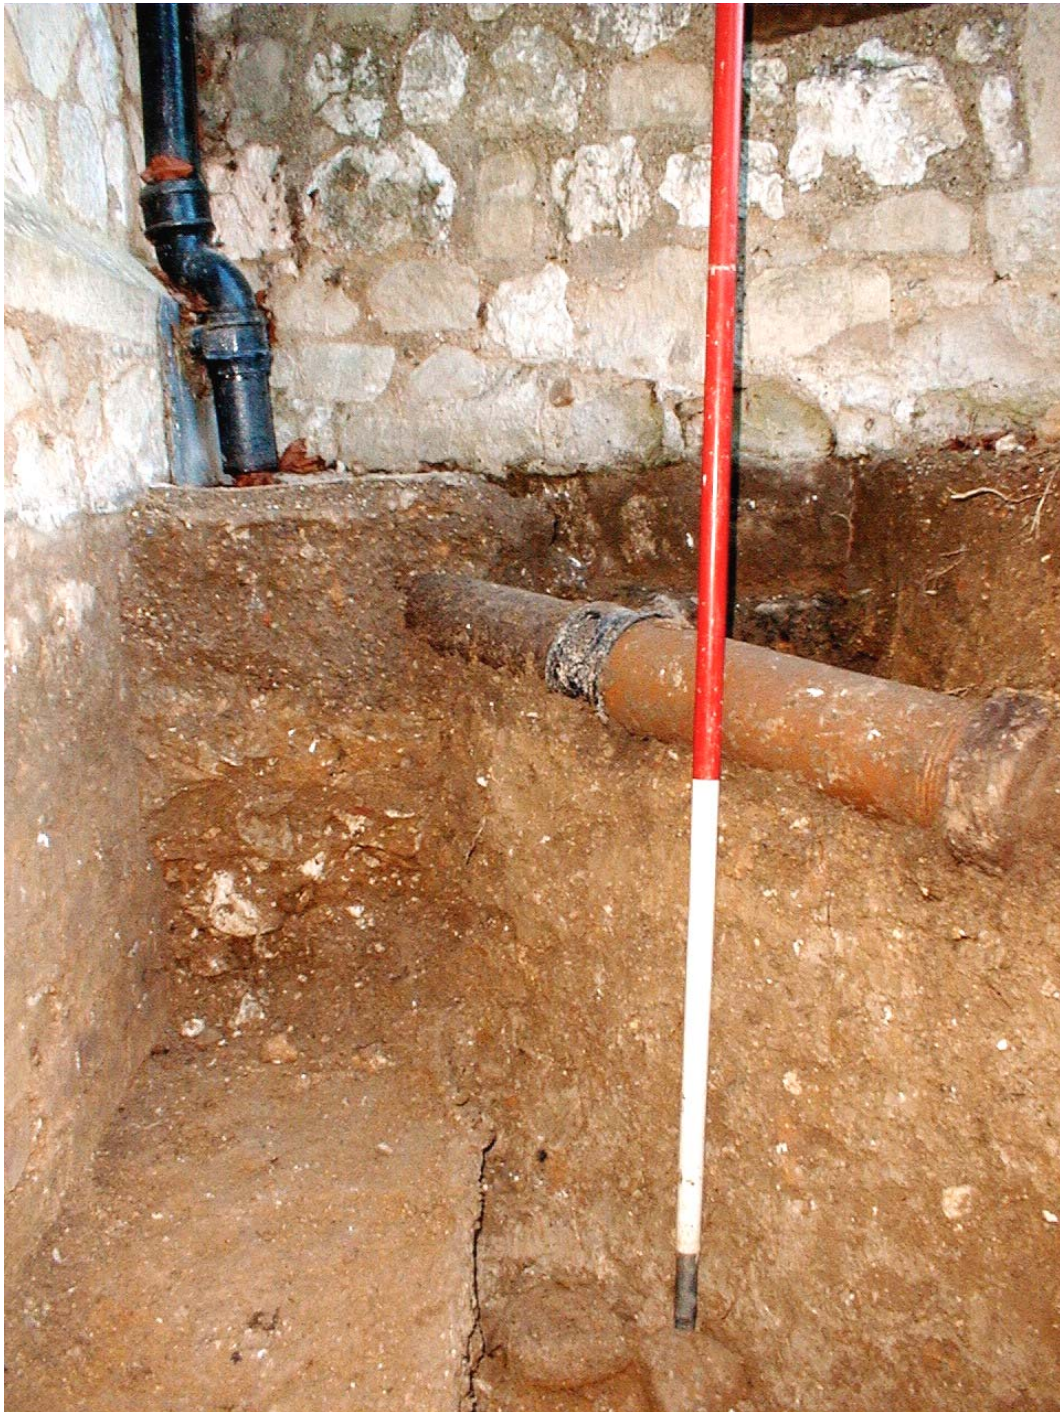
A modern drain was located at the west end of the test pit (Figures 2 and 6). It was aligned NE–SW, *c.* 0.40m wide and ran for 1.13m on a similar alignment to the remaining stub wall of the north transept. Its construction cut [1013] was regular, straight and steep-sided (*c.* 70° from horizontal) with a concave base. It was *c.* 0.30m deep and cut completely through layer (1006). It was backfilled with a firm, dark grey/brown, clayey silt with a moderate amount of chalk and rubble inclusions (1010), in which a plastic drain pipe was set. The pipe was connected to the bottom of a downspout which ran down the chancel wall into a drain cover. No leaks, splits or any other form of damage were noted along this drain.

**Figure 6:** Test Pit 1: structure and position of modern drain.

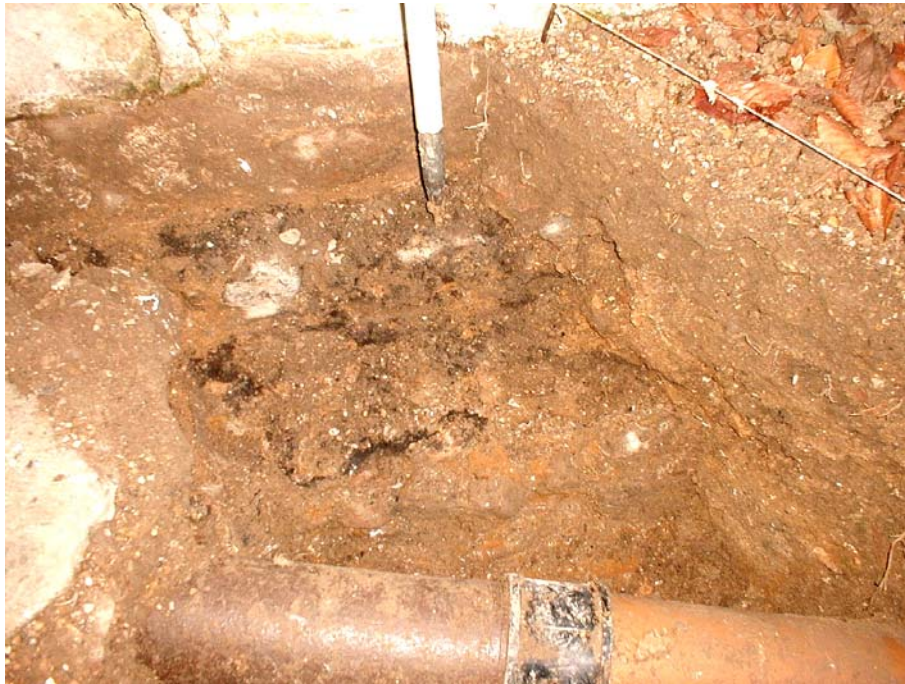
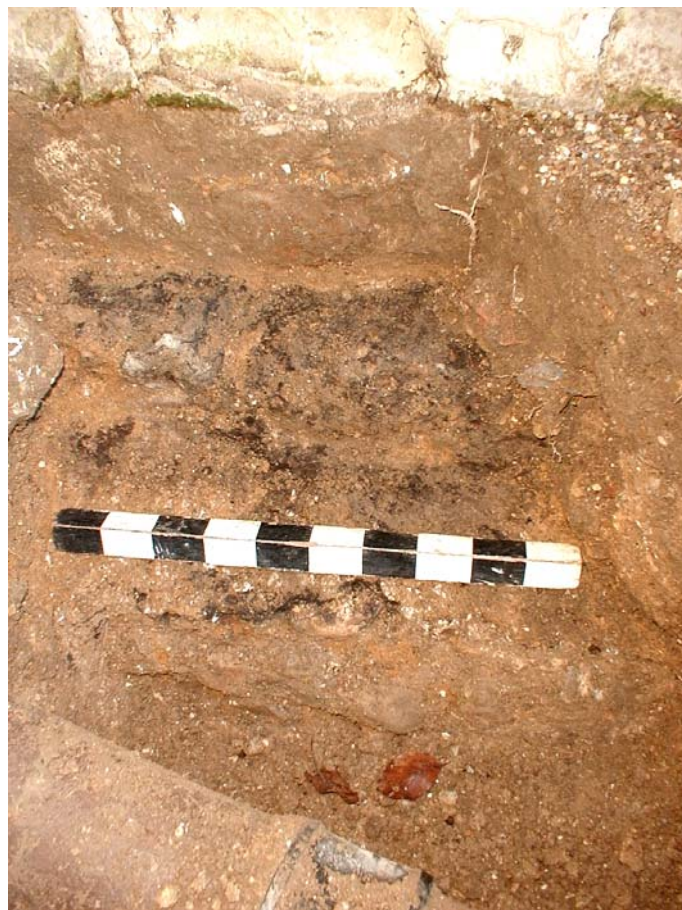
Context (1011) lay directly below the above-ground elements of the transept wall. It consisted of a single course of grey, roughly hewn, rounded, rectangular blocks of clunch, *c.* 0.15m long x 0.11m wide x 0.10m thick (Figures 2 and 7), laid end to end and bonded by a layer of soft, black (ash-based) mortar. This stonework may represent the lowest surviving course of the transept wall.

Context (1011) lay directly over a layer of small (0.07m x 0.06m x 0.05m) rounded stone cobbles (1012). Two complete courses were seen – indicating a roughly regular construction pattern, before the layer was truncated by the modern drain. However,

similar cobbles were visible below the drain, indicating an overall depth of c.0.40m. These cobbles may represent the original foundation of the transept wall.

**Figure 7:** Test Pit 1: truncated north transept foundations.

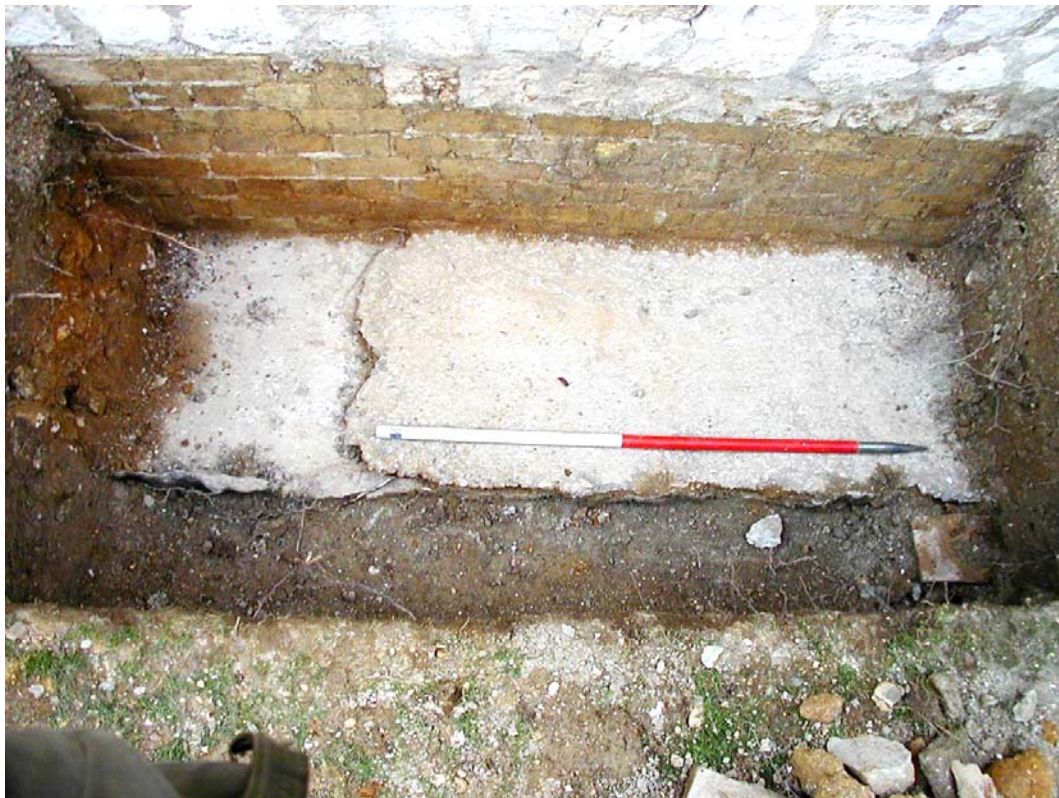
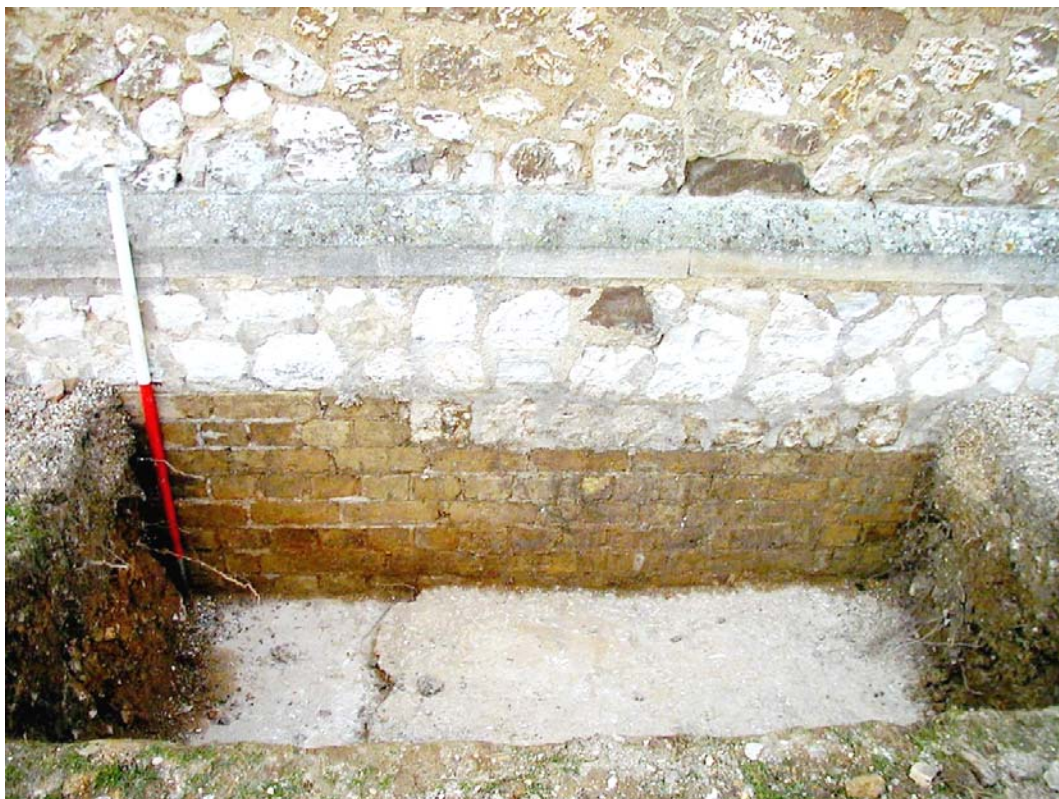
Overall the below ground elements of the east wall of the chancel were very similar to those observed in Test Pit 1. There were, however, two slight differences. An extra, 0.04m thick skim of concrete (1021) appeared to overlie the northern half of the main body of the concrete foundation pad (1020) (Figures 2 and 8). In addition, the height of the clunch- (1014) and brickwork (1022) varied slightly, due to the slope of the ground. At the northern end of the test pit, the ground sloped down slightly and as a result there was an extra course of clunch (three rough courses with six brick courses below). As the ground rose up to the south this changed to two rough courses of clunch (as in Test Pit 1) with eight brick courses to bring the wall down onto the foundation pad.

**Figure 8:** Test Pit 2: east wall of chancel (scale 1.00m)
