**ST MARY'S CHURCH, ASTON  
HERTFORDSHIRE**

**ASSESSMENT OF THE EAST FACE OF THE TOWER**

Document: 2004/95  
Project: 1042

20 September 2004

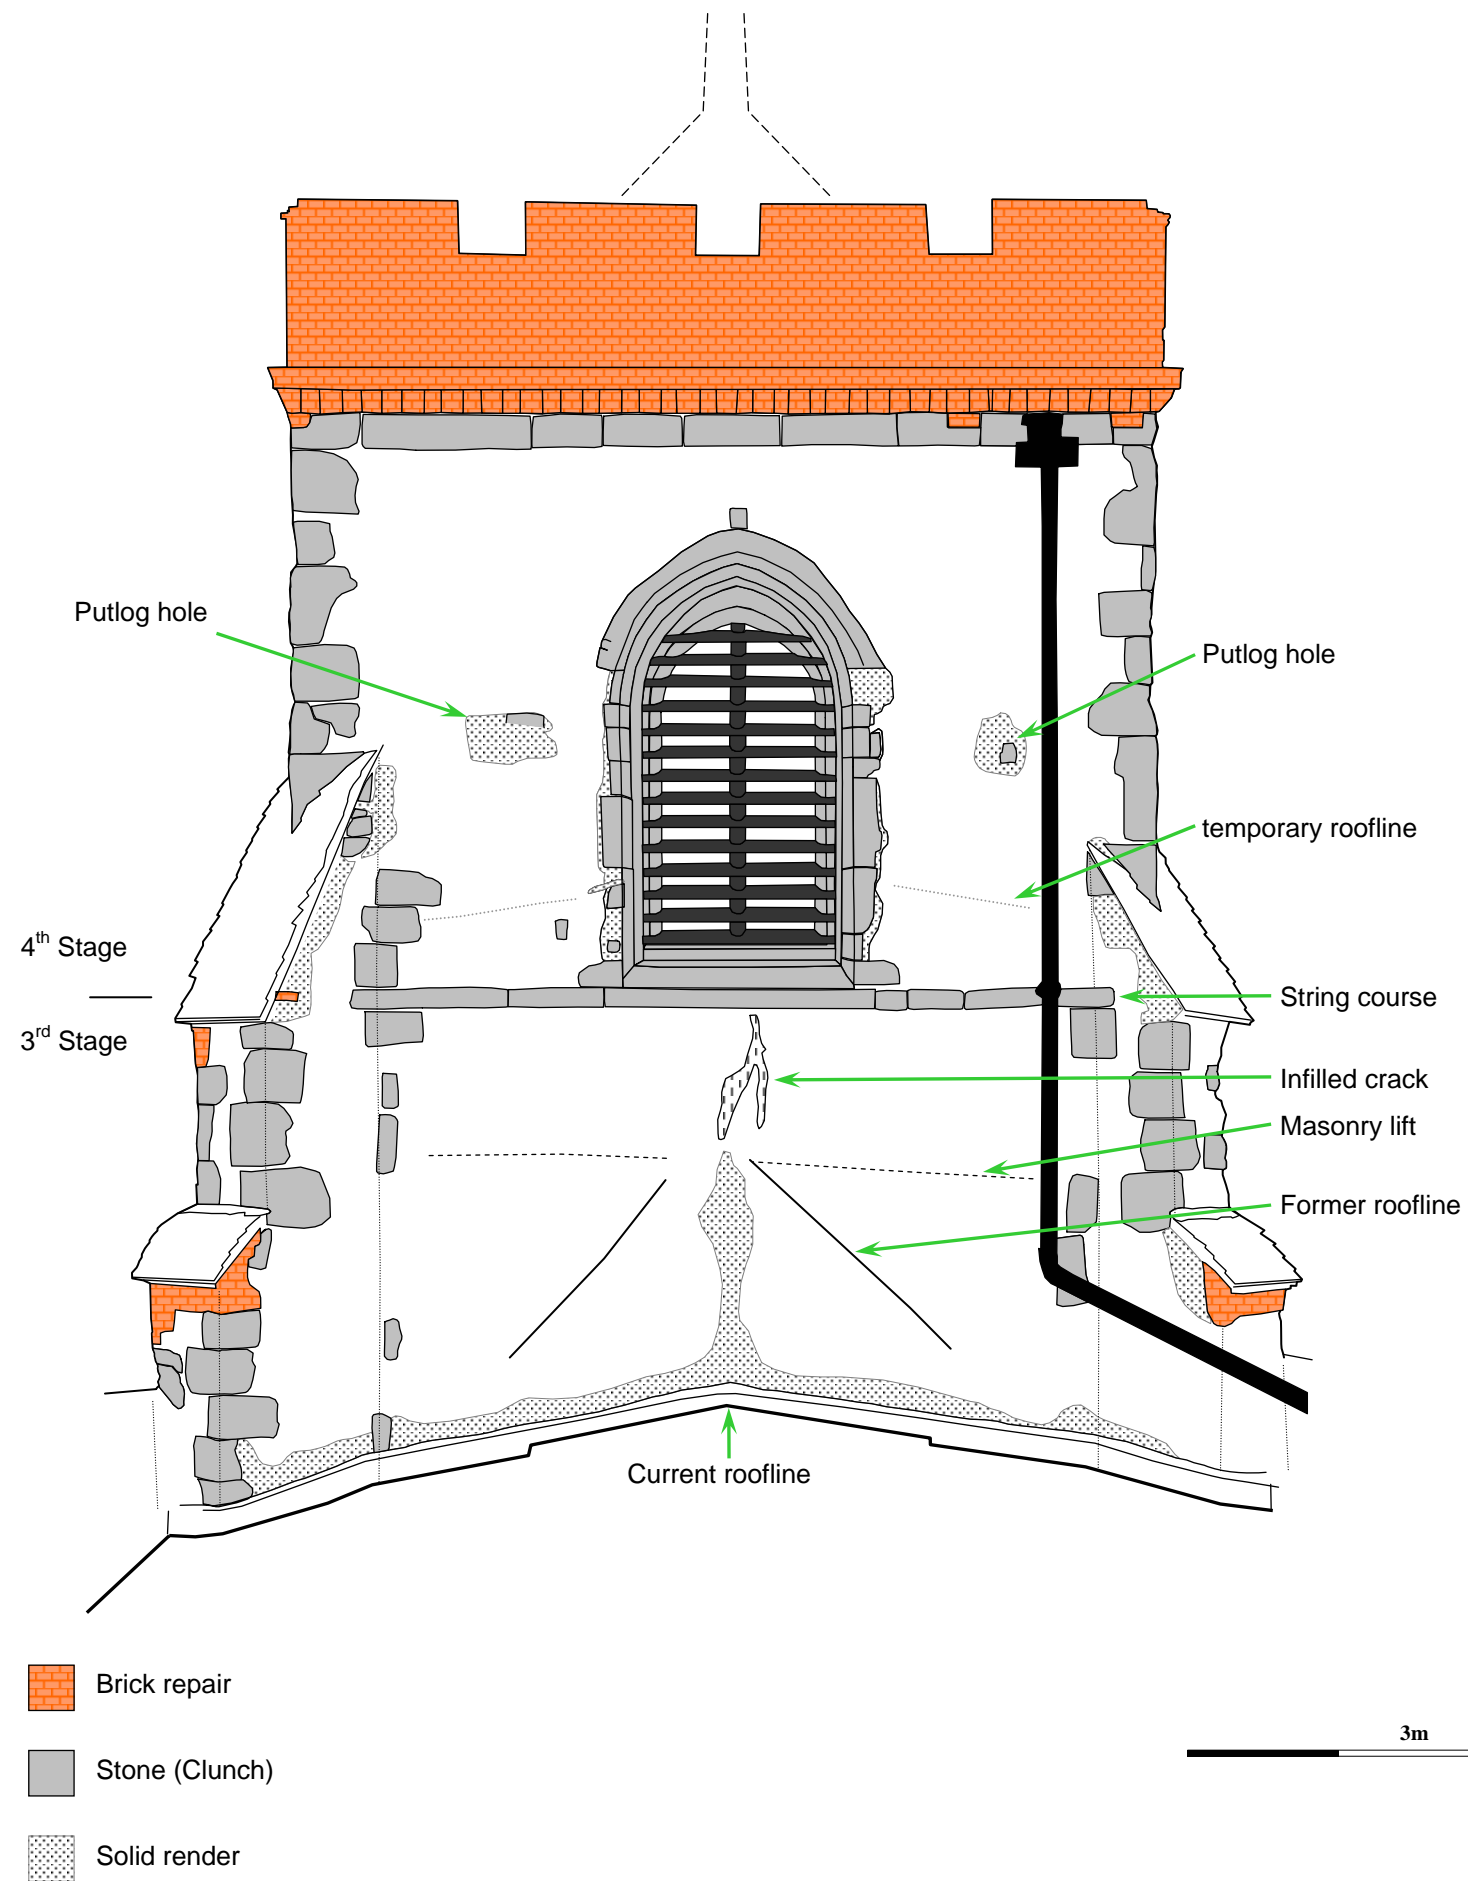
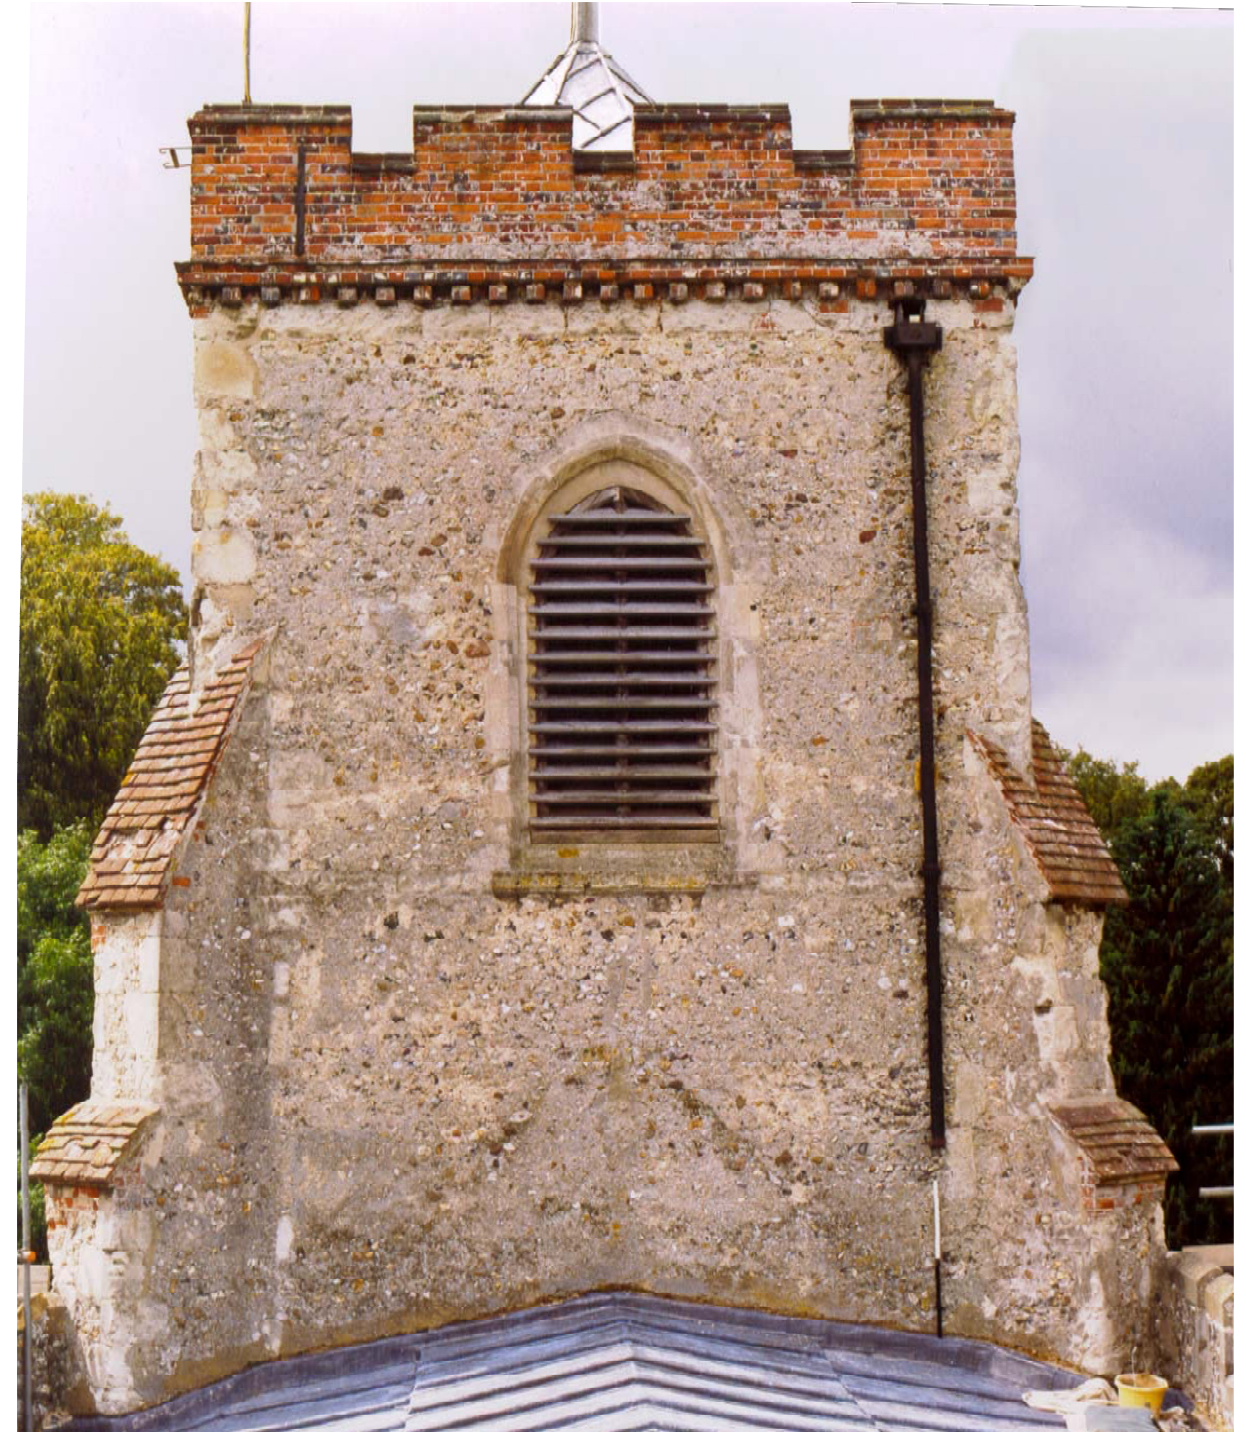
**Figure 1:** East face of tower

On the east face of the tower, above the nave, the last two stages are visible externally, the base of the third stage being partly obscured by the roofline of the nave.

The render on the lower part of the east face survives in quite large areas, probably due to its relatively sheltered location. The flint masonry contains a proportion of medium sized dark brown to mid-reddish brown rounded pebbles. The mortar consists of a light, cream coloured matrix with rounded and sub-angular flint inclusions, mostly between 0.5mm and 2mm with some up to 15mm in size. Although large areas of the mortar are obscured by later render, the mortar used throughout the construction of the tower is consistent throughout. A lift in the masonry is visible in the east face, crossing just below the apex of a former roofline and sloping slightly downwards, from south to north.

Buttresses extend as far as the fourth stage of the tower. The buttresses are constructed in the same flint rubble as the body of the tower, with edges defined by irregular quoins of clunch. The sloping upper faces of the buttresses have been tiled and there is evidence of extensive repair work comprising brick infill, quoins with crisply cut edges that have probably been replaced and multiple layers of rendering.

A number of pieces of masonry occur at the angle where the face of the tower meets the buttresses on either side. These are finished flush with the face of the wall. Those in the third stage of the tower are elongated and set vertically in the wall, contrasting with horizontal rectangular stones at the same location in the fourth stage of the tower.

The current nave roof lies at an angle of approximately 10° from the horizontal. In the masonry above, there is evidence of an earlier, steeper roof with a slope of approximately 45°. Here a triangular area of masonry stands slightly proud of the rest of the wall, with the roofline along the apex of the triangle noticeable by the presence of brown / reddish pebbles and, within the fabric towards the base on the north side, a small strip of lead roofing material or flashing.

A line, parallel with the current roofline, was visible at the time of the survey on the masonry in the lower part of the upper stage of the tower. This was caused by a temporary roof structure that had been dismantled shortly before the survey took place.

The upper part of the tower, above the buttresses, has rectangular quoins set in a face-alternate pattern. A string course of masonry, marks the join of the third and fourth stage of the tower. Unusually, this is flush with the surface of the wall. The string course is tied in with the masonry at the join with the buttress at either side. The lower part of the window in the upper stage sits directly upon the string course, which is extended outwards to form a sill below the window. On either side of the window, there are rectangular irregularities in the masonry indicating the location of putlog holes.
