**MANOR FARM  
BOLNHURST  
BEDFORDSHIRE**

**HISTORIC BUILDING RECORDING**

Project: MF3371  
Document: 2020/31  
Version: 1.1

Issue date: 23rd July 2020

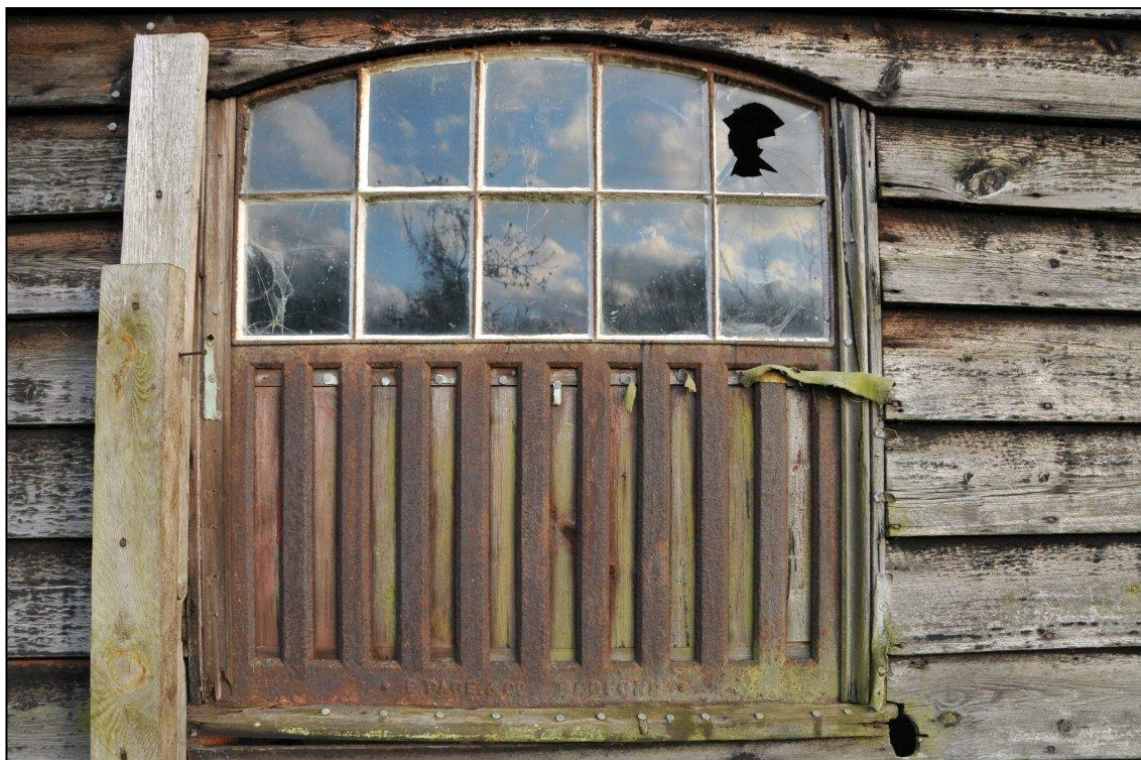
**Image 6:** Barn, ground-floor window in west elevation

Detail of window to right of the sliding doors. Hit-and-miss vent marked 'E Page & Co Bedford'. Note architrave moulding used at sides of window.

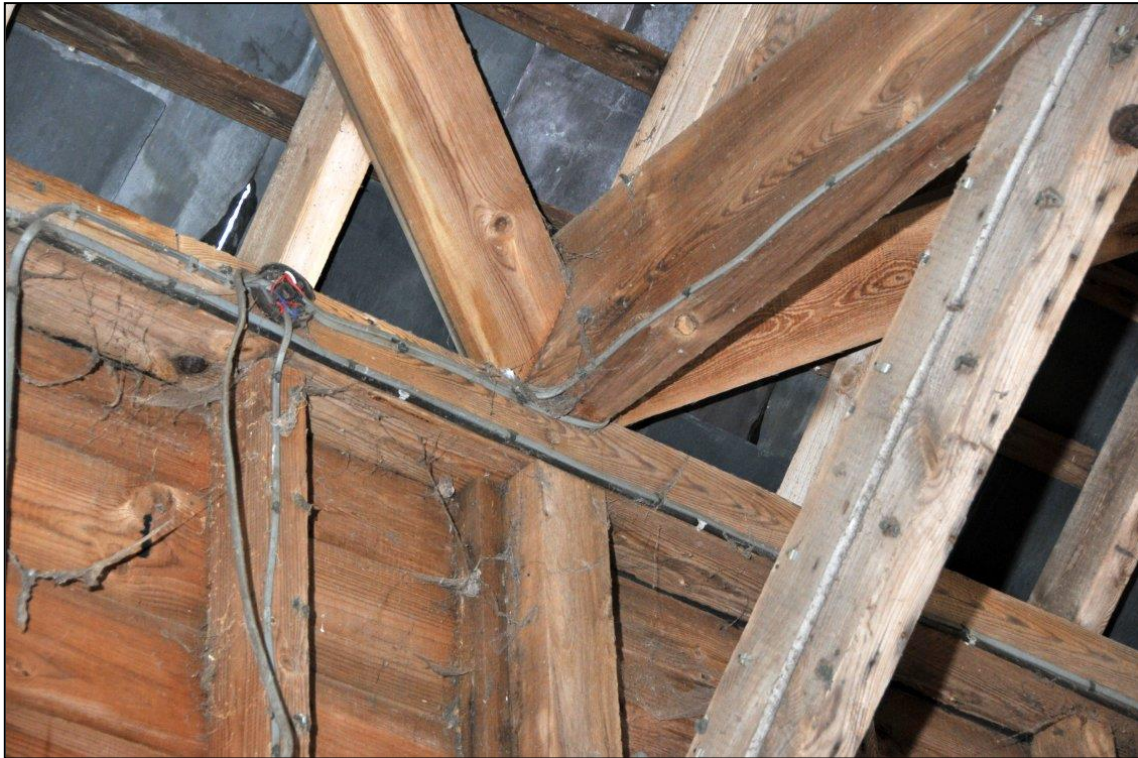
**Image 15:** Barn interior, detail of tie beam

Right: brace below tie beam. Lower centre: main wall post with battens on sides for fixing weatherboard. Upper left to lower right: wall plate with scarf joint at left (obscured by electric junction). Upper centre: tie beam half-dovetailed into the top of the wall plate and lower ends of diagonal roof braces abutting sides of the tie beam.

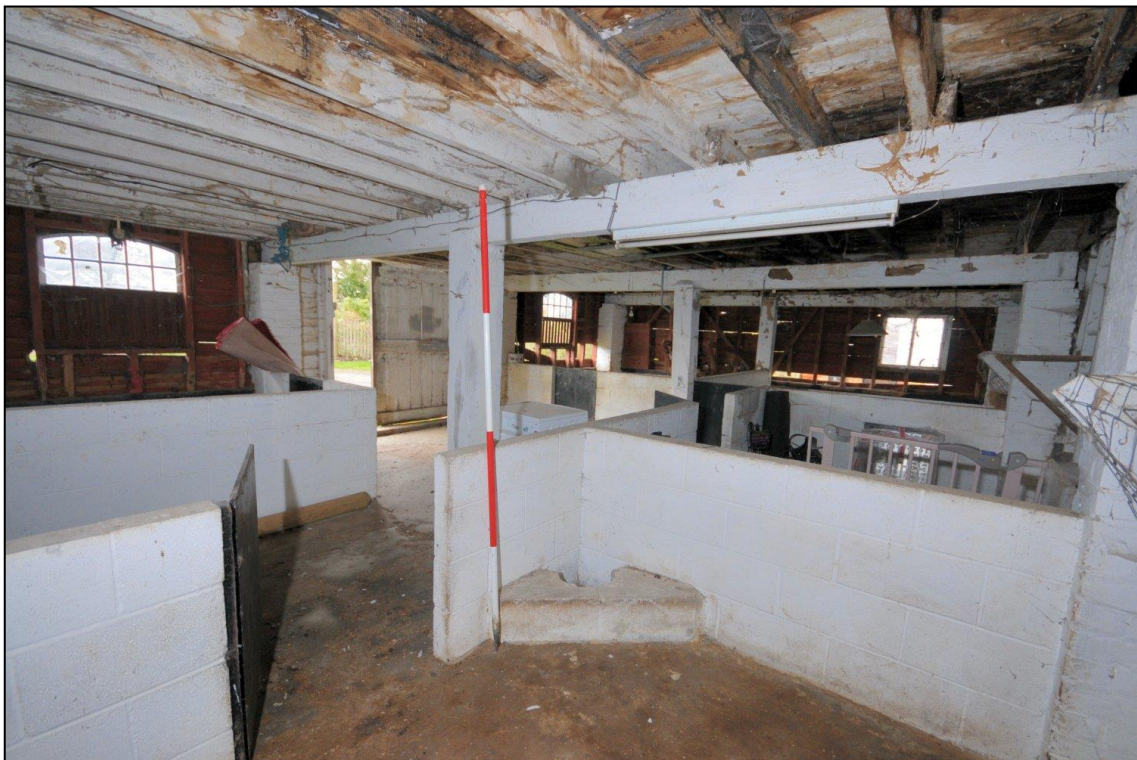
**Image 22:** Barn interior, ground floor at north end  
Looking north-west showing blockwork animal stalls (Scale 2m)

The floor of the loft has joists aligned north–south, which rest on the top of the partition wall and three transverse beams (Image 22). These beams are supported at the centres by timber posts and by brick piers at the ends. The brick piers appear to be in recent machine-made brick (obscured by paint) and may have replaced an earlier arrangement of posts. The ground floor below the loft has two windows in the west wall with hit-and-miss vents, indicating a probable original use of this area for stabling or animal stalls (Image 23).

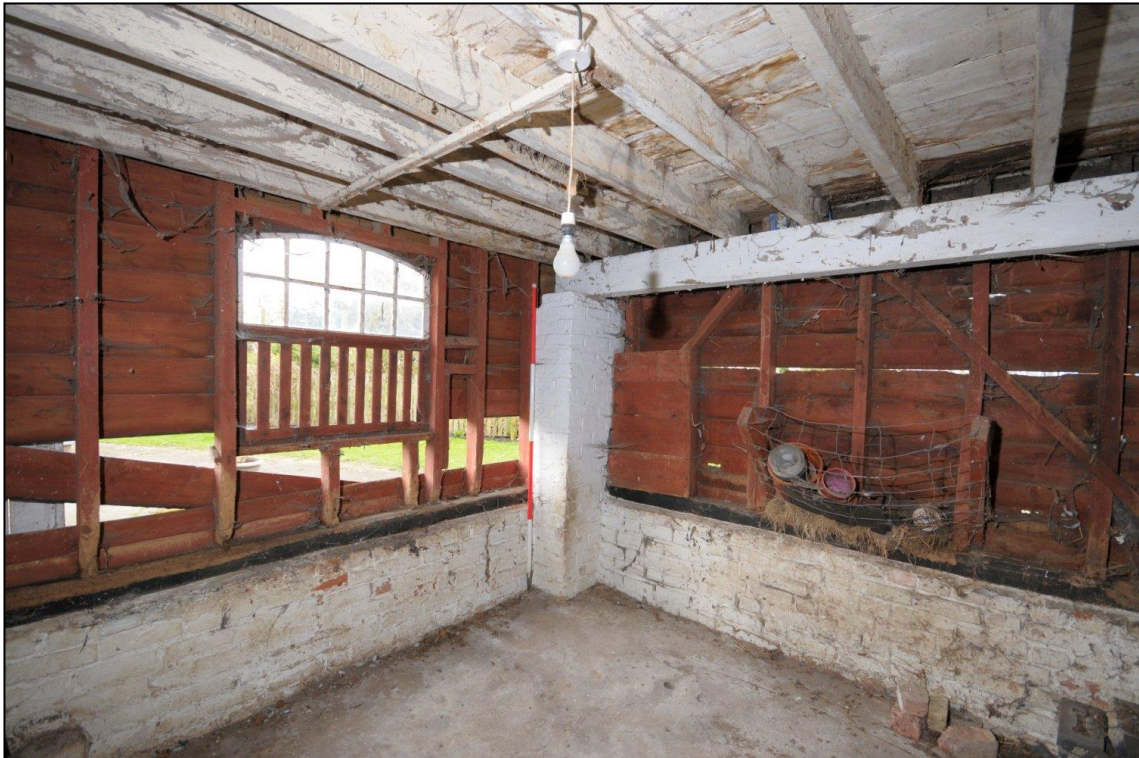
**Image 23:** Barn interior, north-west corner

Looking north-west showing window and brick pillar supporting loft floor (Scale 2m)

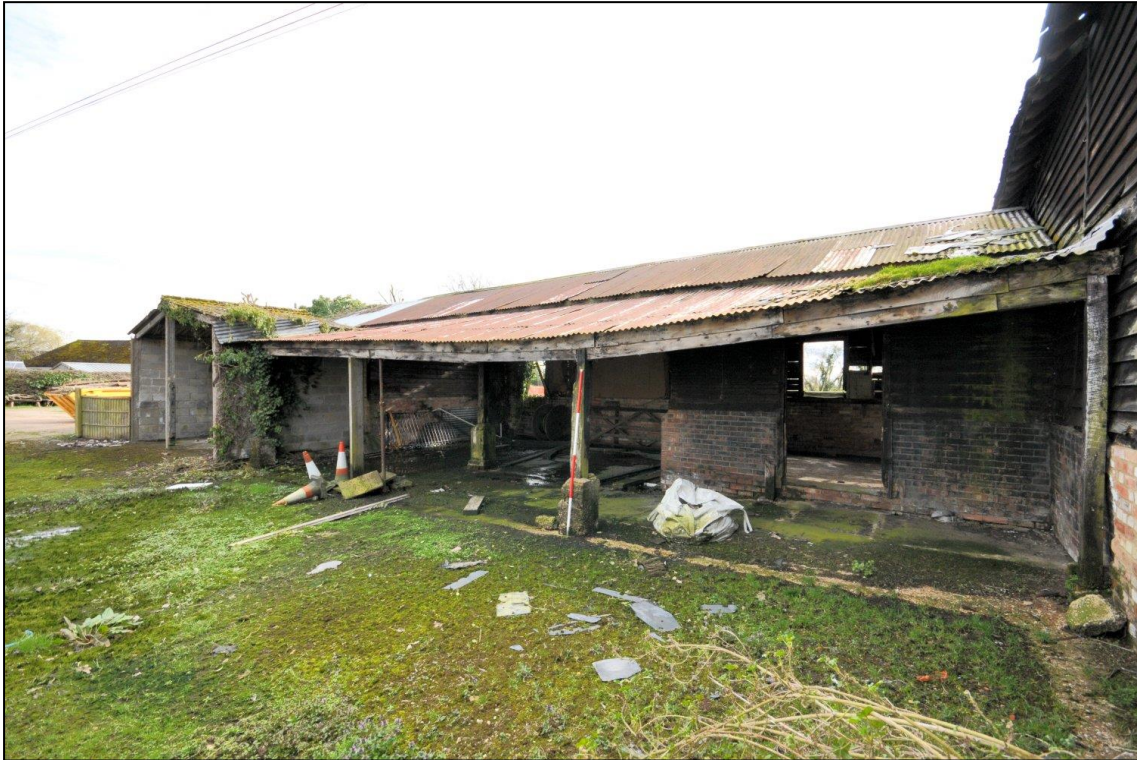
**Image 27:** South range, north elevation

(Image 3). The north elevation has been obscured by later additions and now has an open-fronted shelter extension across the right-hand two thirds and a modern blockwork open-fronted shelter at the left (Image 27). The east elevation contains double-doors to the loose-box/shed compartment.

Looking south-east showing open-fronted section with loose box at right and blockwork building at left (Scale 2m)

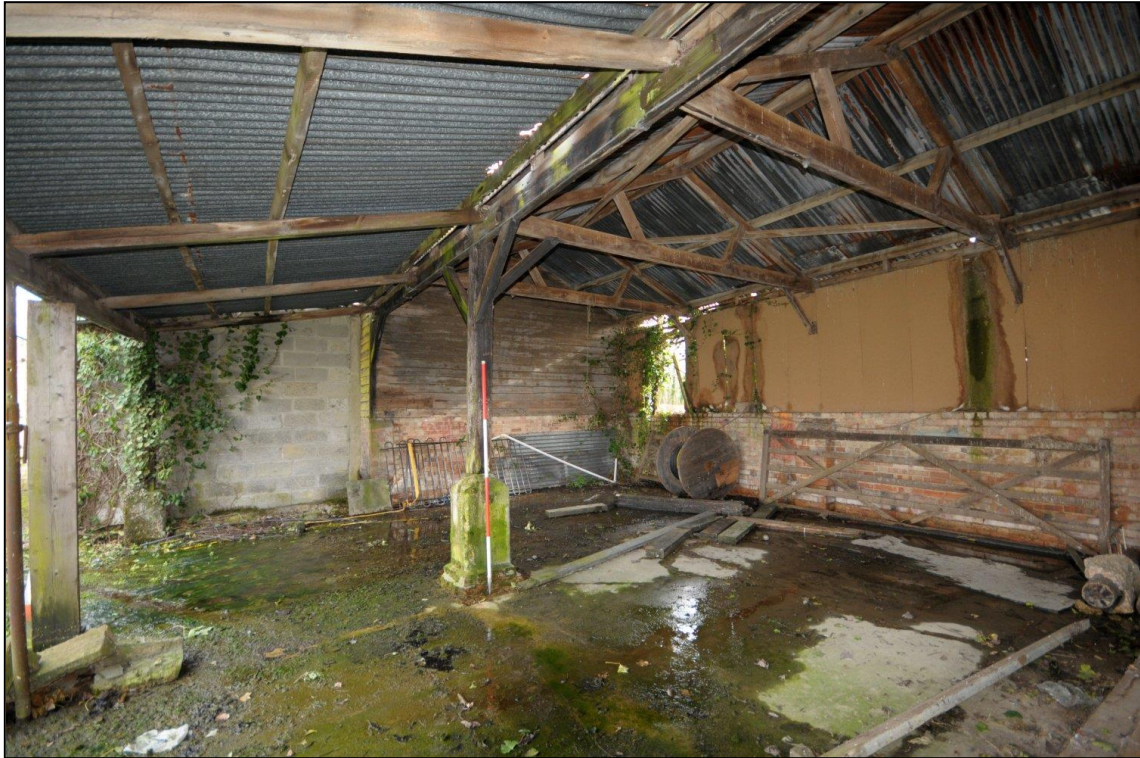
**Image 31:** South range, interior of open-fronted section

Shows original two-bay, open-fronted section at right and later extension at left (Scale 2m)

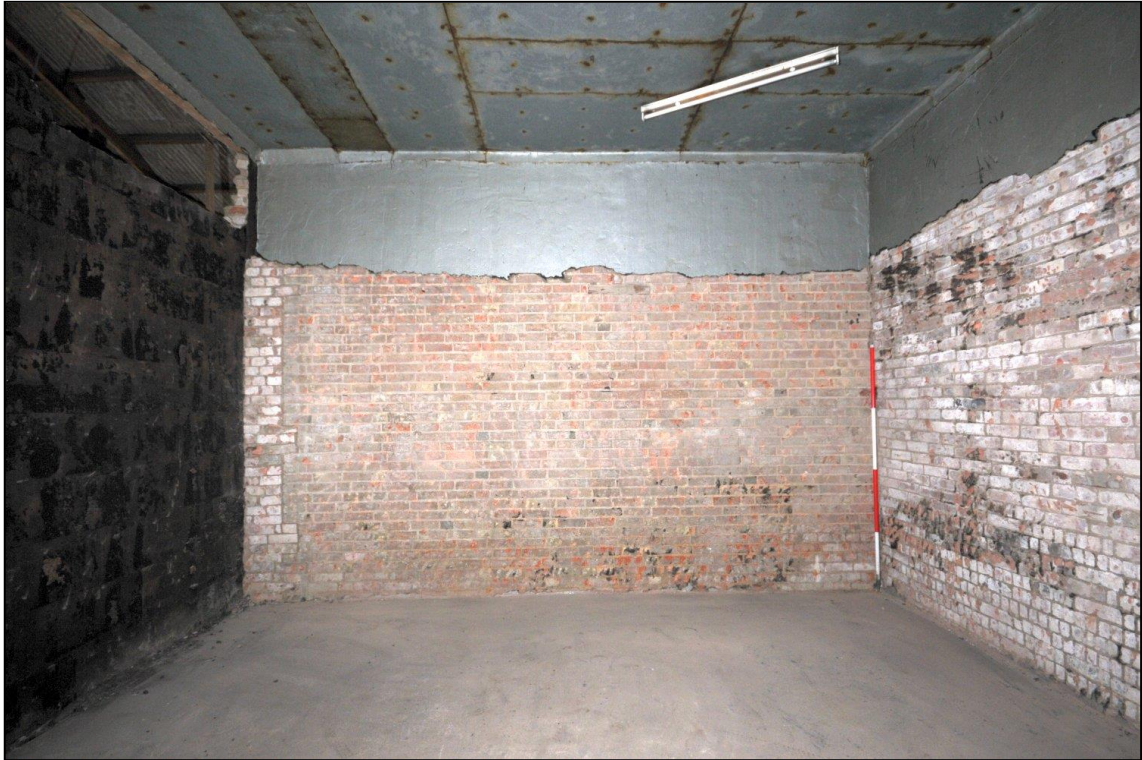
**Image 39:** Workshop range interior, Apple Store

Looking west, showing earlier west wall abutted by the north wall of Apple Store at right and brickwork in Workshop 1 at left, toothed-in to the earlier wall (Scale 2m)

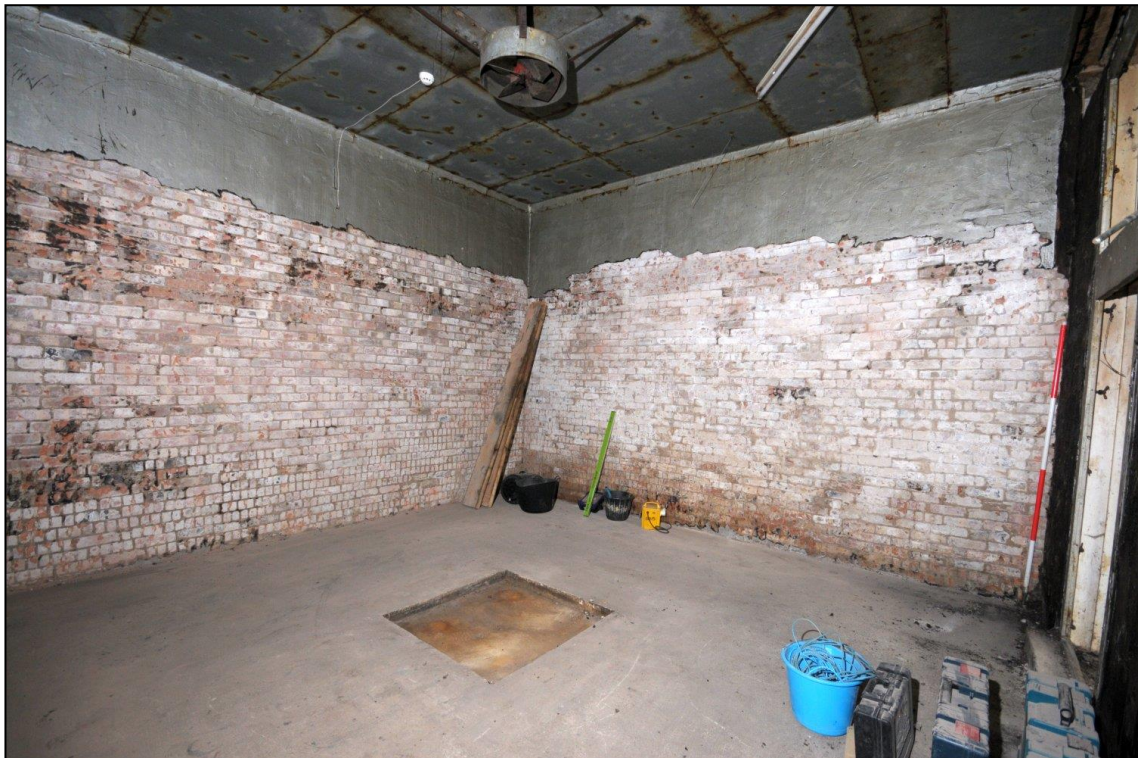
**Image 40:** Workshop range interior, Apple Store

Looking north-east, showing irregular brickwork in north and east walls (Scale 2m)

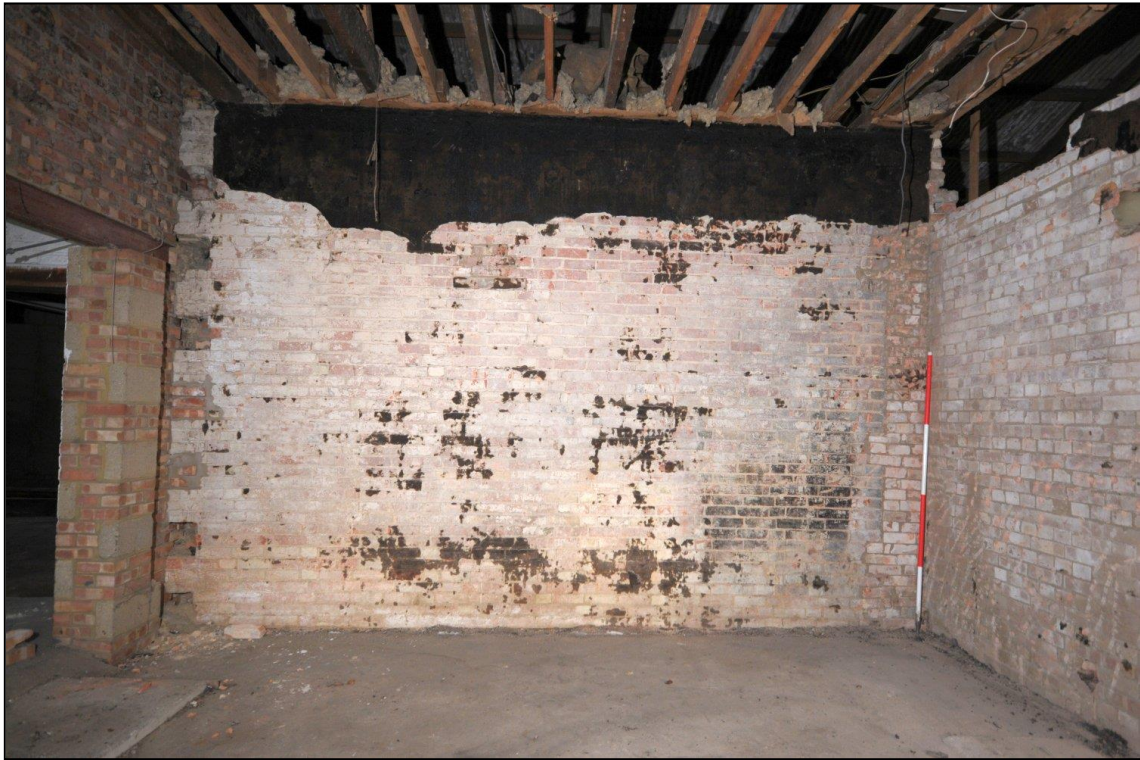
**Image 41:** Workshop range interior, Workshop 2

Looking east, showing east wall, toothed-in to brickwork of Workshop 1 at right (Scale 2m)

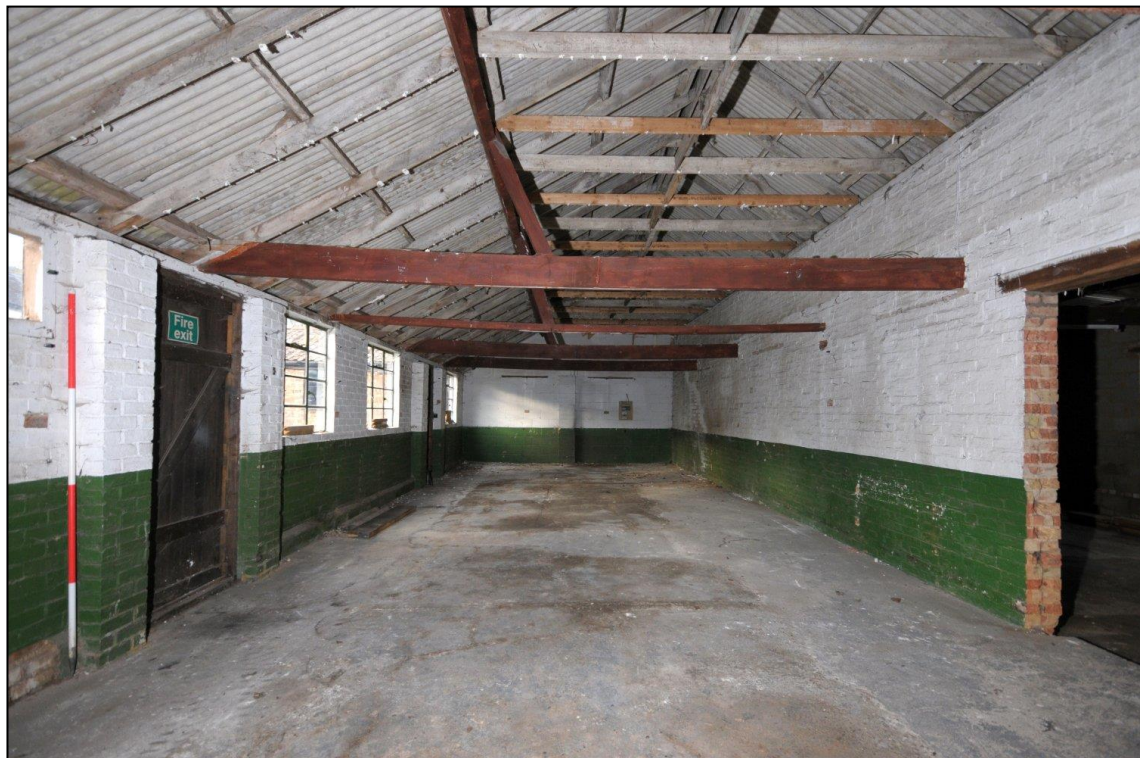
**Image 42:** Workshop range interior, Workshop 3

Looking north, showing Workshop 3 with cut-in door to Workshop 4 at right (Scale 2m)

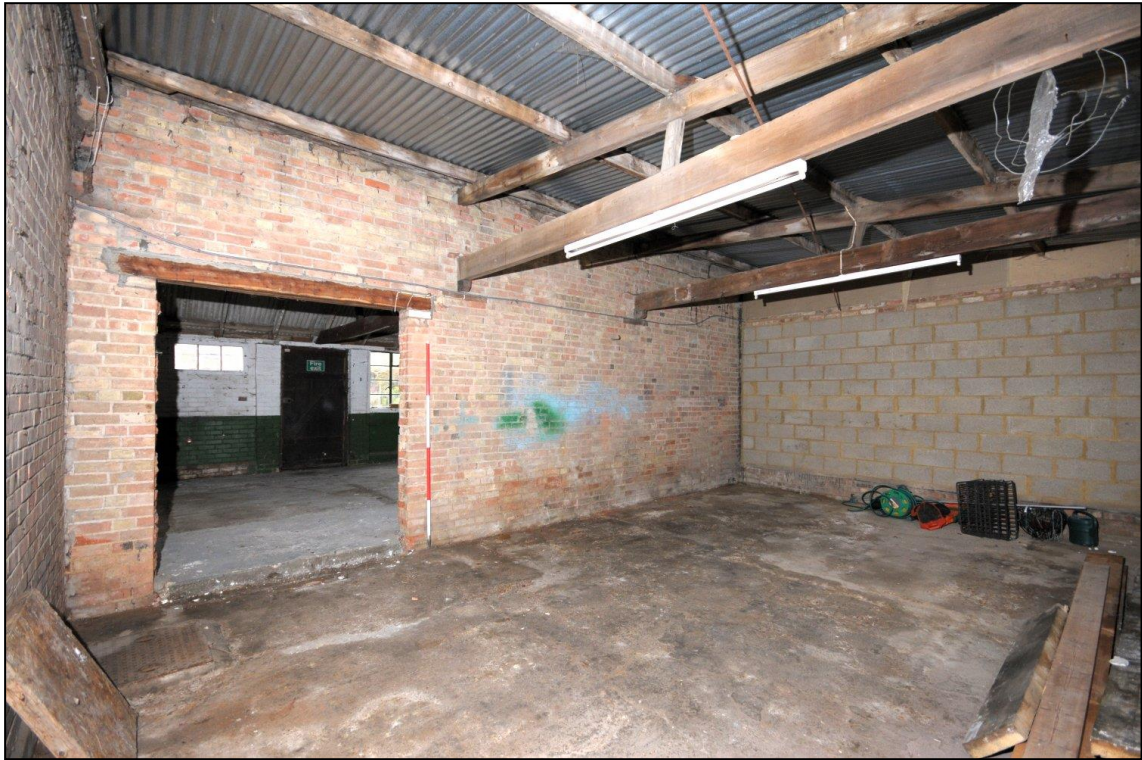
**Image 43:** Workshop range interior, Workshop 4

Looking north-west, showing cut-in opening from Workshop 3 (Scale 2m)
