**ST MARY'S CHURCH  
CARLTON  
BEDFORDSHIRE**

**ARCHAEOLOGICAL OBSERVATION,  
INVESTIGATION, RECORDING, ANALYSIS,  
AND PUBLICATION**

Project Code: SM3597  
Document: 2020/26  
Version: 1.0

Issue date: 4th May 2020

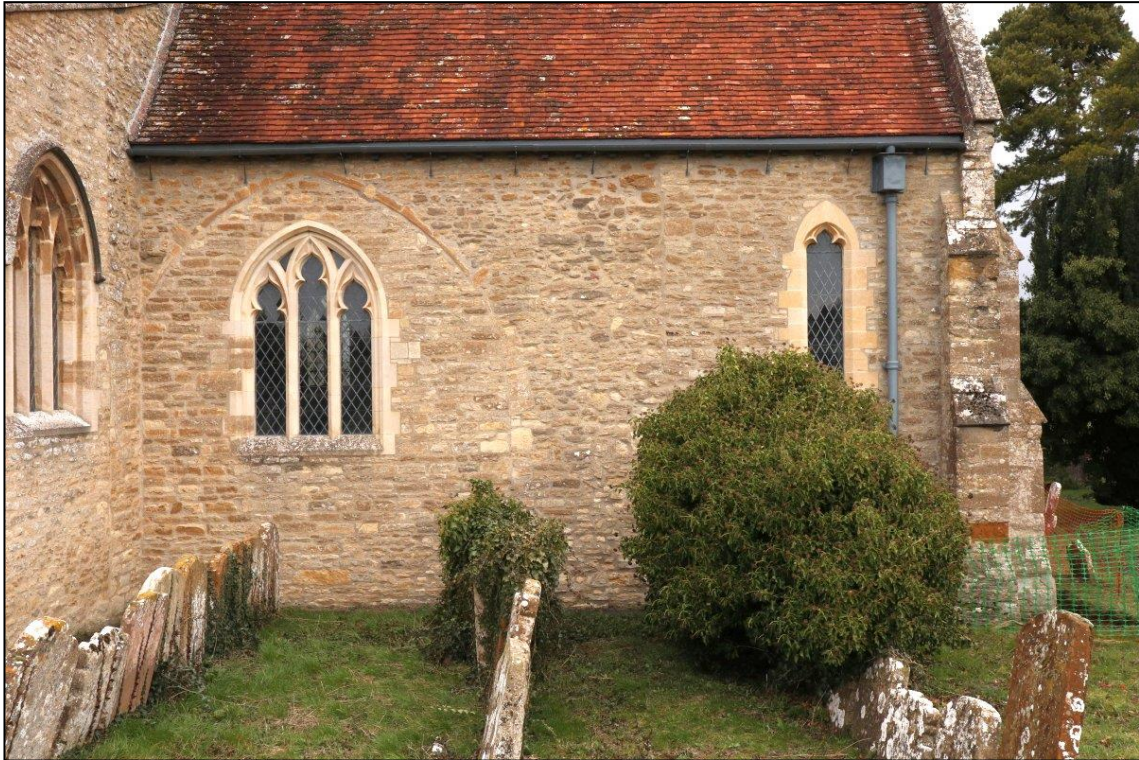
**Image 3:** South side of chancel

Shows blocked arch relating to a former chapel and a vertical straight join where the east end of the chancel was extended.

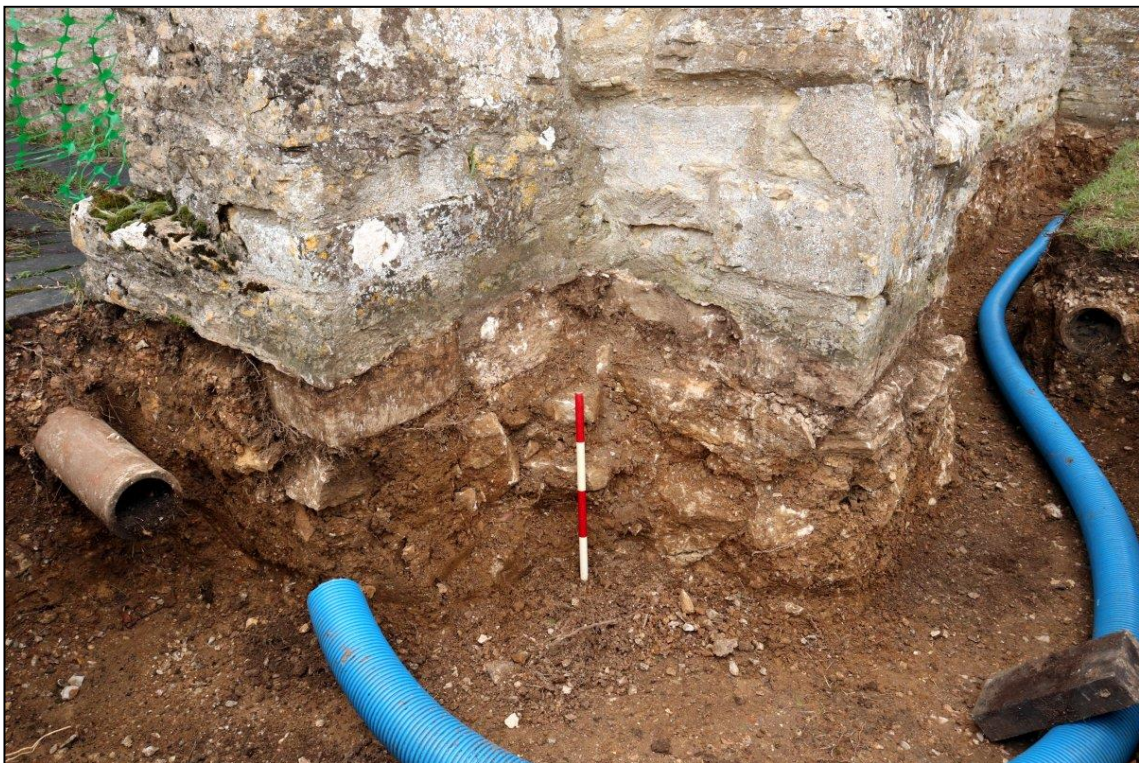
**Image 6:** Trench 1: south-east corner of chancel

The foundations for the buttresses on the south-east and north-east corners of the chancel are similar. Both have very roughly made random rubble foundations, with an irregular offset projecting up to 100mm from the face of the buttress (Figure 7-A; Images 6 and 8).

Foundation (103), looking north-west, showing angle buttresses on south-east corner of chancel (scale 0.4m)

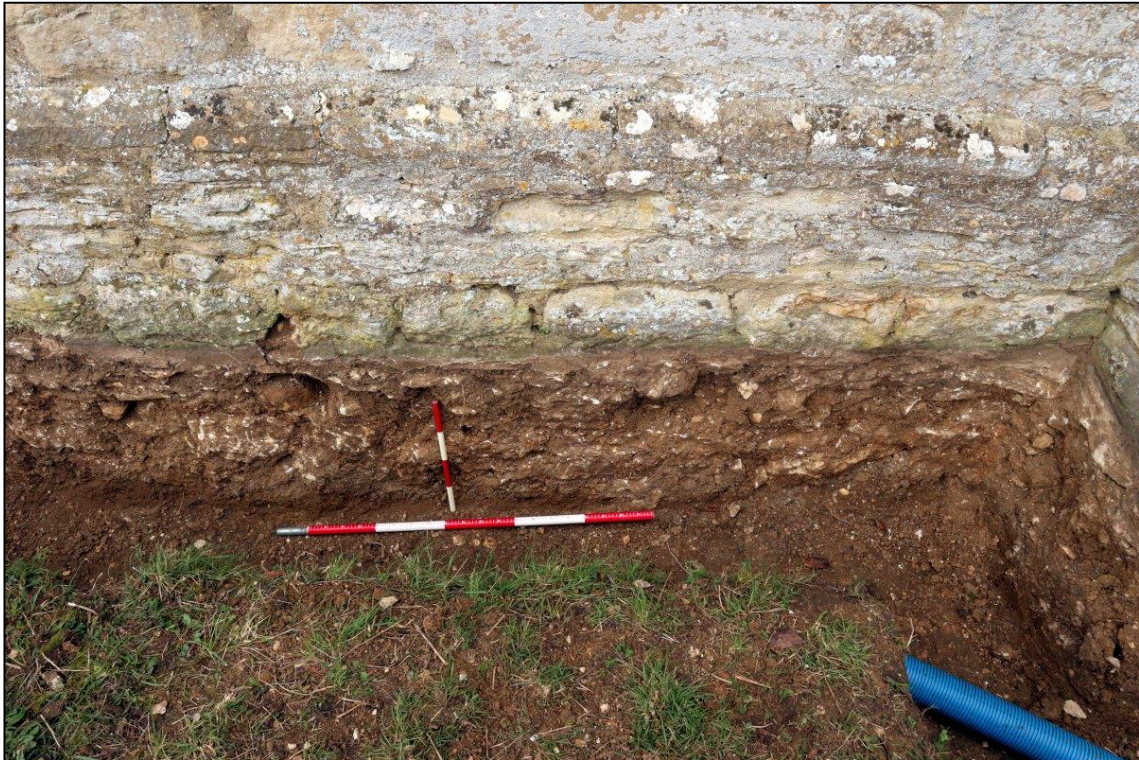
**Image 7:** Trench 1: east wall of chancel

In the east end wall the foundation (103) consists of roughly coursed rubble extending c.400mm below the present ground surface. This part of the foundation has no offset. The wall above is constructed in larger, more regularly coursed stone, with a course of noticeably larger stones at the base of the wall directly on the foundations (Figure-B; Image 7).

Foundation (103), looking west, showing right-hand part of wall adjacent to north-east corner buttress (scales 1m and 0.4m)

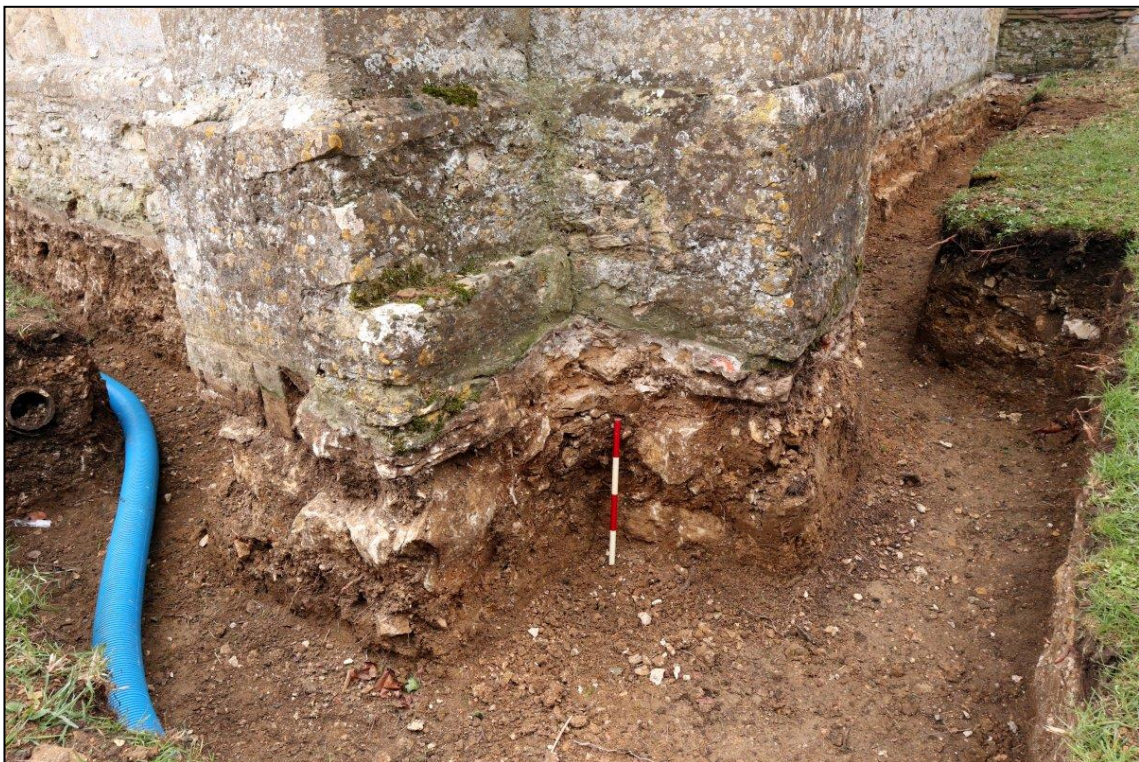
**Image 8:** Trench 1: north-east corner of chancel

Foundation (103), looking south-west, showing angle buttresses on north-east corner of chancel (scale 0.4m)

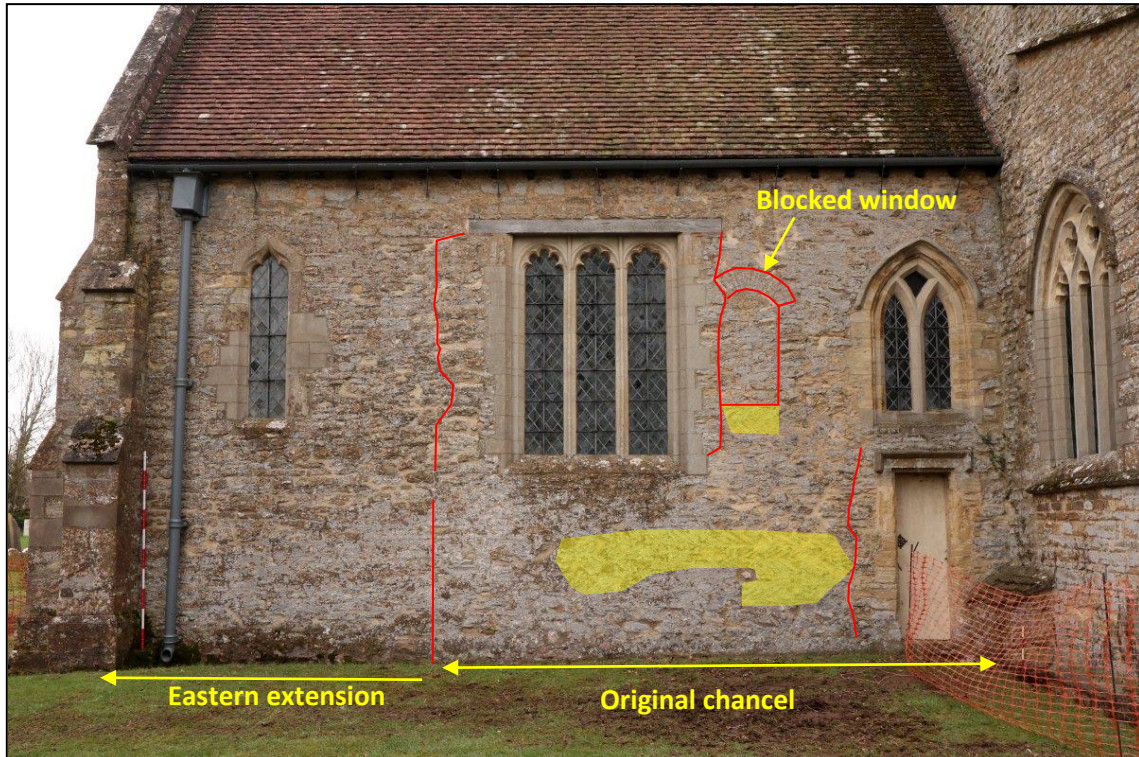
**Image 10:** South wall of chancel (interpretation)

Lines in red indicate changes in masonry and yellow shading indicates areas of herringbone masonry (scale 2m)

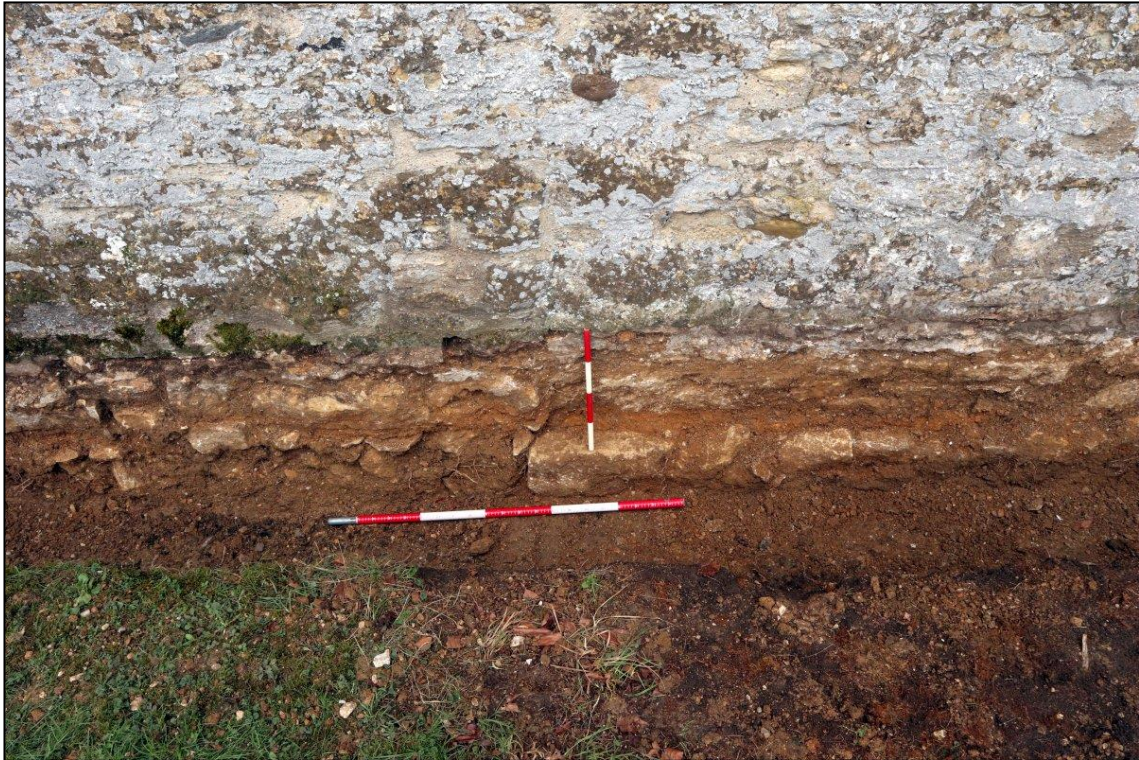
**Image 11:** Trench 1: south wall of chancel, eastern part

The north side of the chancel foundation (103) has a slight (c.100mm) offset at its eastern end, which runs out towards the west where it abuts the earlier part of the chancel (Figure 7-C; Image 11). On this side the chancel foundation (103) consists of roughly coursed rubble, which includes a few larger blocks up to 600mm long and 150mm high in the uppermost course of the foundation.

Shows change in foundations with original chancel foundations (104) to the right and the later extension (103) to the left (scales 1m and 0.4m)

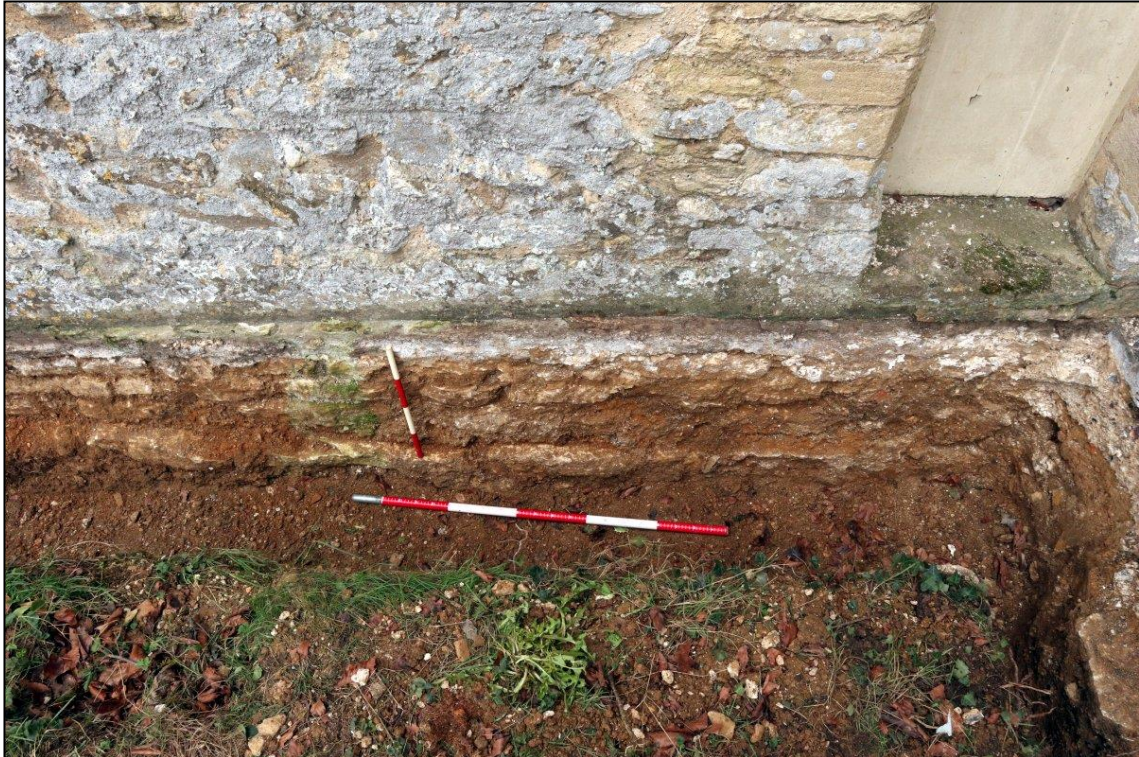
**Image 12:** Trench 1: south wall of chancel, west end

Foundation (104) is an offset foundation projecting between 100mm and 180mm from the face of the wall (Figure 7-D; Images 11 and 12). The offset diminishes towards the west end. It consists of a course of relatively large rubble blocks up to 600mm long and 250mm high. The wall above it is constructed in small and medium-sized roughly coursed rubble masonry, which includes areas of herringbone work and a blocked round-headed window of probable late Saxon date (Images 9 and 10).

Shows foundations (104) with herringbone masonry in the wall above (scales 1m and 0.4m)

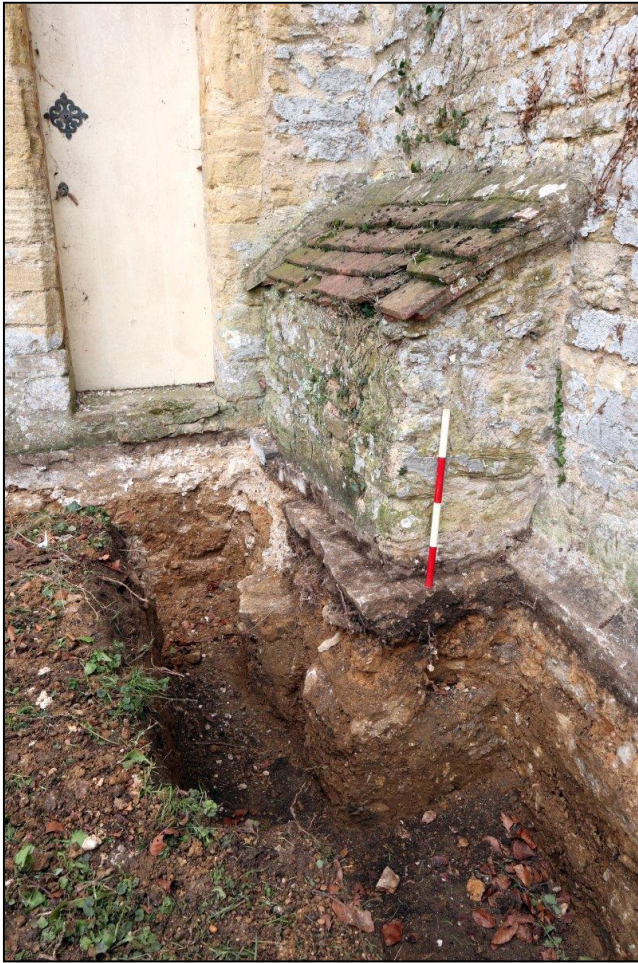
**Image 13:** Trench 1: masonry in angle of chancel and north aisle

A small rectangular block of masonry with tiled weathering abuts the east wall of the north aisle, at its junction with the chancel (Image 13). The foundation (105) of this block is very roughly constructed from uncoursed rubble. The foundation and block of masonry are a later addition, abutting the east end of the north aisle. The function of the masonry is unclear.

Shows block of masonry and foundations (105) abutting east end of north aisle

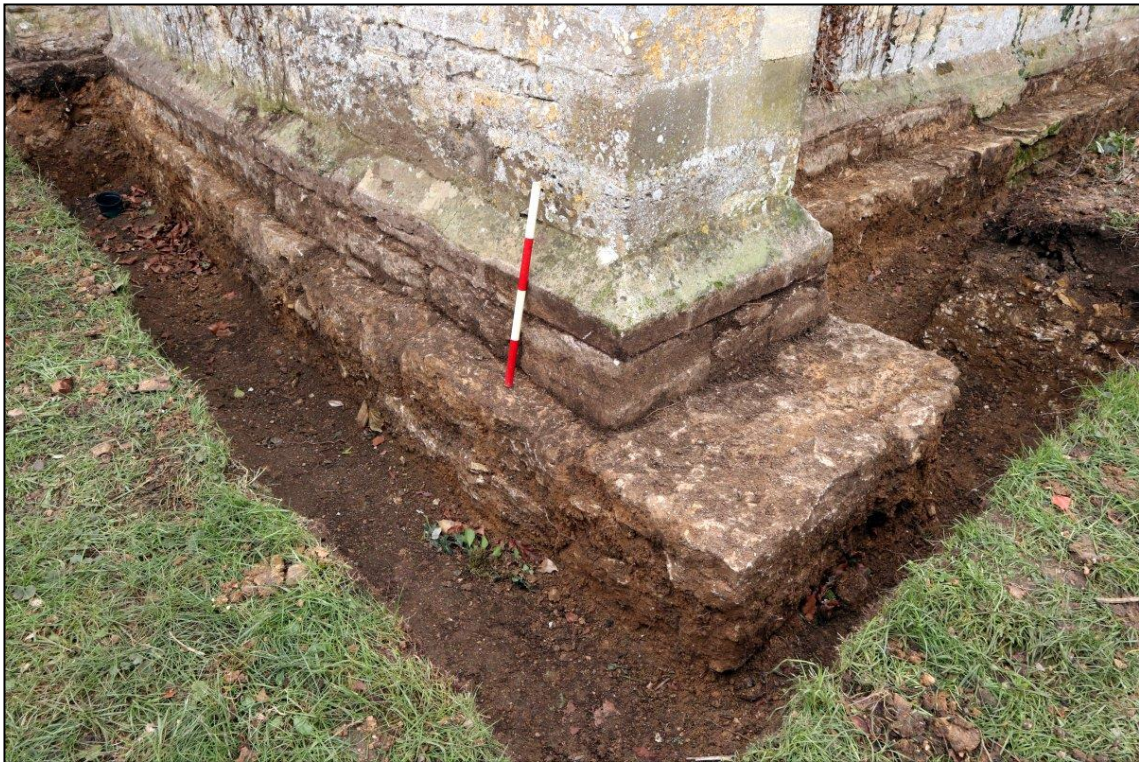
**Image 14:** Trench 1: north-east corner of north aisle

The foundation at the east end of the aisle consists of a fairly narrow offset *c.*130mm wide, with an upper course of large rubble blocks up to 500mm long by 150mm high with smaller coursed rubble in the lower part of the foundation (Figure 7-E, Image 14). The foundation extends northwards to form a foundation pad below the buttress.

Foundations (106) of north aisle, showing north-east corner (scale 0.4m)

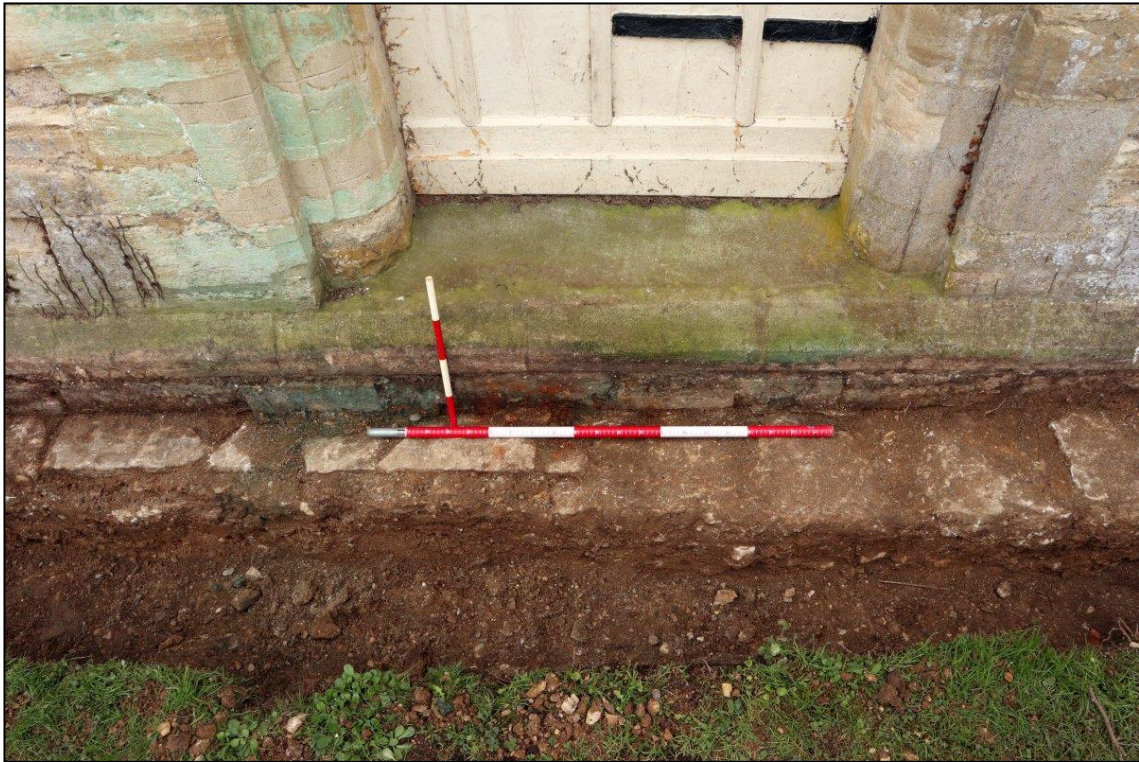
**Image 15:** Trench 1: north side of north aisle

In the north wall the foundation has a *c.*200mm-wide offset, with an upper course of large, thin slabs up to 620mm long by 80mm high (Figure 7-F, Image 15). Towards the west end of the aisle (in front of the north door) there is an abrupt change in the width of the offset (Image 15), possibly corresponding to a break or sectional construction of the foundation.

Shows foundations below door in western part of wall (scales 1m and 0.4m)

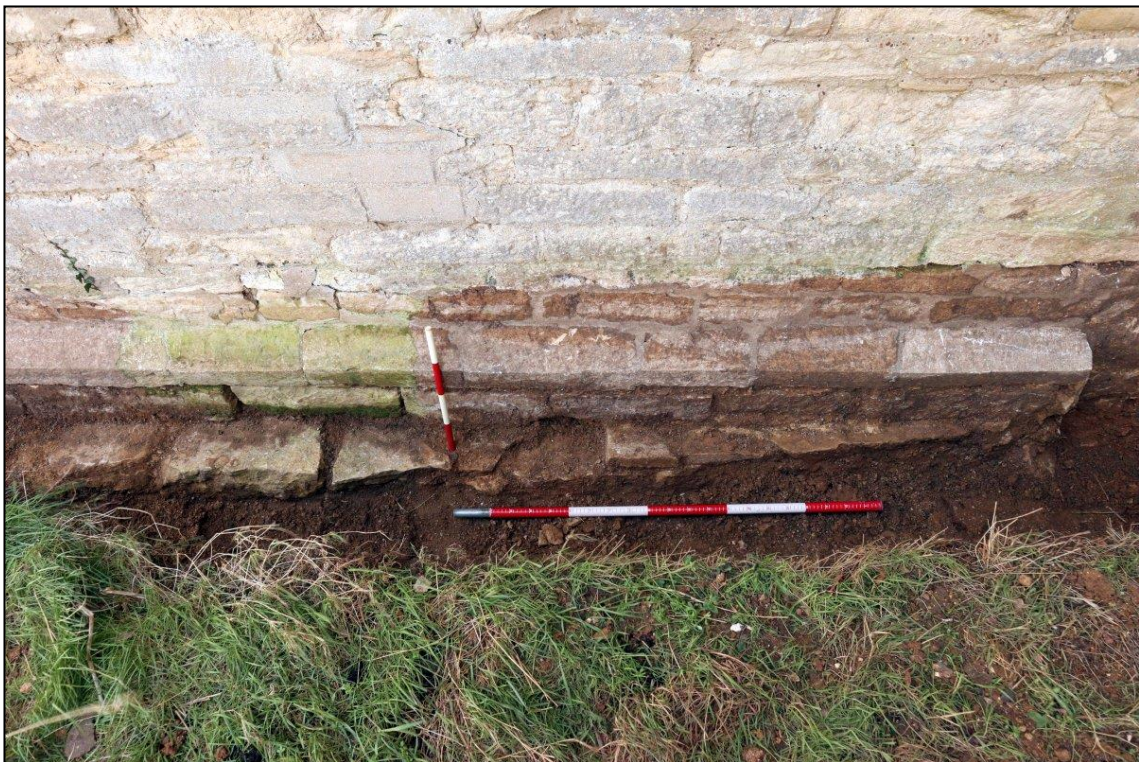
**Image 16:** Trench 1: west end of north aisle

In the west wall the foundation has an offset up to 240mm wide and is made of blocks up to 450mm long by 150mm high (Figure 7-G, Image 16). The offset in the foundation diminishes towards its south end, where it abuts the foundations of the earlier nave.

Shows foundations (106) towards south end of wall (scales 1m and 0.4m)

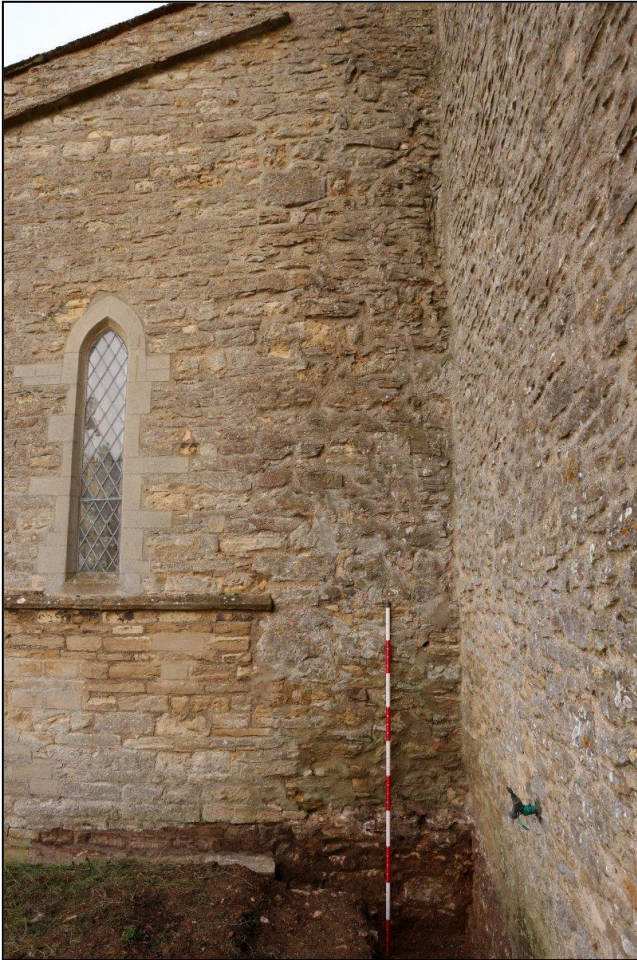
**Image 17:** West end of north aisle and nave

Shows vertical join where north-west corner of nave is abutted by the west end of the north aisle (scale 2m)

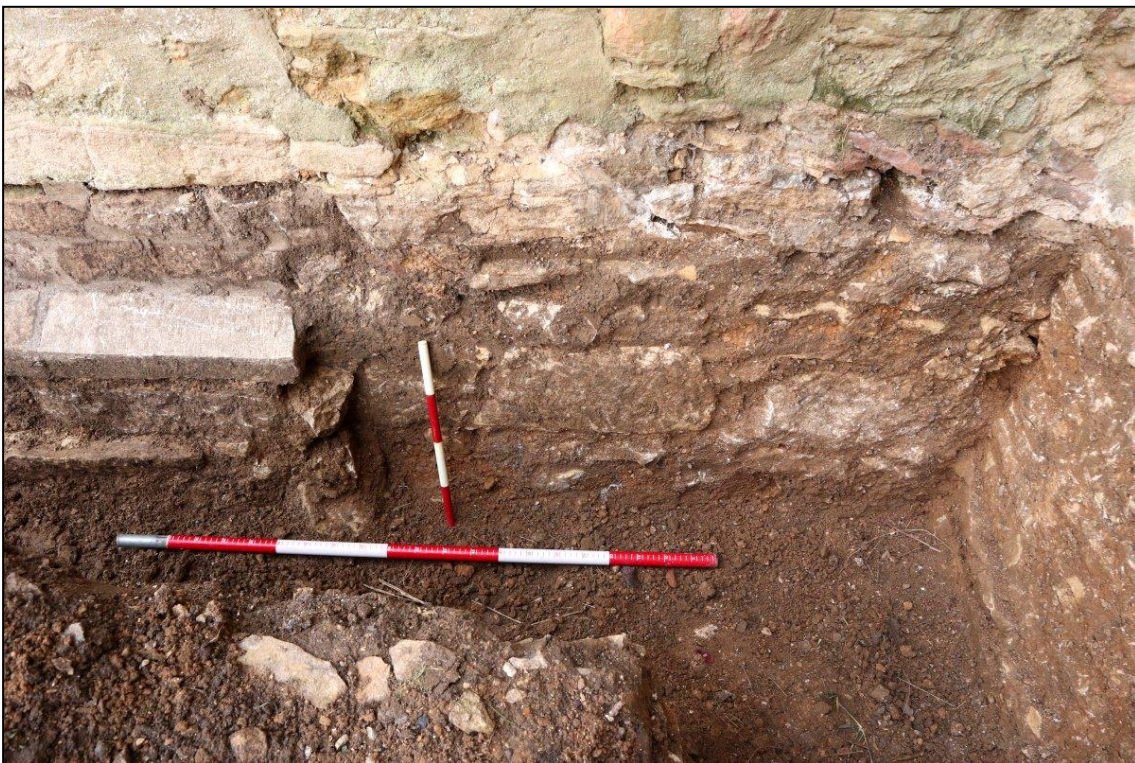
**Image 18:** Trench 1: west end of north aisle and nave

The foundation exposed in the trench was flush with the wall above, having no offset (Figure 8-H; Images 18 and 19). The lower *c.*100mm of the foundation consists of three courses of small, thin rubble. Above this is a course of larger roughly squared blocks up to 400mm long by 180mm high. Where the foundations of the nave meet those of the tower (Image 19) there is a clear difference in the character of the masonry, indicating that they belong to different construction phases. At the junction itself the sequential relationship between the two was unclear. The nave side was fairly poorly defined with soil between the stones. At the point where two walls meet there was a small void.

Shows foundations at junction of north aisle (at left) and north-west corner of nave (scales 1m and 0.4m)

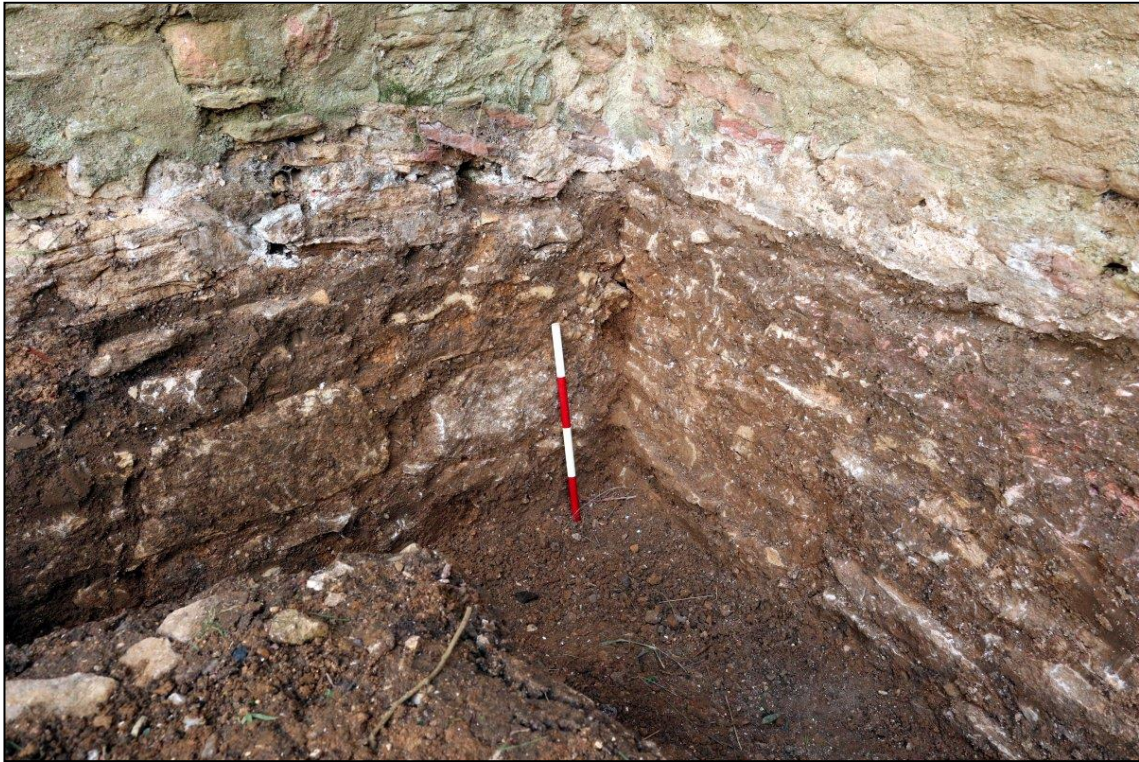
**Image 19:** Trench 1: junction of nave and tower

Shows foundations of north-west corner of nave (107) (left) and the north side of the tower (108) (right) (scale 0.4m)

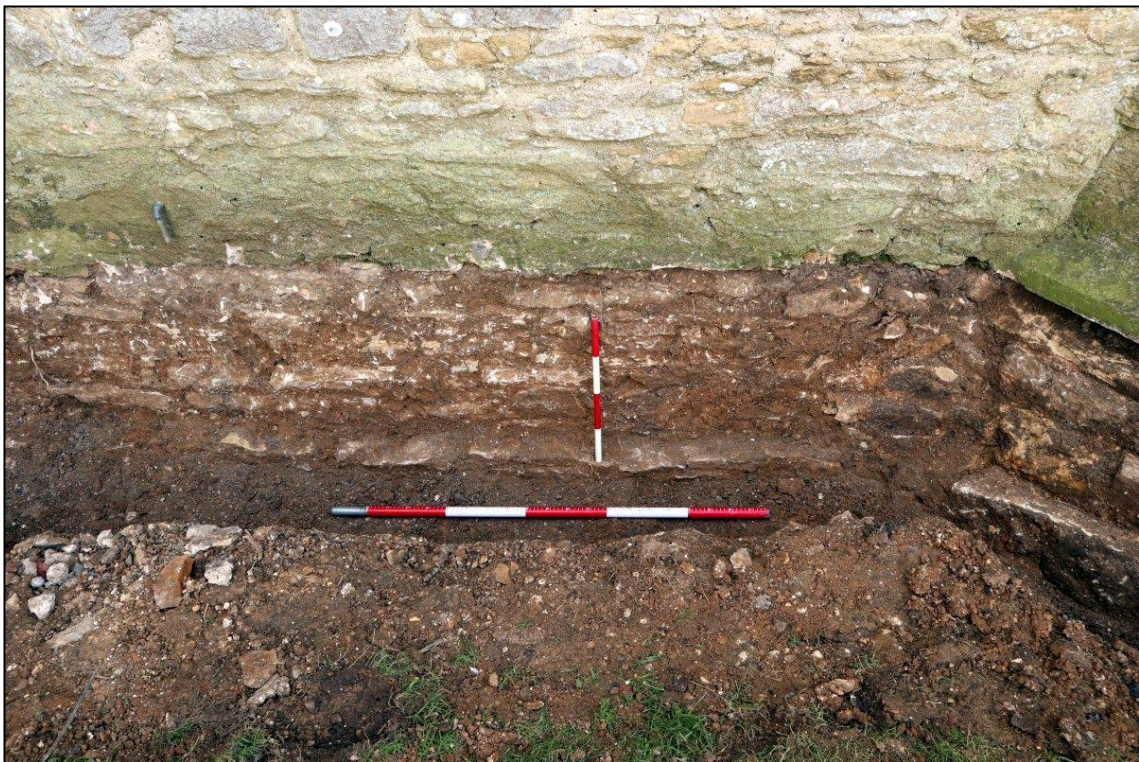
**Image 20:** Trench 1: north side of tower

The foundation (108) is constructed in coursed rubble masonry made from thin slabs with an offset of up to 120mm wide (Figure 8-I; Images 19 and 20).

Shows foundations (108) on north wall of tower (scales 1m and 0.4m)

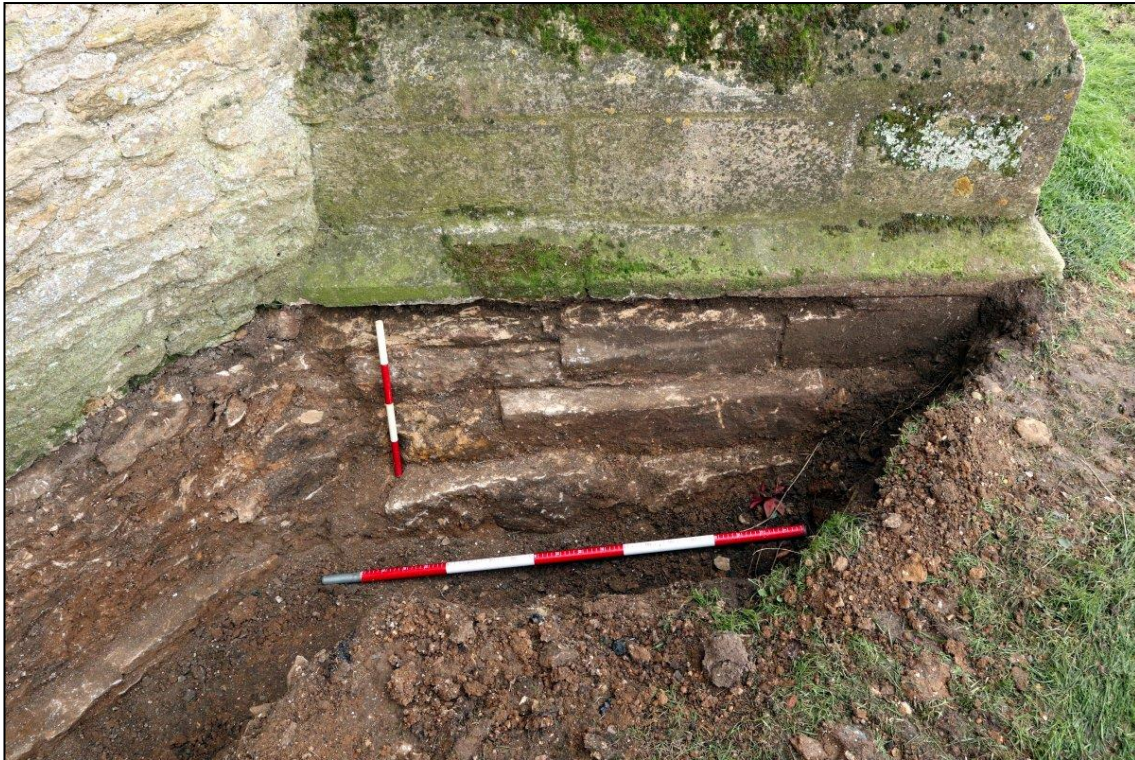
The tower has large diagonal buttresses at the north-west and south-west corners, added during the 15th century. In Trench 1 the foundations (109) of the north-west buttress were partly uncovered (Figure 8-J; Images 21 and 22). The foundation is stepped with two courses of stone, each projecting *c.*70mm. It is formed from large, roughly finished rectangular stones, measuring between 500mm and 700mm long and up to 180mm high. The masonry in the buttress

**Image 21:** Trench 1: north-west corner of tower  
Showing foundations (109) on north-east side of buttress (scales 1m and 0.4m)

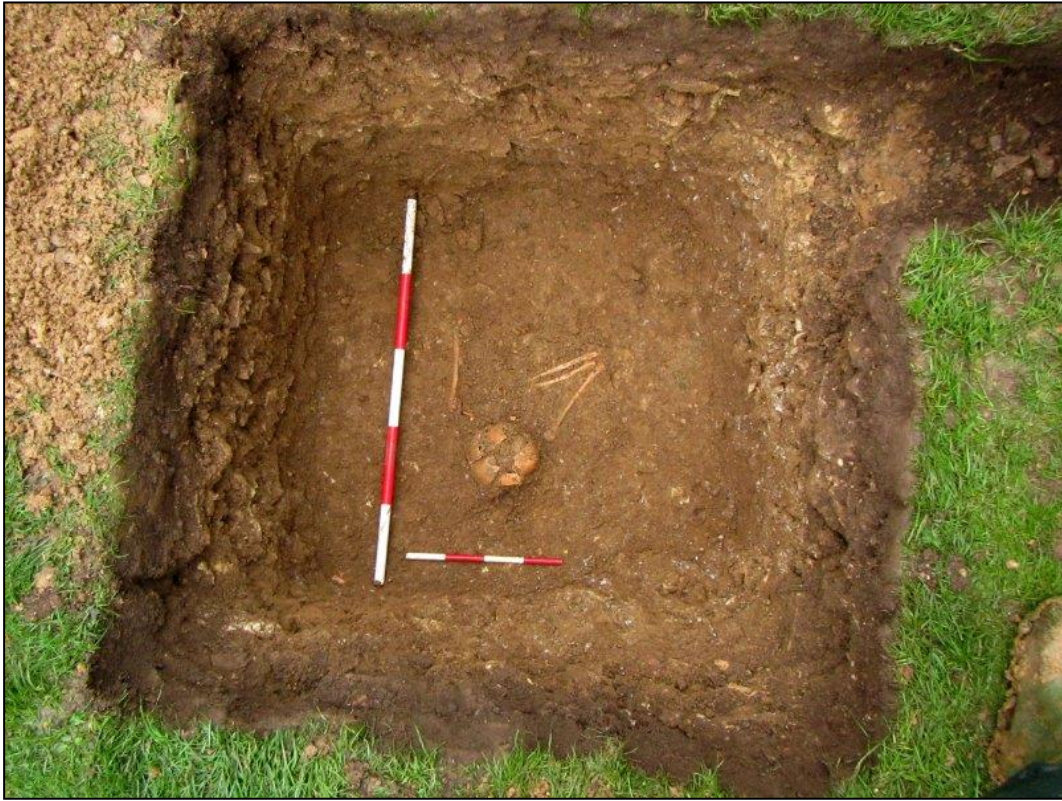
**Image 23:** Trench 2: vertical view

One definite *in-situ* burial (203) was found and evidence for another (204) was seen in the extreme north-east corner of the trench.

North-east at top, showing burial (203) (scales 1m and 0.4m)

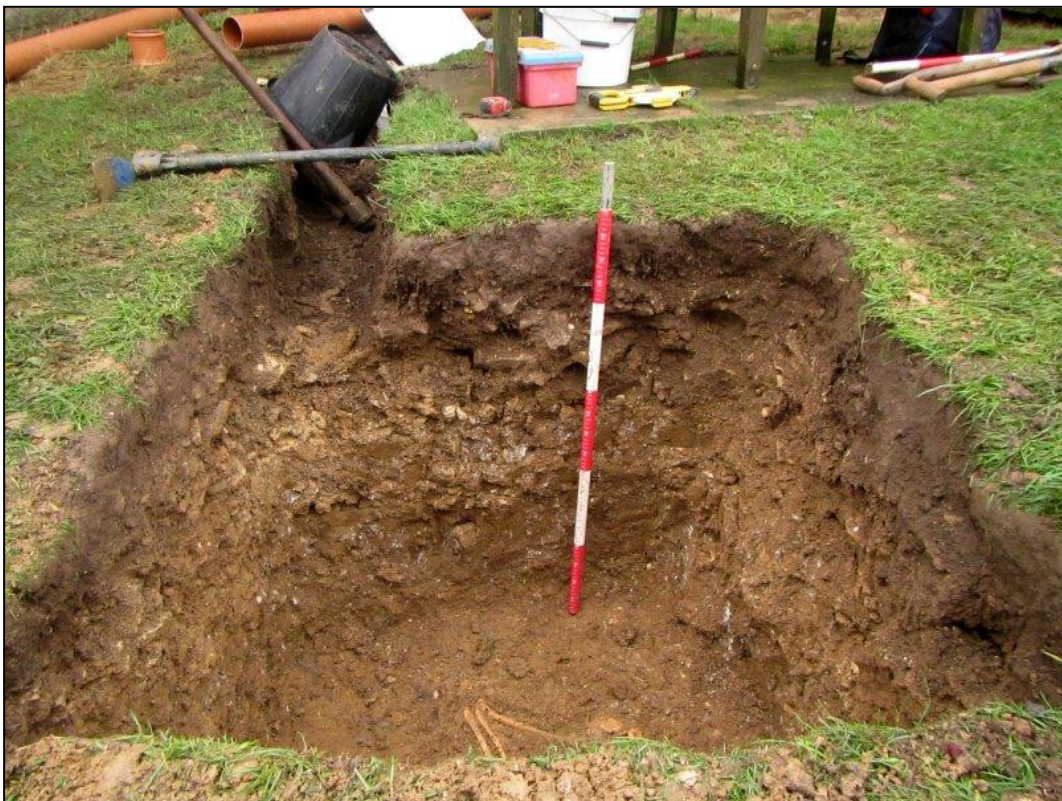
**Image 24:** Trench 2: soil profile

Looking south-east, showing soil layers (200), (201) and (202) (scale 1m)
