**ALL SAINTS' CHURCH  
SUTTON  
BEDFORDSHIRE**

**ARCHAEOLOGICAL INVESTIGATION  
AND RECORDING**

Project: SC1286

Document: 2008/86  
Version 1.0

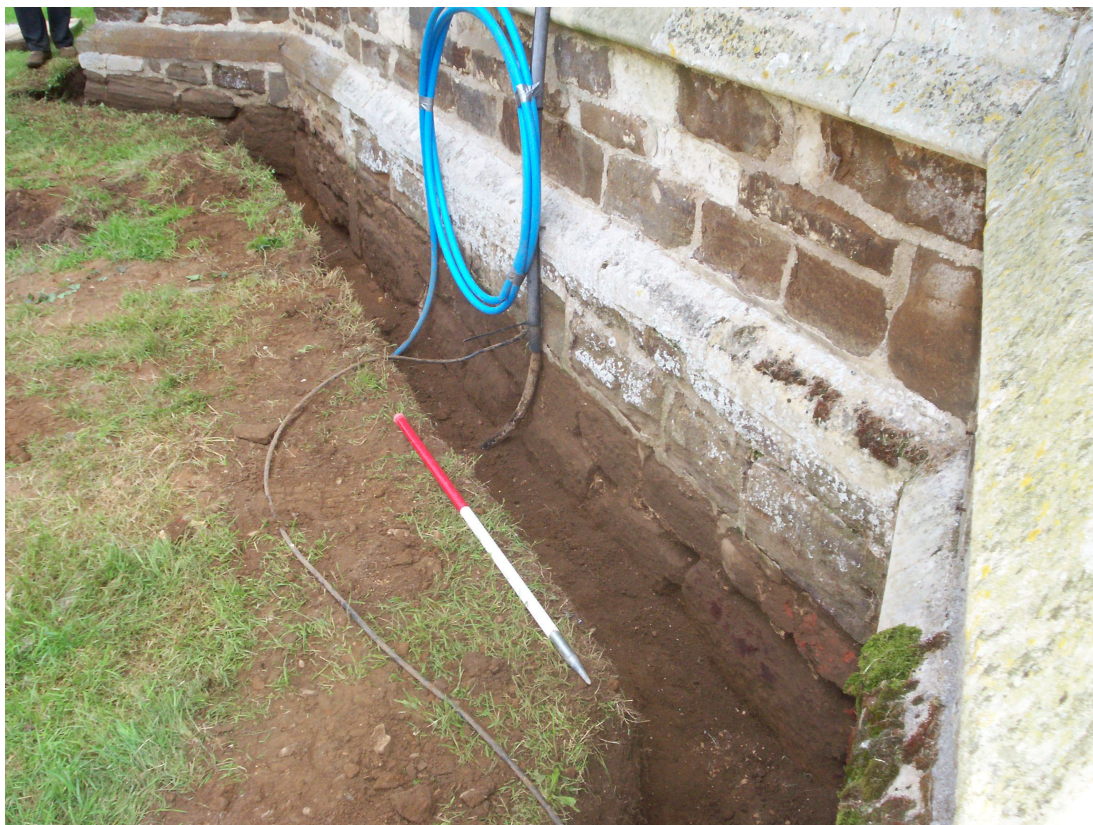
The groundworks for the installation of the French drain adjacent to the west and north wall of the tower comprised the hand excavation of a trench approximately 0.45m wide and 0.55 deep (Figure 4). The soil profile comprised *c.*0.20m of topsoil (103) which overlay brown sandy silt subsoil (104).

**Figure 4:** Excavations for French drain adjacent to west wall of tower

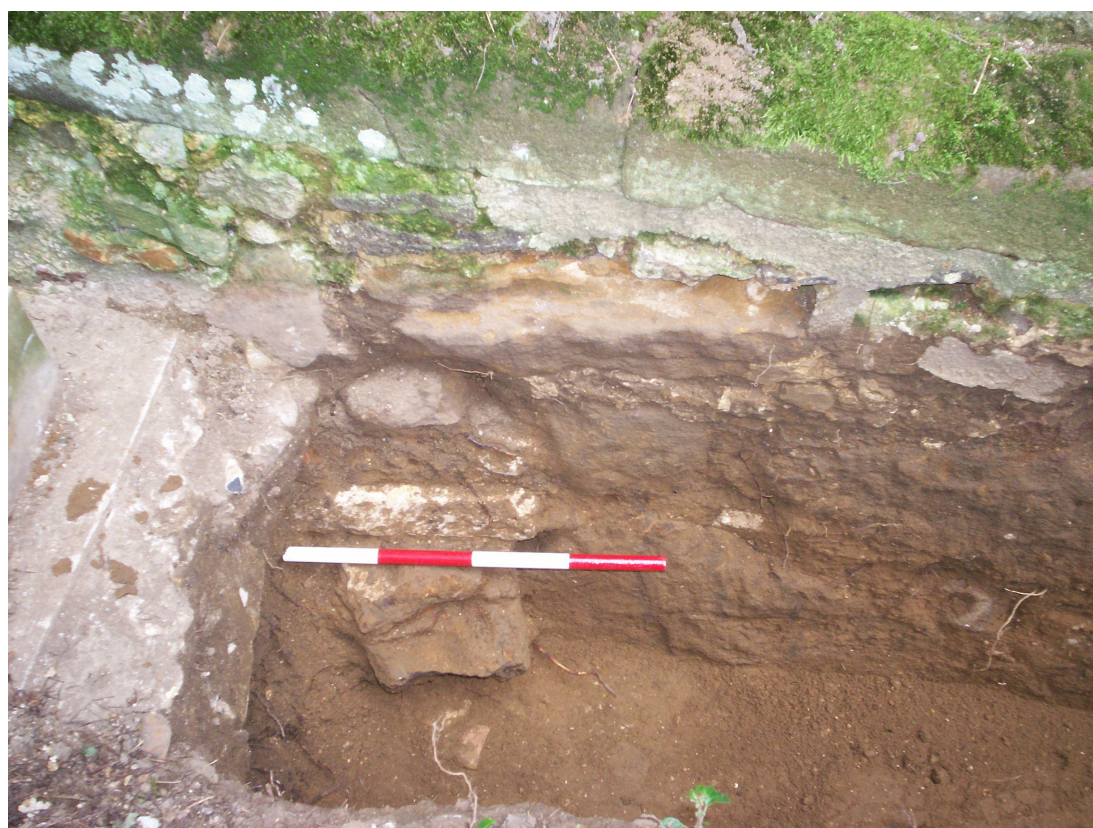
The exposed tower foundations comprised two courses of large, mainly sandstone, blocks (102) with the largest being around 0.90m long and 0.25m thick. The face of the foundation wall was patched in places with brick, mortar and cement. At the eastern end of the northern trench was an apparent cut through the foundations (106). It was roughly arched, approximately 0.23m wide and infilled with mortared pieces of stone (Figure 5).

**Figure 5:** Infilled arched opening (106).

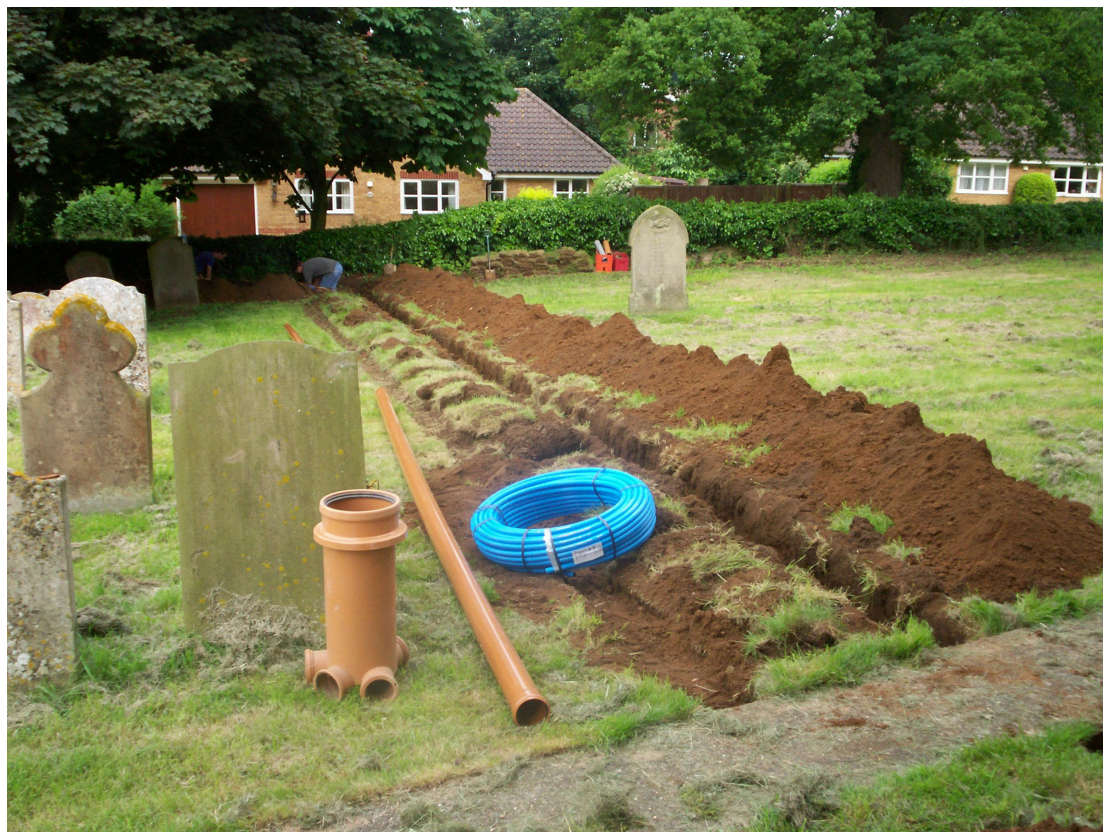
The trench for the soil pipe connecting the tower to the sewer network measured 0.45-0.60m wide and 0.55-0.60m deep (Figure 6). Topsoil (100) and subsoil (101) deposits were as described above but there was considerable root disturbance present in excavations located towards the boundary of the churchyard, in the vicinity of some mature trees.

**Figure 6:** Excavations for soil pipe viewed from the tower.

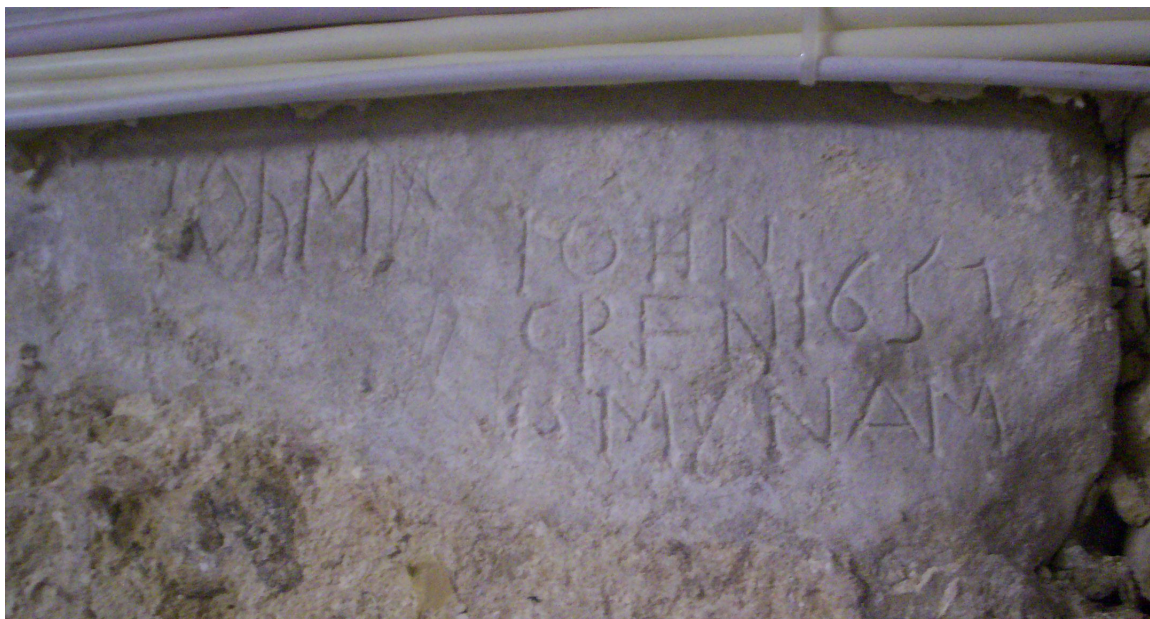
Removal of loose render and plaster from the walls of the tower revealed two roughly carved inscriptions along with some other fainter markings on the north wall (Figure 7). The clearest of the two inscriptions appears to read "JOHN GREN is MY NAM" and is dated 1657. The other main inscription comprises four principal letters or symbols, the meaning of which is not clear.

**Figure 7:** View and interpretation of carved inscriptions located in the tower
