**REDBOURN POST OFFICE
73 HIGH STREET
REDBOURN
HERTFORDSHIRE

BUILDING RECORDING**

Project: RPO1447

Document: 2008/123
Version 1.0

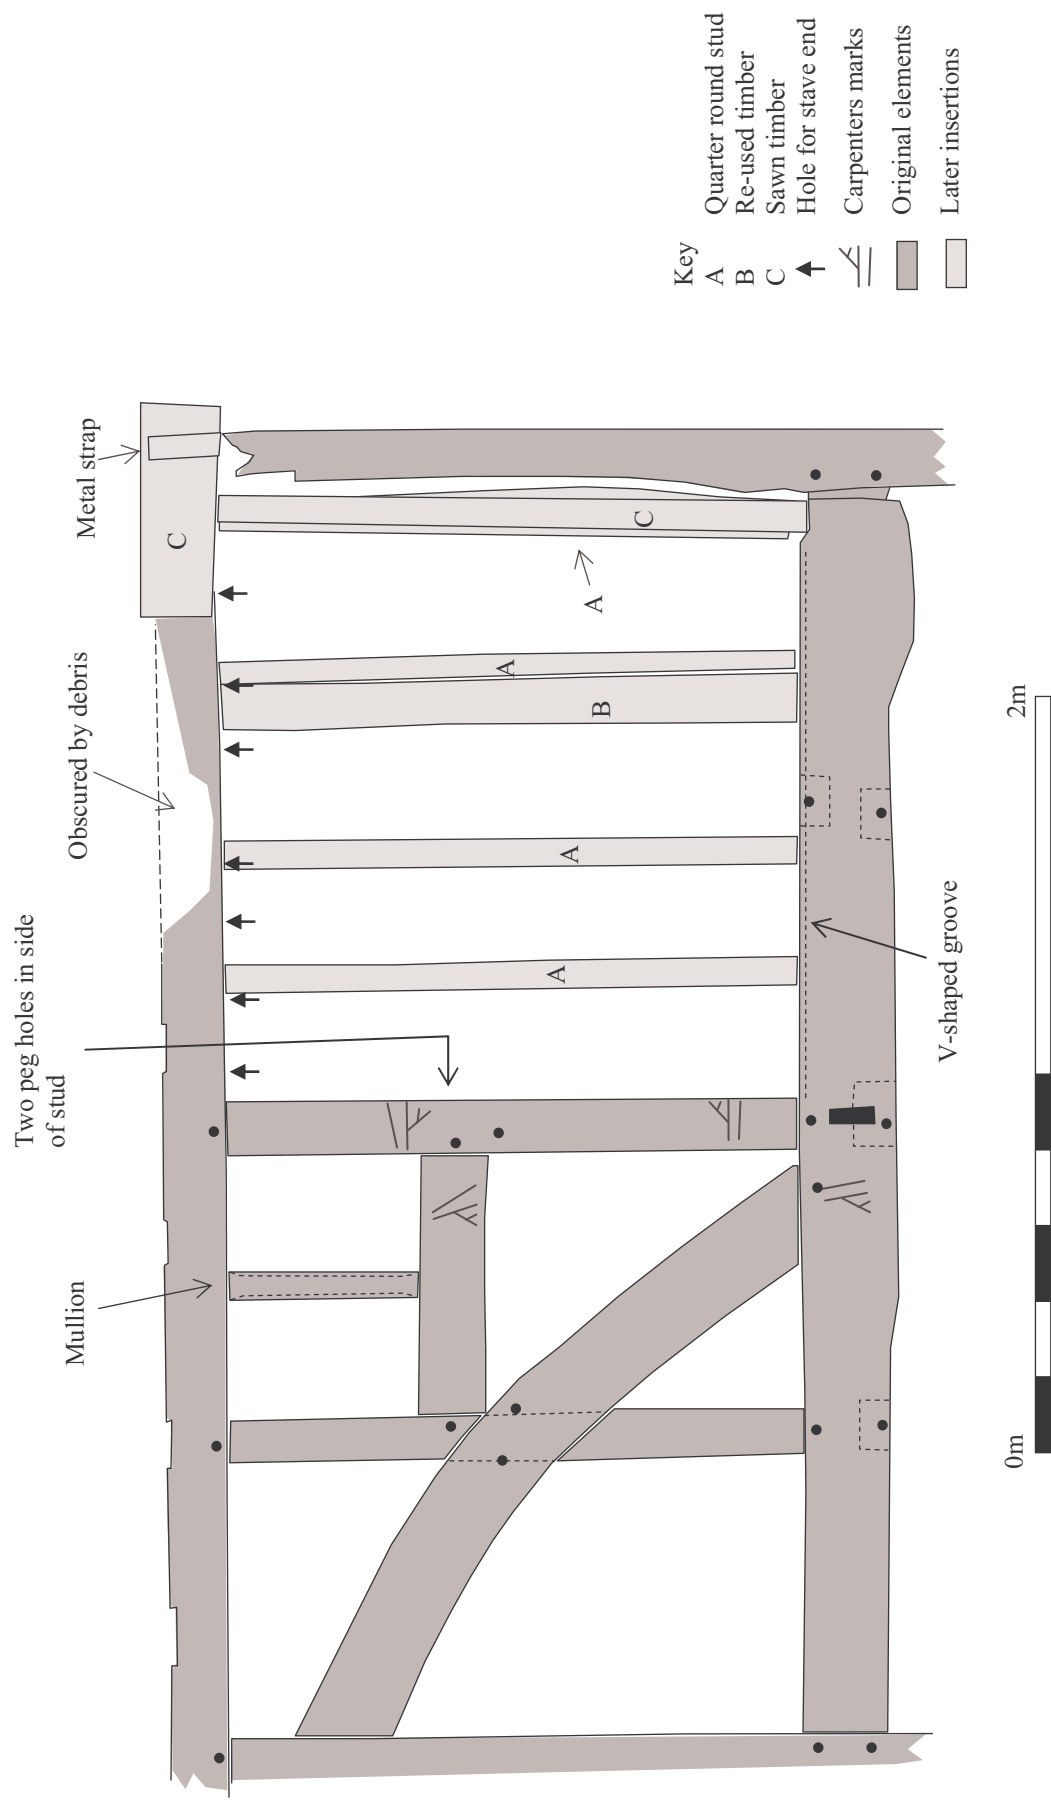
Figure 2: North-east facing elevation of timber frame

The remains were those of the outer face of a timber framed wall aligned NNW-SSE (Plate 1, Figure 2). The surviving original elements of the frame are shaded darker

grey in the figure. These consist of two posts at either end, a lower transverse timber, an upper transverse timber, two studs, a diagonal brace and framing for a window.

The lower transverse timber has a maximum cross section of 300mm by 160mm. It is morticed into the vertical posts at either end. The upper transverse timber is approximately 150mm square in section. It is morticed into the top of the southern post, whilst the relationship with the post at the northern end has been lost due to decay at this point with the junction being partially covered by a modern repair that includes a metal strap. The upper edge of the transverse timber has a series of shallow rebates to receive the lower end of rafters that slope down from the western side of the main range.

A curved down-brace joins the southern post and the lower transverse timber. This timber was only 20mm thick. At its junction with a vertical stud it was let into a shallow rebate in the stud and fixed with three nails; peg holes in the brace at this point did not appear functional, falling either side of the stud behind. There were two vertical studs and mortice holes indicate the presence of a third stud, forming a symmetrical arrangement. The central stud was 140mm by 100mm in cross section. A short rail morticed into the studs at either end formed the sill for a window opening. A mullion in the centre of the window was 70mm wide with chamfered edges. Incised carpenters marks survive where the central stud joins the window sill and the lower transverse timber.

The panels in the southern half of the frame retained a combination of lath and plaster and wattle and daub infilling. The wattle and daub survived only in the panel beneath the window. In the northern half of the frame there was evidence for the structure that would have supported the infill. There are holes in the underside of the upper timber and a V-section slot in the lower timber to take the ends of vertical staves that would support wattle and daub infill.

Later modifications consist of inserted timbers for structural support at the northern end of the frame and studding to support a lath and plaster covering on the opposite (western) side of the wall. The studding consists of four quarter-round uprights. The structural supports include a piece of re-used timber (B) with waney edges that was not morticed into the frame. This appears to be a replacement for the missing original stud. Modern sawn timber (C) and metal strapping has been used to support the northernmost end of the frame where the junction between the vertical post and the upper transverse timber has rotted away.

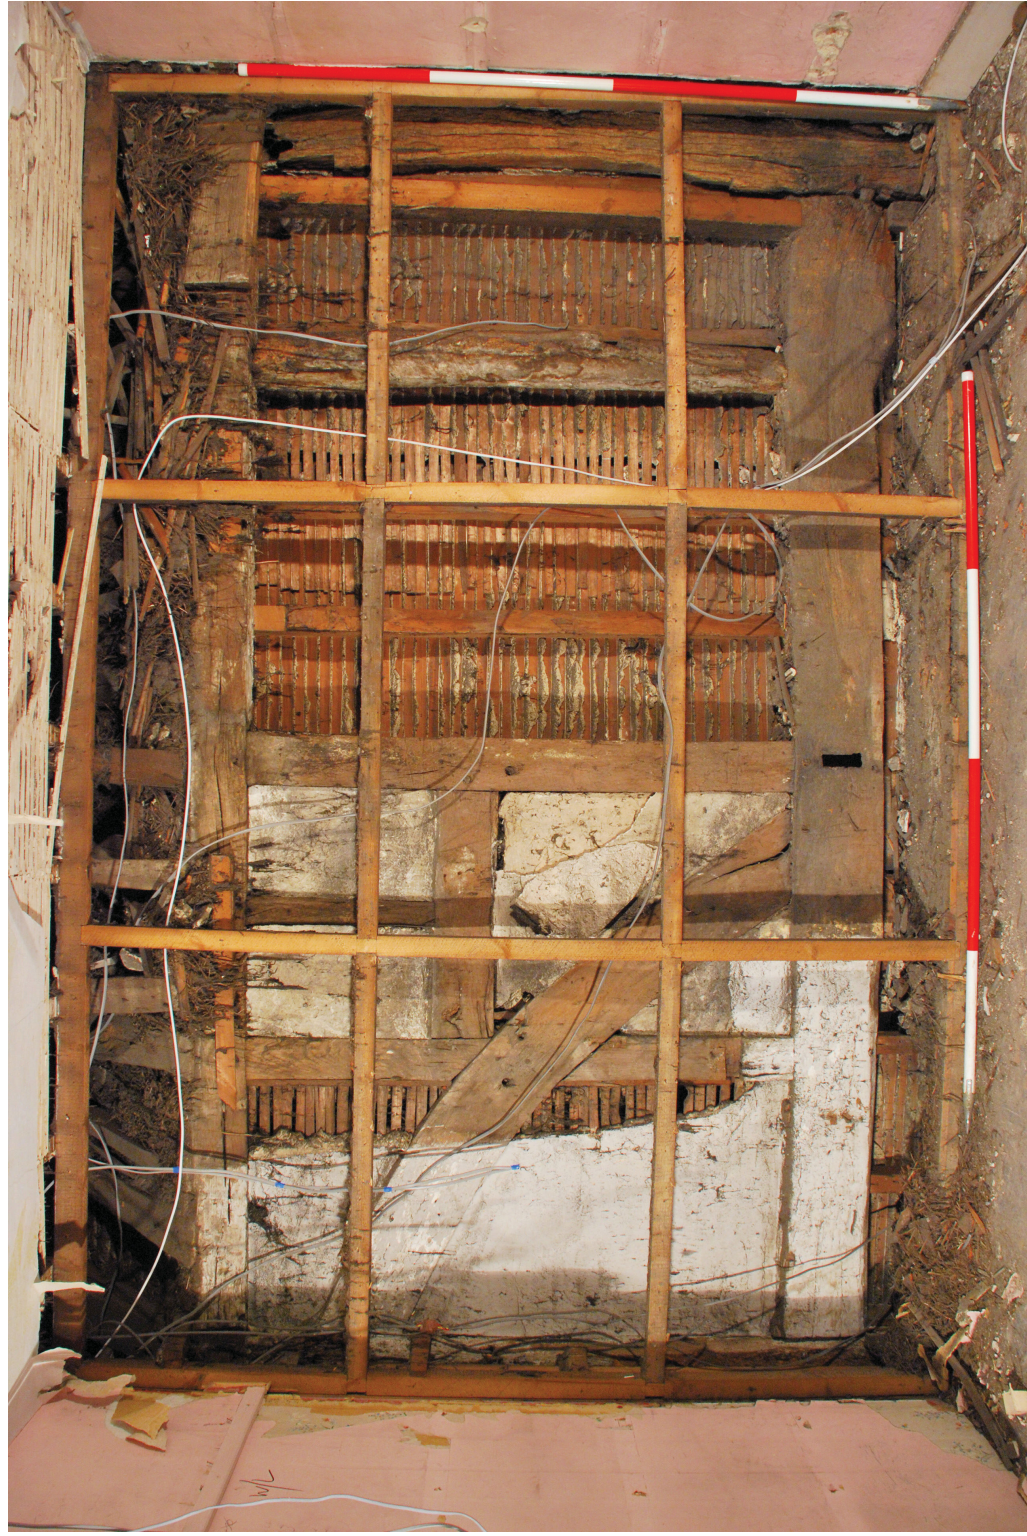
Plate 1: Timber frame

The presence of the blocked window demonstrates that this timber framing formed part of an outer wall. The components of the frame are joined to form a flush face on its eastern side which is therefore the outside face of the wall. It represents the rear wall of the main range along the street frontage. The upper transverse timber of the frame is a wall plate supporting the rafters of the main range. The relationship of this wall to the northern cross wing shows that it predates the construction of the cross wing.
