**ST PAUL'S CHURCH  
ST PAUL'S SQUARE  
BEDFORD**

**ARCHAEOLOGICAL OBSERVATION  
AND INVESTIGATION**

Document:2009/61

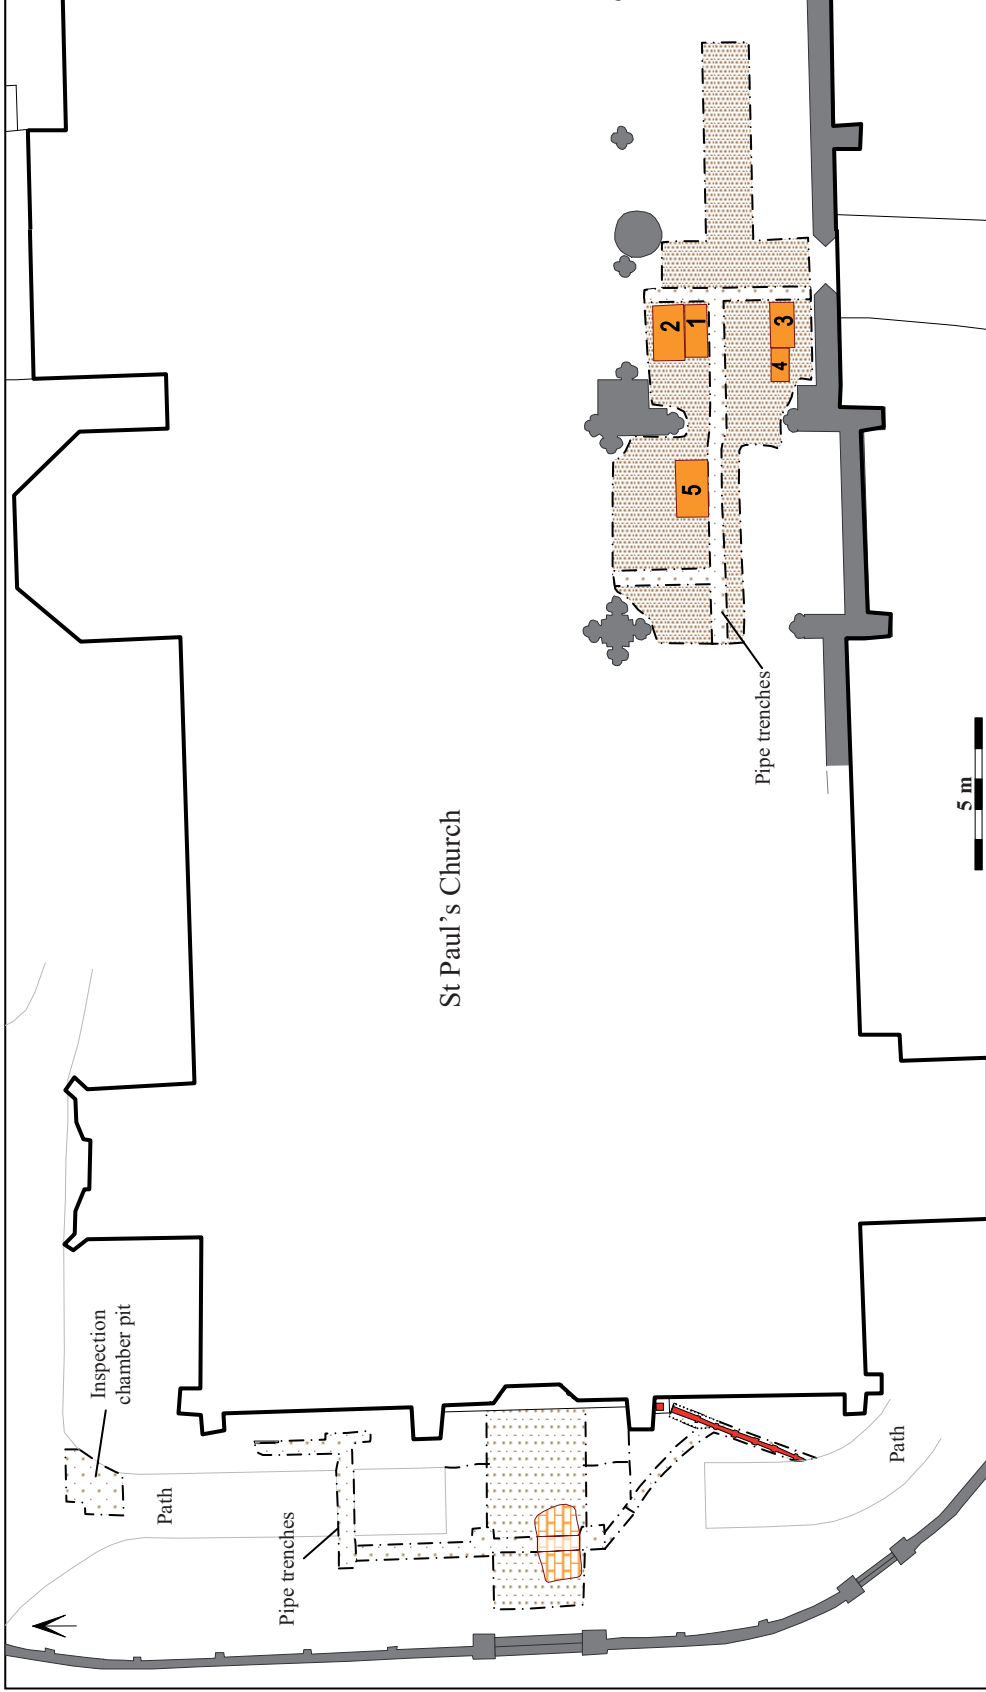
**Figure 2:** Plan of works

The building works took place in two locations (Figure 2). Within the church, in the area of the Trinity Chapel, repair of around 67m<sup>2</sup> of flooring was carried out. This involved the relocation of five memorial stones and the replacement and/or repair of existing Victorian tiles (Photographs 1-3). Outside the church at the west end, the works comprised the removal of paving slabs, limited ground level reduction and excavation of trenches for the rerouting of drainage pipes and the installation of a level access between the churchyard gate and west door.

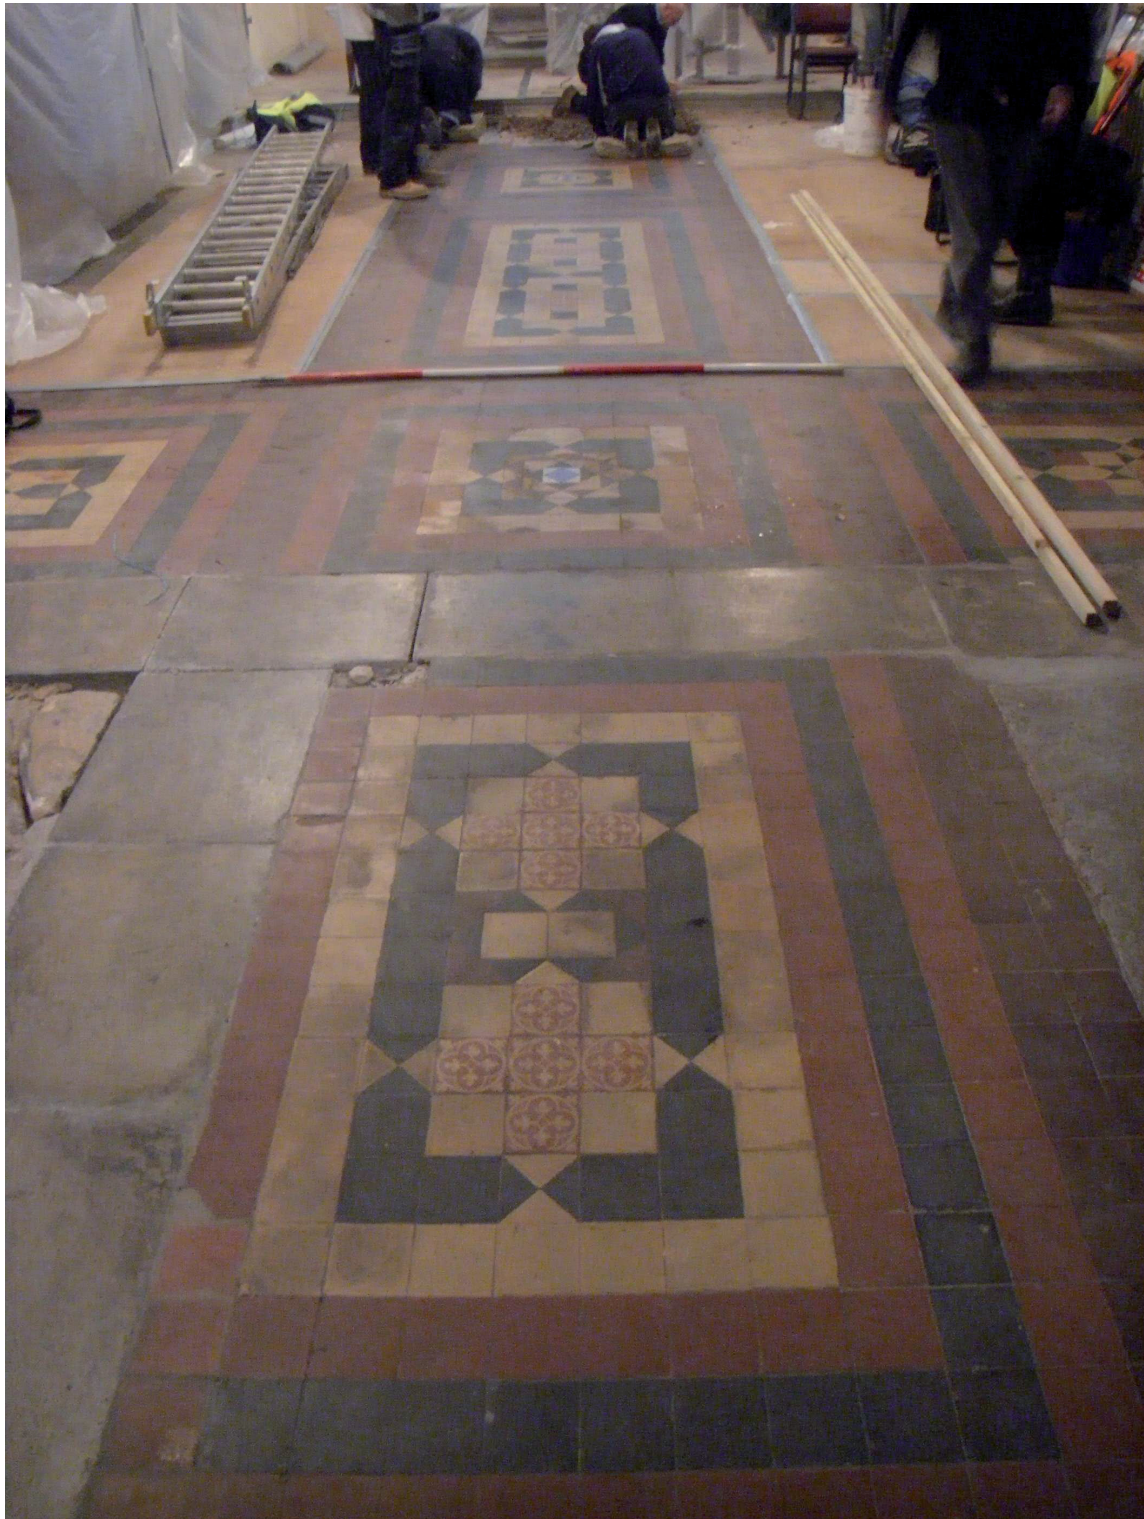
1. Trinity Chapel: Tiling prior to removal

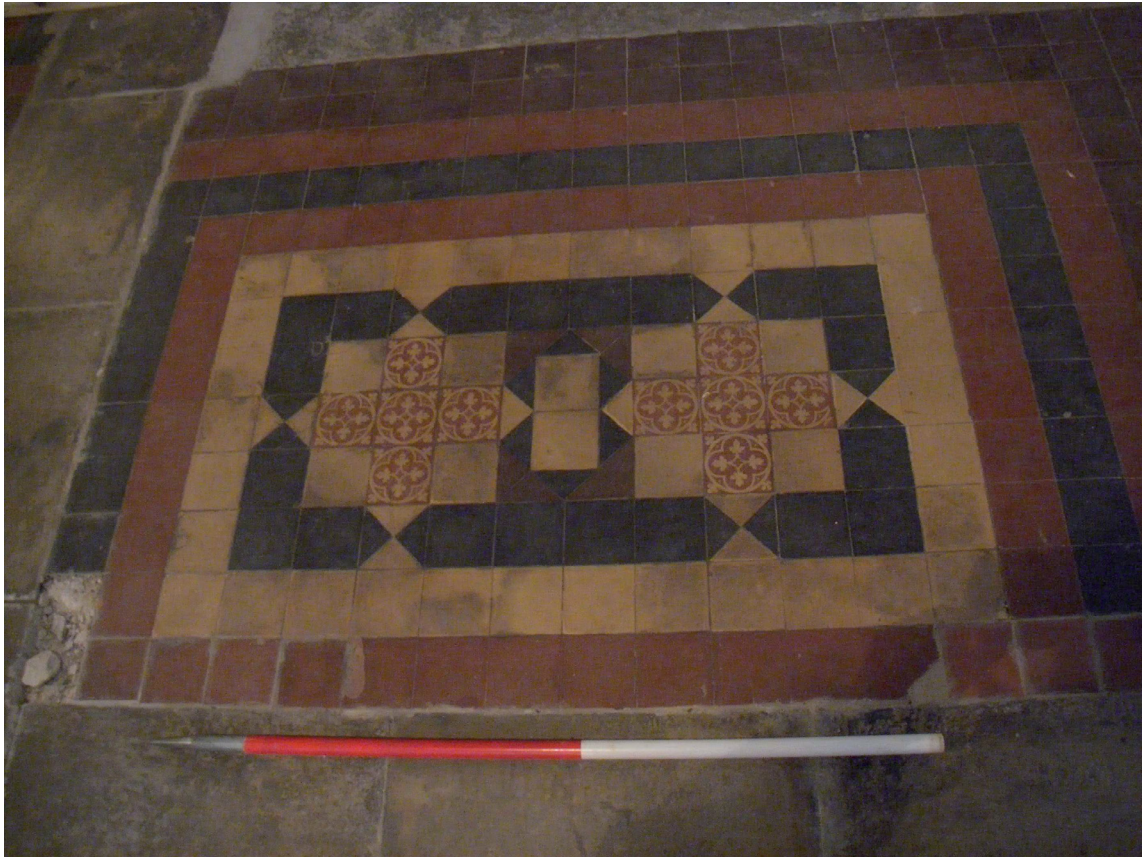
2. Trinity Chapel: Tiling detail

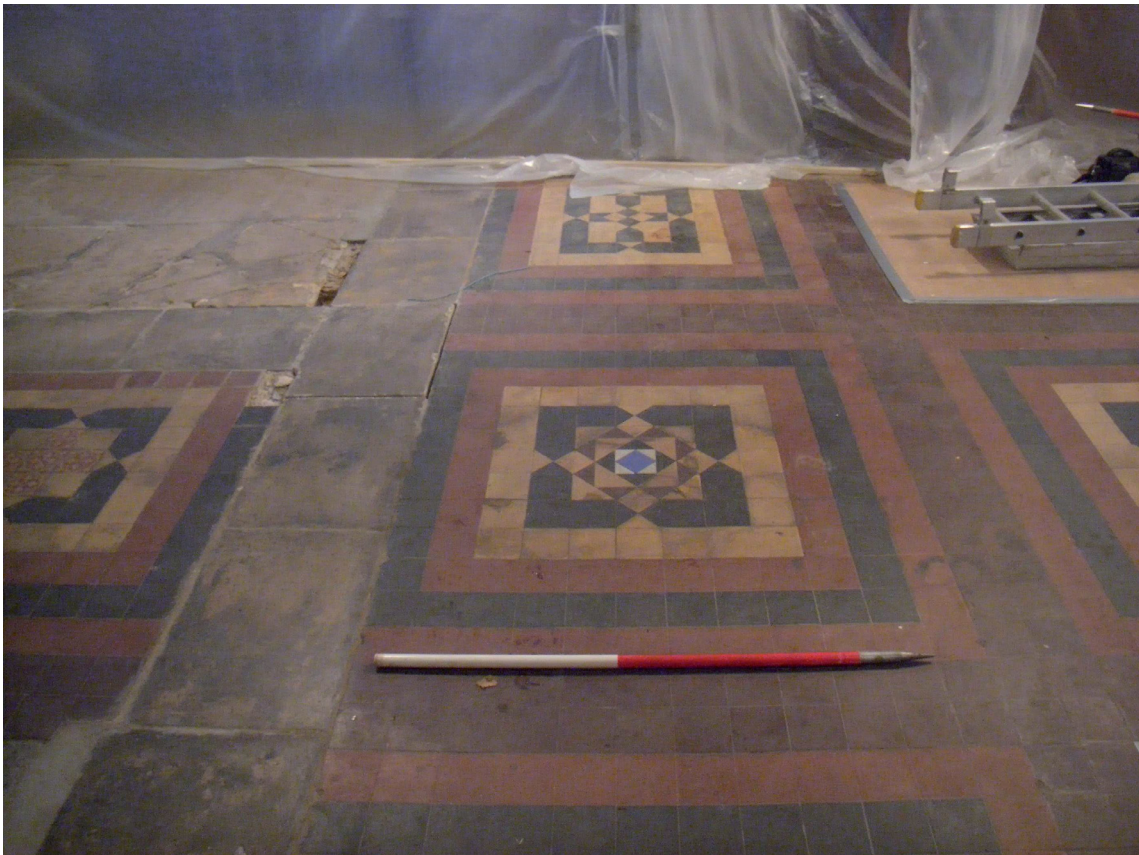
3. Trinity Chapel: Tiling prior to removal

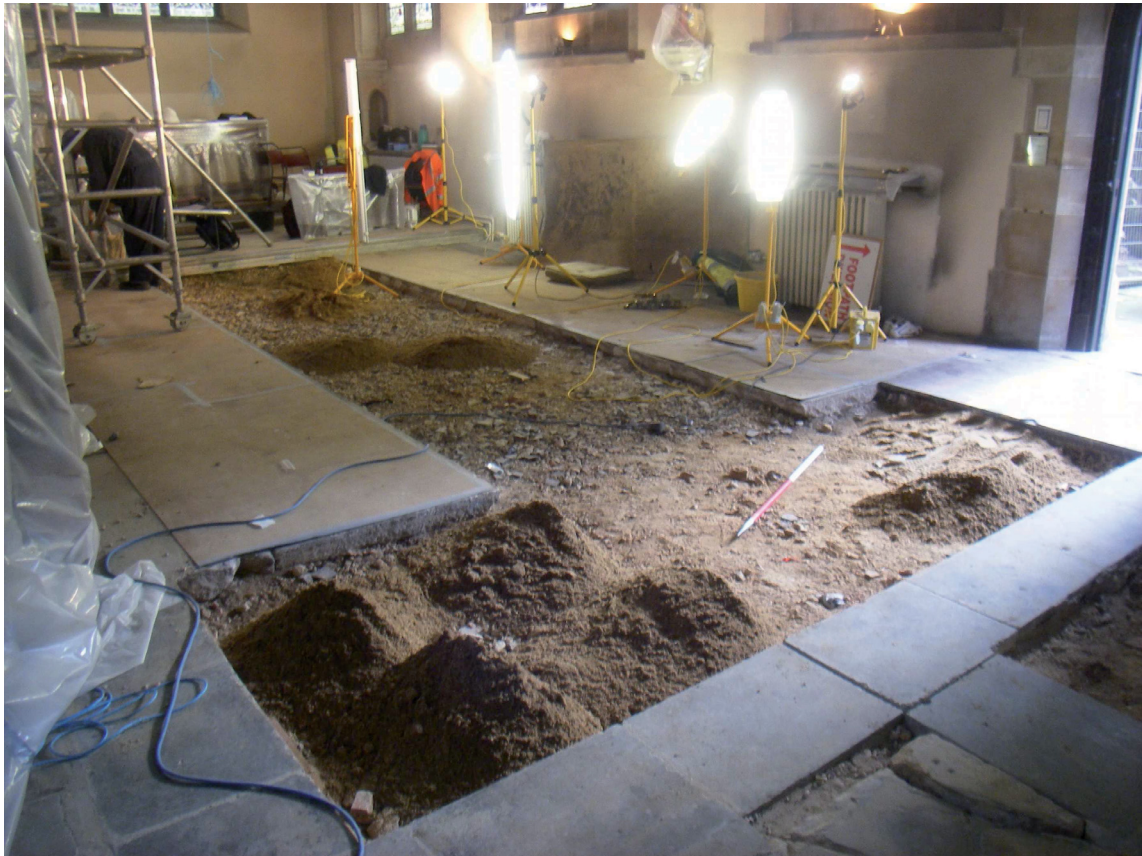
Floor tiles and rubble levelling material was removed to a depth of around 0.20m below the original floor level (Photograph 4). Below this, a layer of mid grey brown sandy silt with occasional inclusions of post-medieval mortar, brick and glass was revealed. A series of modern brick-lined trenches for pipes were found beneath the floor tiles. No archaeological features or structures of interest were revealed during this work.

4. Trinity Chapel: Tiling removed

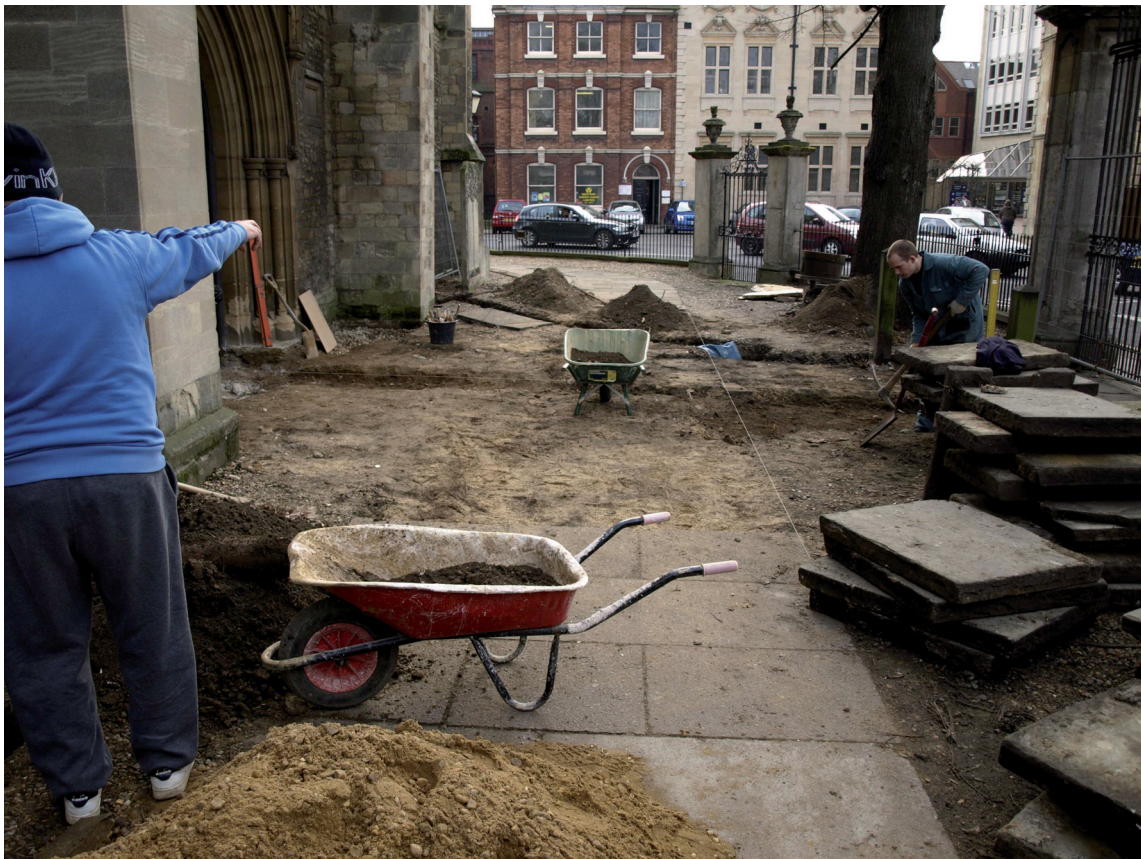
Removal of paving slabs in the vicinity of the west entrance revealed a crushed stone levelling layer over grey brown sandy silt deposits (Photograph 5). The reduction of the ground level in this area by *c.*0.10m revealed a truncated, uneven and undulating portion of brick pavement measuring 2.5m long and 1.35m wide (Photographs 6 and 7). The pavement was located between the west door and churchyard gate and comprised modern (post-1750) red/orange brick.

5. West End: Removal of paving slabs

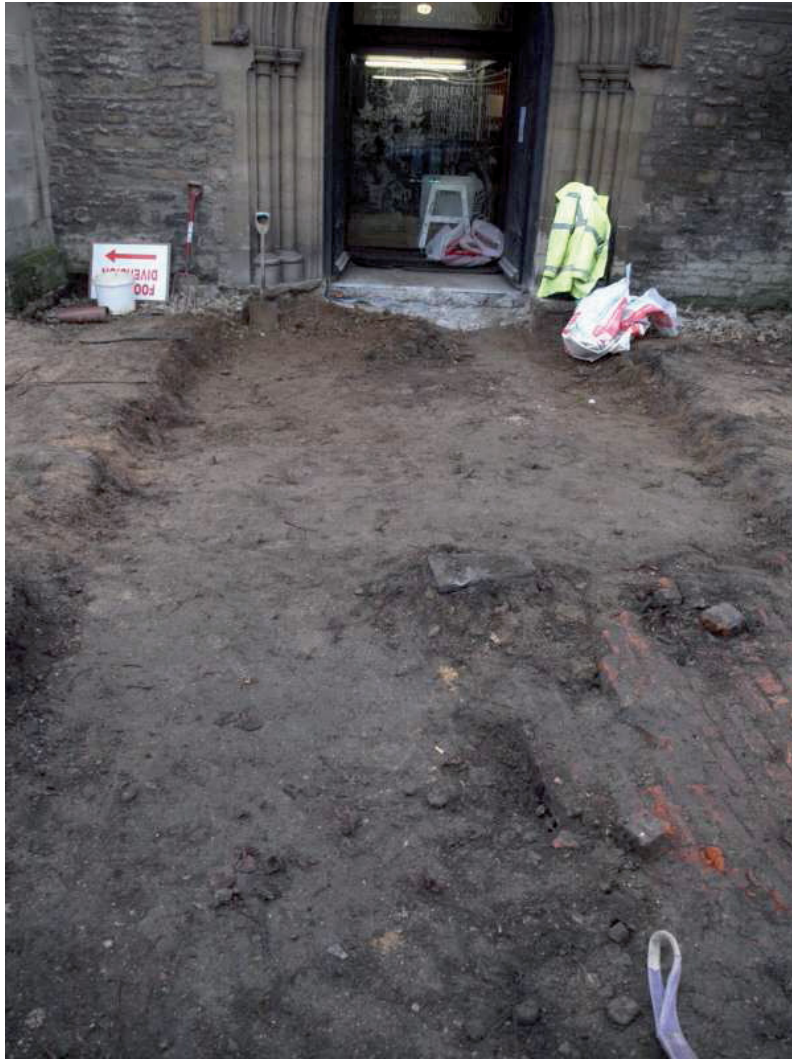
6. West End: Ground reduction in front of west door

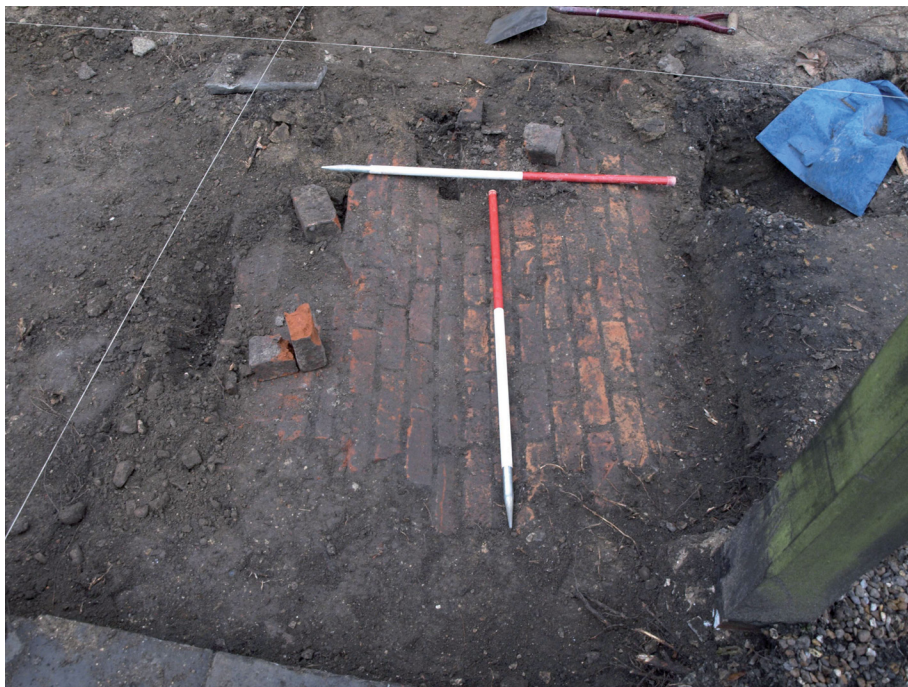
The groundworks associated with the internal church renovations revealed no deposits or features of architectural or archaeological interest. Outside the west entrance, excavations for drainage pipes and the installation of a level access identified a disturbed topsoil deposit in excess of 0.75m deep and a small portion of brick pavement of possible Victorian date. This portion of pavement probably represents the remains of an earlier paved route between the churchyard gate and west door.

7. West End: Remains of brick pavement

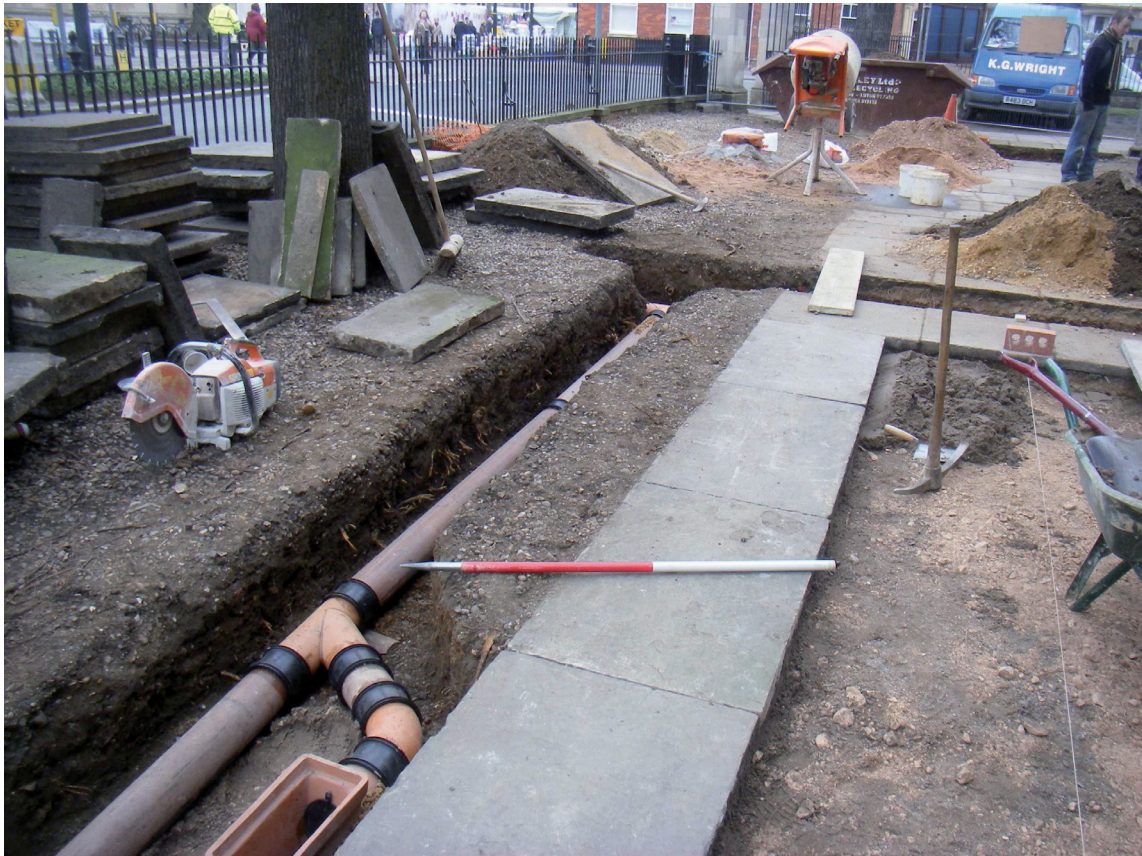
The pipe trenches ranged from 0.4m to 0.5m deep and 0.35m to 0.5m wide and had a combined length of 26m (Photograph 8). A pit for the installation an inspection chamber was also excavated at the north-west corner of the church (Photograph 9). It measured 2.2m long, 1.8m wide and 0.75m deep.

The pipe trenches and inspection chamber pit were cut through the extant gravel surface and a deep topsoil deposit of mid grey brown sandy silt containing fragments of post-medieval clay pipe, roof tile, brick and occasional fragments of possible human bone. This disturbed deposit was the same as that revealed beneath the paving stones and crushed stone in the vicinity of the west door. In the inspection chamber excavation the deposit continued beyond its maximum depth of 0.75m.

8. West End: Excavated drain trenches

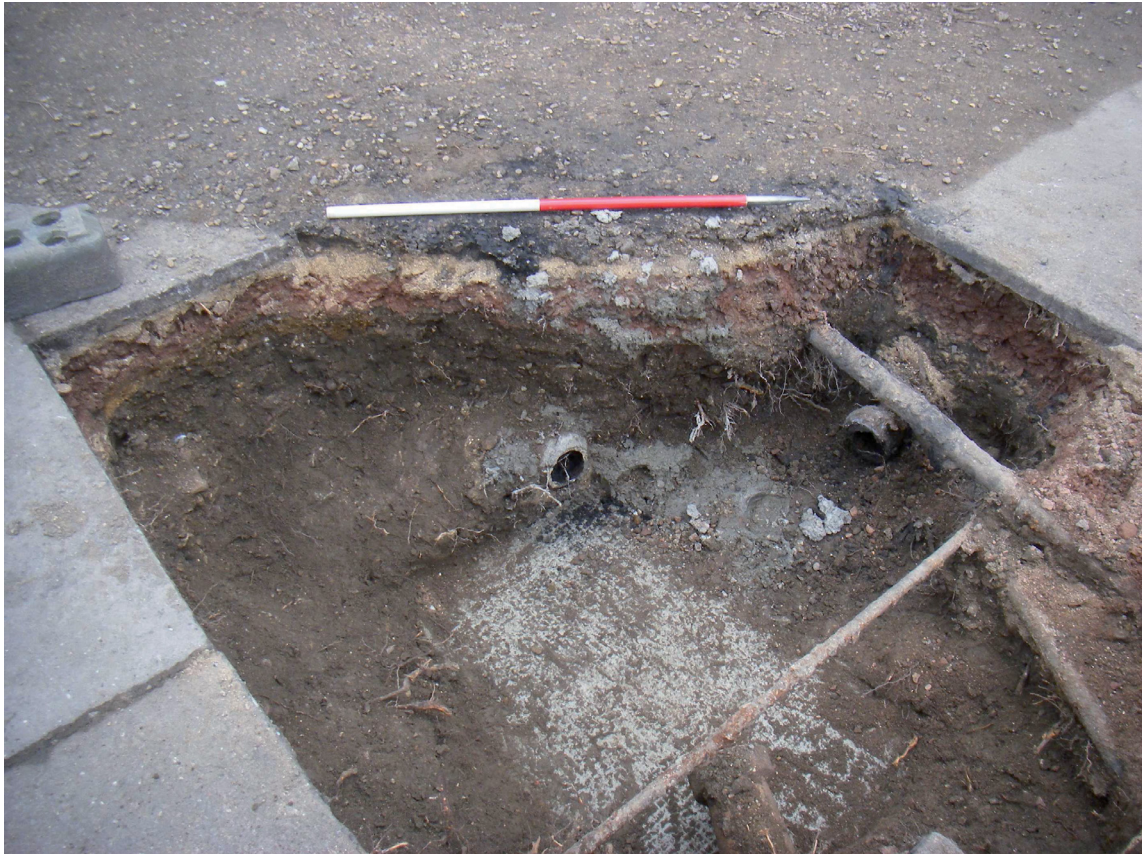
No features or structures of interest were revealed in the pipe or inspection chamber excavations at the west end of the church.

9. West End: Excavation for inspection chamber
