**CHURCH OF ALL SAINTS, RENHOLD,
BEDFORDSHIRE**

**A PROGRAMME OF ARCHAEOLOGICAL
OBSERVATION, INVESTIGATION, RECORDING
ANALYSIS AND PUBLICATION**

Project: ASR1189

Document: 2006/89

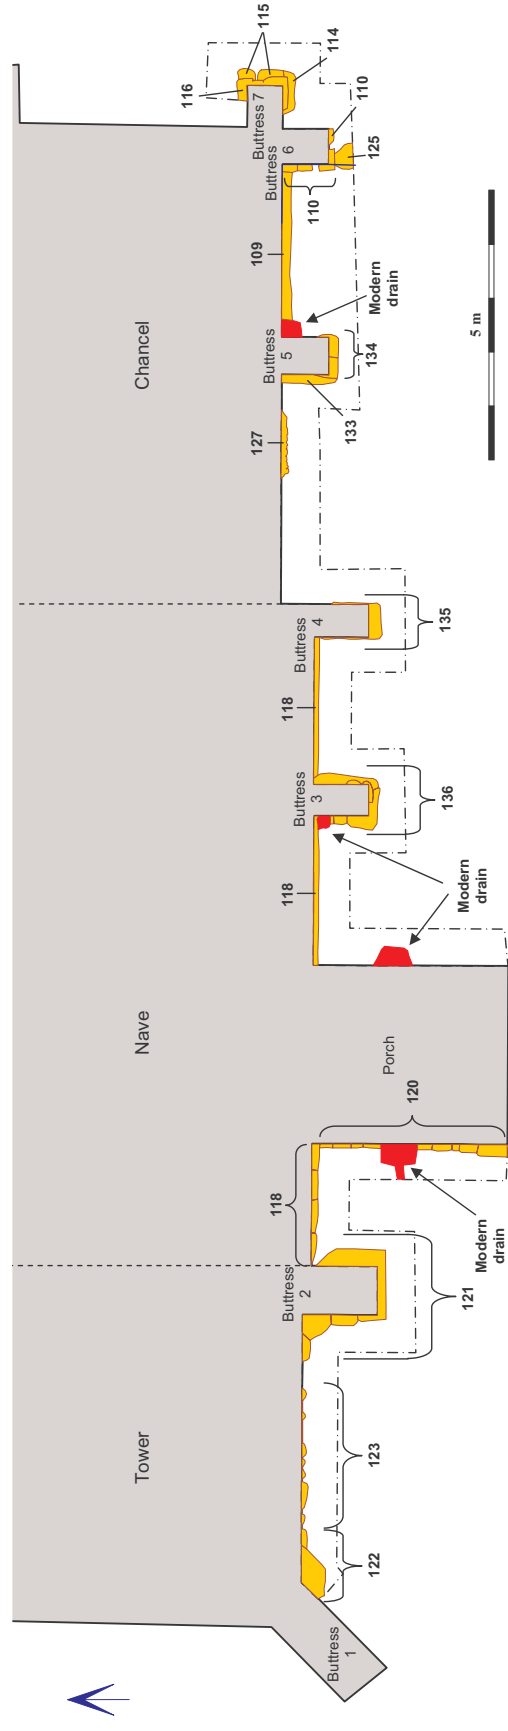
Figure 2: Plan of trench on south side of the church

The works carried out by the contractors (Hibbitt & Sons Masonry) consisted of the insertion of French drains along the south side and south-east corner of the church. This entailed the excavation of trenches approximately 700mm wide and up to 680mm deep along the base of the walls. Test excavation showed the wall to be in need of consolidation. To achieve this, the wall was refaced below ground.

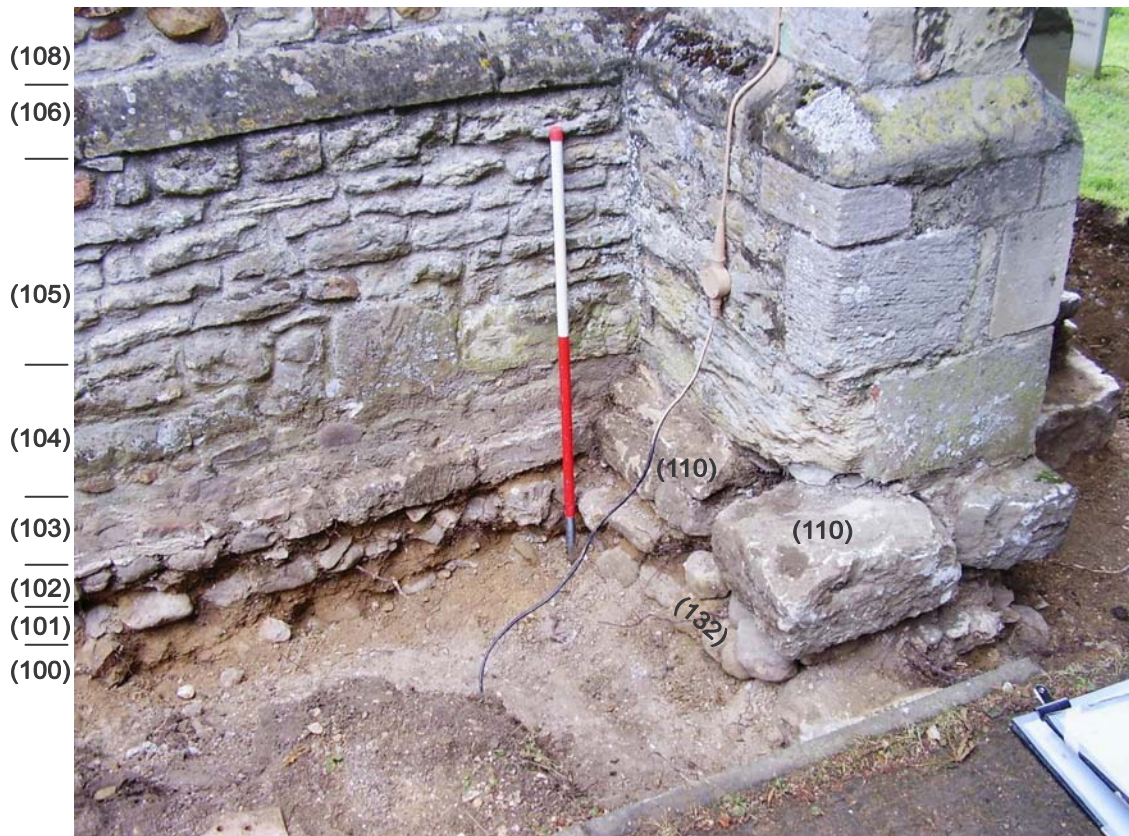
At foundation level, the chancel wall was constructed of rounded, mainly reddish brown pebbles that formed two distinct horizontal bands (Figure 2, Plate 1). The lower band (100) consisted of pebbles, up to c.120mm in size, with occasional rough-faced flints, up to 70mm in size. The stones were very roughly coursed in a loose, broken down, sandy mortar, which formed c. 40% of this part of the foundation. The upper band (101) consisted of larger pebbles, up to 170mm long, roughly coursed in a firmer, sandy mortar which was in better condition.

Above the foundations, a string course of limestone blocks (102) jugged out by 20mm below the chancel wall, forming a plinth that capped the foundations and formed a level surface for the wall construction.

Above the plinth, the chancel wall appeared to have been cut back and refaced with red brown pebbles, up to 90mm in size (103) and limestone blocks squared and built to courses (104) / (105), rising by 0.86m to a chamfered string course (106). This change was probably part of the work carried out in the 15th century.

Above the string course (106), the wall was constructed of rounded red brown pebbles up to 140mm in size (108) with some later repairs in limestone blocks. The pebble facing (108) is probably the original chancel wall and thus pre-dates the 15th-century works. The chancel wall courses exhibited some re-pointing since the 19th-century restoration with mid buff yellow to grey, hard sandy mortars.

Plate 1: Chancel foundation courses (100), (101), foundation plinth (102) and wall (103), (104), (105), (106), (108), and Buttress 6. Scale 1m

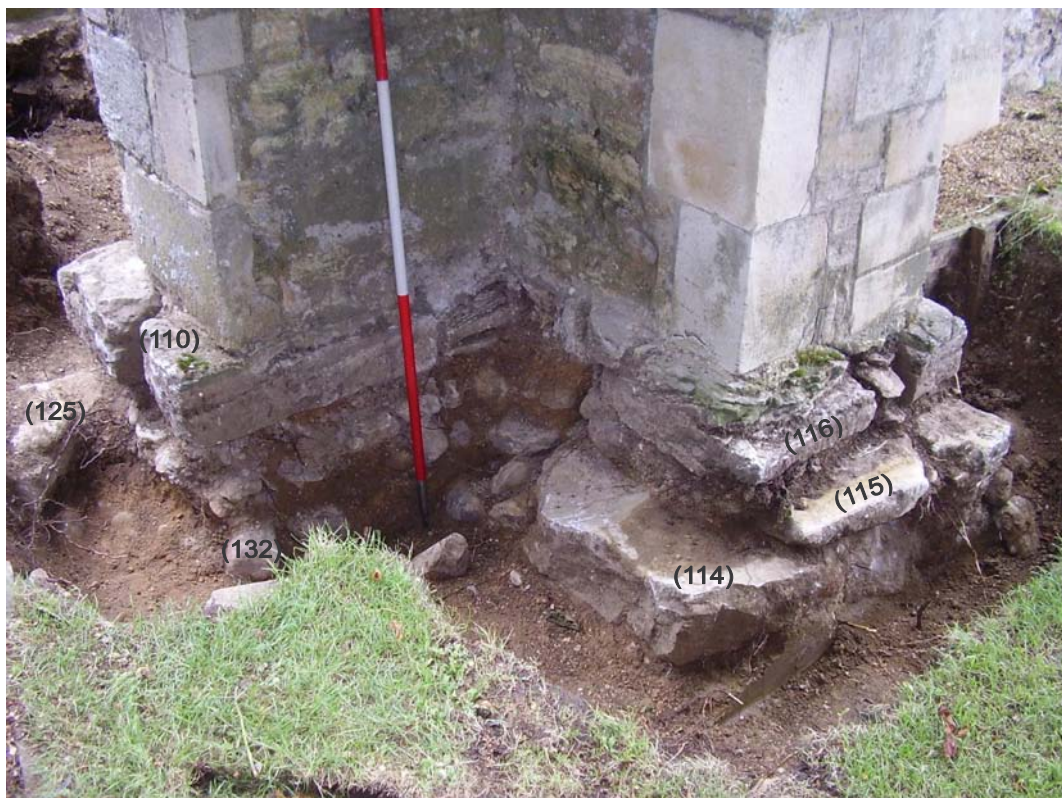
The size and form of the lower foundations of Buttresses 6 and 7, at the south-east corner of the chancel, suggest that the current double buttresses are a replacement for an earlier double buttress (Figure 2, Plate 2).

The foundations of Buttress 6 comprised roughly coursed, rounded pebbles in a loose sandy mortar (132) beneath limestone blocks, squared, built to courses, and bonded with a sandy mortar (110).

The foundations of Buttress 7 comprised two large limestone blocks bonded with loose sandy mortar (114) below two smaller levelling stones, bonded with a sandy mortar (115), placed to form a flat surface for the final layer of buttress padstones (116).

Above the foundations, Buttress 6 and 7 appear very similar in construction. They were of limestone block masonry construction, squared, built to courses with quoins stressed and appear to have been largely restored, probably in the 19th century (Pickford 1978).

A single large limestone block (125), probably associated with the earlier buttress, projected south of the course of rounded pebbles (132) at the base of Buttress 6. It was located above a single course of pebbles in a loose sandy mortar (126). The block was removed in order to complete the programme of drainage works and was replaced next to the buttress during re-instatement.

Plate 2: Chancel south-east corner double buttress. Scale 1m

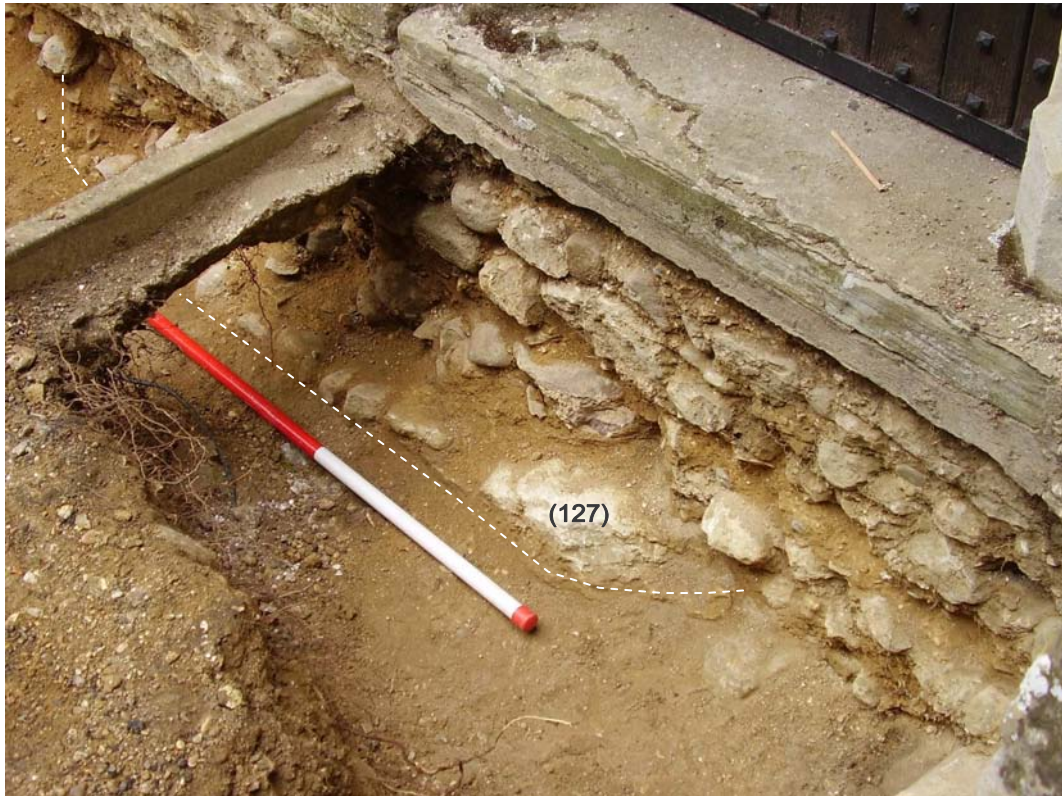
A line of limestone blocks and rounded pebbles (127) projected out from the chancel south wall foundations to the west of Buttress 5 (Figure 2, Plate 3). The projecting stonework was 1.26m long appeared to have 45 degree chamfered edges as it cut back towards the chancel wall foundations. It was bonded with a loose sandy mortar. It may represent the foundation for an earlier south door to the chancel.

Plate 3: Possible earlier chancel south door foundation (127). Scale 1m

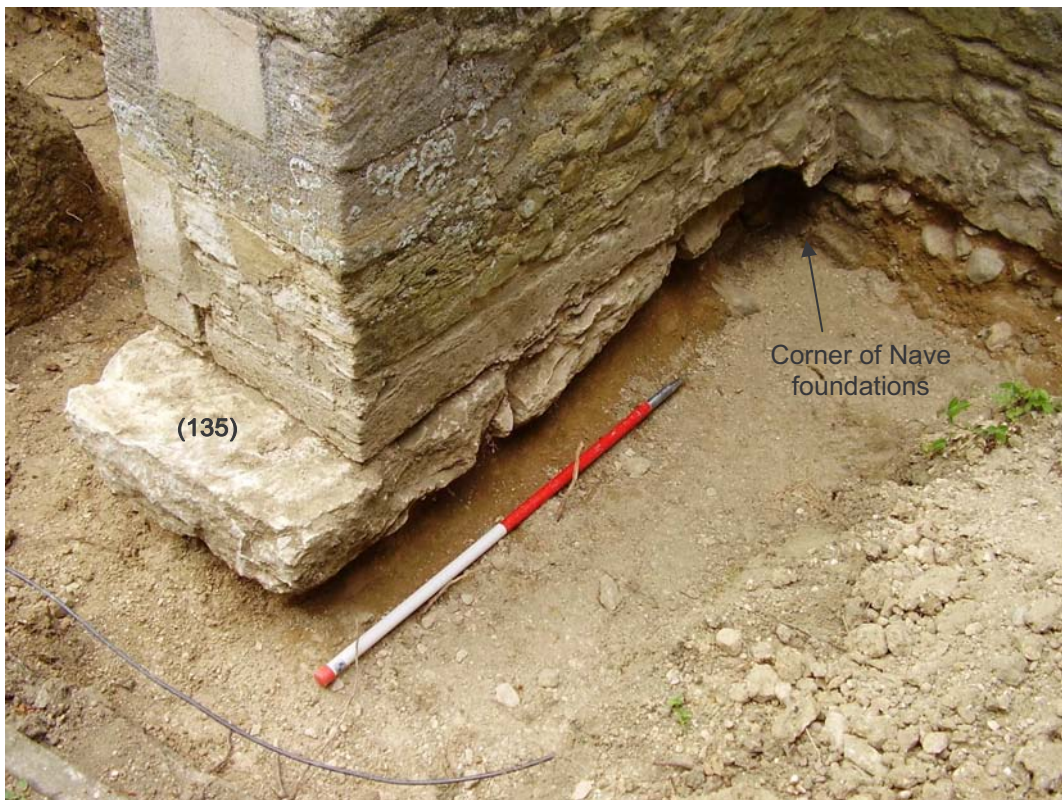
Where the chancel meets the nave, the nave corner foundations were observed beneath Buttress 4 (Plates 4 and 10). The course of oval pebbles and loose, degraded sandy mortar appeared to be identical to the foundations of the chancel, suggesting that the two structures are contemporary. The pebble walls of the nave and chancel are also generally similar in appearance.

The foundations of both Buttress 3 and 4 comprised large limestone padstones (136) and (135) (Plates 4 and 6). The buttresses were probably later additions to the south nave wall rather than being part of its original construction. They probably date to the 15th century when the larger windows were inserted.

Plate 4: Nave Buttress 4 adjoining chancel. Scale 1m

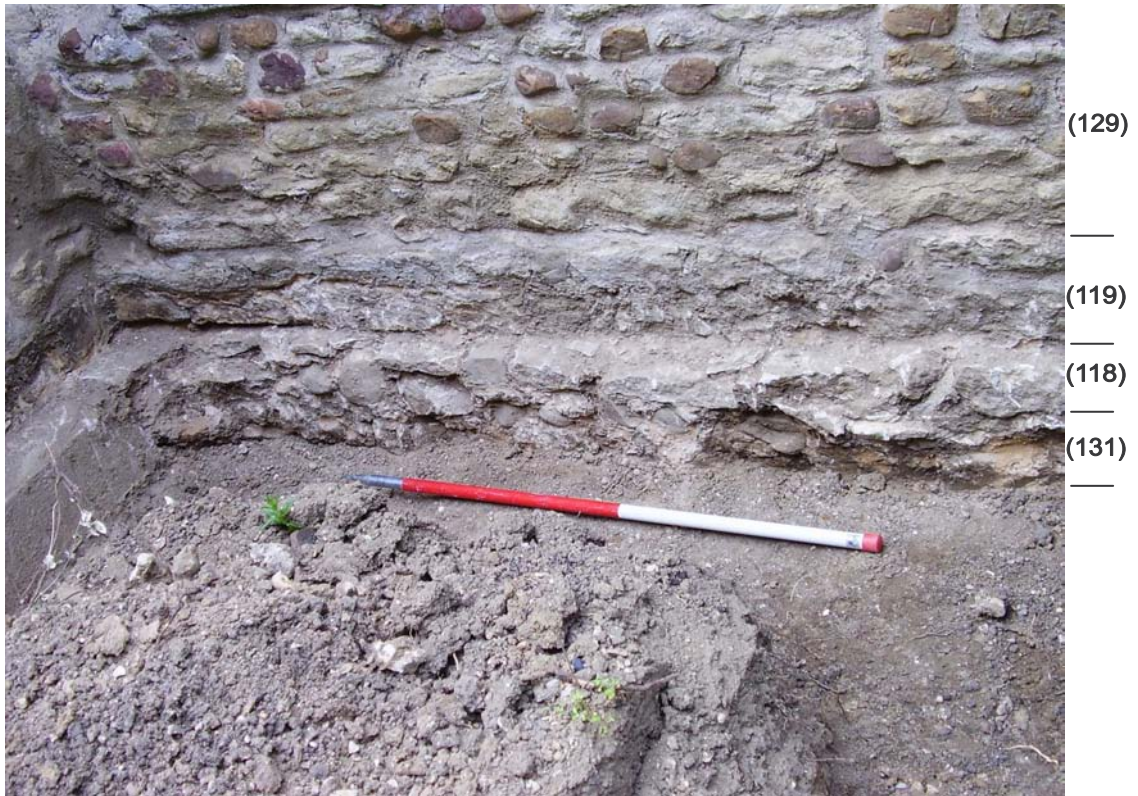
At foundation level, the nave wall was constructed of rounded, mainly reddish brown pebbles and limestone fragments between *c.* 80mm and 170mm in size, bonded with a friable sandy mortar (131) (Figure 2) (Plate 5).

Above the foundations a string course of roughly hewn, squared, limestone blocks, between 90mm and 280mm in length, bonded with a friable sandy mortar (118), projected out some 80mm beneath the nave wall. The blocks formed a plinth that capped the foundations and provided a level building platform for the nave wall.

Above the plinth, the lower section of nave wall appeared to have been cut back and dressed with three string courses of limestone blocks (119) and large sandstone oval pebbles (129), roughly coursed, rising by 480mm and capped with a sandstone chamfered plinth (106). Above the chamfered plinth the wall comprised large, roughly coursed, oval pebbles (128) continuing up to the full height of the nave (Plate 10). The nave wall exhibited episodes of re-pointing, probably post-dating the 19th-century restoration, with mid buff yellow to grey, hard, sandy mortars.

Plate 5: Nave foundation course (131), and plinth (118). Scale 1m

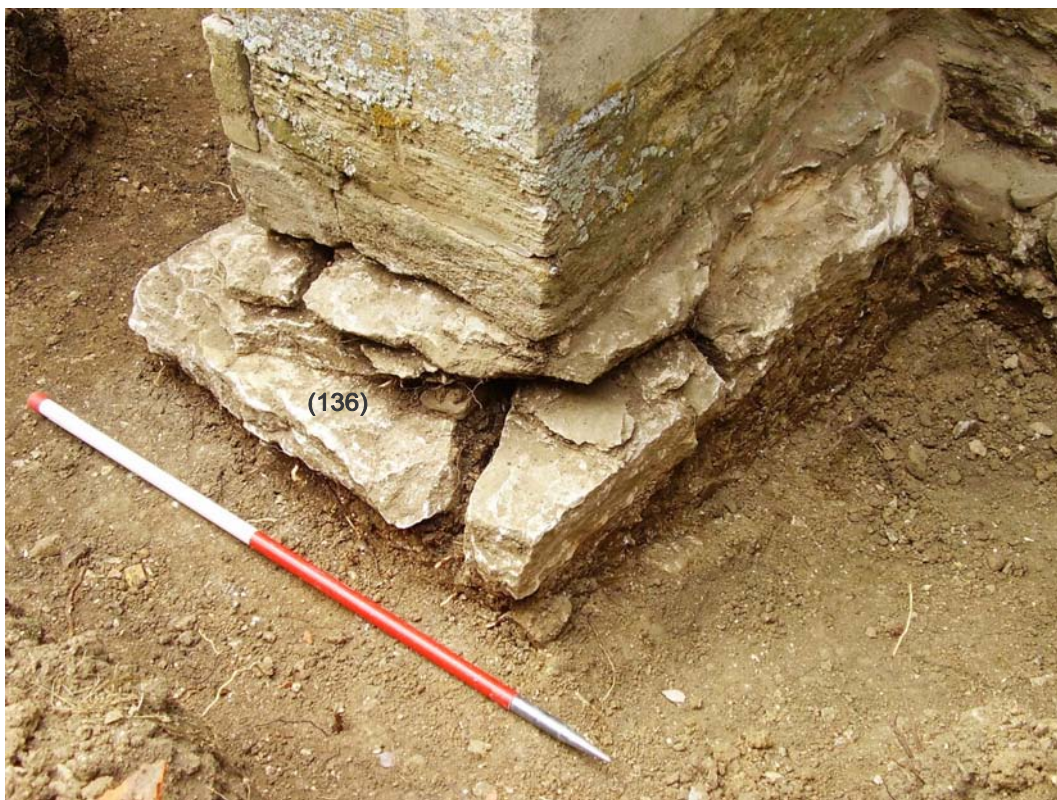
Above ground, the buttresses were constructed of limestone blocks, squared, built to courses with quoins stressed. They appeared outwardly to have been largely rebuilt in the 19th century.

Plate 6: Buttress 3 padstones (136). Scale 1m

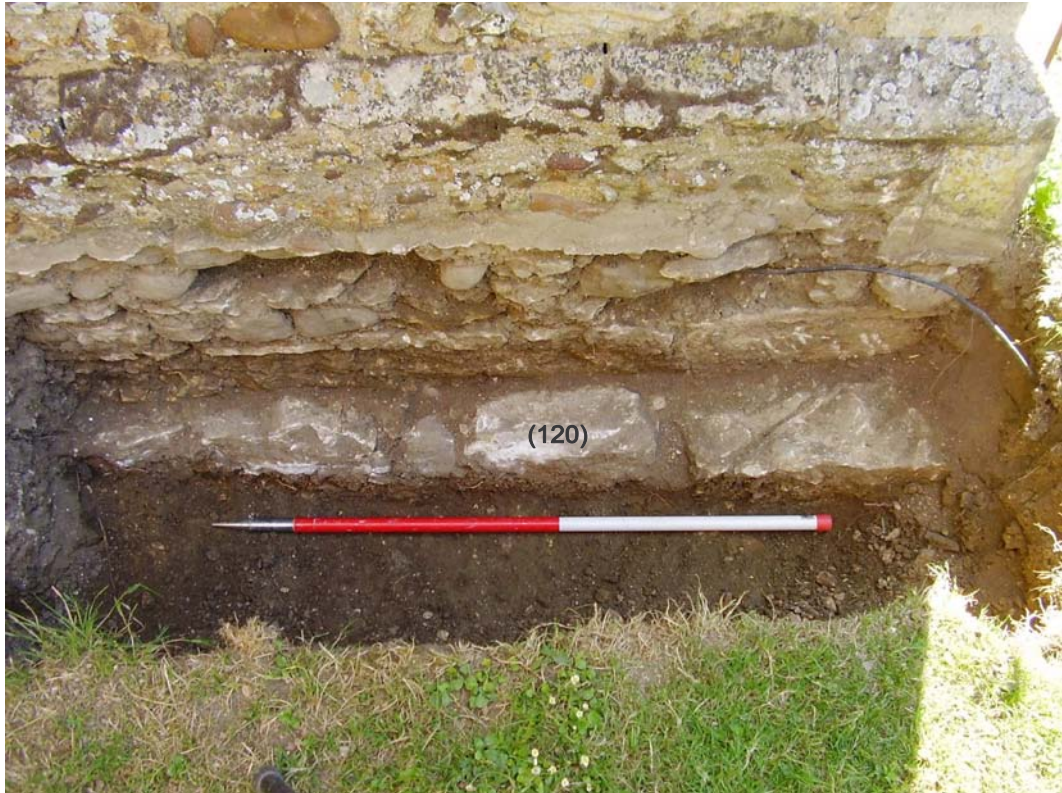
A foundation plinth of un-mortared limestone blocks (120) was observed beneath the west wall of the south porch (Figure 2, Plate 7). Above the plinth, the wall comprised a lower course of roughly hewn, squared limestone blocks, above which the porch was of red brown pebble construction, similar to the nave wall (128).

Plate 7: Foundation plinth (120) beneath west wall of south porch Scale 1m

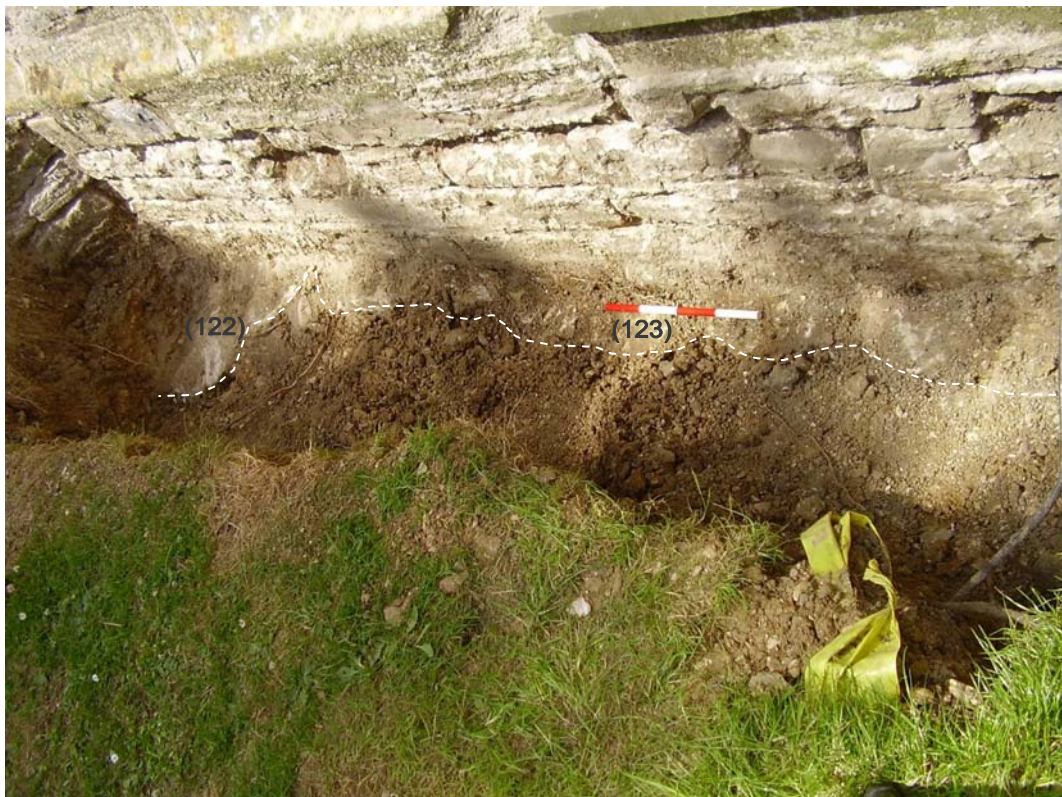
The tower south wall foundations comprised limestone masonry, squared and built to courses, above a base of sub-oval roughly hewn, limestone padstones (123) which were observed at a depth of 0.55m below the current ground surface (Figure 2, Plate 8).

Buttresses 1 and 2 on the south wall of the tower were set on substantial limestone padstones (122) and (121) (Plates 8 and 9). A gap in the masonry between Buttress 2 and the tower at foundation level indicates separate construction at foundation level. However, above foundation level, the buttress is integral with the stonework of the tower.

Plate 8: Tower padstones (123). Scale 40cm

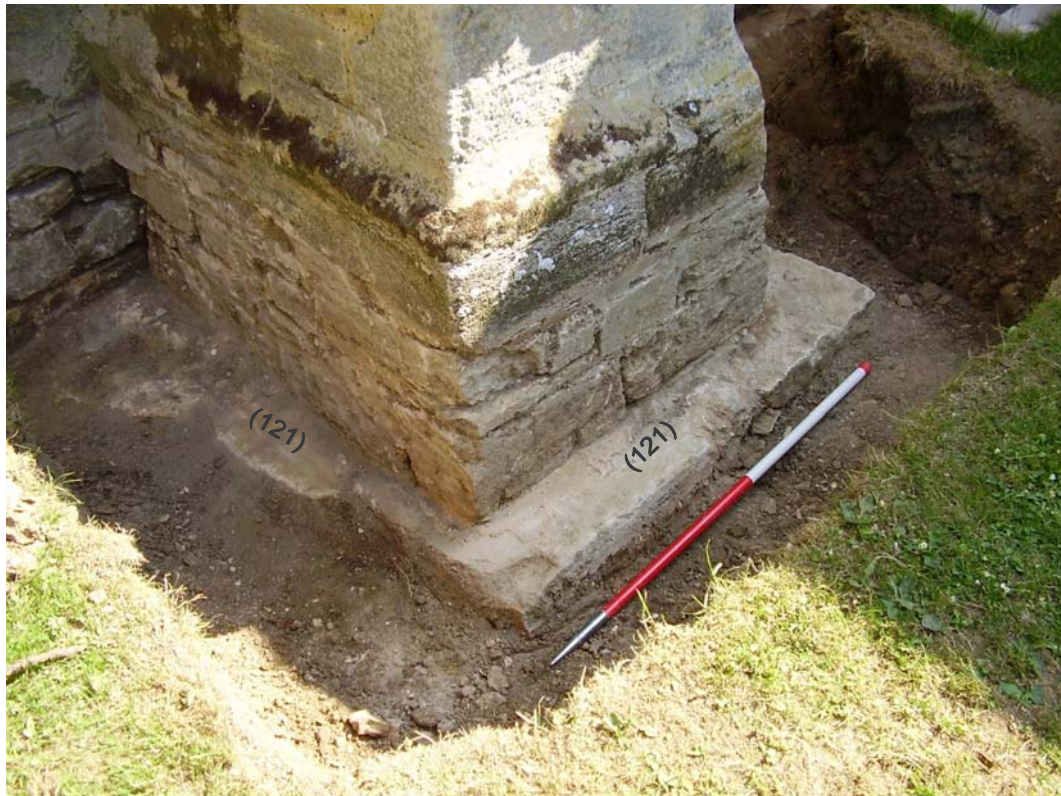
Plate 9: Tower padstones beneath Buttress 2. Scale 1m

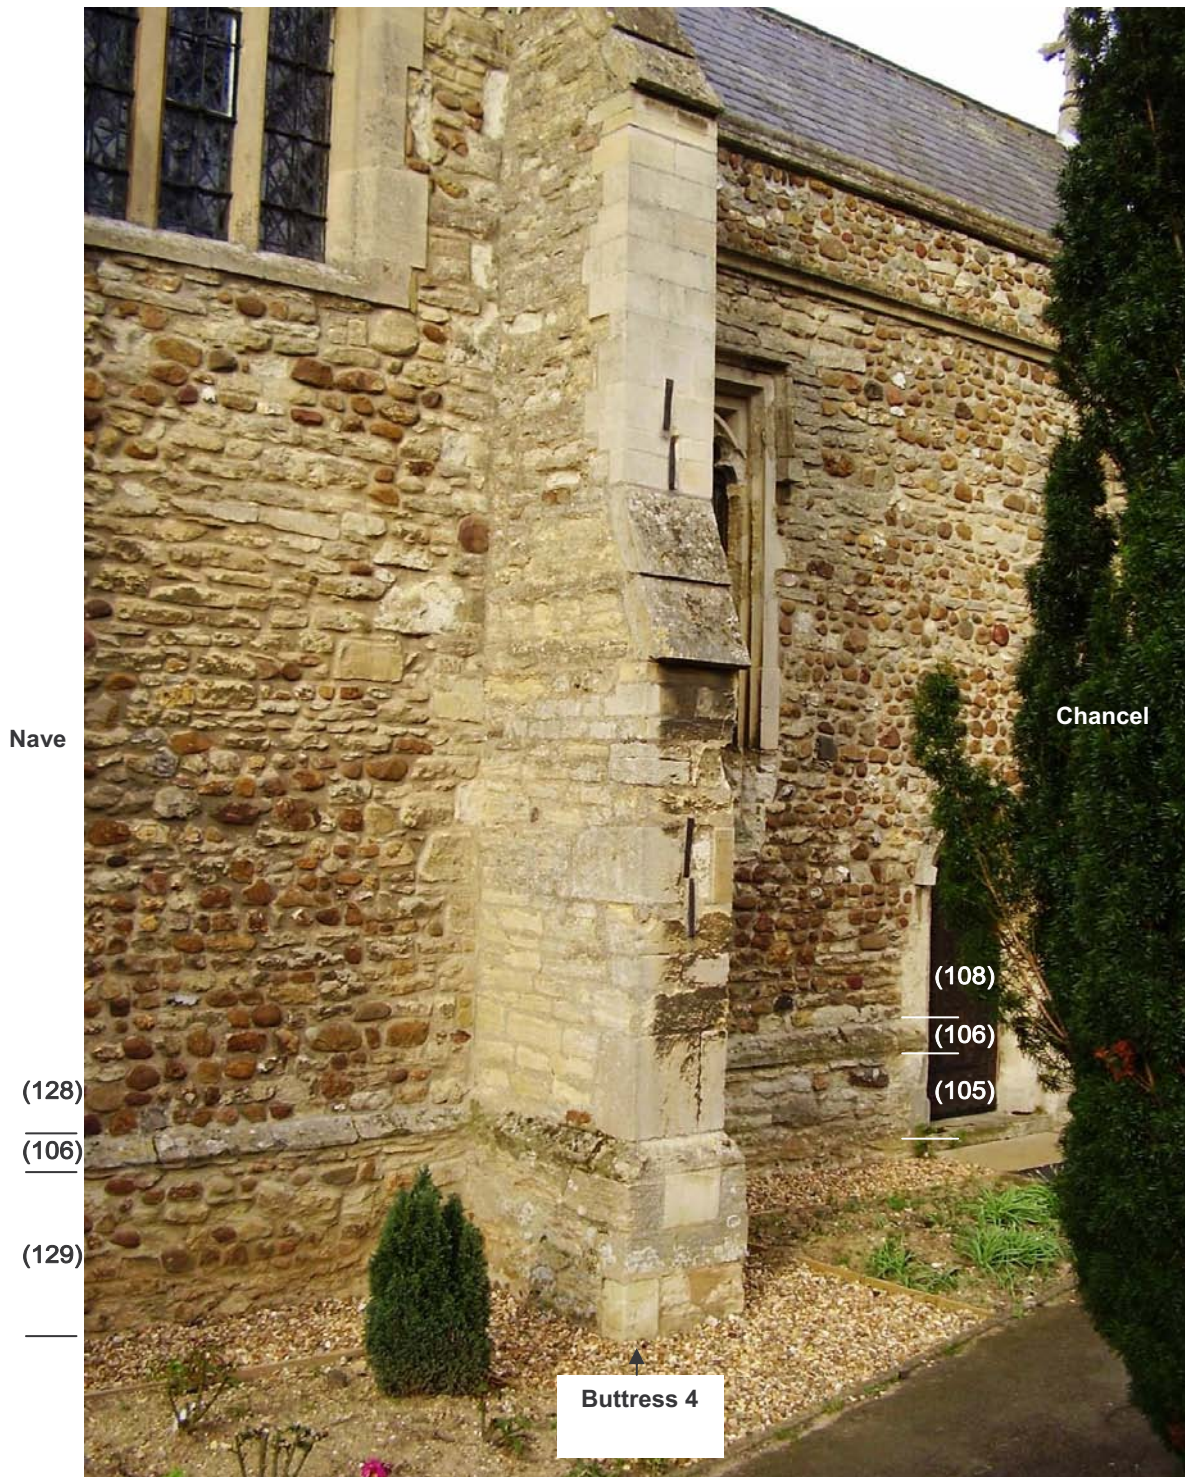
Within the area affected by the current drainage works, the most obvious evidence of this was the buttresses. Their perfectly finished, machine- or saw-cut stones suggest that they were part of the 19th-century restoration work. They appear to have been almost completely rebuilt, leaving only slight traces of earlier buttress foundations at the south-east corner of the chancel (Plates 2 and 10)

Plate 10: Nave, Buttress 4 and chancel. (post-reinstatement)
