**THE CHURCH OF ST. JAMES  
BIDDENHAM  
BEDFORDSHIRE**

**ARCHAEOLOGICAL WATCHING BRIEF**

Document: 2009/60

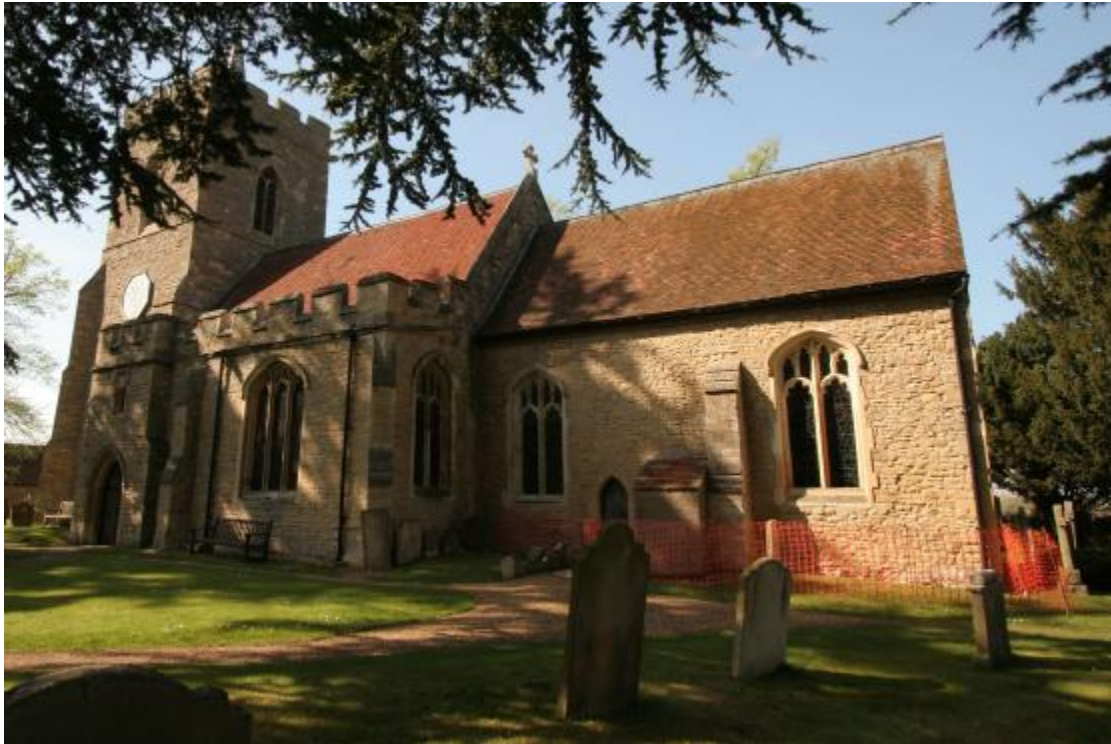
**Plate 1:** General view of the area of works on south side of the church

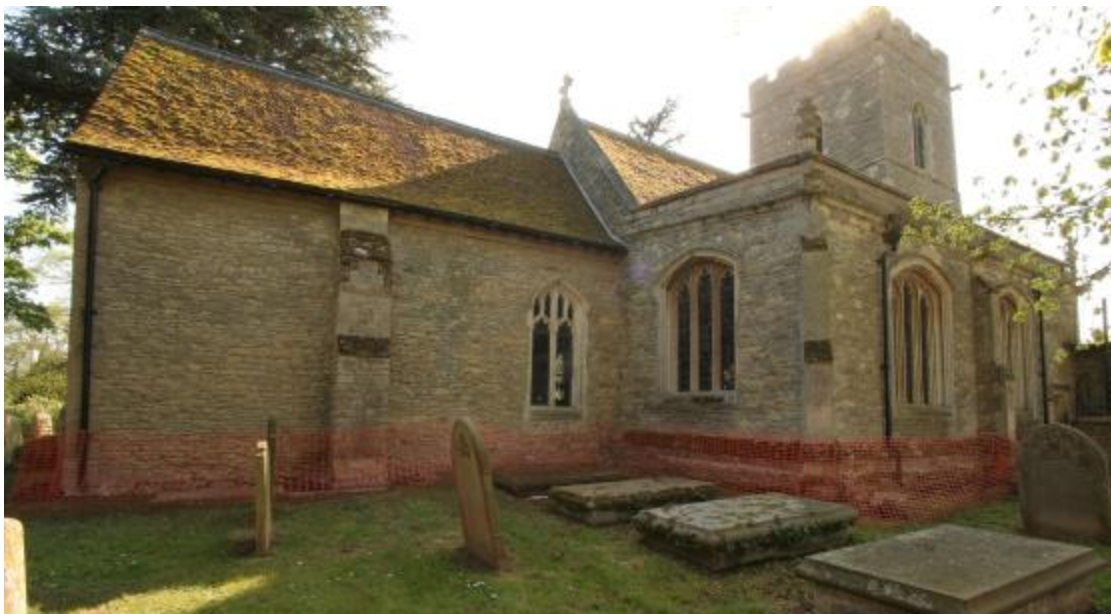
**Plate 2:** General view of the area of works on the north side of the church

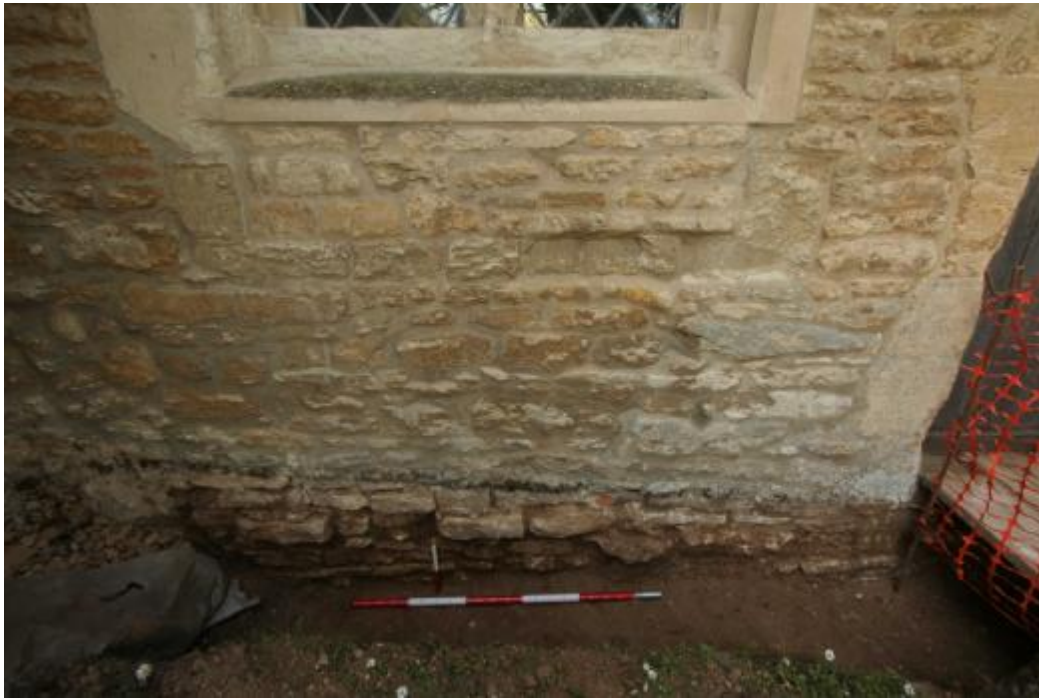
The western section of the trench along the south wall of the chancel was up to 0.5m deep (Plate 3). The lower part of the wall visible in this section of trench consisted of up to five courses of roughly coursed rubble masonry. The limestone masonry includes thin slabs and thicker blocks up to 0.3m long and up to 0.1m thick. There was no sign of a foundation plinth within the depth of the trench.

**Plate 3:** South wall of chancel, showing western end

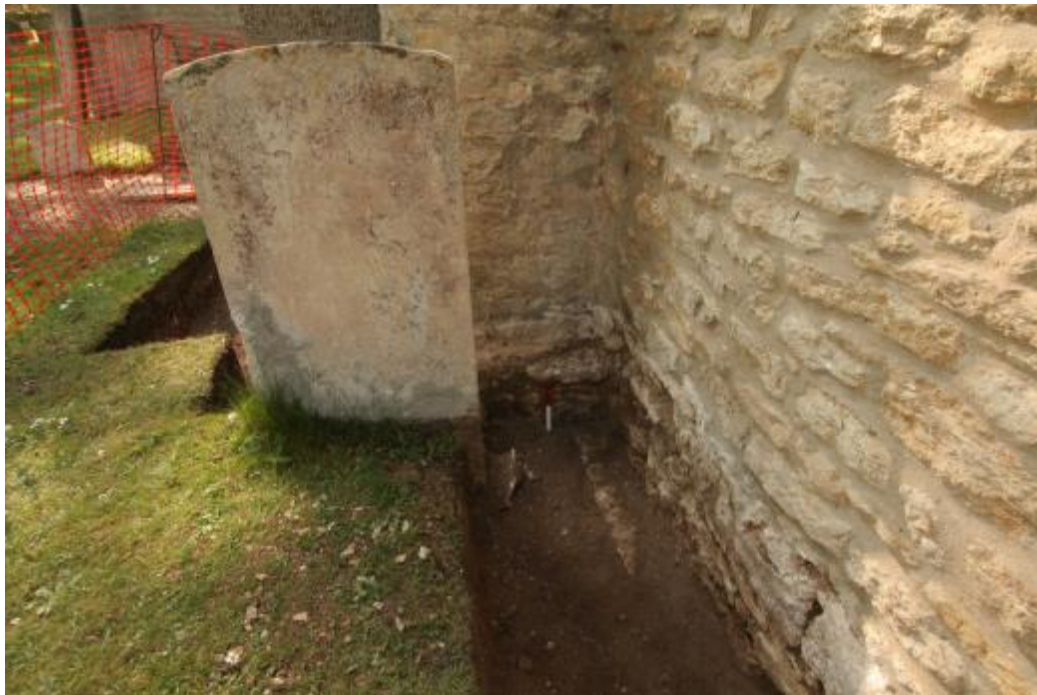
The buttress on the south wall of the chancel measures 0.6m from east to west by 0.66m from north to south at its base (Plate 4). The buttress is on a roughly built foundation situated only 0.1m below the current ground level. The foundation projects only slightly beyond the face of the buttress (0.08m) and consists of random rubble with irregular limestone blocks with some pebbles. The limestone in the foundation included at least one block of soft, shelly limestone of a type not noticeable in the rest of the building.

The trench dug along the eastern section of the south chancel wall was 0.45m deep at the buttress, decreasing to 0.2m at the eastern end of the wall (Plate 4). The upper face of a foundation plinth was visible in the deepest part of the trench. The plinth projects 0.14m beyond the face of the wall and consists of blocks of limestone c.0.2m long. The foundation appeared to be continuing towards the east but was not exposed where the trench became shallower towards the east. Up to five courses of masonry were visible above the foundation in this part of the trench. This consists of roughly coursed rubble masonry comprising limestone in slabs up to 0.3m long by 0.1m thick and sub-square blocks up to 0.25m long. A lead pipe was observed which exits the wall just below ground level, 1.4m from the east end of the chancel. The pipe is 0.04m in diameter and projects 0.36m from the wall. A patch of mortar above the pipe would appear to be the repair to the wall for the hole created for the pipe.

**Plate 4:** South wall of chancel, showing eastern end and buttress

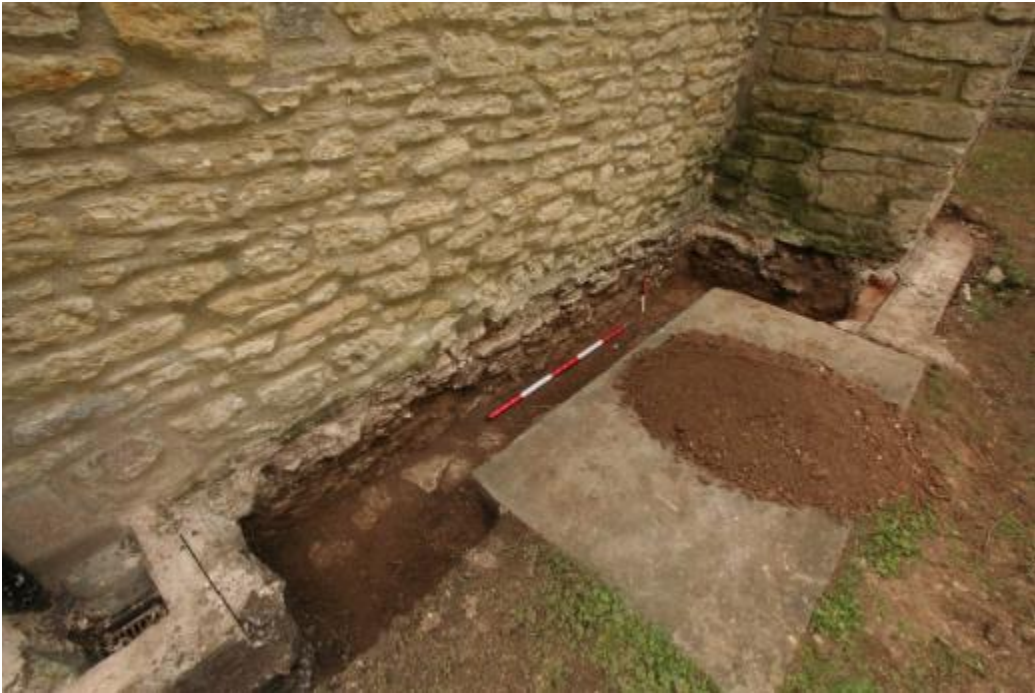
The trench next to the eastern end of the north wall of the chancel was excavated to a depth of 0.34m (Plate 5). In this section of the trench the upper surface of a foundation plinth was partially visible in the base of the trench. The remains that could be seen comprised irregular or broken limestone towards the east end and a rectangular slab adjacent to the buttress. The foundation projected 0.24m beyond the face of the chancel wall. The wall above the foundation consisted of four courses of masonry within the trench. This consists of roughly coursed limestone masonry constructed mainly of unshaped blocks up to 0.25m long and less than 0.1m thick with some thinner slabs.

The buttress on the north wall of the chancel projects 1m from the face of the wall at its base and is 0.8m wide from east to west (Plate 5). It is built in roughly coursed limestone masonry with large sub-rectangular limestone

blocks up to 0.5m long and 0.2m thick. Within the depth of the trench up to three courses of masonry were visible with no evidence for a separate foundation. The northern edge of the buttress appeared to have been damaged below ground level by the construction of a brick and concrete lined channel that runs parallel to its northern face.

**Plate 5:** North wall of chancel, showing western end and buttress

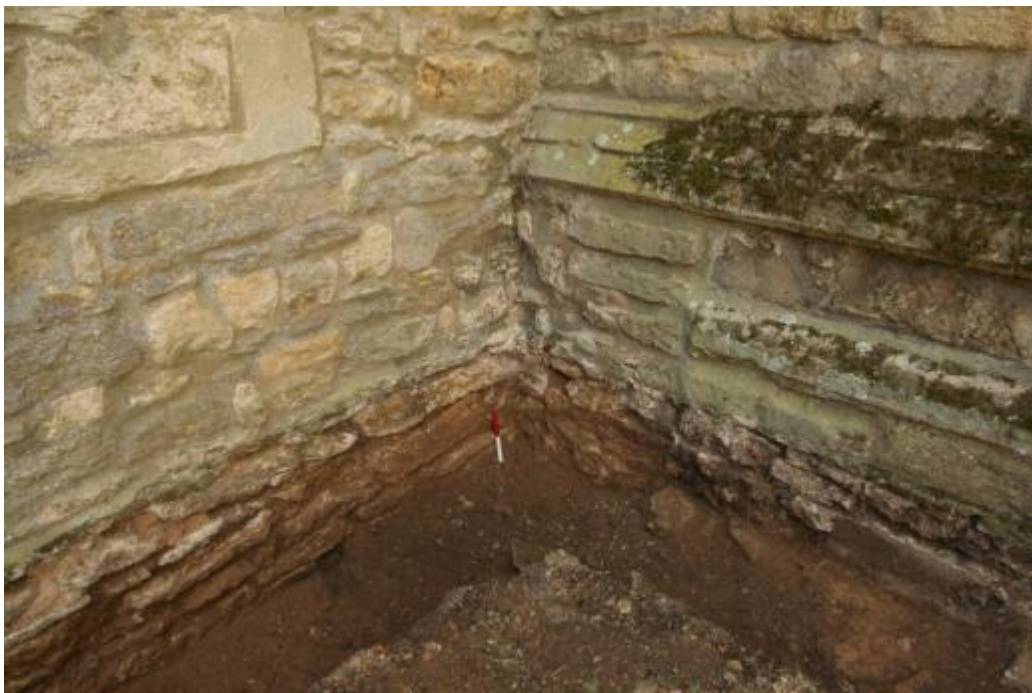
The trench next to the western end of the north wall of the chancel was excavated to a depth of 0.45m (Plate 6). No evidence of a distinct foundation was seen along this section of the chancel wall to the west of the buttress. The walling visible within the trench consisted of up to five courses of rubble masonry. The largest blocks in the wall, measuring up to 0.4m long and over 0.1m thick, are situated in the part of the wall closest to the junction with the nave. The remains of a disused brick and concrete lined duct containing a broken cast iron pipe met the wall c.1.5m to the west of the buttress. This was presumably part of a heating system.

The base of the wall below ground level consists of two courses of roughly coursed rubble masonry above the foundation plinth. This included blocks of limestone up to 0.4m long and 0.12m thick. Changes in the masonry are evident at the southern end of the wall close to the junction with the chancel wall (Plate 6). A clearly defined vertical break lies 0.6m from the north wall of the chancel. This was visible from the base of the trench up to the lower side of the moulded chamfer, around 0.6m above ground level. The plain chamfered course of stone terminates on this line whilst the moulded chamfer continues over it. The position of this vertical break corresponds to the likely location of the north-east corner of the nave before the addition of the north aisle. At the junction with the chancel wall the masonry appears very irregular

with small jumbled blocks and it is possible that this represents another break in the masonry.

**Plate 6:** Junction of north wall of chancel and east end of north aisle

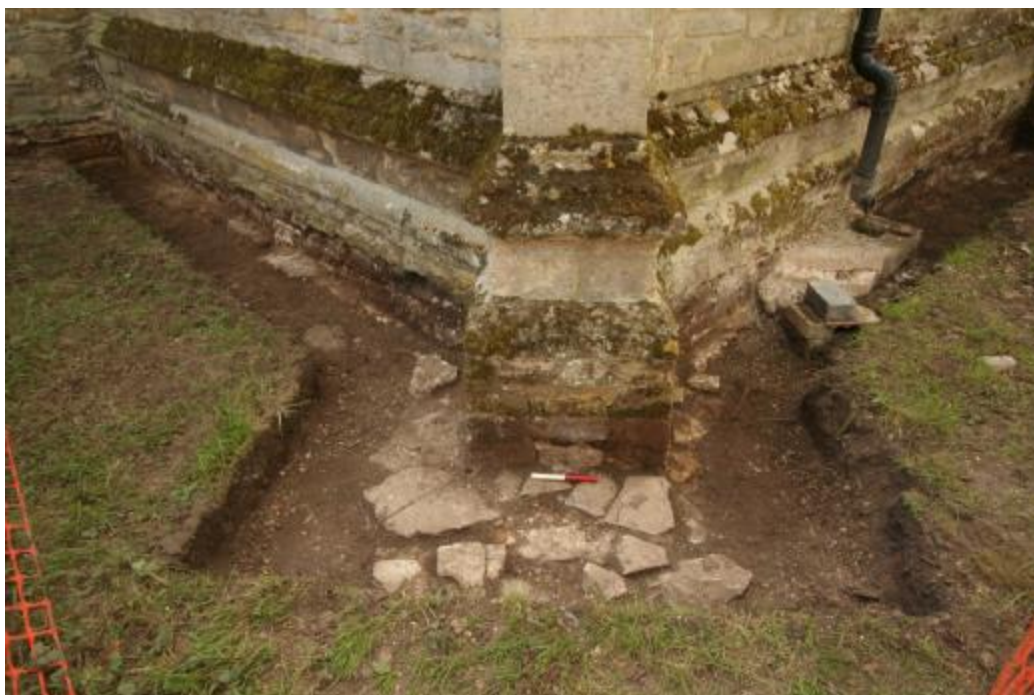
The north-east corner of the north aisle has a diagonal buttress, projecting 0.6m from the junction with the north and east walls and 0.6m wide at its base (Plate 7). It is constructed of squared and faced limestone. It was set on a foundation of irregular limestone blocks in mortar forming a base c.1.2m long and 1.1m wide.

Plate 7: North-east corner of north aisle
