**CHURCH OF ST NICHOLAS
STEVENAGE
HERTFORDSHIRE**

**ARCHAEOLOGICAL INVESTIGATION
AND REPORTING**

Project: SN1523

Document: 2009/94
Version 1.0

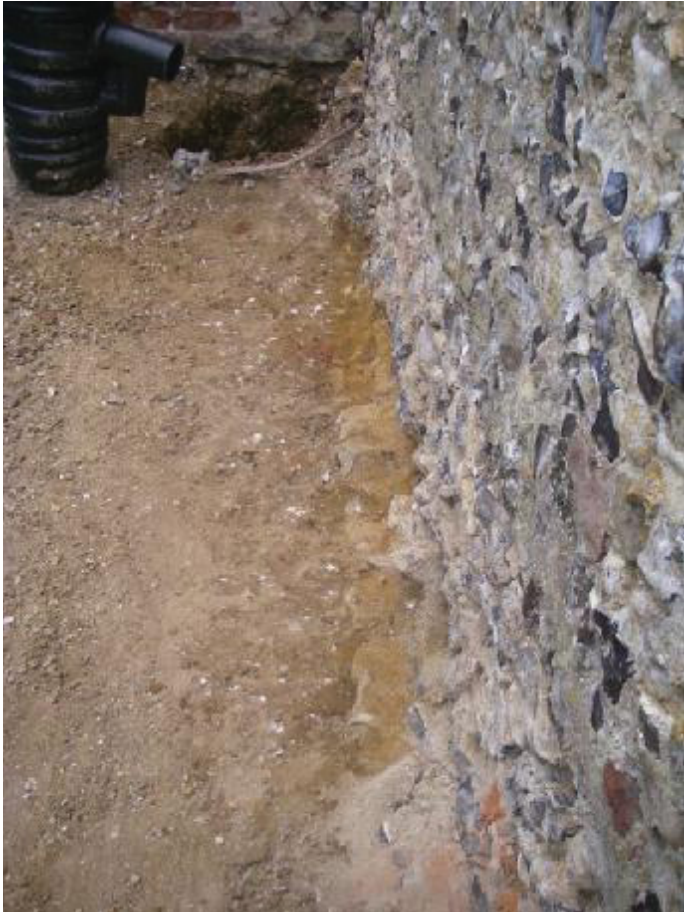
Exposed lower wall segments consisted of the same flint stonework that is visible in the exposed upper sections of the church walls (Plates 1-3). At the base of the wall, a narrow foundation plinth of mortared flint pebbles extended outwards for *c.* 100mm (Plate 1).

Plate 1: Flint masonry and flint foundation. Northern wall.

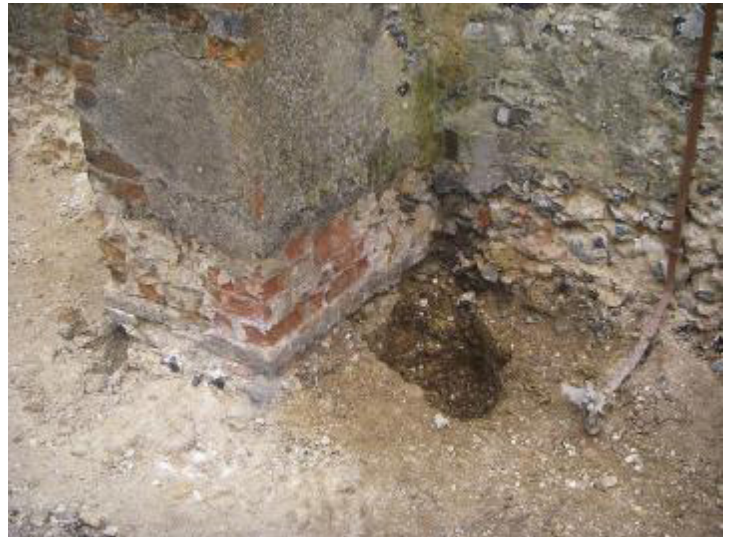
Buttresses along the north wall are partly built of red brick of varying sizes, supporting a core of flint rubble masonry that ties in with the walls of the church (Plate 2). Stone ashlar blocks around the door surround in the north wall are backed by coarse yellow bricks, tied in with the flint masonry of the main wall face (Plate 3).

Plate 2: Brick masonry in buttress. Northern wall.

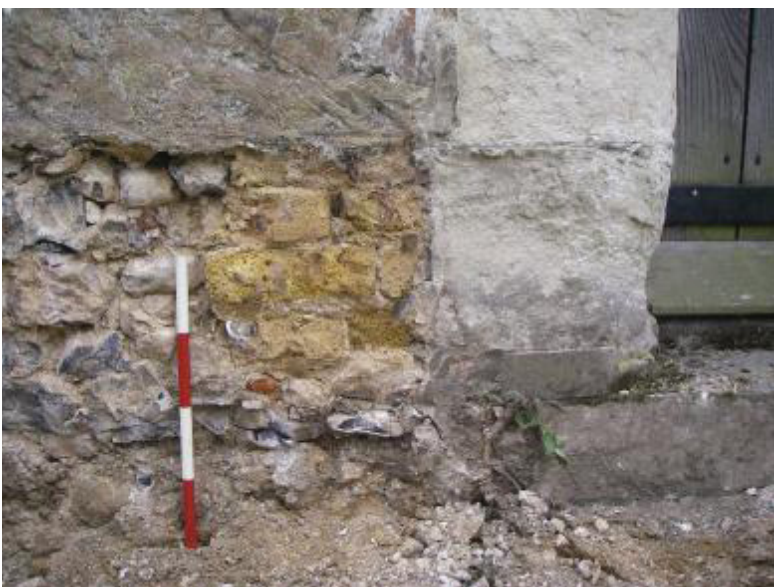
Plate 3: Yellow brick around door in northern wall

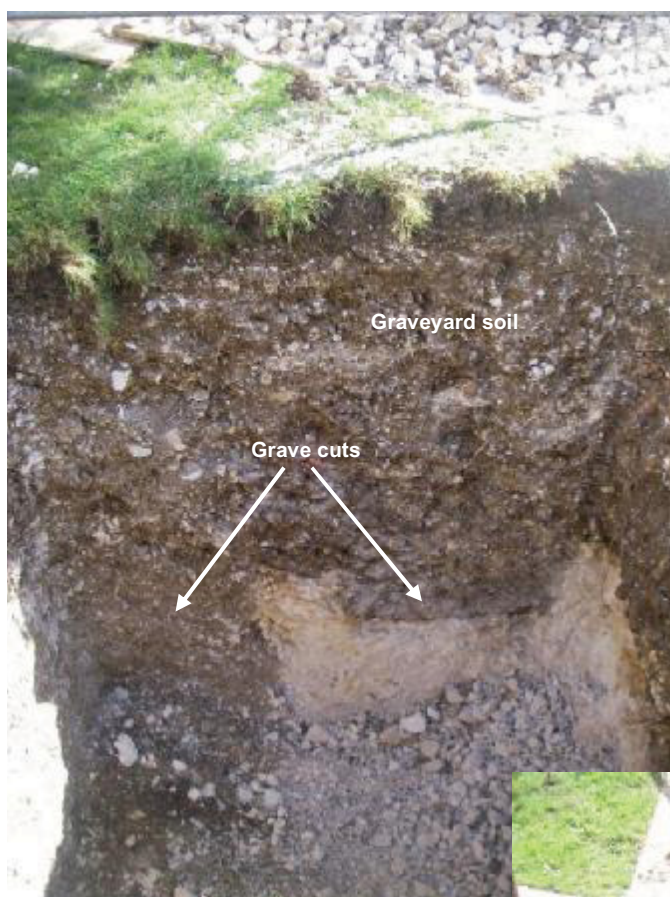
Layers within the soakaways consisted of 0.20m of topsoil above a graveyard soil consisting of mottled dark brown and white silty clay and chalk with moderate inclusions of small and medium sized flint pebbles (Plates 4 and 5). Undisturbed chalk bedrock was reached at a depth of 1.20–1.80m below ground level.

The sides of the south-eastern Soakaway 3 showed the remains of possible grave cuts (Plates 4 and 5). A thin layer of darker soil in the base of one of the grave cuts may represent organic material, possibly the remains of a coffin. Isolated iron nails and a coffin handle were found within the soil.

Plate 4:
Grave cuts in
west-facing
section of
Soakaway 3

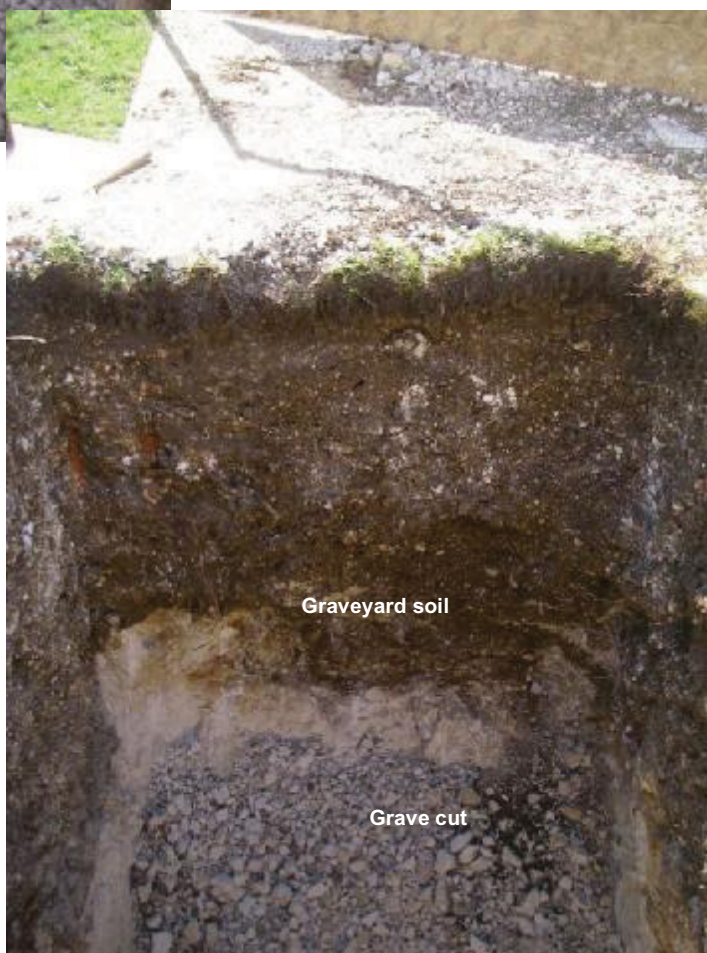
Plate 5: Grave cut in
north-facing section of
Soakaway 3
