**PRIORY CHURCH OF ST PETER
DUNSTABLE**

**ARCHAEOLOGICAL INVESTIGATION
AND REPORTING**

Project: SPD1642

Document: 2010/96
Version 1.0

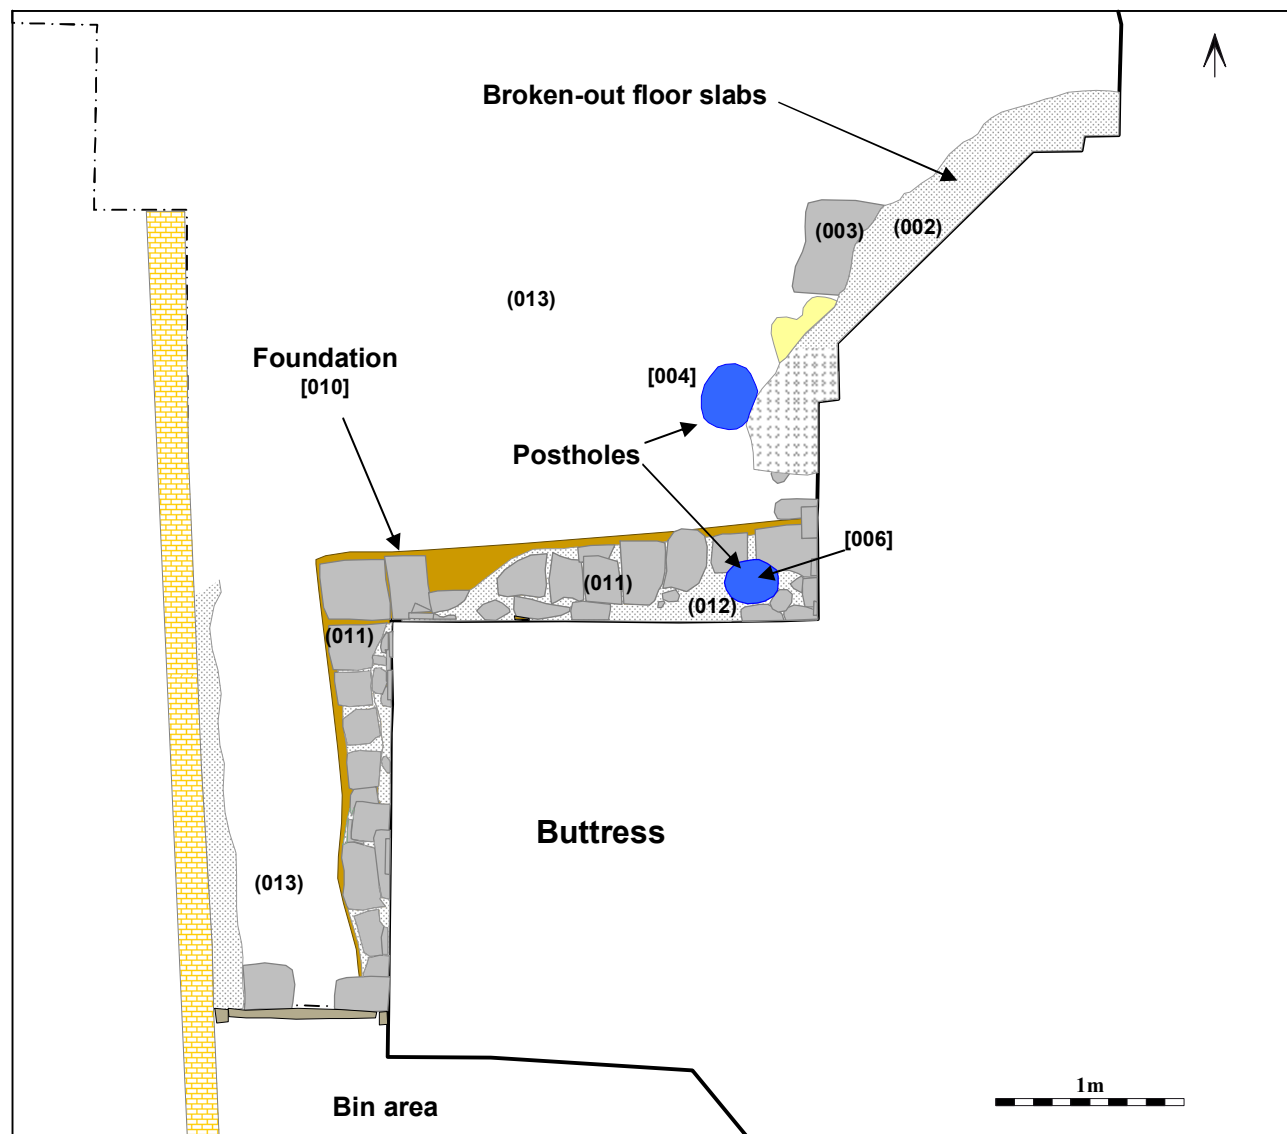
Two postholes [004] and [006] were also revealed (Figures 4, 5 and 6). They were 0.26–0.30m in diameter and 0.10m deep. Posthole [006] was cut into foundation material (012), part of the foundation cut [010] for the southern buttress on the western façade. Removal of deposits (011) and (012) within foundation cut [010] (Figures 4, 7 and 8) revealed that it was 0.30–0.50m wide and filled with roughly hewn, large and medium-sized clunch blocks (011). Smaller clunch fragments and fragments of tile filled the gaps between the larger stones and were pushed underneath the first course of ashlar masonry of the buttress itself. The stones were bonded by a pale yellow, sandy, lime mortar (012).

The foundation was cut into a further make-up layer (013) which consisted of firm mid yellowish grey sandy silt with frequent small fragments of clunch, flint and chalk and moderate small tile fragments (Figure 4). It extended throughout the area of investigation outside the west door and was left *in situ* as formation level had been reached.

Ground reduction works outside the west central door revealed parts of the foundations of the south-western buttress. The foundation cut was considerably larger than the buttress itself and on a slightly different alignment. It was exposed and cleaned. Its size and alignment do suggest that it could have been part of the foundation cut for the original 15th-century buttress.

Figure 4:
Foundation of south-western buttress
(for location of plan see Figure 2)

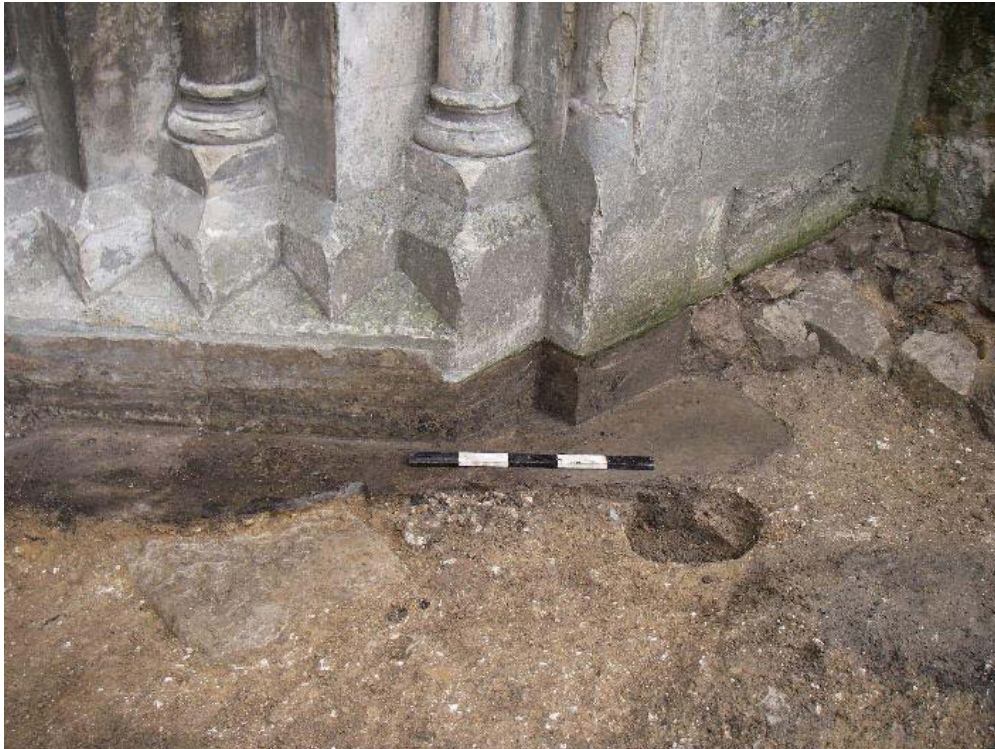
In the area immediately outside the west door, the remains of earlier paving slabs were revealed below the modern floor foundation. They consisted of large, flat concrete-like paving slabs (002) sitting flush with the base of the walls. The outside facing side of the slabs was broken off and the remains were no more than 0.30m wide (Figures 4 and 5).

The broken-out floor slabs, exposed below the recently removed step and flagstones outside the central door, most likely date to the middle of the last century. A drawing by Fowler of the west front of the church in 1945 shows a paved walkway leading up to the central door and the remainder of the ground also seems to be paved (Fowler 1959, 18). In addition a larger part of the pedestal for the rows of columns flanking the west central door is exposed on the drawing, suggesting that the floor level was lower several decades ago.

Figure 5: Early 20th-century paving slabs and make-up layers (0.5m scale)

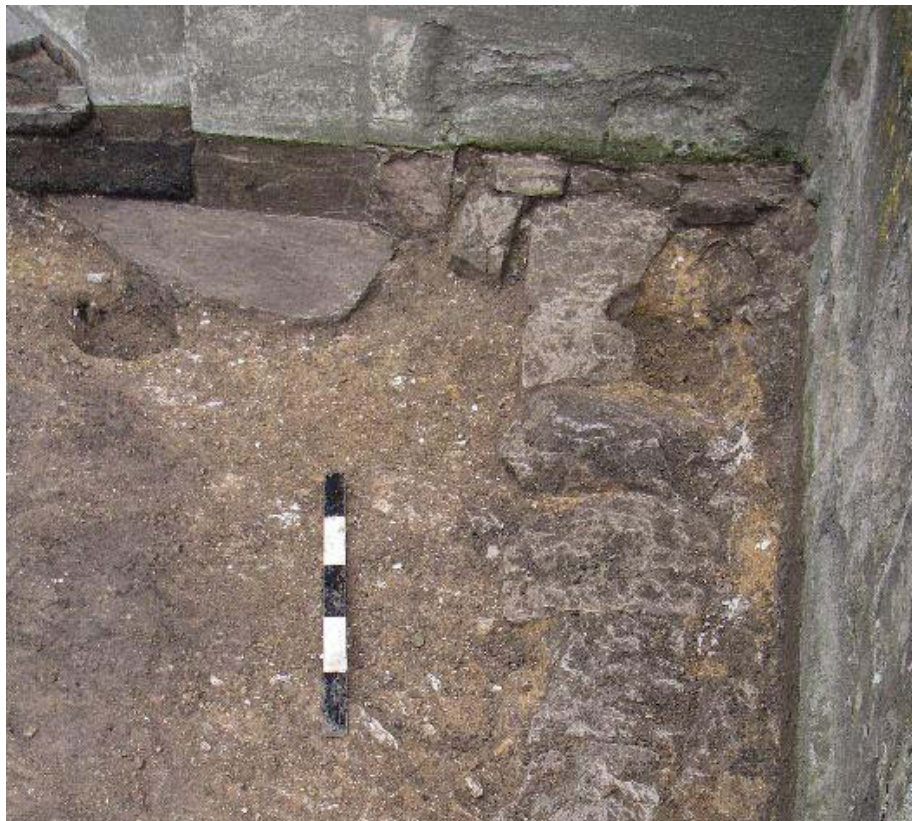
Similarly, the two postholes excavated immediately adjacent to the buttress and western façade most likely represent the remains of scaffolding, probably erected to aid repair work to the buttress in 1930.

Figure 6: Two scaffolding postholes, truncating buttress foundation and make-up layers (0.5m scale)

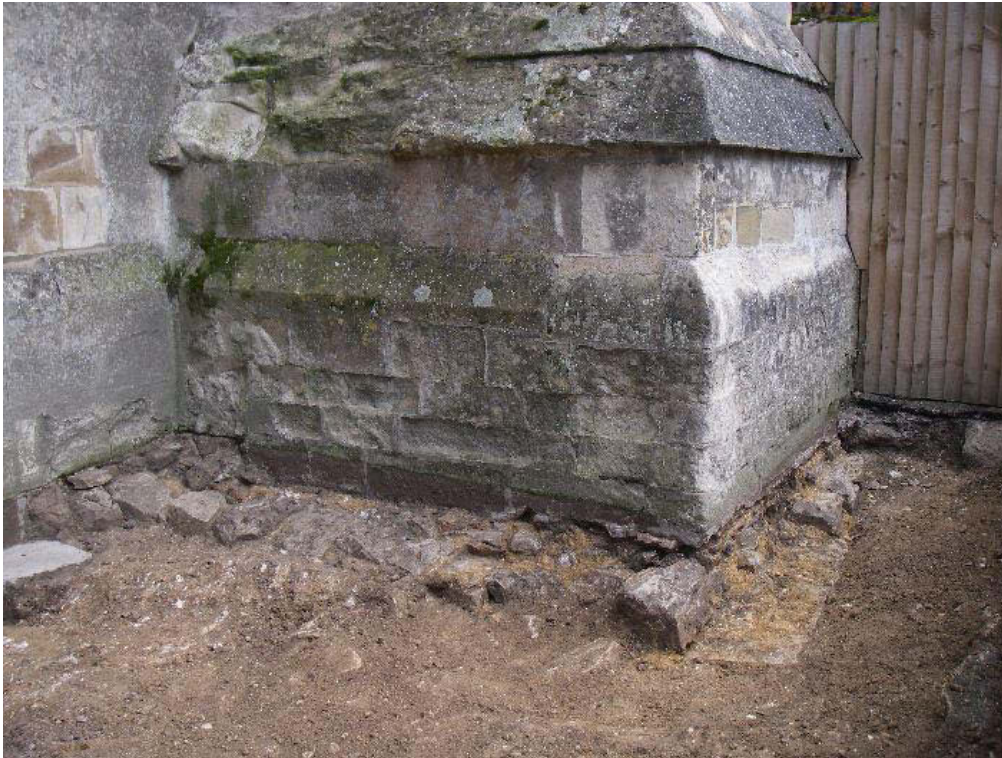
Some of the clunch rubble fill in the top of the cut came away easily from the sides of the buttress. This loose deposit may have been disturbed previously and it is considered likely that the upper layers of this deposit, as well as some of the clunch blocks and small tile fragments exposed below the dressed masonry, actually date from the restoration of the buttress in 1930.

Figure 7: Foundation of south-western buttress in plan

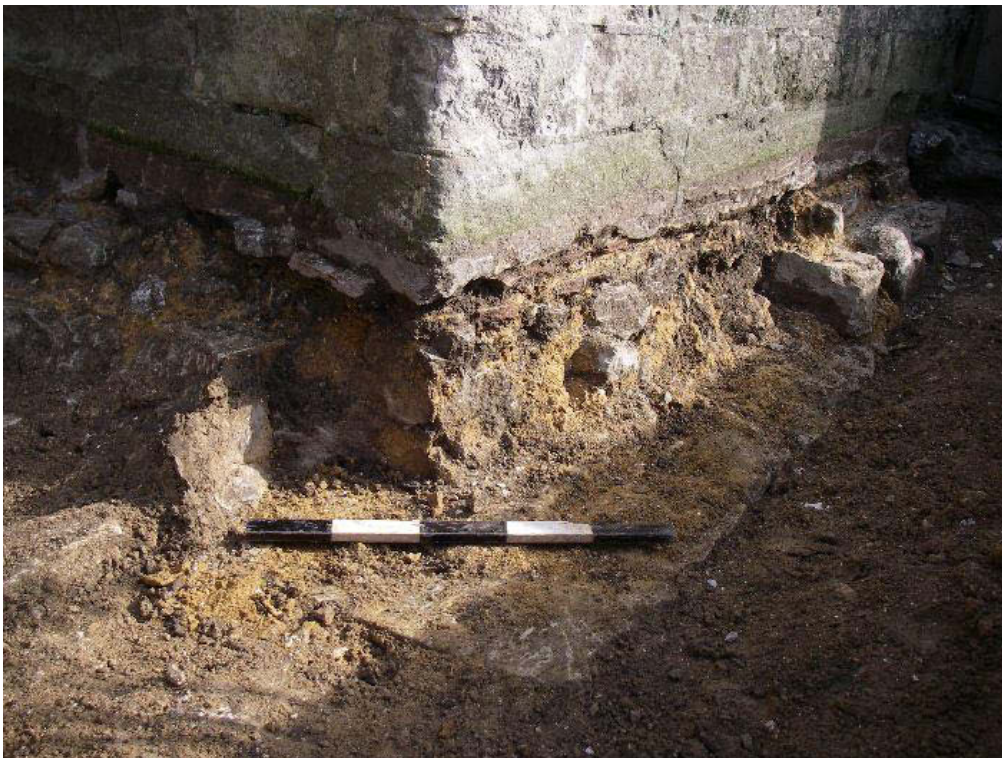
Figure 8: Foundation of south-western buttress elevation detail

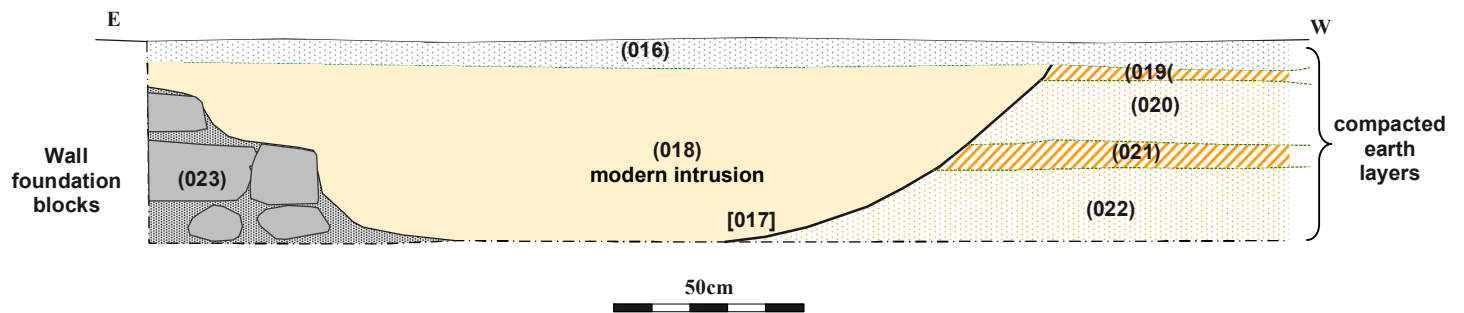
The eastern end of the foul water drain, outside the north-west door, revealed two courses of dressed clunch with white mortar (023), part of the foundations underneath the northern buttress. A series of thin layers of grey sandy silt with moderate small stones and tile fragments (020) and (022), interspersed with a thin compacted chalk band (021) were recorded in the side of the trench (Figure 9). These layers are reminiscent of the make-up layers recorded in plan outside the main, central entrance and may represent further former ground surfaces.

Figure 9: Section of foundation and compacted earth layers at eastern end of foul water drain outside north-west doorway (for location of section see Figure 3)

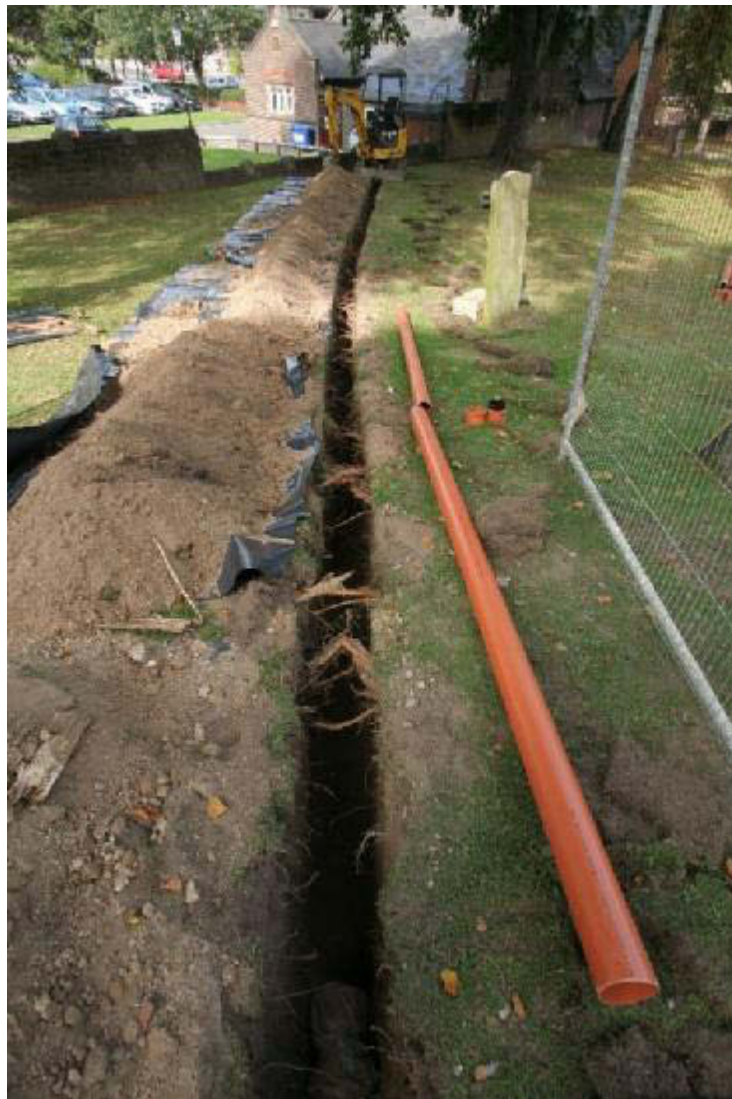
Within the churchyard, the trench for the foul water drain revealed a homogenous graveyard soil (025) below a thin layer of turf c. 100mm thick (Figure 10). The graveyard soil contained occasional fragments of brick and tile and a small amount of disarticulated human bone, which was re-interred.

Figure 10: Foul water drain looking north-west towards Church Hall

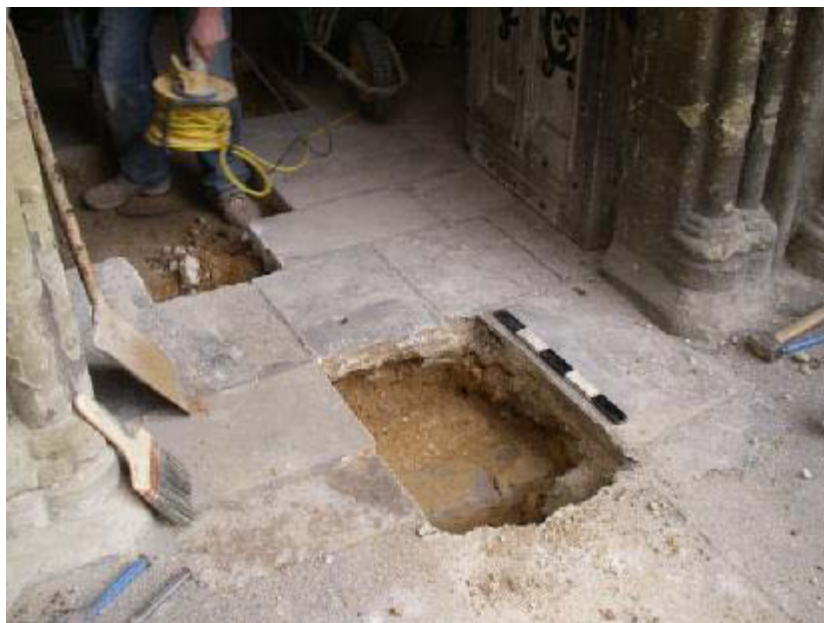
Part of the foundation of the north-west doorway, consisting of dressed ashlar blocks, was revealed at a depth of 0.22m below the current paving slabs in the centre of the north-west door (Figure 11). The blocks are probably too far below ground level to represent an earlier threshold.

Figure 11: Dressed foundation or threshold blocks within north-west doorway

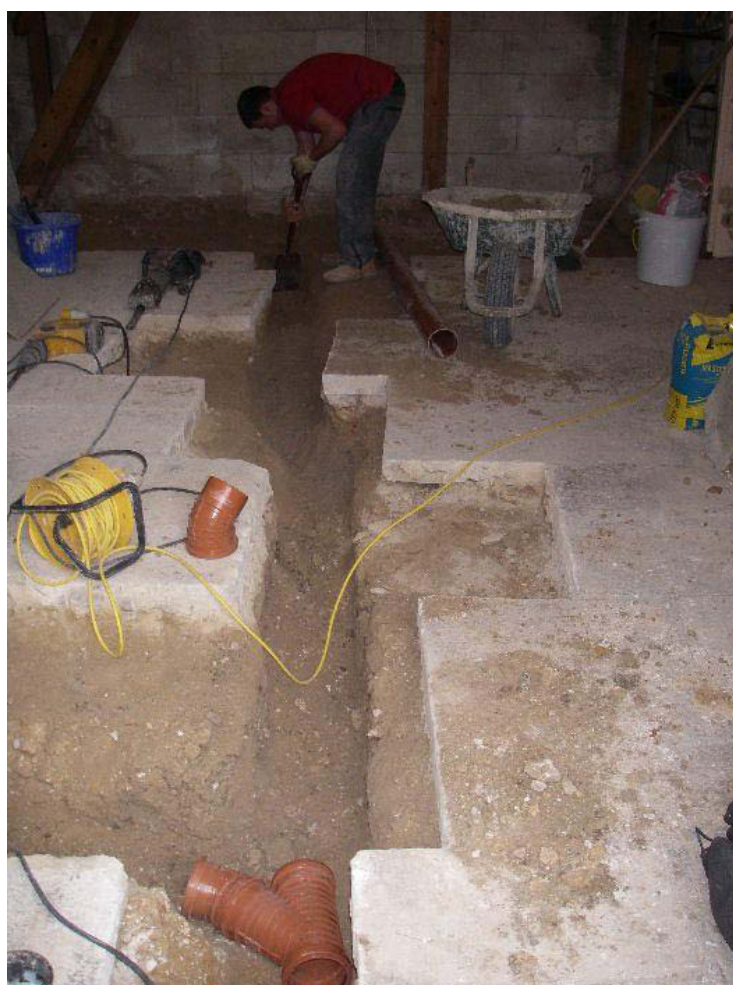
Groundworks in the north-west entrance lobby consisted of ground reduction of c. 300mm below an in-built cupboard that had been removed to make way for the proposed lavatory (Figures 3 and 12). Made ground below the cupboard consisted of compact clunch rubble. Some of the rubble blocks were roughly hewn and must represent re-used masonry from other parts of the church.

Figure 12: Foul water drain inside entrance lobby (fully excavated)
