BARN AT HAZEL GILL, MALLERSTANG, CUMBRIA

Heritage Assessment

November 2022

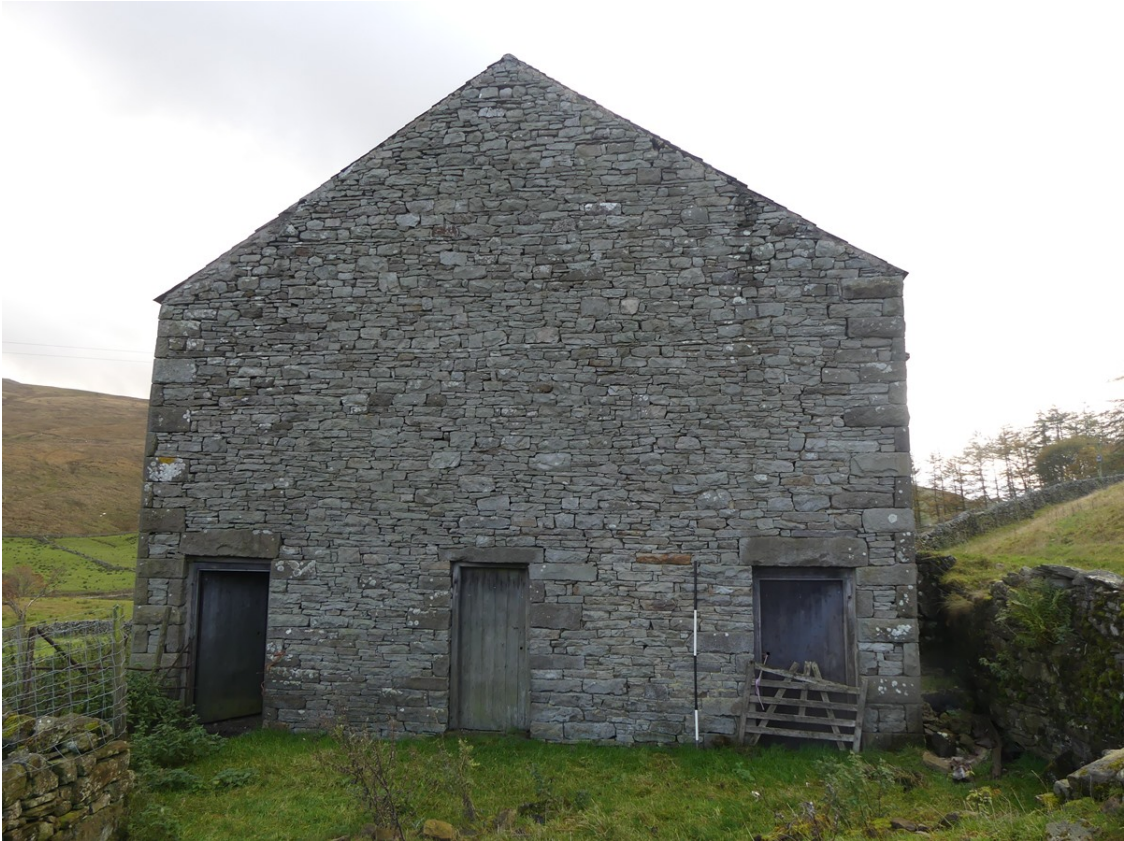
4.2.1 **North external elevation:** this comprises the gable end (Plate 5). The lower ground floor has three doorways all with stone lintels, although the central one is thinner than the other two, and relatively modern plank and batten doors (Plate 6 to Plate 8). The corners are finished with dressed quoins and there is an owl hole just below the apex with a thin lintel and sill, filled with a single rounded stone (Plate 9).

Plate 5: North external elevation, viewed from the north

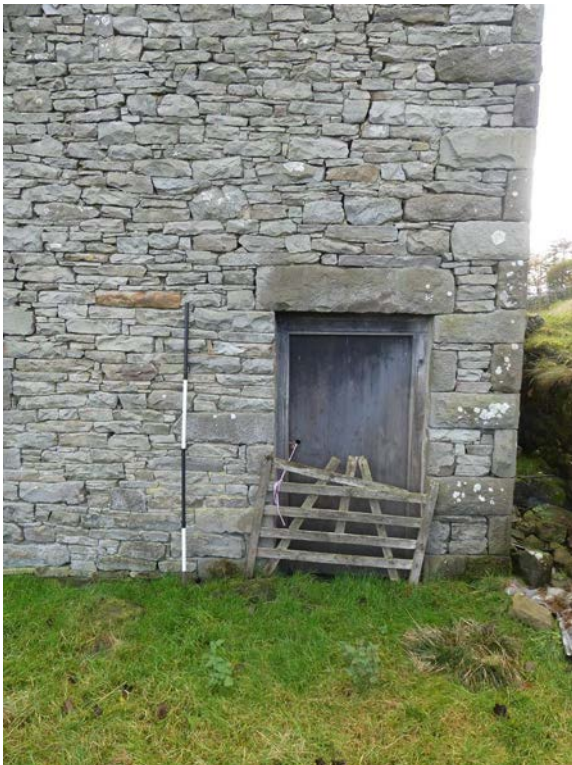
Plate 6 (left): West doorway at lower ground floor level in the north external elevation, viewed from the north

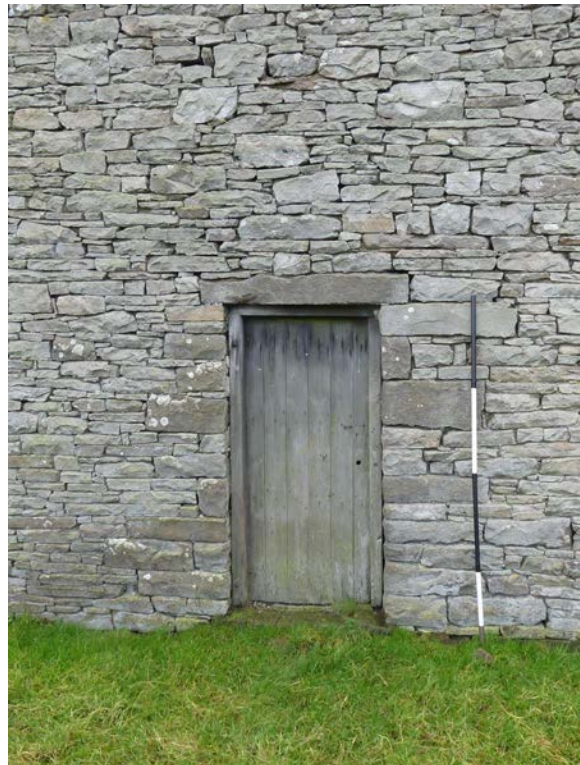
Plate 7 (right): Central doorway at lower ground floor level in the north external elevation, viewed from the north

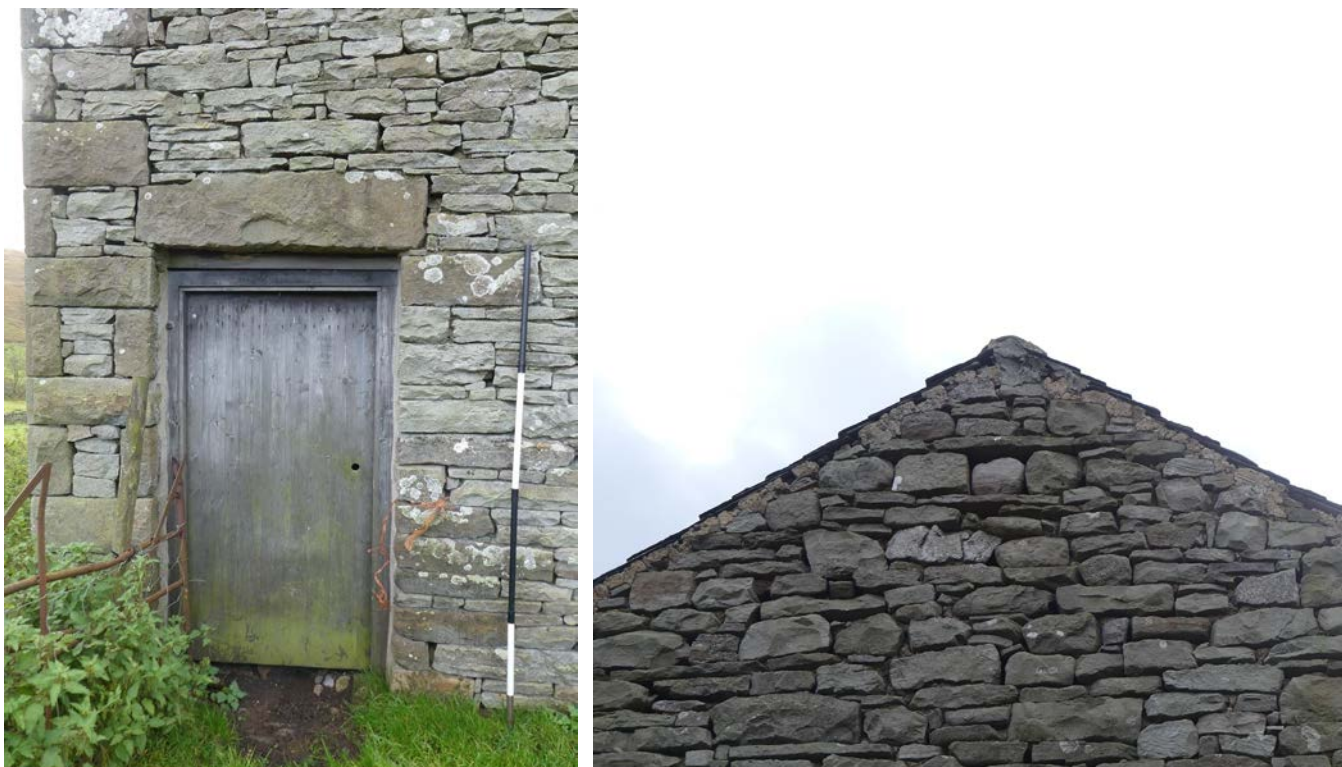
Plate 8 (left): East doorway at lower ground floor level in the north external elevation, viewed from the north

Plate 9 (right): Owl hole at the apex of the north external elevation, viewed from the north

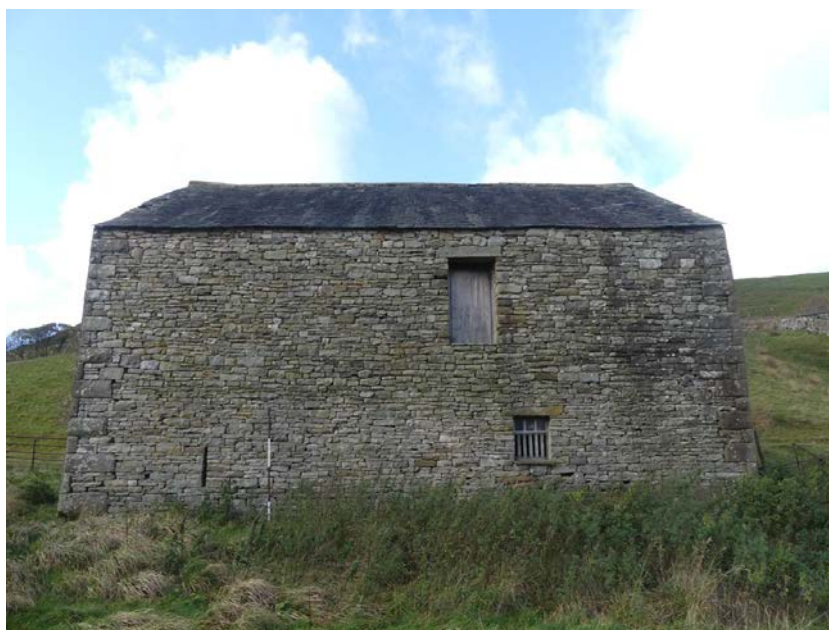
4.2.2 **East external elevation:** this is the downslope side of the building (Plate 10). It has a small aperture on the north side of the lower ground floor level with a casement with three-lights in the top and timber slats in the bottom, a stone lintel and thin stone sill (Plate 11). To the south, at the same level, there is a narrow ventilation slot (Plate 12). The upper ground floor has a doorway north of the centre with a heavy stone lintel and relatively new timber plank and batten door (Plate 13). The corners of the elevation are finished with quoins.

Plate 10: East external elevation, viewed from the east

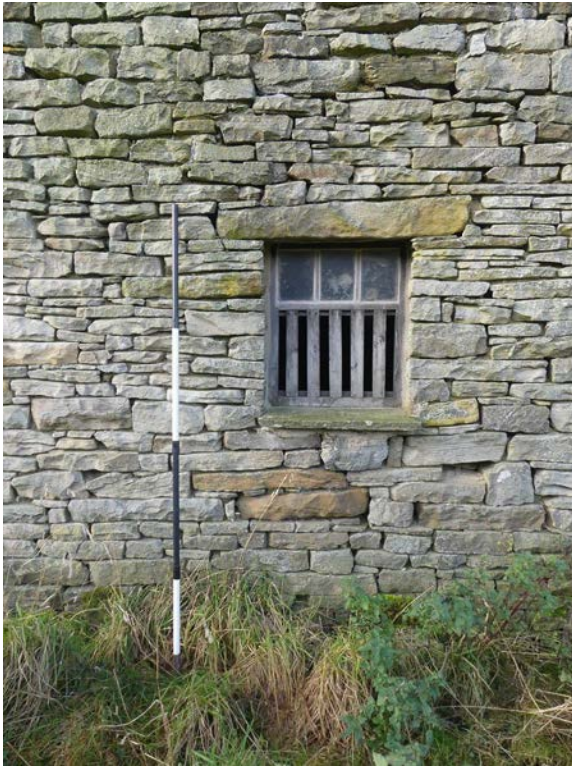
Plate 11 (left): Lower ground floor window on the north side of the east external elevation, viewed from the east

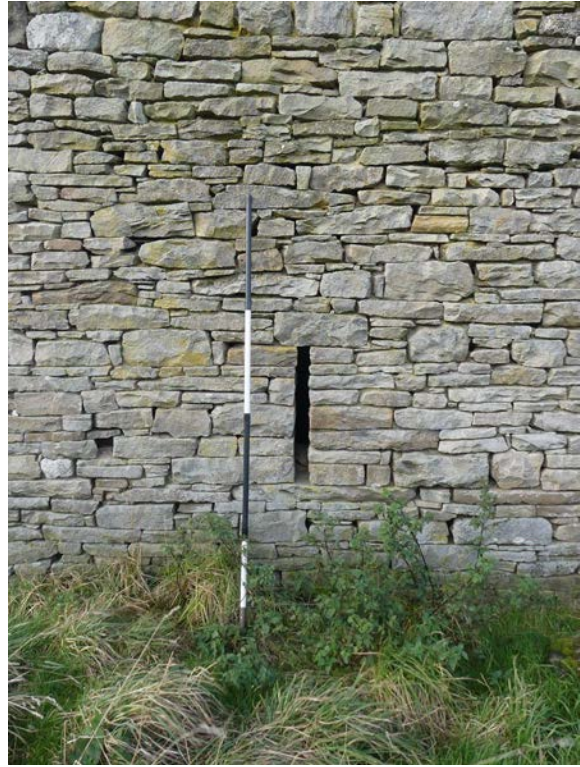
Plate 12 (right): Lower ground floor ventilation slot on the south side of the east external elevation, viewed from the east

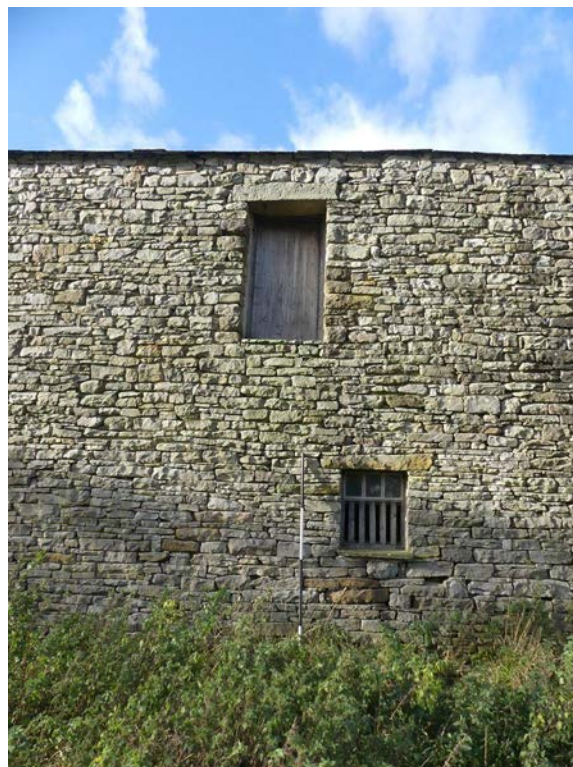
Plate 13: Upper ground floor doorway in the east external elevation, viewed from the east

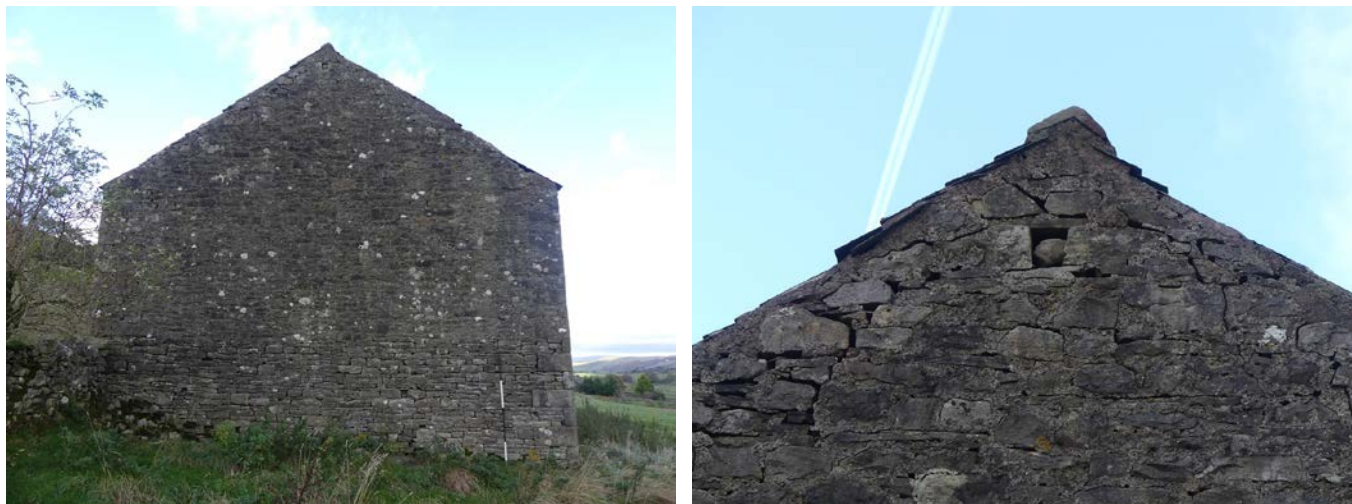
4.2.3 **South external elevation:** this forms the opposing gable and is largely plain (Plate 14), although there is an owl hole below the apex, also filled with a single rounded stone and with a thin stone sill and

lintel (Plate 15), and the corners are finished with dressed quoins. The upper part of the elevation is also filled with the remnants of roughcast render or heavy pointing.

Plate 14 (left): South external elevation, viewed from the south

Plate 15 (right): Owl hole below the apex of the south external elevation, viewed from the south

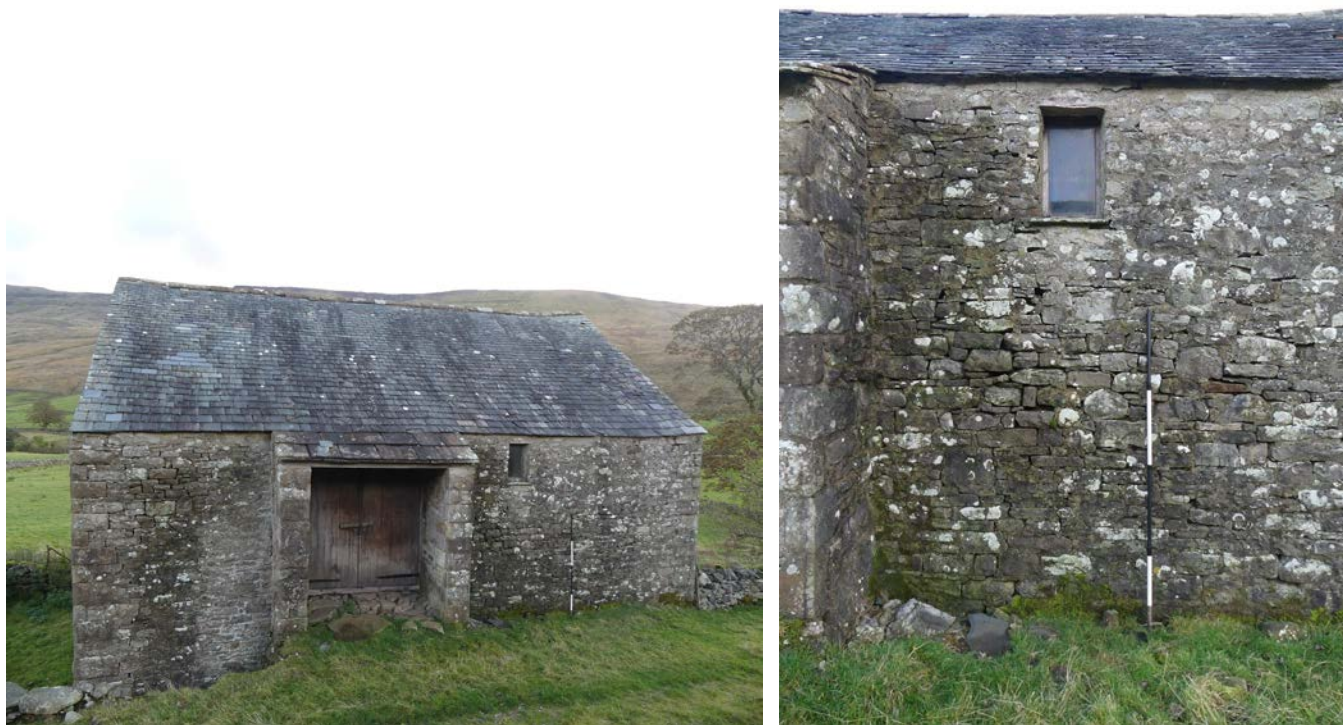
4.2.4 **West external elevation:** this is the upslope side of the building and so only the upper ground floor is visible, apart from a small section on the north side where the retaining wall extending to the north forms a recessed area (Plate 16). There is a small window high on the south side, with a modern single-light casement and thin stone sill (Plate 17). Slightly north of the centre is a wagon doorway with porched or cheeked entrance, housing a relatively modern double plank and batten doorway on long strap hinges (Plate 18). This has substantial sawn timber lintels extending over this and supporting the porch opening. The north flank of the porch is supported by a relieving arch, which presumably formed part of the original ramp into the barn, the space between which is now filled with rough blocks of stone (Plate 19).

Plate 16 (left): West external elevation, viewed from the west

Plate 17 (right): Window on the south side of the west external elevation, viewed from the west

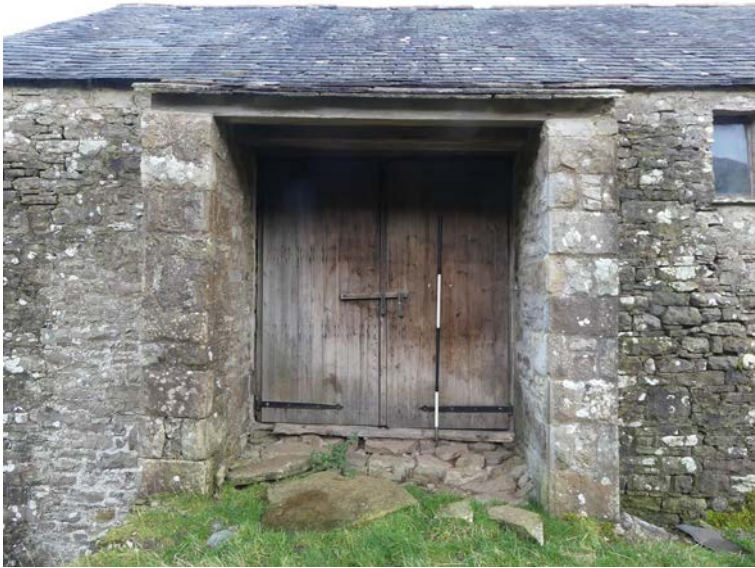
Plate 18 (left): Wagon doorway in the west external elevation, viewed from the west

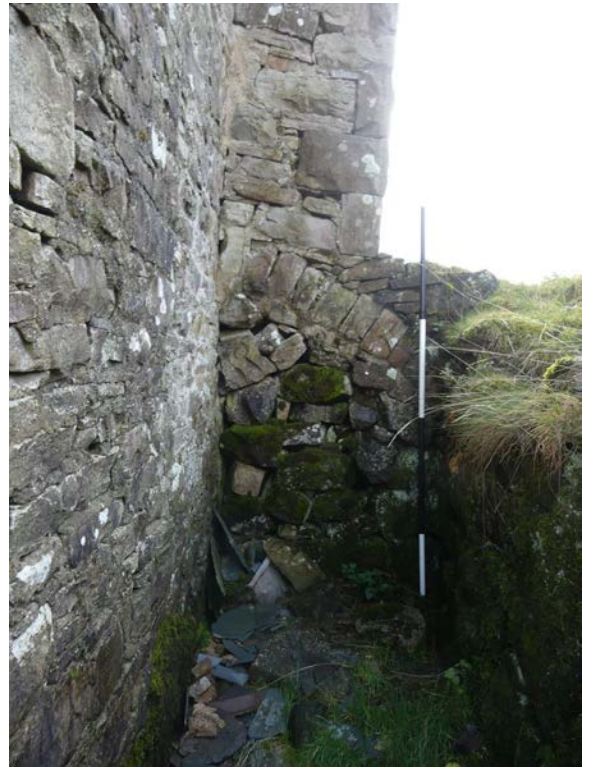
Plate 19 (right): Arch below the north side of the porch in the west external elevation, viewed from the north

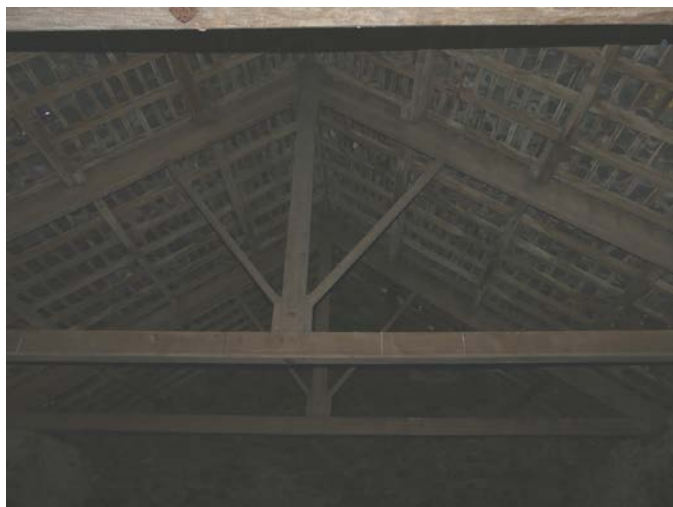
Plate 20 (left): General view of the central truss in upper ground floor Room 1, viewed from the north

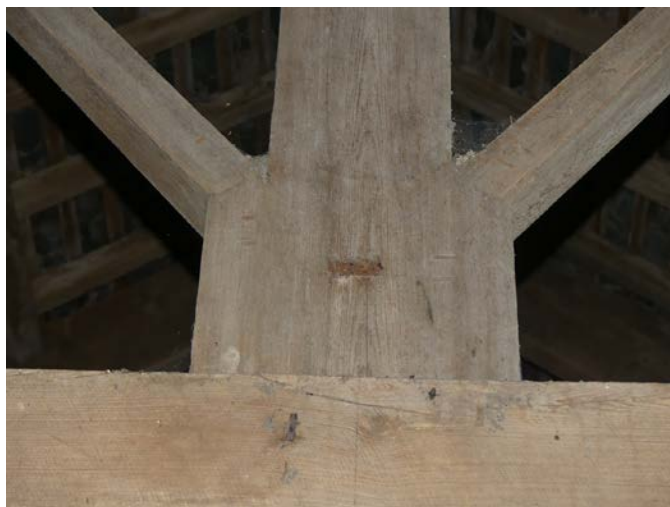
Plate 21 (right): Detail of the carpenter's marks on the central truss in upper ground floor Room 1, viewed from the north

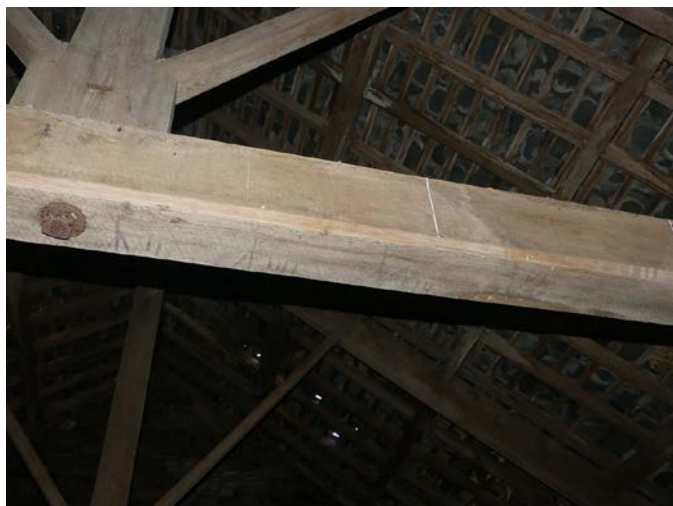
Plate 22 (left): Detail of Baltic marks on the central truss in upper ground floor Room 1, viewed from the north

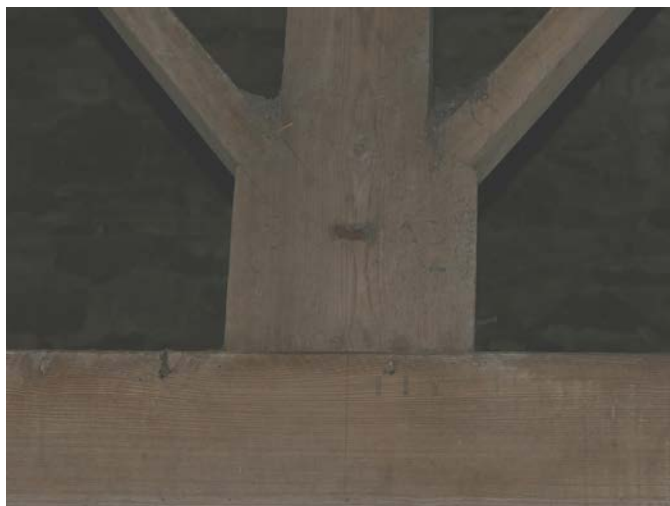
Plate 23 (right): Detail of the carpenter's marks on the southern truss in upper ground floor Room 1, viewed from the north

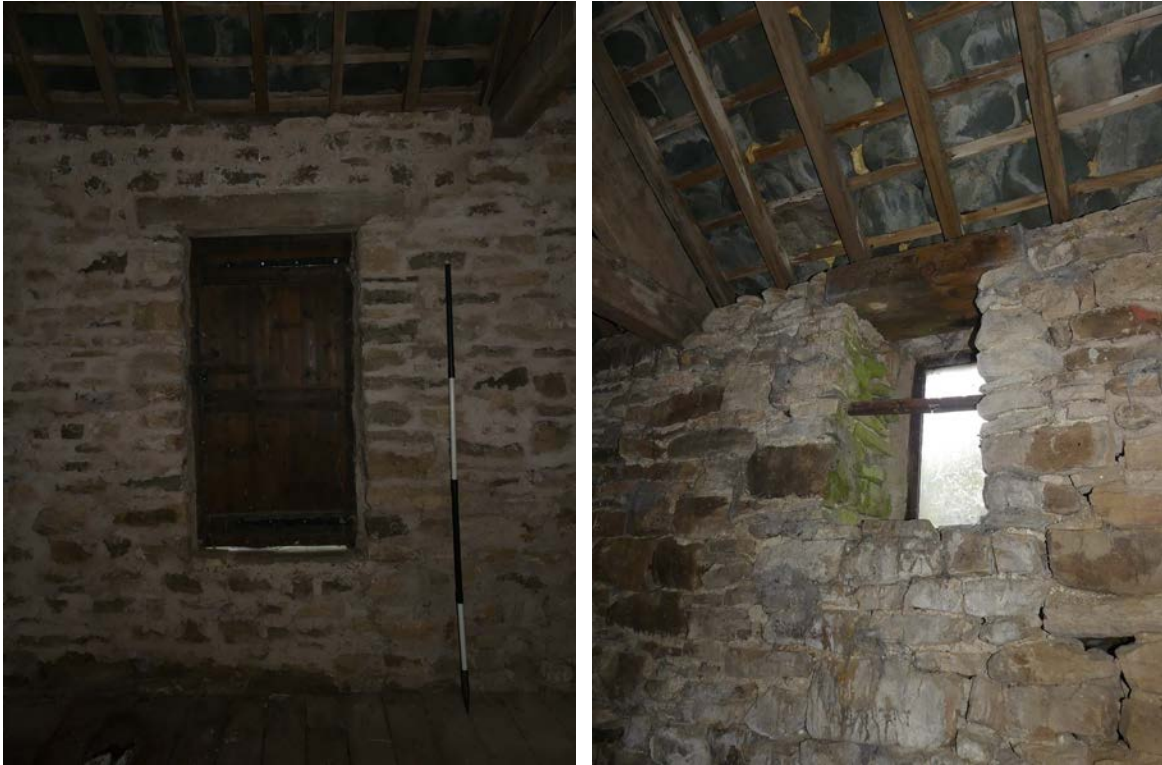
Plate 24 (left): Doorway in the east elevation of upper ground floor Room 1, viewed from the west

Plate 25 (right): Window in the west elevation of upper ground floor Room 1, viewed from the north-east

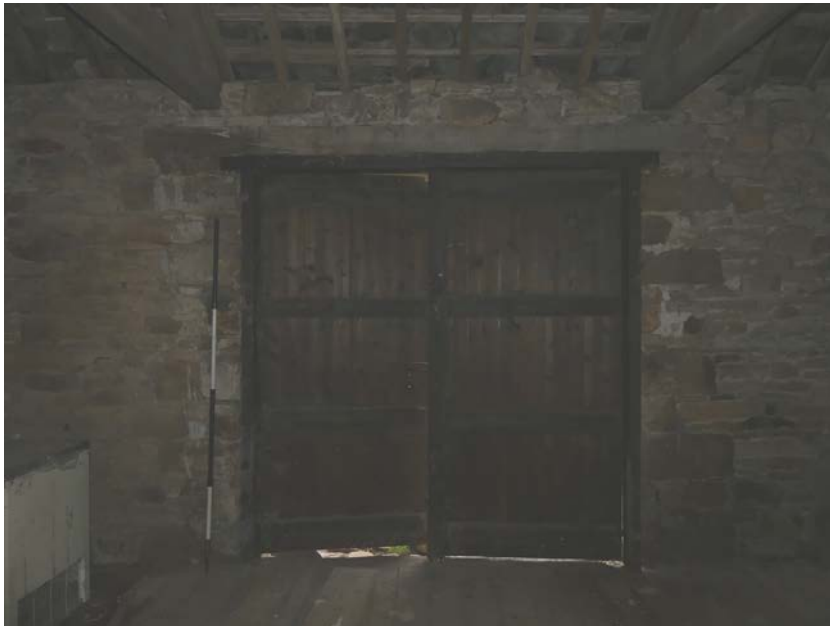
Plate 26: Wagon doorway in the west elevation of upper ground floor Room 1, viewed from the east

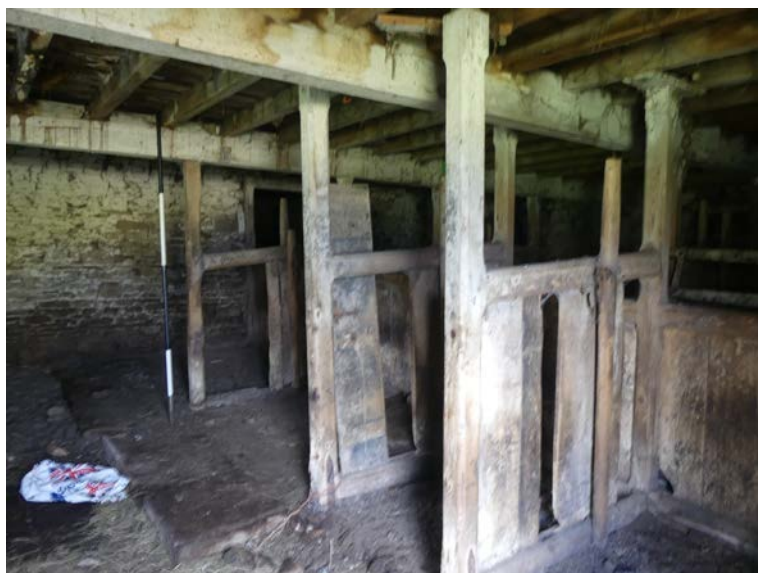
Plate 27 (left): General view of the stalls on the east side of lower ground floor Room 1, from the north-east

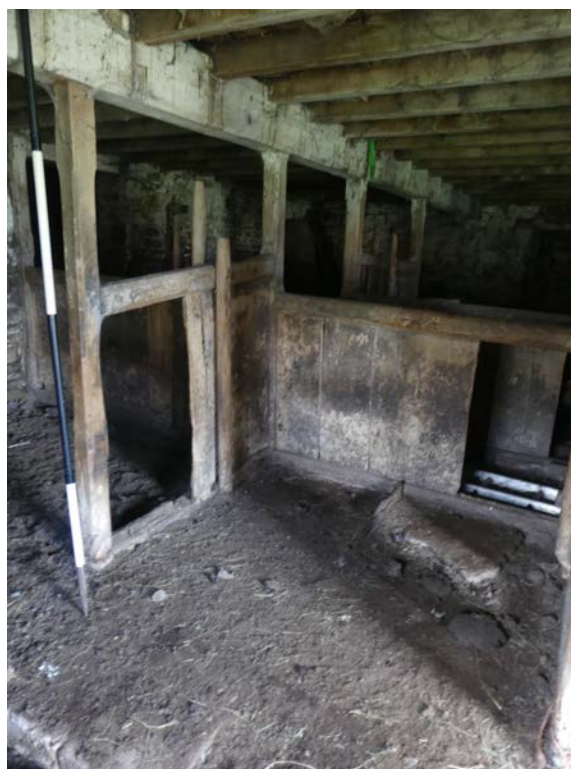
Plate 28 (right): Detail of the southern stall at the south end of the east side of lower ground floor Room 1, viewed from the north-east

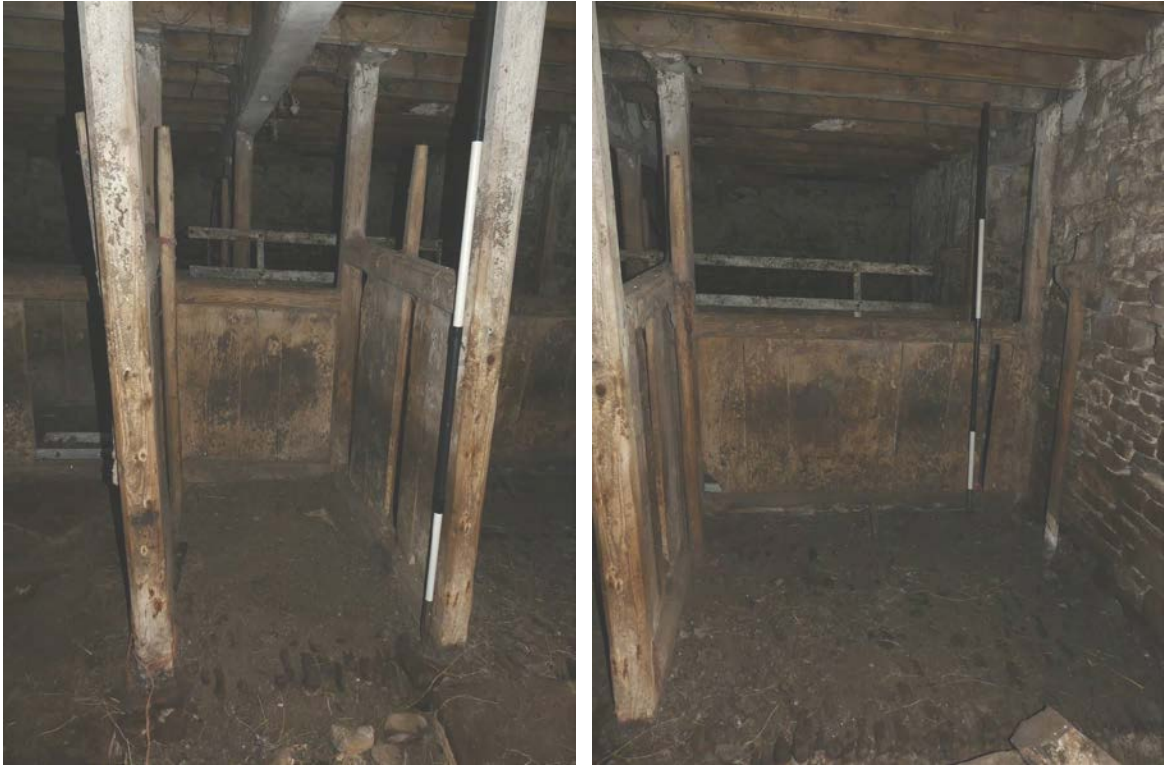
Plate 29 (left): North of centre stall on the east side of lower ground floor Room 1, viewed from the east

Plate 30 (right): Northern stall on the east side of lower ground floor Room 1, viewed from the east

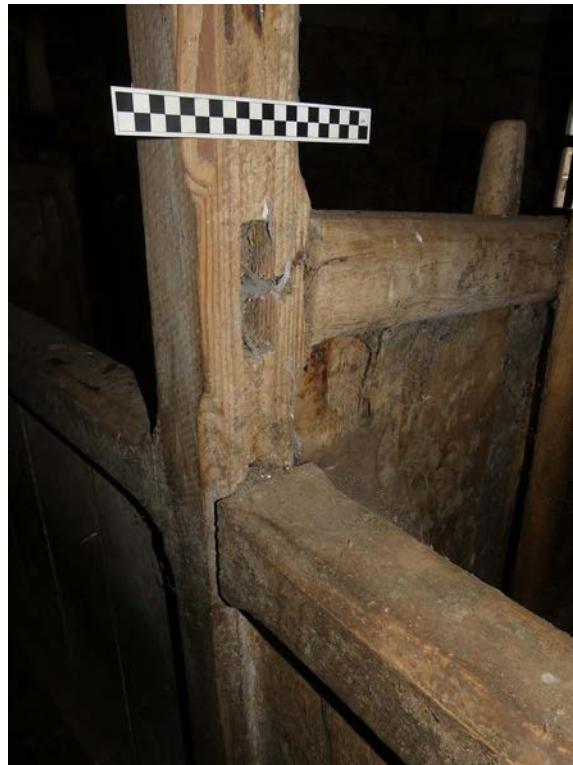
Plate 31: Altered section of the eastern stalls in lower ground floor Room 1, viewed from the south-west

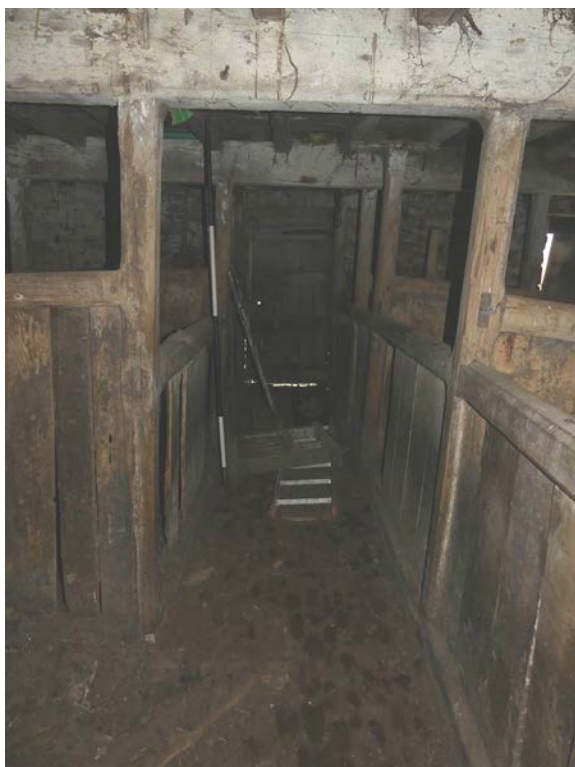
Plate 32 (left): The central feed passage in lower ground floor Room 1, viewed from the south

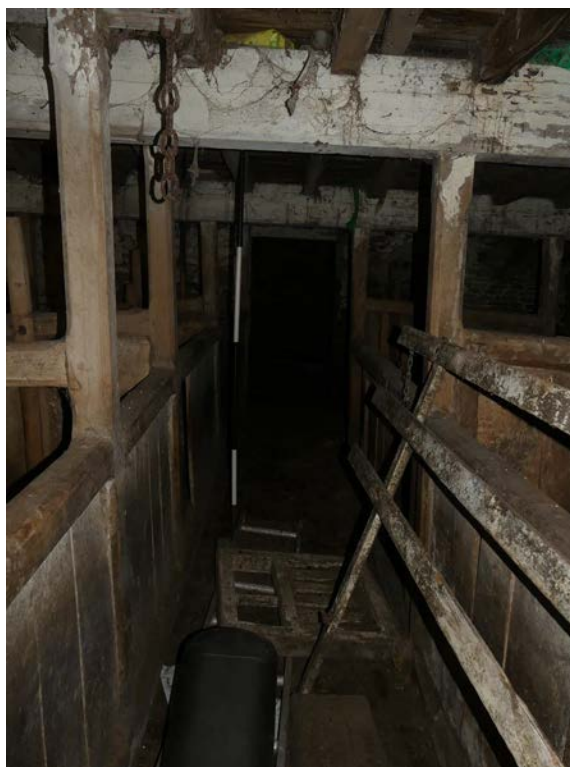
Plate 33 (right): The central feed passage in lower ground floor Room 1, viewed from the north

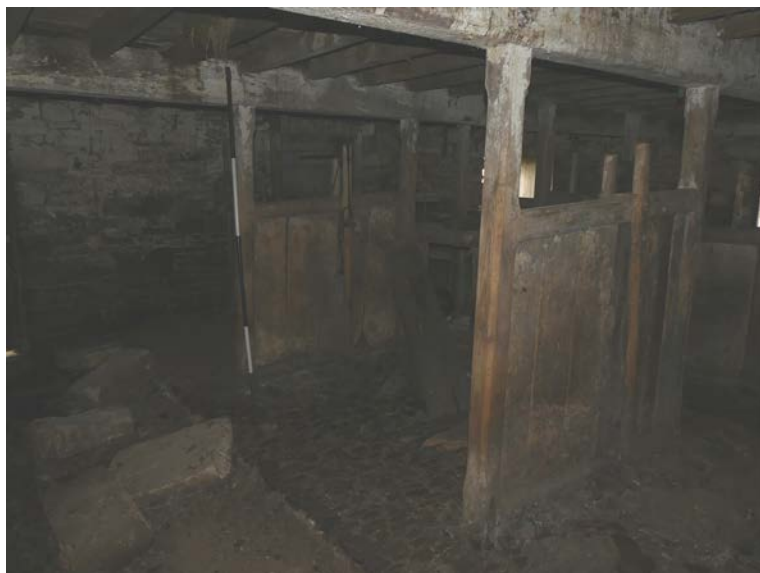
Plate 34 (left): General view of the stalls on the west side of lower ground floor Room 1, viewed from the south-west

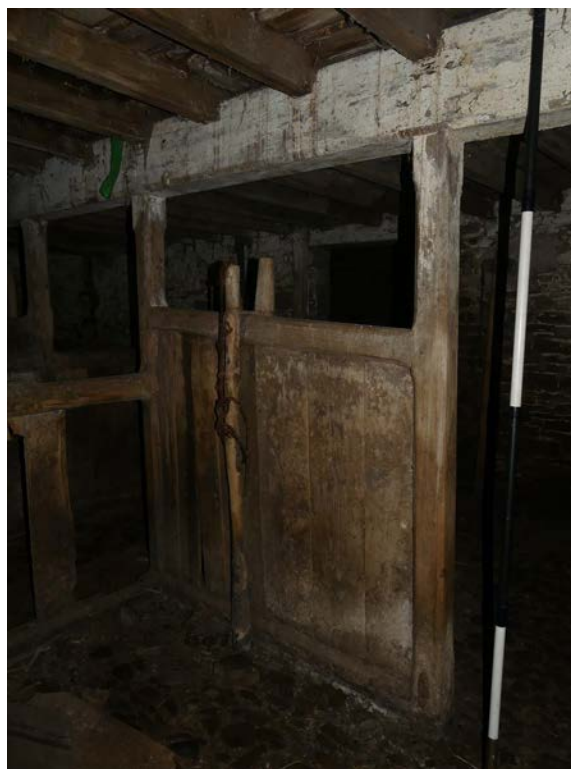
Plate 35 (right): The southern stall on the west side of the lower ground floor Room 1, viewed from the north-west

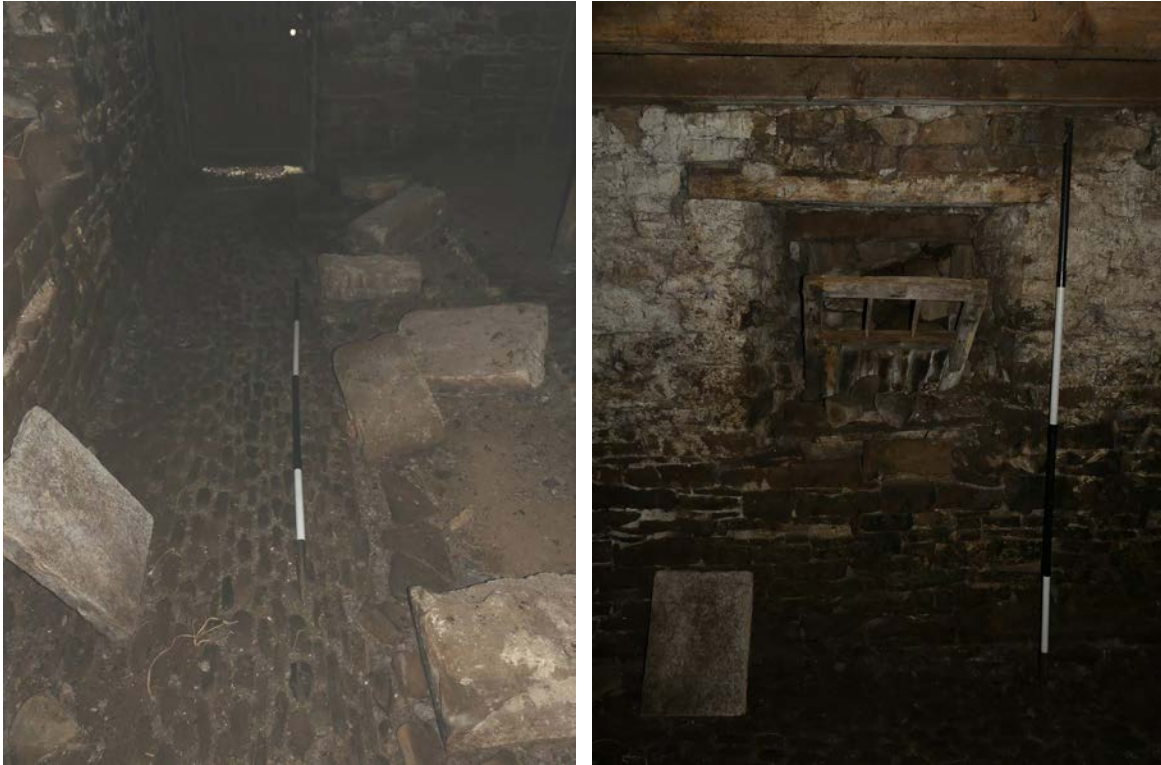
Plate 36 (left): The floor on the west side of lower ground floor Room 1, viewed from the south

Plate 37 (right): The blocked window in the west elevation of lower ground floor Room 1, viewed from the east

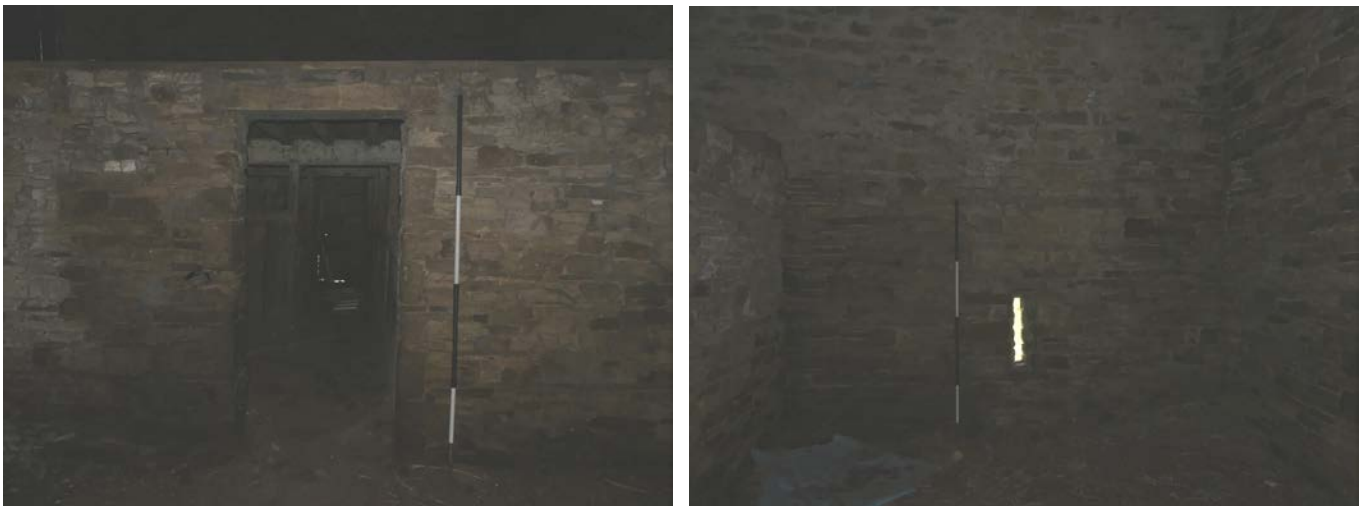
Plate 38 (left): Doorway in the north elevation of lower ground floor Room 2, viewed from the south

Plate 39 (right): Ventilation slot in the east elevation of lower ground floor Room 2, viewed from the west

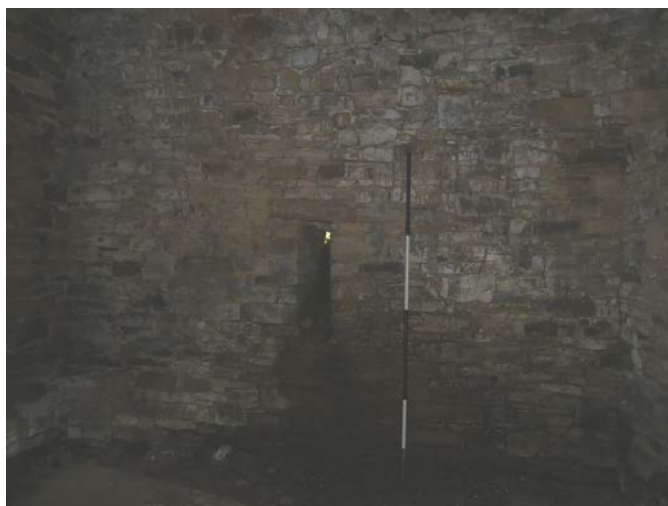
Plate 40: Ventilation slot in the west elevation of lower ground floor Room 2, viewed from the east
