PRIORY CHURCH OF ST MARY AND ST MICHAEL, CARTMEL, CUMBRIA

Archaeological Assessment

Client: PCC Cartmel Priory

March 2023

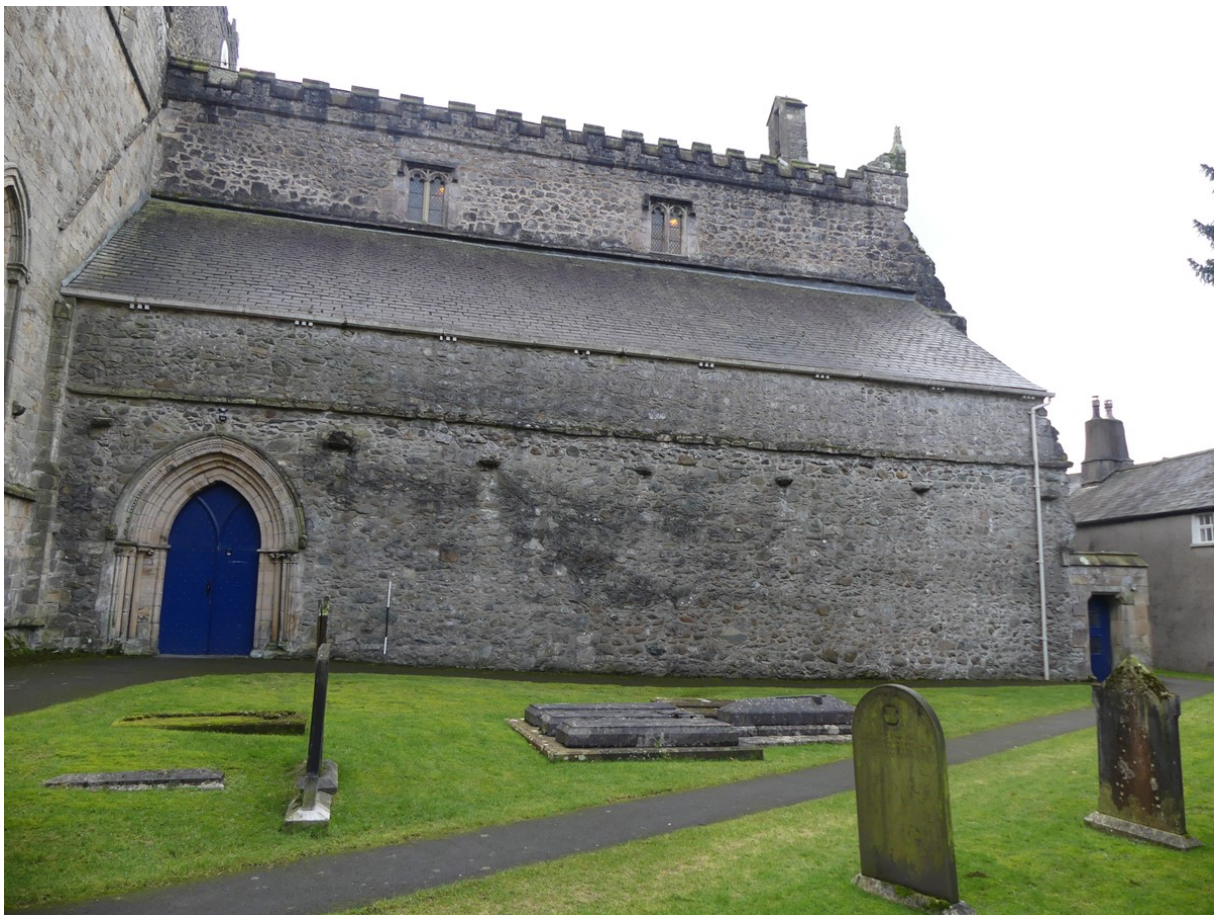
4.1.1 The wall is largely constructed from random courses of rounded and angular stone of various types, for example local slates, volcanics and some limestone with thick cement pointing. There is a doorway on the east side with an ornate pointed arch with engaged columns and other decorative details. Above the level of this door is a row of seven projecting rough corbels, while the west end of the wall at this height the wall is stepped and finished with rough quoins. The lower level has some possible lines of joins and a possible blocked arched opening to the west of the extant doorway, within which are at least two pieces of dressed sandstone, presumably reused. The west end at the base has been extended by a single-storey addition, constructed from ashlar dressed blocks of pale yellow sandstone with triangular stone coping and incorporating a doorway. This has quoined jambs and chamfered top plus a chamfered plinth at the base. Above the row of corbels is an evident area of a different build about 0.5m tall, where the wall has presumably been raised, in very random courses. Above this is a projecting string course; at its east end the first three parts of this are well dressed slabs with a chamfered face, but the rest are very rough slabs. Above this is a fairly uniform area of more consistent limestone blocks, extending to the roof. Within this section, on the east side, is an obvious aperture, blocked with stone.

Plate 8: General view of the external elevation, from the north

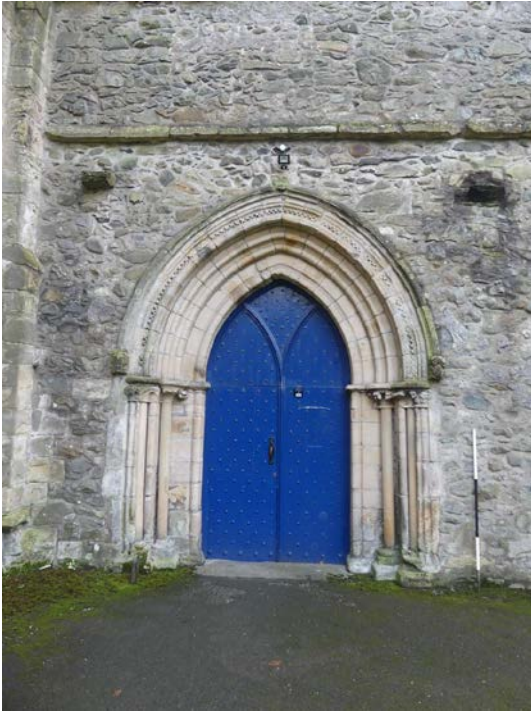
Plate 9 (left): Extant doorway on the east side of the external elevation, viewed from the north

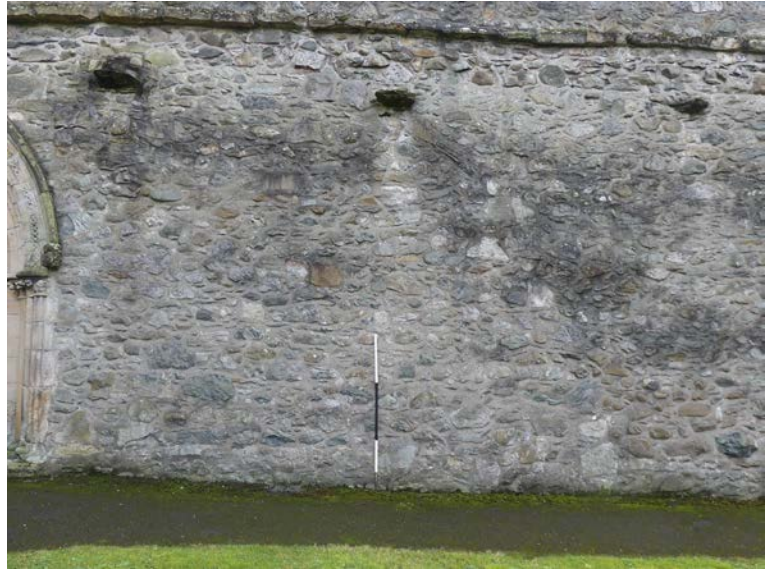
Plate 10 (right): Possible blocked doorway in the centre of the external elevation, viewed from the north

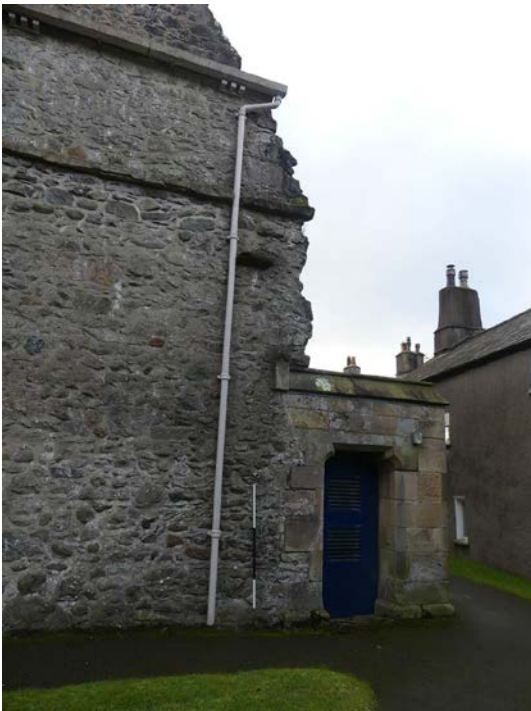
Plate 11 (left): The west end of the external elevation, viewed from the north

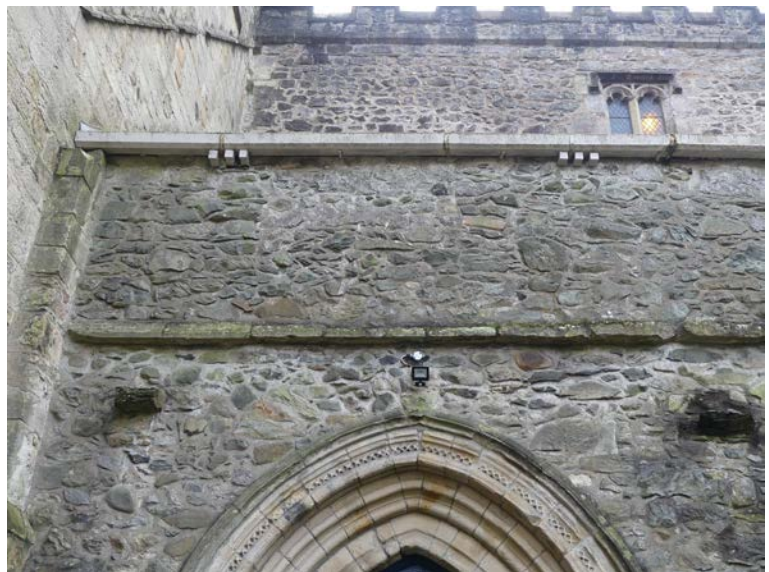
Plate 12 (right): Dressed string course and upper-level blocked aperture on the east side of the external elevation, viewed from the north

5.1.4 **Phase 3 (15th-16th century):** the wall line was evidently raised again, as shown by an obvious change of build in the external elevation, which included the creation of a drip course of stone flags. This also included a small window on the east side. This change was presumably in order to accommodate the current roof.

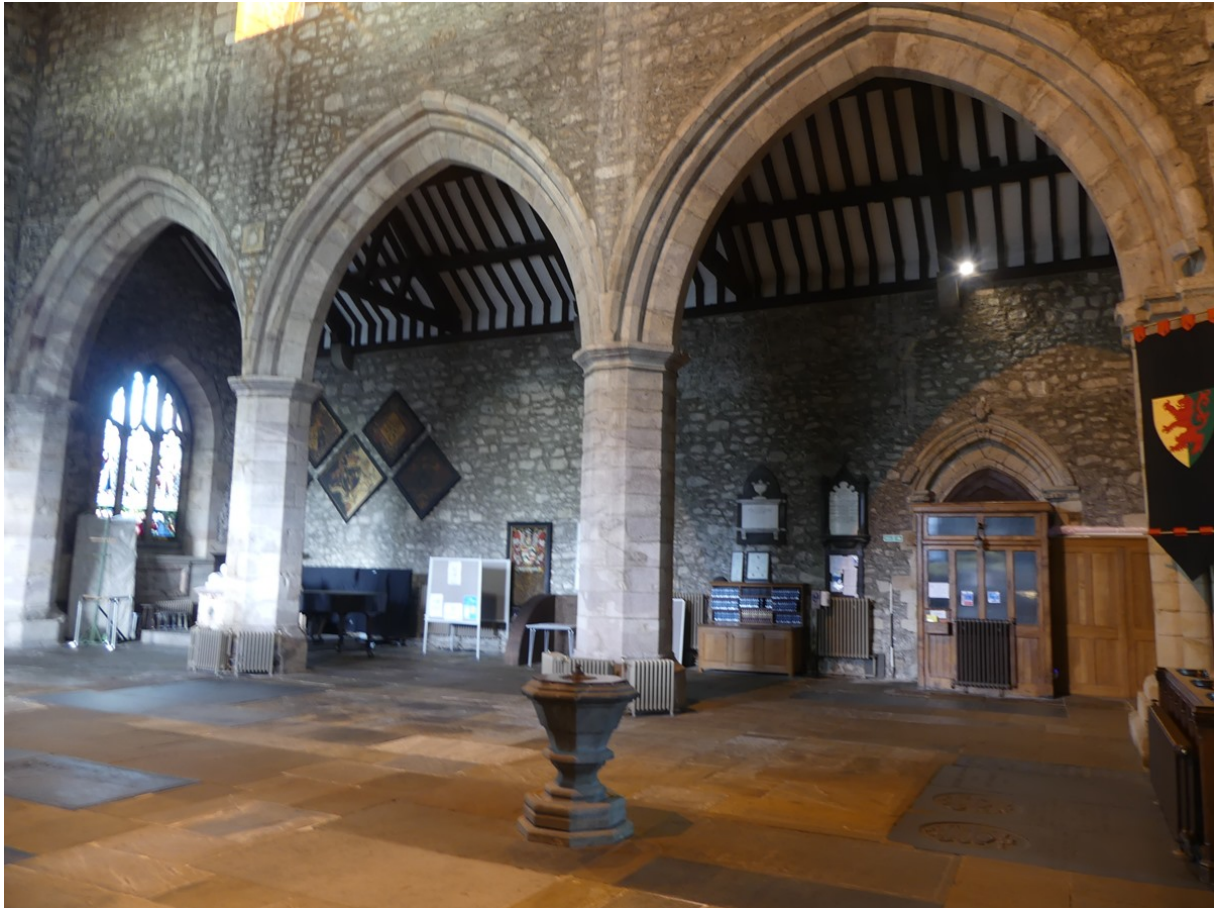
4.2.1 This also has a random course, with a combination of angular and rounded stones, a mix of volcanic and possibly limestone (although the pale colour could be due to staining by plaster or lime wash) with thick concrete pointing. The lower part, about 2.5m tall, of the west side steps out and is a

Plate 13: General view of the interior elevation, from the south-east

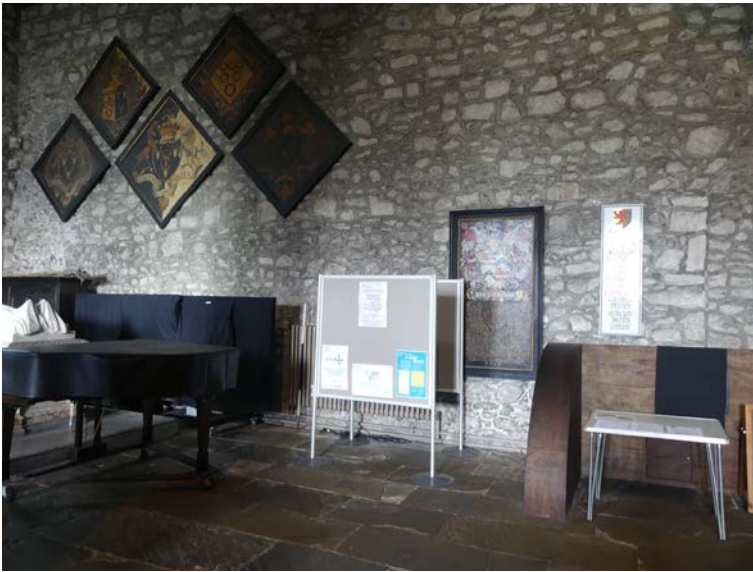
more random build extending for 10.25m from the west end where it comes to a straight quoined end. This is possibly a blocked doorway as there is a partial line of the corresponding jamb 1.1m to the east. To the east is the extant doorway with a pointed arch and moulded surrounds and carved decorative details, with a later timber porch added over. There are three projecting stones in the north-west corner and three projecting semi-circular stone corbels supporting the roof trusses. At the east end, above the top of the doorway, is a projecting step about 4.5m from the ground.

Plate 14 (left): The stepped section on the west side of the internal elevation, viewed from the south-east

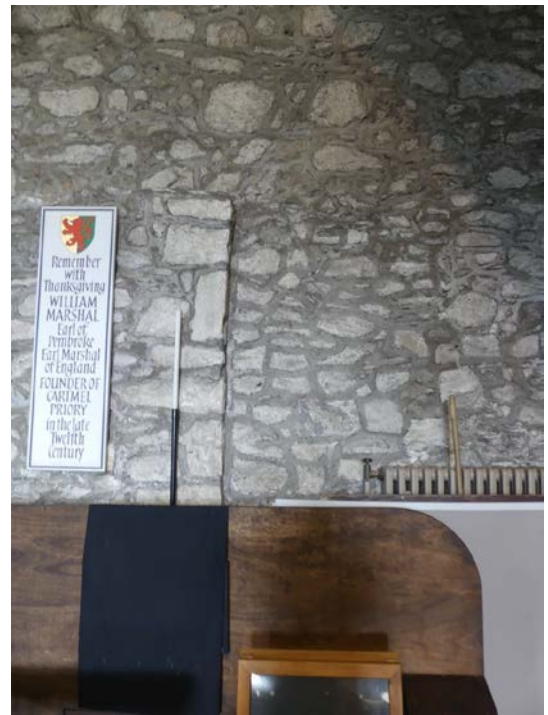
Plate 15 (right): The quoined end to the stepped section of the internal elevation, viewed from the south

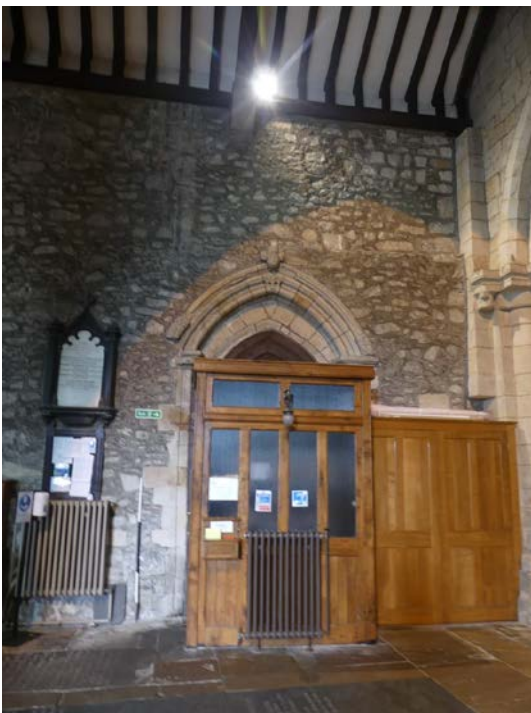
Plate 16 (left): Extant doorway on the east side of internal elevation, viewed from the south

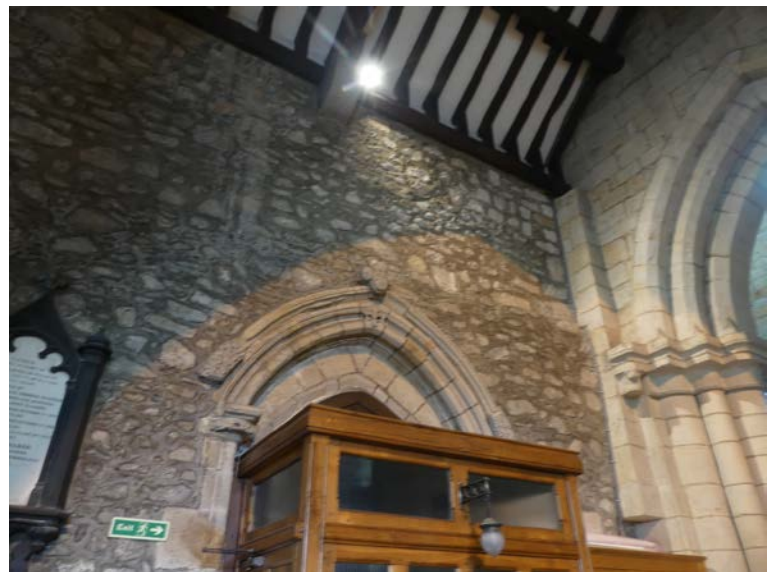
Plate 17 (right): Stepped section high on the east side of the internal elevation, viewed from the south-west
