FORMER PRESBYTERIAN CHURCH, SCHOOL STREET, BARROW-IN-FURNESS, CUMBRIA

Archaeological Building Recording

Client: Barrow Borough
Council

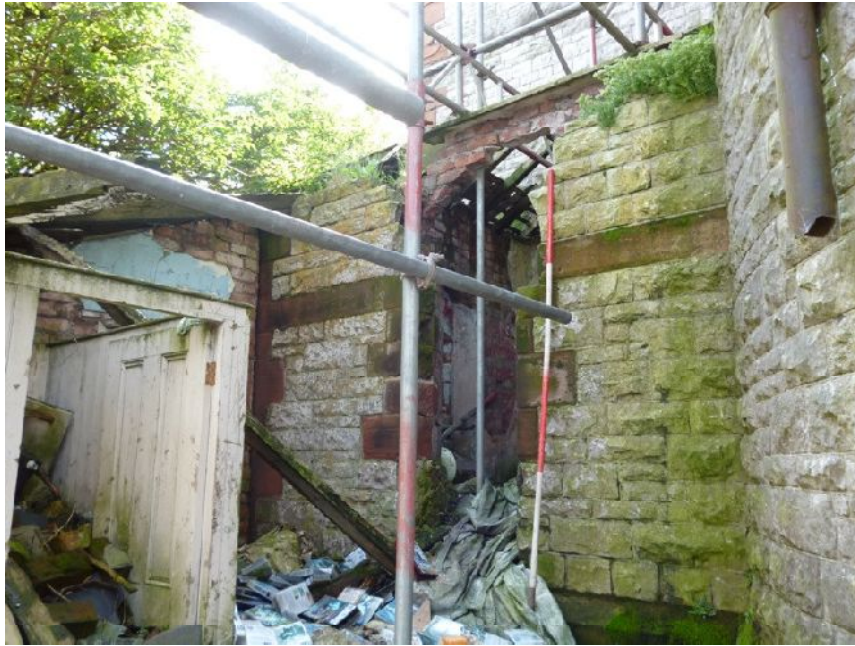
4.2.1 **North-east elevation:** the south-east side of the original external elevation is partially obscured by the later brick outshut (forming Room G5), which is constructed from machine-made red brick, marked 'FURNESS BRICK C^O L^D BARROW', laid in stretcher bond and has a window in the north-west side. This has a dressed sandstone sill and is blocked with brick. The remains of the monopitch roof including the barge board are present on top of the wall. Behind this is the external elevation proper, the south-east end of which comprises the remains of a single storey outshut (Room G4) with a relatively ragged hole in the wall forming a doorway between G4 and G5, which was evidently originally a window (Plate 16). The scar of its round head is visible but the stone work has broken away and it has dressed sandstone quoins in the jambs and what are probably the remains of a sandstone sill. The south-east side of this wall is also finished with sandstone quoins and a string course and projecting angled plinth run across the elevation. The roof of the outshut is monopitch, although little of its structure remains, with only a scar in the wall above denoting the position of the actual roof line. Above the outshut the wall is relatively plain and of limestone construction with red sandstone details. It returns in the centre of the elevation to form a rounded section (forming the apse internally). This has a window in the south-east side at the first floor level with a rounded head finished with ashlar red sandstone and similar quoins, although the position of the lower internal head is visible making it appear a different size inside and out. In the north-east face there are two windows in a similar style, one on each floor. Below the ground floor window the projecting plinth continues around the rounded section, and below this, but effectively built into it, is a plain rectangular aperture with sandstone quoins and sill, which evidently formed a vent into a below-floor area. To the north-west of the rounded section the elevation has a smaller ground floor window, but in the same general style, and below the plinth the top part of a window is evidently, clearly lighting a cellar or below-ground area, again with sandstone lintel and quoins. All of the ground floor windows, and this lower window, have been blocked with concrete blocks.

Plate 16 (left): Damaged window, on the south-east side of the north-east external elevation, latterly used as a doorway between G4 and G5

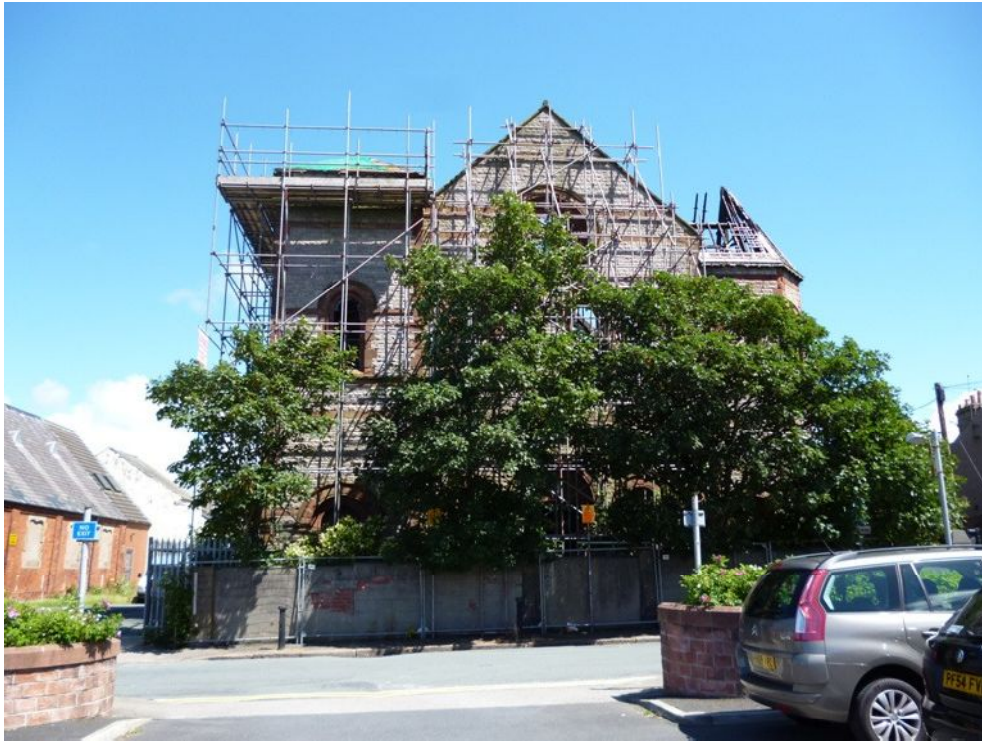
4.2.3 **South-west elevation:** this forms the front façade of the building, with the main access to and from School Street (Plate 19). It has towers at either end, on the ground floor of each is a doorway accessed by a flight of yellow sandstone steps, although some of these have been replaced with concrete. Both doors are broadly the same, with dressed sandstone quoins incorporating a moulded shaft and segmented arches forming round heads, above which is a hood mould with a projecting stop (Plate 20 and Plate 21). The doors are of heavy plank construction with decorative iron strap hinges and ring handles. In the centre is the main doorway, which has similar dressed quoins with moulded shafts, and a round headed segmented arch with a hood mould, below which is a flattened arch forming a tympanum of ashlar blocks (Plate 22). The door is again accessed via four sandstone steps, the top one being a replacement in concrete, with a later iron handrail attached between the bottom step and the quoins and a scrolled iron bracket for a gas lamp attached to the upper arch and the remains of a plastic fitting, presumably a burglar alarm, below. The actual door is largely destroyed but remnants of it remain, and it was clearly of similar construction to those at either end with the same strap hinges (Plate 23). The central doorway is flanked by a pair of windows in a similar style to those throughout the building with dressed sandstone quoins and hoodmould, both of which are blocked with concrete blocks. On the south-east side of the central section there is a projecting buttress, with an angled top and red sandstone quoins, which extends to the first floor. The first floor has a row of four windows in two pairs, again in a similar style to the rest, and above these there is a large octofoil rose window, again with dressed sandstone details and moulded surrounds with two string courses butting against it. Some remnants of the lead work and glazing remains in all of the upper level windows. At the top of the gable that forms the centre there is a further narrow slot opening and the wall top is finished with sandstone coping. The towers at either end both have a single window at first floor level, again in the same style as the rest, and they incorporate several string courses and corners are finished with red sandstone quoins. Each tower has as the remaining structure of a pyramidal roof.

Plate 19: General view of the south-west external elevation

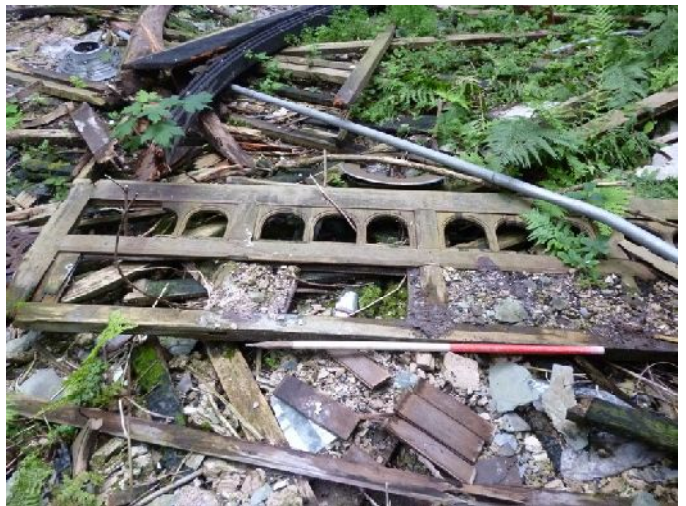
Plate 30 (right): Loose piece of gallery amongst debris, Room G1

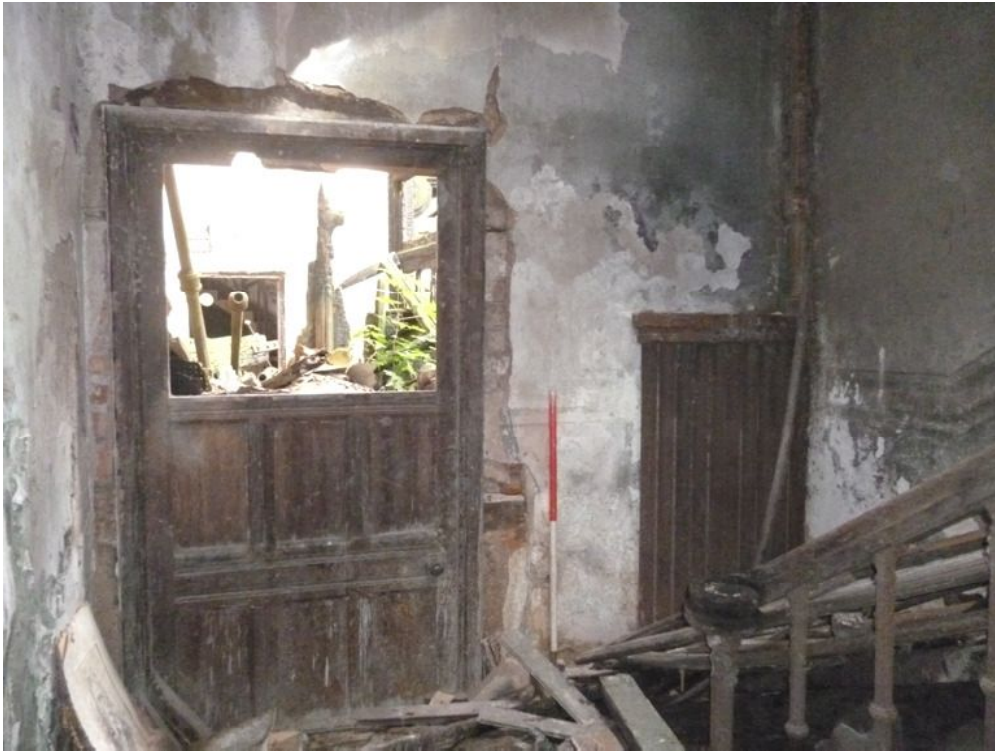
4.3.6 **Ground floor, Room 4:** this forms the interior of the tower in the south corner. The floor is covered by debris to a considerable depth, even covering the lower part of the staircase, making access extremely difficult. It is open to the floor above, and has a staircase against the north-east and south-east walls, the steps of which are constructed from pale yellow sandstone with a cast iron newel post and balusters and turned timber hand rail as per Room G3 (Plate 44). The walls are finished with plaster throughout with a moulded skirting and painted pattern, like that in Room G2 and G3, remaining. There is a chamfered timber bracket with iron coat hooks around the south corner (Plate 45). The south-west elevation has a central doorway with a timber door of similar construction to that in Room G3 (Plate 46). The north-west elevation also has a doorway, with the lower part of a panelled door remaining and there are iron pipes in the north corner, presumably also forming part of the heating system (Plate 47).

Plate 47: North-west elevation of Room G4 showing door and iron pipes

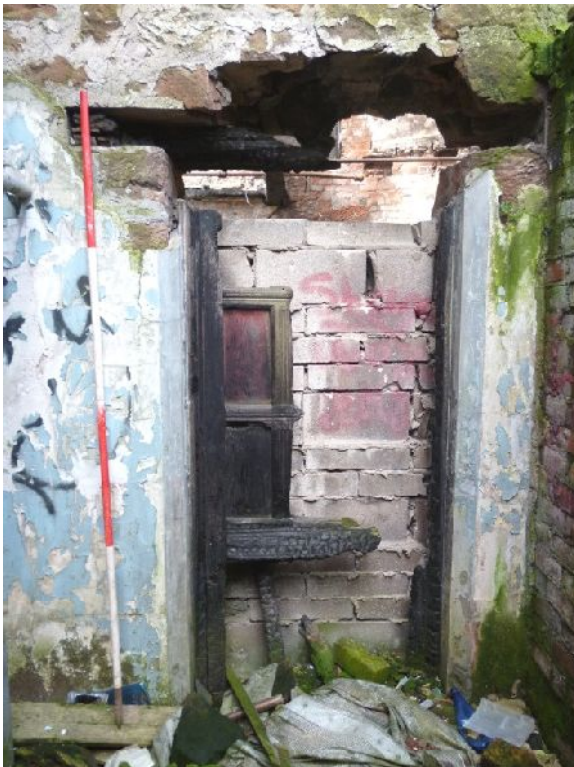
4.3.7 **Ground floor, Room 5:** this comprises the interior of the small outshut projecting from the south-east side of the north-east elevation. Again the floor is covered by debris and it is open to the roof, although only a small amount of the structure of this remains showing it was angled and supported by a single purlin running between the east and west corners. The walls are a mixture of exposed brick and stone, the plaster mostly having come away. The north-east elevation has a large opening in the centre, which has splayed jambs although its head has largely collapsed. This was presumably originally a window, but was subsequently converted into a doorway leading to Room G6 as the original sill has evidently been broken through. The south-east elevation has a central window with a round head and stone outer detailing although internally most of the finish is lost (Plate 48). The south-west elevation has a small fireplace on the south-east side with only a very basic splayed opening below a sandstone lintel (Plate 49). To the north-west there is a doorway with a chamfered surround and 12-panel door with beading (Plate 49). Above the doorframe there is a section, which was evidently filled with timber below the lintel proper, perhaps suggesting this doorway has been modified. The north-west elevation has a metal mesh panel on the south-west side, running the full height of the wall, presumably hiding pipes or cables behind. There is a doorway to the north-east with the burnt remains of a timber lintel and what was presumably originally a 12-panel door, with the stonework above the lintel largely collapsed (Plate 50).

Plate 50 (left): Damaged doorway in the north-west elevation of Room G5

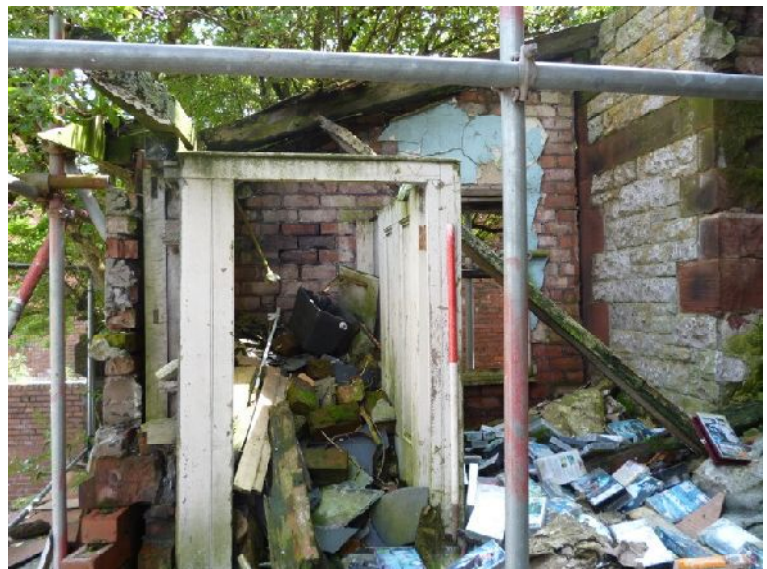
Plate 51 (right): General view of Room G6 showing internal stud walling

constructed from tongue and groove planks, which evidently formed a toilet cubicle, with a doorway on the north-west side with a four panel door still *in situ* (Plate 51). The north-east elevation has a window in what originally would have been the centre, with the remains of a single-light timber casement; the wall to the north-west of this has collapsed as has the north-west elevation. The south-east elevation has holes for a bracket on the north-east side for a supporting a toilet cistern, which is sitting loose amongst the debris, and there is a central window with a two-light timber casement and sill to the south-west. The south-west elevation forms part of the original external elevation and is described in *Section 4.2.1*.

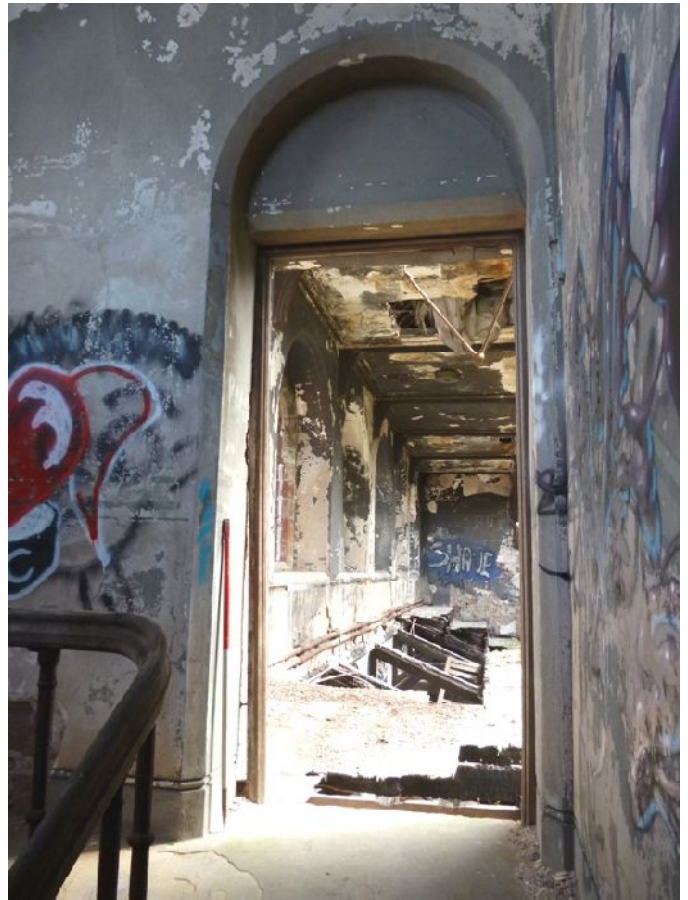
east onto the gallery, with the burnt remains of a door frame with a relatively plain chamfered finish (Plate 60).

Plate 60 (right): Doorway leading to gallery to north-east from Room F3
