'GRANGE LIDO', GRANGE-OVER-SANDS, CUMBRIA

Archaeological Building Recording

Client: NPS North West Ltd

March 2013

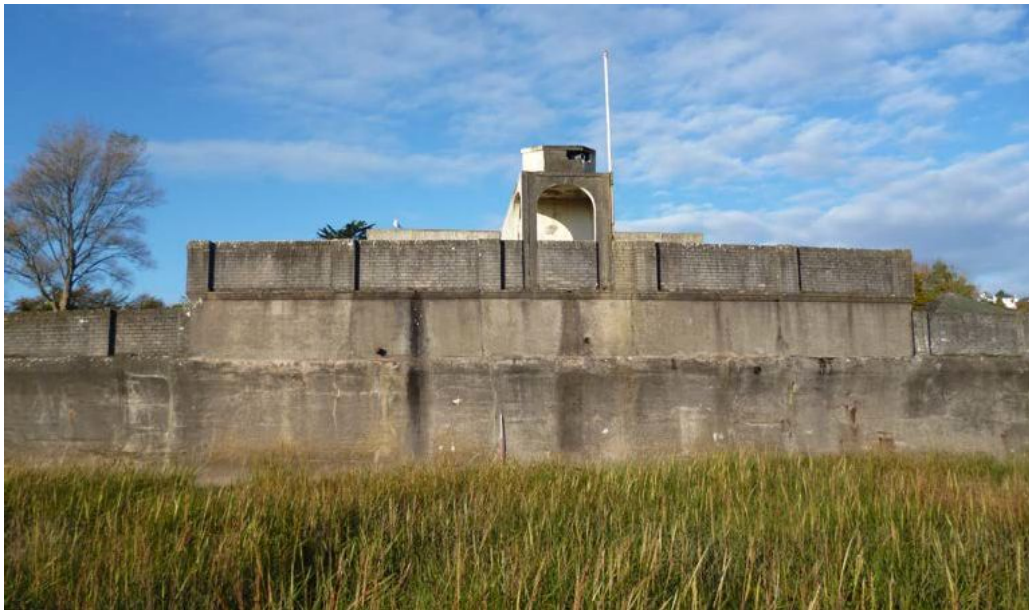
4.2.6 **East Building, East Elevation:** the lower part of the east elevation comprises the outer retaining wall (Plate 38; see Section 4.2.21 below). This is topped with a concrete stilt structure with a round arch, which has a flat roof housing a small structure containing a telescope (Plate 39). Inside this structure the main central part houses the access to the diving platforms, which is blocked with boarding. The scars of steps are apparent on the north and south sides of this structure (see Plate 37 and Plate 41), although access to the flanking diving boards is also blocked with boarding.

Plate 38: East elevation of the east building, showing the outer retaining wall

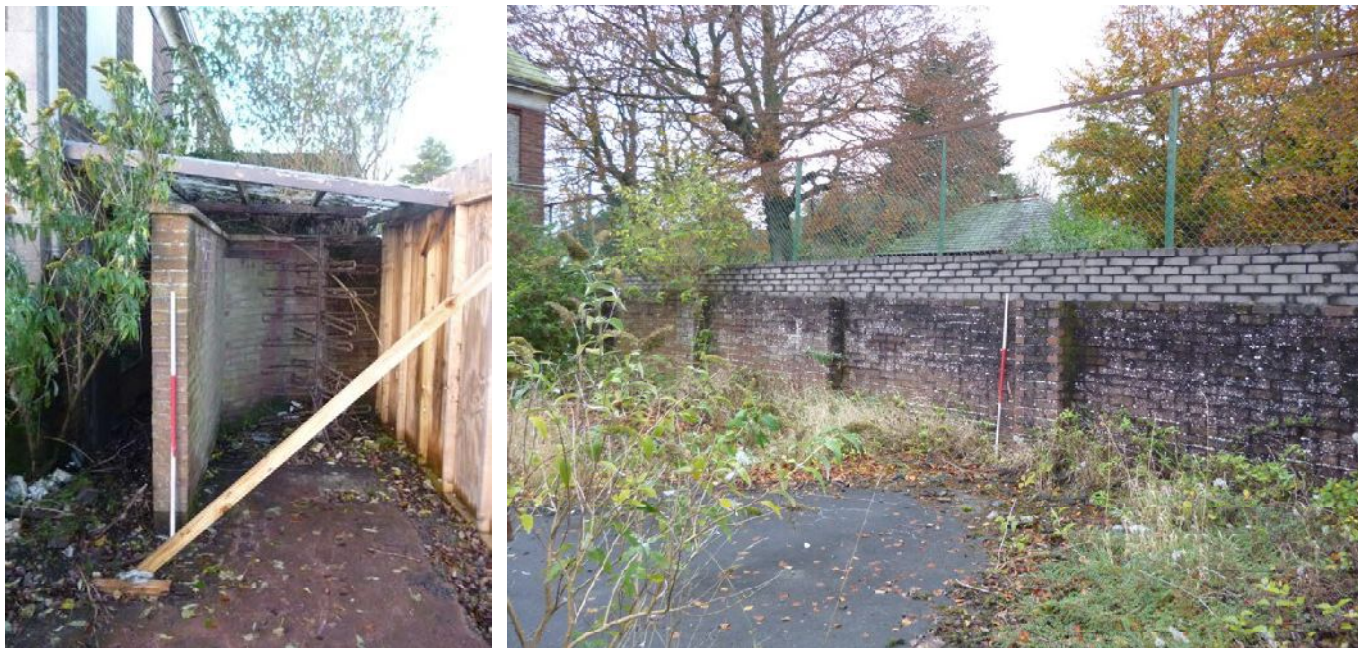
4.2.19 **Boundary walls:** the western boundary wall had collapsed prior to the building recording, south of the west building, but the rubble shows that it too was constructed from Askam bricks and it originally incorporated an iron turnstile, which still stands at the south end below a rough timber shelter with a corrugated plastic roof against the north-west corner of the south building (Plate 62). The west boundary wall north of the west building is still extant (see Plate 63 to Plate 65). The lower part is constructed from Askam bricks with a row of buttress along it, and this is topped with six courses of later concrete blocks and an attached wire mesh fence.

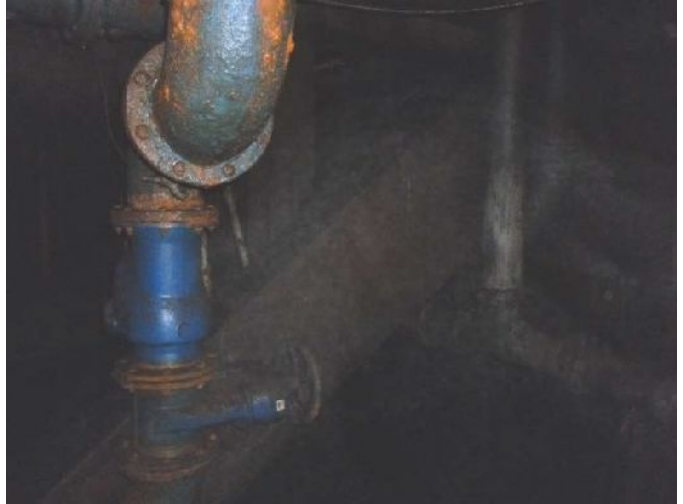
Plate 210 (right): Replaced valve in the room below the pump/filter house
