# THE CHAPEL, NORTH ROAD, HOLME, MILNTHORPE, CUMBRIA

## Archaeological Building Recording

April 2013

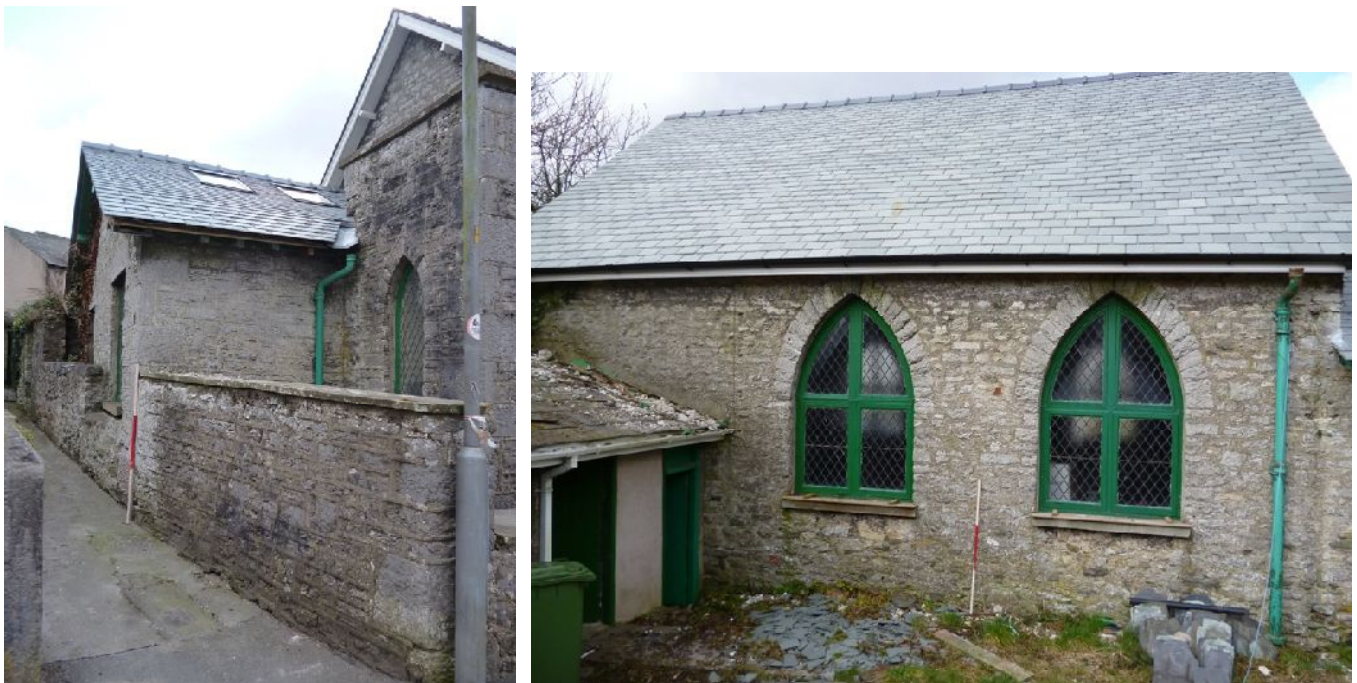
4.2.1 **North elevation:** this comprises dressed stone with mortar bonding; the east end of the elevation extends out from the main body of the building and has a modern gabled slate roof (Plate 10; Figure 2). To the west of this is a flat stone roof over the entrance porch. There are two rectangular windows in the east section, with flat stone lintels and four-light casements, and a small window in the west section with a pointed arch.

4.2.2 **East elevation:** this also comprises dressed stone with mortar bonding and two pointed arch windows with yellow sandstone lintels (Plate 11; Figure 2). There is also a doorway at the north end of the elevation with a large stone lintel and a tongue and groove plank door (Plate 12).

Plate 10 (left): North external elevation

Plate 11 (right): South end of east external elevation

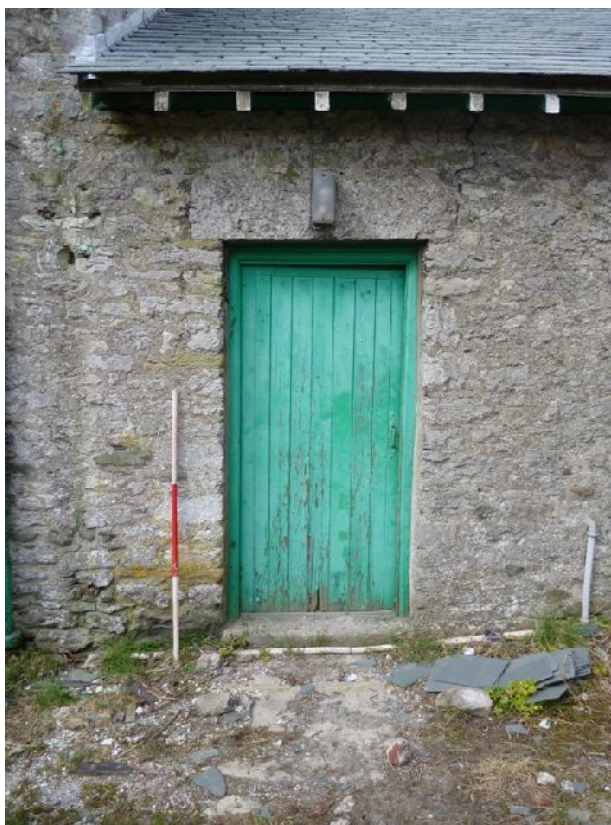
**Plate 12: Plank door at north end of east external elevation**

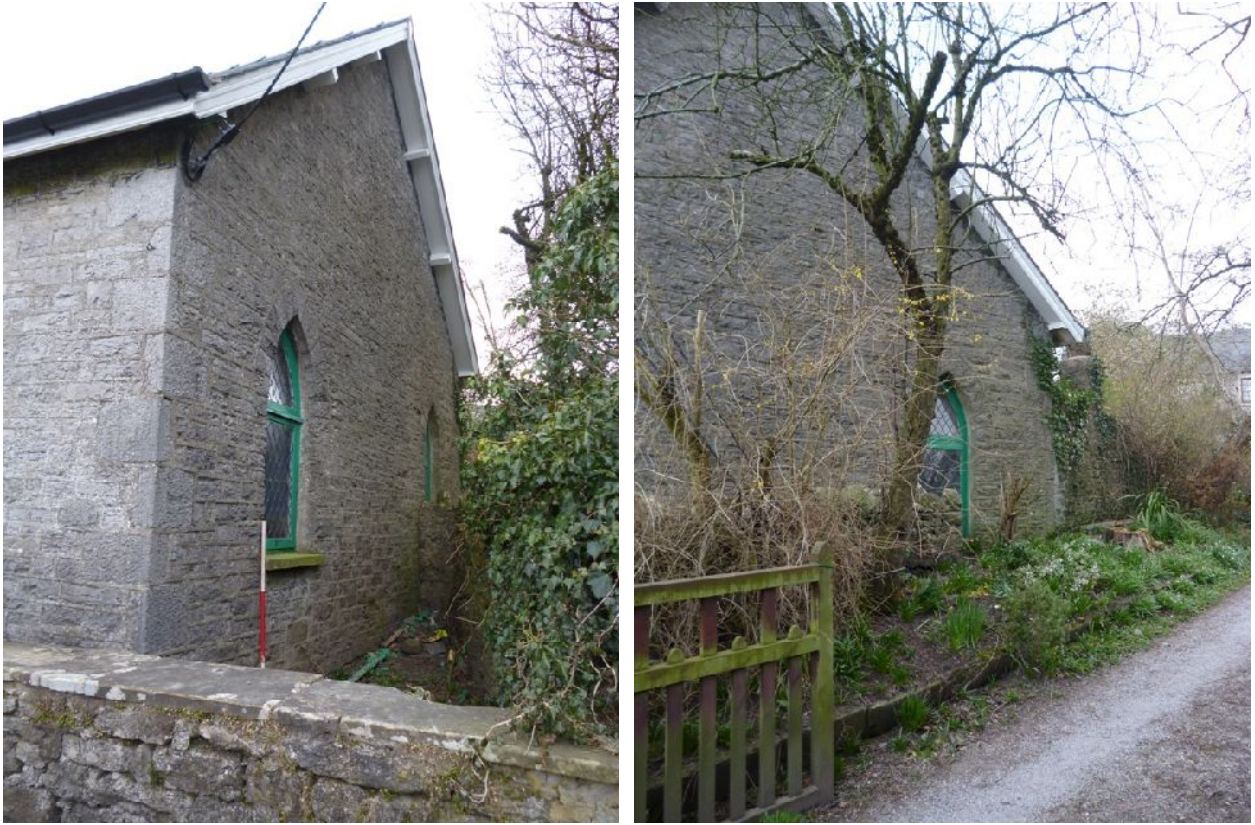
4.2.3 **South- elevation:** this too comprises dressed stone with mortar bonding and has two pointed arch windows (Figure 3; Plate 13). Abutting this elevation is the rear elevation of the outbuildings which are plain although there is a chimney (Plate 14) that currently serves no purpose as there does not appear to be any evidence of a fireplace within the interior.

**Plate 13 (left): South external elevation**

**Plate 14 (right): East side of the south external elevation showing the rear wall of the outshut**

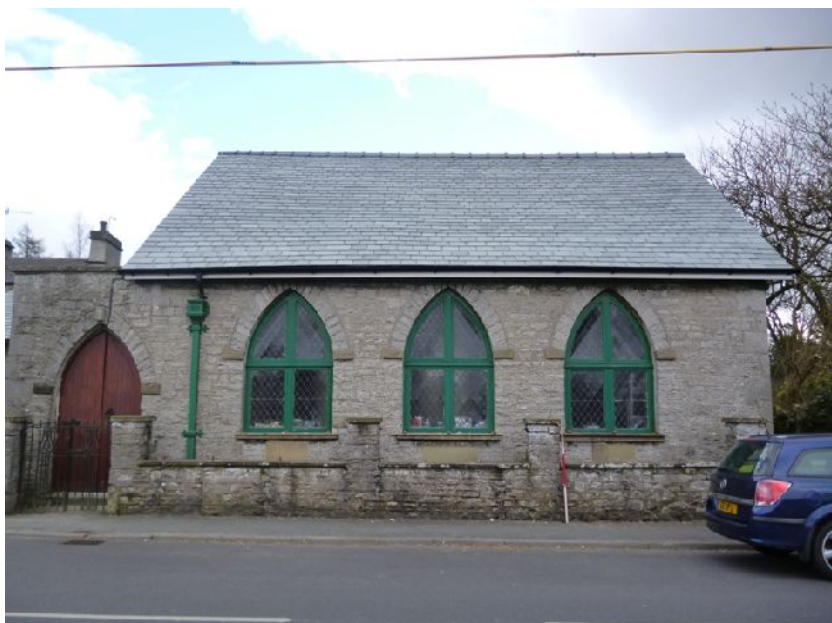
4.2.4 **West elevation:** this too comprises dressed stone with mortar bonding and has three pointed arch windows with projecting sandstone kneelers at the base of each arch (Plate 15; Figure 3). At the north end is a large pointed arch double doorway at the north end with a tongue and groove plank door with an elaborate knocker (Plate 16). Immediately to the south of this is an iron down pipe with decorative brackets, the hopper of which is marked '1923' (Plate 17). Beneath each of the windows is a sandstone plaque; the central one comprising a single rectangular block, those to the north and south made up of six smaller squares in two rows of three forming a similarly sized panel.

**Plate 15 (left): West external elevation**

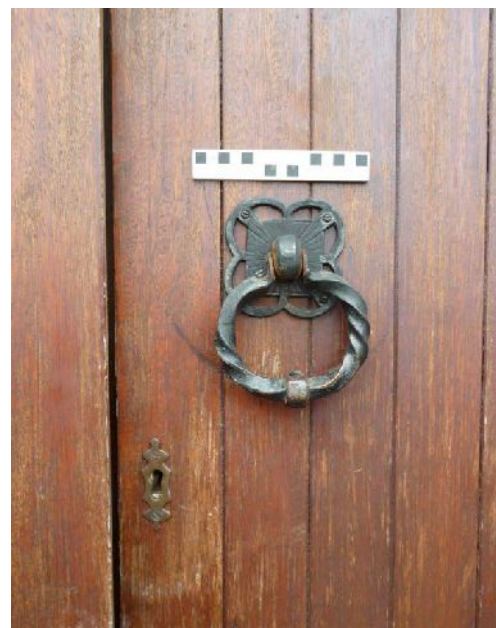
**Plate 16 (right): Detail of the door knocker**

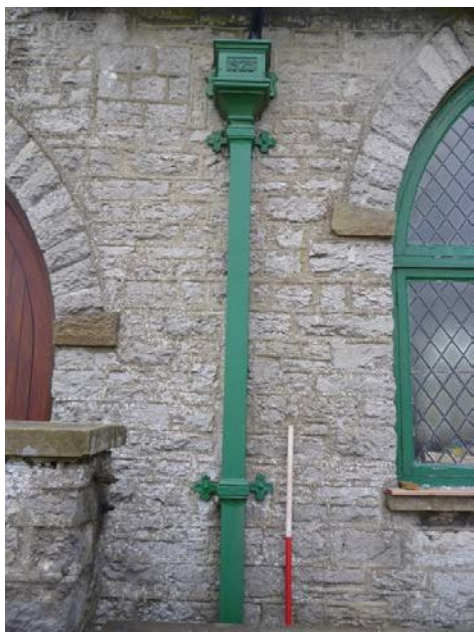
**Plate 17 (left): Downpipe and dated hopper**

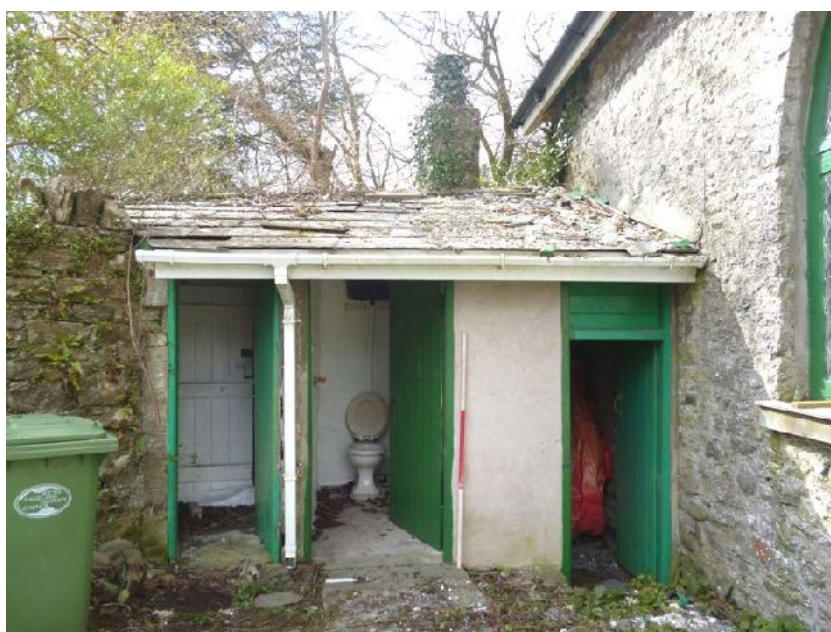
**Plate 18 (right): North elevation of attached outshuts**

4.2.5 **Outbuilding**: this comprises a low monopitch structure divided into three separate rooms (Figure 4), the dividing walls built from either concrete blocks or bricks (Plate 18). The central part currently comprises a toilet with the adjoining areas used as storage space. The roof is finished with slate and the floor is concrete. The interior walls are plain and modern. A chimney is visible from the south of the property although there is no evidence of a fireplace within the building, although there is a block of masonry opposing this and incorporated into the north wall.

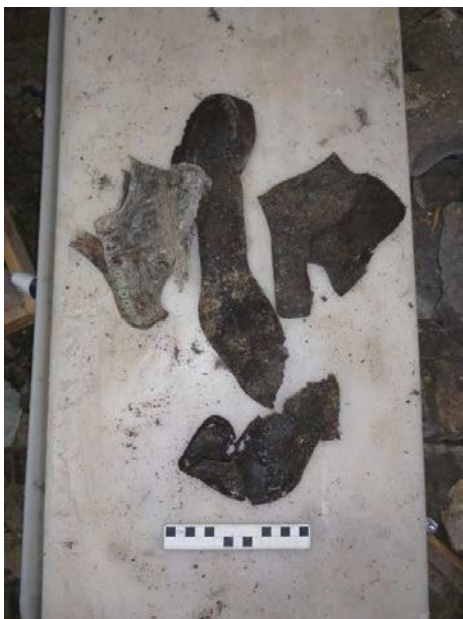
Plate 19 (left): Fragments of leather shoe amongst the material below the floorboards

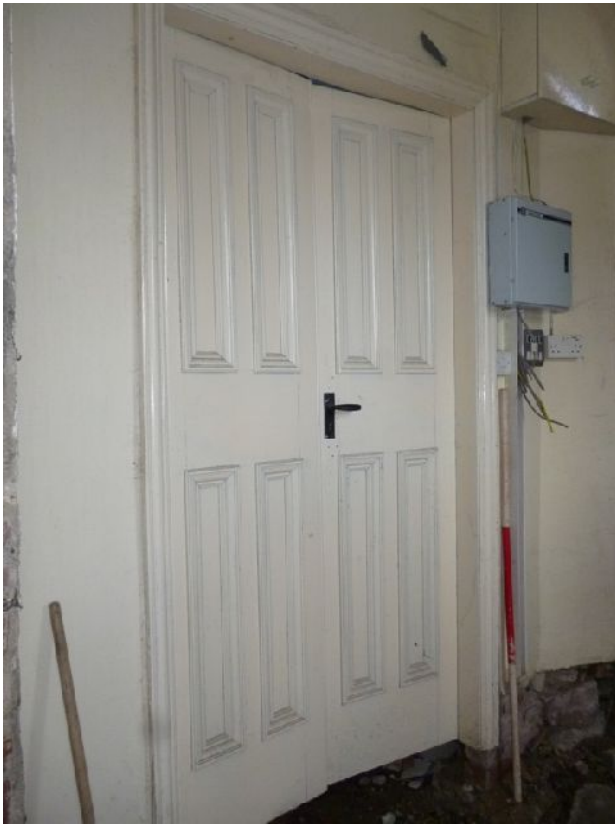
Plate 21 (left): Doorway in the south elevation of the north-west room

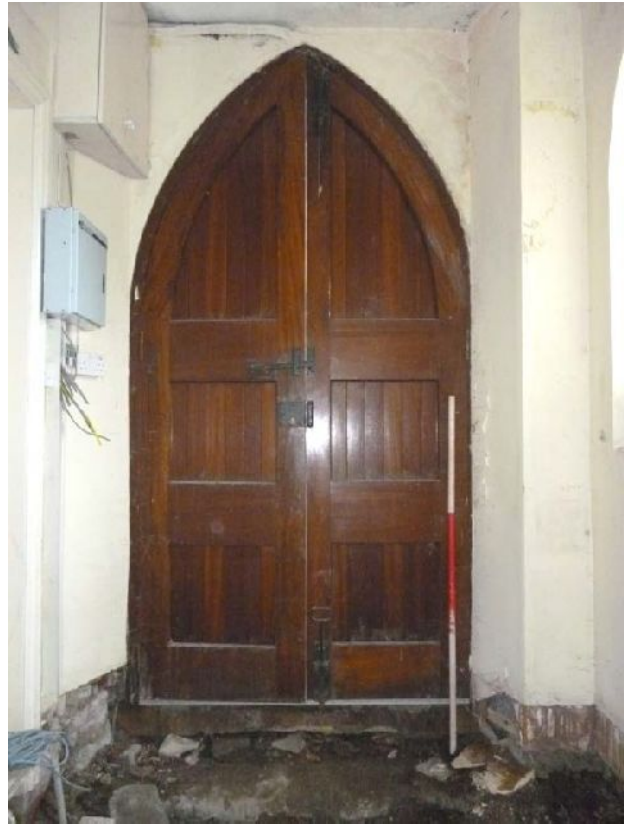
Plate 22 (right): Doorway in the east elevation of the north-west room

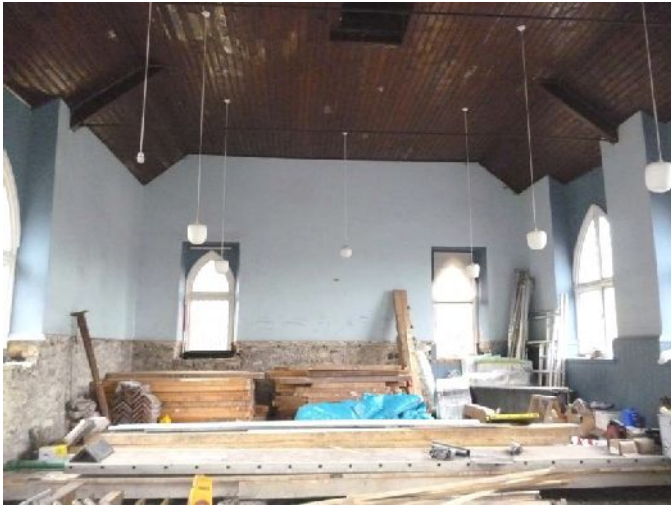
4.3.3 **South Room:** the roof in this room is a suspended varnished timber ceiling constructed from tongue and groove boards, which slope at the edges to follow the line of the roof and the ends of the principal rafters from the roof trusses visible (Plate 23; Figure 5). The floor is partially furnished with suspended floorboards towards the south end, supported on a low stone footing (Plate 24; Figure 4). In the other half of the room the floorboards have been removed leaving a compacted earth and plaster surface. The north elevation has a large opening, which would originally have held a timber screen that would have divided the north-east room and the south room on the east side, above which is a wide moulded timber rail (Plate 25). The west end of the elevation houses the double doorway leading into the north-west room, which is of the same form as described above (*Section 4.3.2*). The east wall follows the same pattern as elsewhere in the chapel in that it is finished with plaster apart from the lower part which has exposed stonework, although this is exposed because of timber panelling having been removed. There are two windows with pointed arches, four-light casements, and diagonal leaded panes within splayed reveals (Plate 26). The south wall is similarly finished, again with exposed stonework across the lower part. It has two windows with pointed arches and timber two-light casements with diagonal leaded panes within slightly splayed recesses (Plate 27). The west elevation is finished with plaster across the upper part but unlike the other elevations has the timber tongue and groove panelling remaining across the lower part, topped by a thin moulded rail. There are three windows, as per the east elevation, with pointed arches and timber frames within splayed reveals and four-light casements with diagonal leaded panes. The roof space could not be safely accessed but it is apparent that the ends of the tie beams are visible projecting through the planking covering the ceiling (Plate 23) allowing some idea of the truss arrangement to be determined, especially through comparison with the original drawings (Figure 5; see Plate 8).

**Plate 23 (left): South end of south room**

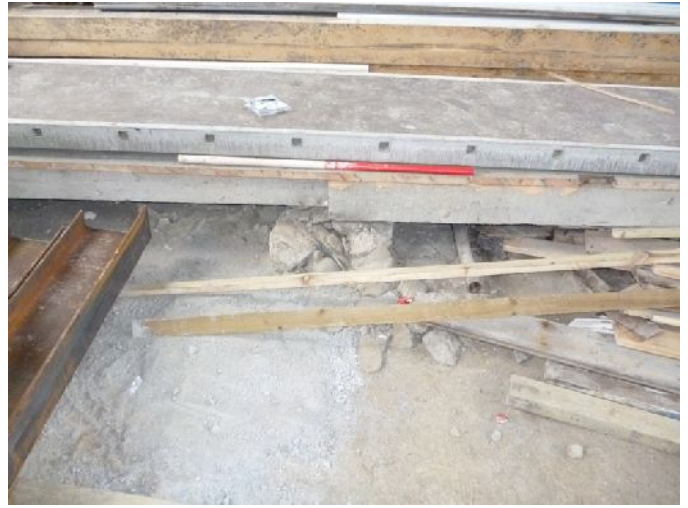
**Plate 24 (right): Exposed footing supporting timber floor**

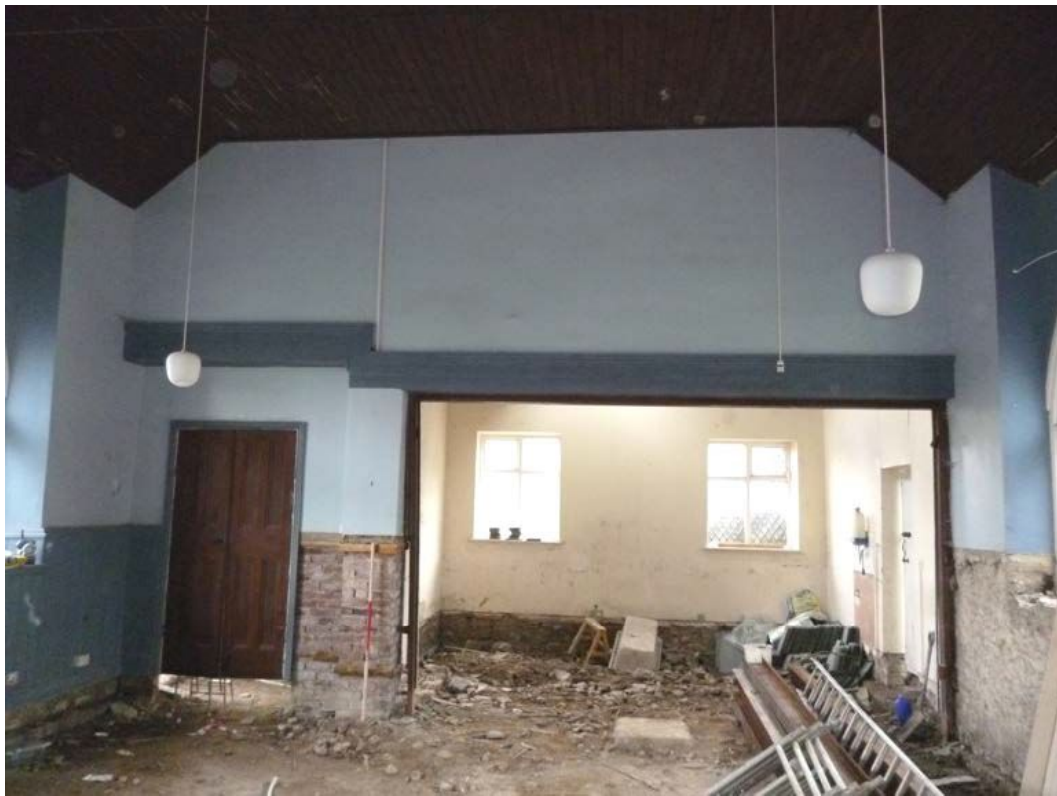
**Plate 25: The north end of the south room**

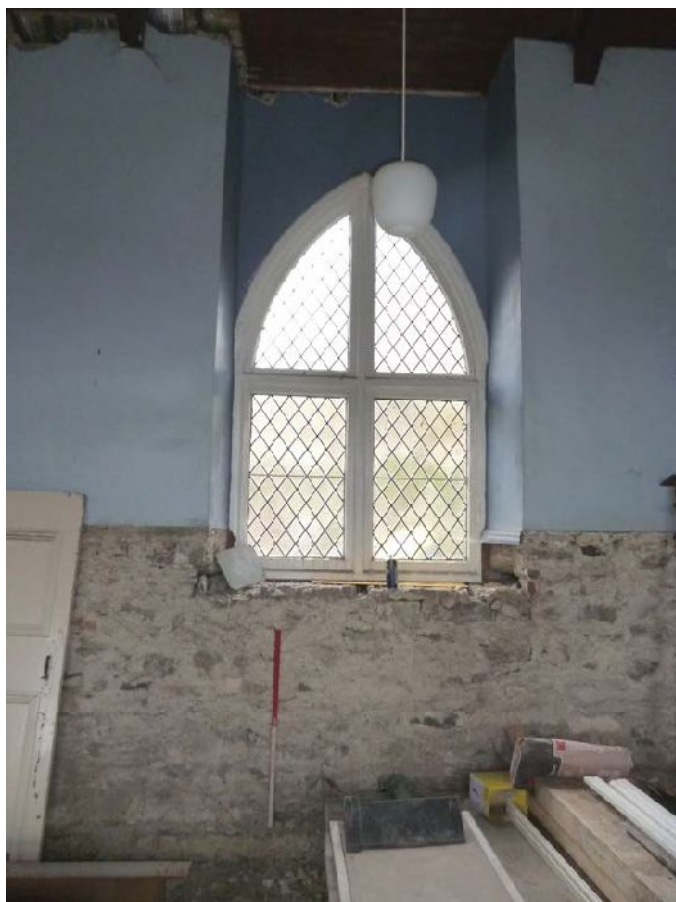
**Plate 26 (left): Detail of window in east elevation**

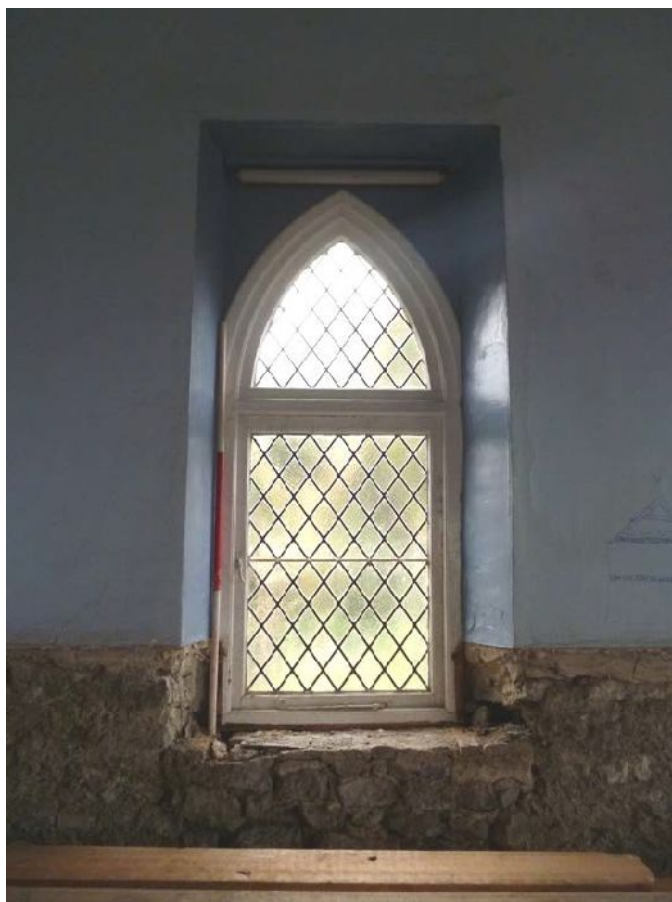
**Plate 27 (right): Detail of window in south elevation**
