SHIP INN, PIEL ISLAND, BARROW-IN-FURNESS, CUMBRIA

Architectural Evaluation

Client: Barrow Borough Council
NGR: SD 23336 63773

© Greenlane Archaeology Ltd
June 2007

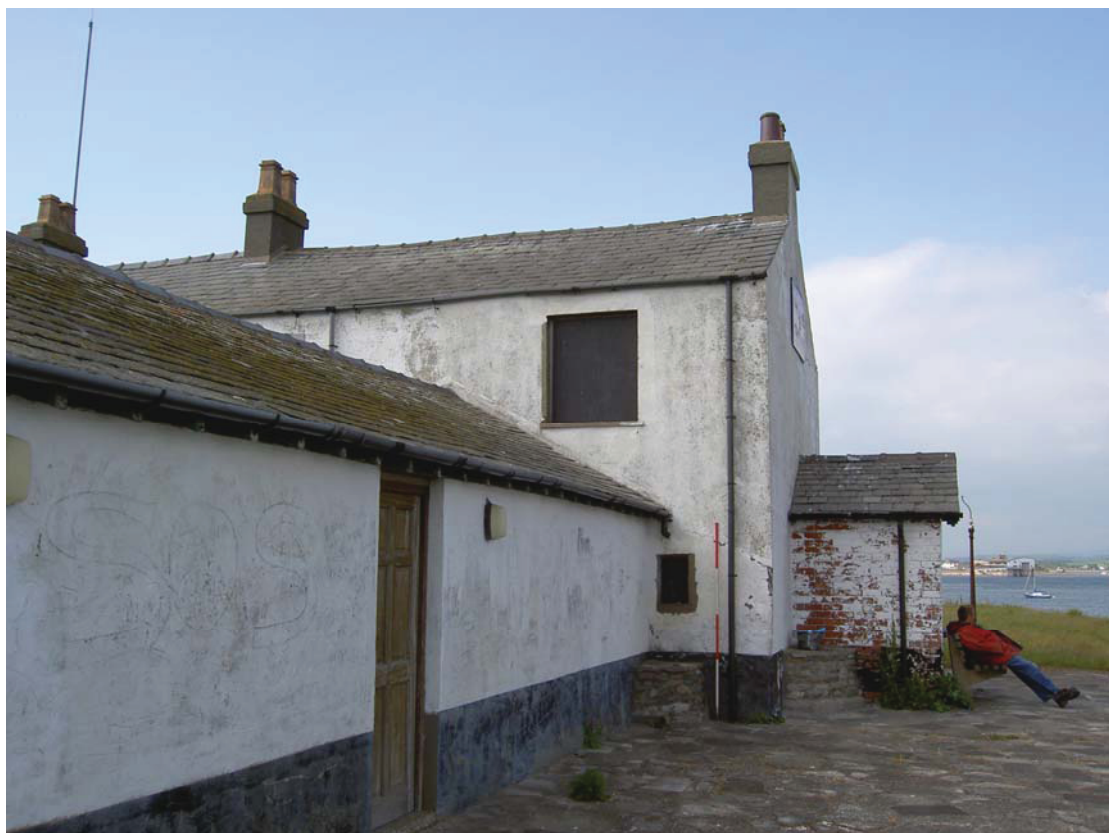
Plate 34: The east end of the south external elevation showing the repointed window surround above the pool room and the porch attached to the east end

6.3.6 **Window, east end of south elevation:** the window at the east end of the south elevation, above the present pool room, has lost the majority of its surround due to modern repointing. This should be replaced.

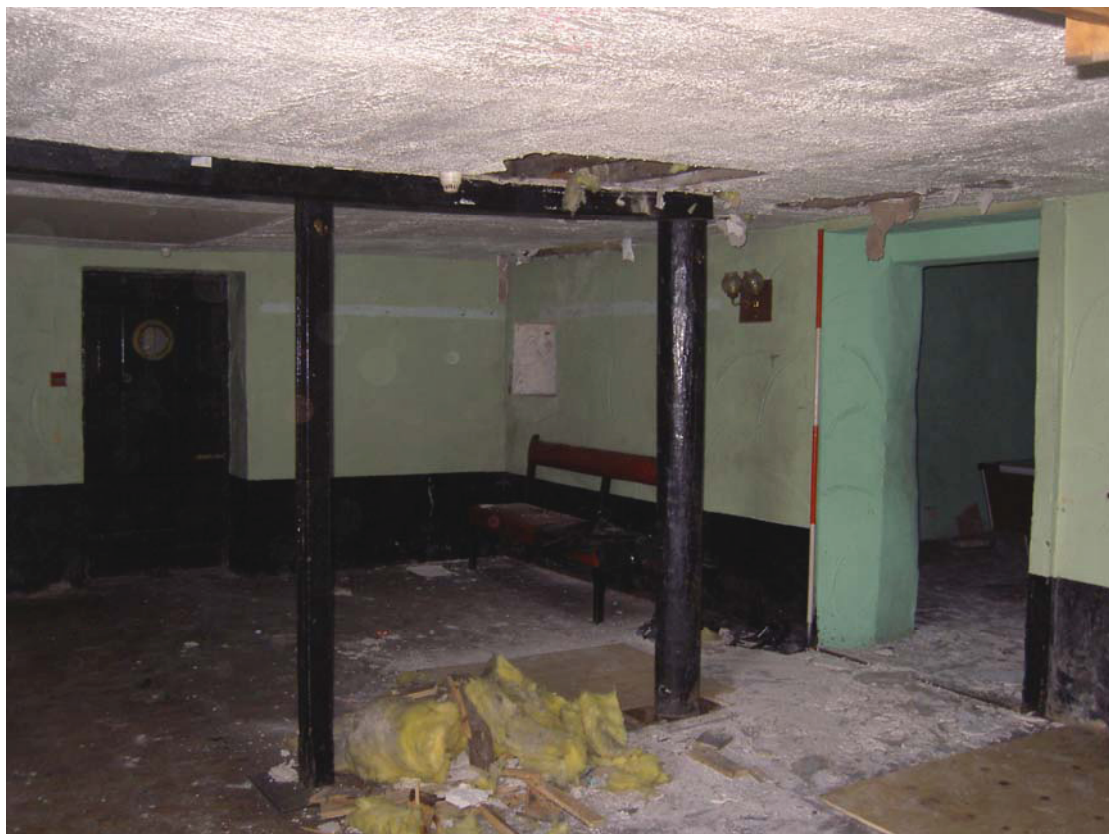
Plate 46: Inserted beam and posts in ground floor Room 9

6.3.17 **Beam and posts in bar:** the short chamfered beam and supporting posts in the main bar are not original and were probably first added as a result of the construction of the extension to the south. These could justifiably be removed and replaced with a beam spanning the full width of the room assuming cost and engineering practicalities allow.

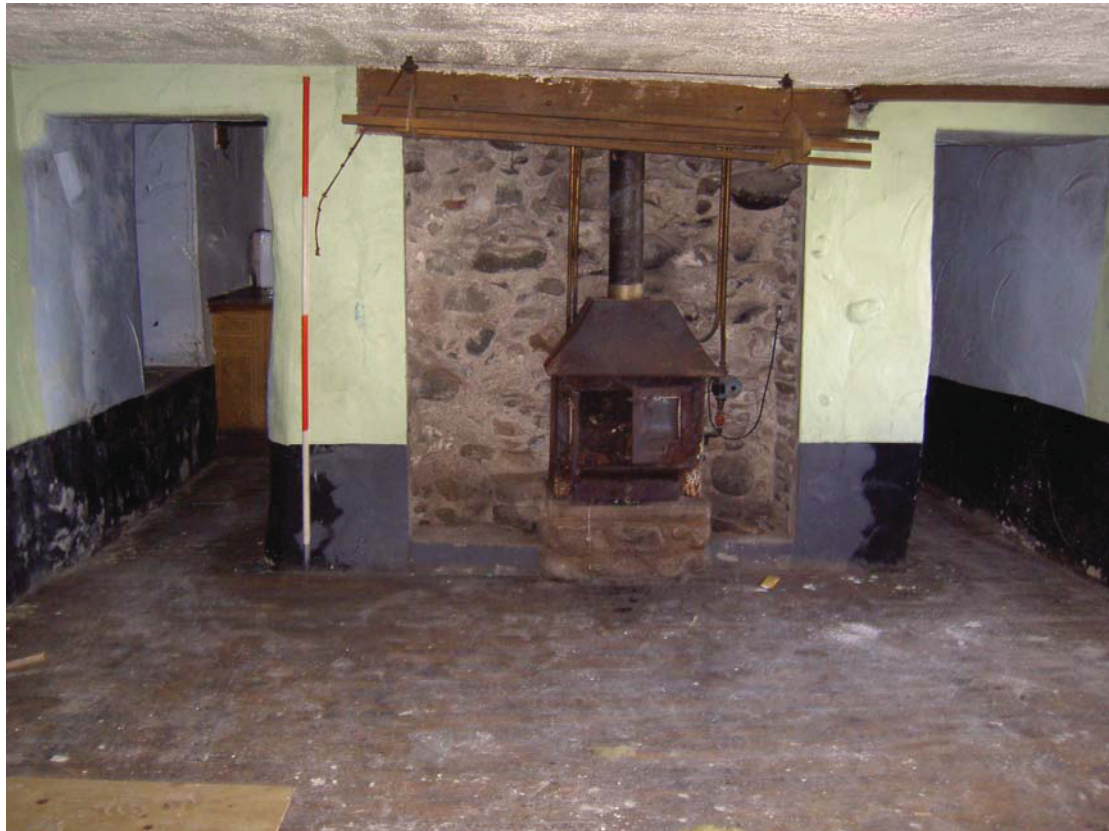
Plate 47: Enlarged fireplace in ground floor Room 9

6.3.2 **Fireplace, ground floor Room 9:** the fireplace in the main bar (Ground floor Room 9) has been over-widened to accommodate a wood-burning stove; fortunately the proposal to open up what was apparently perceived as the 'original fireplace' on both sides was never carried out – this would not only have been extremely inappropriate (the fireplace would never have been accessed from both sides), it might have structurally damaged a main supporting wall. Ideally the opening should be returned to something more appropriate and smaller, perhaps with a stone surround similar to those elsewhere in the building. This would probably be prohibitively expensive, however, so an alternative might be to square off the internal edges of the jambs or simply leave it as much as possible in its current condition.

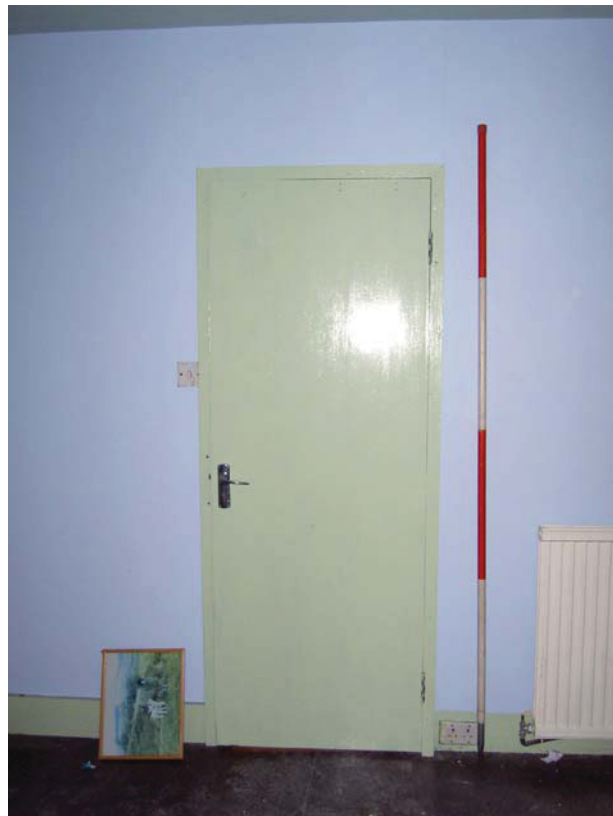
Plate 54: Typical modern plywood door, first floor Room 7

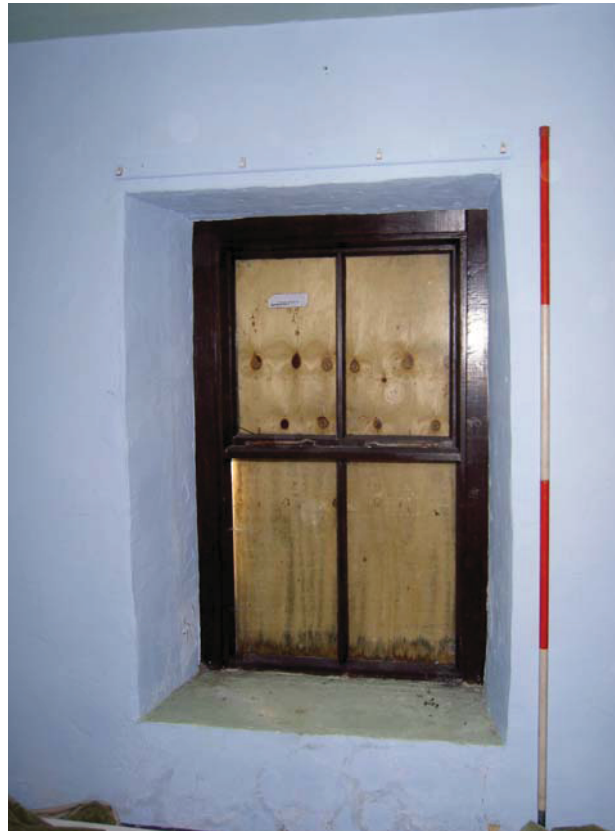
Plate 55: Typical modern window, first floor Room 7

6.3.18 **Windows:** the majority of the windows are modern replacements and have unsuitable casements. The four sliding sash windows at the east end of the north elevation and one in the south elevation are probably original, and, in addition, there are some, probably later sliding sash windows. The original sash windows should be retained, the later sash windows could justifiably be retained, and the modern casements should be replaced with sliding sash casements, preferably of 12-lights and matching those that already exist. Ideally the small inserted windows should be removed and blocked, but as these are the sole source of light for some parts of building this is unlikely to be practical (the small inserted window at the east end of the south elevation on the ground floor does not appear to serve any useful function however);

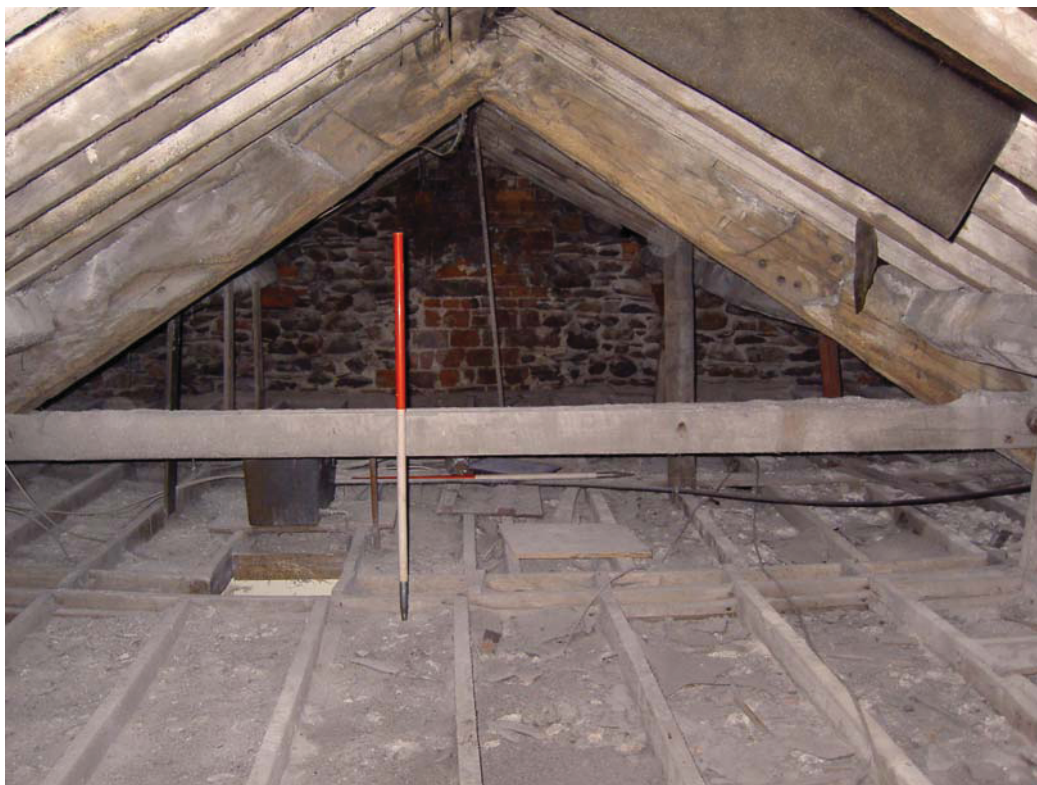
4.6.5 Roof space, above first floor Rooms 8-10: this comprises a single large open area open to the roof, which is supported by a single truss comprising a pair of principal rafters (Fig 10), both of which are evidently re-used cruck blade fragments, with empty diagonal joist slots and peg holes in the west face (Fig 11; Plate 56). Slots for a missing collar, cutting through the earlier slot on the south side, are also evident as are carpenter's marks in the form of Roman numerals ('I' and 'II'), some of which evidently relate to the original use of the timber (one has been partially cut through where the principal rafters are jointed together). A later collar, comprising two pieces of timber bolted to either side of the principal rafters, has been added at a lower level. The truss supports a single purlin in each pitch, although there are empty slots for one or two earlier purlins, and a ridge purlin. All but the ridge purlin hand-finished, and some are evidently re-used, and they over-lap at the truss. The north-east section is a former beam, and has numerous joist holes in one face, while the south-east section is formed from two pieces of timber scarf-jointed together with numerous peg holes in one face. The rafters and ridge purlin are later machine cut replacements. In both the east and west elevations the line of an earlier gable is visible (Plates 57-58); this evidently had a much steeper pitch and was subsequently raised in height. The render scar is visible across the position of the chimney in the west end (Plate 58). Relatively early hand-made brick has been used in the flues at both stages, although the bricks in the earlier, lower gables are evidently thinner. The build of both the original wall and later extension generally comprises random courses of rounded stones.

Plate 56: Detail of truss in roof space above first floor Rooms 8-10, showing re-used cruck blade fragments

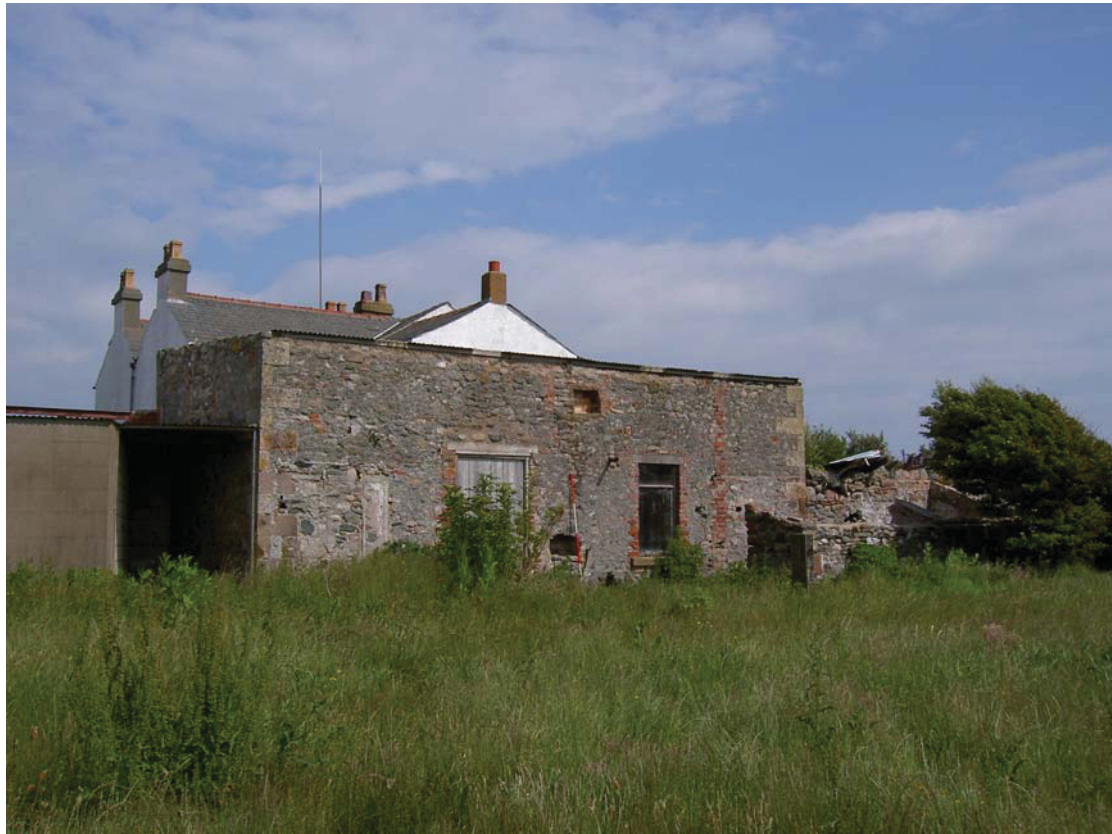
Plate 59: Derelict barn and outsheds to west of inn

6.3.3 **Bunk house, toilet block, barn, and outbuildings:** the bunk house and toilet block are extremely inappropriate and adversely affect the setting of the building. The damage to the original barn is also regrettable, as this formed an important part of the site from at least the 19th century onwards. The ideal solution would be to remove the two modern outbuildings and house the facilities they provide in the original barn, following extensive repair perhaps including the restoration of the original roof-line, and associated outbuildings (depending on whether they were being used for their intended purpose – housing animals). Again, this would probably be prohibitively expensive, so an alternative might be to finish the modern outbuildings in a more appropriate fashion, something matching the inn, and carry out basic renovation to the barn and outbuildings to prevent their total deterioration. The concrete block walls added between the barn and inn should be removed.

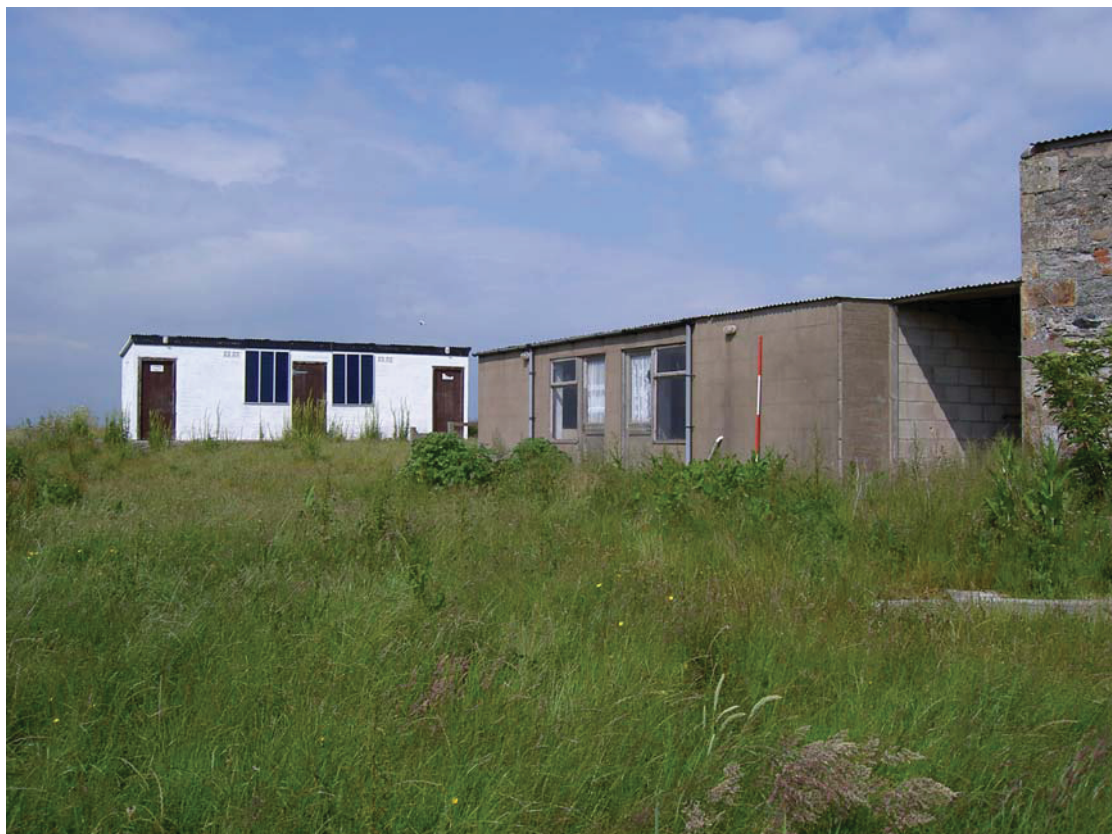
Plate 60: Modern bunk house and toilet block to north-west of inn
