OXENDALE HALL BARN, OSBALDESTON, LANCASHIRE

Archaeological Building Recording and Watching Brief

Client: Belmore Holdings Ltd

December 2017

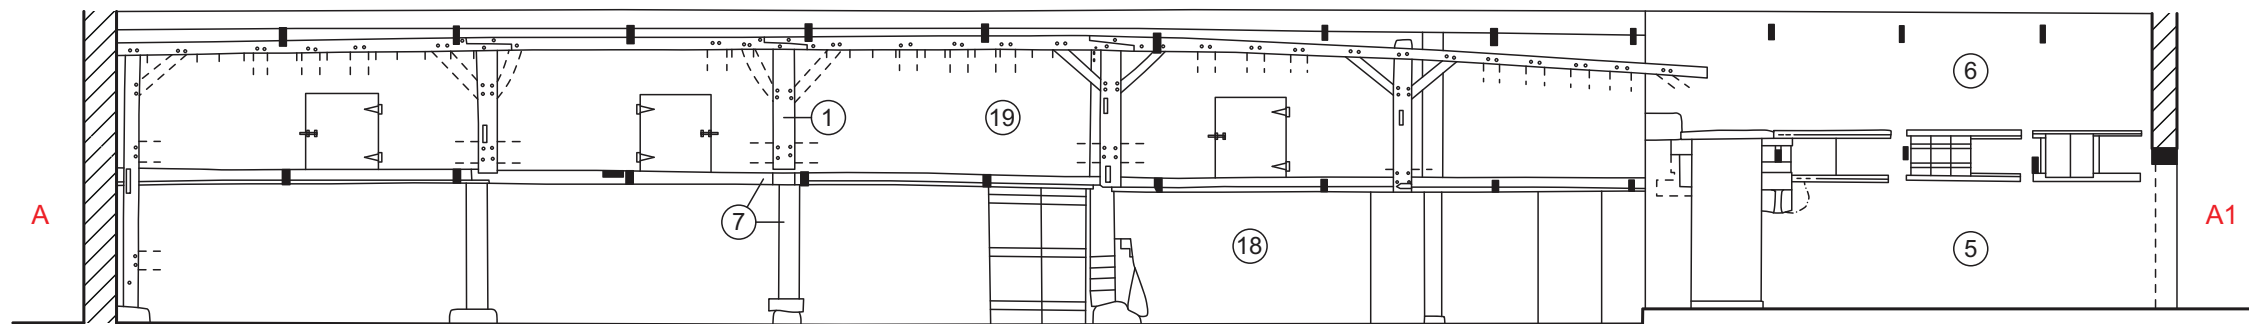
Figure 3: West external elevation and west-facing internal elevation of Room 4

6.1.3 **Phase 2 (18th century):** it is apparent that the south end of the original barn had begun to structurally fail at some stage, given the drop in level of the Phase 1 wall plate (Figure 3). Presumably a truss forming the end wall at this location had become unsound, which is perhaps not unlikely given that it would have been exposed to the elements; it is noteworthy that the corresponding truss at the north end (Truss 1) was badly affected by not only woodworm but also fire. In order to prevent the collapse of the south end of the barn a section of L-shaped stone wall was added (**02**). That this was added very soon after the removal of the original gable/truss can be seen by the manner in which the wind braces were incorporated into it at this time. This addition probably soon led to the removal of other parts of the original timber framing and subsequent infilling with brick across much of the east elevation (**03**) or more stone (**04**, although this section was perhaps added slightly later to accommodate the construction of a small outshut (**09**)). The form of the brick in **03** suggests an 18th century date, which is likely to correspond to much of this phase.

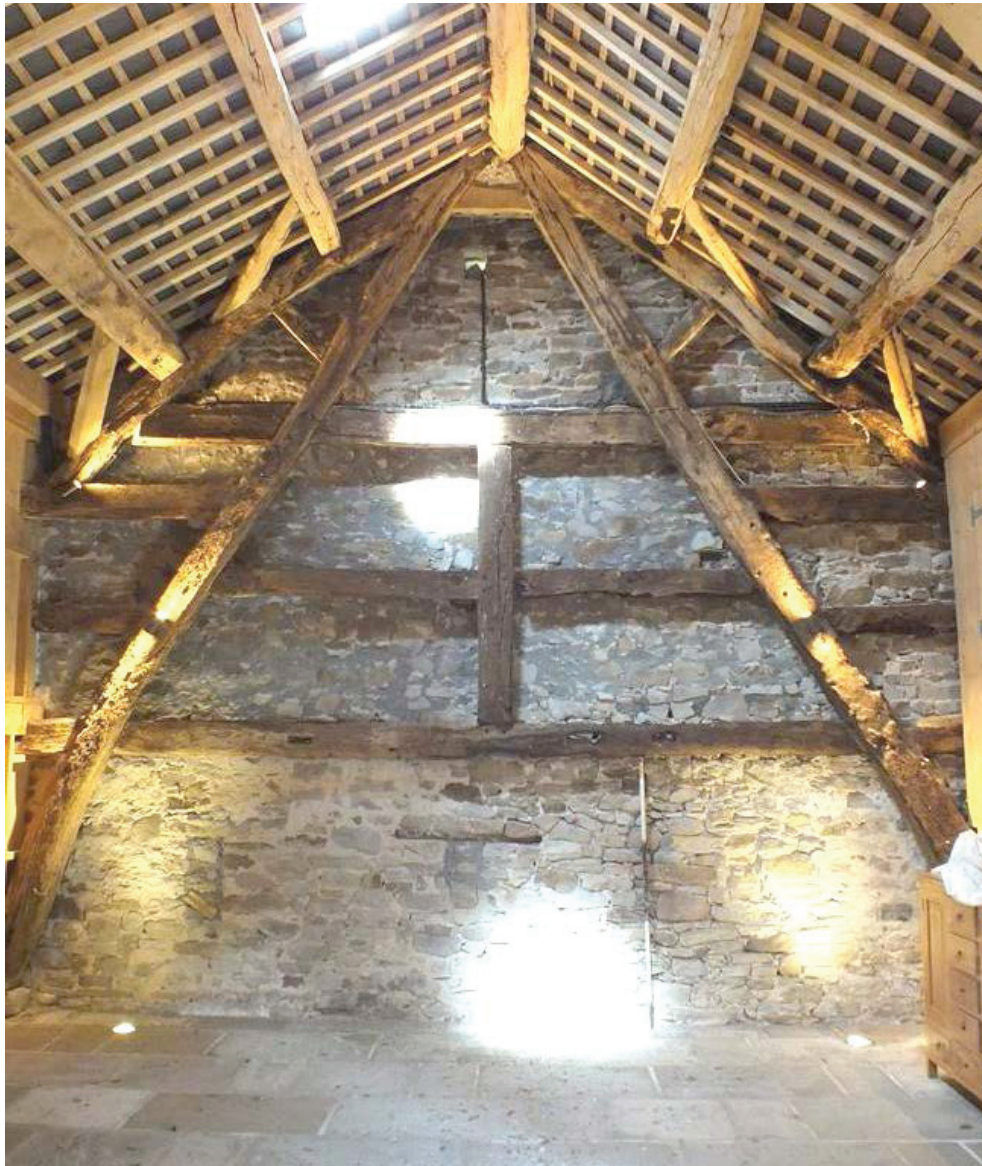
Plate 31: South face of Truss 1, Room 2

- **Truss 1** is a closed truss set against the north wall (Plate 31), so it was not possible to examine its north face. It is heavily wood wormed and fire damaged, particularly on the east side (Figure 5). The cruck blades of this truss are much thinner than the rest and straighter with supporting spurs extending to the walls to the east and west and angled braces attached to the packing pieces. There are also horizontally set timbers with holes in the underside (Plate 32) and slots in the top for stud walling. This is also present in the braces and the collar at the top. These horizontal timbers are supported by an upright post in the centre and the bottom timber has three slots for joining timbers to north/south but no peg holes. There is a further slot at the base of each cruck for another east/west timber and corresponding slot in the centre for another vertical timber. There are later iron loops attached, presumably tethers, fixed into the south face of the base of each cruck blade (Plate 33 and Plate 34).

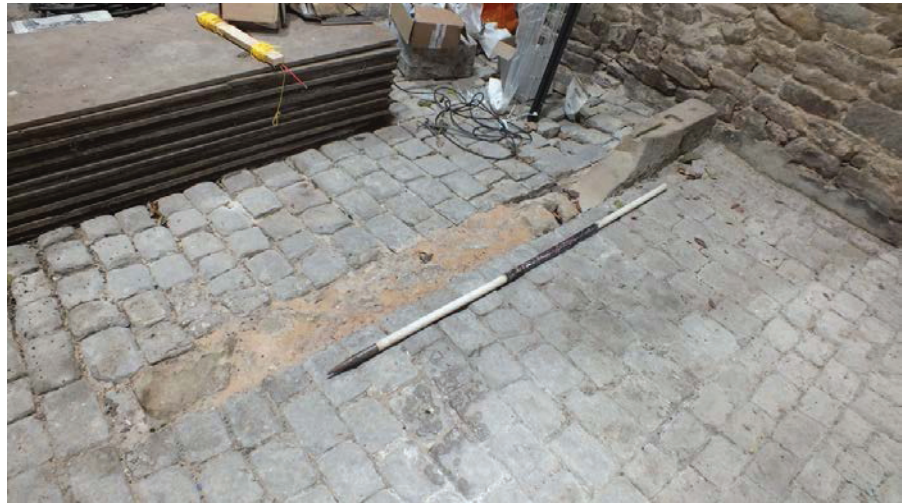
Plate 75 (right): Long stone block for timber stall to the north in Room 3, showing damage

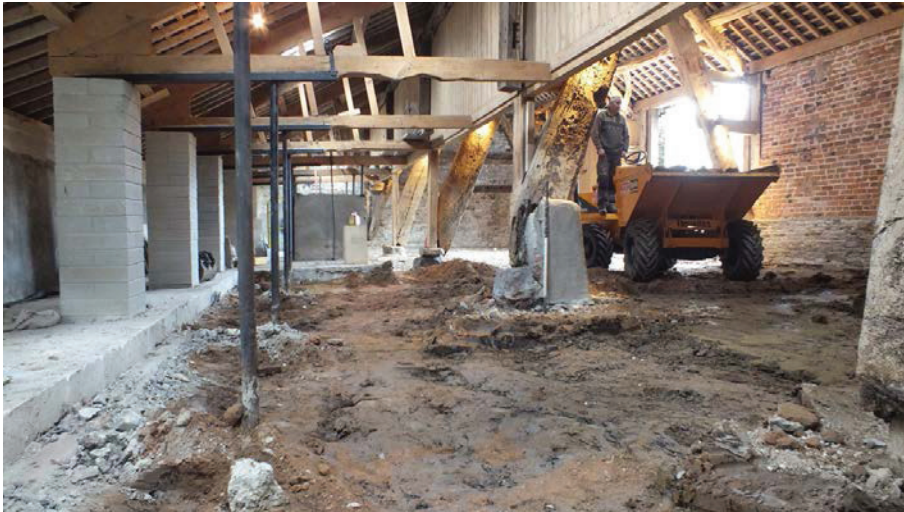
5.1.2 Below the brick and concrete flooring in Room 4 there was a thin layer of light orange sand (**100**) on top of a hard, dark grey-brown clay (**111**) (Plate 106 to Plate 108). This sand was probably brought in as bedding material below the red brick floor, most notably to the north end of the room beyond the line of Room 3 (Plate 106), although a patch of firmer light orange sand was noted in line with the north end of Room 3 in Room 4. In contrast, Room 2 had a coarse, light grey angular gravel (**101**), c0.06m thick on top of the clay natural, although this again was probably some sort of bedding material for the stone flag floor. The underlying clay 'natural' layer was very firm and had very few inclusions. It was noted to be a lighter brown to the north end of Room 2, but it still contained very few inclusions.

Plate 106: Sandy deposit (100) below the stalls at the north end of Room 4

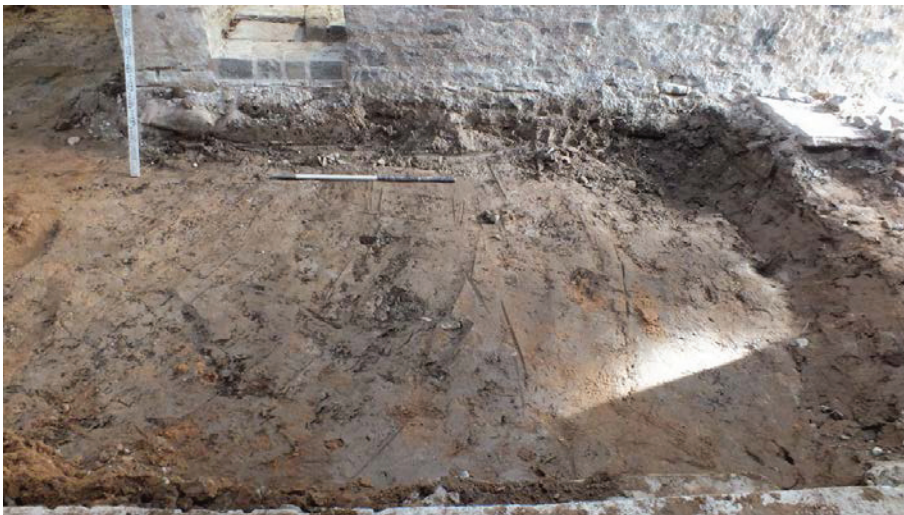
Plate 107: Natural clay (111) exposed at the south end of Room 4

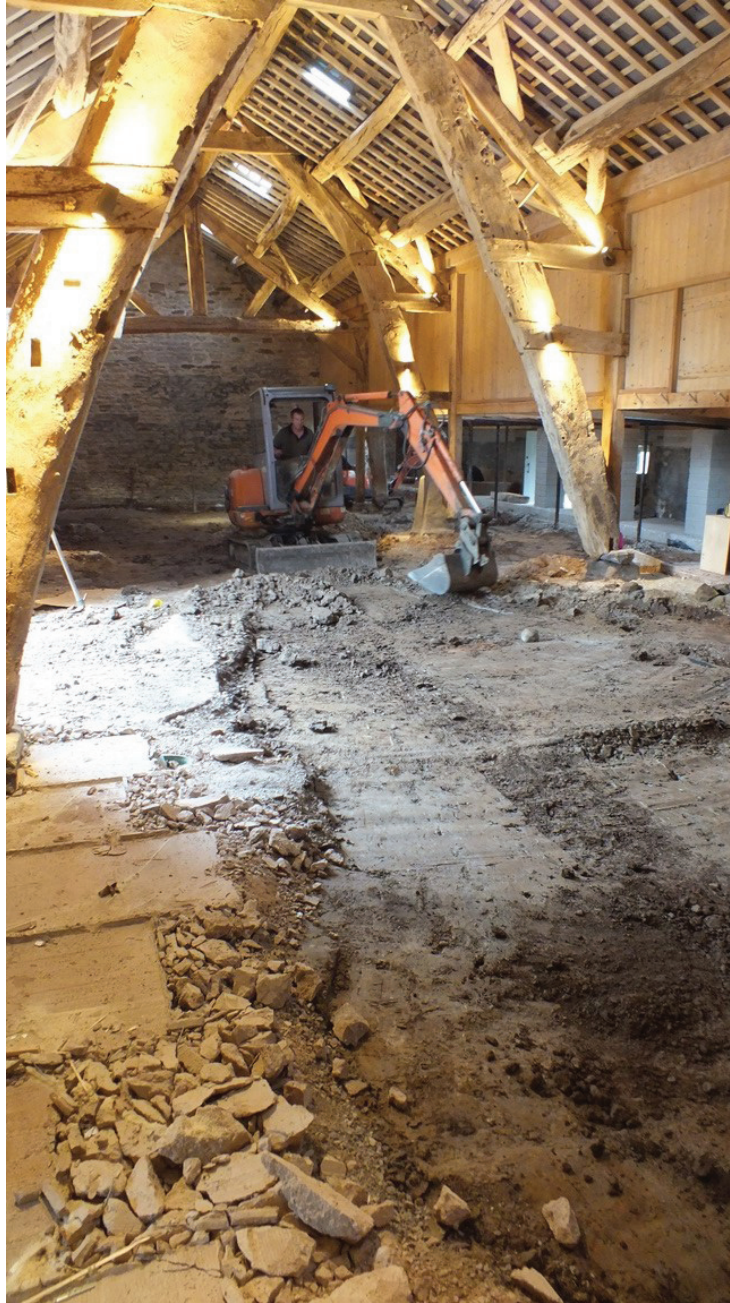
Plate 112: Wide cut for a drain at the north end of Room 2, viewed from the north-east

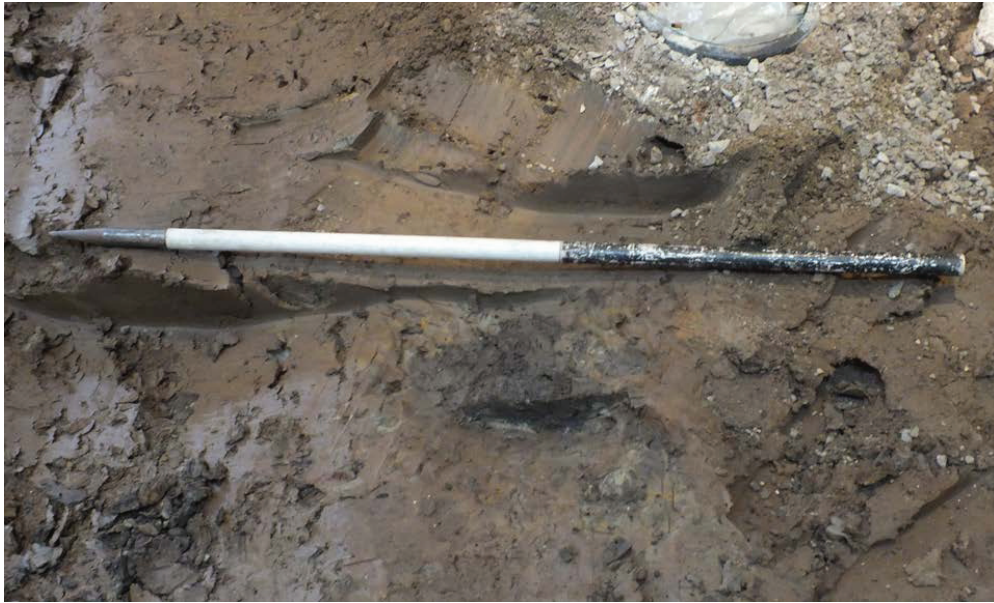
5.1.6 A small sub-circular pit (**103**) was exposed close to the east cruck of Truss 4. It was c0.24m wide and 0.06m deep with a concave base and was filled with a firm, dark grey clay which had no inclusions or finds (Plate 116; one of the recessed light cases is visible to the top right of the plate).

Plate 116: Pit 103, viewed from the south-west

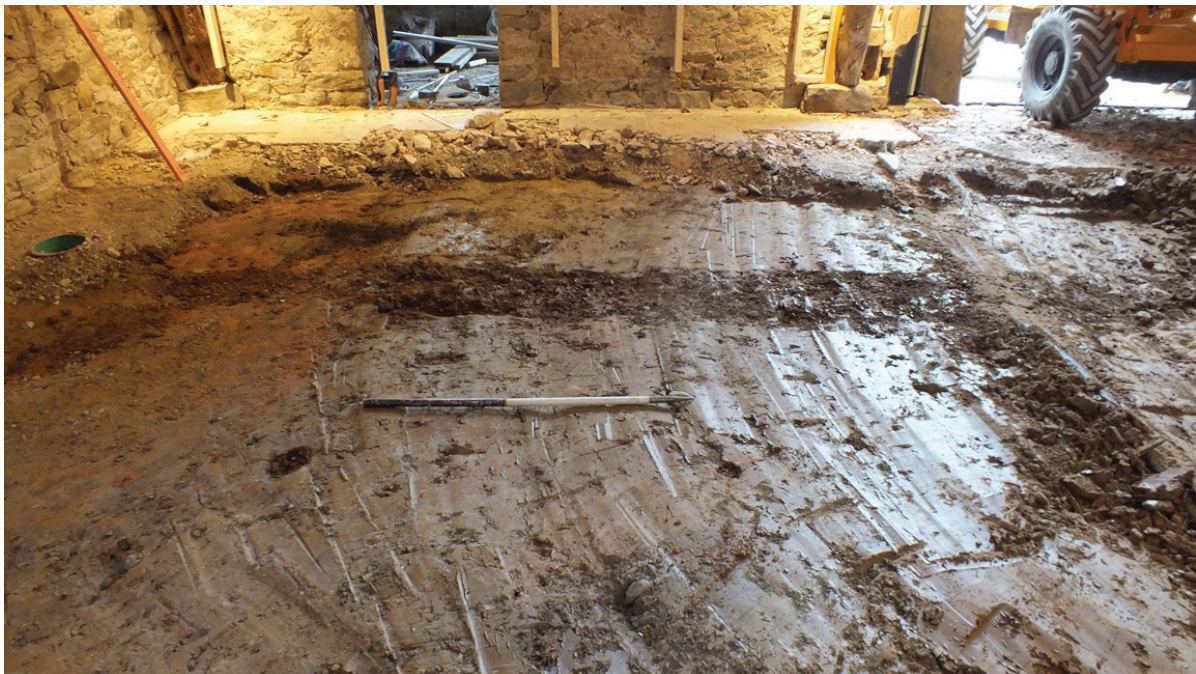
5.1.7 Three round stake holes (**106**, **108** and **110**) were noted in Bay 1 of Room 2. Two of the stake holes (**108** and **110**) were c0.08m wide and the other was 0.12m wide. Two of the stake holes (**106** and **108**) show up as darker circles at either end of the ranging rod in Plate 117 and the third is visible close to the electric cable trench to the right hand side of the plate on the far side of the wider drain cut. The wider stake hole (**110**) is visible in the foreground of Plate 118, a smaller one (**106**) is visible between that and the workman to the top of the picture, almost in a line, and the white end of the ranging rod points to the third (**108**) at the left hand side of the picture. All of them still contained the tip of a fairly soft, pointed wooden stake, penetrating a few inches into the clay natural, but no other fill deposit or packing material was present.

Plate 117: Stake holes at the north end of Room 2, viewed from the west

6.2.2 The stakes (within stake holes 106, 108 and 110) at the north end of Room 2 could conceivably represent some sort of partition(s) at this end of the room, perhaps stalls for keeping livestock, but it is uncertain how old these stakes are. However, the fact that some timber survived in relatively dry conditions suggests that these relatively late. As suggested above they are probably late 18th or 19th century.

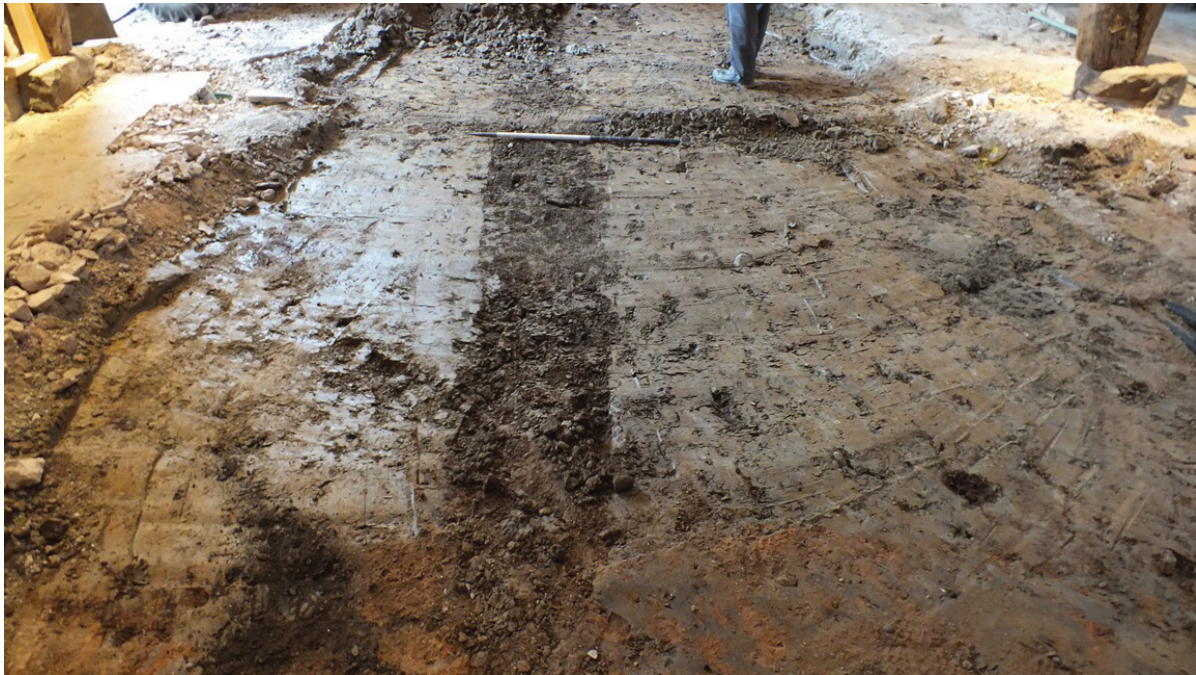
Plate 118: Stake holes at the north end of Room 2, viewed from the north

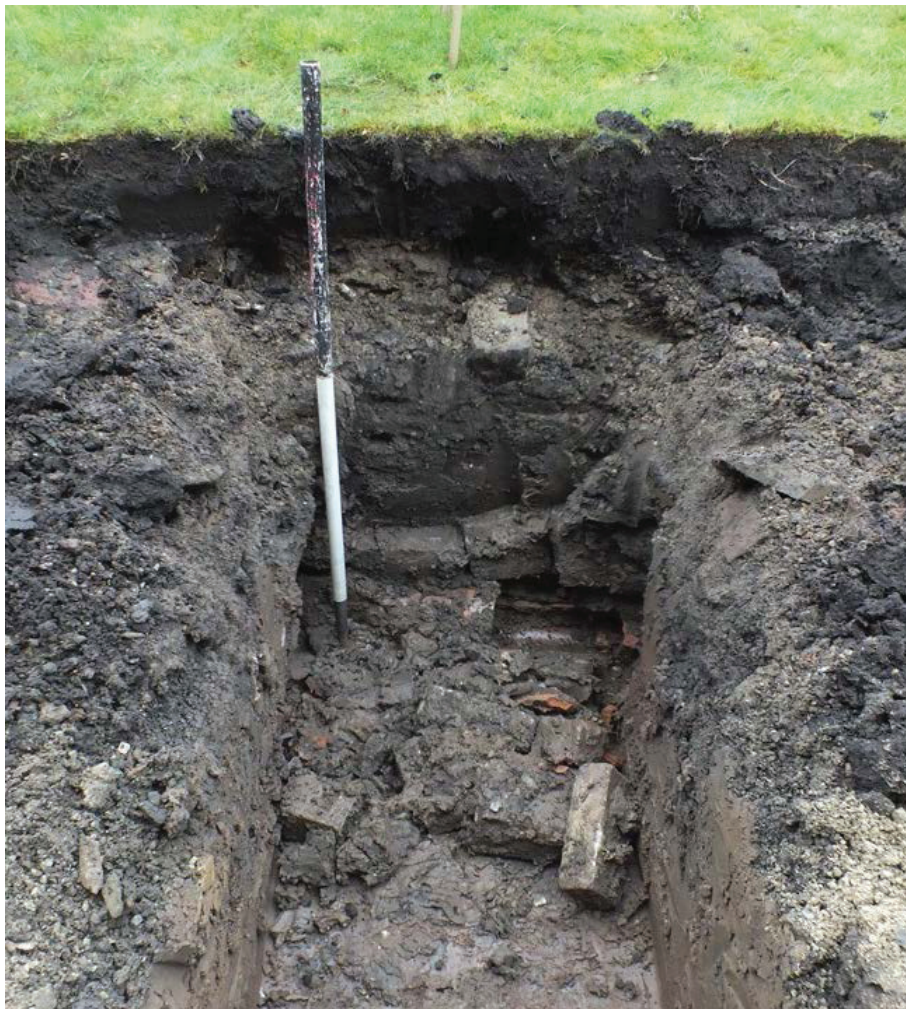
Plate 120: Ceramic drain below setts to the south end of the trench to the south of the barn
