SEASCALE MILL, SEASCALE, CUMBRIA

Archaeological Building Recording

Client: John Coward Architects

February 2018

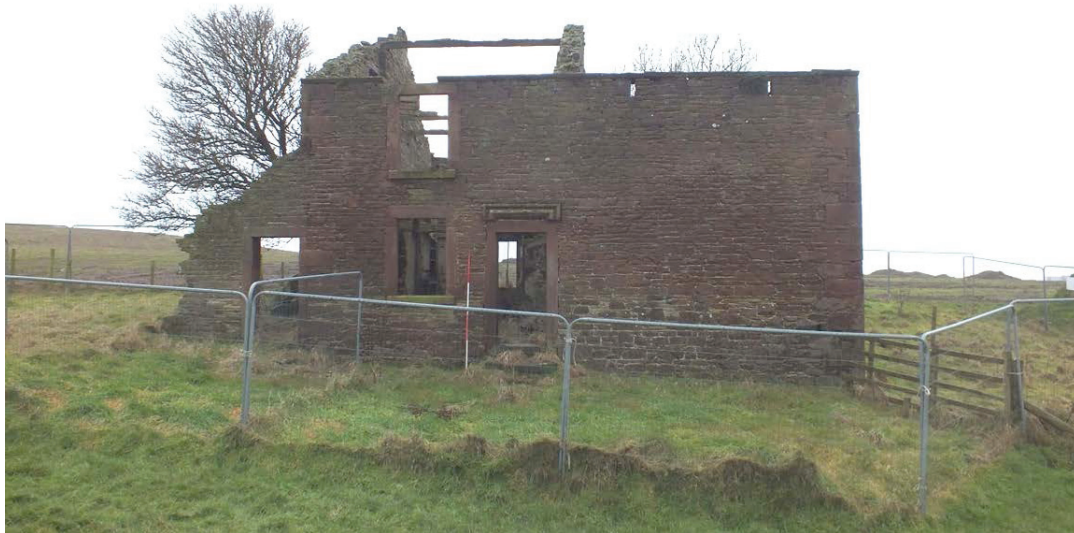
Plate 6: North-east external elevation of Building 1

4.2.1 **Building 1, north-east external elevation:** the north-east external elevation is mostly intact to the projecting stone gutter at the top (Plate 6). There are quoins at either end but the south-east end originally extended further and has now collapsed. There is an off-centre door, up three steps, with a plain square surround and an additional moulded lintel above (Plate 7). There are windows to the south-east on ground and first floors with square surrounds and projecting lintels (Plate 8). There is a further ground floor doorway up two steps to the south-east with a dressed lintel and square south-east surround and quoins in the north-west jamb. These do not extend above but do continue at the top. The wall has collapsed to the south-east but a slope at the top in concrete suggests there was a mono-pitch roof to this side. There are two small vents at the top on the north-west side.

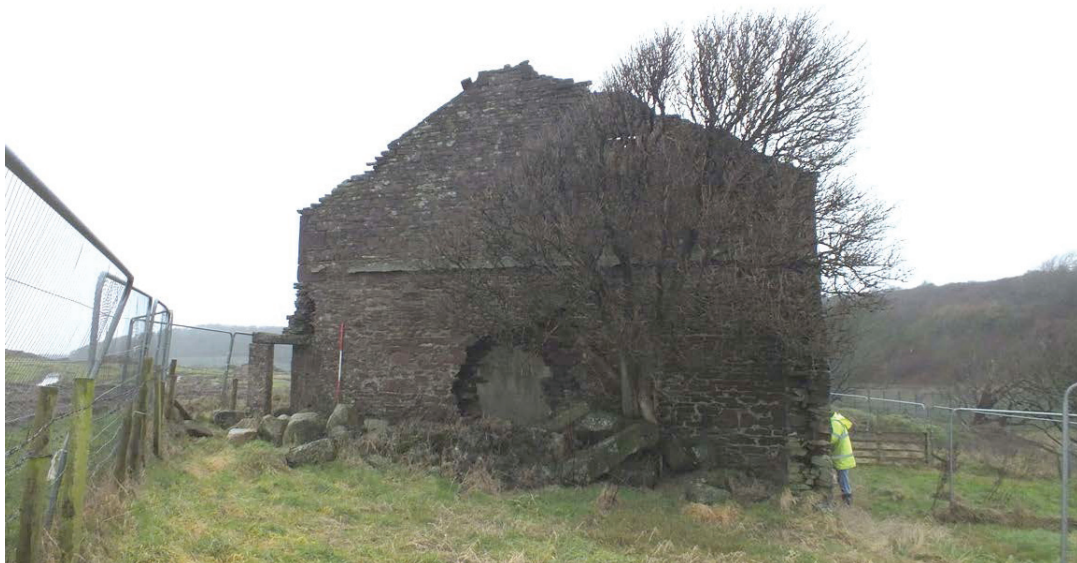
Plate 9: South-east external elevation of Building 1

4.2.2 Building 1, south-east external elevation: this elevation comprised the gable end, with the projecting stubs of north-east and south-west walls at either end (Plate 9). There is a large hole in the base, which is possibly a collapsed flue. There is a concrete scar of a monopitch roof along the top and the gable is topped by a truncated chimney. There are quoins on either side, stopping at the top of the monopitch but incorporated into the jambs. The side walls are keyed in, so the outshut is part of the original structure. There is a small window high on the north-east side with square jambs.

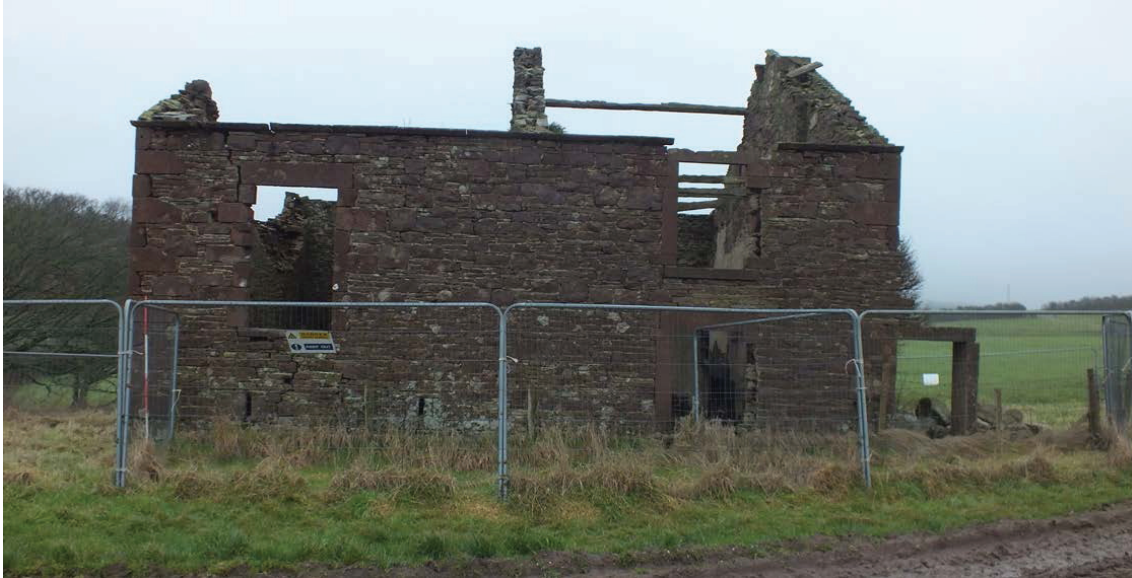
Plate 10: South-west external elevation of Building 1

4.2.3 **Building 1, south-west external elevation:** there are two vent slots at nearly ground level on the north-west side with a pitching door above with quoined jambs and thin dressed sill and lintel (Plate 10). There is a dressed stone gutter along the top and a further window to the south-east with a mostly square surround and dressed sill and lintel. The door below has a dressed surround although the south-east jamb has gone. The elevation continues to the south-east on the ground floor with a door and stub wall, which has collapsed beyond that.

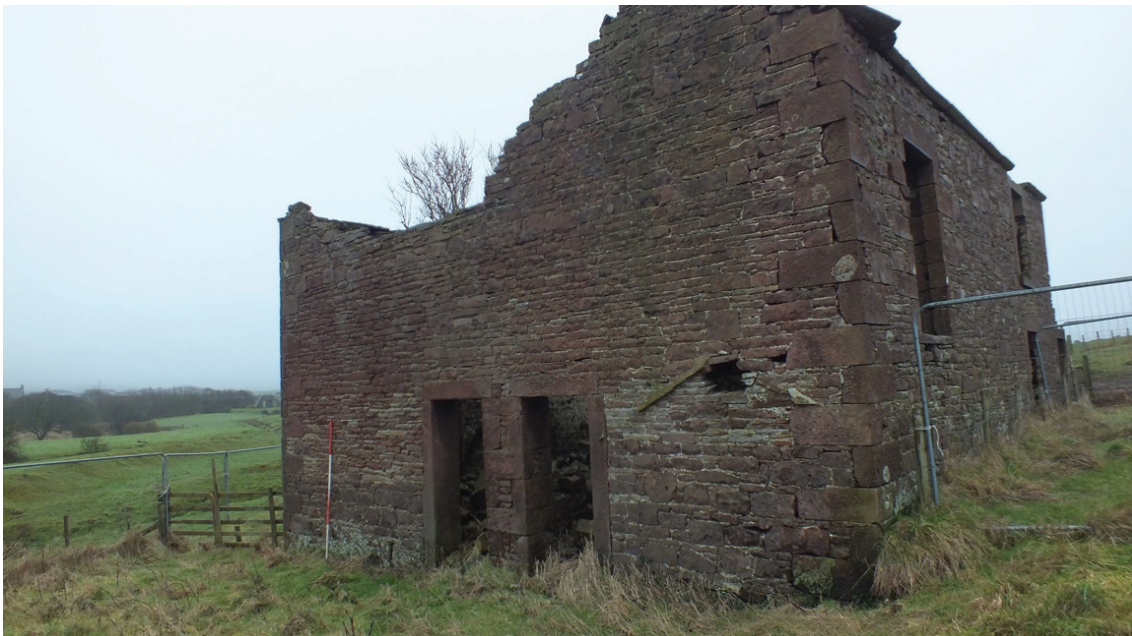
Plate 11: North-west external elevation of Building 1, viewed from the west

4.2.4 **Building 1, north-west external elevation:** the top part of the north-west facing gable end has mostly collapsed and is plain, with quoins at the ends. There are two doorways on the ground floor with square stone surrounds (Plate 11 and Plate 12). There is a concrete scar from a small monopitch roof to the south-west with the hole for a ridge purlin. There is a low level slot vent on the ground level to the north-east of the doors.

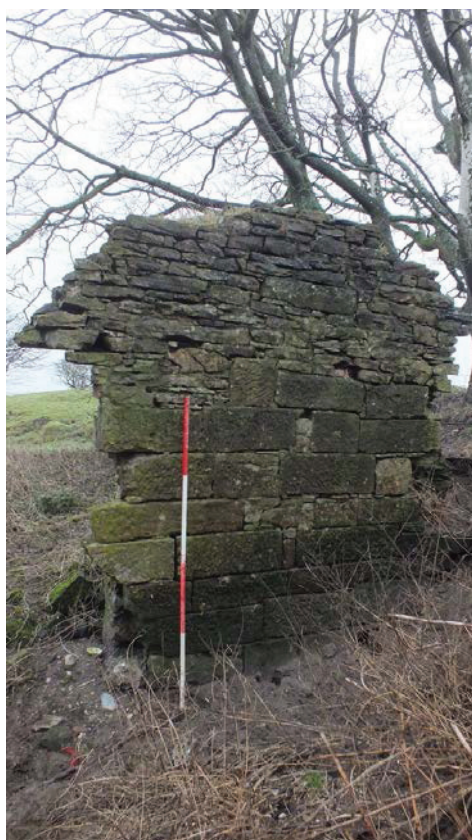
Plate 13 (left): South end of the west elevation of Building 2, viewed from the south-west

4.2.5 **Building 2, west elevation:** the lower part is dressed blocks and the upper part is more random rubble (Plate 13). There is an opening low on the north side with the possible base of an arch, corresponding to a gap in west wall of the wheel pit (Plate 14), which perhaps denotes the position of the water wheel’s axle (Plate 15). This wall continues to the north and is also constructed from dressed blocks. The east side of the wheel pit is also constructed from dressed blocks although less courses are visible (Plate 16).

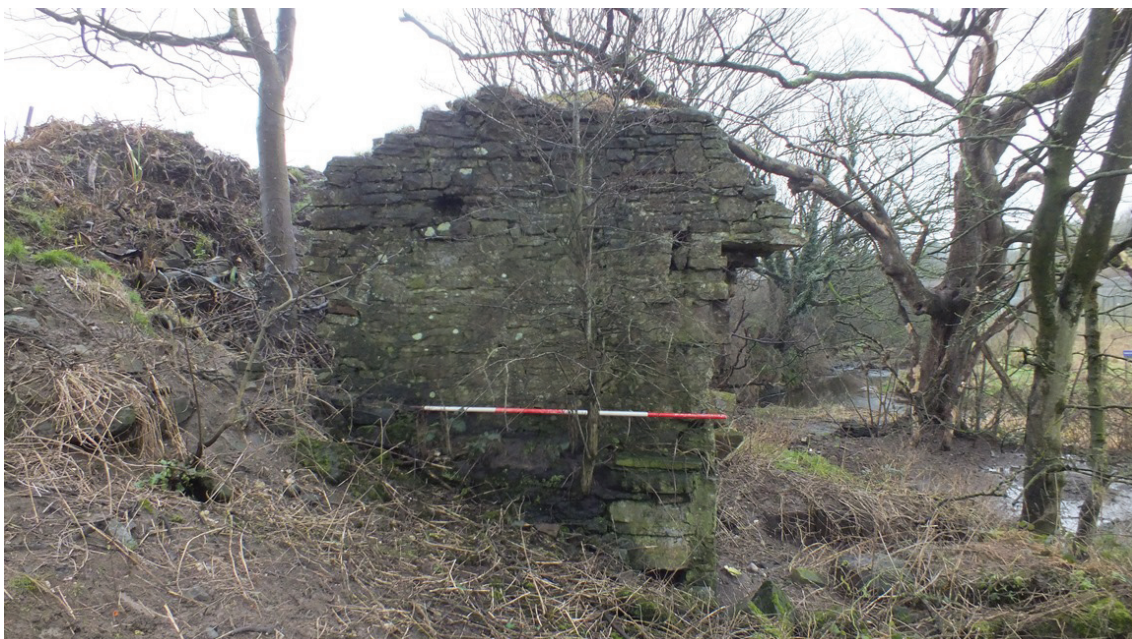
Plate 17: East elevation of Building 2, viewed from the east

4.2.6 **Building 2, east elevation:** the east elevation comprises much rougher blocks in more irregular courses with a plinth at the base (Plate 17) and the jamb of an opening on the north side (Plate 18). This perhaps represents two openings one above the other or simply a single large opening. There is a small slot to the south of this and a small alcove (possibly a putlog hole) to the south. There is further piece of wall in the slope to the east and a square block of dressed stone on the north-west side adjacent to a partially buried mill stone.

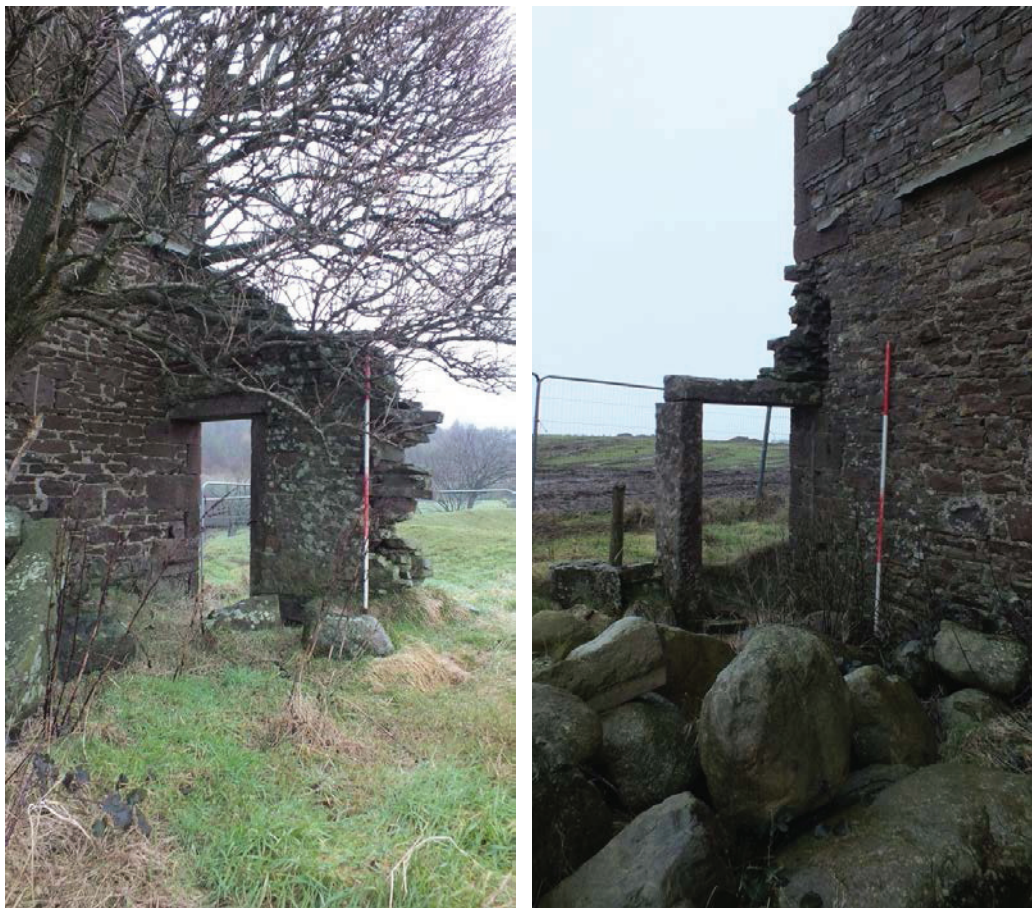
4.3.1 **Building 1, ground floor, Room 1 (G1):** this room at the south-east end of the structure has now largely collapsed, so the north-west elevation is the same as the south-east external elevation. The floor is overgrown and covered with rubble. The monopitch roof has collapsed as is the south-east elevation, and the south-east end of the north-east elevation. The walls are exposed stone. The door on the north-west side has a stone surround, slightly rebated, with an iron fitting and timber lintel over stone (Plate 19). The south-west elevation now comprises just a door surround to the north-west and the remaining iron fittings (Plate 20).

Plate 19 (left): North-east internal elevation of G2, viewed from the south

Plate 20 (right): South-west internal elevation of G2, viewed from the east

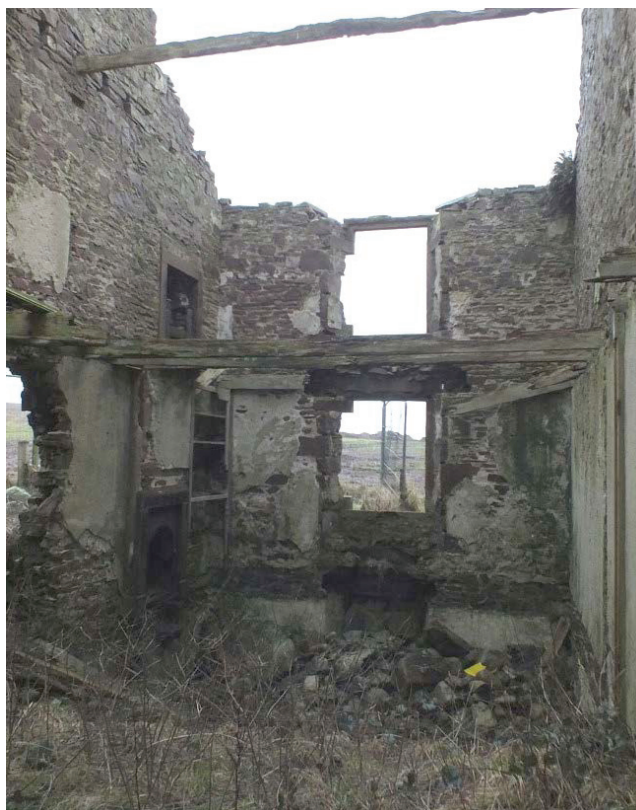
Plate 21: South-west internal elevation of G2, viewed from the north-east

4.3.2 **Building 1, ground floor, Room 2 (G2):** the floor in this room is covered in rubble and overgrown. The ceiling is gone and nothing remains of the floor above apart from the ends of the beams and joists on the south-west side, aligned north-west/south-east. It is now a single large room and is there is a large hole to the cellar on the south-west side. The walls have remnants of plaster. On the north-east elevation there is a doorway and window. The window has splayed jambs and both the window and door have timber lintels. The door surround is plain. The north-west elevation is plain with a timber batten midway which was possibly part of stud wall. The south-west elevation has central windows at cellar and ground floor level with splayed jambs. The lintels have gone and both apparently have stone sills (Plate 21). The south-east elevation has alcove on either side with the remains of cupboards, timber surrounds and shelves. There is a collapsed section leaving a hole near the centre of the elevation on the south-west side. There are chimneybreasts either side of this hole with fireplaces. The one to the south-west is smaller, with an iron insert with a round head (Plate 22). The larger one to the north-east has a hob grate and stove on the south-west side (Plate 23). Both have plain stone surrounds.

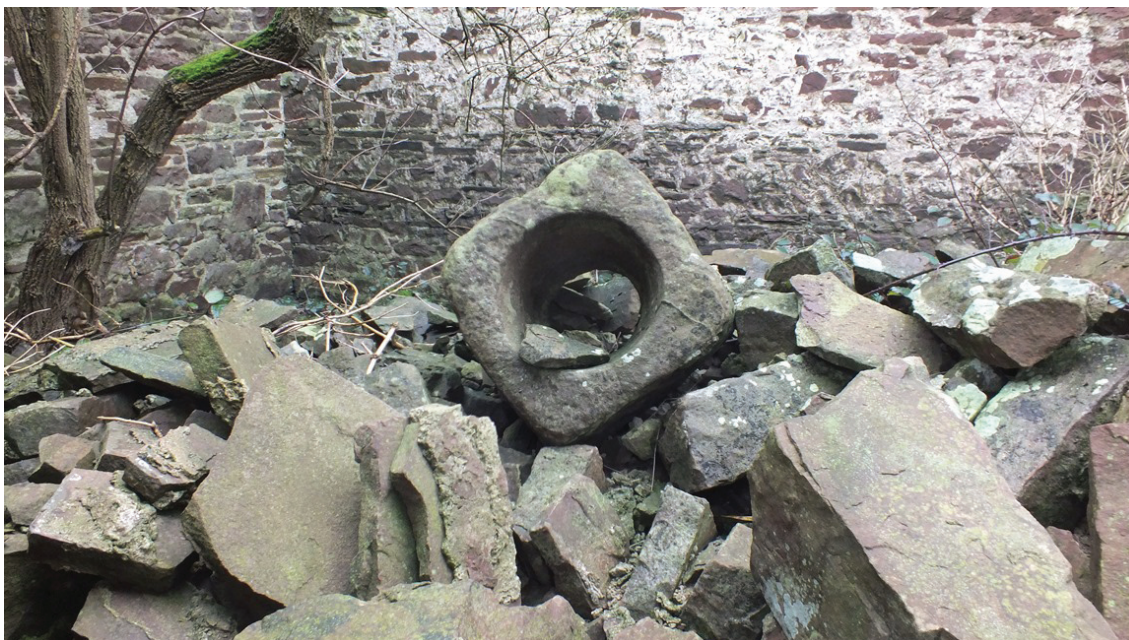
Plate 24: Rubble on the floor of G3, viewed from the north-west

4.3.3 **Building 1, ground floor, Room 3 (G3):** the floor is obscured by vegetation and rubble, including a carved round 'bowl' in a square block (Plate 24), and the roof is gone. The walls have remnants of whitewash. There was a north-west/south-east aligned wall dividing the room slightly to the south-west of the centre, butting the main wall at the ends, but this has collapsed. The top of the north-west elevation has collapsed. There is a doorway with square surrounds and iron fittings on the north-west elevation either side of the dividing wall. The south-east elevation is fairly plain apart from two small alcoves with small stone lintels (Plate 25). There are two low-level blocked vent slots and a row of joist holes below the loading door (at first floor level; described as part of **F2**) on the south-west elevation (Plate 26).

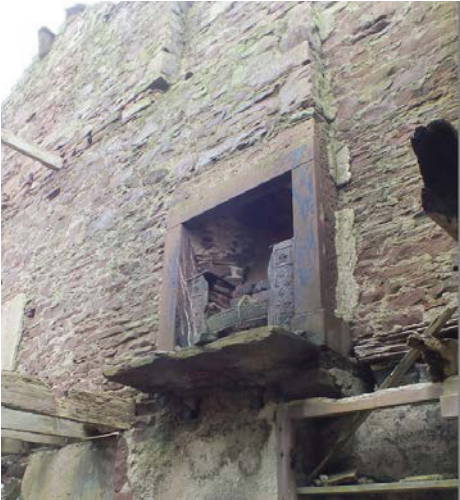
Plate 27 (left): Fireplace on the south-west side of the south-east internal elevation of Room F1, viewed from the west

jamb. The north-west elevation is plain and the south-east elevation has alcove at either end. There is a fireplace on the south-west side with square surround and an iron hob grate with floral decoration (Plate 27), and an attic window on the north-east side with fairly square jambs in the recess for the chimneybreast (Plate 28).
