SEA VIEW FARM, RINGSTONES LANE, LOWGILL, LANCASHIRE

Archaeological Building Recording

June 2018

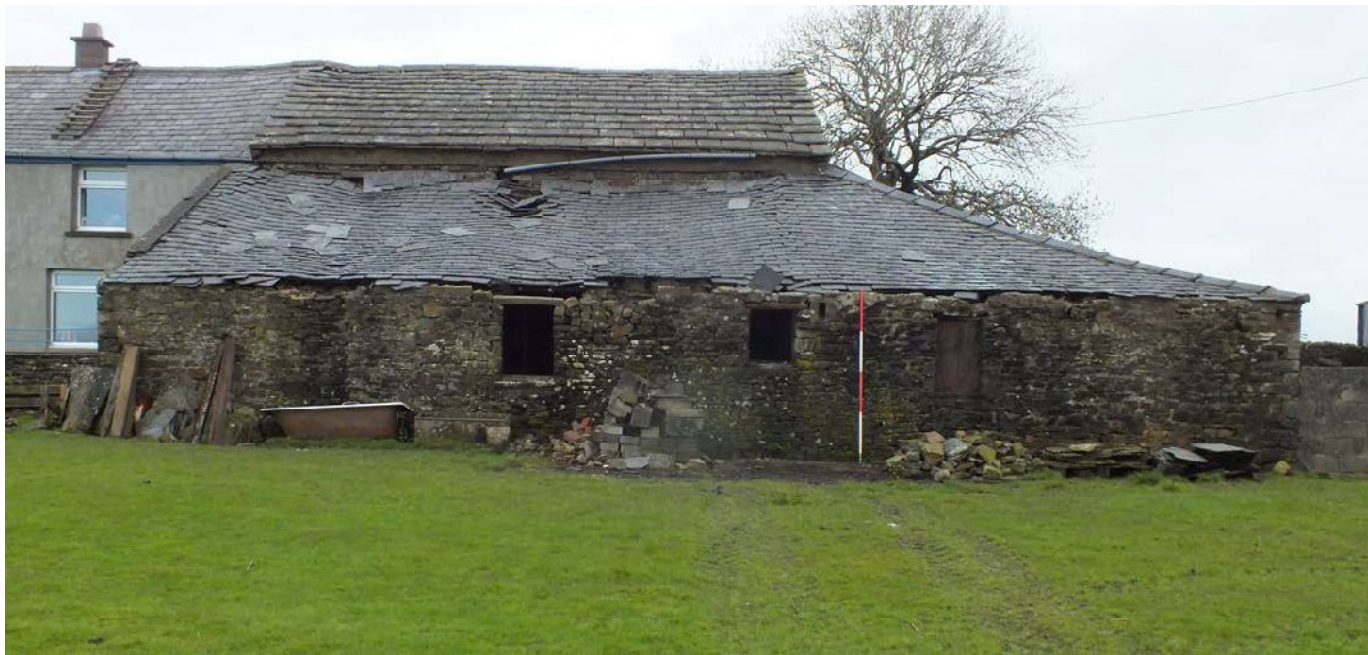
4.2.3 **South-west elevation:** the south-west elevation is entirely stone-built with quoins at both ends (Plate 17; Figure 2). The slate roof of this end of the shippon (Barn 1) has a concrete edge to the north-west end and ridge tiles to the south-east at the corner. Barn 3 is visible above with a concrete skim and stone roof above. The shippon (Barn 1) extends slightly beyond Barn 3 to the north-west and parts of the roof of the shippon (Barn 1) and some of the stonework has collapsed, notably along the top at the front

Plate 17: South-west external elevation

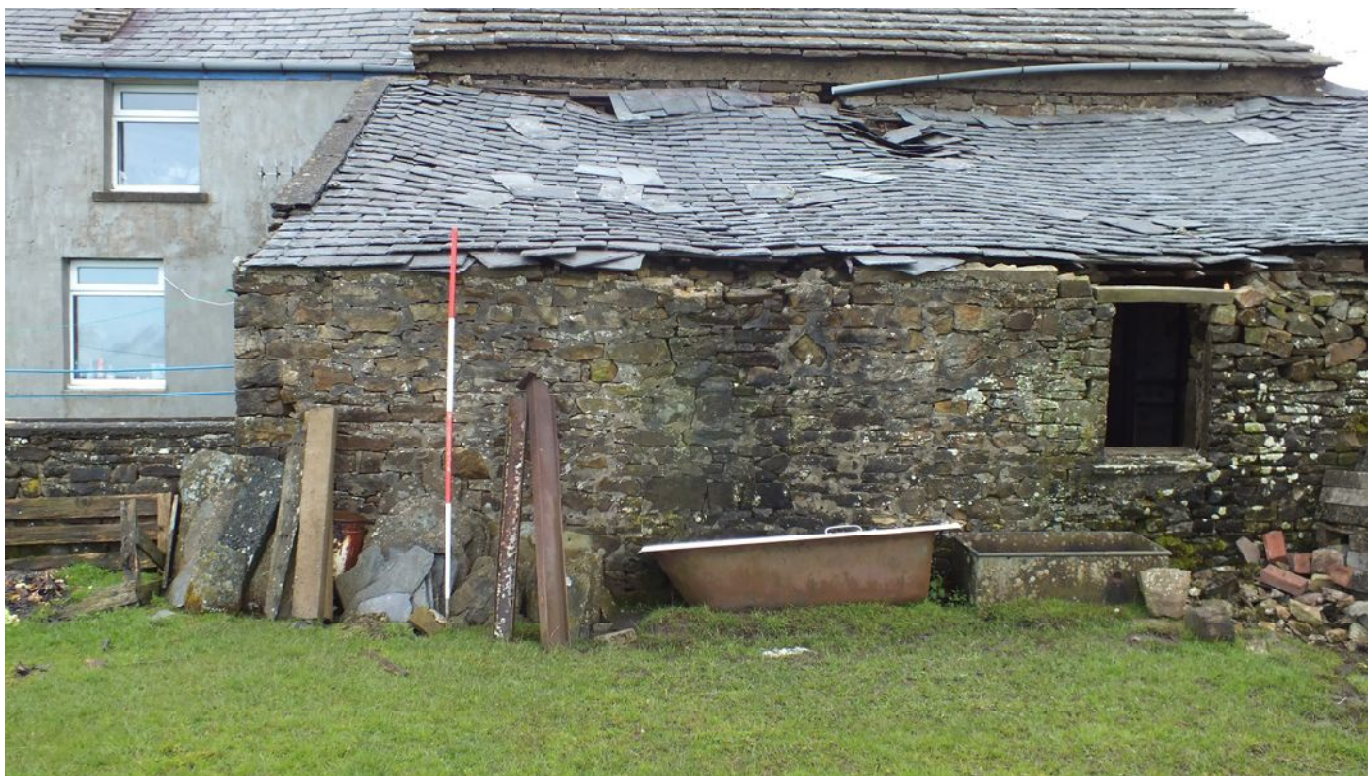
but also revealing some of the stonework of Barn 3 to the rear. There are three windows in this side: the window opening to the north-west has a stone lintel and sill but no window frame (Plate 18); the central window opening has a timber lintel and concrete over the stones of the sill and no window frame (Plate 19); and, the window to the south-east, which is boarded from the outside, is missing its lintel and has a stone sill (Plate 19). There is a low-level blocked aperture to the south-east of that which has been infilled with modern brick. Three possible small beam slots were noted to the south-east end (Plate 20; Figure 2), so there was presumably another small structure added to this side at this end at one point which has since been removed. A concrete block wall butts and is partially tied-in to the south-east end of the elevation (Plate 20).

Plate 18: North-west end of the south-west external elevation

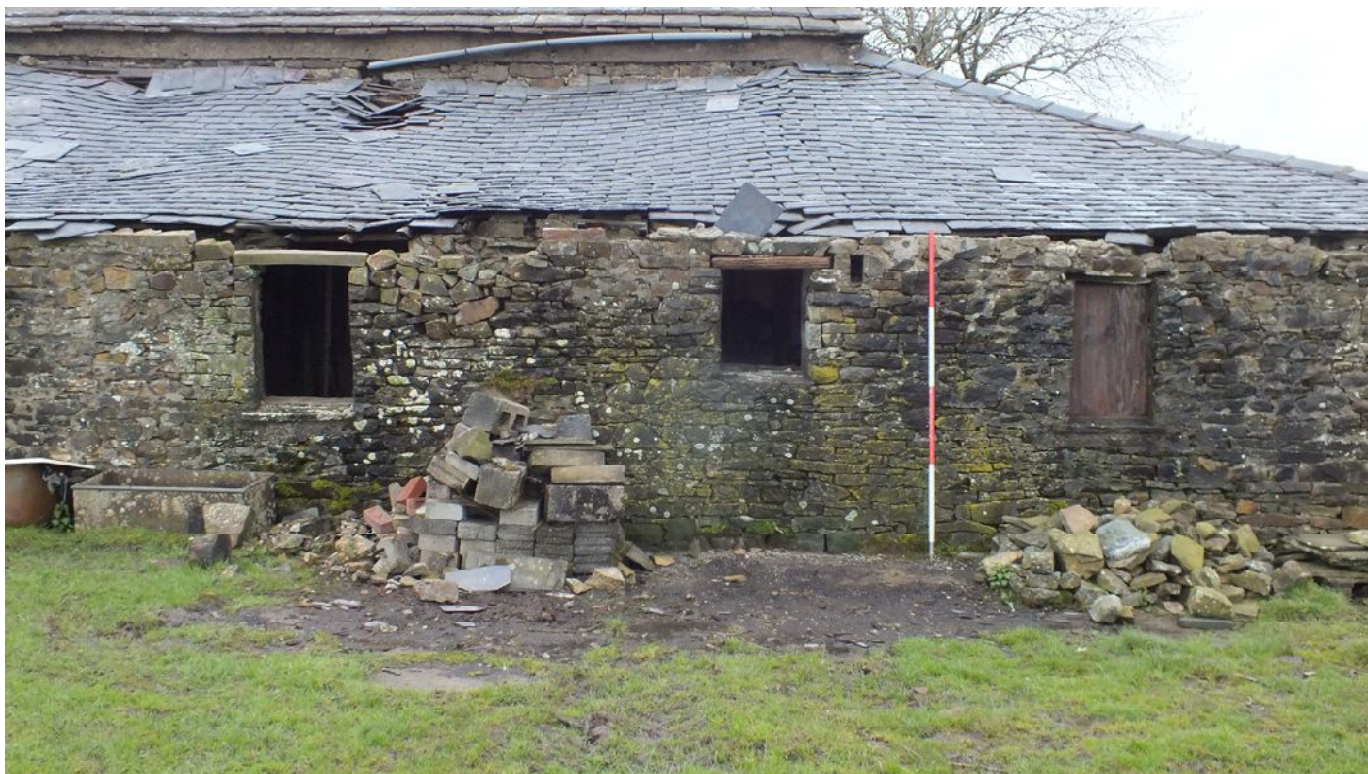
Plate 19: Centre of the south-west external elevation

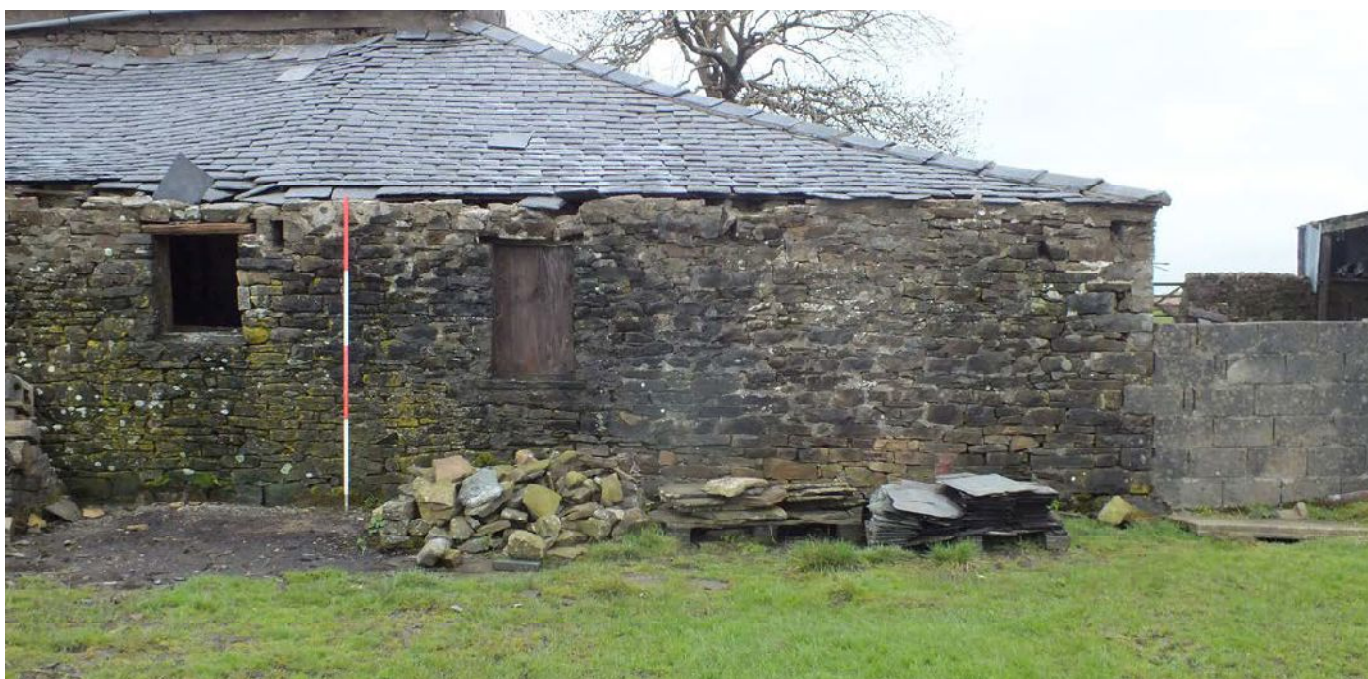
Plate 20: South-east end of the south-west external elevation

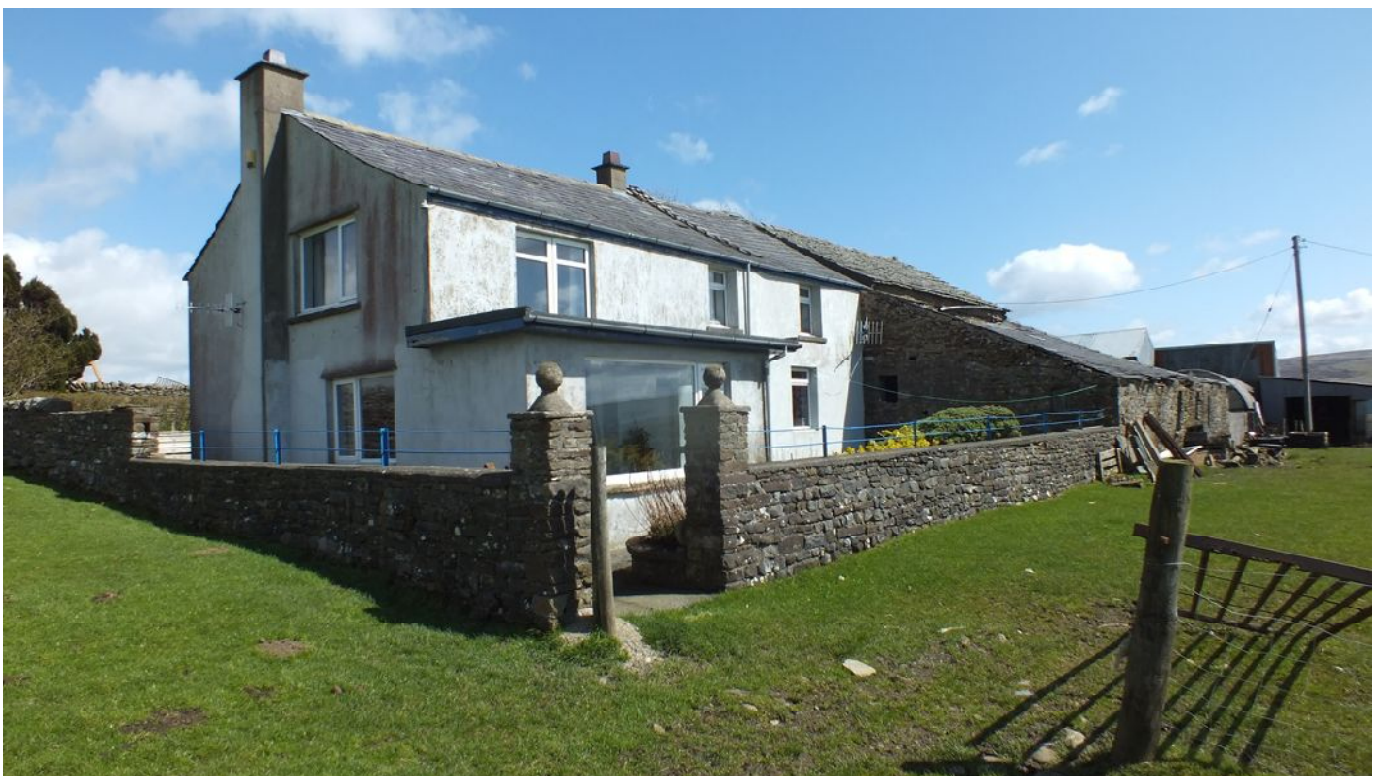
elevation of Barn 1 is to the south-west side of the house (Plate 23). It is stone-built with concrete pointing over the lower part and more regular flatter stone courses above that to the existing roofline and there is some repointing to the roofline. The roof slopes upwards from the south-west to the north-east, where it butts the house, and there is a garden wall made from stone butting the south-west end (Figure 2; Plate 24). There are quoins in the wall at this end. The window opening at the north-east end of the elevation has a stone lintel and sill and no window frame and is partially in-filled with stone at the base. A smaller window to the south-west has a stone lintel and sill and a single-light, fixed timber casement. There is a small low-level opening between the two windows which has been infilled with brick.

Plate 23: Barn 1 to the south-west side of the house

5.2.4 The roof of Barn 1 is supported by several props, especially at the north-west end, and it is clearly in need of repair. The top edge of the south-west elevation and south-east elevation of Barn 1 in particular are also in need of repair. It appears that the south-east elevation of Barn 2 has had some repairs carried out with red brick infill and concrete repointing.

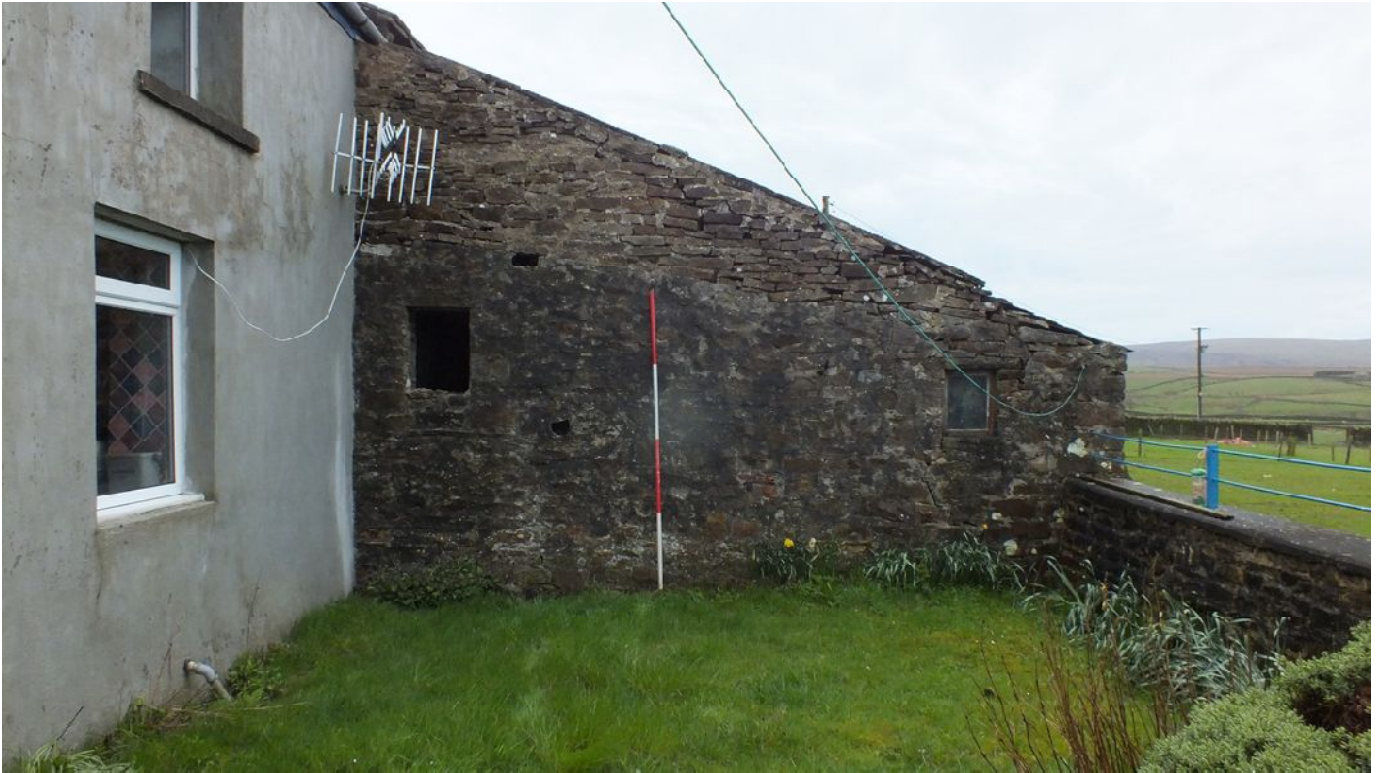
Plate 24: North-west external elevation of Barn 1

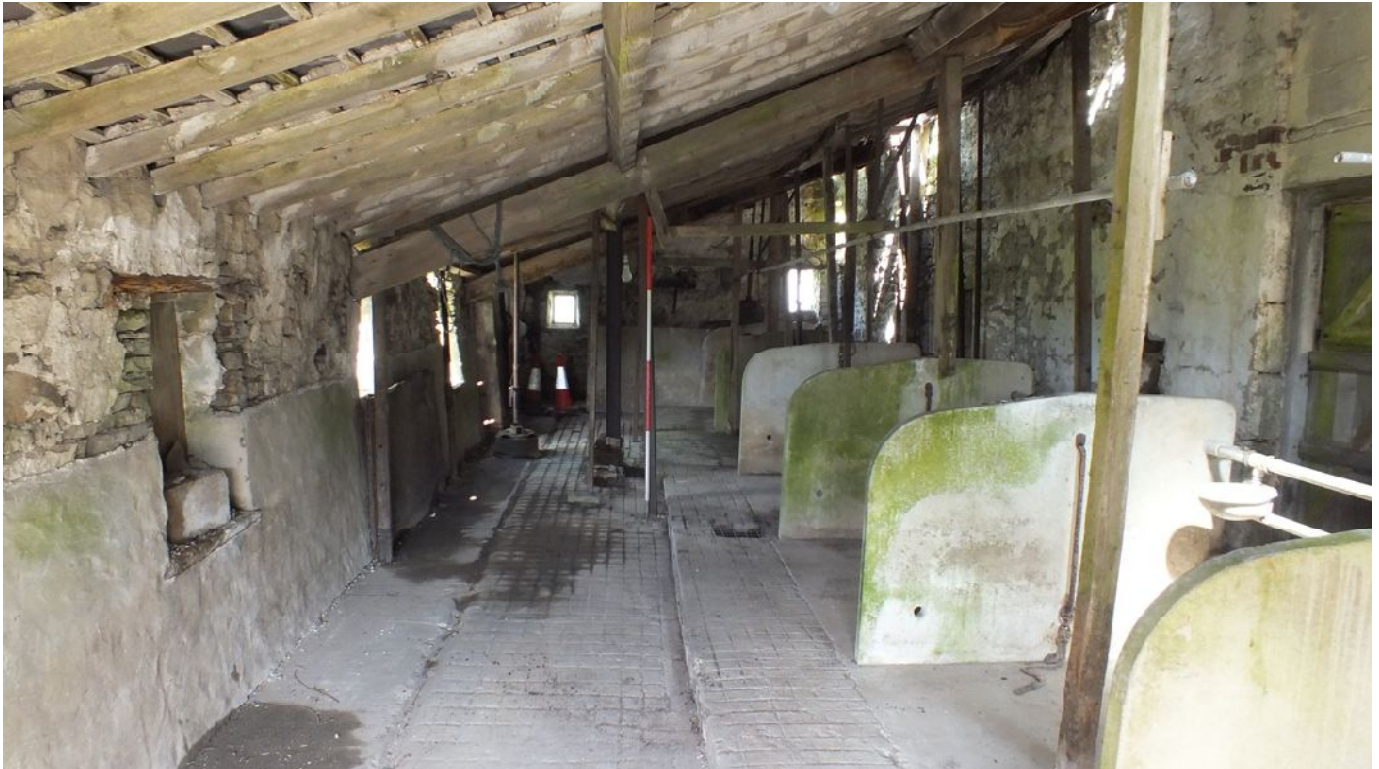
4.3.1 **Barn 1:** Barn 1 comprises a large rectangular room, aligned north-west/south-east to the south-west side of Barns 2 and 3 (Figure 3). The mono-pitched roof slopes upwards towards the side of the other two barns (Figure 5) and the machine-cut timbers and slates are exposed (Plate 25). The roof is supported by two timber beams, aligned north-east/south-west, so the barn is effectively split into three bays from south-west to north-east. There are several metal props and additional timber and I-beam supports in place at the north-west end of the room in particular. The floor is a mix of grid-pattern and plain concrete, with a feed passage along the north-east side and a lower dung channel to the south-west side (Plate 26); both the feed passage and concrete stalls are raised relative to the dung channel. There are five stalls with troughs and tethering posts (Plate 27) and a low, modern redbrick wall partition at the north-west end of the most northerly stall.

Plate 25: General view of the north-west end of Barn 1

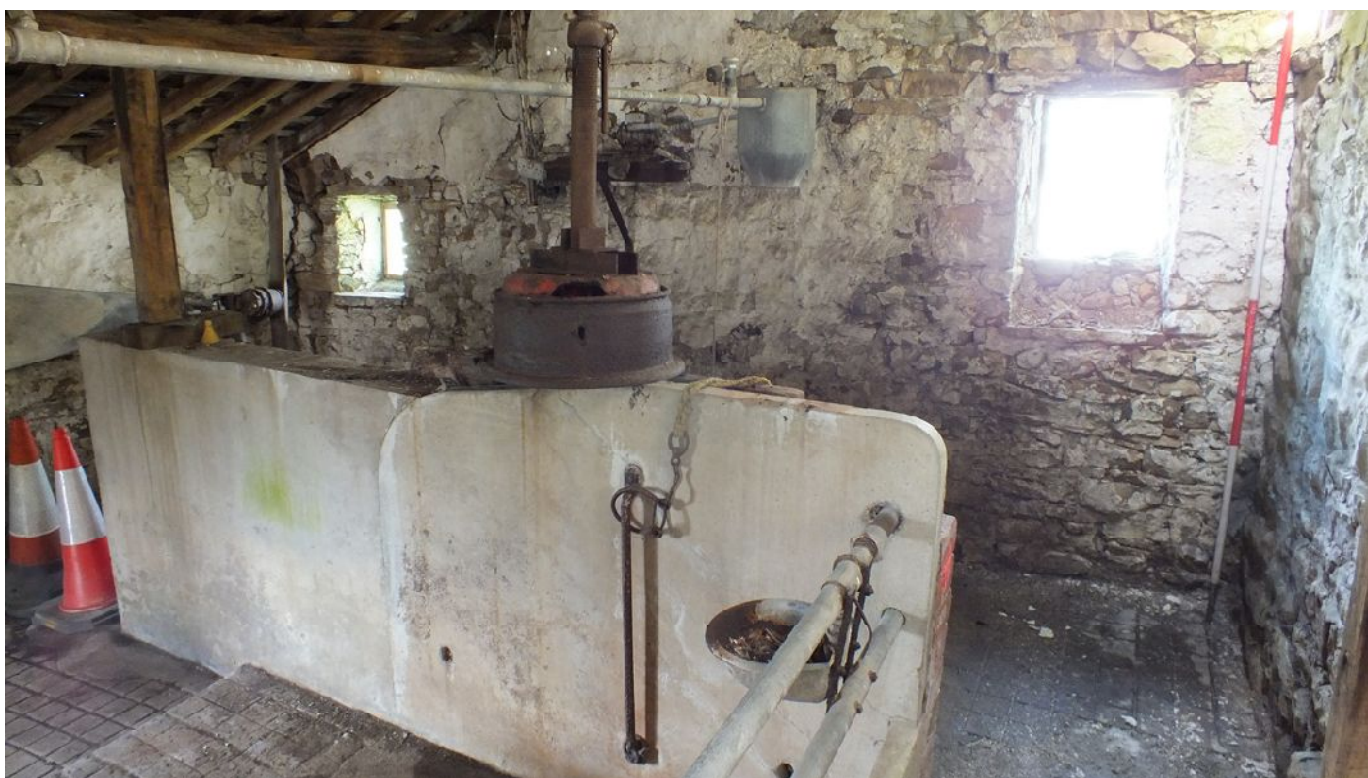
4.3.2 The north-west elevation is mostly exposed stone with some white plaster remaining (Plate 29). There are two window openings, both with stone sills and lintels (Plate 29). The one to the south-west has a single-light timber casement (fixed) (Plate 29) and the other is part blocked with stone and has no window frame (Plate 30).

Plate 29: North-west internal elevation of Barn 1

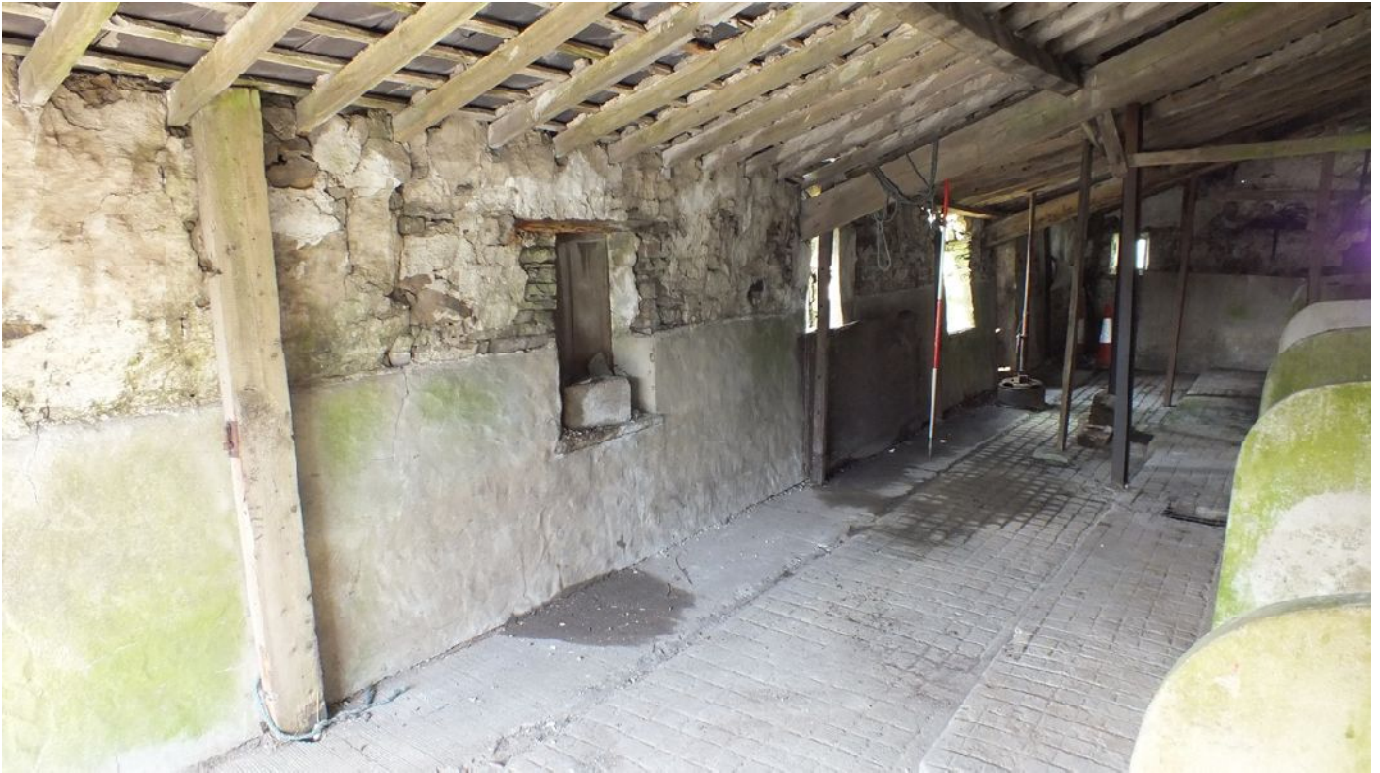
4.3.5 The south-west elevation has a concrete skim along the base of the wall up to the brick partition at the north-west end of the room (Plate 40). The rest is exposed stone with lime mortar and plaster (visible to the left hand side of Plate 28). There are three window openings in this side: the one to the south-east is slightly splayed, has a timber lintel, stone sill and no frame, and is boarded over (Plate 41); the centre window opening has a timber lintel and concrete sill but no window frame (Plate 41); and, the one to the north-west has a stone lintel and sill, slightly splayed jambs, and no window frame (Plate 42).

Plate 40: South-west internal elevation of Barn 1

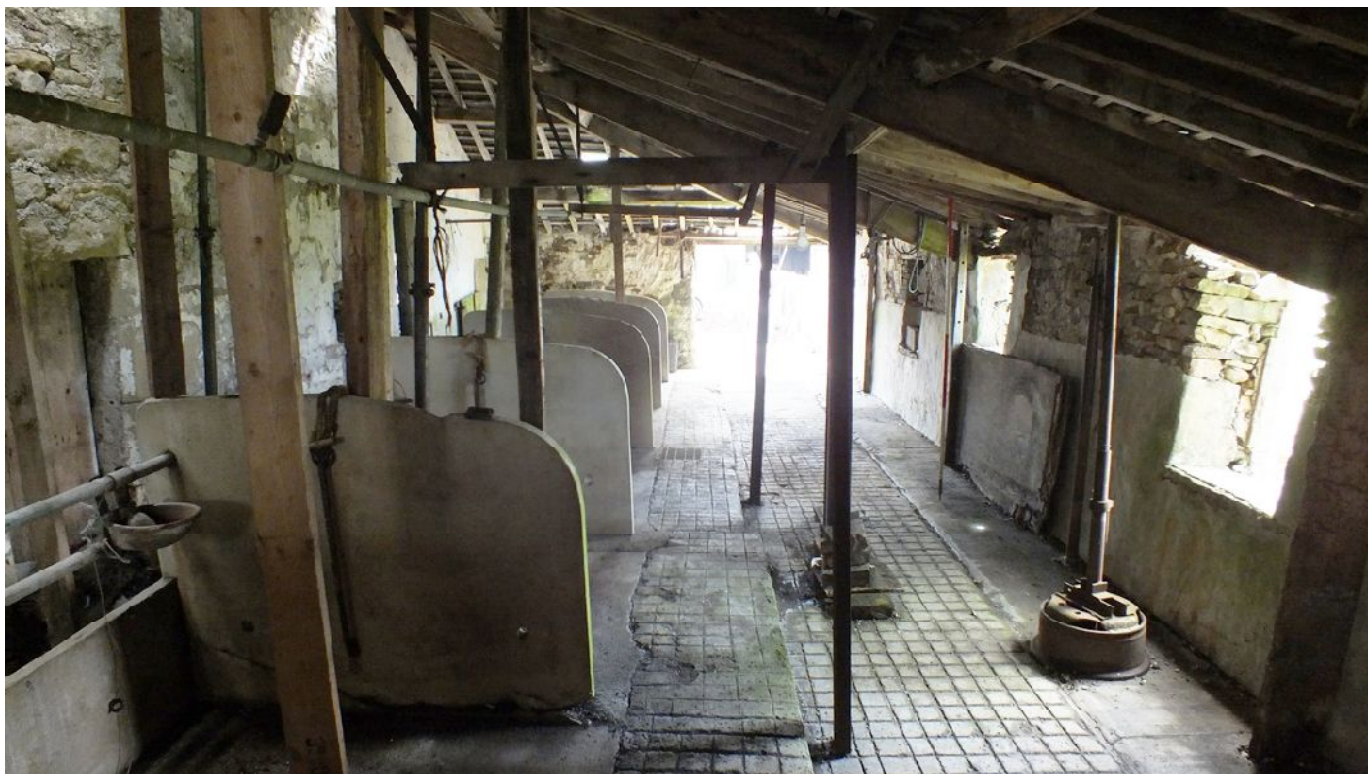
Plate 42: General view of Barn 1 from the north-west end

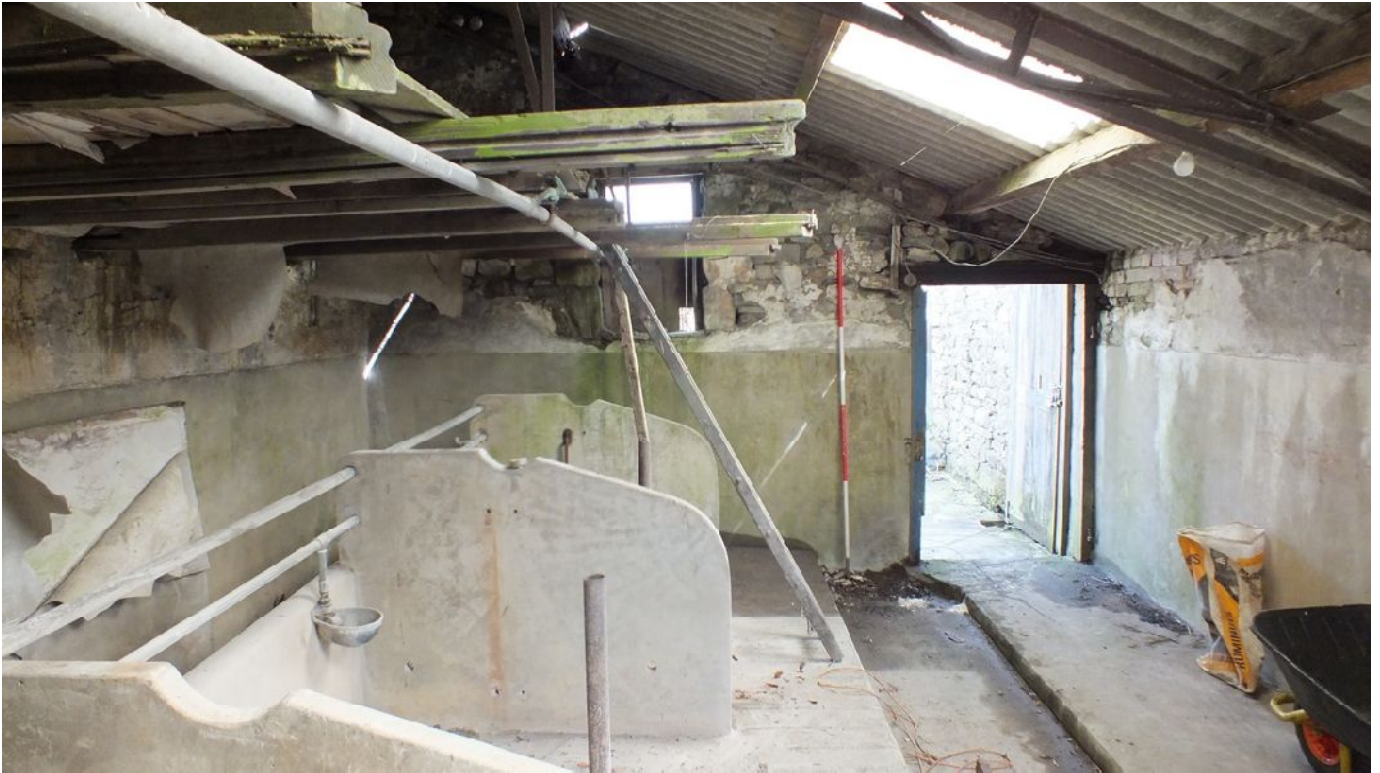
4.3.8 There is a high-level window on the north-east elevation with a stone sill and covered lintel. It was originally a three-light window, but the bottom two are broken and boarded from the outside. The doorway at the south-east end has a timber lintel internally and timber frame but the door is missing (Plate 48).

Plate 48: North-east internal elevation of Barn 2

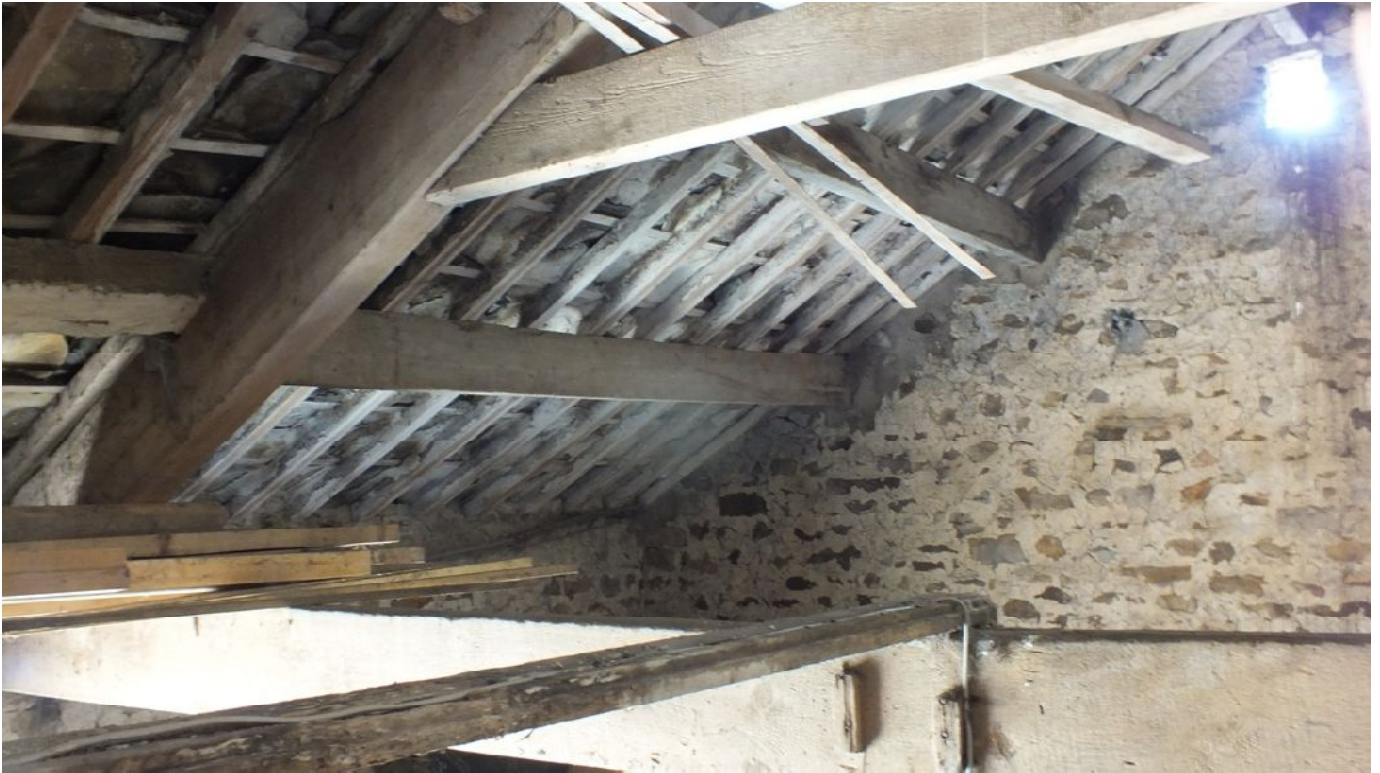
Plate 55: Replacement purlins at the south-east end of Barn 3

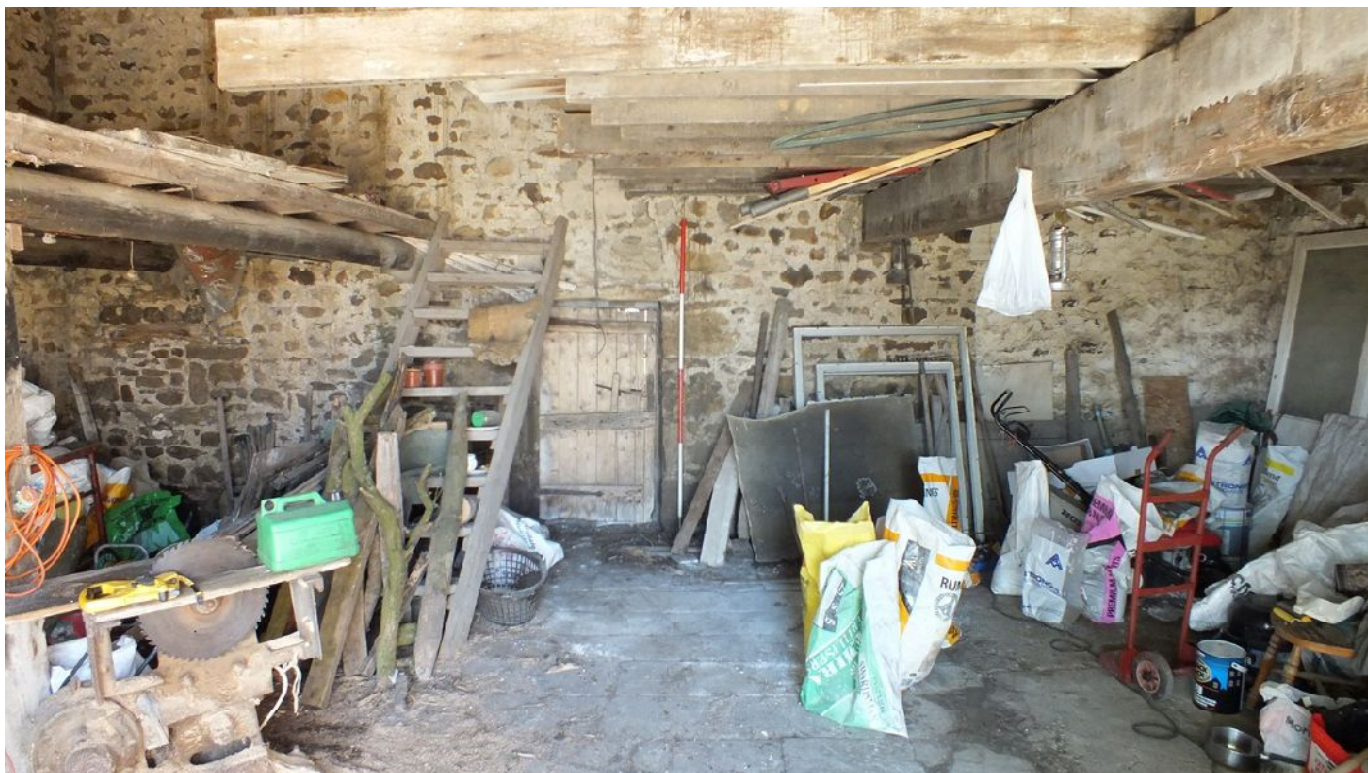
4.3.15 There is a blocked window at the south-east end of the south-west elevation with an old timber lintel and stone sill (Plate 71 and Plate 72). The doorway midway along this side of the room has quoins in the jambs and long strap hinges and a plank and batten door (Plate 73). Some but not all of the quoins are noted to be continuous through to this side from Barn 1 and the elevation is plain to the north-west of that. The upper floor level of this elevation is also plain (Plate 74 and Plate 75).

Plate 71: The south-west internal elevation of Barn 3 at ground floor level
