# GIBRALTAR FARMHOUSE, LINDETH ROAD, SILVERDALE, LANCASHIRE

## Archaeological Building Recording

October 2019

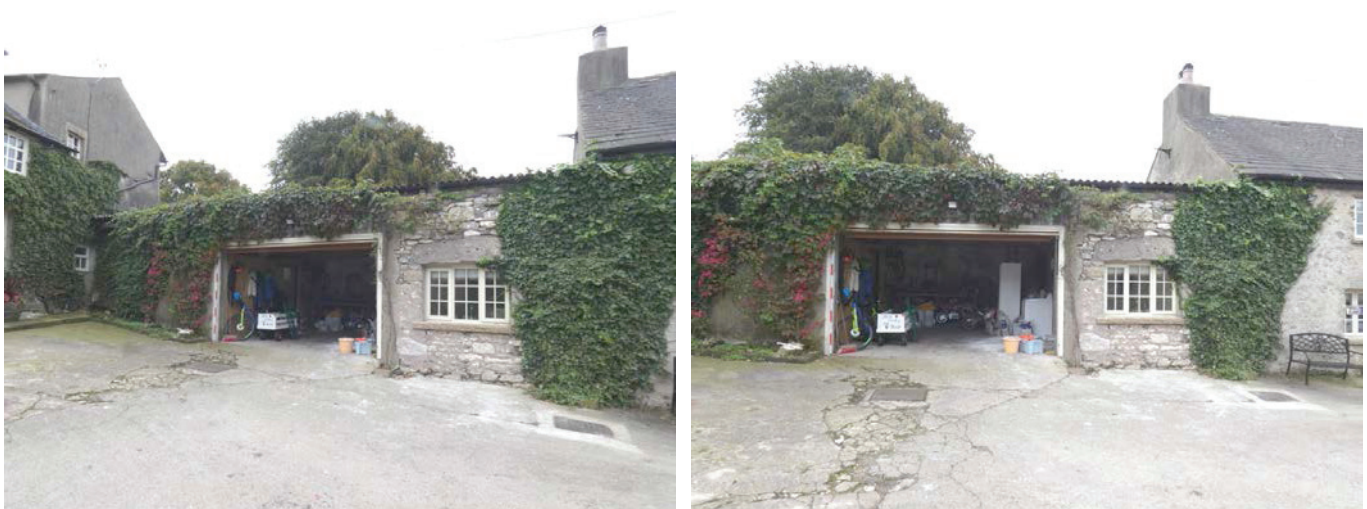
4.2.1 **North-east external elevation:** this is finished with smooth concrete render at the south-east end and also partially obscured by vegetation (Plate 10). There is a slight step back at the south-east end, perhaps originally a doorway, which has a machine cut lintel over it, although this is essentially just part of the wall plate for the roof, to which plastic rainwater goods have been attached. In the centre there is a large garage door with an electronic timber plank door with four six-light windows (Plate 11 and Plate 12). The lintel is hidden by timber plank cladding. To the north-east the wall has been substantially rebuilt leaving exposed stone, with slobbered mortar over the lower part, and incorporates a large window with three six-light hinged timber casements (Plate 11). This has a heavy limestone lintel and thinner yellow sandstone sill, below which is a straight butt joint on the south-east side. The junction with the projecting section forming part of the main house is obscured but it seems to be continuous, with no obvious quoins or butt joints.

Plate 10 (left): The south-east end of the north-east external elevation, viewed from the north

Plate 11 (right): The central and north-west end of the north-east external elevation, viewed from the north-east

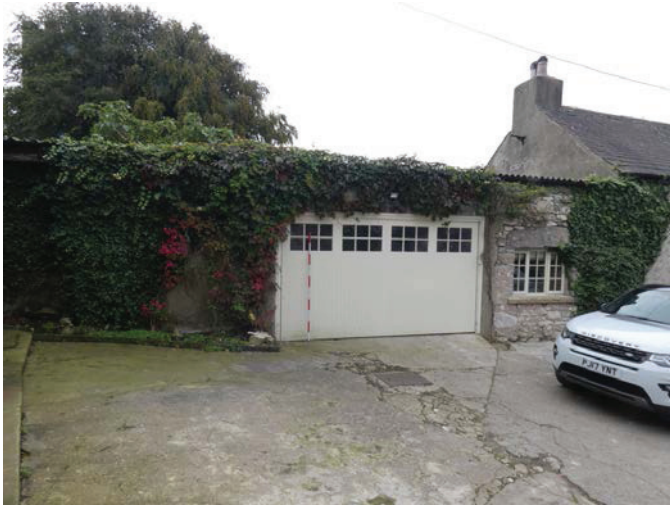
**Plate 12 (left): The garage door in the north-east external elevation, viewed from the north-east**

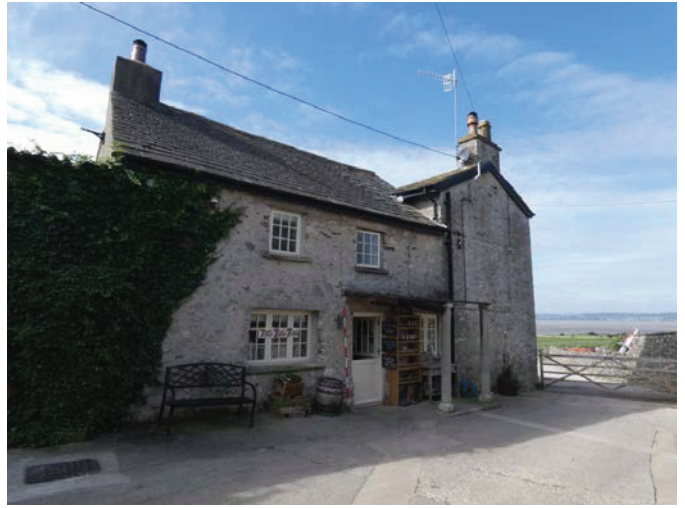
**Plate 13 (right): The north-east external elevation continuing into the main house, viewed from the east**

4.2.2 The elevation continues into the house at the north-west east end, which retains its original fabric of slobbered limestone rubble throughout (Plate 13). There are two windows on the first floor each with nine-light hinged timber casements and concrete lintels and sills, while on the ground floor there are two windows, one with three six-light casements and a concrete lintel and sill on the south-east side and one with two six-light casements and a stone lintel and concrete sill to the north-west. Between these is a doorway with a modern split timber door, over which is a large canopy constructed from a single massive slate flag supported on two plain cylindrical limestone pillars with neatly finished projecting bases and rougher blocks on the top (Plate 14). The end of the elevation comprises the gable end of the house proper, the quoins of which form the north-west jamb of the north-west window (Plate 14), but these do not extend higher than the window, although there is step in the wall line. The gable is otherwise plain, although there are quoins on the north-west side, which are larger and more irregular towards the bottom, and it is topped with a square chimney with two ceramic pots and barge boards (Plate 15).

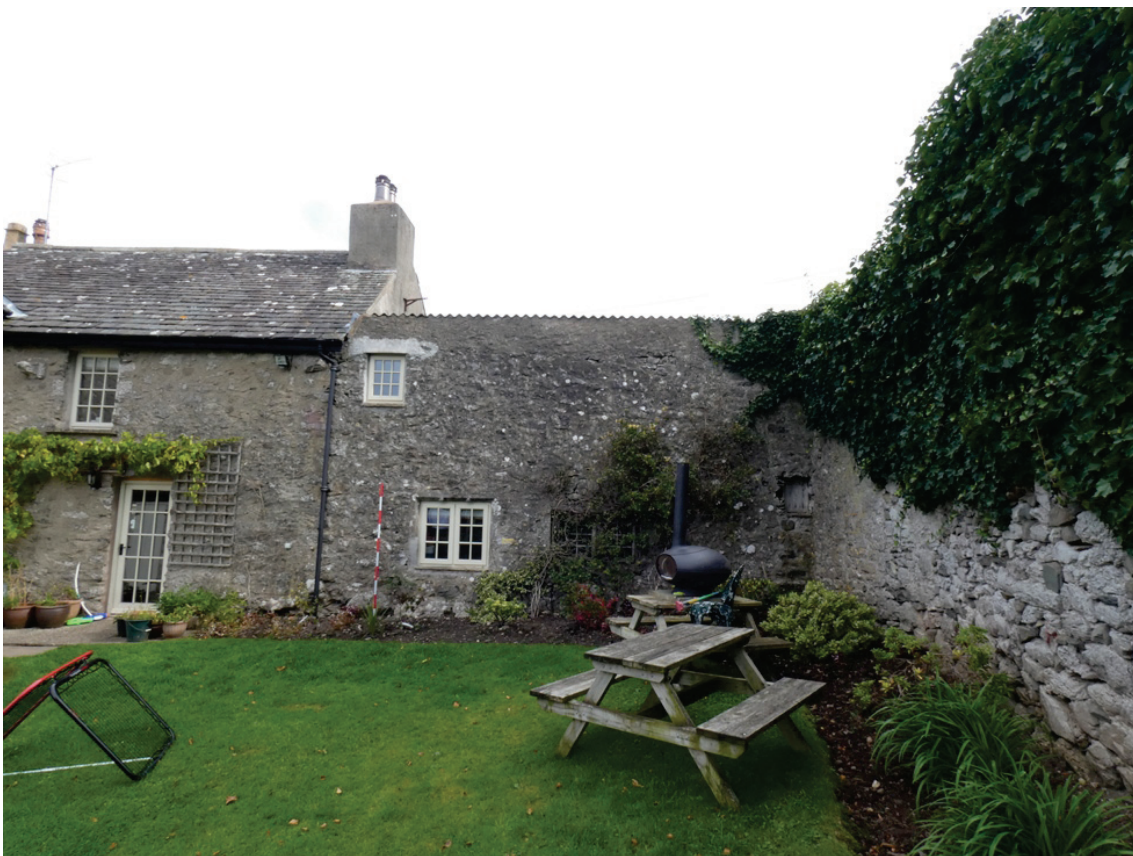
**4.2.4 South-west external elevation:** this is entirely of slobbered rubble construction with large boulders at the base and concrete pointing, although there have been numerous alterations. It is shortened relative to the north-east elevation by the position of the boundary wall, which it butts against at its south-east end (Plate 18 and Plate 19). There is a small window at this point, with a plain timber surround and timber plank shutter (Plate 20). To the north-west there are two further low ground floor windows; the south-east has the remains of a stone mullion window forming the surround on all but the north-west side and the sill, which is concrete (Plate 21). A machine cut very simple frame has been inserted into this with a wire mesh over and a modern window comprising two six-light timber casements inserted behind this. The window to the north-west is taller and also has the remains of a stone mullion forming the surround but it has evidently been extended at the bottom to make it taller and this part is finished with concrete (Plate 22). A modern window comprising two six-light hinged casements has been incorporated into it. Above these windows the wall top has evidently been raised, above the eaves of the wall to the north-west, and this incorporates a further window on the north-west side with a nine-light casement, which has concrete over the lintel and a modern stone sill and has evidently been inserted or modified (Plate 18). There is no obvious joint in the main wall, which continues into the house part to the north-west. This has a doorway on the ground floor with a stone lintel and window on the first with a

**Plate 18:** General view of the south-west external elevation, viewed from the south-west

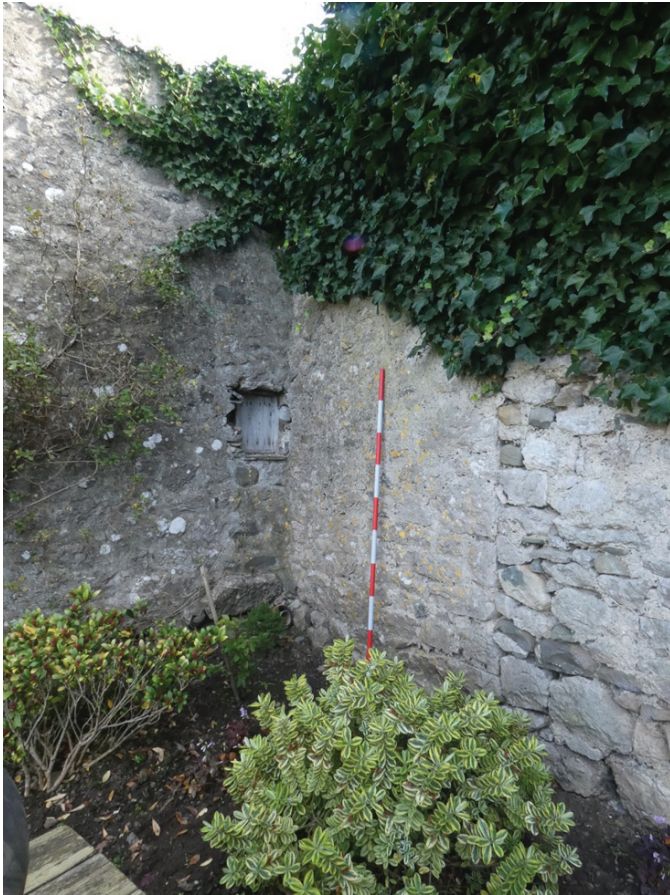
**Plate 19 (left): Small opening at the south-east end of the south-west external elevation and the relationship of the building to the adjoining wall, viewed from the west**

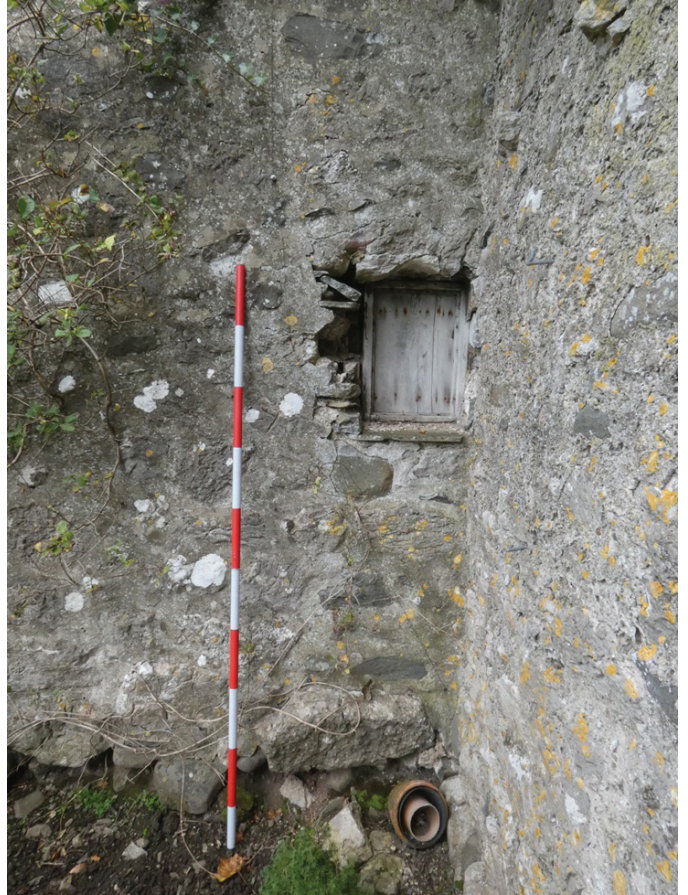
**Plate 20 (right): Detail of the small opening at the south-east end of the south-west external elevation, viewed from the south-west**

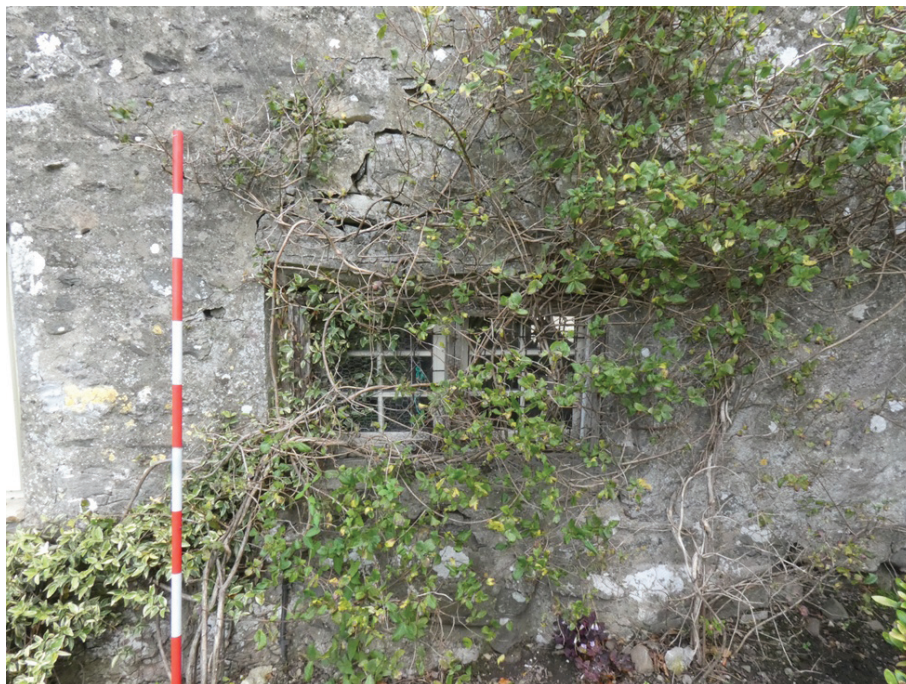
**Plate 21: South-east window retaining elements of a stone mullion in the south-west external elevation, viewed from the south-west**

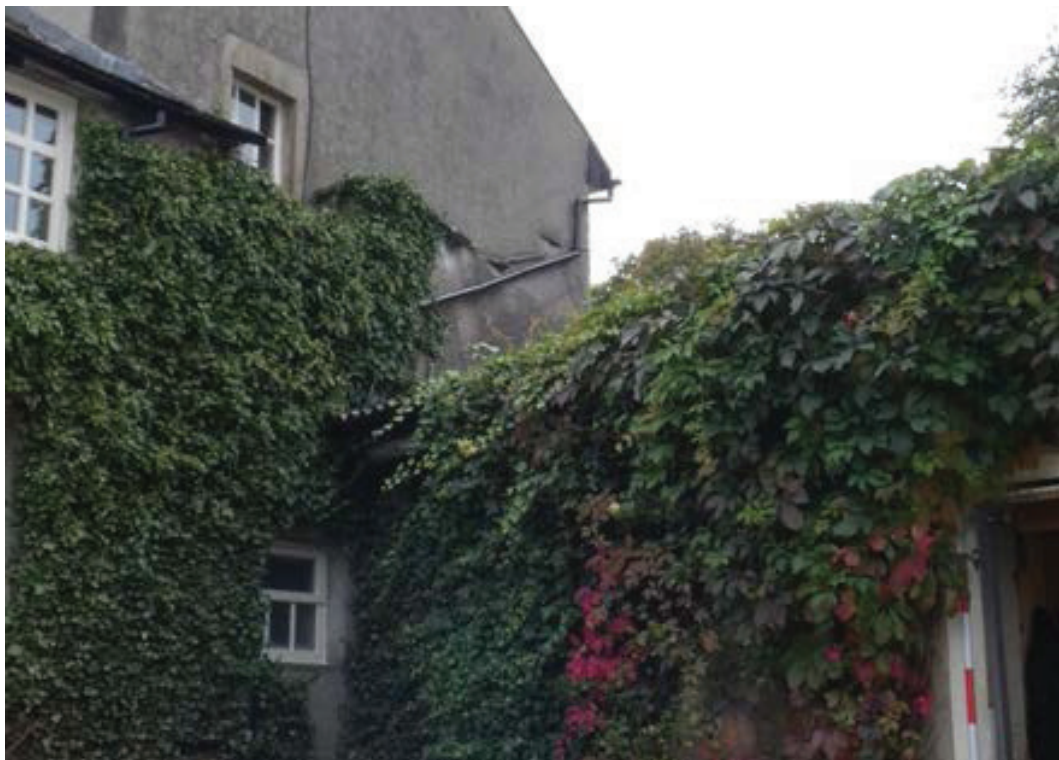
4.2.5 ***South-east external elevation***: while there is no south-east external elevation as such the north-west elevation of the adjoining building shows the line of the original roof as a line of thick slates projecting through the render (Plate 24). These follow the line of the roof but then very obviously go around a first-floor window in the adjoining building. In addition, the step in the south-east end of the north-east elevation also appears to have been deliberately constructed in order to accommodate a window in the adjoining building.

**Plate 24: Details of the former roof line visible in the north-west external elevation of the adjoining building, viewed from the east**

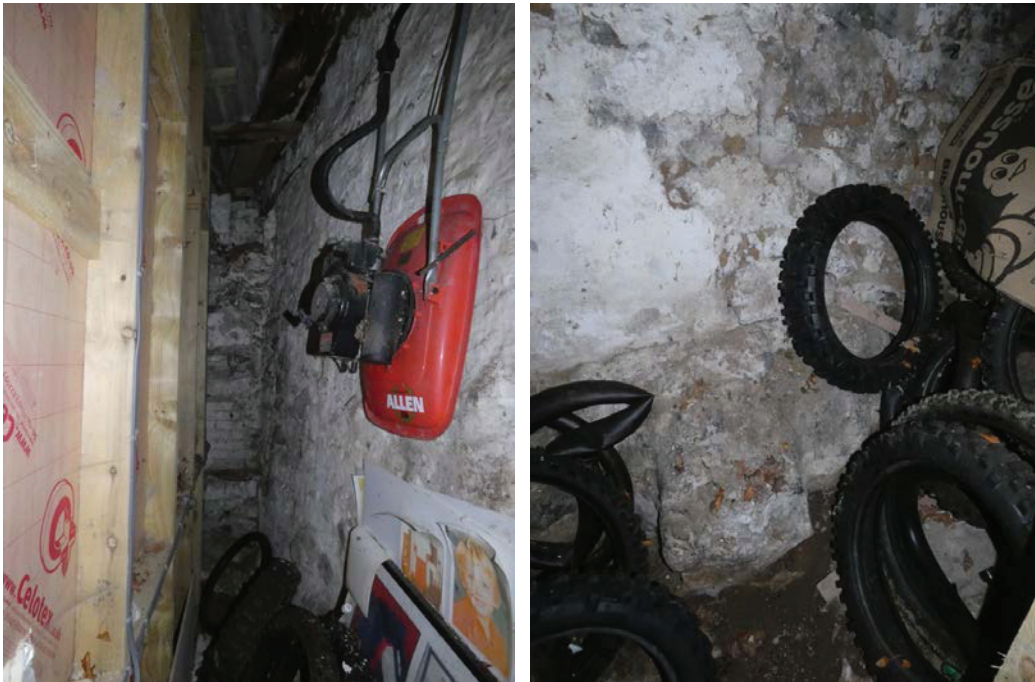
4.3.1 **Ground floor Room 1:** this only comprises a small space between the adjoining building to the south-east and the inserted stud wall forming Room 2 to the north-west (Plate 25). The south-east elevation is essentially plain stone finished with the remnants of limewash and with some large boulders on the north-east side continuing round to the south-west elevation (Plate 26). A stone 'lintel' connects these two elevations across the corner (Plate 27) but the south-west elevation is otherwise plain. The north-west elevation is a modern stud partition inserted across the original building and constructed from timber stud and plasterboard. The north-east elevation only comprises a small section and is stone built but with some rebuild in brick, possibly denoting the position of a blocked aperture.

Plate 25 (left): General view of Room 1, from the south-west

Plate 26 (right): The boulders in the south corner, viewed from the north-west

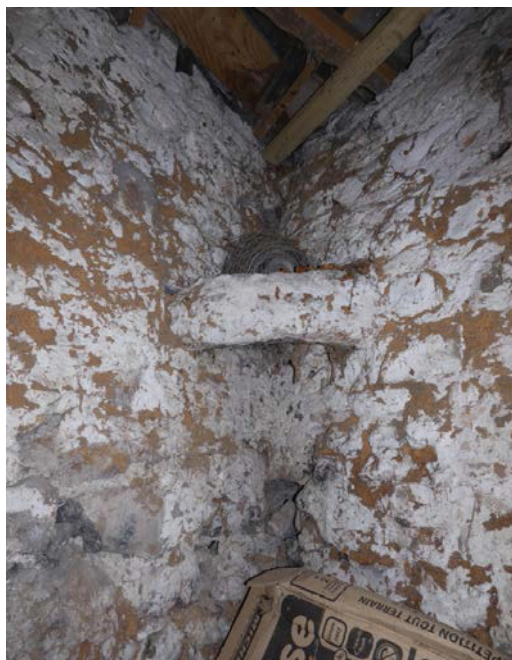
Plate 27: Stone 'lintel' across the south corner of Room 1, viewed from the north

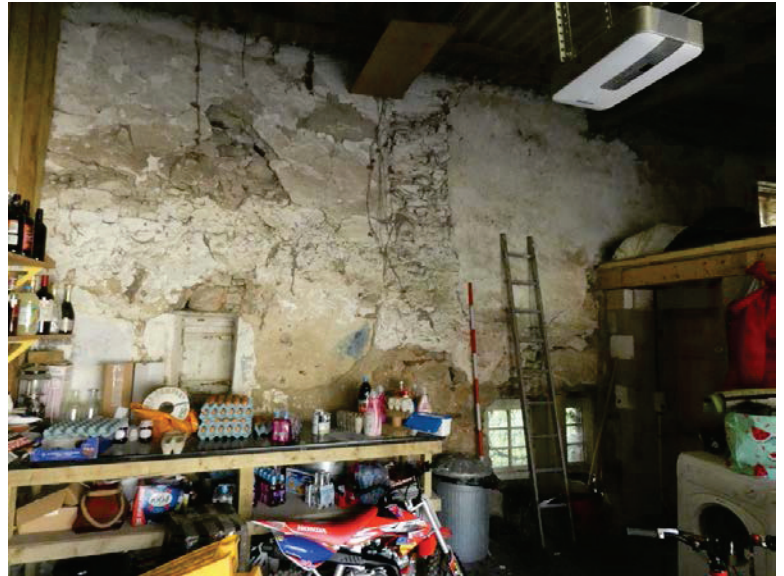
**Plate 33 (right):** General view of the south-west elevation of Room 3, showing the scar of the probable dividing wall

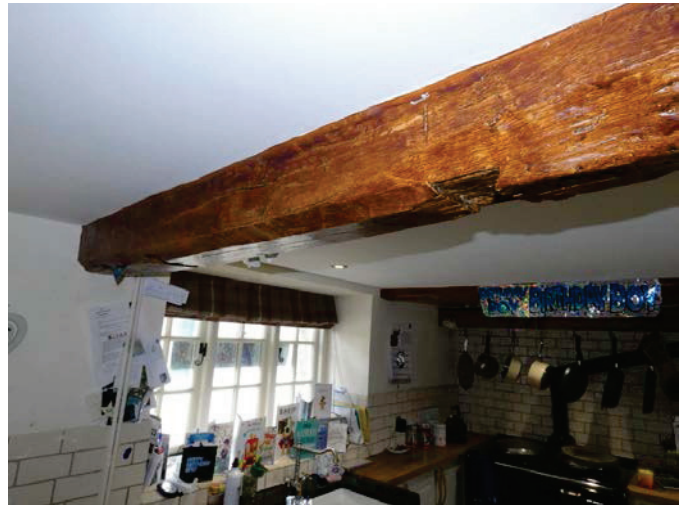
Plate 39 (right): South-eastern beam in Room 5 showing empty slots, viewed from the west

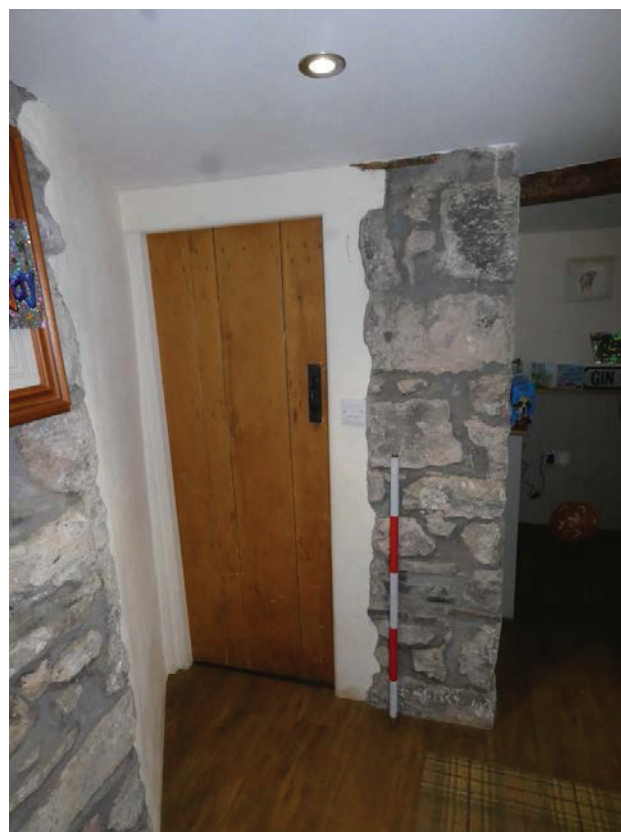
**Plate 43 (right): Early door in the north-west elevation, Room 5, viewed from the south-east**
