# FORMER TOLL HOUSE, DALTONGATE, ULVERSTON, CUMBRIA

## Archaeological Building Recording

June 2021

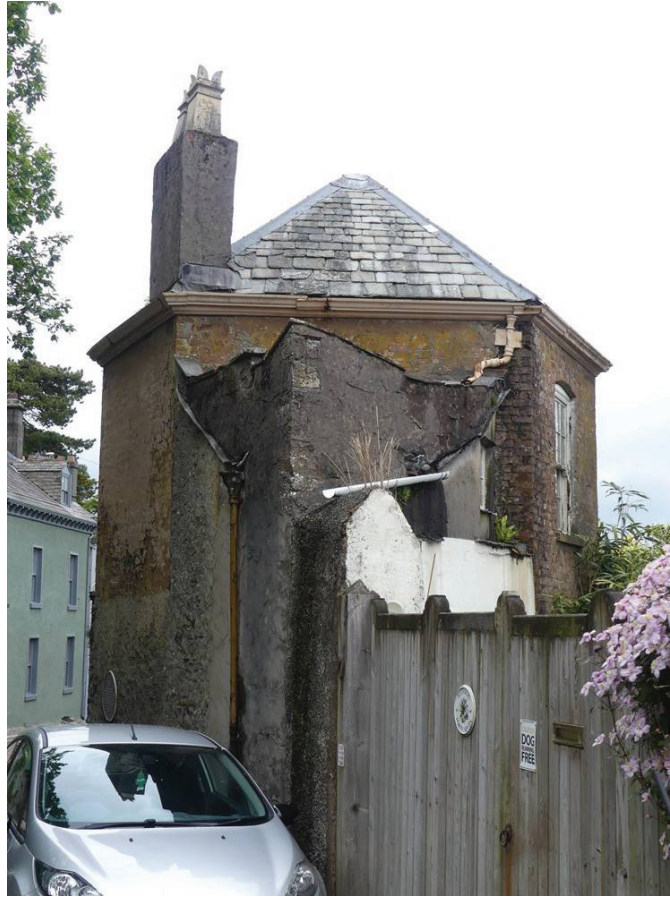
4.2.1 **South-west external elevation:** this is partly obscured by an adjoining boundary wall and not fully accessible due to the adjoining property's yard (Plate 11). The projecting triangular section has flag stones along the top of a parapet above the roof proper, which incorporates a lead gutter connecting to a downpipe into the street. There are roughly dressed quoins at the corner of the triangular section and an early, probably lead, downpipe from the moulded iron gutter along the main part of the roof.

**Plate 11: The south-west side of the building, viewed from the south-west**

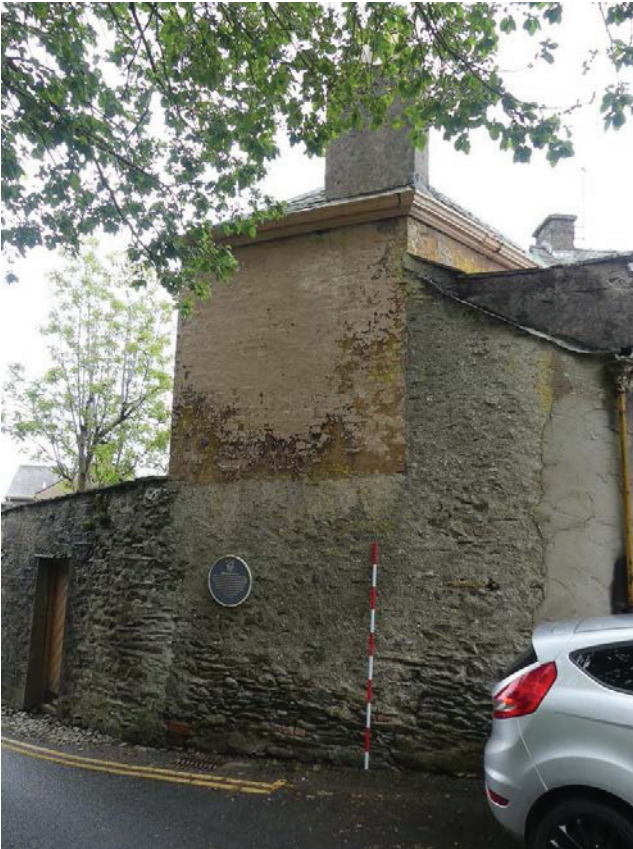
4.2.2 **North-west external elevation:** this is extended to the south-west by a tall boundary wall (Plate 12). The rear triangular section butts the brick first floor but continues the masonry build of the ground floor and both areas are finished with some original lime roughcast (Plate 13). It is otherwise relatively plain, apart from the chimney stack, which is finished with render. There is a cast metal heritage plaque on the north-east side (Plate 14), which reads:

Plate 12 (left): General view of the north-west external elevation, viewed from the west

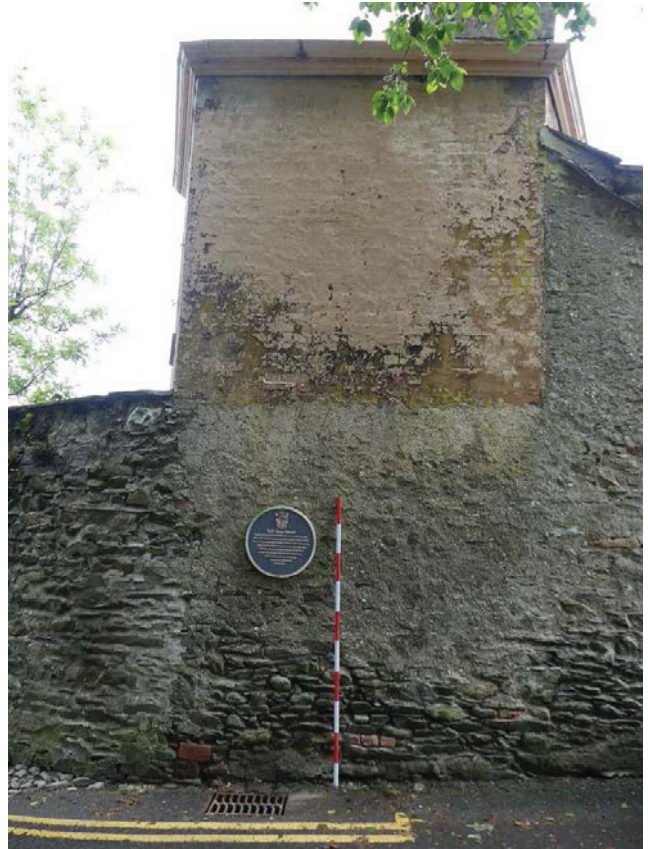
Plate 13 (right): Detail of the fabric of the north-west external elevation, viewed from the north-west

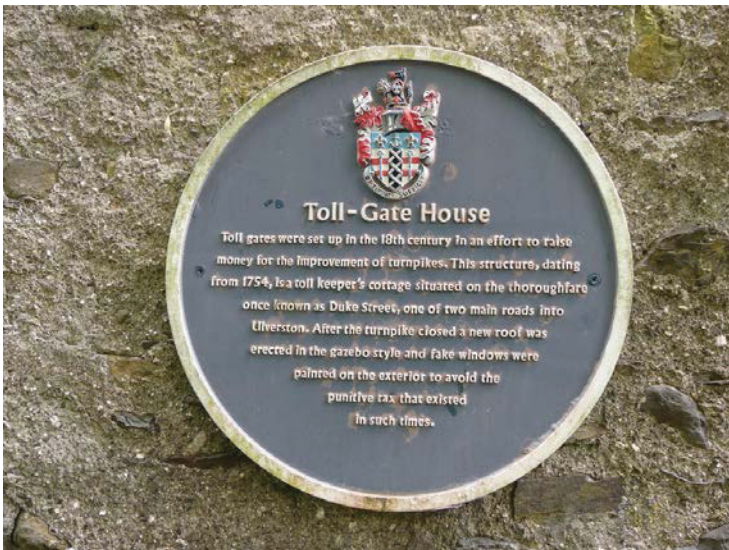
Plate 14 (left): Detail of the heritage plaque on the north-west elevation, viewed from the north-west

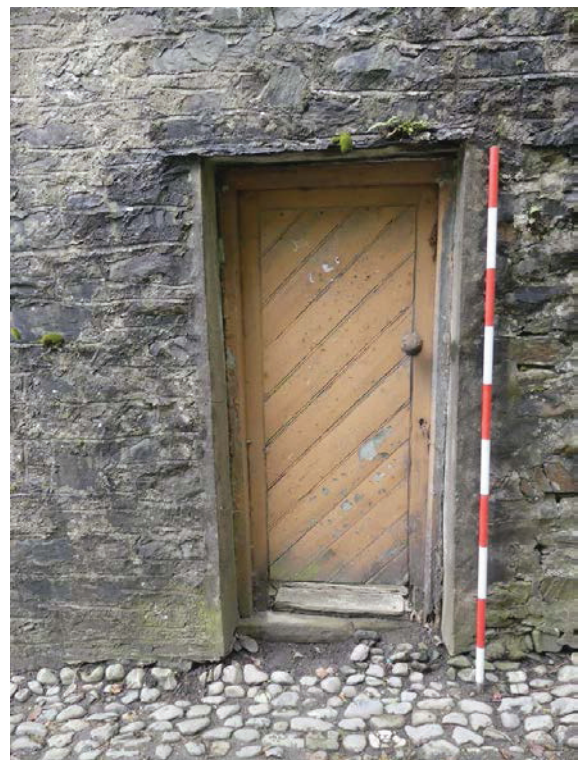
The wall is continued to the north-east by a tall boundary wall, which butts against the structure, and has a pedestrian doorway within it with concrete rendered surrounds, a stone (slate) lintel, worn sandstone step, and plank and batten door, the planks beaded and set diagonally (Plate 15). The boundary wall continues to the north-east where it is heavily pointed in concrete and topped with flag stones and one concrete slab. There is now a large entrance within it but this has evidently been enlarged from an earlier opening or inserted.

Plate 15 (right): The doorway in the boundary wall to the north-east of the north-west elevation, viewed from the north-west

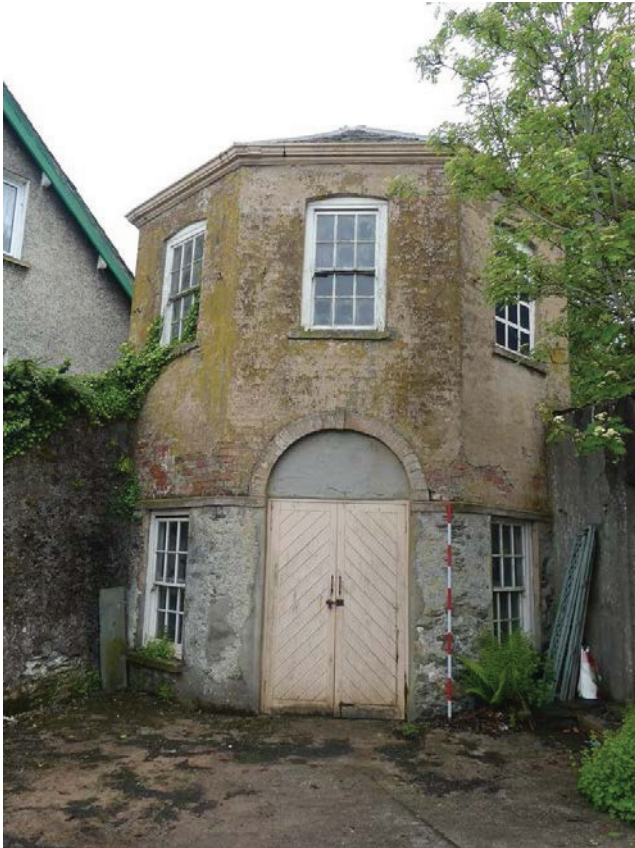
**4.2.3 North-east external elevation:** this is the front and comprises three sides of the hexagonal plan. The ground floor has a central doorway with a semi-circular arch over constructed from voussoir stone with a projecting key stone (Plate 16). The space below is now filled and finished with a rough skim of concrete. There is a double door below of fairly recent plank and batten construction with fairly plain diagonally-set planks and modern handles. A stone string course forms the lintel of a pair of flanking windows, both of which have concrete render over the jambs and 12 light (six over six) sliding sash casements with horns. The first floor is of brick construction but largely finished with a painted coat of what is probably thick limewash. There are three windows, one per face, all in the same style as those on the ground floor but with flat brick arches. The north-west window is blind or blocked and the casement painted onto the shallow reveal and the tall boundary wall adjoins the north-west side (Plate 17).

**Plate 16 (left): General view of the north-east external elevation, from the north-east**

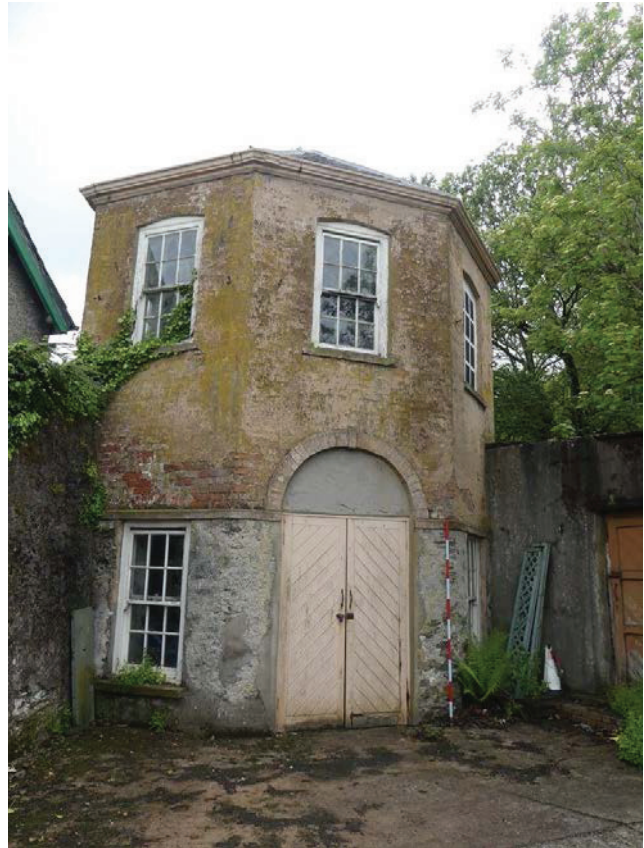
**Plate 17 (right): The north-east external elevation and the adjoining boundary wall, viewed from the east**

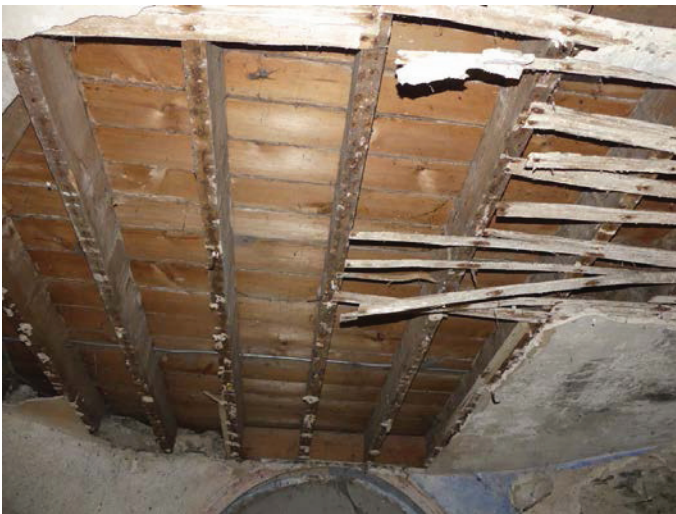
4.3.1 **Ground floor:** this has a concrete floor, evidently quite recent and raised relative to the original. The ceiling is finished with the remains of lath and plaster, with joists that are sawn pine and narrow tongue and groove floorboards above (Plate 18). The walls are finished with lime plaster and blue distemper over masonry. The north-east side has a wide doorway with concrete over the jambs and a double plank and batten door with diagonally-set planks and stop-chamfered battens (Plate 19). This is flanked by windows in square reveals extending to the ground and with a heavy timber lintel over the east. The south-east elevation has two large alcoves semi-circular in plan and with semi-circular brick arches (Plate 20). There is a scar for a single thick shelf in each and both have a masonry sill in the base, the south of which holds a stone sink fed by lead pipes coming from under the stairs to the south-west (Plate 21). The south-west side has the entry to the stairs, which are up a single step and through a doorway with a semi-circular brick arch (Plate 22). The north-west side has a small fireplace with an iron bar forming the lintel of the opening, with a brass fitting for a gas light above (Plate 23 and Plate 24). The fireplace comprises an iron hob grate with some floral decoration, the sides of which extend below the level of the concrete floor. To the north-east there is another, smaller, alcove, again semi-circular in plan and with a semi-circular arch, although this is still finished with plaster (Plate 23).

Plate 18 (left): Ceiling in the ground floor room, viewed from the south-west

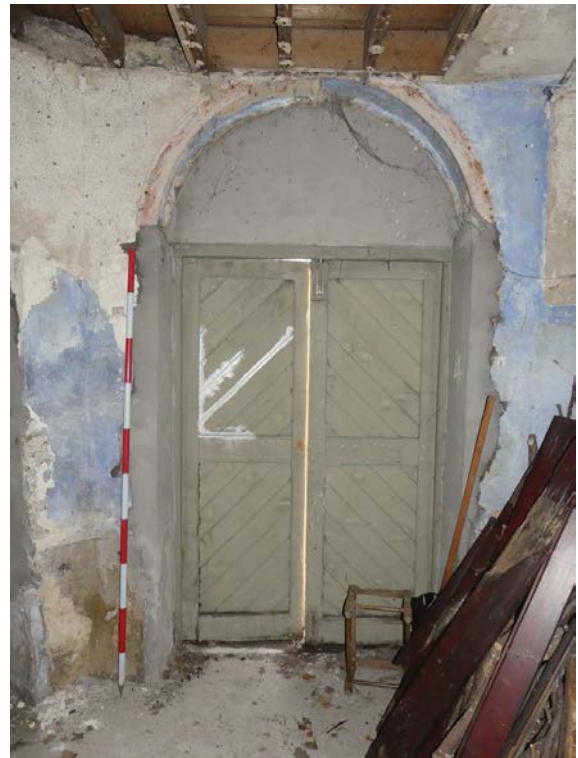
Plate 19 (right): Doorway to the north-east in the ground floor room, viewed from the south-west

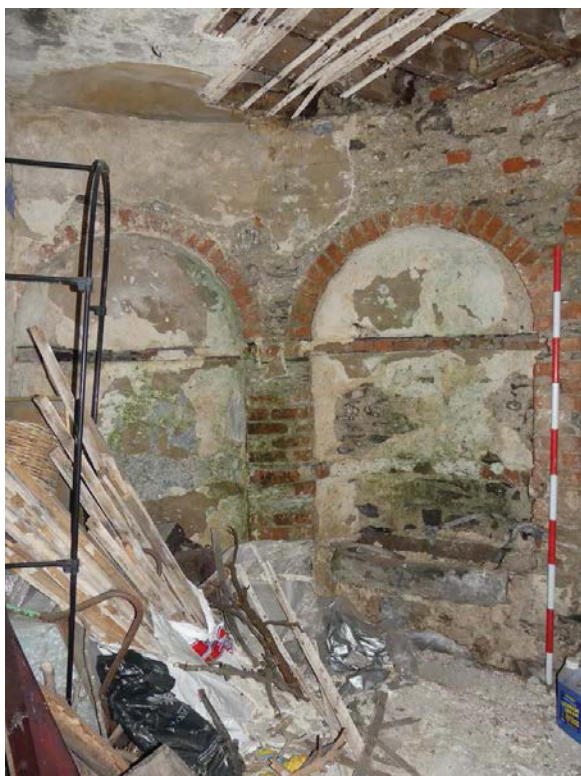
Plate 20 (left): Alcoves on the south-east side of the ground floor room, viewed from the north-west

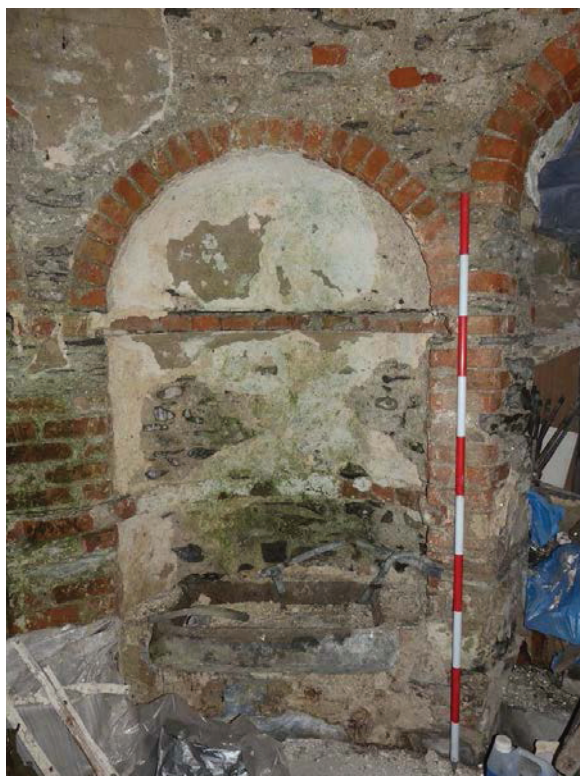
Plate 21 (right): Alcove containing a stone sink on the south-east side of the ground floor room, viewed from the north-west

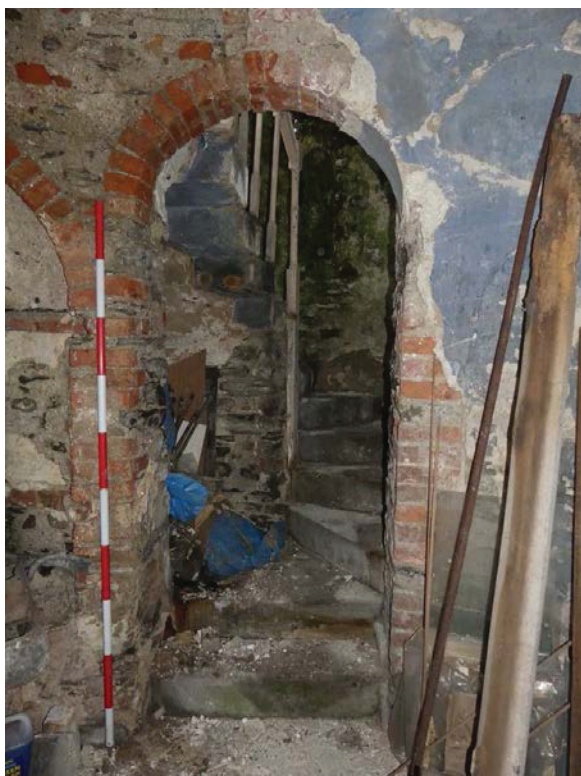
Plate 22 (left): Access to the stairs on the south-west side of the ground floor room, viewed from the north-east

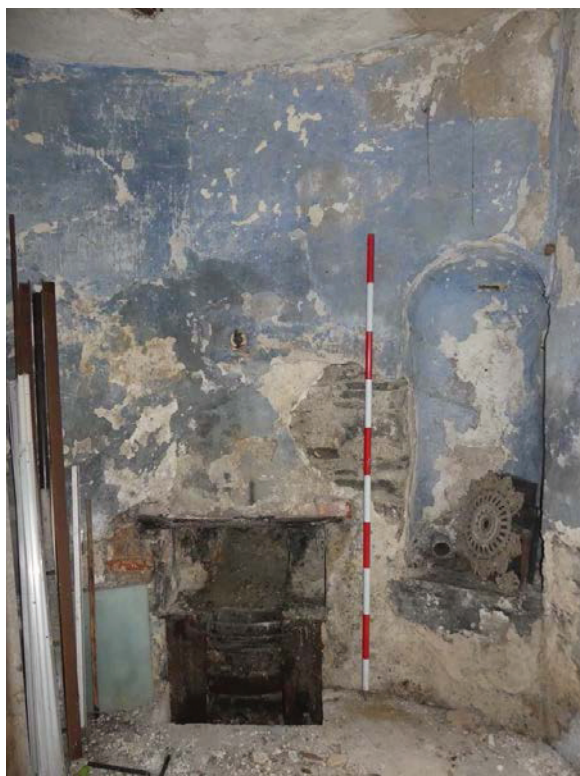
Plate 23 (right): Fireplace and alcove on the north-west side of the ground floor room, viewed from the south-east

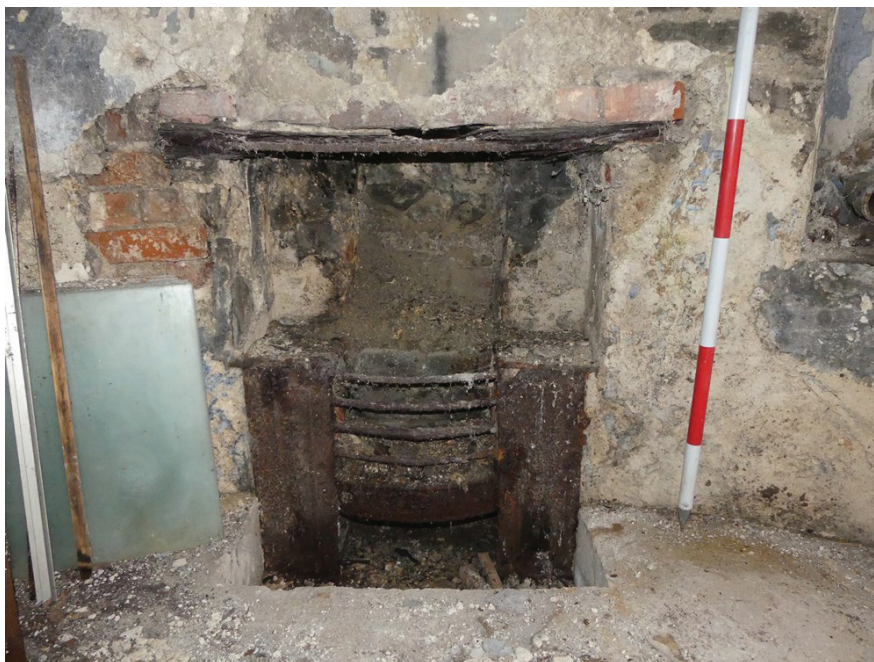
**Plate 24: Detail of the fireplace on the north-west side of the ground floor room, viewed from the south-east**

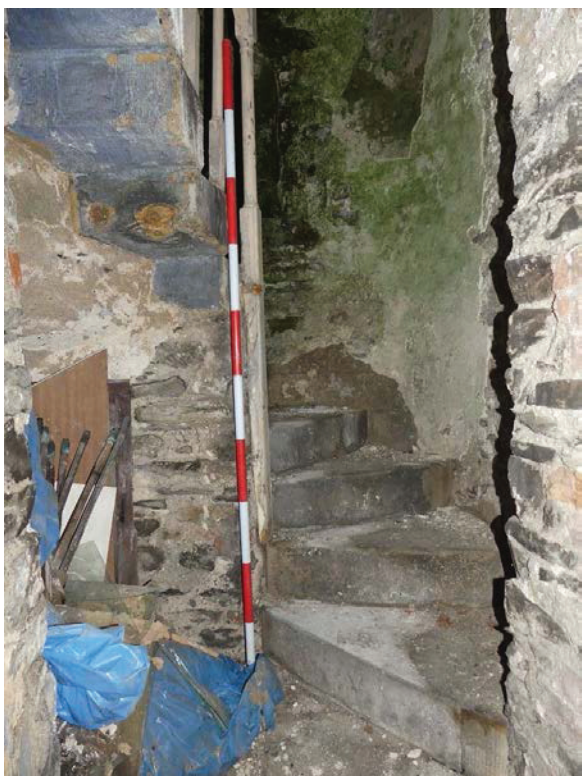
4.3.2 **Staircase:** the stairs form an essentially circular curve within the triangular section of the building, with the steps constructed from a dressed fine-grained buff sandstone (Plate 25). There is a very thin beaded newel post at the centre and fairly plain turned balusters on square bases and a simple handrail. A glass stopper from a bottle or decanter has been attached to the top of the newel post (Plate 26). In the space below the stairs a lead pipe projects through the wall, apparently providing the water to the sink in the adjoining room, although cut off at this point. The walls are of masonry construction, with the remains of lime plaster present throughout, and it is evident that this was originally scored to give the appearance of ashlar blocks. The north-east elevation comprises essentially just the access to the room beyond, down a short flight of steps and through a round-headed brick arch. At first floor level the stairs arrive at a doorway to the first-floor room, which has six panels with a simple moulded beading. To the south-west there are two alcoves in the wall, with round heads and semi-circular in plan (Plate 27), and to the south-east there is a small four-light window just below the top of the wall. There is an alcove at ground floor level in the north-west elevation that is very narrow and has a flat top, above which are three further alcoves, two semi-circular in plan and with semi-circular arches, and a square one at the top of the wall (Plate 28).

**Plate 25 (left): Detail of the stone steps, viewed from the north-east**

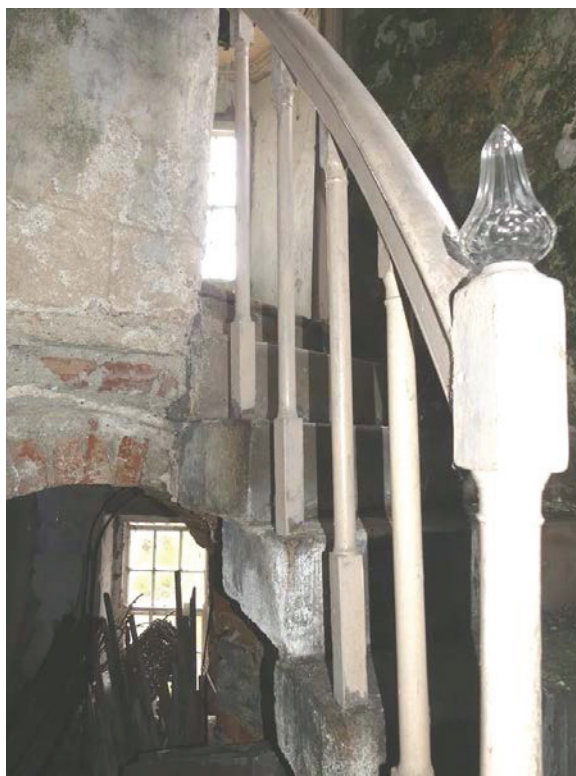
**Plate 26 (right): Detail of the newel post and balusters, viewed from the south-west**

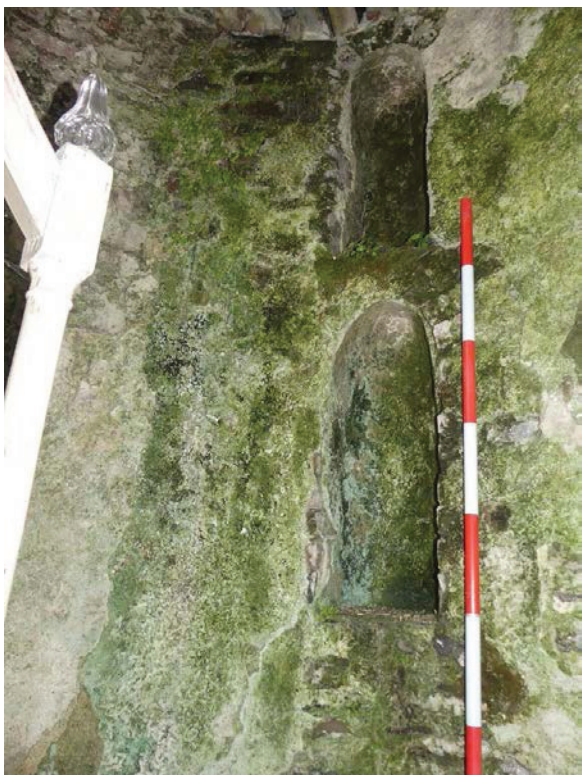
**Plate 27 (left): Alcoves in the south-west wall of the staircase, viewed from the north-east**

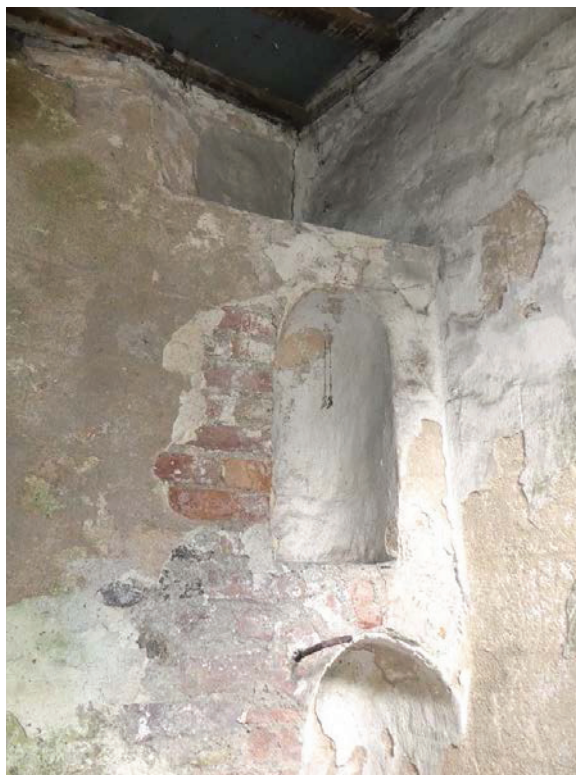
**Plate 28 (right): Alcoves in the north-west wall of the staircase, viewed from the south-east**

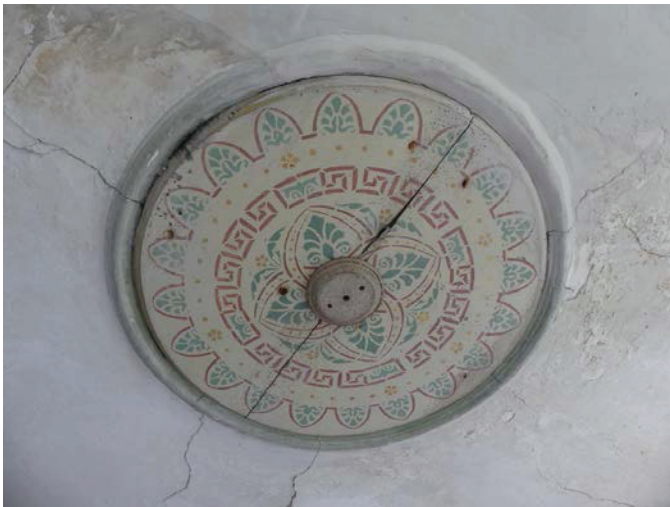
4.3.3 **First floor:** this has a narrow tongue and groove board floor and lath and plaster ceiling with a central roundel decorated with stencilled colour design of acanthus leaves and Greek key with a central

timber boss probably a later addition for a more recent light fitting (Plate 29). It was not possible to safely access the roof space above. The walls are finished with plaster and distemper and there is a simple ovolo-moulded skirting board and a moulded cornice, again decorated with a coloured stencil creating a faux denticular moulding and coloured bands (Plate 30). There are three windows to the north-east and south-east all with modern sliding sash casements with concrete in the jambs where they were inserted (Plate 31 and Plate 32). There are brass fittings attached to a timber base for old gas lighting on the north-west side and just the timber base remaining to the south-east. There is a slight alcove for the blind window on the north-west side (Plate 31) and the south-east window is within a recess that extends to the floor, unlike the others (Plate 33). To the south-west there is a doorway to the stairs with a six-panel door with simple moulded beading, a decorative metal handle and two finger plates and L-shaped hinges (Plate 34). To the north-west of this is a pointed alcove in the wall and north-west of this is a fireplace (Plate 35). This has a substantial timber entablature over it decorated with denticulate and floral, almost Rococo, designs and egg and dart along the outer surround. There is a beaded stone surround below this and an iron insert, probably a later addition, with geometric designs (Plate 36). The remains of a weathervane are lying loose on the floor nearby.

**Plate 29 (left): Detail of the ceiling roundel on the first floor**

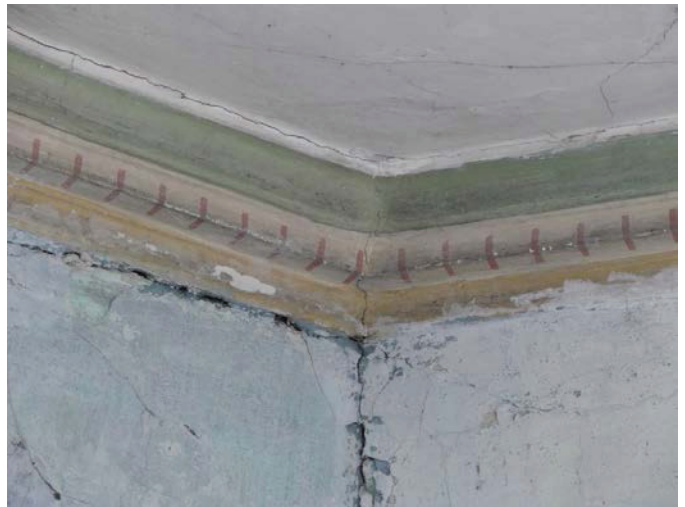
**Plate 30 (right): Detail of the painted cornice on the first floor**

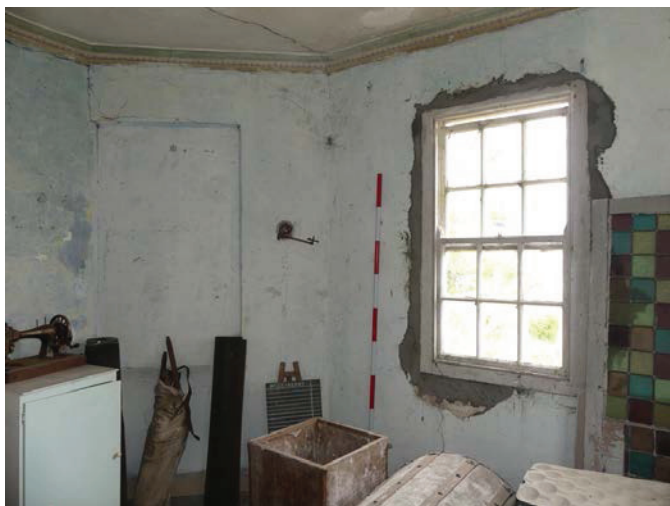
**Plate 31 (left): The blind window to the north-west and a window in the north-east elevation of the first-floor room, viewed from the south**

5.2.3 **Phase 2 (19<sup>th</sup> century):** it is not clear whether the blind window in the north-west elevation represents an original window that was blocked or whether it was built blind in order to maintain the symmetry of the elevation while avoiding window tax. The presence of a recess on the internal elevation suggests it was an original window that was blocked. The reasons for this change are unknown. While it might be suggested it was because of window tax this only applied to buildings with 10 or more windows (Richardson 1989, 49). An alternative suggestion is that the building was constructed before the creation of the turnpike in 1763, or perhaps even before the construction of the properties on the opposite side of Daltongate, then it became less desirable to have a functioning window facing that direction. In either case, it suggests that it was blocked in the late 18<sup>th</sup> or early 19<sup>th</sup> century. Other alterations in this period are less obvious. The narrow boards and neatly finished timbers of the first floor suggest that this might have been replaced during this phase, and it is apparent that the iron insert in the first-floor fireplace is a later addition.

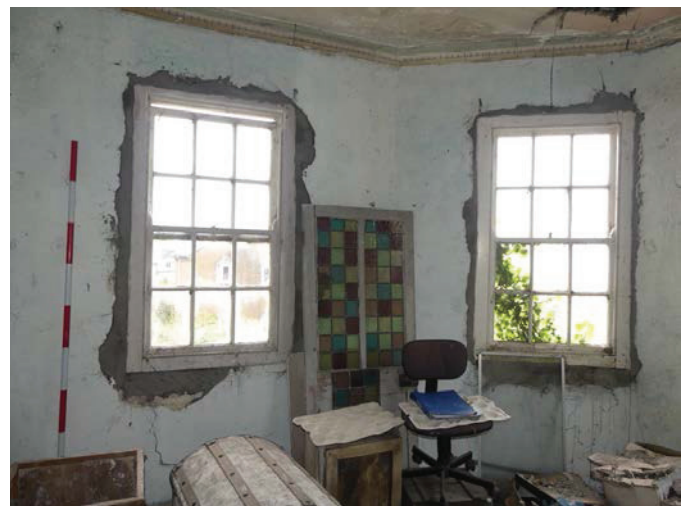
**Plate 32 (right): Windows in the north-east elevation of the first-floor room, viewed from the south-west**

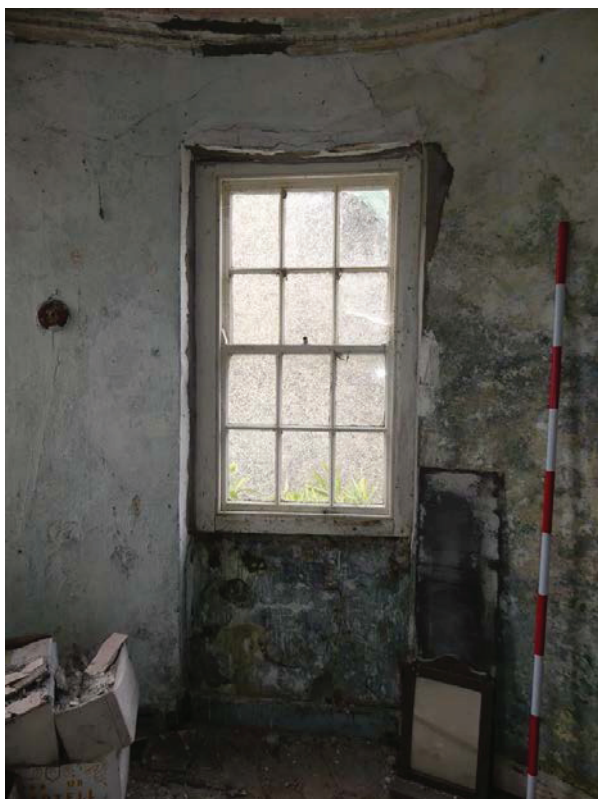
Plate 33 (left): The window in the recess to the south-east in the first-floor room, viewed from the north-west

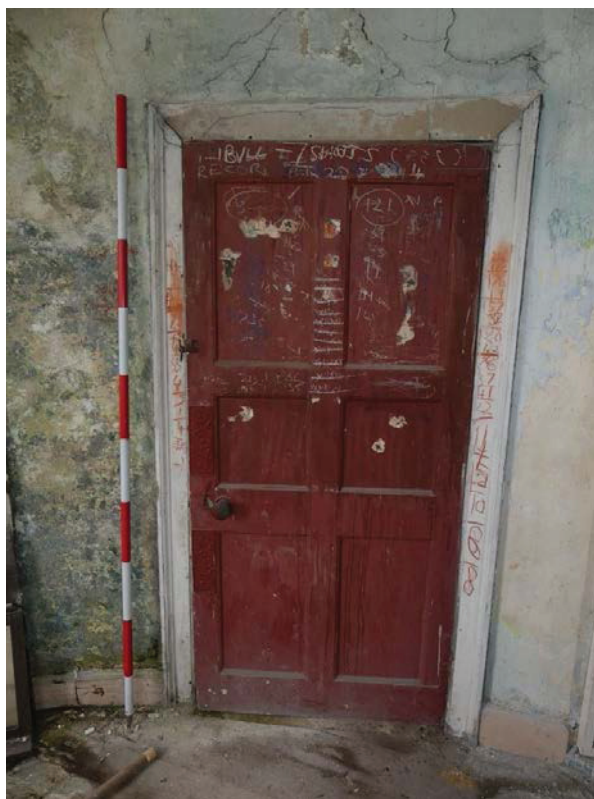
Plate 34 (right): The doorway to the south-west in the first-floor room, viewed from the north-east

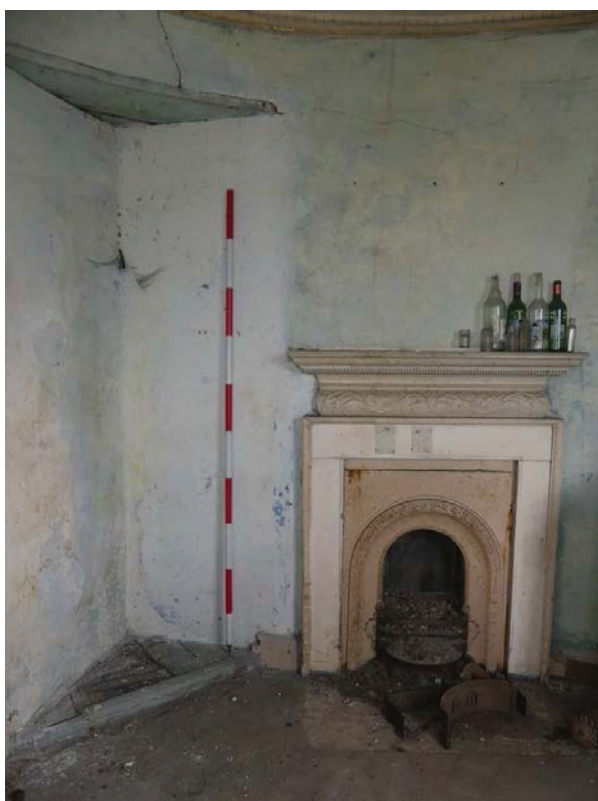
Plate 35 (left): The alcove and fireplace on the north-west side of the first floor, viewed from the south-east

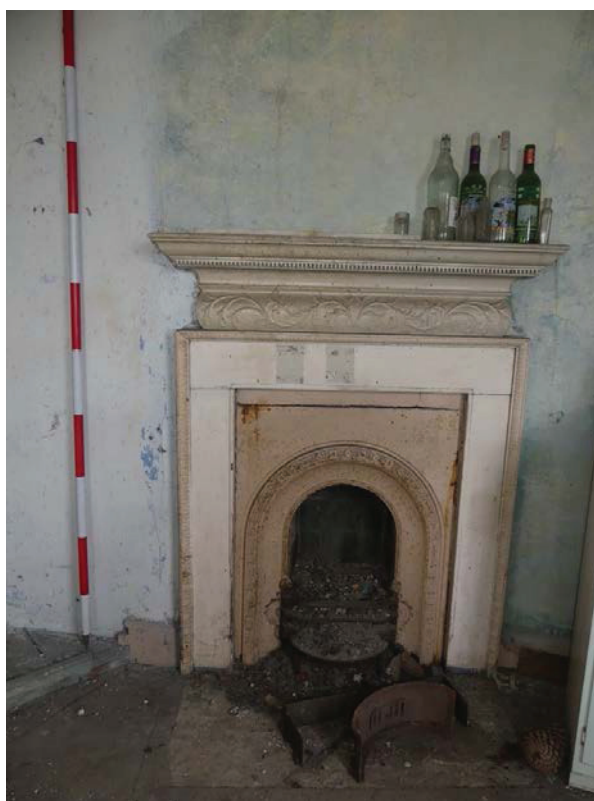
Plate 36 (right): Detail of the fireplace on the north-west side of the first floor, viewed from the south-east
