SINKFALL FARM, RAKESMOOR LANE, BARROW-IN-FURNESS, CUMBRIA

Archaeological Building Recording

Client: Brian Armistead

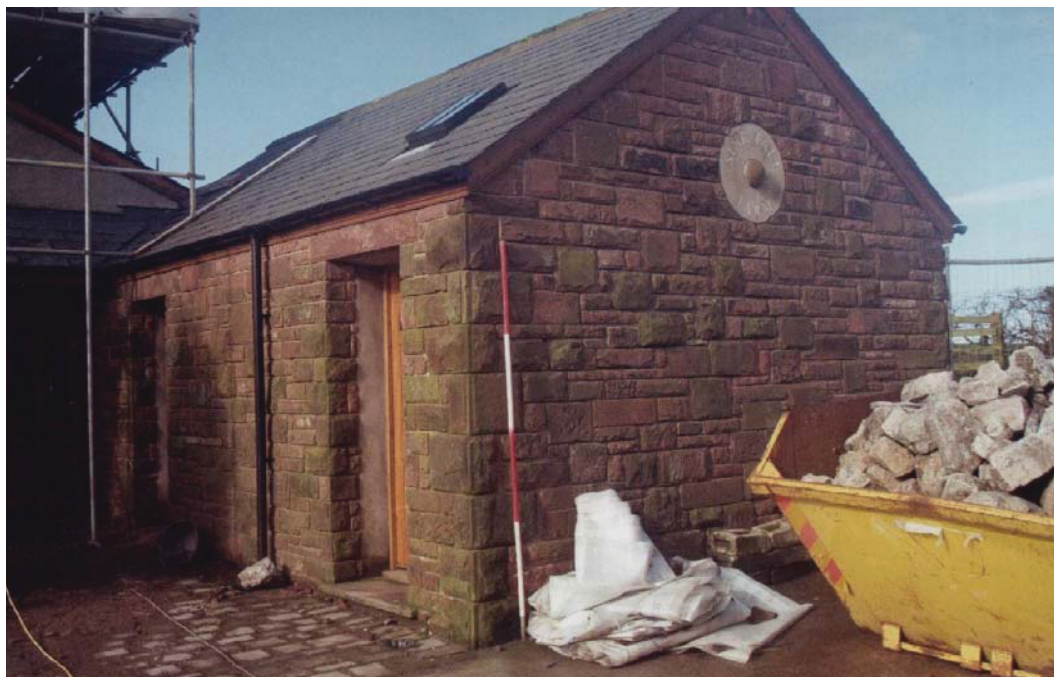
Plate 7: Building 1 from the east

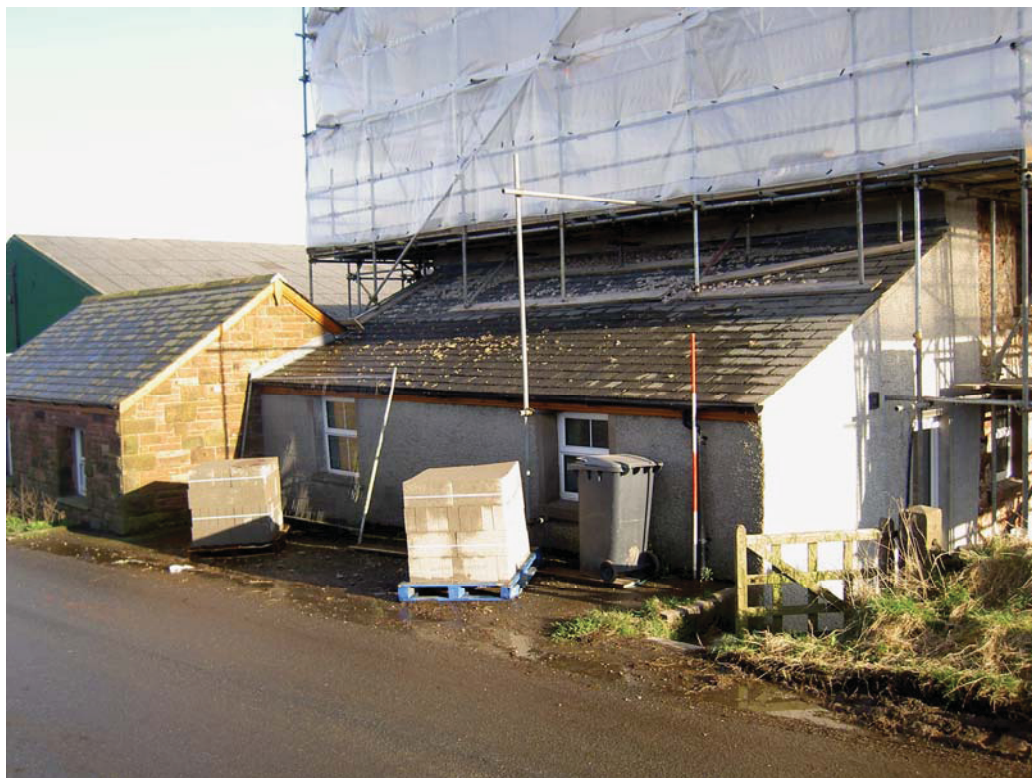
4.2.5 **Building 2:** this building was a single storey outshot on the north end of the earlier farmhouse extension - Building 3. The walls were covered in roughcast render and the monopitch roof was clad in modern un-graduated slate tiles (Plate 8).

Plate 8: Building 2 from the north-west

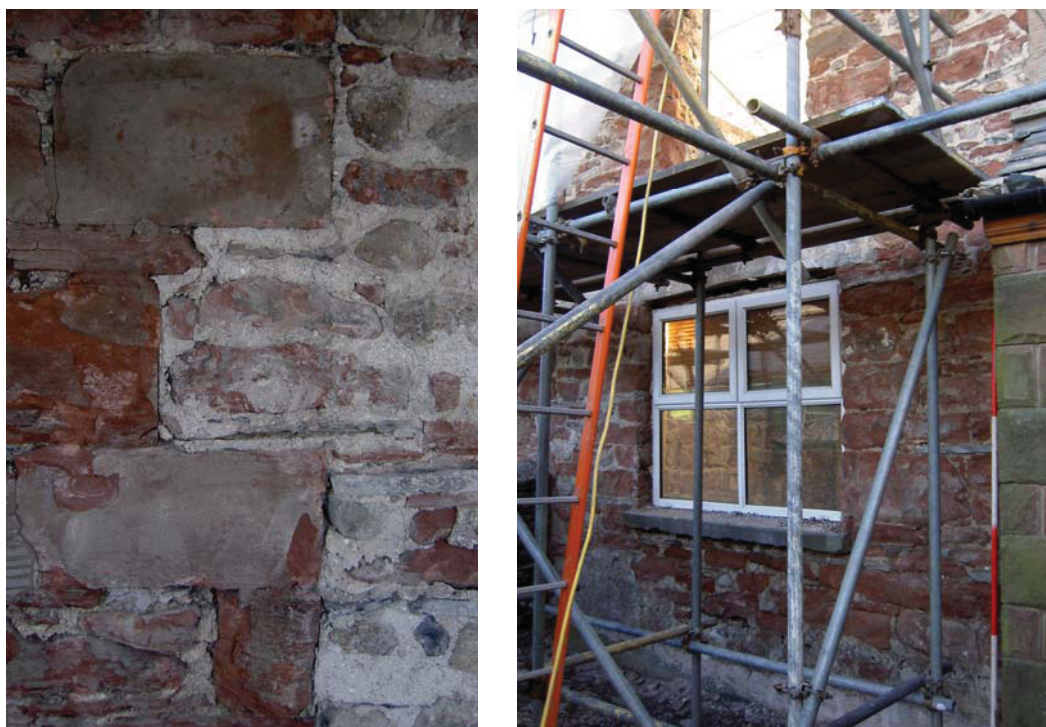
Plate 9: (left) Building 3 butting Building 4 to the left

Plate 10: (right) South window in east elevation of farmhouse, Building 3

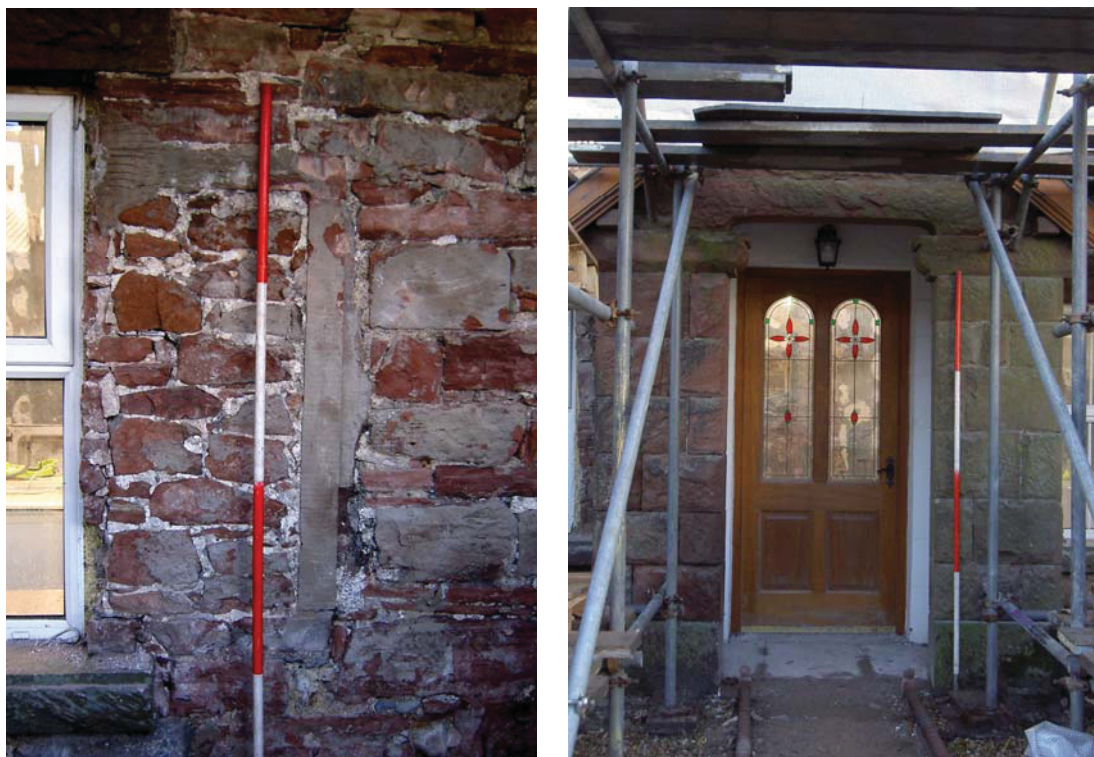
4.2.13 **East elevation:** the ground floor had a porched central doorway that was flanked by a pair of windows, with another pair on the first floor. The lower northern window housed a uPVC two light casement set within un-quoined jambs, and between a substantial red sandstone lintel and a thick grey sandstone sill with a rusticated face. This window had been inserted and this insertion had truncated the south side of the original window surround that was plain sandstone and appeared to be 18th century in date (Plate 11). The lower southern window was identical to that north of the porch; it too had un-quoined jambs and had been inserted. It is possible that this window is an enlargement of the original aperture which may well also have had a plain sandstone surround. Between the windows a modern porch had been added (Plate 12), the walls were constructed from concrete blocks and faced with rusticated machine cut sandstone blocks. These cut sandstone blocks were of a similar style to those that were used to construct the porch on Building 2 and the quoins of Building 1. Two red sandstone ovolo-moulded corbels supported the lintel which had a concave underside; these sandstones were probably re-used from elsewhere. The gable over the lintel was built up in red sandstone and supported a roof finished with Welsh slate, as present on Building 1; the same treated bargeboard was also used beneath the slates. The first floor elevation had been lost to the south of the upper southern window, leaving only the sill and the northern jamb. This northern jamb was un-quoined and it is possible that if an original window existed in this area that it was further to the south. The northern upper window of this elevation also appeared to be inserted, the casement had been removed and the jambs were

Plate 11: (left) Original window in east elevation of farmhouse, Building 4

Plate 12: (right) Modern porch of farmhouse

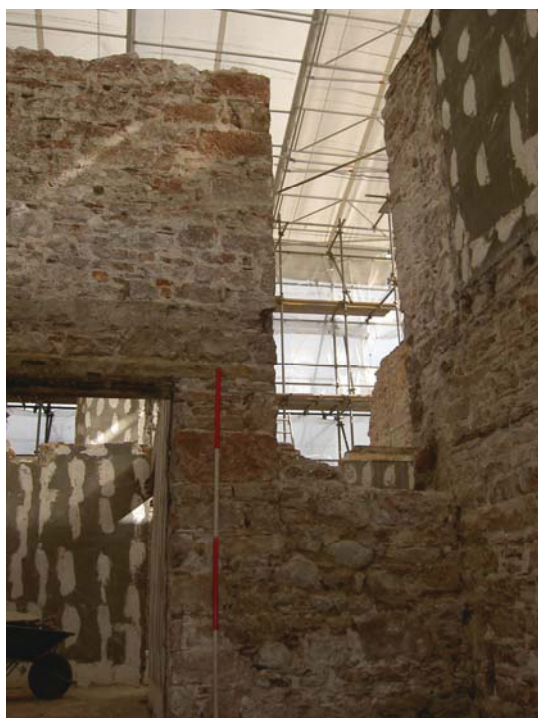
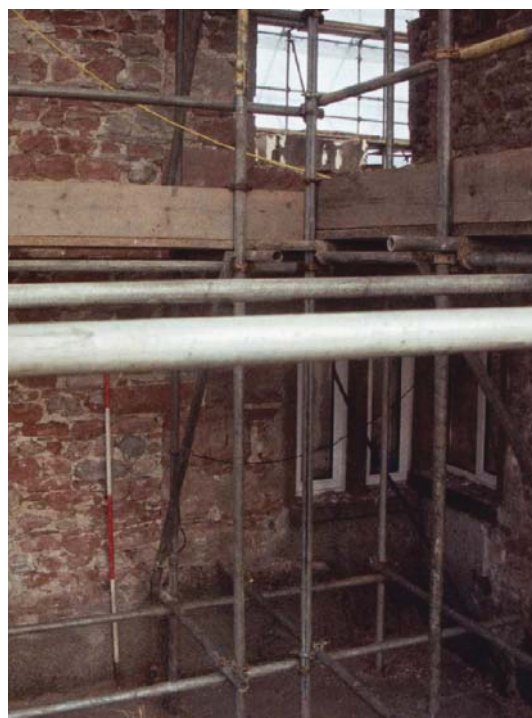
Plate 13: (left) Stair light on west elevation of Building 4

Plate 14: (right) Mullioned window at rear of farmhouse

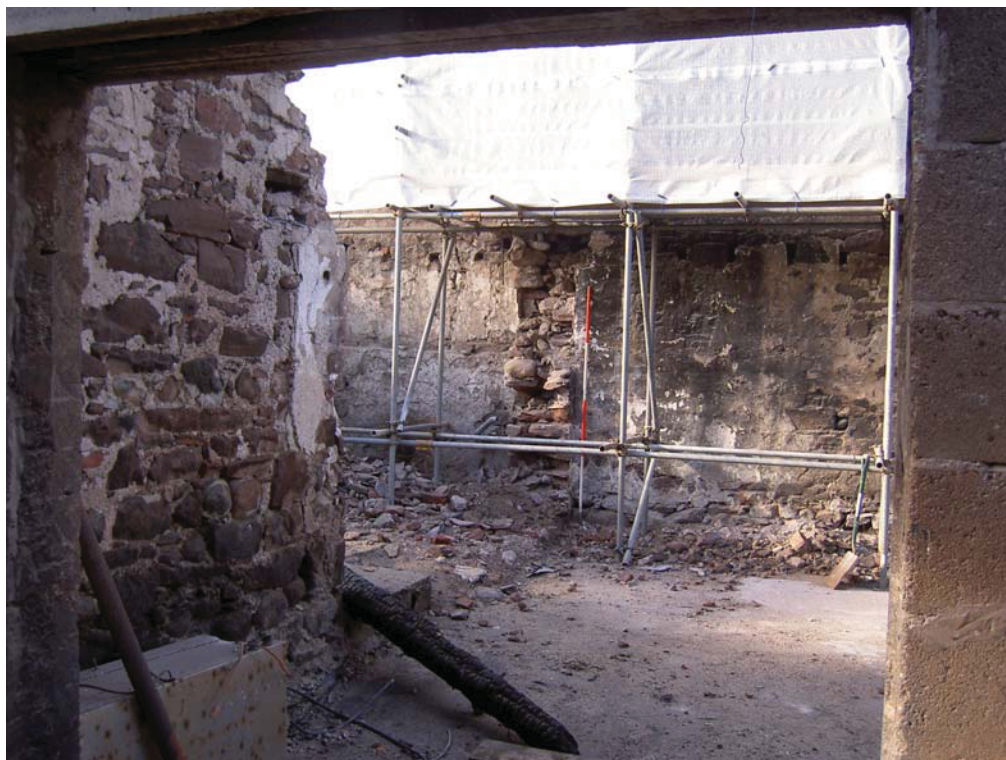
Plate 15: North-west end of Building 6

4.2.21 **East elevation:** the north end of this elevation has been knocked down due to fire damage (Plate 15). It appeared from the lack of quoins at the south ends of Building 4 and the wall stub remaining at the junction with Building 4 that one continuous wall formed the entire range of the original farmhouse (Building 4) and threshing barn Building 6/9). There was pedestrian doorway into the north part of this barn (Building 6) which has a substantial red sandstone lintel with a chamfered underside, this had been re-used and inserted into the blockwork construction of this part of the elevation. Above this doorway were the remains of a window which comprised the southern jamb and red sandstone sill which was chamfered on the upper edge of its face (Plate 16). South of the pedestrian doorway was a wagon door that may have originally been the entrance to the threshing floor as it had an opposing door of a similar width on the west elevation. This access led into the part of the barn that is Building 9 and this has been divided off from Building 6 internally by a concrete block wall. The part of the original elevation into which this door was set has been entirely re-built as it has been widened and raised in height to facilitate access for more modern farm machinery. A concrete lintel has been added above the doorway which is keyed into the blockwork partition on the north side of the doorway. South of the wagon doorway the original elevation has been preserved although much of it has become obscured by the addition of Building 10. Inside Building 10 there was a pedestrian doorway into Building 9, this appeared to be an original entrance for the south-east corner of the main barn. The jambs of the doorway were well faced and there was a large oak lintel over the doorway which was roughly squared. Within the hayloft of Building 10 more of the southern part of the eastern elevation of Building 9 could be seen, and in this area two mason's marks were recorded in the red sandstone (Plate 17 and Plate 18).

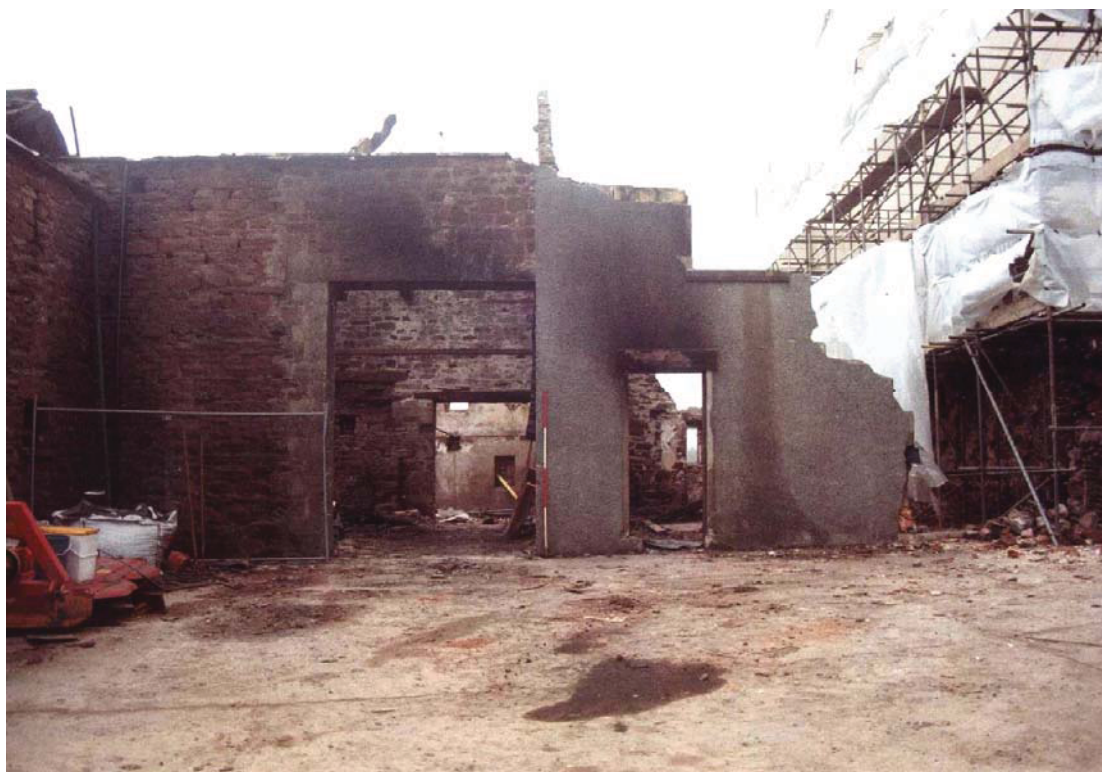
Plate 16: Rendered west elevation of re-built part of Building 6

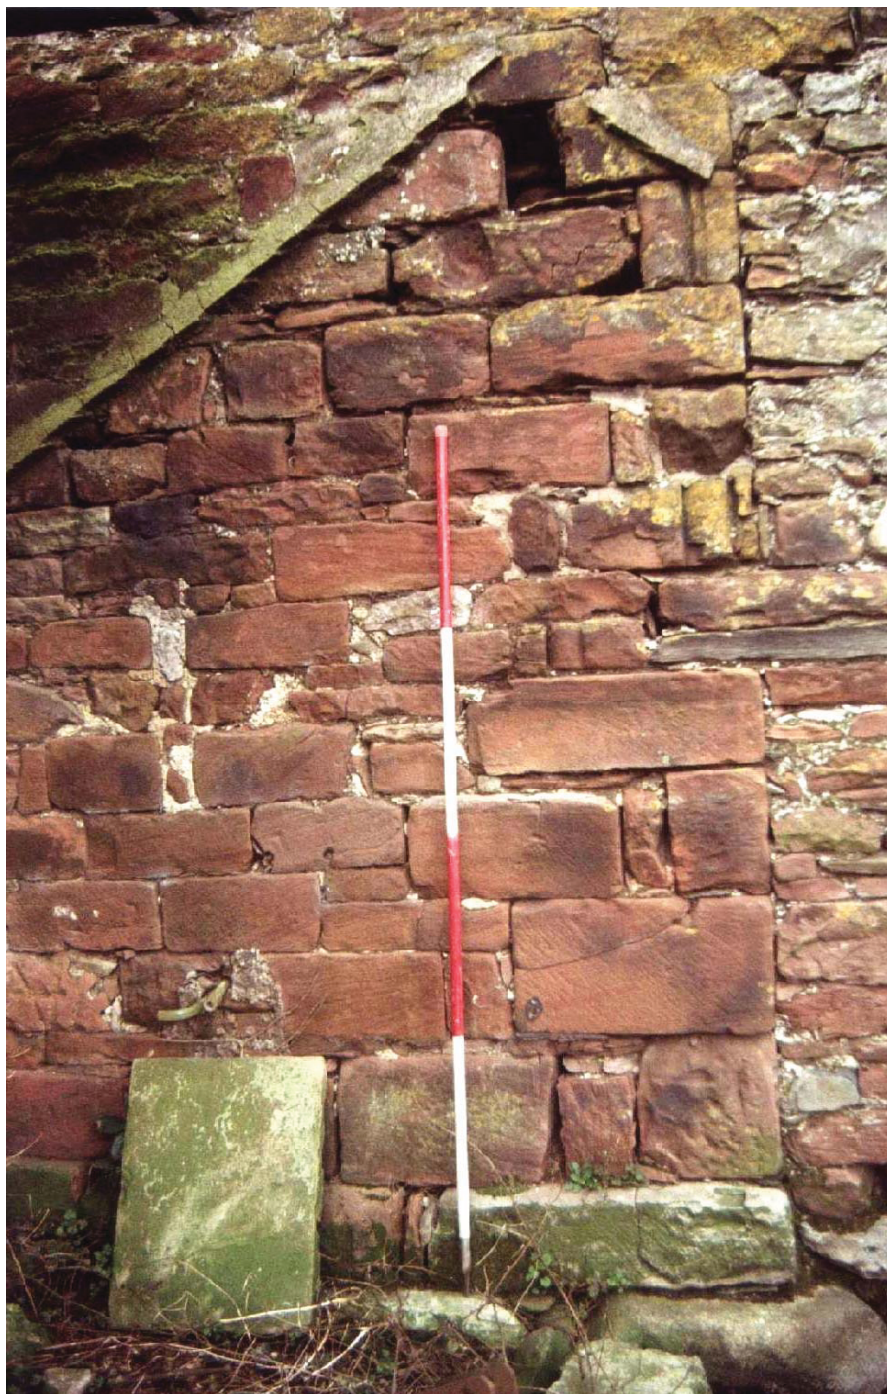
4.2.22 South elevation: this elevation ran flush with the south elevation of Building 10, it was clear that Building 10 had been added on at a later date (Plate 19). Numerous examples of moulded stonework were located at the east end of the south elevation, close to Building 10 (see Plate 19). These stones were generally column pieces, engaged column pieces or door and window surrounds, which are assumed to come from Furness Abbey. The fluted column fragment (Plate 20) has a very

Plate 19: Moulded stonework on south side of Building 9

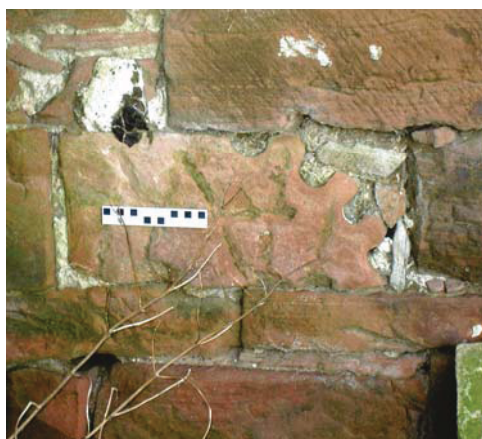
Plate 20: Detail of a moulded stone shown in Plate 18, south side of Building 9

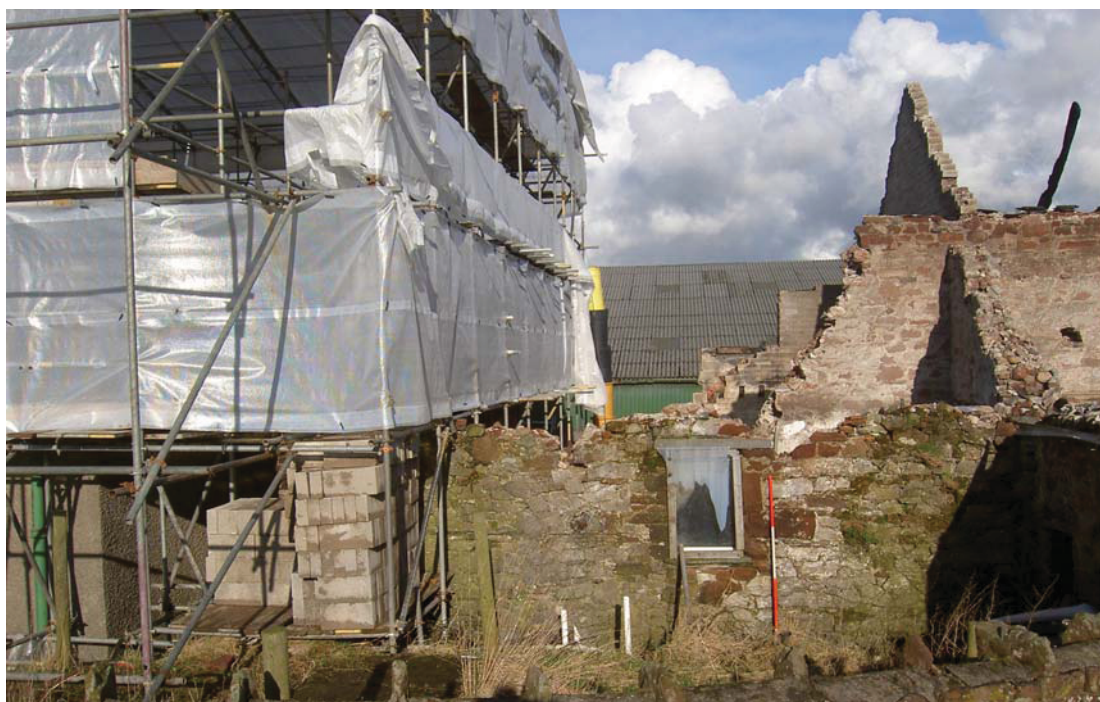
Plate 23: West elevation of Building 7

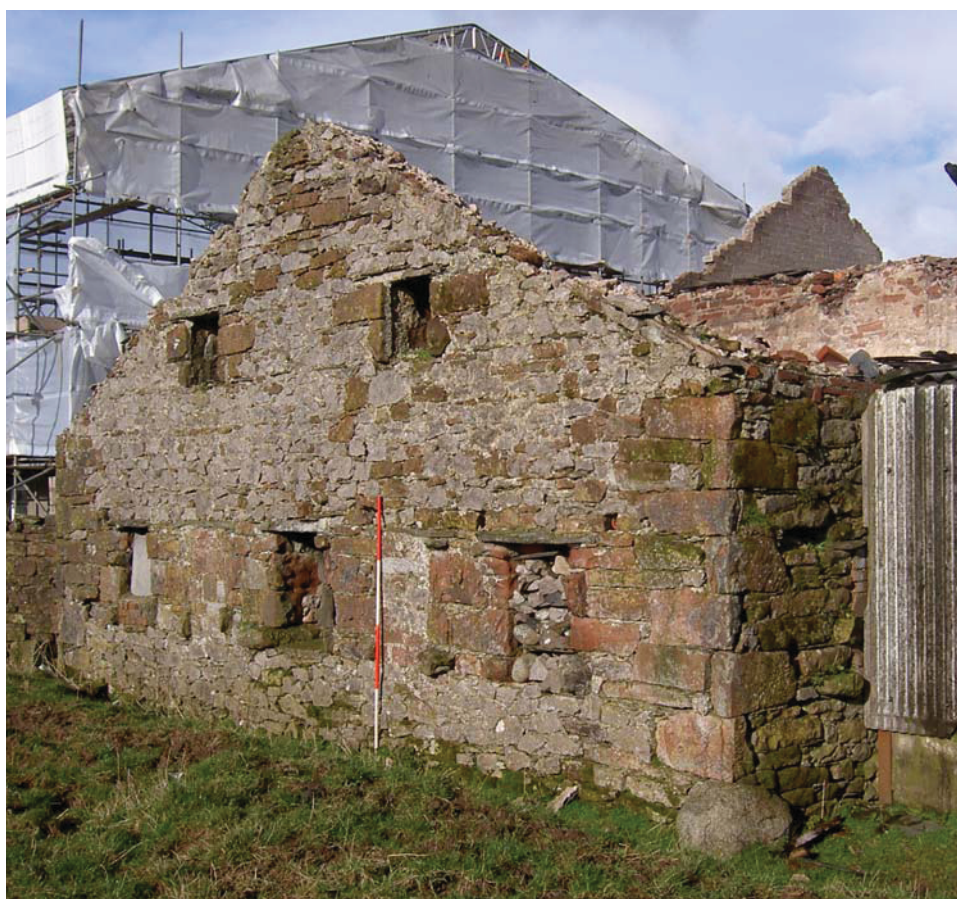
4.2.28 **West elevation:** this elevation had the same windows as were found on the north and south elevations (Plate 24); there were five on the ground floor and two further up in the gable which would have served the first floor. The windows were evenly spaced along the elevation, the central aperture was unblocked, either side of that the windows had been blocked by red sandstone and limestone. The north end window had been part blocked with red brick and board over that and the south window had a blocking of loose limestone rubble. Each window featured a slate sill and over each corner of the sill there was a square vent, into some of these ceramic pipes had been inserted. At the lower corner of each aperture a projecting stone had been built into each of the jambs. The upper windows were constructed in a similar fashion although they were more widely spaced apart and the projecting stones at their lower corners were less pronounced and the southern of these two windows had been glazed. In all there were three phases of blocking evident in the windows of this elevation. The first phase removed two of the central lower windows entirely, the lower portions of the end lower windows were later blocked, and then these windows were fully blocked. The lower corners of this elevation had been built directly on to large boulders and appeared to lack foundations. It was also evident that some landscaping had occurred prior to the construction of this building, as there was a drop from the field height to the west to the base of the west and north elevations.

Plate 24: West elevation of Building 8

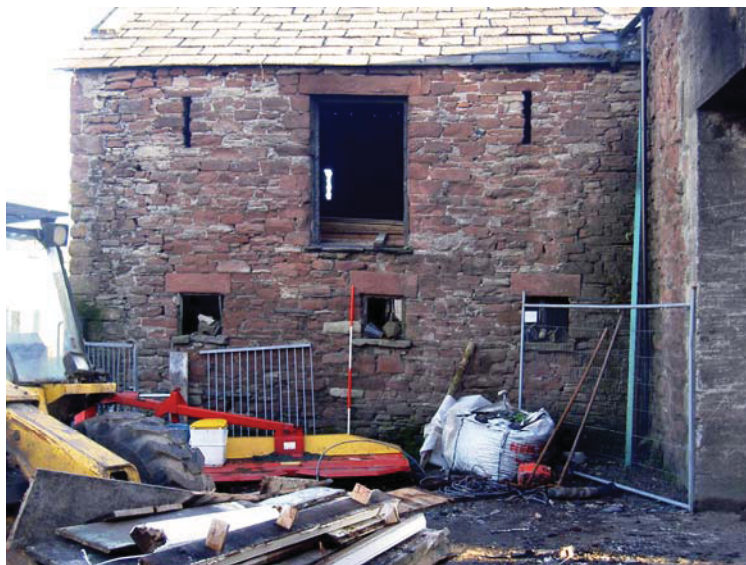
Plate 25: Building 10 from the north

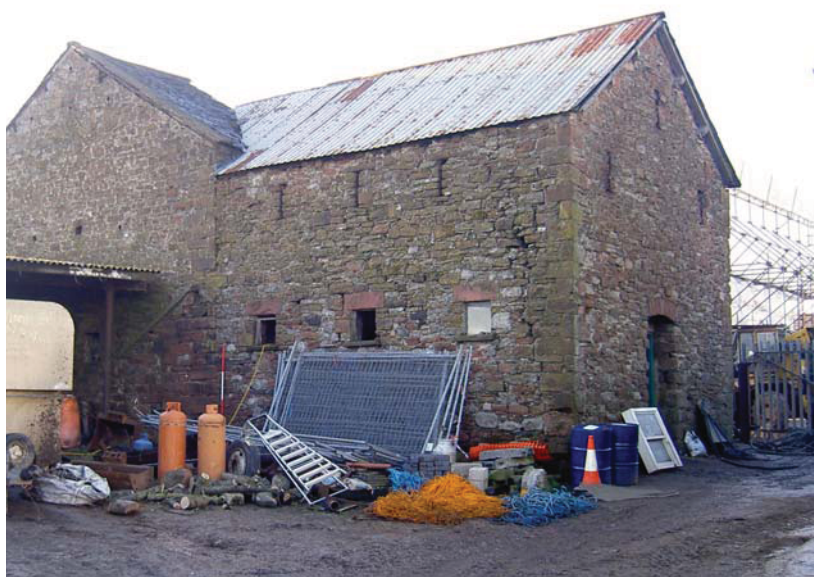
4.2.32 **South elevation:** this elevation had three lower windows to provide light and ventilate the shippon; these were identical in form to those on the north elevation (Section 4.2.30). The upper floor had 3 evenly spaced slot vents, and the roof on this side of the apex was clad in corrugated iron (Plate 26).

Plate 26: Building 10 from the south-east

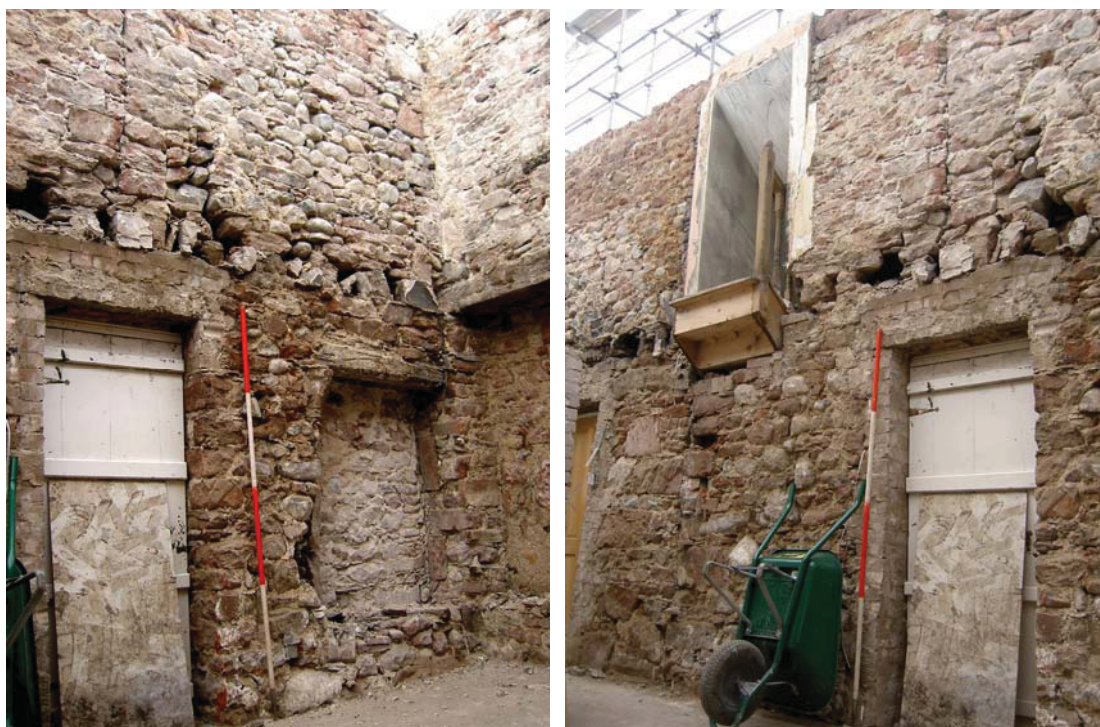
Plate 27: (left) Inserted door and blocked window in north elevation of Building 3

Plate 28: (right) Inserted staircase and blocked door in upper north elevation of Building 3

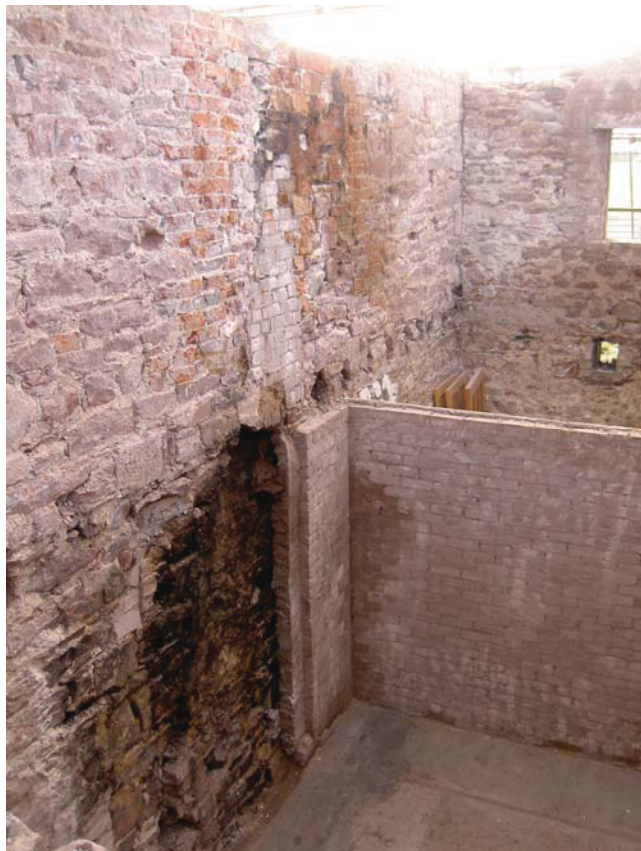
Plate 29: Blocked fireplace and flue lines, South elevation of Building 3

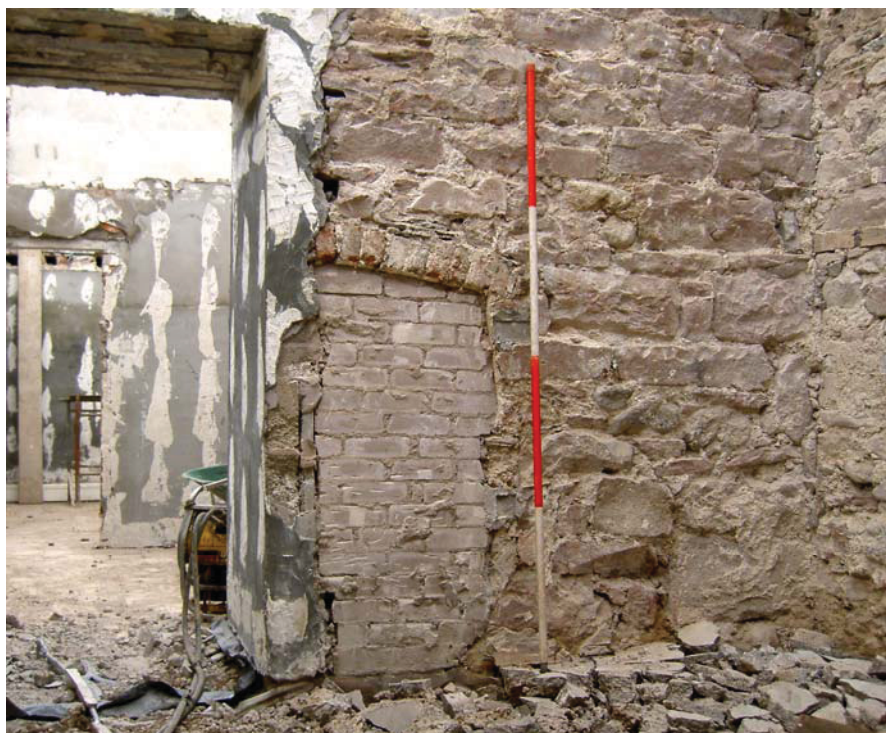
Plate 30: Doorway inserted through blocked fireplace, South elevation Building 3

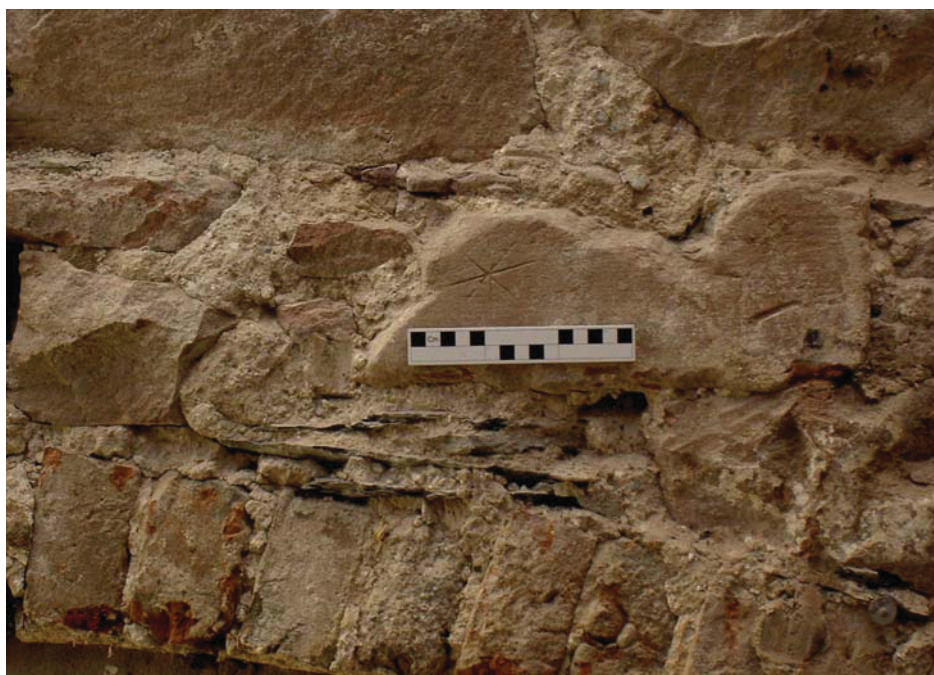
Plate 31: Masons mark over blocked fireplace, South elevation of Building 3

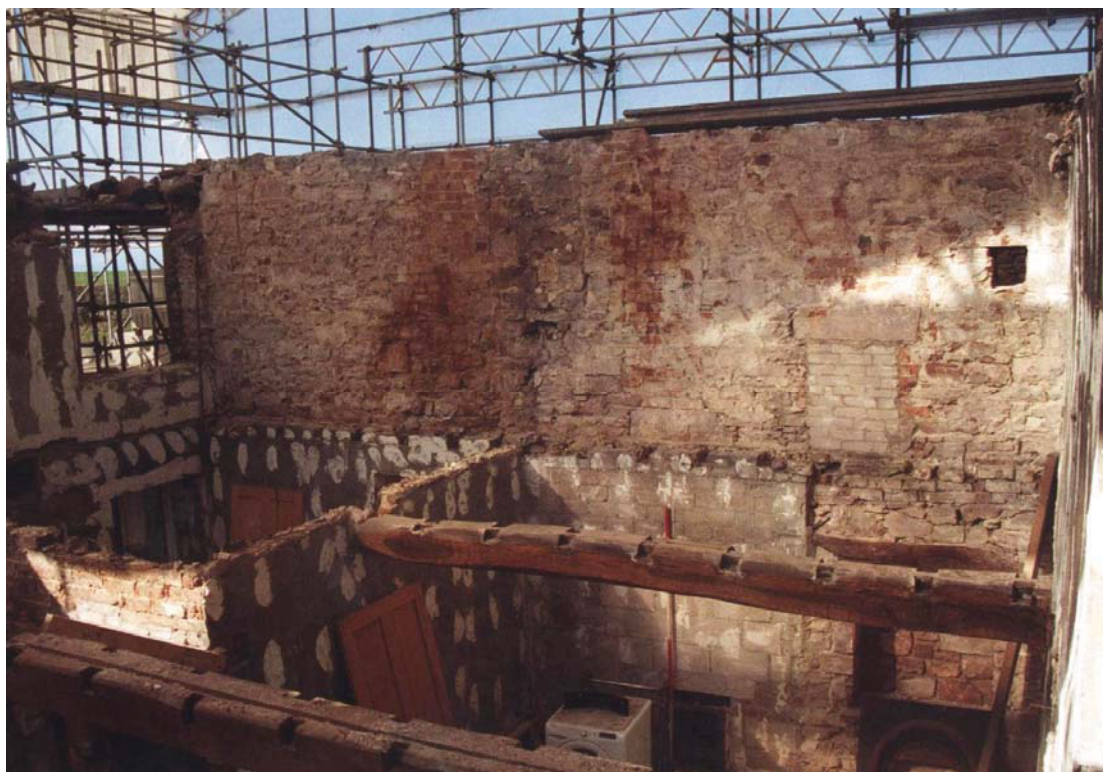
Plate 32: North elevation of Building 4

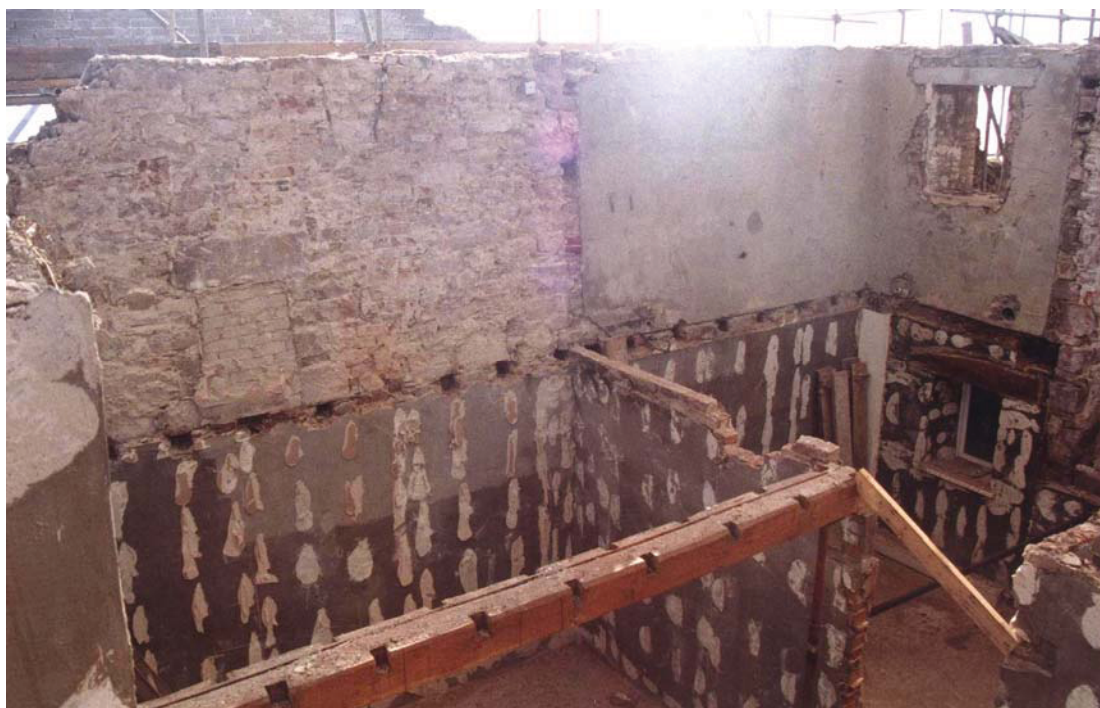
above it there was a small square aperture that had been blocked with red brick, once again this mirrored the slot on the opposing elevation. The very east end of this elevation had been lost as with the south end of the east part of this building, this would have occurred when the north end of the east elevation of Building 6 was demolished after being damaged by fire.

Plate 33: South elevation of Building 4

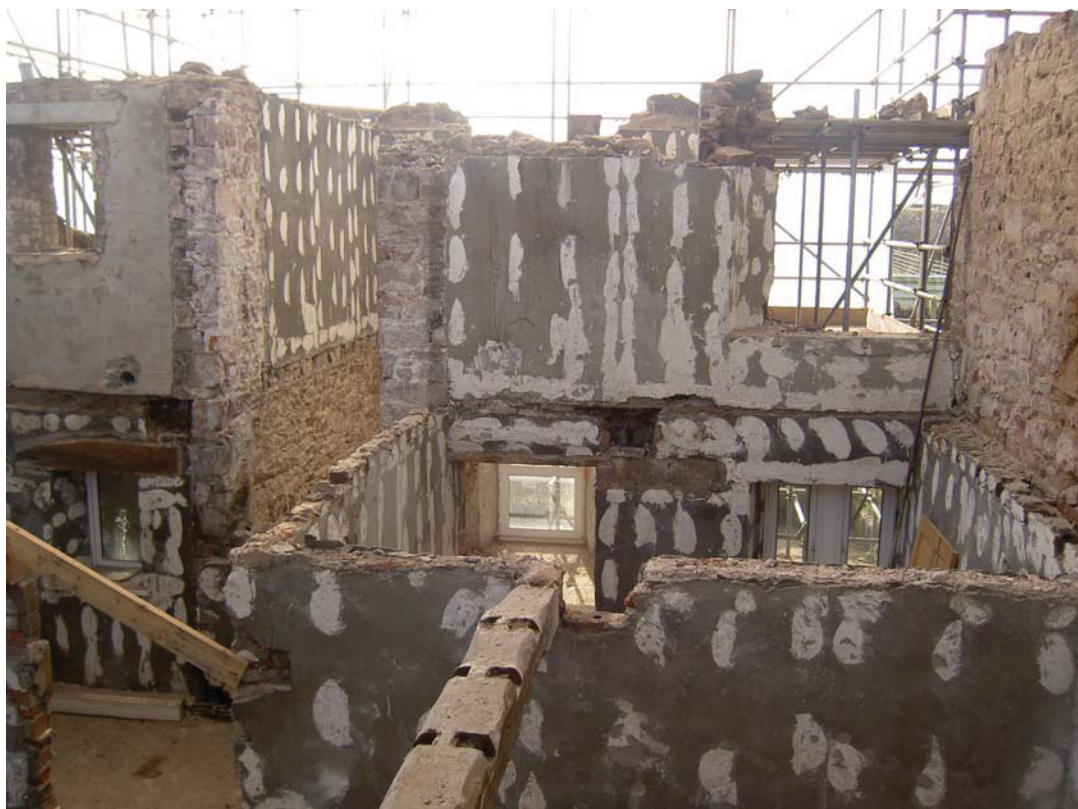
Plate 34: West elevation of Building 4

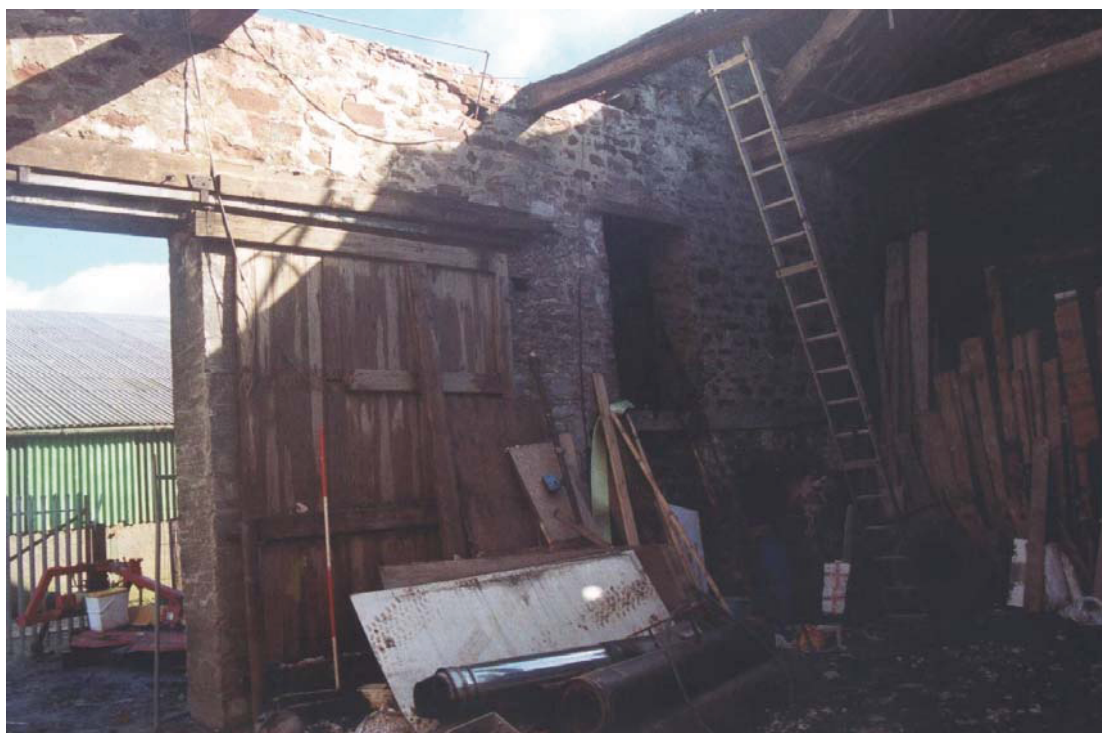
Plate 35: Eastern doorways of Building 9

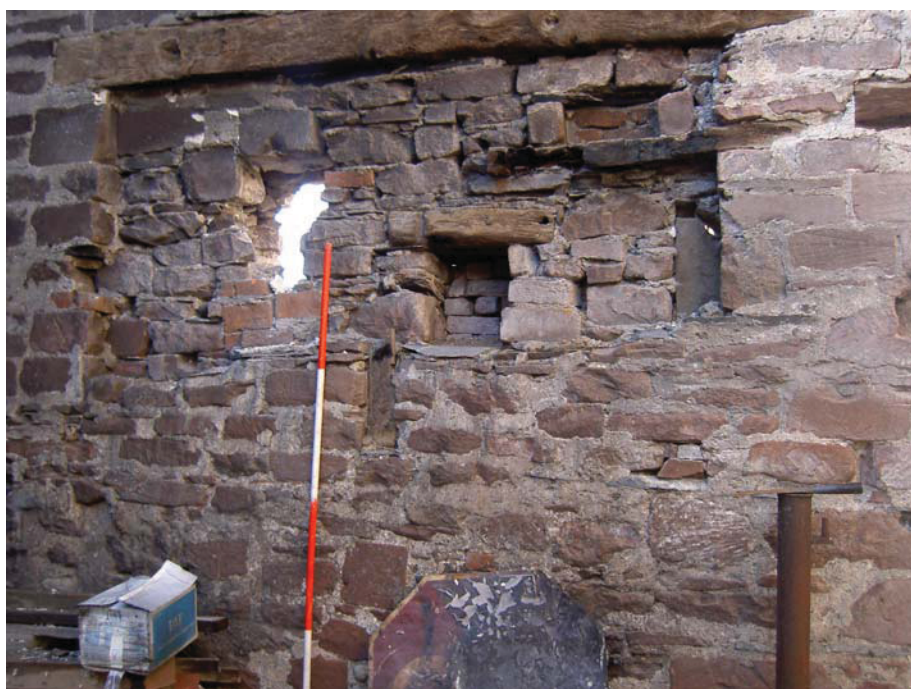
Plate 37: Blocked window and horse gin shaft housing in West wall of Building 9

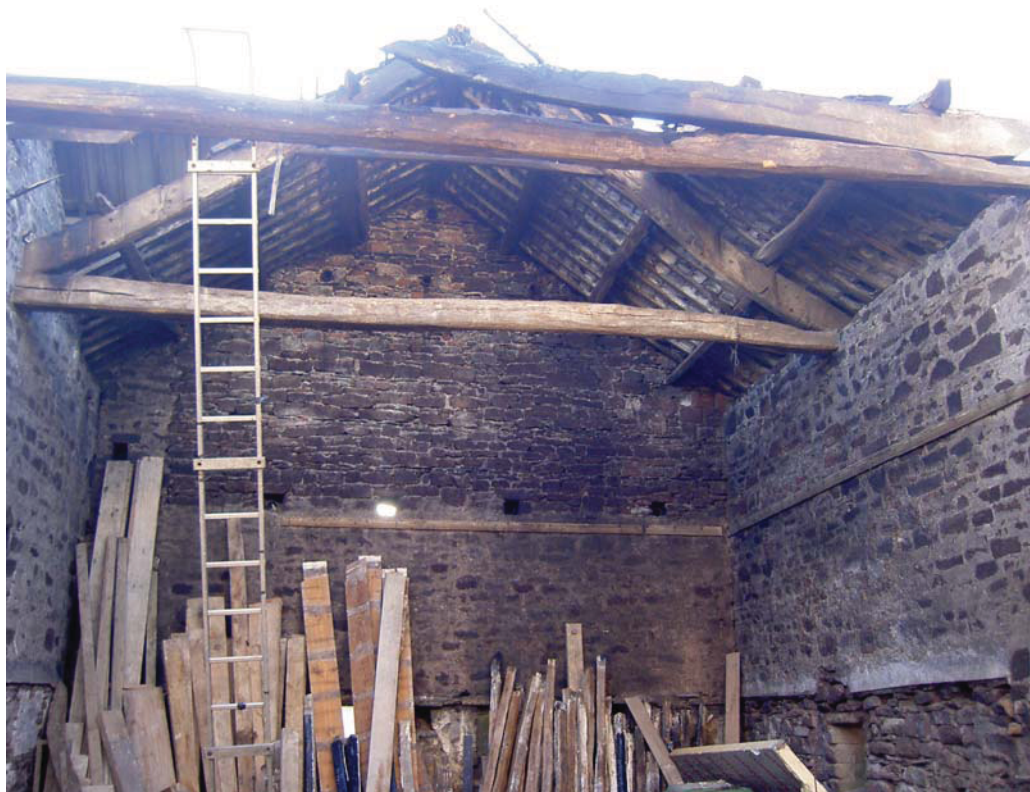
Plate 40: South elevation of Building 9

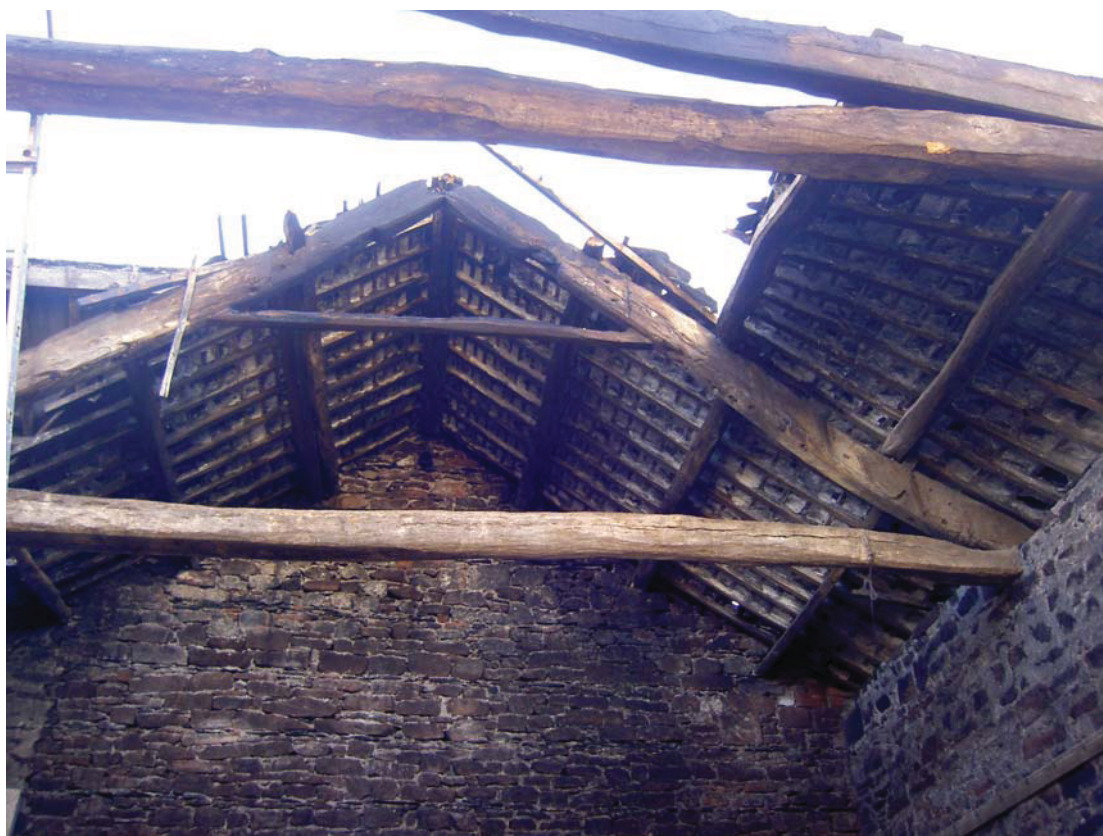
4.3.33 Roof timbers: only the southern truss of the 5 original trusses has survived the recent fire and earlier modern alterations. The tie-beam truss had an upper brace and was formed from hand finished oak. The principle rafters had been re-used and were formed from inverted cruck blades that displayed the slots for the pegged lap joints and notches on the underside that would have originally accommodated the purlins (see *Figure 5*; *Plate 41*). There were three purlins per pitch and these were also fashioned from hand finished oak, most were round wood although some were squarer in section and may represent replacements. The rafters were square in section suggesting that the building had been re-clad at some point.

Plate 41: Southern roof truss, Building 9

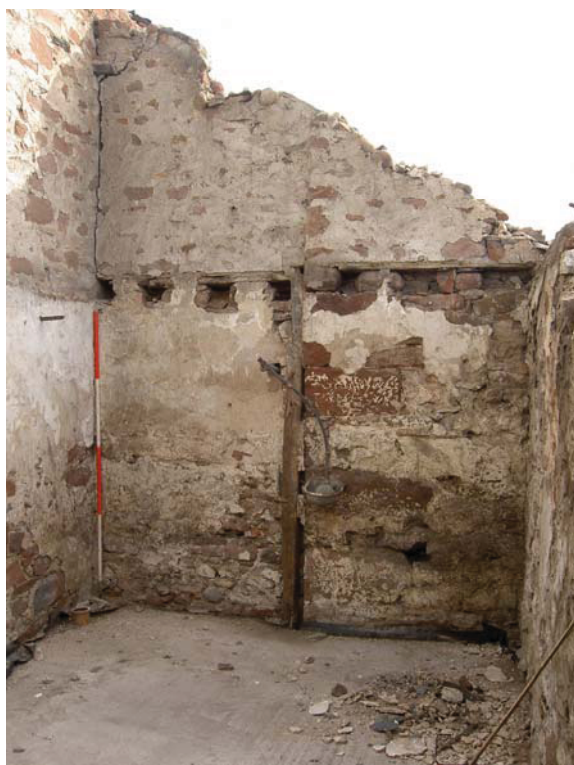
4.3.37 **South elevation:** this elevation was largely formed by the earlier Building 8. There was a blocked door at the east end (Plate 42); the quoins at the west end of this doorway were still visible beneath the plaster and whitewash. The doorway was originally an entrance to Building 8 from the north-west side of the farmhouse, it had been blocked with red sandstone rubble that had then been plastered and whitewashed. Above the doorway there was a row of joist holes that matched those on the north elevation. Above the joist holes the only part of the elevation that belonged to Building 7 rose in a triangle from the west to the east and facilitated the mono-pitched roof. This part of the elevation formed the half loft and was plastered but plain. There was a timber at the west side of the doorway that was presumably a tethering post, and a single trough was located on the wall to the west. It seems likely that this building had functioned as a loose box or stable, given that it had a trough, whitewashed walls and a half loft to store hay or straw.

Plate 42: Blocked door of Building 8 in South elevation of Building 7

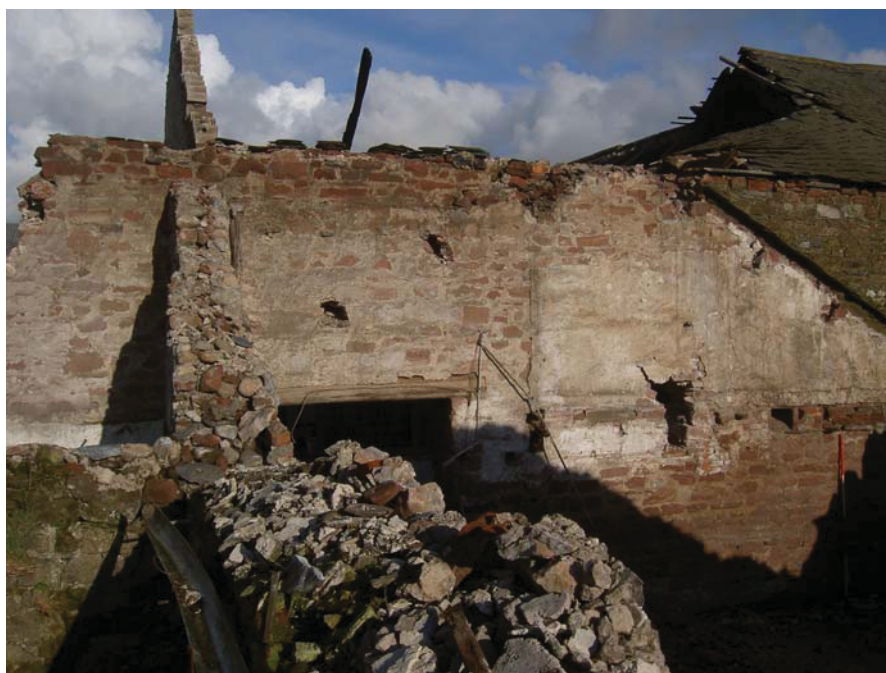
Plate 43: Gable scar of Building 8 on West elevation of Building 9

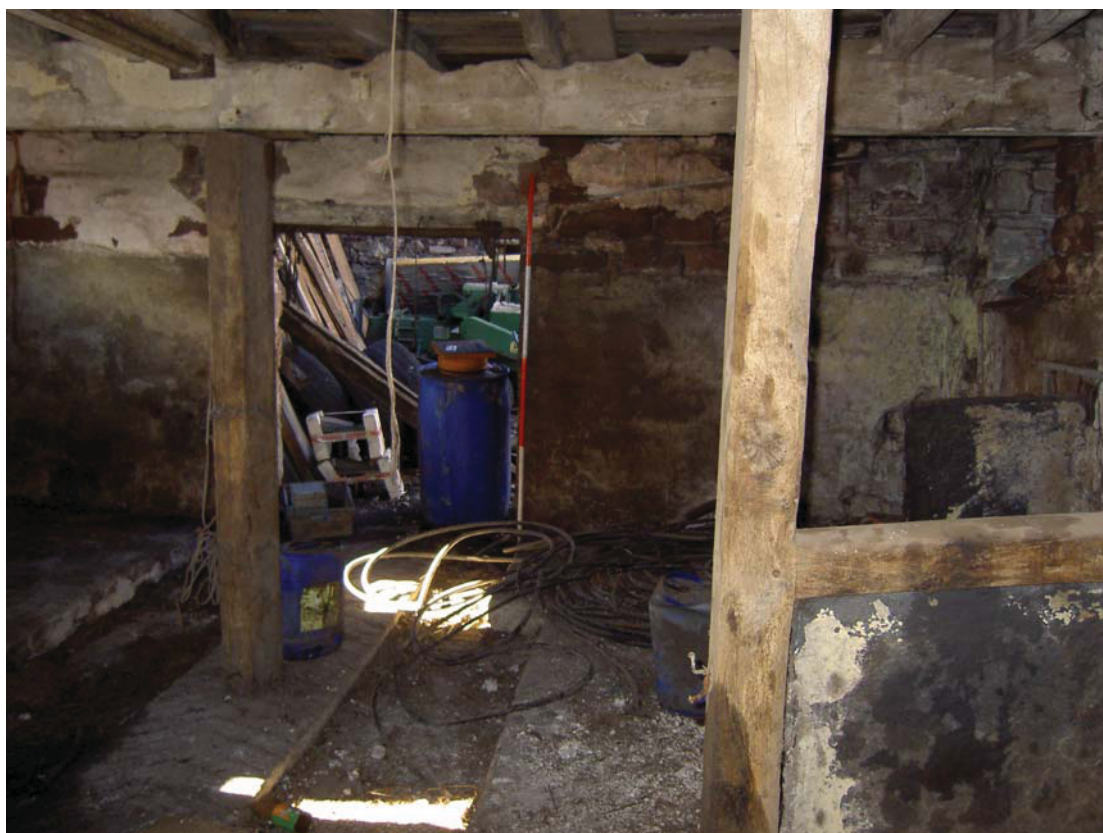
Plate 44: Stall partitions in shippon of Building 10
