SINKFALL FARM, RAKESMOOR LANE, BARROW-IN-FURNESS, CUMBRIA

Archaeological Building Recording

Client: Brian Armistead

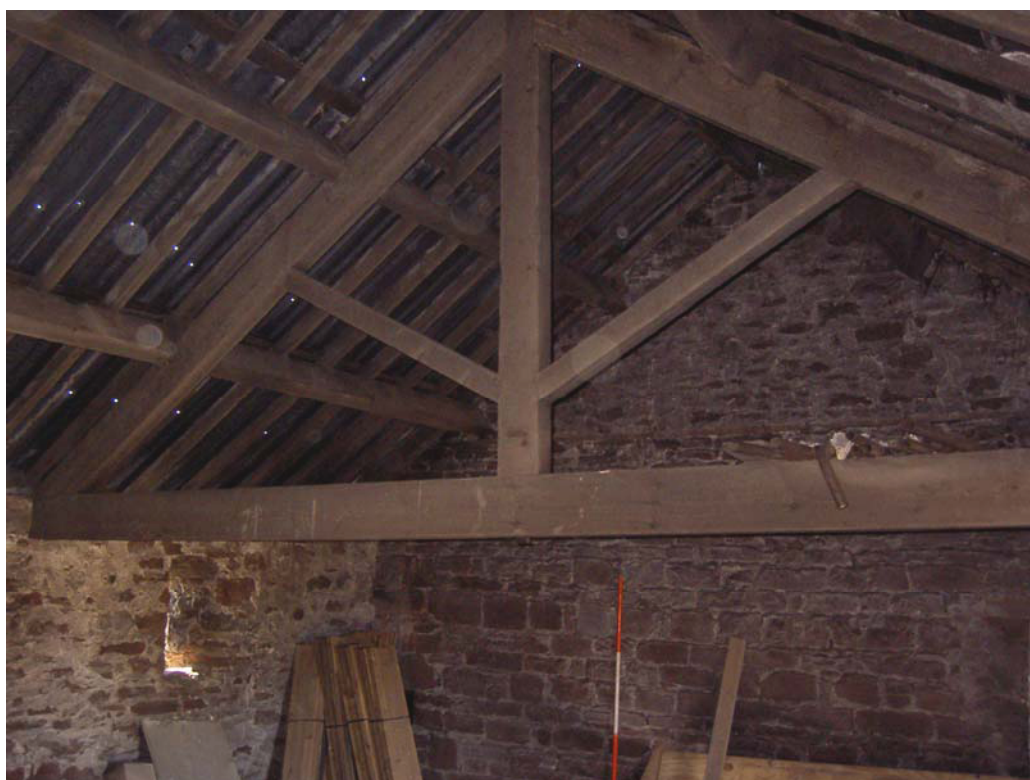
Plate 45: East side of truss in hayloft, Building 10
