Historic Building Recording at

# **JSASTC, HASLAR ROAD, GOSPORT**

For Stride Treglown

Client:	Stride Treglown
Local Authority:	Gosport Borough Council
NGR:	461863, 991990
Planning App:	RG/K.9913/71
Author:	Madigan, K.
Doc Ref:	LPI223L-HBR.v.1.3
Site Code:	HRG11
Date:	October 11

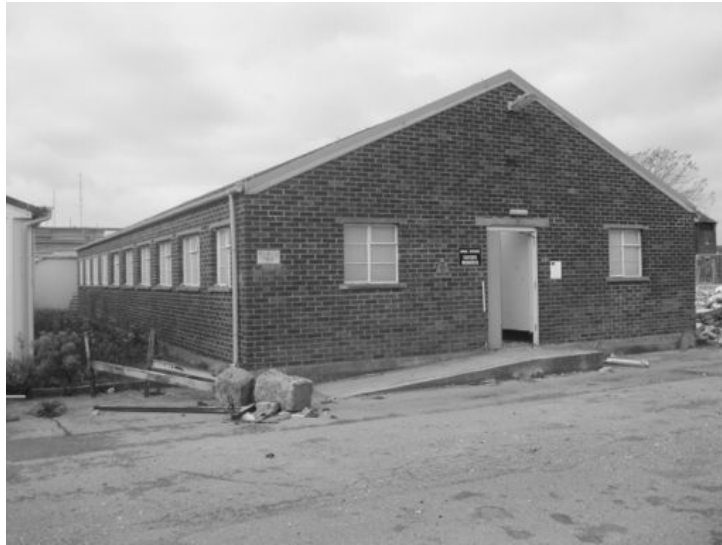
and sill. A grey plastic gutter runs the length of the elevation with a down pipe at the northern end (PLATE 1).

*Plate 1 - North and east facing elevations of building 144*

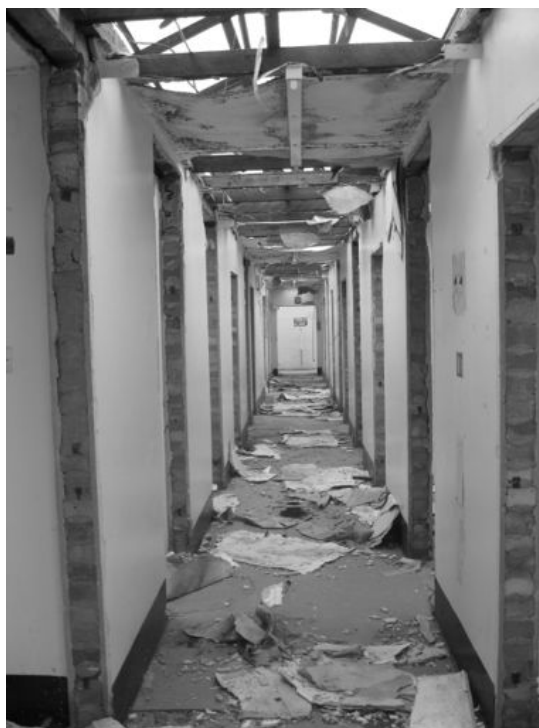
Plate 3 - Interior of building 144, facing south

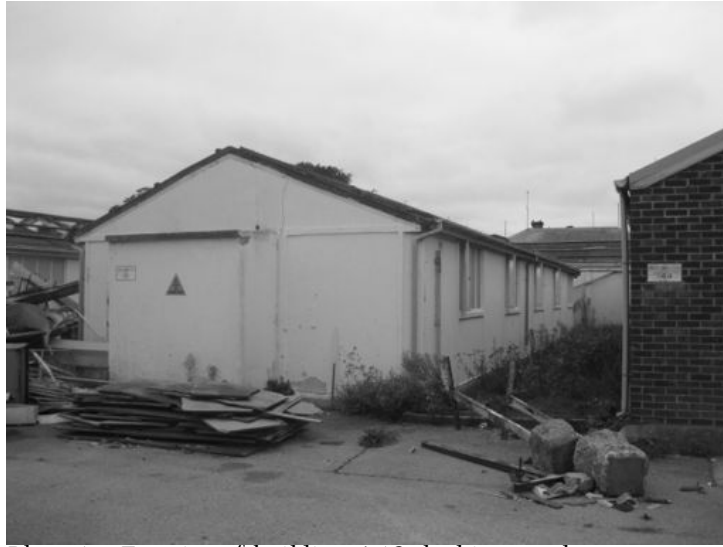
- 5.4.1. All four elevations of this building are constructed of cream painted prefabricated, precast, reinforced asbestos and concrete panels which have been bolted together over a steel frame. The four corners of the building have curved indentations. The building is a one storey structure which sits beneath a pitched roof that appears to have consisted of corrugated iron sheeting, though this sheeting was removed before the survey took place. The building sits upon a flat concrete platform (PLATE 4).

Plate 4 - Exterior of building 143, looking southeast

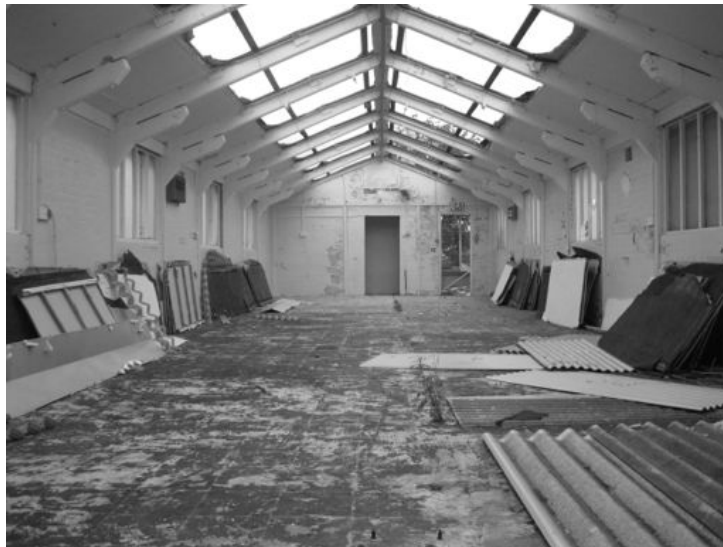
- 5.4.5. The interior of building 143 is an open plan space with no sign of prior partitioning. The roof structure is clearly visible with a steel inverted v-shaped trusses mounted and bolted onto steel braces. The steel braces are in turn bolted to vertical steel supports. All four internal walls are constructed of cream painted brickwork (PLATE 5).

- 5.4.6. The principal rafters in the roof structure, as shown in PLATE 5, sit on inclined hammer beams, where the principal rafters meet the wall plate. These were specifically used instead of tie beams to create open spaces.

Plate 5 - Interior of building 143, looking north

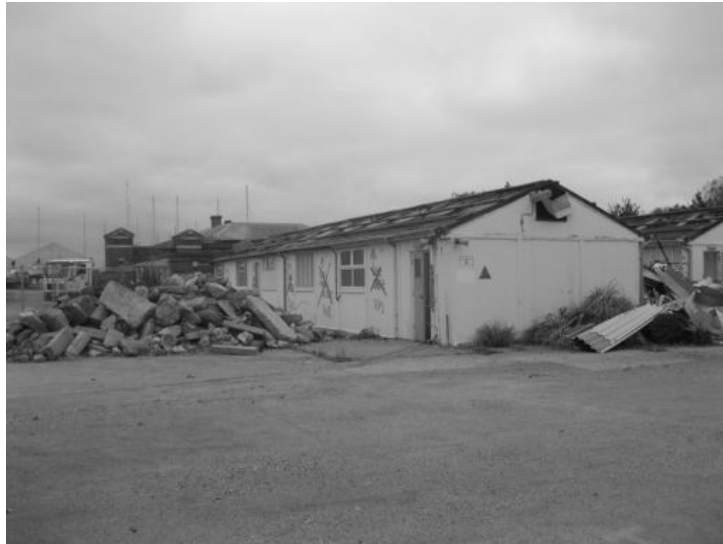
Plate 6 - North and east facing elevations of building 142

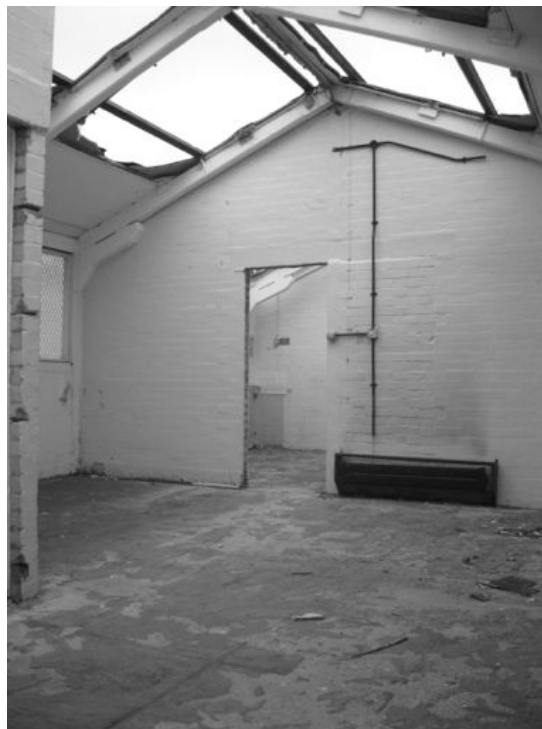
- 5.5.6. The interior of building 142 consists of seven small rooms (PLATE 7). All internal walls are constructed of cream painted brickwork. There are twelve windows in total with five on the east, five on the west and two on the southern elevations. All windows on the west side of the building are identical to those on the west facing elevation of building 143 (see 5.4.3). All of the windows are placed behind metal security grills.
- 5.5.7. Some of the rooms in building 142 have tiles on the walls indicating that sinks once occupied the spaces. One internal doorway is blocked up with bricks but all doors and door frames have been removed.
- 5.5.8. The roof, beam and framework structure of this building is identical to that of building 143 (see 5.4.5). The flooring is also identical with remnants of tiling over a screed base.

Plate 7 - Interior of building 142 looking northwest

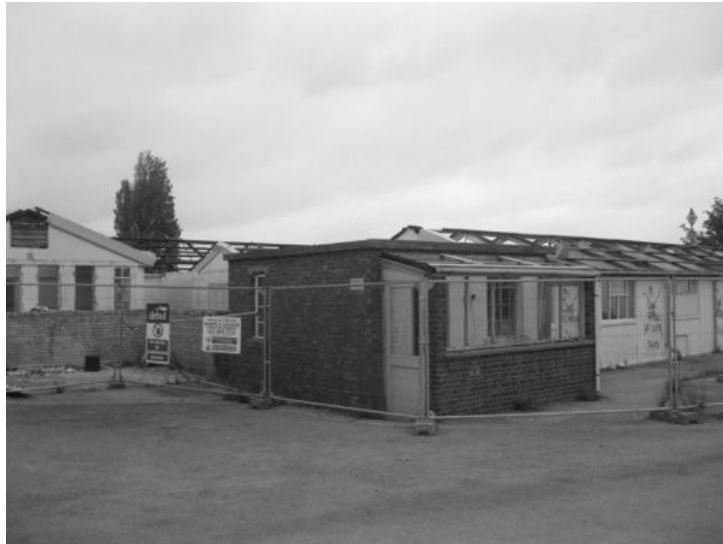
- 5.6.1. Building 141 is set at the southeastern corner of the blocks that make up the JSASTC complex on this side of the road. The building is constructed of stock red brick in an alternating header and stretcher pattern with a hard sandy yellow mortar. Each brick measures 220mm by 70mm by 105mm. The building is a one storey structure which sits beneath a flat roof that has been covered in black bitumen felt (PLATE 8).

Plate 8 - Exterior of Building 141

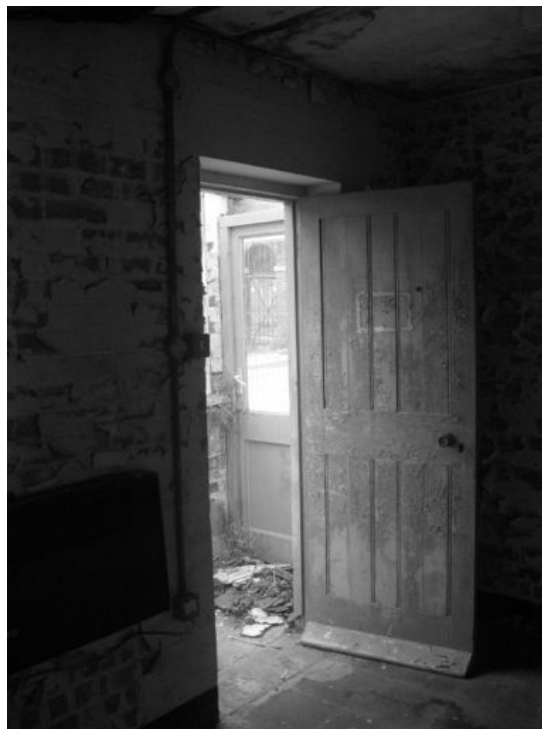
Plate 9 - Interior of building 141 looking southeast

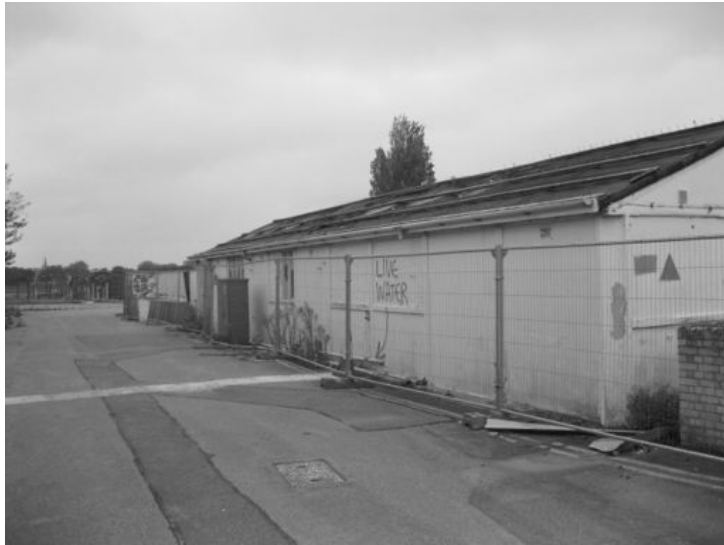
- 5.7.3. The south facing elevation has four windows. Two of which have been blocked up with sheets of plywood. Two windows at the western end of the elevation are identical to the windows described in 5.4.3. A large double door occupies the far western end of the elevation. It is painted blue and is of the 'fire door type' design. A grey plastic gutter runs the length of the elevation (PLATE 10).

Plate 10 - South facing elevation of building 146

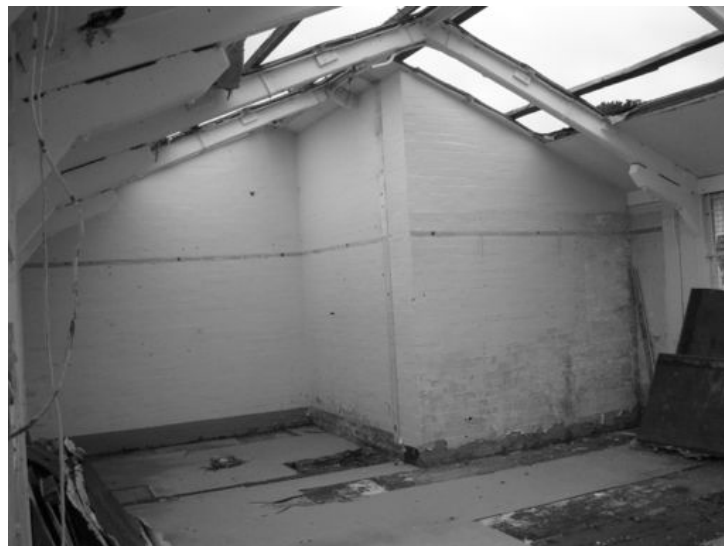
- 5.7.4. The interior of building 146 is divided into several rooms that indicate that this was a shower and toilet block. Some of the rooms were not accessible during the day of the site visit due to obstructions associated with the stripping out of the building. Those accessed show clear evidence of tiling relating to the wet room use of the building as well as evidence of changing rooms from where pegs and benches had been attached to the walls.
- 5.7.5. It was possible to see that the roof structure is identical to the roof structure in buildings 142, 143, 144 (PLATE 11).

Plate 11 - A changing room in building 146

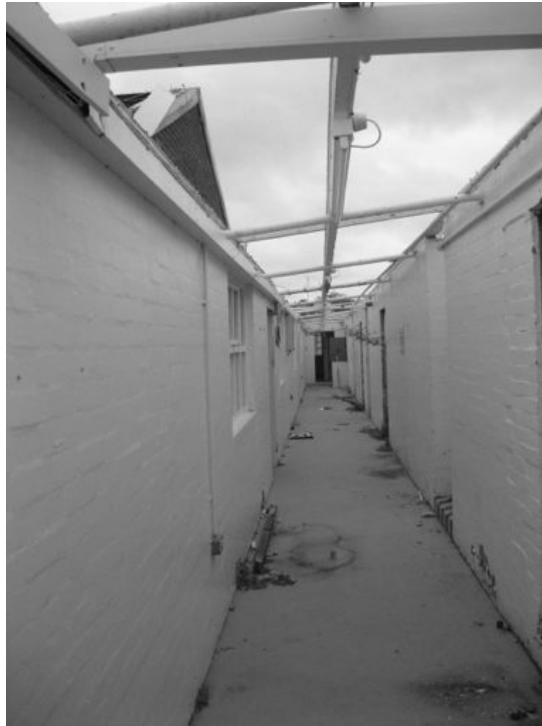
5.8.2. At the southern end of buildings 142, 143, 144, the removed 145, to the west of 141 and the north of 146 is an inserted corridor that allowed all of the buildings to be linked together and accessed via a covered walkway (PLATE 12).

Plate 12 - Interior corridor looking east

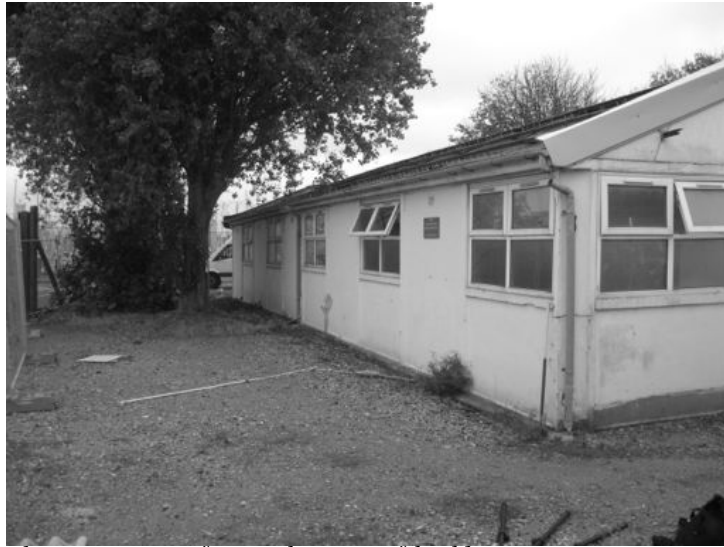
Plate 13 - West facing elevation of building 72

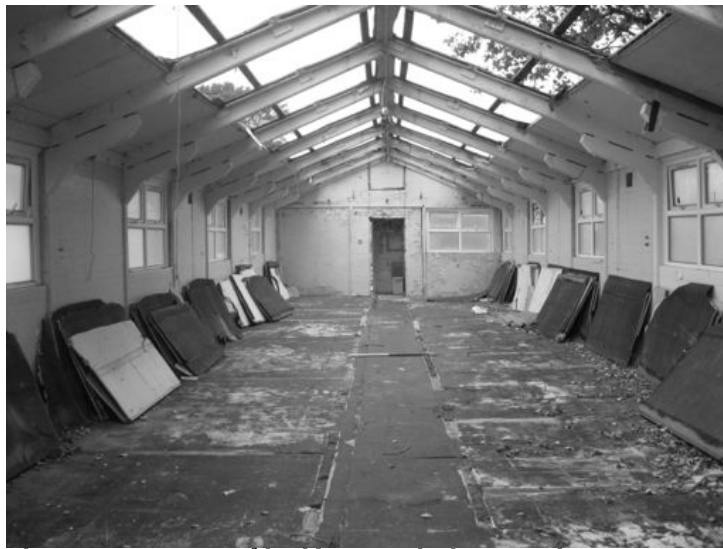
Plate 14 - Interior of building 72, looking south

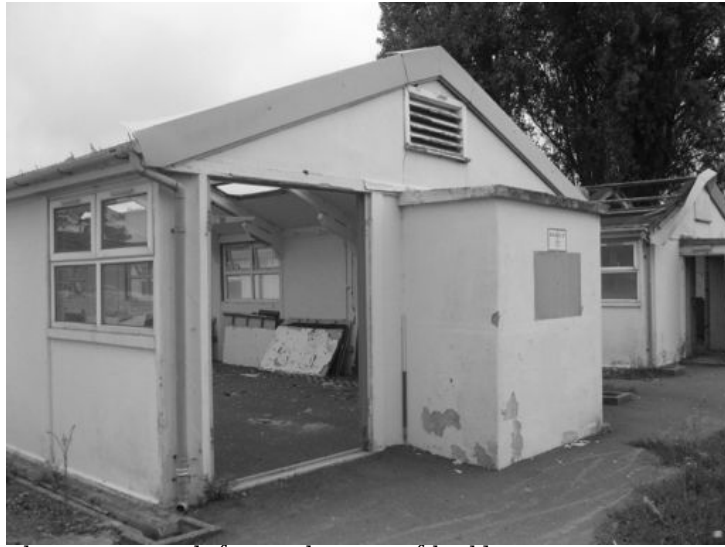
Plate 15 - North facing elevation of building 73

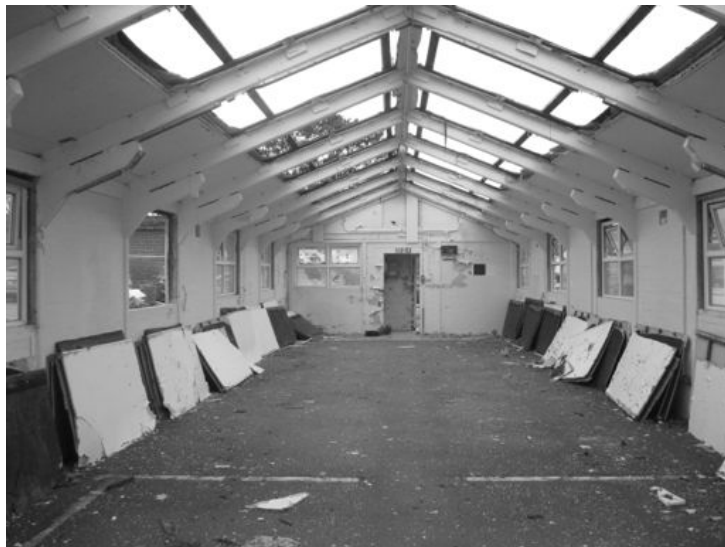
- 5.10.5.The roof structure is clearly visible with a steel inverted v-shaped trusses mounted and bolted onto steel braces. The steel braces are in turn bolted to vertical steel supports. This is identical to the structure of buildings 72, 142,143 and 146. All four internal walls are constructed of cream painted brickwork (PLATE 16).

Plate 16 - Interior of building 73, looking south

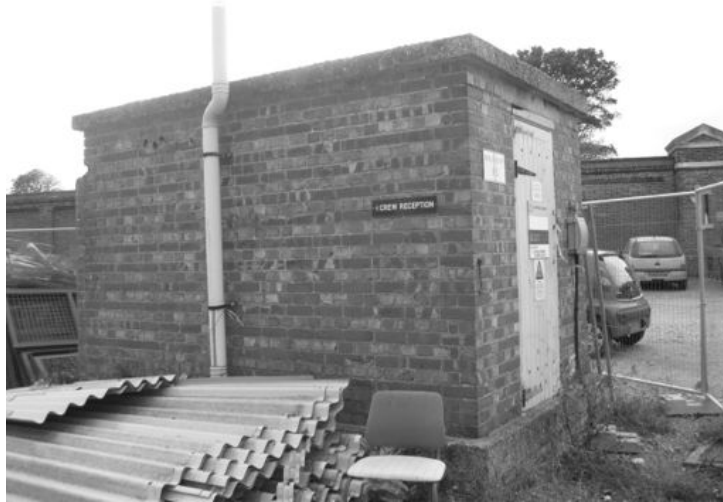
Plate 17 - Building 83 looking south

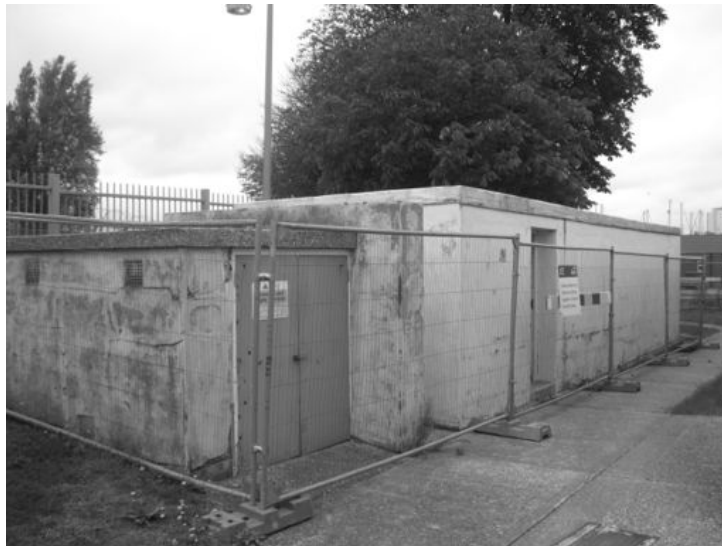
Plate 18 - Building 47 looking northwest

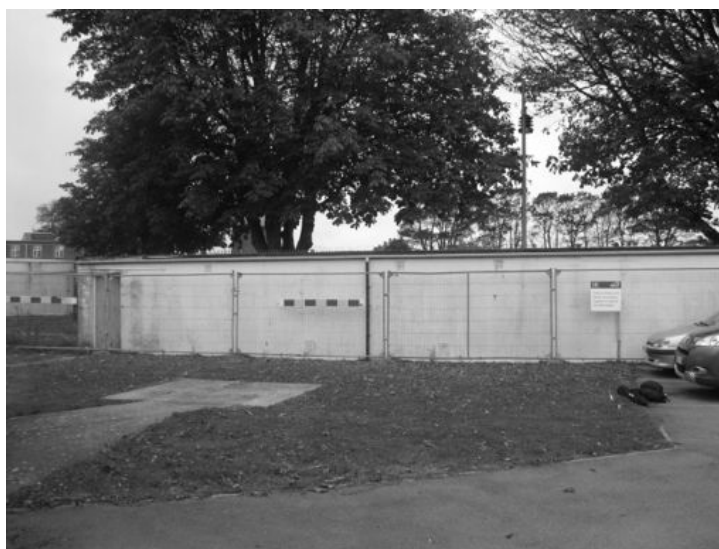
*Plate 19 - East facing elevation of building 48*
