Historic Building Recording and Fieldwalking at

# **LOACHBROOK FARM CONGLETON**

Client:	CgMs
Local Authority:	Cheshire East Council
NGR:	383125,363225
Planning App:	APP/R0660/A/11/2158727
Author(s):	B. Poole
Doc Ref:	LPI607C-HBR-v1.2
Site Code:	CON/LBF 13
Date:	October 13

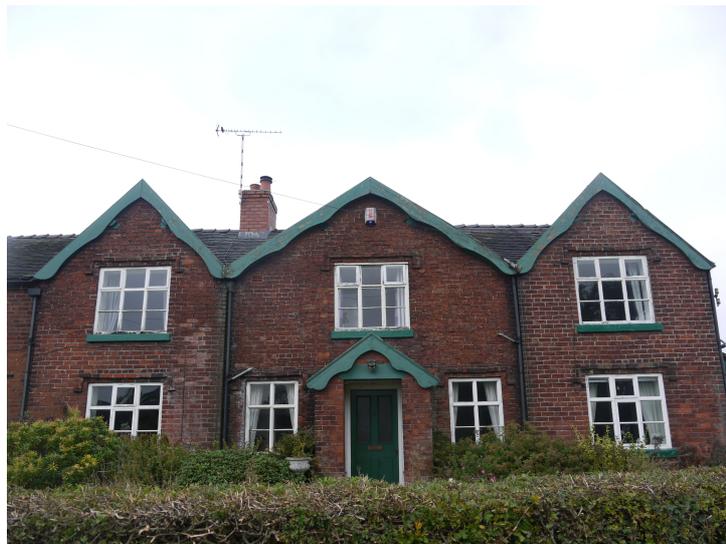
Plate 1 - Eastern elevation, north end

6.4.The eastern elevation of the property marks its façade facing the nearest settlement, Congleton . The decorative nature of this elevation clearly shows the public face of the building, a Victorian 'Olde English' style with decorative wooden bargeboards painted green around each of the three gables at the northern end (PLATE 1).

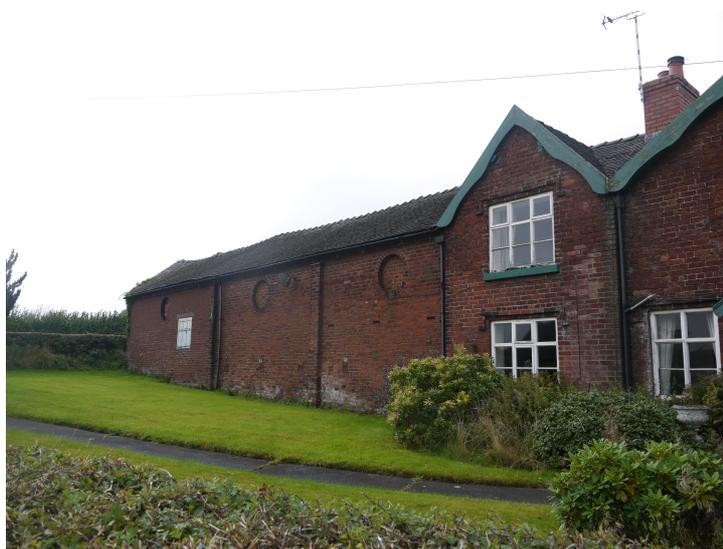
Plate 2 - Eastern elevation, southern end

6.6. The fenestration of this face is of square pane wooden framed windows with stone sills and decorative brick lintels above each window similar in style to Gothic hood moulds, with the exception of the southern window, which has a stone lintel and plain brick sill. Although this window differs from those seen to the northern end it is still thought to be an original fixture. The difference represents a distinction between the areas of the structure. The northern three bays are part of the dwelling element of the property, whereas the southern two thirds of this elevation relate to a large barn area (PLATE 2).

6.7. Along the barn elevation a series of three bricked up circular windows are present at first floor level. Two buttresses are located even spaced along the barn. These are keyed into the structure and are original elements to the building.

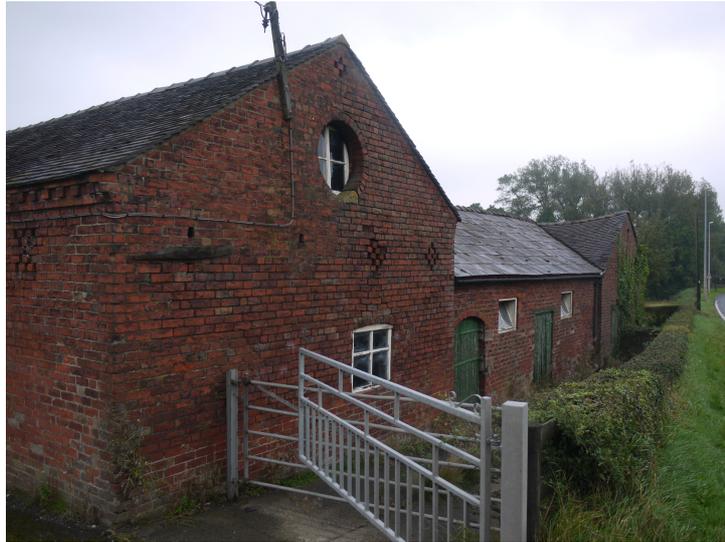
Plate 3 - Southern elevation

- 6.9. The southern elevation (PLATE 3) fronts onto the A534, the main road leading to Congleton. This elevation is less decorative than that of the house frontage, an indicator that these are outbuildings and as such did not warrant the same level of decorative finish. The elevation can be seen to comprise two phases of construction. At the eastern and western extents are two, two storey, gable ends (FIGURE 9), which are thought to be contemporary. These are in a random coursed brickwork. The eastern extent is mainly obscured by vegetation. However a narrow rectangular wooden framed window can be seen below the apex of the gable. An inserted doorway is located at ground floor level at the western side of the eastern block. This doorway has a wooden frame and the rough brickwork around it suggests that this was inserted at some point after the original construction.

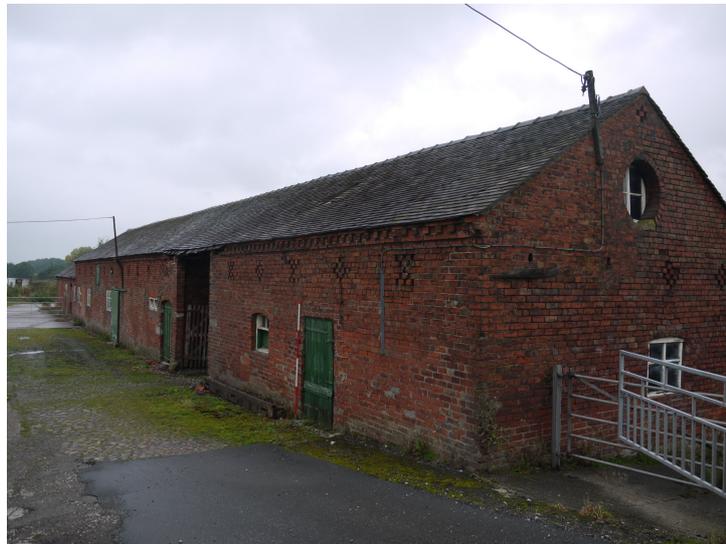
Plate 4 - Western elevation

6.15. The western elevation looks out onto the fields to the west of the property and has a brick façade in English garden wall bond (PLATE 4). The grey slate pitched roof has grey ridge tiles across the full length of the elevation. This range can be divided into three distinct blocks. The southern block and central block are both two storeys and contemporary with the original 1840-1873 structure. These are divided by a carriage access into the courtyard. The northern block is a single storey structure and is a later extension to the complex, dating to between 1882 to 1909.

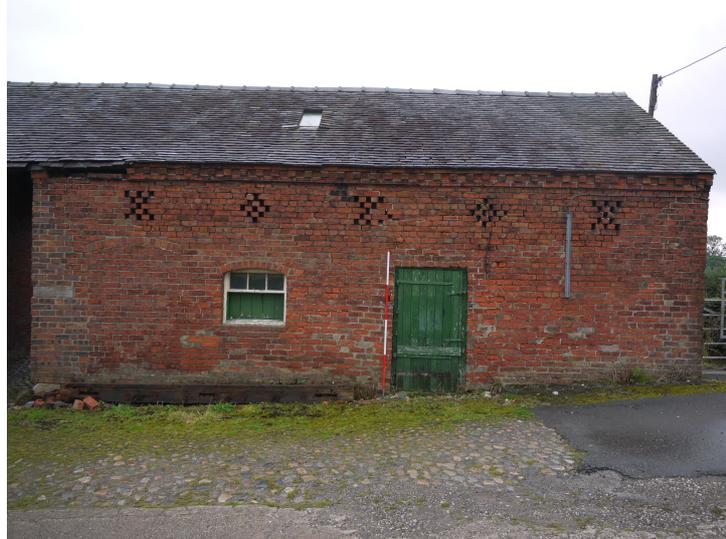
Plate 5 - Southern block of western elevation

- 6.16. The southern block has an inserted roof light in the western pitch just off centre, to the north. Below the eaves the same denticulated three course brick band (PLATE 5) can be seen that was present on the eastern barn elevation.

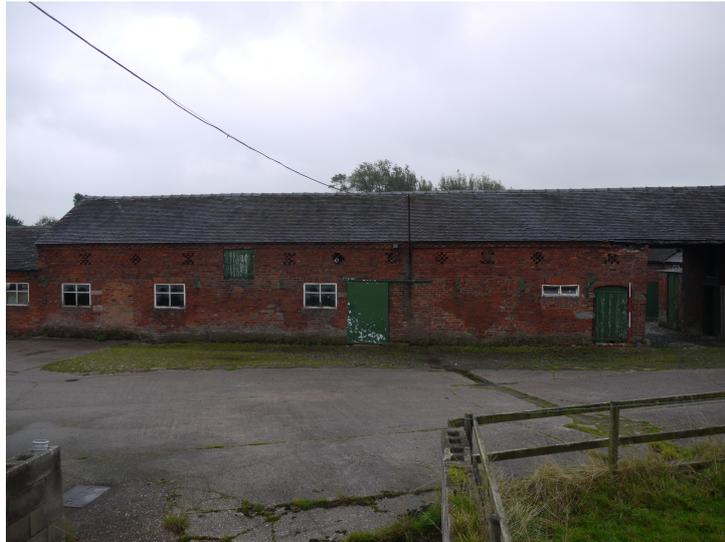
Plate 6 - Central block of western elevation

- 6.19. The central block (PLATE 6) matches the style of the southern block with a denticulated brick band below the eaves and alternating cross and diamond brick vents at first floor level. Brick repair work is seen on the southern edge of the elevation, where the carriage entrance is located. This matches that seen on the southern block and is thought to be part of the same repair phase. Again, as with the southern block the stone hinge blocks have been retained as part of the repair work.

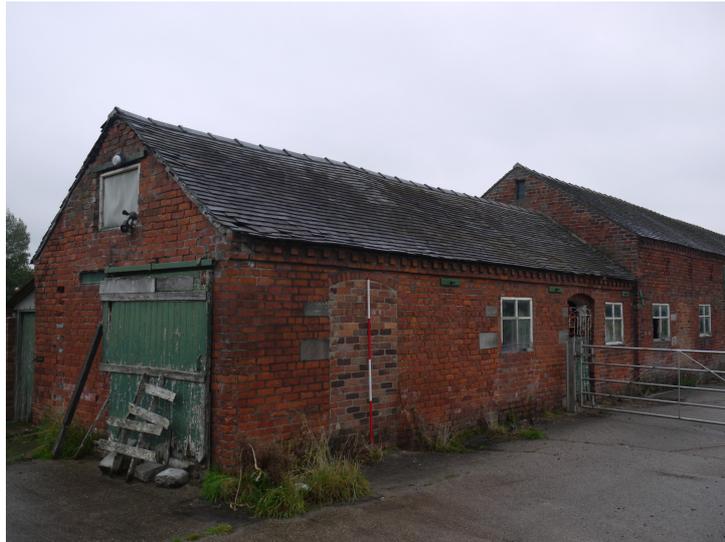
Plate 7 - Northern end of western elevation

6.23. The northern block is a later, single storey, extension to the western range (PLATE 7). The pitched roof and decoration has been designed to match that of the original building, with denticulation below the eaves and recessed brick doorways with stone hinge blocks. However, the joint of the northern and central blocks clearly shows that the northern section is a later addition. Cartographic research shows that this dates to between 1882 and 1909.

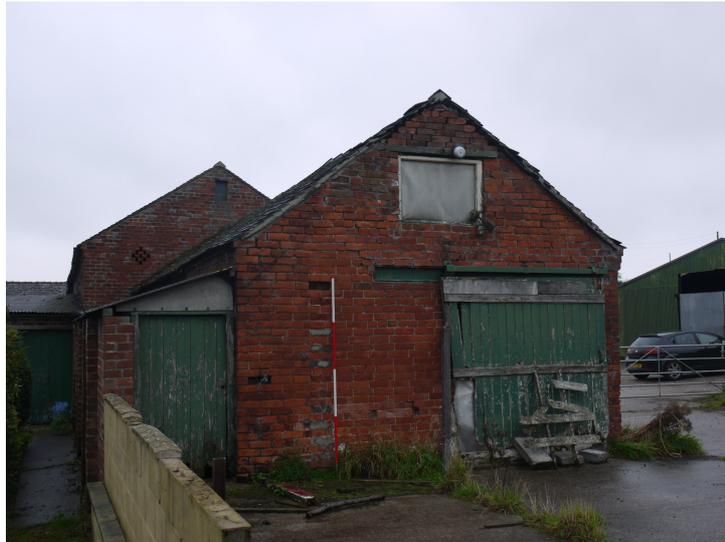
Plate 8 - Northern elevation, western end

6.26. The western section can be seen in PLATE 8 and contains a large double doorway to the western edge of the elevation and a single pane wooden frame window above it, in the gable wall. To the east of the doorway is a wall scar indicating that a previous garden wall has been removed from this point. The garden wall can be seen on several of the earlier Ordnance Survey maps. To the east of the wall scar is a small lean to area with wooden doorway. This is a late 20<sup>th</sup> century extension to create a covered walkway next to the late 18<sup>th</sup> century extension.

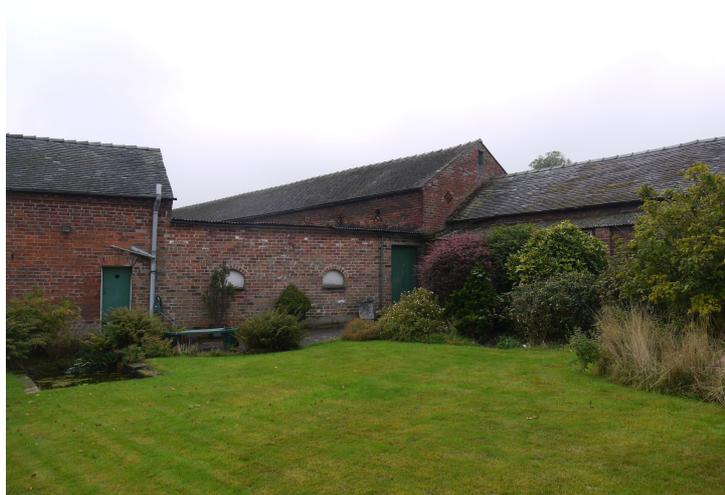
Plate 9 - Central area of northern elevation

6.28. The central section of the northern elevation is an external brick wall in a later brick type in stretcher courses. The wall must post date the 1964 to 1970 lean to extension to the west as it butts against it (PLATE 9).

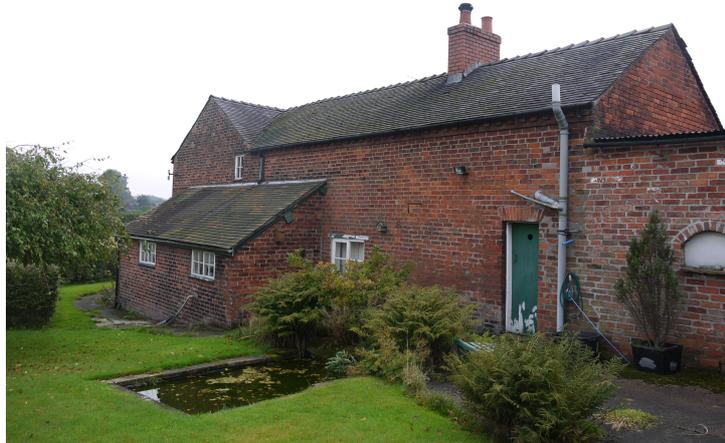
Plate 10 - Northern elevation, eastern end

6.29. The eastern area of the northern elevation is a two storey structure in with a single storey extension to the eastern edge (PLATE 10). The majority of the roof line has an east west orientation, with a return apex along a north south alignment at the eastern end.

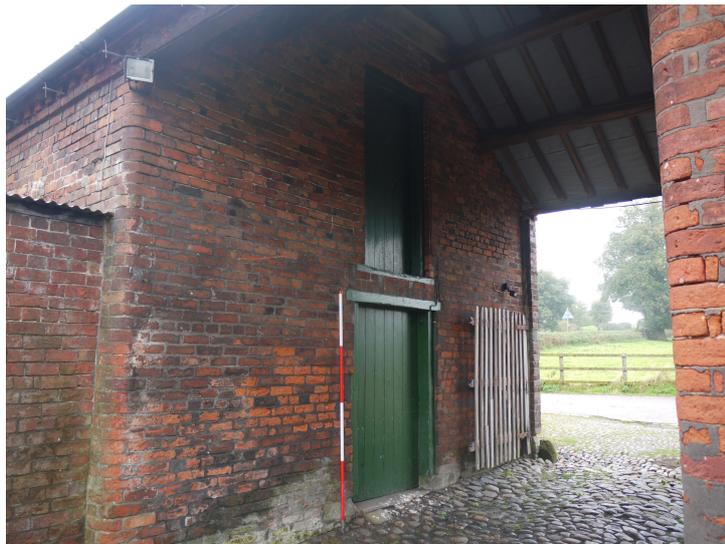
Plate 11 - Southern block, carriage entrance

6.32. On the southern block (PLATE 11) two wooden doorways are located centrally, one above the other. These are thought to be original features of the structure.

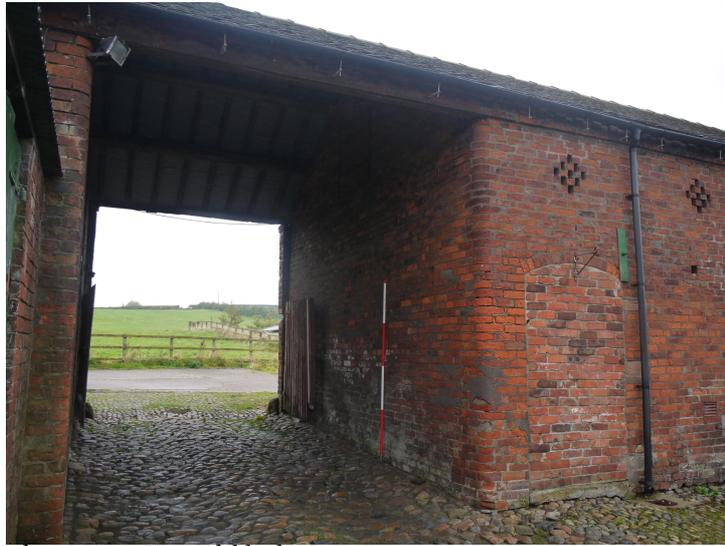
Plate 12 - Central block carriage entrance

6.33. On the central block a single hatch is located at frost floor level (PLATE 12). On both southern and central blocks the entrance to the courtyard has radius bricks forming a rounded corner.

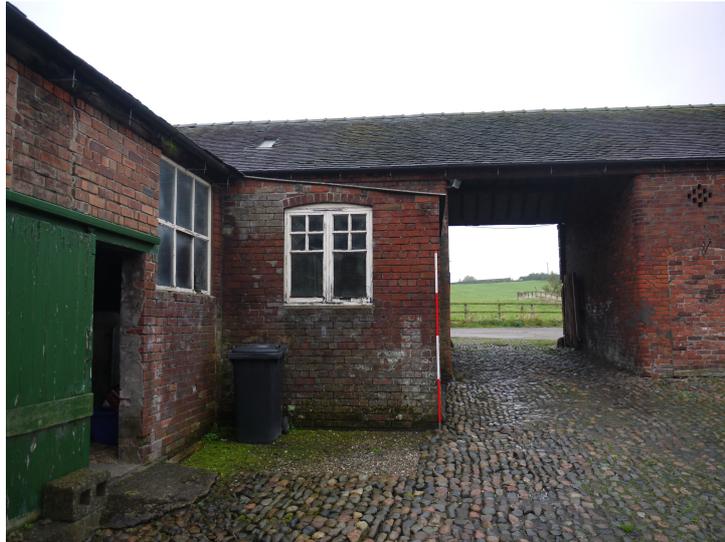
*Plate 13 - Lean to on western courtyard elevation*

6.35. The small lean to has what appears to be an asbestos roof, however this would need to be confirmed by a specialist. On the western elevation of the lean to is a large 10 pane wood frame window with brick arched lintel (PLATE 13). The construction of the lean to is of English garden wall bond.

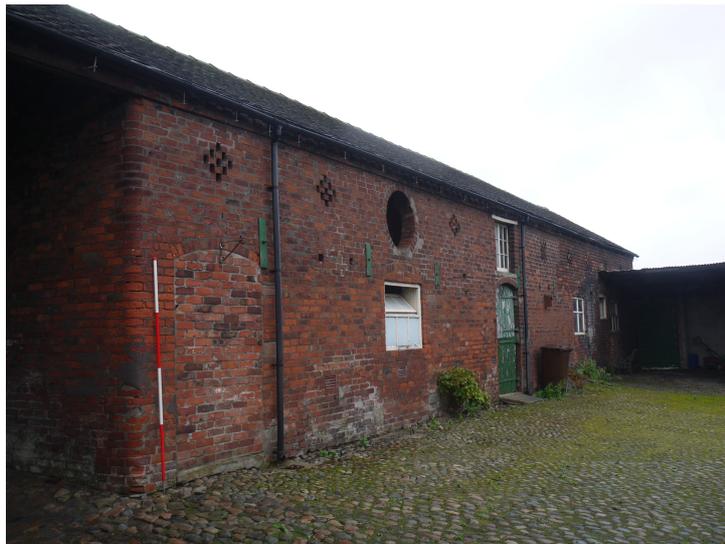
*Plate 14 - Western courtyard elevation*

6.36. The main elevation of the central block matches the styling seen on its counterpart (PLATE 6 & PLATE 14). Below the eaves is the three course decorative denticulated brick band. At first floor level are a series of alternating diamond and cross brick vents.

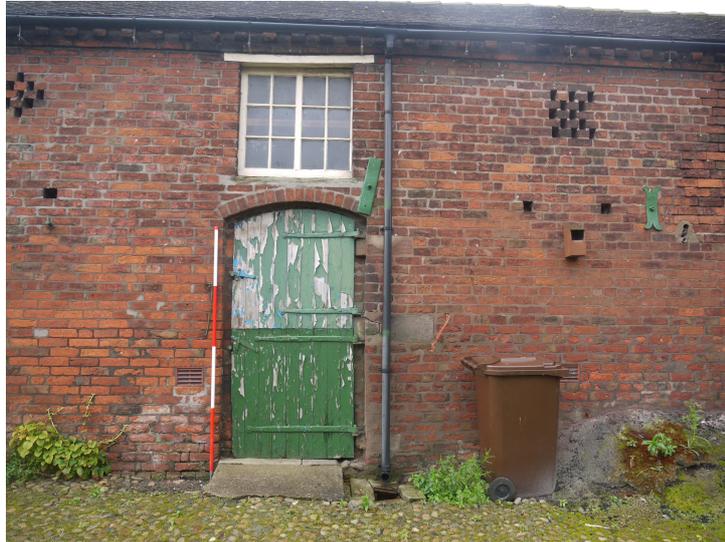
Plate 15 - Central doorway on western elevation

southernmost doorway does not have an inserted window. This leaves a single entrance to the barn at the central doorway. All of the doorways match with header brick shallow arched lintels and recessed brick door jambs. On the northern jamb of each door are three stone hinge blocks (PLATE 15).

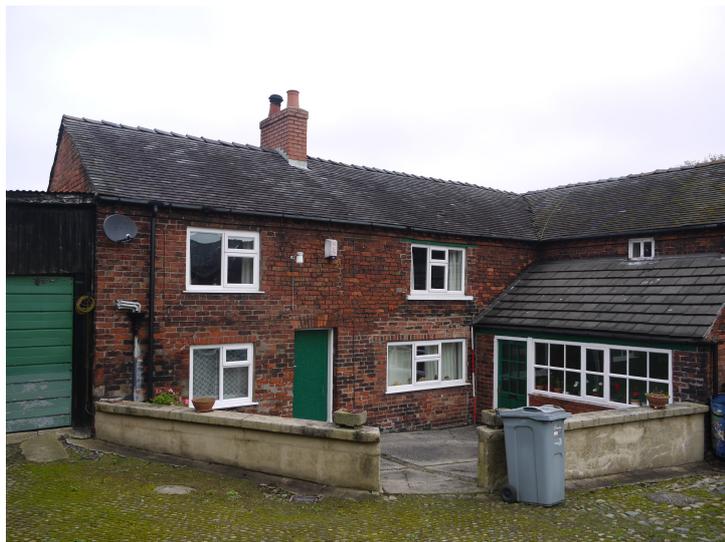
Plate 16 - Courtyard northern elevation

6.39. The northern elevation of the courtyard represents the domestic dwelling part of the complex (PLATE 16).

bands below the eaves and an English garden wall brick bond. All of the windows on this elevation have been replaced by late 20<sup>th</sup> century uPVC double glazed units. The eastern window can be seen to replace an earlier doorway and window unit (FIGURE 13). The central doorway has an on end brick lintel in a fan style. This appears to be an original feature of the property.

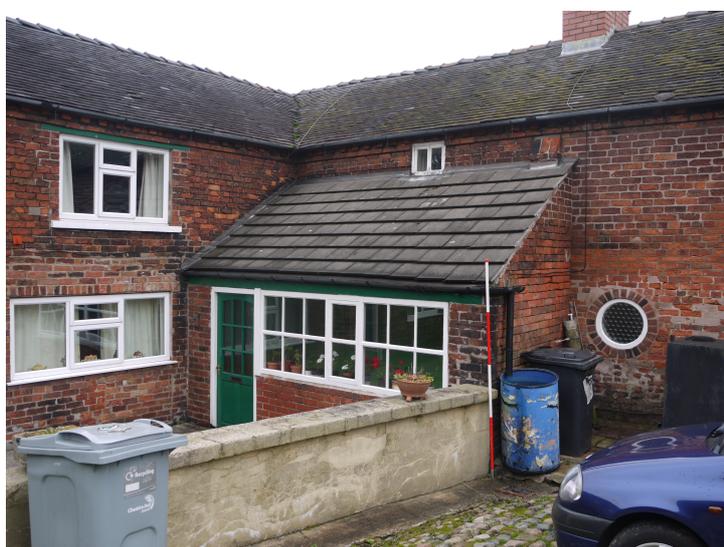
Plate 17 - Single storey extension on eastern elevation

6.41. The eastern elevation of the courtyard has been heavily modified (FIGURE 14). At the northern end extent of the elevation a single storey extension has been added (PLATE 17). This dates to between 1840 and 1873. Although the dates are close to that of the original construction it is clearly a later addition. The doorway and windows are all wooden framed and single glazed units.

6.43. The rest of the eastern elevation in the courtyard relates to the attached barn. The decorative brick bands below the eaves continue along the length of the face. Two round brick window openings are present at first floor level. A third round window can be seen at ground floor level next to the single storey extension and is a late 20<sup>th</sup> century insertion (PLATE 17). Above this inserted window is an area of brick repair.

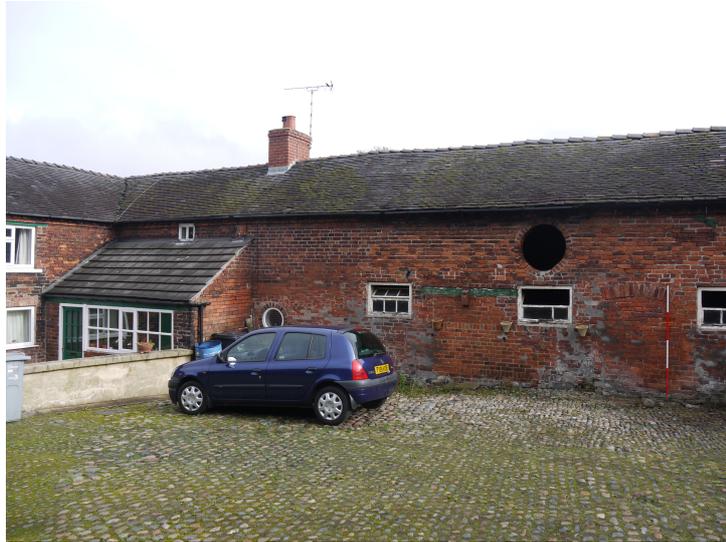
Plate 18 - Courtyard eastern elevation, showing two blocked doors and fenestration

blocked doorway matches the style seen on the other original elevations of the structure, with shallow header brick arched lintel and recessed brick doorway, with stone hinge blocks on the northern jamb (PLATE 18).

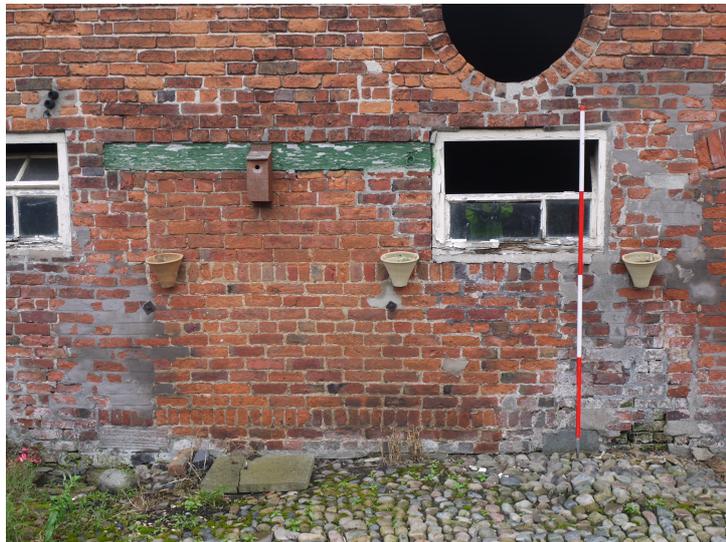
Plate 19 - Blocked doorway and inserted window

6.45. The northern blocked door has been so heavily modified that all original elements have been removed. A wooden lintel has been inserted, not thought to be an original fixture, as has one of the ground floor windows on this elevation (PLATE 19).

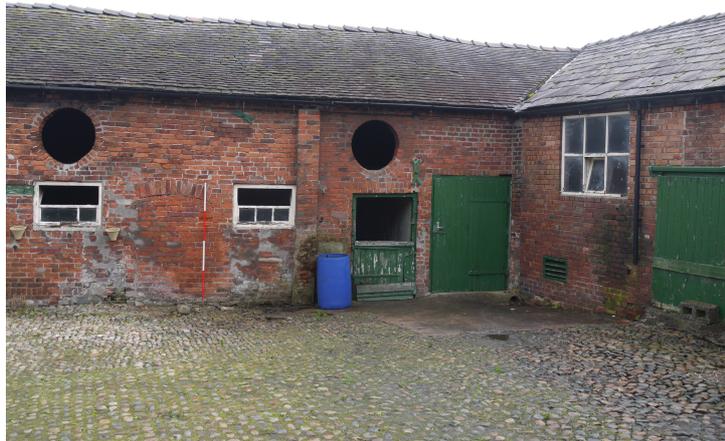
Plate 20 - Southern end of courtyard eastern elevation

6.47. At the southern end of the elevation are two inserted doorways. The northern doorway leads into the barn and is a single width wooden framed stable door, likely 20<sup>th</sup> century in date. To the south of this is a larger doorway (PLATE 20). In this area a great deal of the brickwork has been repaired at some point in the 20<sup>th</sup> century.

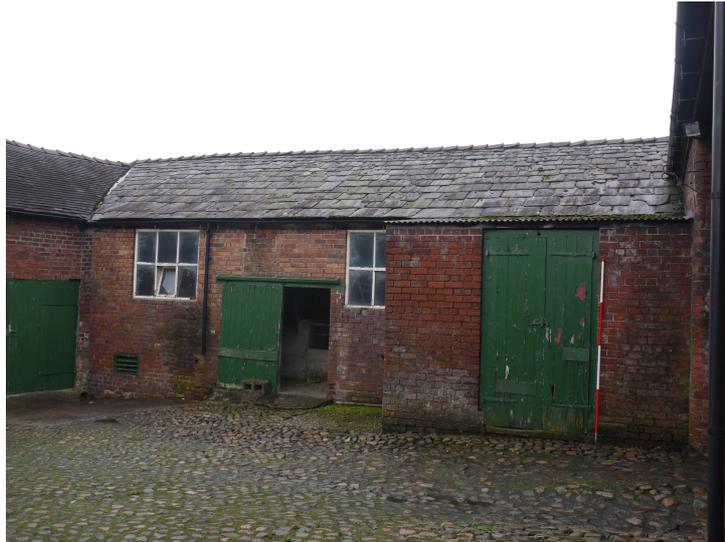
Plate 21 - Courtyard southern elevation

6.48. The southern elevation of the courtyard is of red brick in an English garden wall bond, with a central single doorway, which has had a later sliding door installed (FIGURE 15). Set higher than the doorway, to either side of it, are two large metal frame six pane windows. These are thought to be 20<sup>th</sup> century in date (PLATE 21).

6.49. Above the doorway is an area of brick repair. Although the appearance of this suggests a blocked hatch, internally there is no evidence for a hatch. Therefore, it is likely that this just represents a phase of brick repair.

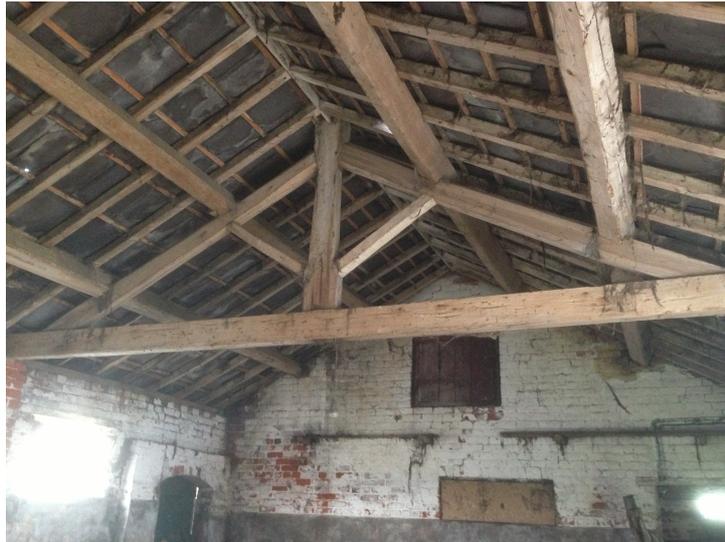
Plate 23 - G2, looking northeast

6.56. Room G2 is located in the southern range of outbuildings. This is also an open plan space, with double height ceiling.

6.58. The ceiling is clearly a replacement, with 20<sup>th</sup> century materials used for the framework.

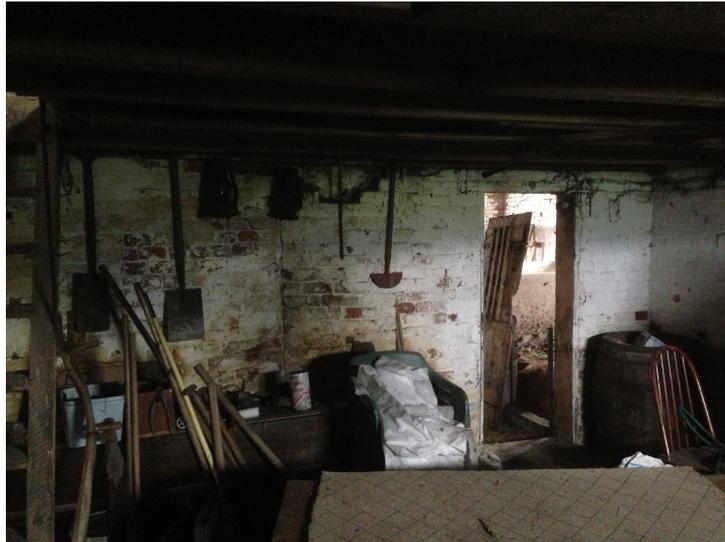
Plate 24 - G4, looking east

6.61. Room G4 (PLATE 24) is located at the southwestern extent of the complex. The room appears to have been partitioned at some point in the 20<sup>th</sup> century to annex a small store area (not accessible) at the southern end of the room. Along the northern wall of G4 is a rough wooden staircase leading to F3.

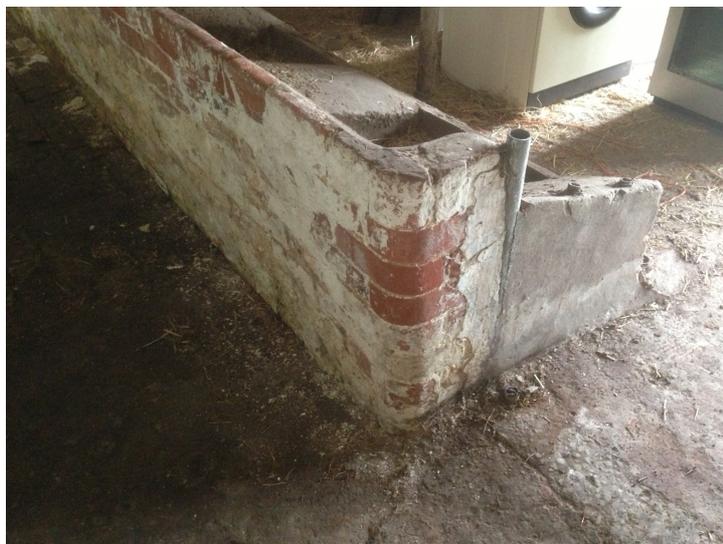
Plate 26 - Corner of dwarf wall in G6

6.65. The historic fabric is clearly visible in this room. The external walls, with blocked doorways, have been painted white, and the walkway to the east of the raised floor area has a typically Victorian brick floor. The dwarf wall has a radius on its corner matching that of the courtyard entrance (PLATE 26).

6.66. The majority of the beams are replacements, indicating that the ceiling/first floor boards have been repaired in the 20<sup>th</sup> century.

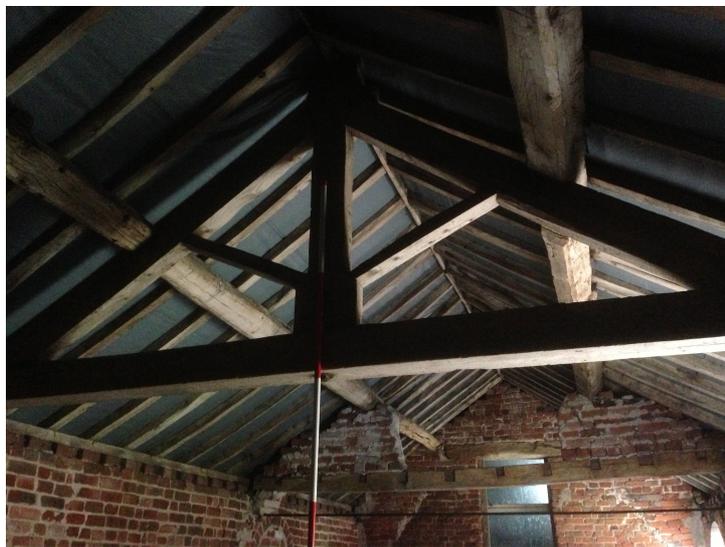
Plate 28 - Room F1, looking south

6.70. The floorboards in F1 are modern replacements. It is thought that this would have always functioned as a hay store or similar, with loading access onto the courtyard. The roof structure is a later replacement. The materials are a combination of modern timber and re-used timbers (PLATE 28). The presence of cut-outs for beams along the

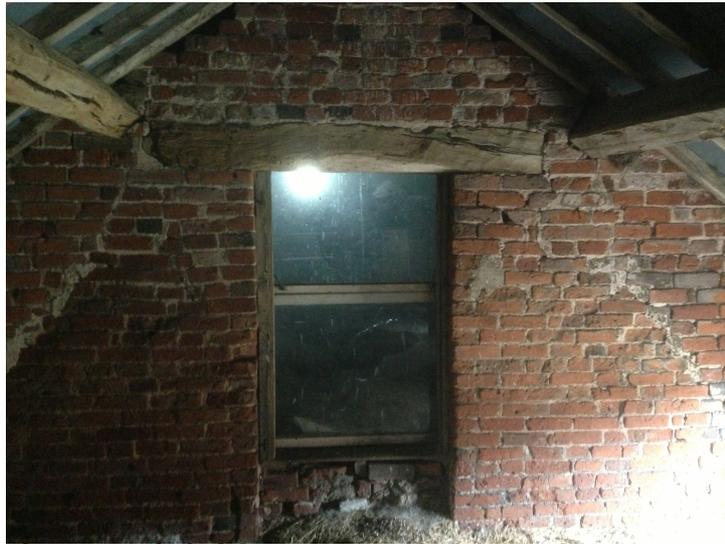
Plate 29 - Blocked doorway in F1, looking south

6.71. A blocked doorway, with inserted window, can be seen on the southern wall of F1 (PLATE 29). This would have originally given access to F2. Also visible in this wall is a repair to the roof structure. The gable wall beyond the limit of the purlins has been replaced. This is thought to have occurred after the doorway was replaced with a window, possibly due to the loss of integrity during the replacement work.

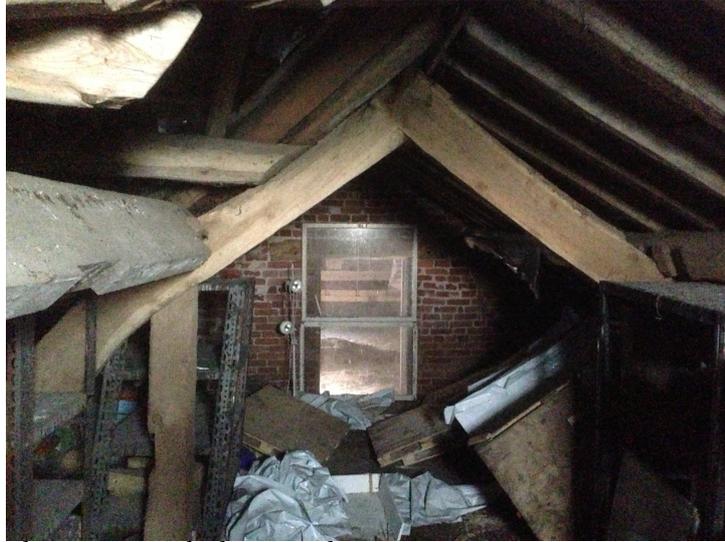
Plate 30 - F2, looking north

6.72. Room F2 is located at the southeastern corner of the complex, above G3. The room is now used as a store, however its original function is unclear. It is a small area with low roof timbers, where the junction of the two roof apex meet, making it an unusual space. The timbers present in F2 are a mixture of re-used and modern materials. None are thought to be original element of the structure, although the re-used timbers do appear to have some antiquity, possibly coming from a cruck frame building (PLATE 30).

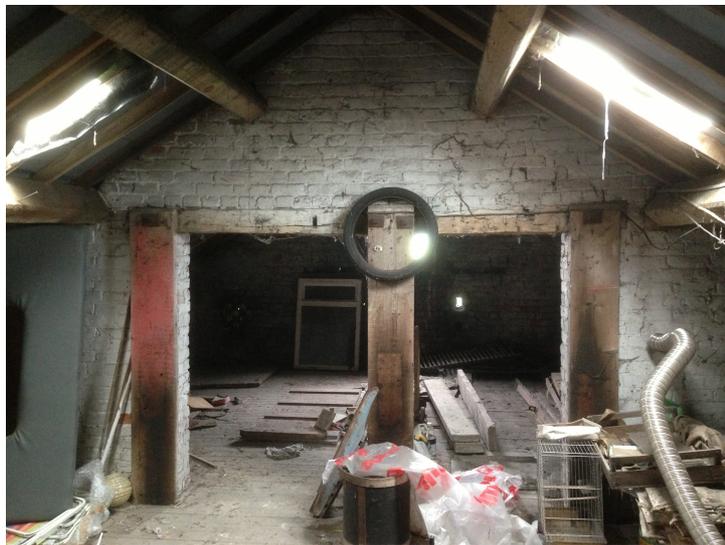
Plate 31 - F3, looking south

6.73. Room F3 is located at the southwestern extent, above G4. This room has been divided into two sections via a partial dividing wall of brick and timber uprights (PLATE 31). The roof structure and floorboards are 20<sup>th</sup> century replacements, and roof lights have been added to allow more light into the room.
