Archaeological Watching Brief Report

# STRETTON WATERMILL

Client:	Grosvenor Construction
Local Authority:	Cheshire West and Chester Council
NGR:	345405,352895
Planning App:	14/00363/LBC
Author(s):	Poole, B.
Doc Ref:	LPI77IC -WBR-vI.3
Site Code:	CDN/SWM 14
Date:	November 2014

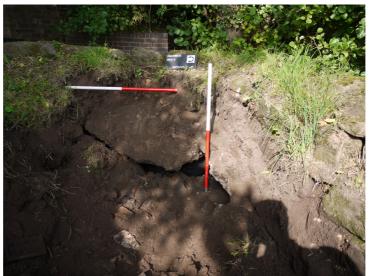
- **4.2.**A small, 1.5 tonne, tracked excavator removed the overburden (101) from the eastern face of the sluice wall (100). This exposed the construction form of the wall and clearly demonstrated late 20<sup>th</sup> century intervention works had been undertaken.

- 4.3.Deposit (101) was a loose, mid brown, silt loam with a grass surface. This extended to a depth of 1.6m below current ground level. Within (101) were fragments of sandstone, brick tile, plastic sheeting, plastic bottle caps and golf balls. The loose nature of the deposit and the late 20<sup>th</sup> to early 21<sup>st</sup> century finds recovered indicate that this is a backfill material which appears to relate to previous repair works to the sluice wall (PLATE 1). The golf course opened in 1998, and the presence of golf balls within the backfill suggests that the repair work was carried out after that date.

Plate 1: East facing election of sluice wall during removal of overburden, 2x 1m scales.

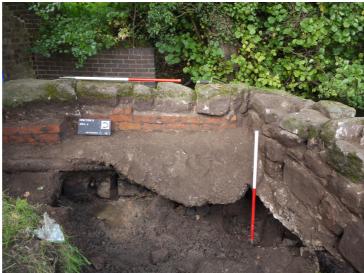
**4.4.**The backfill, (101), overlay a concrete support (102) for the wall. This extended from the southern sluice wall to the northern sluice wall and sloped down to the east (PLATE 2).

Plate 2: East facing elevation of sluice wall, 2x 1m scales.

- **4.6.**The sluice wall could be seen to have several phases of repair. The floor of the sluice was of large squared sandstone cobbles, above which the walls had been constructed. The cobbles can be clearly seen below the upstanding wall in the eastern elevation in PLATE 2 (FIGURE 7).
- 4.7. The inner face of the sluice wall (100) was of brick in English Garden wall bond,

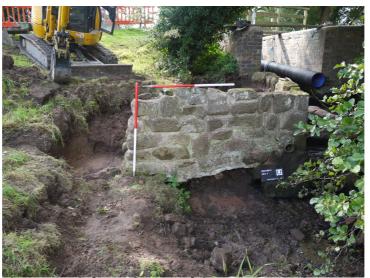
**4.5.** The concrete could be seen to be covering a cast metal drainage pipe which ran from south to north, falling to an outlet on the north wall (FIGURE 6 & PLATE 3). The concrete support appears to have inadvertently formed a run off channel for surface water, which has allowed water to flow beneath it, washing out the lower deposits and the lower courses of the north wall, seen as a void below the wall in PLATE 3.

Plate 3: North facing elevation of sluice, 2 x 1m scales.

**5.10.**Water ingress has continued, possibly from both high ground and seeping in from the floor of the sluice. This has washed away the lower deposits and created a void below the north wall.

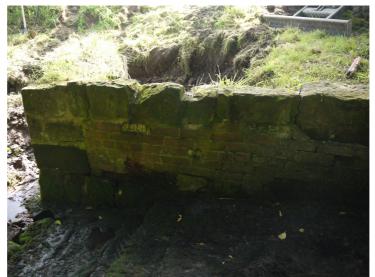
with a sandstone coping course (PLATE 4). The brick appears to be a later repair.

Plate 4: Inner face of sluice wall, looking east.

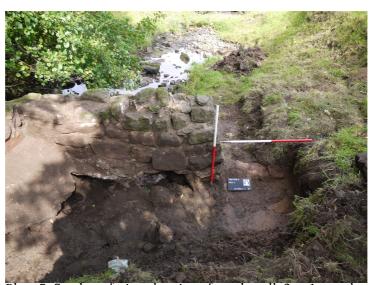
**4.8.** The northern wall is of sandstone in a coursed bond, with hard grey mortar. At the eastern extent of the northern wall a single sandstone foundation block was identified (104) below the backfill material (101). This block extended beyond the finished face of the north wall, although appeared to be contemporary with the lowest course of the wall (PLATE 5).

Plate 5: Southern facing elevation of north wall,  $2 \times 1$ m scale, looking north.

**4.9.**This suggests that the foundation course of the wall, the lowest visible course exposed, relates to an earlier wall, and that the upstanding wall is of a later date. It is clear that the upstanding wall has a finishing course at its eastern end.
