Historic Building Recording at

OSEA ISLAND MERSEA

For Matrix Complex

Client:	Matrix Complex
Local Authority:	Maldon District Council
NGR:	591491, 206241
Planning App:	FUL/MAL/12/00657
Author(s):	J. Duffy
Doc Ref:	LPI686E-HBR-v1.1
Site Code:	HTOI 15
Date:	October 15

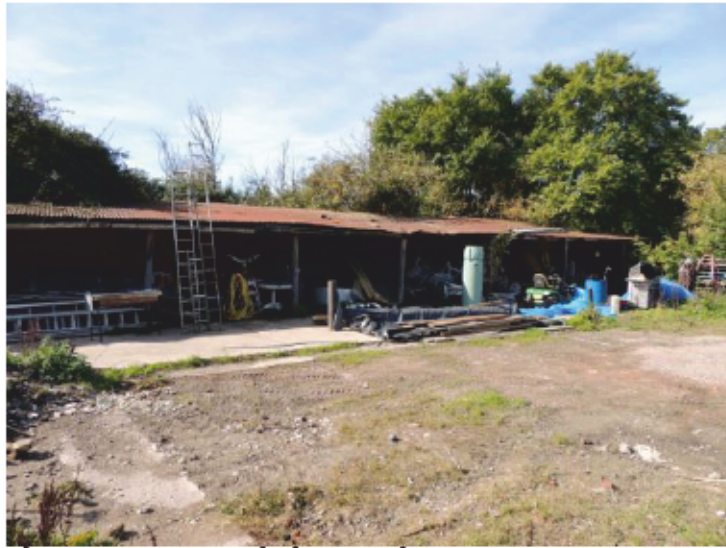
Plate 1 - Structure 1 looking northwest

- 6.3.1. The structure was constructed with a brick and breeze block west wall, a timber frame north and south wall with corrugated iron covering at the north end (PLATE 1). The east side of the structure was open and consisted of nine vertical timber posts, creating 8 bays, which supported the roof structure. The structure measured 29.2m by 3.3m.

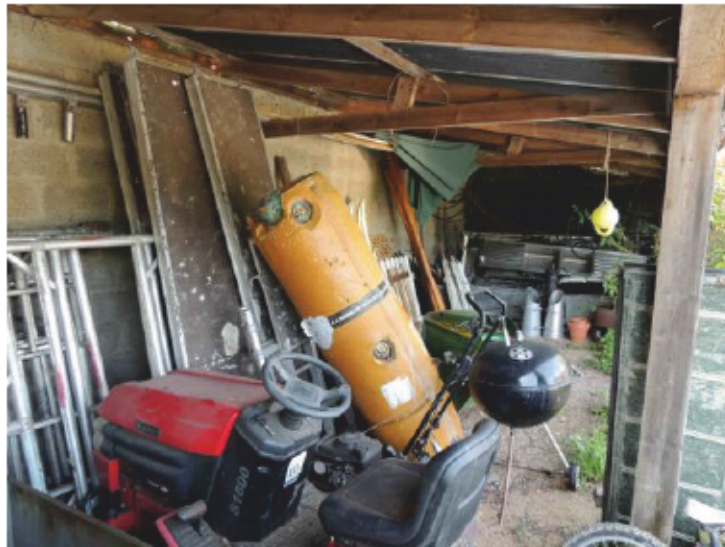
Plate 2 - Structure 1 North End looking north

- 6.3.2. The west wall of the structure was constructed using breeze blocks for the northern three bays (PLATE 2) and red brick topped by two courses of breeze block (PLATE 3) with the exception of the southern bay which was topped by three courses of breeze block.

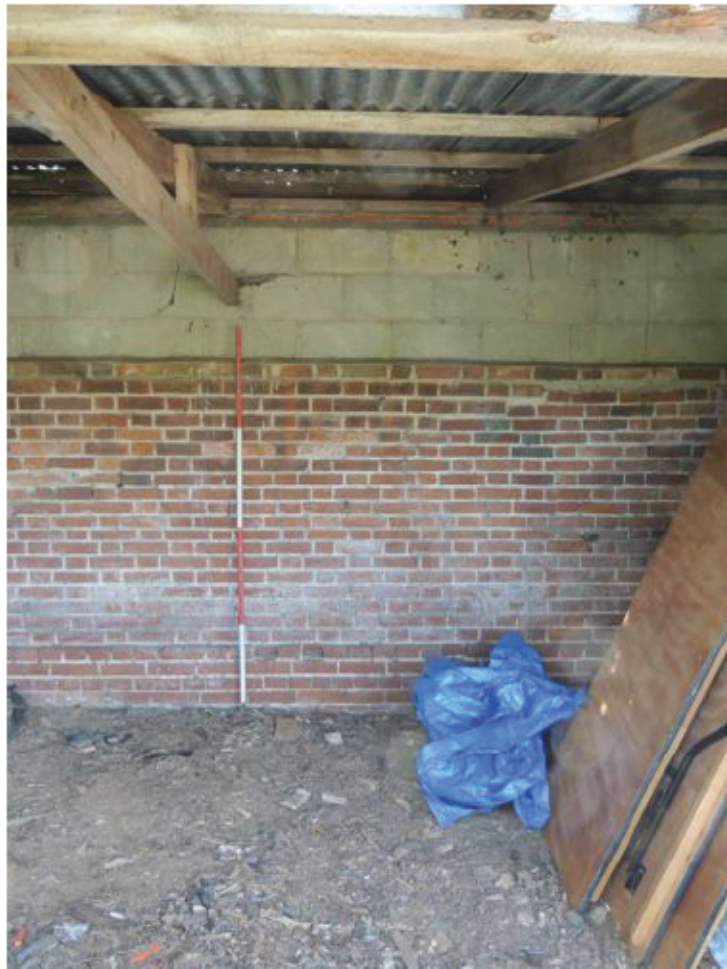
Plate 4 - Structure 1 South End looking west

- 6.3.3. The bricks measured 230mm by 120mm by 70mm and were probably mid to late 20th century. They were laid in Flemish bond and had been repointed in a light grey mortar. The lower four courses protruded 90mm from the upper courses (PLATE 4).

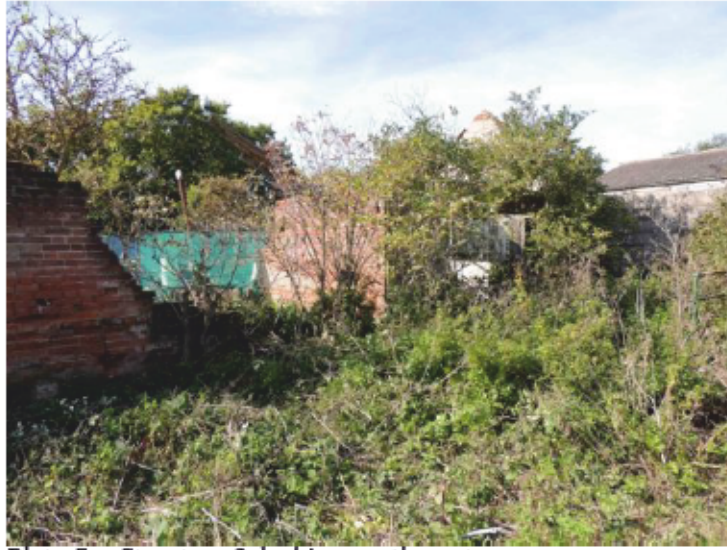
Plate 5 - Structure 2 looking north west

6.4.1. Structure 2 consisted of a small building built with breeze blocks although the south wall was brick built (PLATE 5). The roof was tiles on a wooden frame which had largely collapsed into the structure at the time of the survey. The structure was 3.5m by 4.7m. The breeze blocks, which form the majority of the structure, were a later, mid to late 20th century, addition to the existing brick wall.

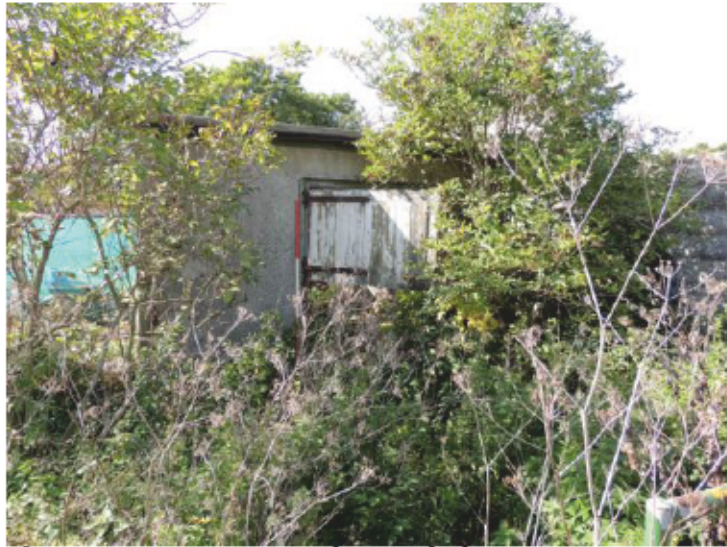
Plate 6 - Structure 2 East Elevation looking west

6.4.2. The east wall was built using breeze blocks each measuring 450mm by 210mm and is cement rendered (PLATE 6). The wall had a wooden stable door near the centre and to the north was a three paned metal framed window with internal iron bars behind the window.

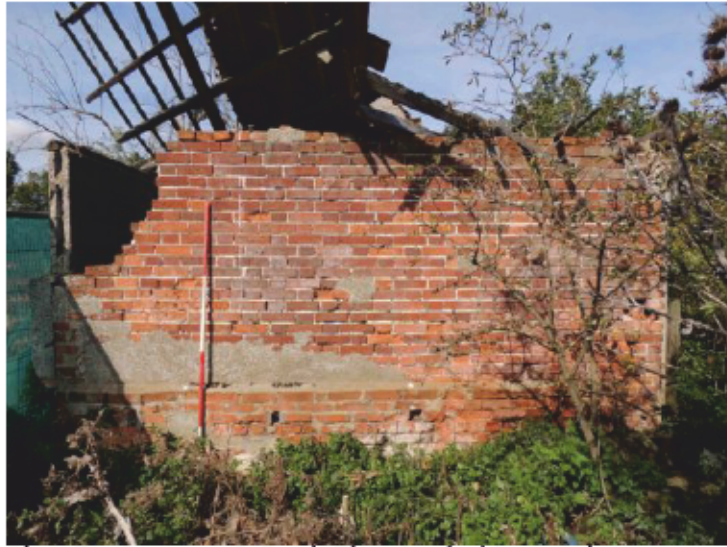
Plate 7 - Structure 2 South Elevation looking north

6.4.3. The south wall was constructed using red brick with the lower courses constructed in English Garden Wall bond and the upper courses in Flemish bond (PLATE 7). The bricks measured 220mm by 110mm by 65mm and appeared to be late 19th century or early 20th century in date.

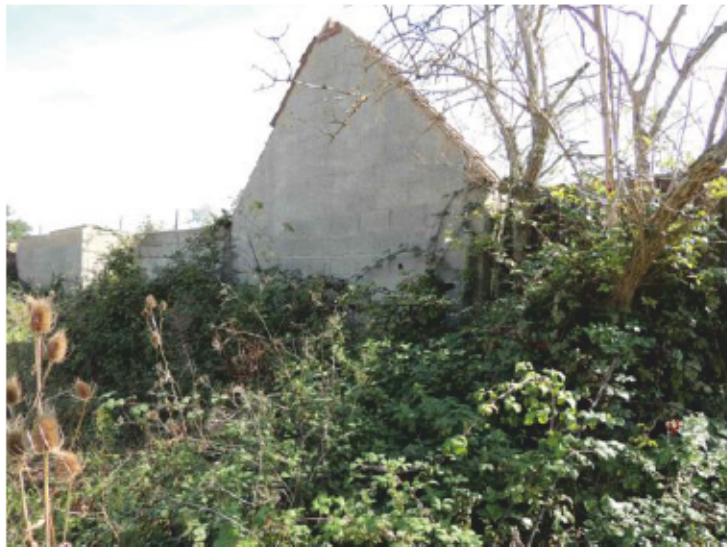
Plate 8 - Structure 2 North Elevation looking south east

6.4.5. The north wall was also entirely constructed using breeze blocks and formed a gable end for the roof structure (PLATE 8). No corresponding gable end was noted in the south wall. The blocks measured 450mm by 210mm and were identical to the other blocks in the west and east walls. The breeze block wall continues beyond the building to the east forming a boundary wall.

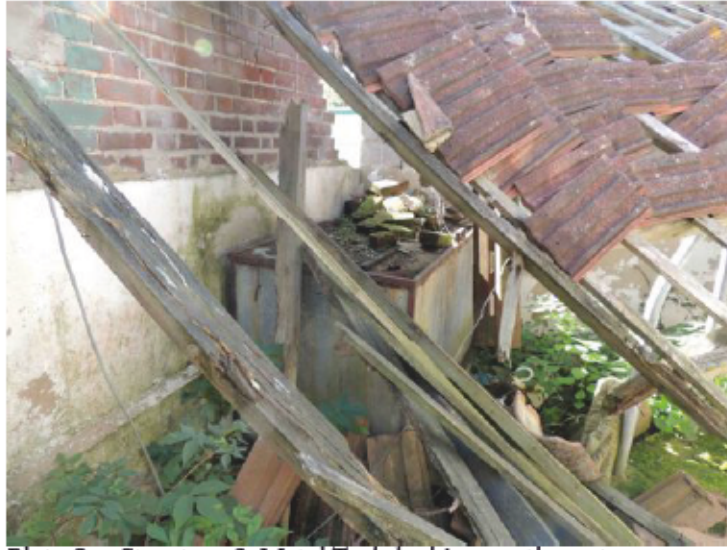
Plate 9 - Structure 2 Metal Tank looking south west

cement render which extended around all four walls and across the floor. A wall mounted tap was visible on the south wall and a large metal tank was in the southwest corner (PLATE 9). The tank was inaccessible due to the collapsed roof structure.

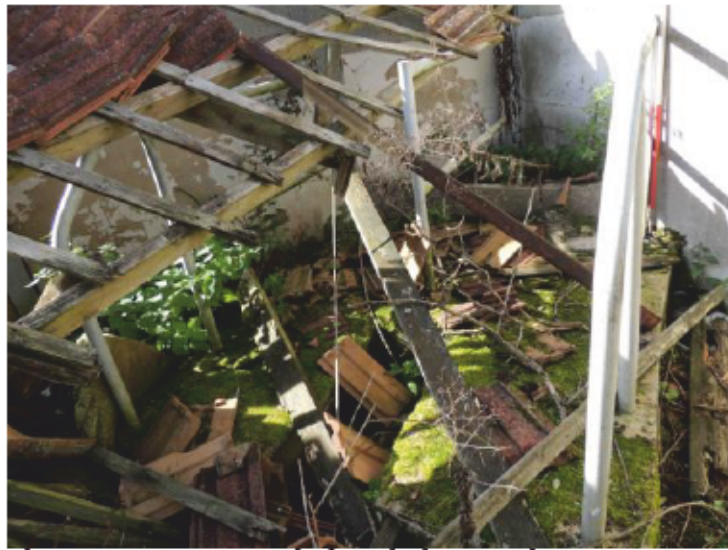
Plate 10 - Structure 2 Platform looking north west

6.5.2. The inside of the structure was dominated by a concrete platform with white painted railings a probable on both sides and a shorter railing in the centre (PLATE 10). A trough was located in the northwest corner of the room at the end of the platform. The platform appears to be for livestock and is likely a small milking shed for cows.

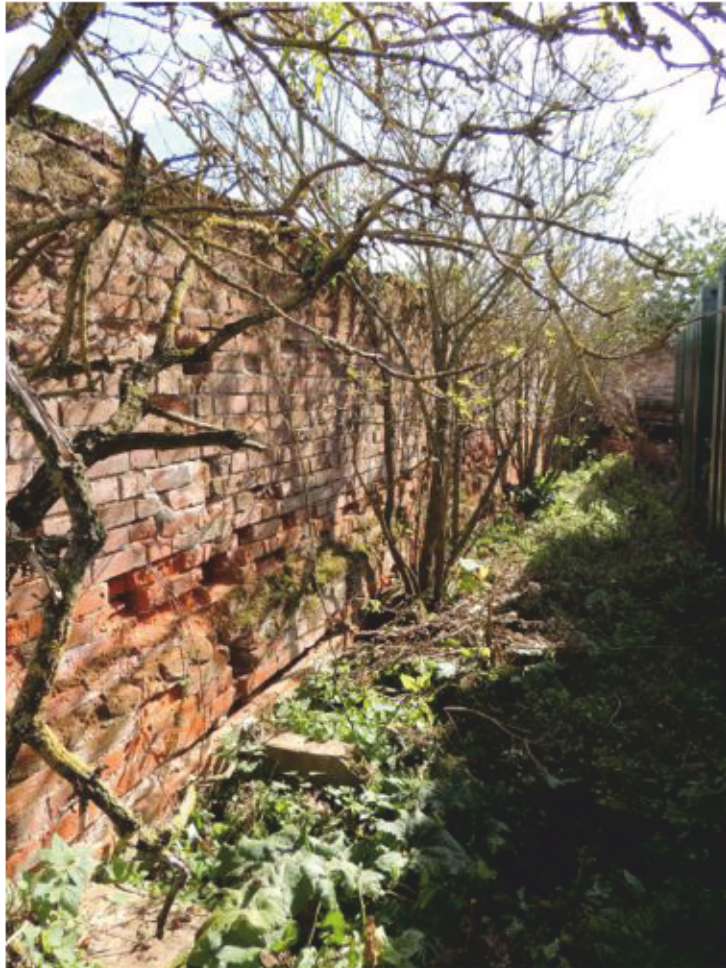
Plate 13 - Structure 3 West Elevation looking south east

6.6.1. Structure 3 was a red brick wall extending south from close to Structure 2 for 18.4m before turning west for 3.5m before turning south again for 5.5m which then turns east for approximately 2m but is largely collapsed (PLATEs 11 AND 12). The west elevation was partly obscured during the survey due to the presence of several storage containers (PLATE 13).

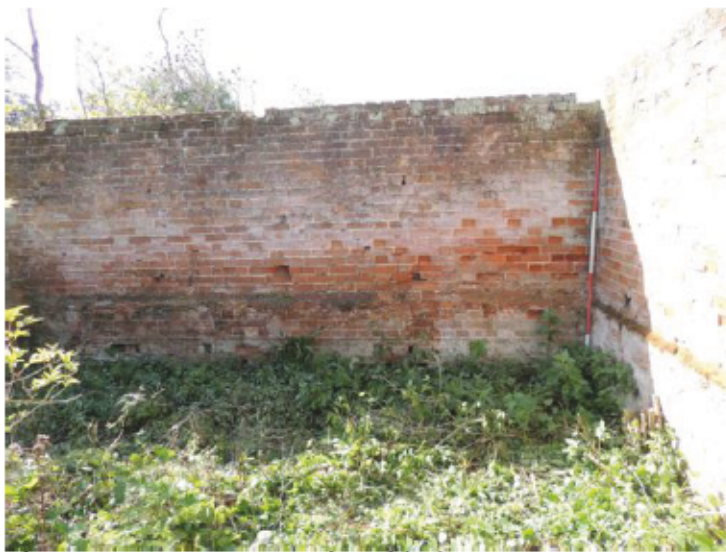
Plate 14 - Structure 3 South End looking west

6.6.2. The bricks measured 235mm by 110mm by 65mm with the lower 11 courses protruding slightly and laid in English bond with the upper courses laid in Flemish bond (PLATE 14). The bricks were bonded by a light grey mortar and were heavily eroded. The wall may have originally connected to the brick work in Structure 2, as the style and size are similar, but the northern end of Structure 3 is now collapsed and partly removed.

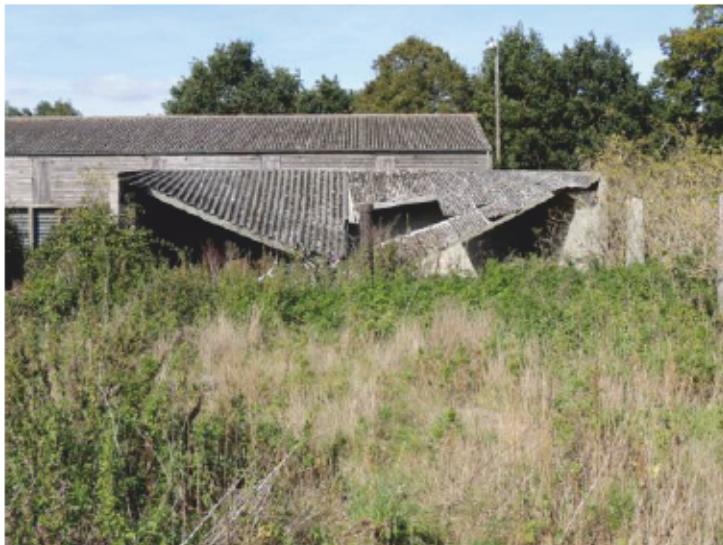
Plate 16 - Structure 4 looking north

- 6.7.1. Structure 4 measured 9m by 5m and was formed by three breeze block walls with an open face to the south (PLATE 16). The structure was 11 courses high and each breeze block measured 450mm by 220mm (PLATE 17).
- 6.7.2. The roof structure was collapsed into the building but was of a timber frame with asbestos sheet covering.
- 6.7.3. The inside of the structure was not safe to examine in detail due to the collapsed roof structure but the building appeared to be for farm use possibly as a shelter for livestock.

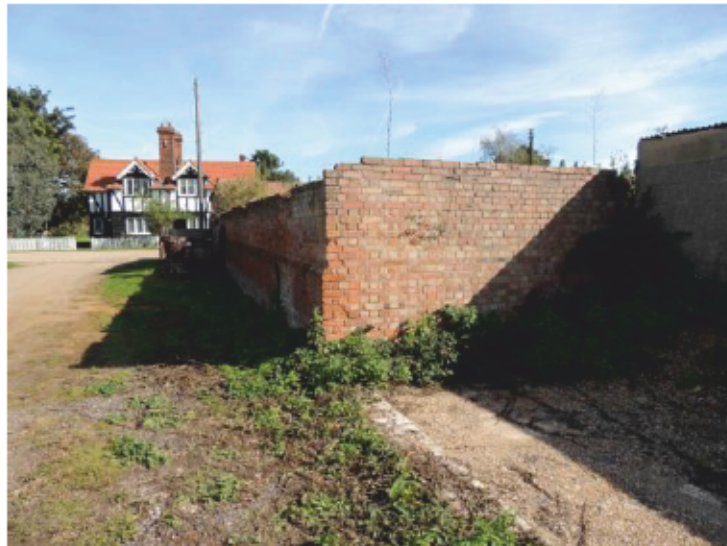
Plate 18 - Structure 5 looking east

- 6.8.1. Structure 5 is a red brick wall extending north from the north east corner of Structure 4 and then extending east to Structure 6 (PLATE 18).
- 6.8.2. The western wall of the structure is red brick laid in English bond, although the top three courses are laid as stretchers only, with a light grey mortar (PLATE 19). The bricks measure 240mm by 110mm by 60mm with a total of 29 courses visible.
- 6.8.3. The north wall ran 14m east to west and was also red brick with light grey mortar and the remains of a white wash on some of the brick work (PLATES 20 AND 21). The lower 15 courses were English bond and the upper 12 courses were Flemish bond. The lower English bond courses protruded from the upper courses in a similar manner to Structure 3.
- 6.8.4. The structure appears similar to Structure 3 in its form and was a similar boundary or garden wall.

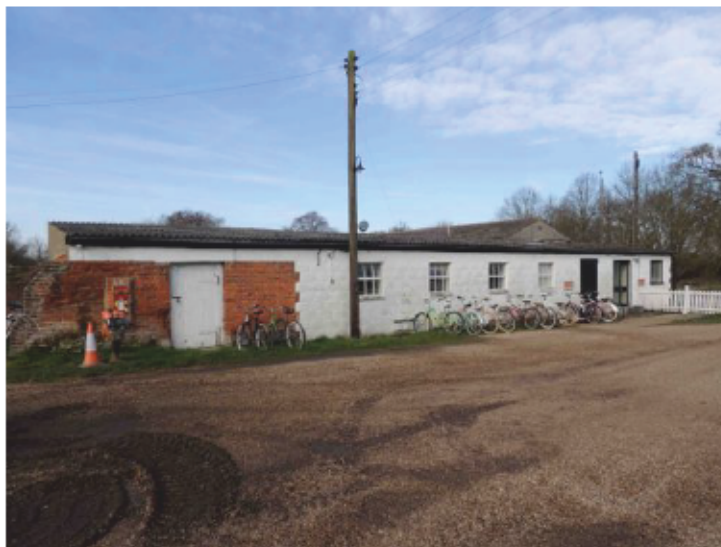
Plate 22 - Structure 6 looking north west

- 6.9.1. Structure 6 was a single storey building located at the eastern side of the farmyard area (PLATE 22). It was constructed of red brick and breeze blocks and measured 25m by 6m (FIGURE 3). The structure has a wood frame roof covered by corrugated iron and slopes from the west elevation down to the east.

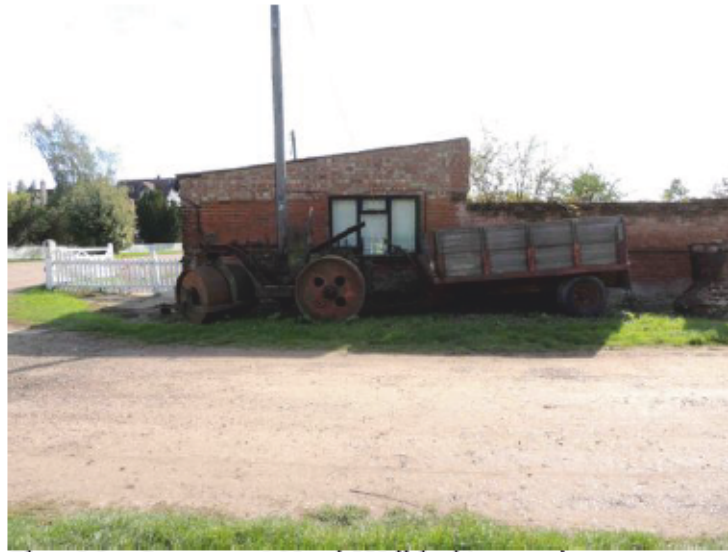
Plate 23 - Structure 6 North Wall looking south

6.9.2. The north elevation was a continuation of the north wall of Structure 5 and was identical in form to the wall extending to the west (PLATE 23). The elevation contained an inserted wooden framed window and had more recent brick addition above the window, to support the roof structure, and on the eastern corner of the elevation. These newer brick addition was English bond with a light grey mortar and the bricks measured 230mm by 120mm by 70mm. The rebuilt corner of the wall was used to key in the breeze block construction of the east elevation.

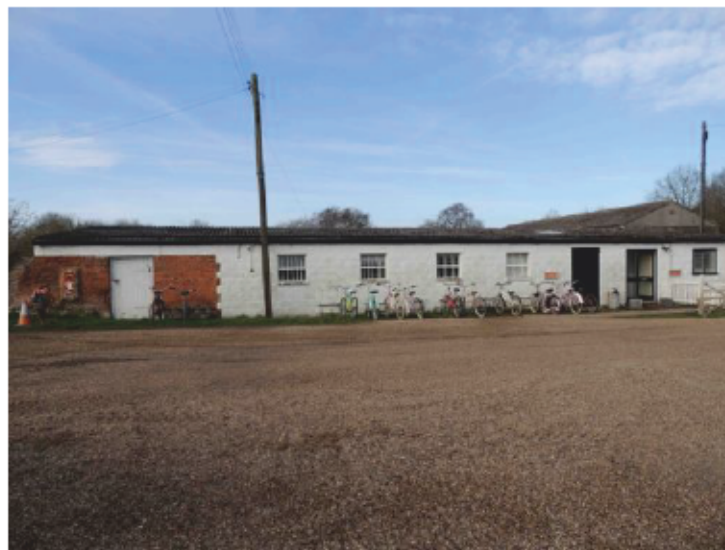
Plate 24 - Structure 6 East Elevation looking west

6.9.3. The east elevation was largely constructed using white painted breeze blocks with the southern 4.95m built using red brick (PLATE 24). At the northern end of the elevation was a wood framed two pane window adjacent to a glass panelled door leading into an entrance way to Room 1 of the building (PLATE 25).

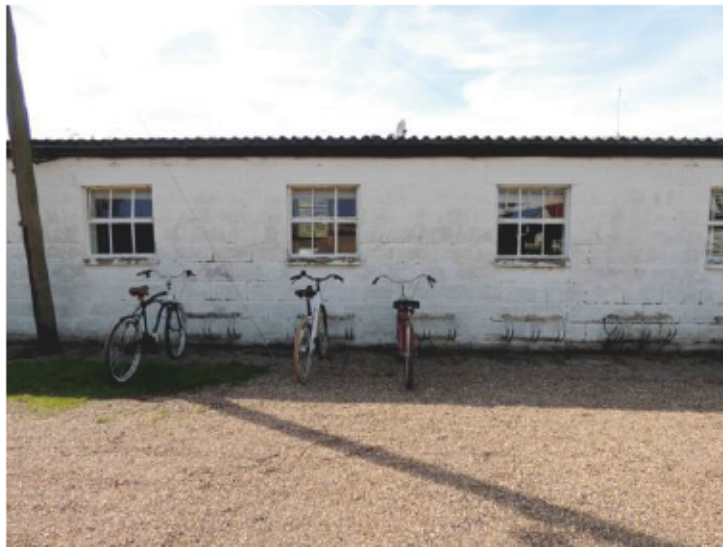
Plate 26 - Structure 6 East Elevation Middle looking west

6.9.4. Next to the glass panelled door was a black painted wooden door leading into Room 2 of the building. Four 6 pane metal framed windows, measuring 900mm by 950mm, were visible along the elevation with the breeze block construction (PLATE 26).

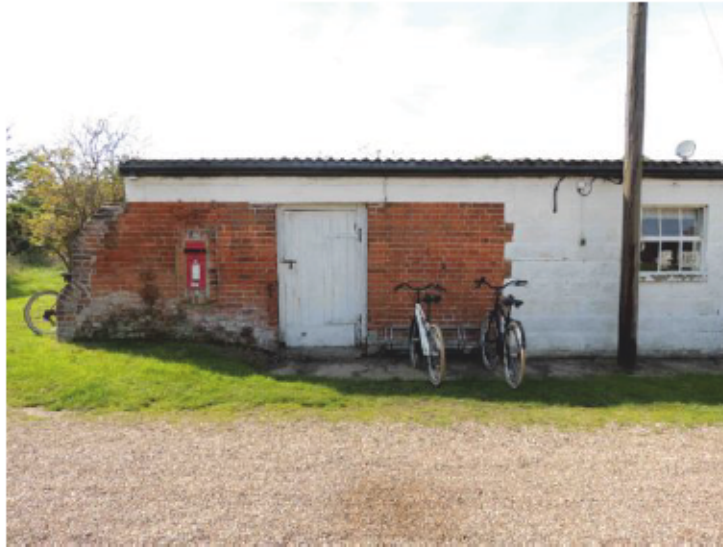
Plate 27 - Structure 6 East Elevation South End looking west

6.9.5. A white painted wooden door, leading into Room 4 of the building, was built into the brick work at the southern end of the elevation (PLATE 27). The red bricks measured 245mm by 116mm by 60mm with a light grey mortar in English bond. The brick work was topped by two courses of breeze block supporting the roof structure.

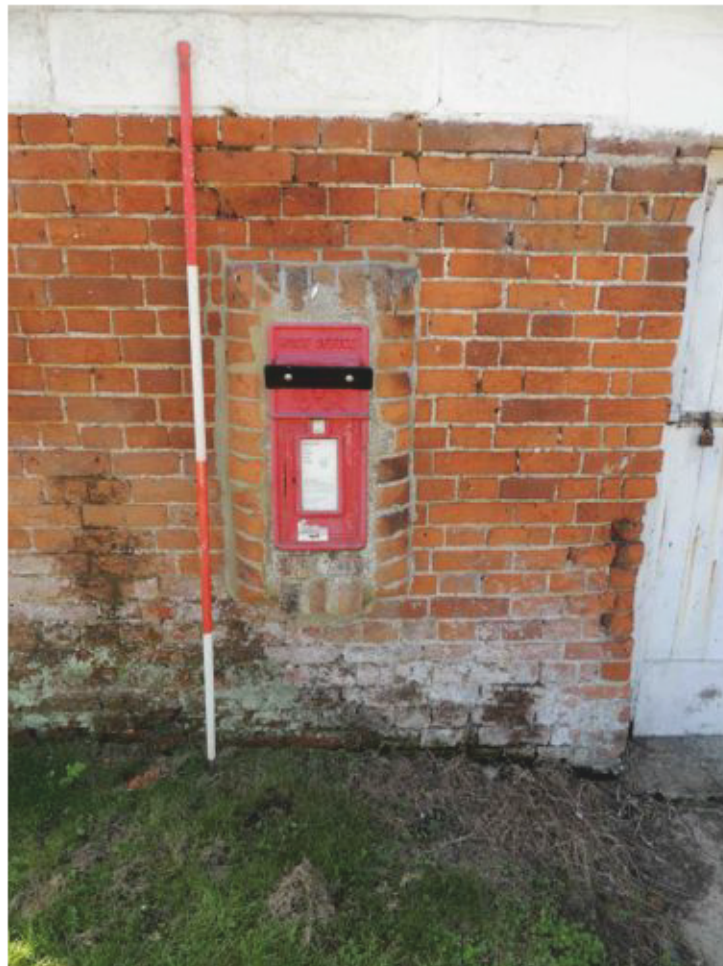
Plate 28 - Structure 6 Letterbox Detail looking west

6.9.6. 0.75m south of the door was, now unused, red letter box built into the wall within protruding brick work (PLATE 28). The letter box is marked with King George VI dating the box to between 1936 and 1952. The letter box is built into the same brick work that makes up the rest of the wall indicating that this was of the same date.

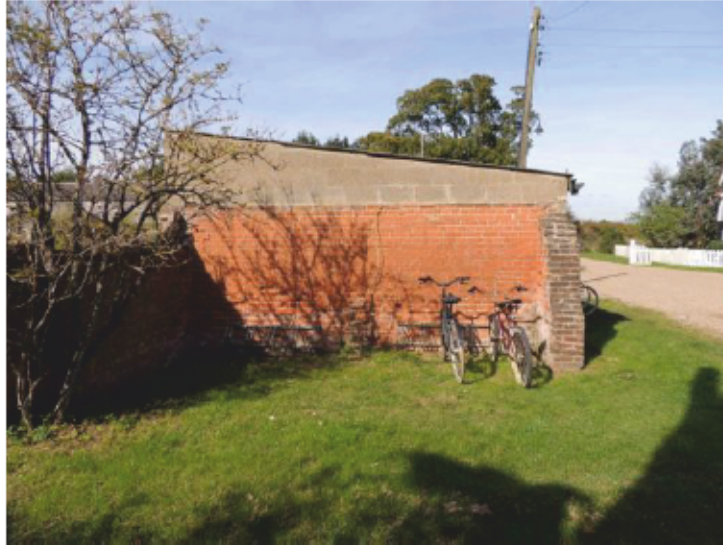
Plate 29 - Structure 6 South Elevation looking north

- 6.9.7. The south elevation is a continuation of the brick work from the east elevation with no distinctive features (PLATE 29). The brick work from the east and west elevations continue beyond the south elevation. The continuation of the east elevation forms a corner buttress and the continuation of the west elevation is a boundary wall.
- 6.9.8. The brick work is topped by between one and four courses of breeze blocks supporting the roof structure.

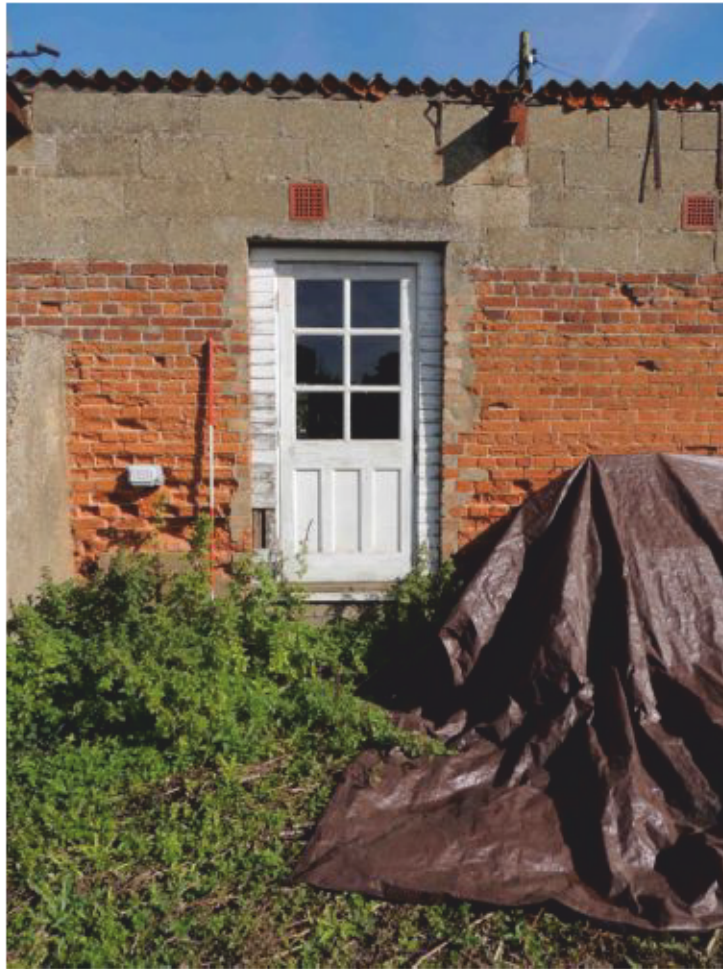
Plate 31 - Structure 6 West Elevation Detail looking east

- 6.9.10. A white painted wooden door with six glass panels has been inserted into the brick and newer brick work can be seen surrounding the wooden frame of the door (PLATE 31).

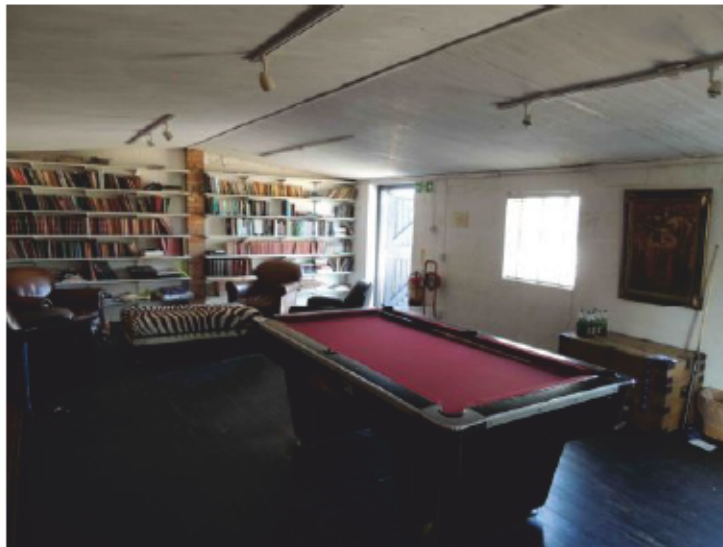
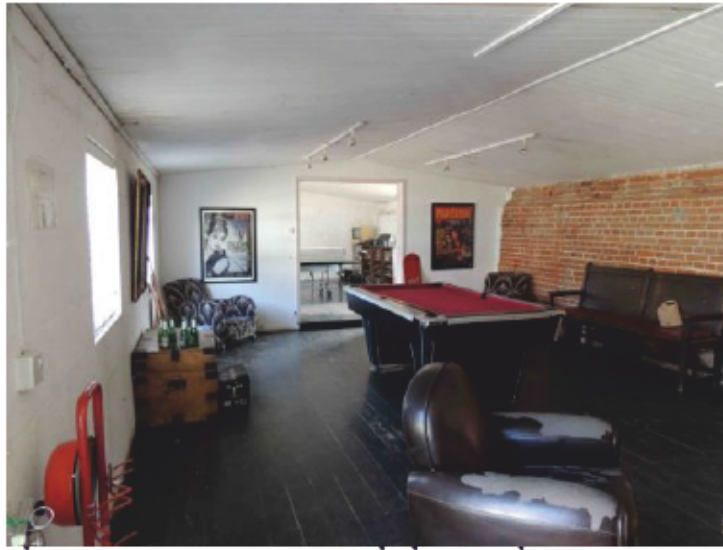
6.10.3. Room 2 is the northern of the two central rooms and is accessed externally by the black painted wooden door visible in the east elevation (PLATES 34 AND 35). Access to Room 3 is provided through a set of white painted wooden double doors in the centre of the south wall of the room.

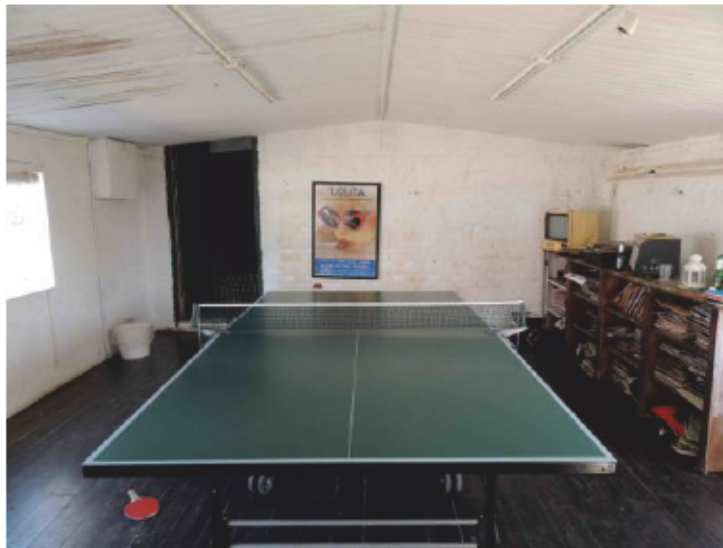
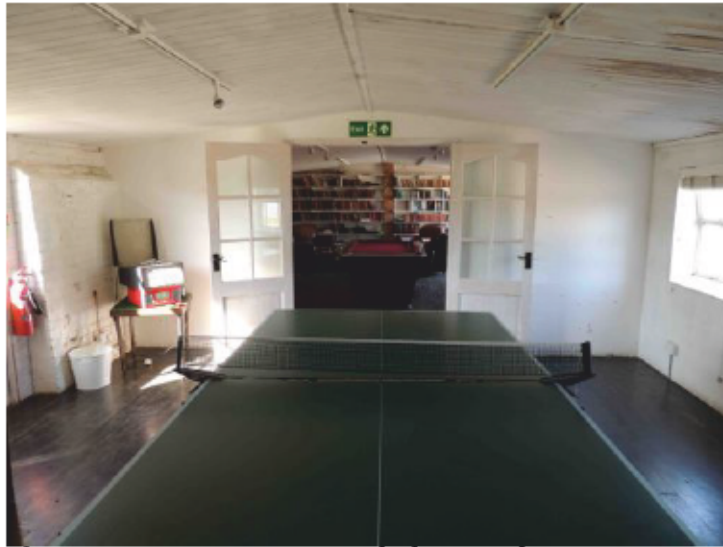
6.10.5. Room 3 has a white painted plastered north wall, white painted breeze block east wall and a white painted brick west and south walls (PLATES 36 AND 37). The inserted door on the west elevation leads into this room in the west wall. At the east end of the south wall a wooden door leads into Room 4. The ceiling and floor are identical to Room 2. The east wall has the remaining two windows in it.

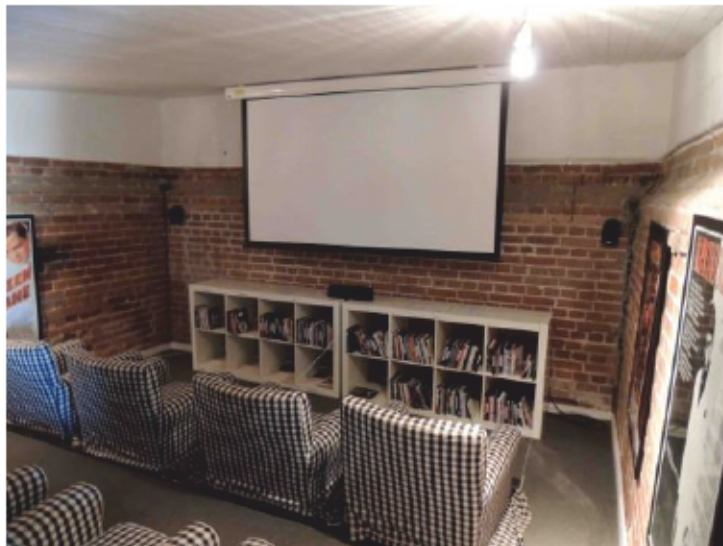
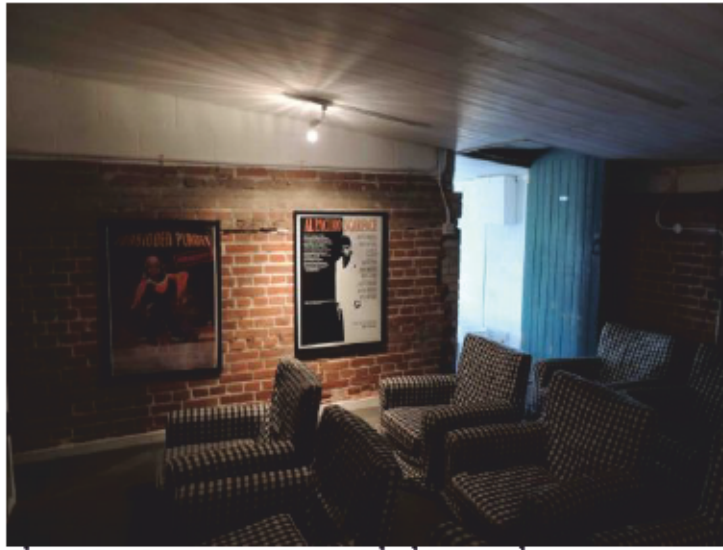
6.10.6. Room 4 is at the southern limit of the building and is in use as a cinema (PLATES 38 AND 39). There are no windows in the room and the southernmost door in the east elevation leads into this room although no access is currently possible through this door.

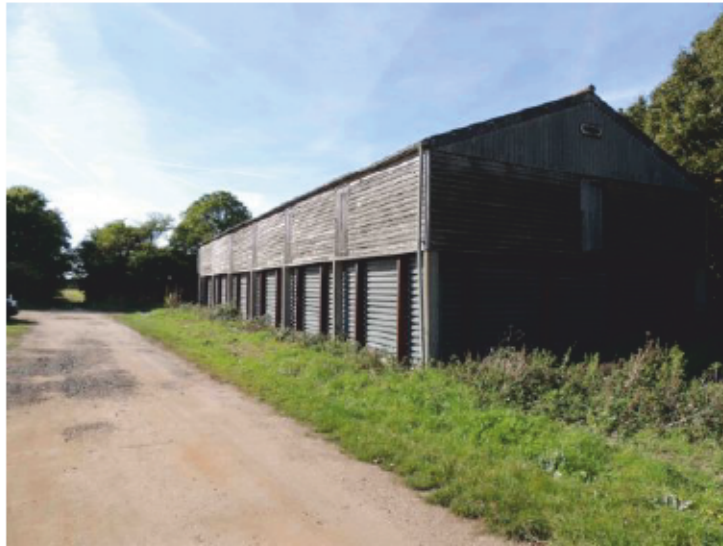
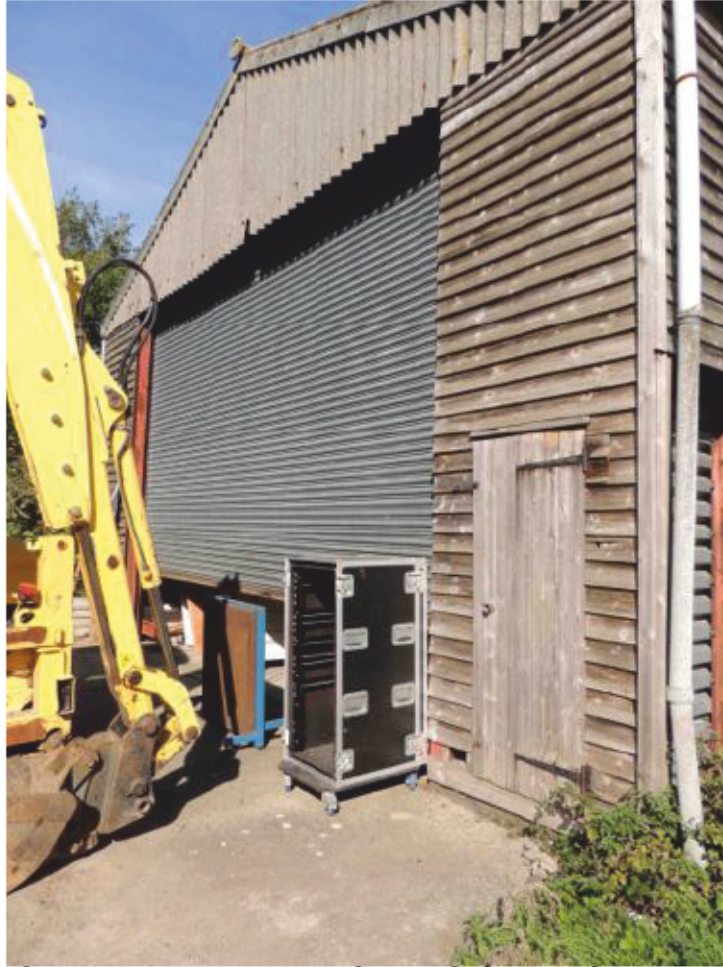
6.11.1.Structure 7 is a barn at the northern limit of the farmyard (PLATES 40 AND 41).

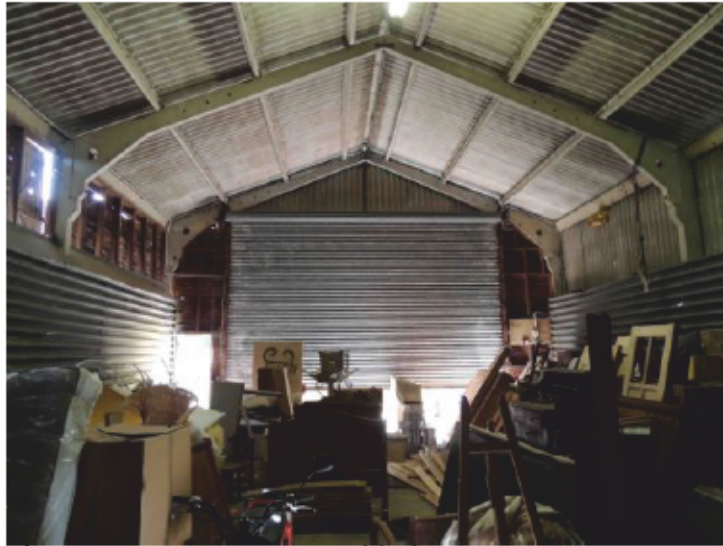
Plate 43 - Structure 7 Internal looking west

6.11.3.Access is through a wooden door at the south end of the west elevation and a large metal roller door in the centre of the west elevation (PLATEs 41 AND 43).
