Historic Building Record & Watching Brief

10-20 DOCK STREET LONDON E1

For Purple Property Holdings

Client:	Purple Property Holdings
Local Authority:	London Borough of Tower Hamlets
NGR:	534250,180750
Planning App:	04/0993 - Appeal Ref: APP/E5900/A/04/1168750
Author(s):	G Hunt
Doc Ref:	LP0309L-AMR-v1.9
Date:	May 10

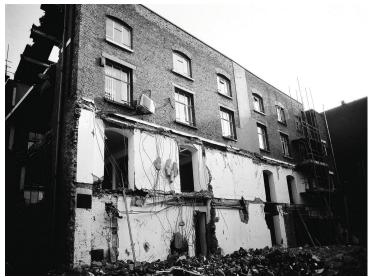
5.3.33. The bays in the northern half of the building have all been substantially modified, bay 4 has been entirely blocked (or may not have had a door), bay 5 has had the doorway much reduced and moved and bay 6 has been blocked.

Plate 2 - West elevation revealed after demolition of 20th century additions.

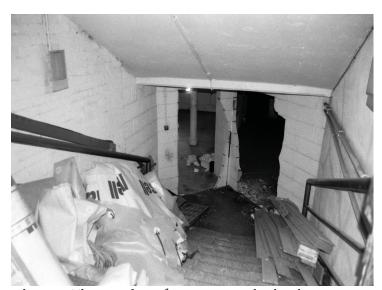
Plate 3 - The view down from pavement level to basement level in space B.1.

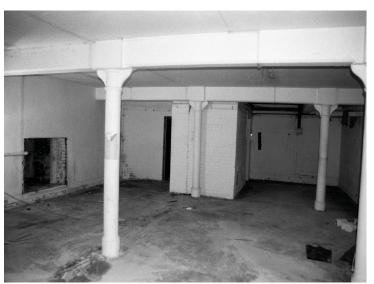
Plate 4 - View from the north west corner of B.3 looking across bays 6 and 5 towards the lift block in bay 4. Note also the recess in bay 5 of the east wall (left).

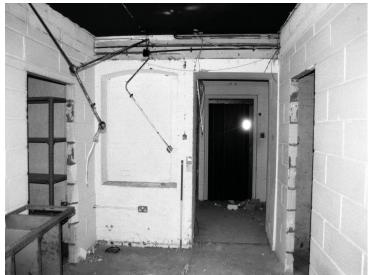
is blocked to the full thickness of the wall at the base and a recess is left above. However closer inspection indicates that the brickwork at the base does not match with the brickwork of the spine wall itself and is clearly later.

Plate 6 - View north from the doorway of B.8-B.7 towards B.4. Note the lift in the distance as well as the blocked window to the left of the doorway. The doorway on the left leads to B.9 and the doorway on the right leads to B.6.

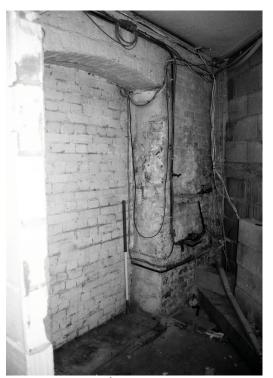
5.4.39.The space seems to have acted as some kind of store room or cupboard, although was quite damp at the time of survey.

Plate 7 - View of the blocked doorway in B.6, viewed from the doorway to B.7. On the right, the diagonal breezeblock wall described in the text.

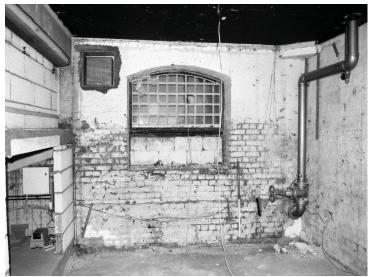
Plate 8 - The east wall of B.8. Showing the window detail, as well as the undercroft area (on left). Ventilator (top left of window). Sprinkler system valve (on right) and the base of the G.5 fireplace (top right corner of the room).

- **5.4.43.**There is a modern ventilator installed to the top left of the window, presumably to combat the evident damp problem of the space. The white painted walls all show signs of damp.

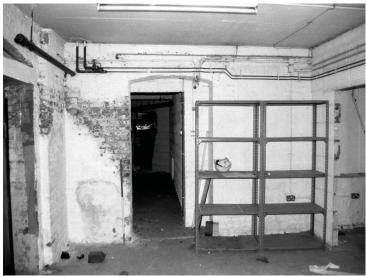
Plate 10 - South wall of B.9, this is the spine wall. Note the partially blocked original aperture. Also on far left of frame, a recessed area.

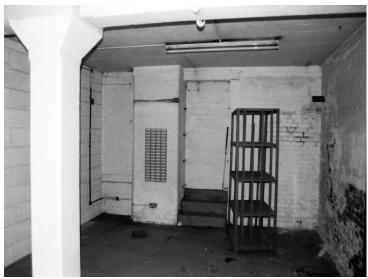
- **5.4.50.** A similar but blocked recess is to be found in the centre of bay 2 in this wall.
- **5.4.51.**In the south wall, there are several further details to note. As in B.8, there is a rounded brick pier in the place of a column, and there is also a doorway with stairs to the west of this pier. This is also visible from G.6, although how this would have worked with the difference in levels is unclear. The doorway has a concrete lintel indicating that it is probably not part of the original build. See G.6 for further details.
- **5.4.52.** Also of note is that in this room the cast iron column has been reinforced by a concrete casing. During the survey it was thought the cast iron had been replaced, but subsequent evidence from the watching brief indicates that this was in fact just reinforcement (see below).

Plate 11 - View of the south wall of B.9, note the brick pier, blocked doorway and concrete column detail.

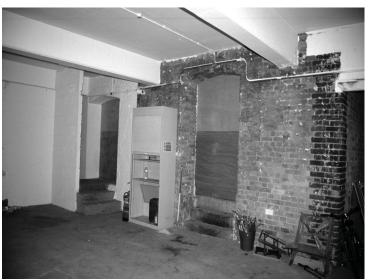
Plate 13 - View of the south west corner of the historic core building, seen from G.7. Note the two modified window apertures, bay 2 foreground bay 3 in distance.

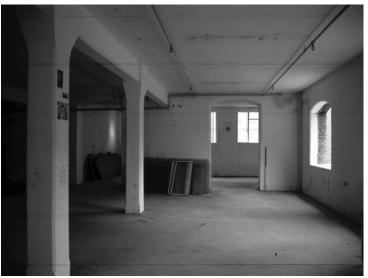
Plate 14 - Room 1.1, bay 6 looking west towards room 1.2. Note modified window aperture and columns.

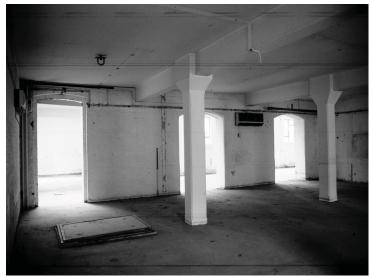
Plate 15 - View of 1.3 from the south east corner, looking towards 1.4. Note atypical doorway in bay 1 (left)

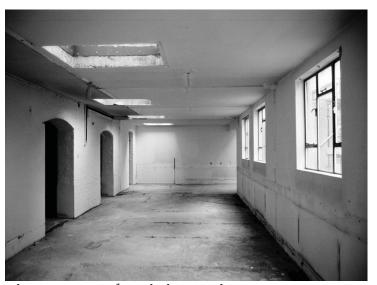
Plate 16 - View of 1.4 looking south

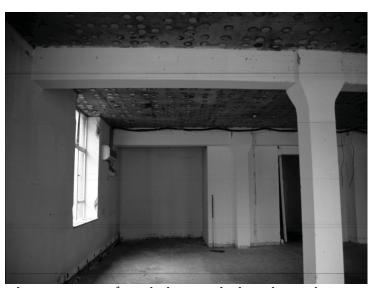
Plate 17 - View of 2.1 looking south along the east bay. Note window (east facade) and columns.

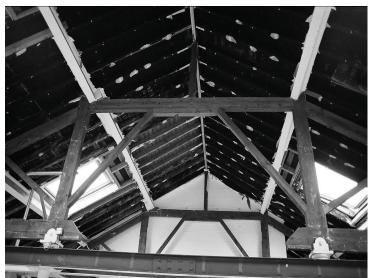
Plate 18 - Roof truss in 3.1. Note modern addition of steel joist, and original open tie-beam arrangement.

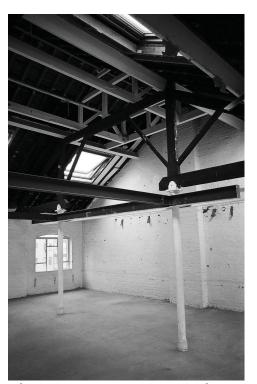
Plate 19 - Bay 1 in room 3.2. Shows window, truss, mezzanine floor joists and brick pier in south wall.

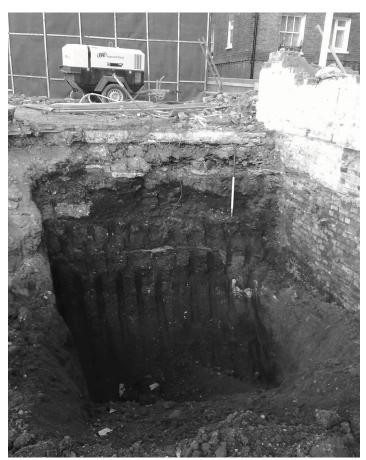
Plate 20 - Deep section through deposits.

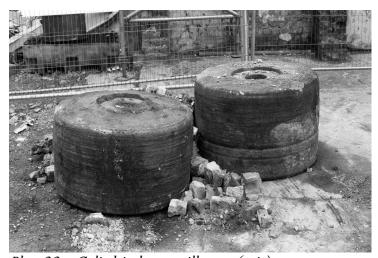
Plate 22 - Cylindrical type mill stone (pair)

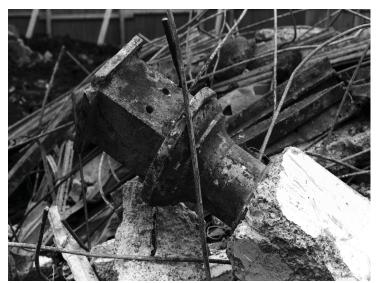
6.4.4. Another useful detail noted during demolition was that all of the square concrete columns recorded during the building recording were in fact cast iron columns with a cast concrete outer. Presumably these casings were cast *in situ*.

Plate 23 - Cast iron column after demolition. Concrete casing has broken away from the capital, but remains in place on the shaft.

- **7.6.2.** The cast iron columns were clad in concrete and the former floors replaced with cast concrete slabs. The cladding of the columns seems unlikely to have been for reinforcing their load bearing strength. Rather the two most plausible interpretations are either as increased fire protection or perhaps as a decorative 'modernisation' of the columns.

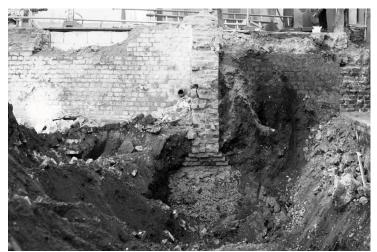
Plate 24 - Area bay 1 and 2 looking east. Wall with underpinning.

6.4.5. The area of bay 1 was also observed in zone 2 of the watching brief. The internal wall between G.6 and G.5 was observed in cross section. It was noted to have a heavy concrete strip foundation indicating that the building had clearly been underpinned at some time.
