ST MARGARET PATTENS Eastcheap London EC3M

Standing Building Survey Report

November 2014

Site Code SMR14 NGR TQ3313080840 OASIS reference molas1-193904

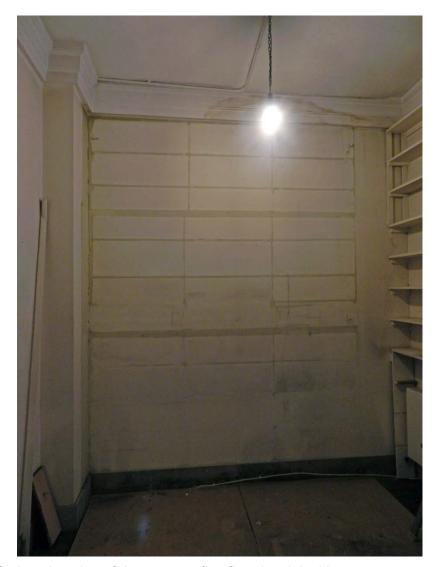
Fig 11 East facing elevation of the tower at first floor level, looking west

3.3.3 A coving ran around the uppermost part of the wall which is contemporary with the conversion of this part of the building to classrooms (Bradley & Pevsner 1997, 2002 ed., 236). A shelving unit had been formerly placed against the east elevation similar to that still in situ against the north elevation, although this was removed prior to survey work commencing. The scars of the shelving were visible in the render (Fig 11)

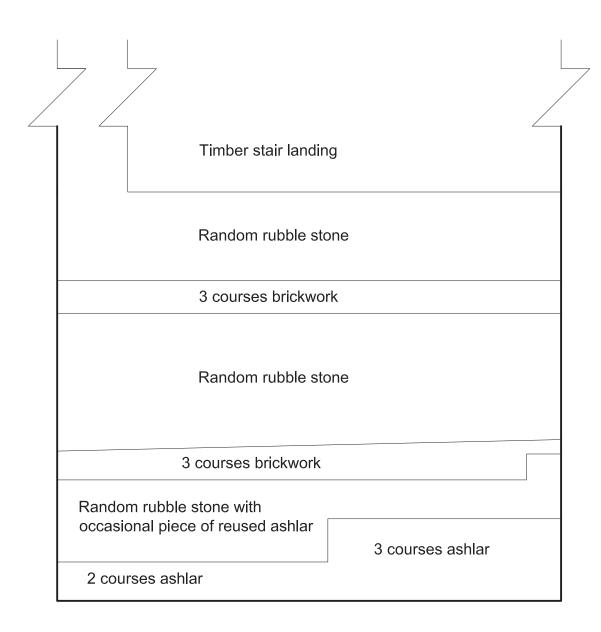
- 3.2.1 The west facing elevation of the first floor of the tower is constructed from a mixture of brick, ashlar and rubble stone (Drawing 1). The entire elevation has been covered by limewash which has obscured the petrology of the stone and colour of the bricks. There is some eveidence of coursing to the stonework however there are also large areas of uncoursed random rubble. In particular there are two distinct bands of brickwork. It was not possible to analyse the brickwork in situ beyond taking dimensions due to the limewash. However the size of the brickwork is certainly concurrent with post-1666 brick dimensions as is the dark orange-red colour of the bricks observed within the wall core.

- 3.2.2 The random nature of the masonry of the west elevation is consistent with that of the other three elevations of the first floor, although the adjacent wall of the canted spiral stair elevation to the north is of dressed and coursed ashlar. However this random character to the masonry is at odds with the finely dressed masonry of the exterior of the tower. It seems probable that economy came into play during construction and freshly cut ashlar was chosen for the exterior whereas reused material from the late medieval church was utilised for the interior elevations of the tower. A similar approach was also observed during the near contemporary Wren build at Christchurch Greyfriars (MOLA 2011), where the tower was completed in 1704.

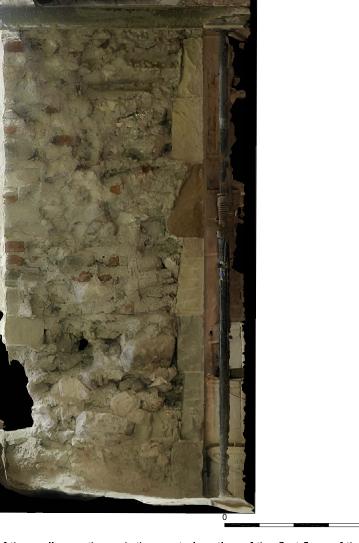
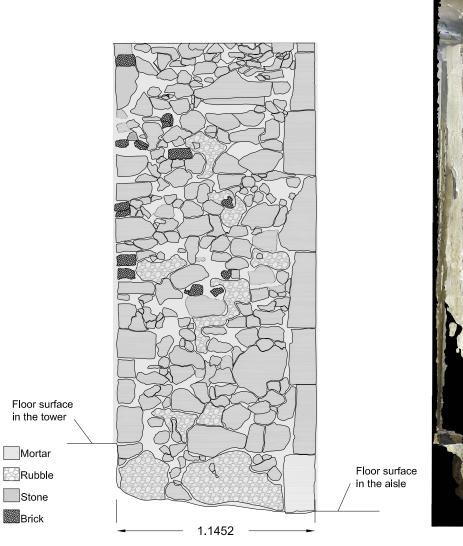
Drawing 2 Scale drawing (left) and scaled photograph (right) of the south facing section of the wall core through the east elevation of the first floor of the tower

3.4.1 Contractors cut a new door through the existing masonry during September and October 2014 which measured 1m in width by 2.7m externally and 2.3m in height internally. The intervention was located 0.3m from the return with the south elevation of the tower. The wall was demonstrated to be 1.145 metres (about 3feet 3 inches) in thickness (Drawing 2). The wall core was made up of a mixture of brick, clunch, and fragments of Kentish Ragstone, Caen and Portland stone. The latter was probably produced during the process of cutting the ashlar and moulded masonry for existing structure by Wren's masons. Other material was possibly salvaged from the late medieval church destroyed by the 1666 Great Fire.

3.4.2 Eighteen pieces of late medieval masonry were retrieved by the contractors from the core of the wall. These comprise architectural fragments of which include mouldings, shafts, voussoirs, window tracery and mullions. The discovery of this material is considered to be extremely significant as previous evidence for the character of the medieval church on the site has not been recorded before. The fragments also act as evidence that the existing church was partially constructed from material salvaged from the church destroyed by the Great Fire of 1666 – a common factor with many other City churches (MOLA 2011).
