Winchester City Mill

INTERPRETIVE HISTORIC
BUILDING SURVEY

Commissioned by
THE NATIONAL TRUST

Archaeological Standing Building Recording Report

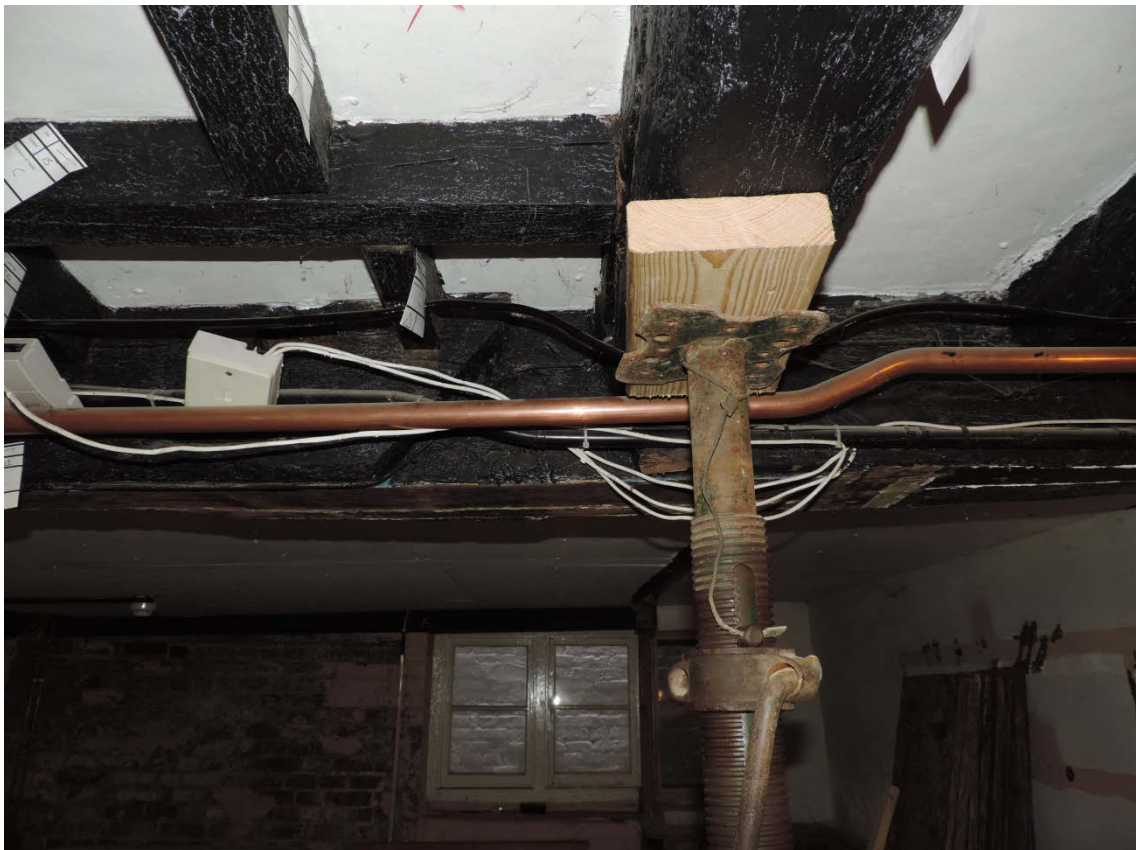
- A large reused wall plate – beam Timber [101] The largest reused timber in the floor was E-W bridging beam, Timber [101], which was of boxed heart oak over 250mm (10”) deep and c. 5.0m long. In addition to the later mortises for common joists, it also had earlier redundant joints on its south face showing it had been a wall plate in a large building. These joints included typical rafter seating joints which had been filled with resin towards the east end. Also visible was a half lap dovetail such as were typically used for tie beams. Because the north face was obscured with plasterboard it could not be seen whether, what would have been the lower face in the parent building joined a timber framed or of masonry wall, i.e. whether any post or stud mortises survived. However, the nearly square section of the timber does suggest a probable origin in a building with timber framed walls (This could be checked when the remaining plaster board to the north is removed.). The original use of the timber could span the late medieval to 17th century period, and it would have come from a large building.

Fig 2 Reused wall plate timber beam [101] showing the half lap dovetail joint

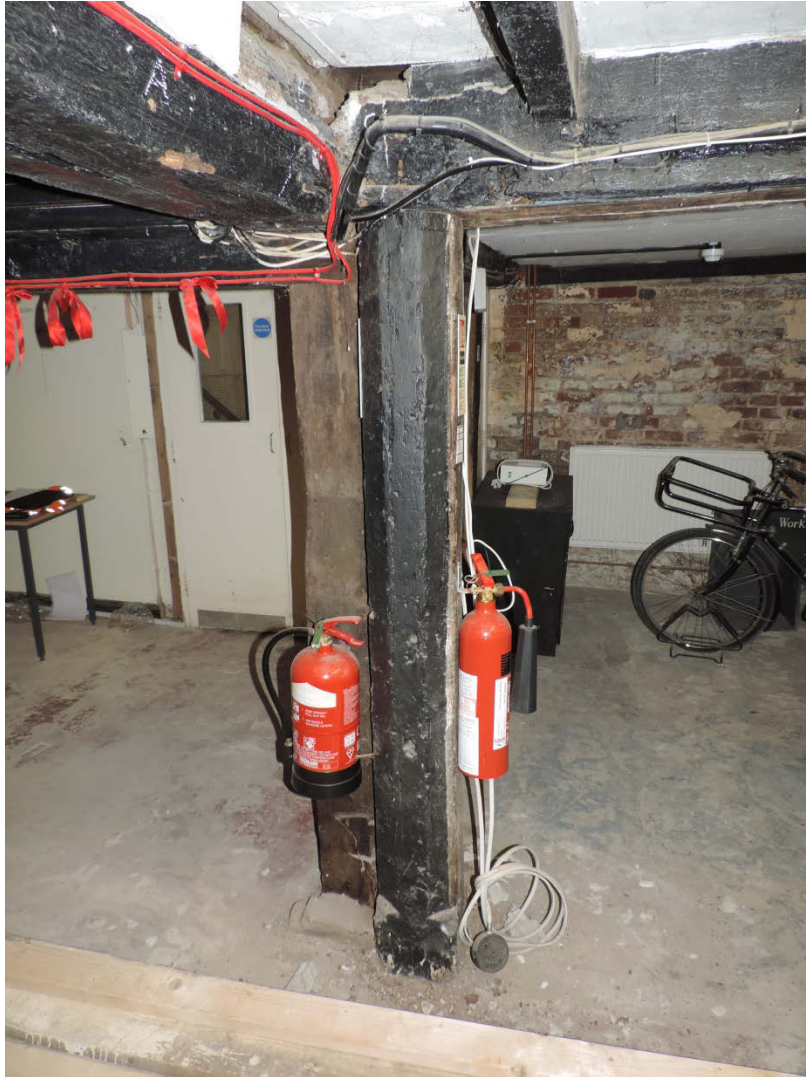
- A reused, octagonal crown post- post Timber [200] at the west end of the bridging beam [101] an octagonal oak post had been inserted as a prop where the joint with beam [102] was weak. This item, Timber [200], was neatly hewn and planned down to the diagnostic 8 sided cross section except at the ends where it was left square with a carefully made chamfer stop. Such a carefully made

timber was clearly originally a decorative post in a roof structure, almost certainly a crown post. Such timbers were usually used to support central 'collar purlins' and would originally have been joined to light braces connecting them to the collar purlin and adjacent rafters and a tie beam below. The jointed end or ends of this example had been cut off for its reuse as a simple prop timber. This timber is unlikely to have been taken from an earlier roof on the mill site itself and must be of late 13th to c. early 15th century date, one of the very oldest associated with the floor. Should the post become redundant after the repairs are made it would be worth retaining for display with an explanatory diagram.

Fig 3 Timber post [200], likely a reused crown post.

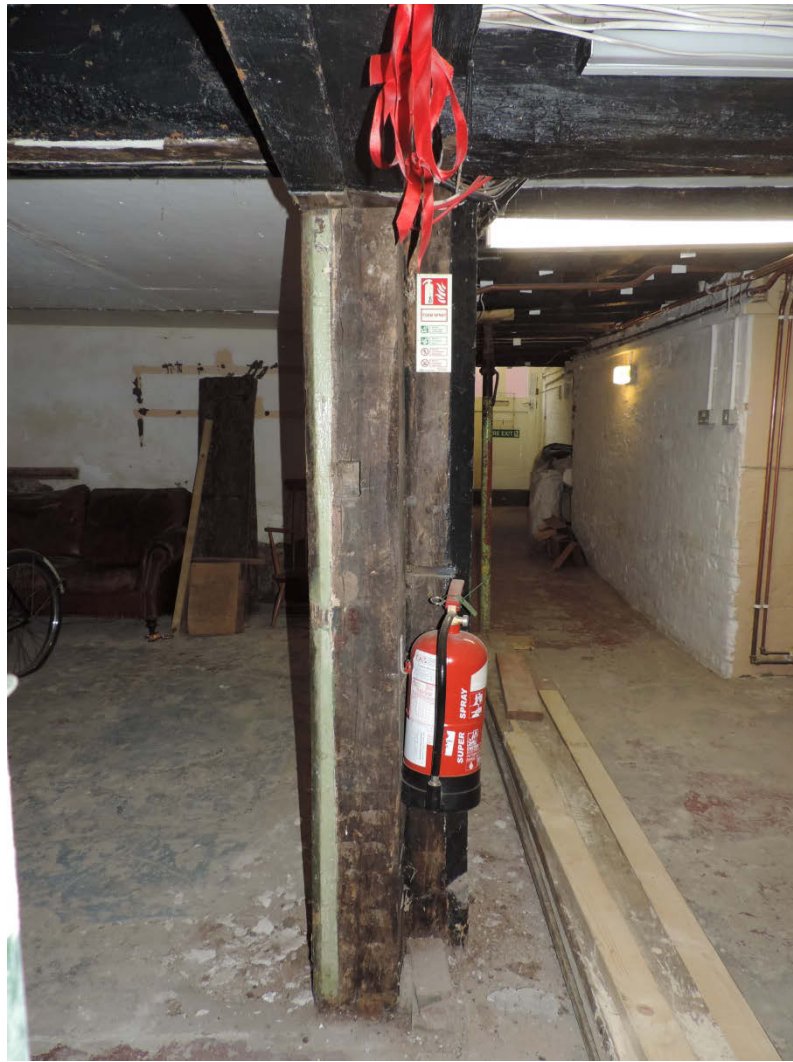
- A reused mid-wall plate or bridging beam- post Timber [206]. This boxed heart beam had two chamfered corners and a set of redundant 'bare faced soffit mortises' that would have originally been for common joists (Hewett 1980 p.282). It is likely that this timber is of c. 17th to early 18th century date.

Fig 4 Timber [206], facing east

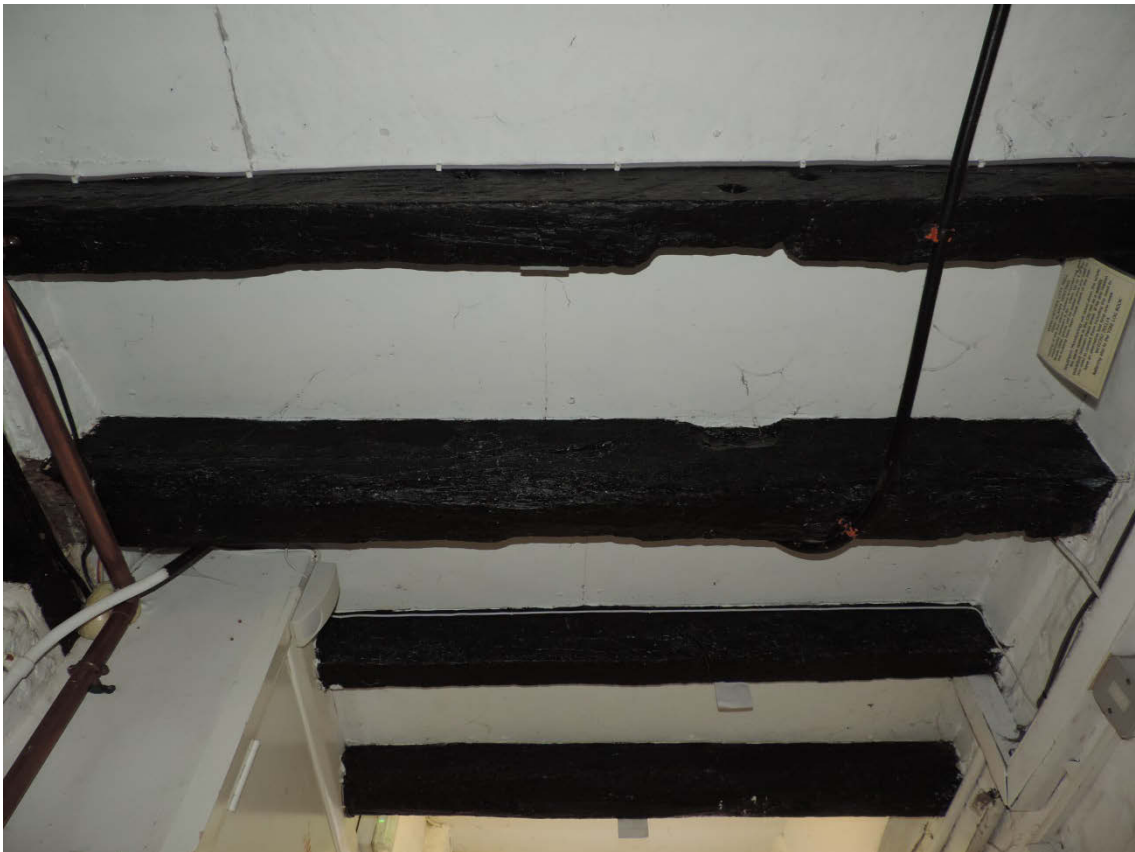
- A reused building timber with a simple lap joint- Joist Timber [03] One of the first joist timbers visible when approaching from the eastern, Water Lane end, Timber [03], was a particularly weathered oak timber with a simple lap joint in an original hewn face, now set facing east. The lap joint was originally secured with one large peg and traces of 'in cuts' from a broad chisel or possibly a 'twybill' could be seen around the edges of the lap joint. Such features suggest an origin in medieval roof carpentry.

Fig 5 Timber [03], second from top, facing east

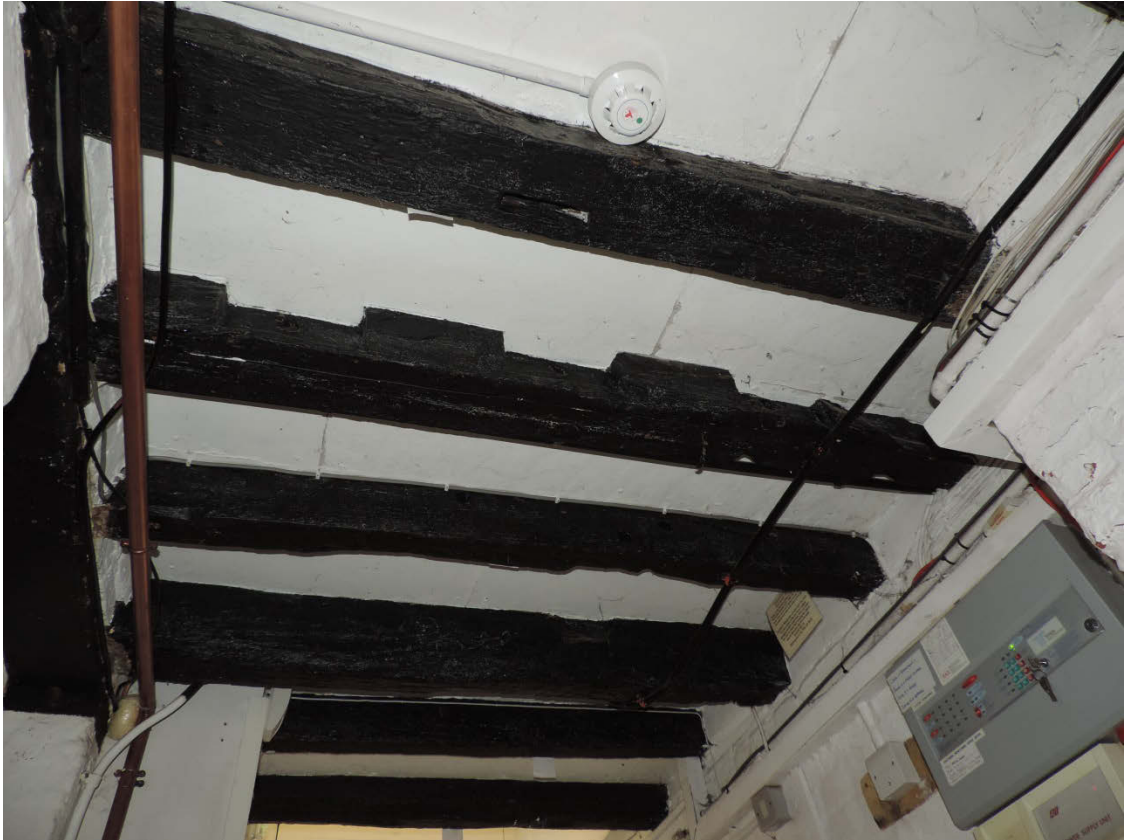
- A reused building timber with mortises for close set studs and wattle stave holes for a lighter wall above- Joist Timber [05] Resawing of two faces of this timber exposed single pegged mortices on the west face and crude tapering sockets for light staves on the east face. Presumably it was once part of a much larger beam sawn lengthwise into three elements for reuse. The close set mortises exposed by re-sawing the west face, as found, seem to be relics of close studding i.e. the tenoning in of close set regular studs into a horizontal mid wall plate. On the east face the crudely drilled and carved sockets exposed must have been for the feet of light infill staves used to support either wattle infill or laths rendered over. Thus, even though the timber was extensively reworked for reuse we can visualize it as part of the wall of a late medieval to c. 16th century timber framed building, of reasonable size and status that once stood in the town. The cost of transporting second hand timber over any great distance in a moderately well wooded area implies that it was likely to have been fairly locally sourced.

Fig 6 Timber [05], second from the top, showing multiple split mortises, facing east

5	Joist	Reused timber now resawn on the underside and west elevation. Originally a First floor wall plate. Resawing of two faces of this timber exposed single pegged mortises on the west face and crude tapering sockets for light staves on the east face. Once part of a much larger timber likely dating to the late medieval to c.16th century. Some borer damage. Full length and height not fully seen. Thick black paint obscures much of the finer detail.	Length: 1.30m Width: 0.13m Height: 0.11-0.13m	B
6	Joist	Reused timber joist, empty mortise to underside not pegged suggesting 16th century or later. Some borer damage. Full length and height not fully seen. Thick black paint obscures much of the finer detail.	Length: 1.30m Width: 0.13m Height: 0.11-0.13m	B
7	Joist	Possibly reused timber, suggested by weathered surfaces. Single iron nail in east face. Some borer damage. Full length and height not fully seen. Thick black paint obscures much of the finer detail.	Length: 1.26m Width: 0.13m Height: 0.135m	B

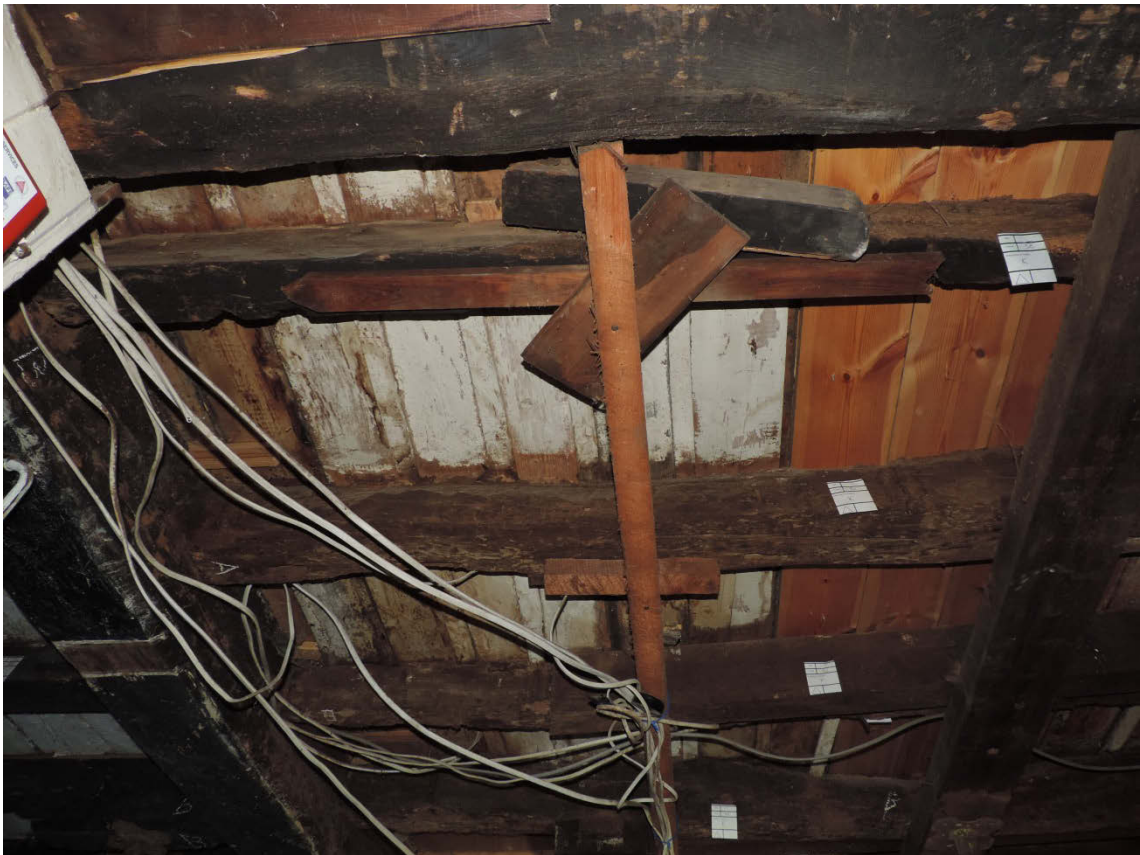
- Timber [51] was another complex reused oak joist. This joist was also originally clearly a horizontal beam in a building. It had relict augured and chiselled small, un-pegged mortises set at regular intervals on its current soffit which must have once held light studs in place. These probably used to support nailed on laths covered with render. A larger double pegged mortise was also visible that would presumably, have held the tenon of a larger post, such as a door jam in a partition wall. A broadly c. 16th century dating seems likely for the first use of this timber.

Fig 7 Timber [51], third labelled timber from the bottom, facing west

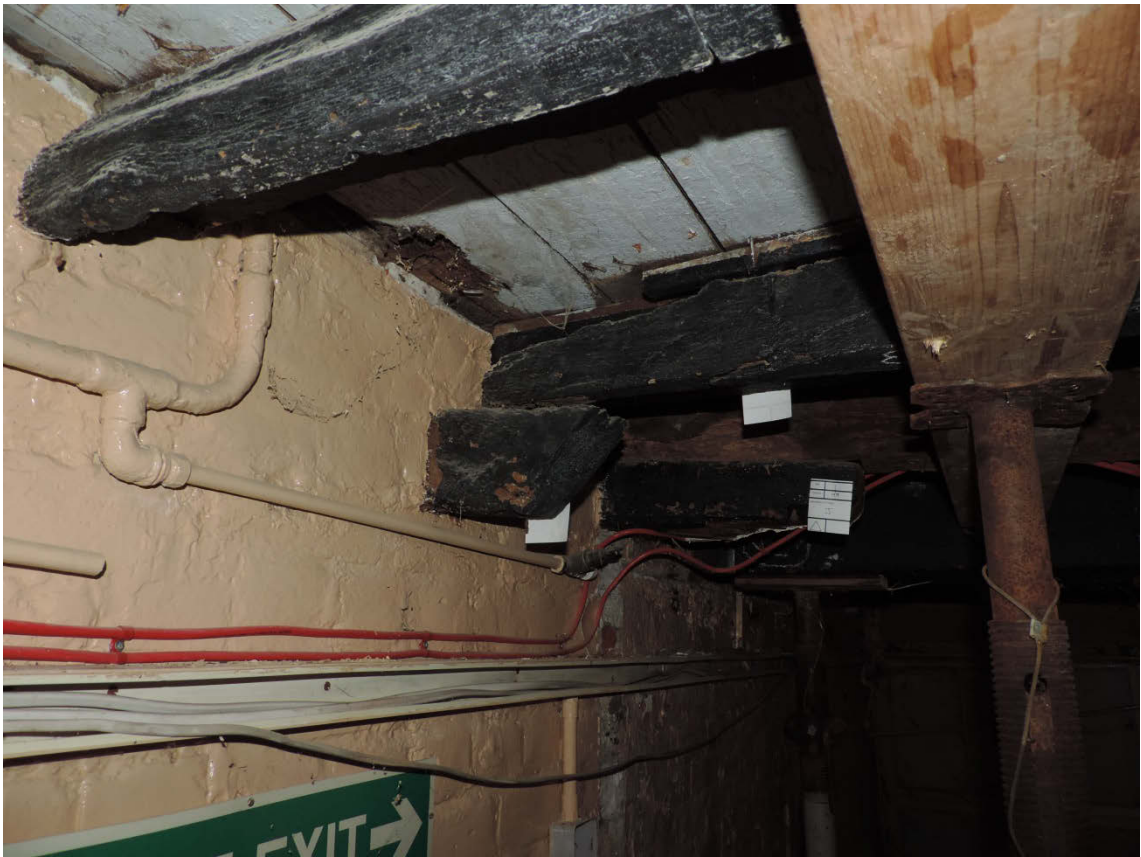
- 2.3.5 There are a few timbers that have been added for additional support to failing timber ends. Several of these are corbels to support the rotten end of a joist; a group of these were recorded in the southern wall of Area J. See Fig 7.

Fig 8 Showing a typical added corbel to support a joist likely too rotten at the end to stay within the wall.

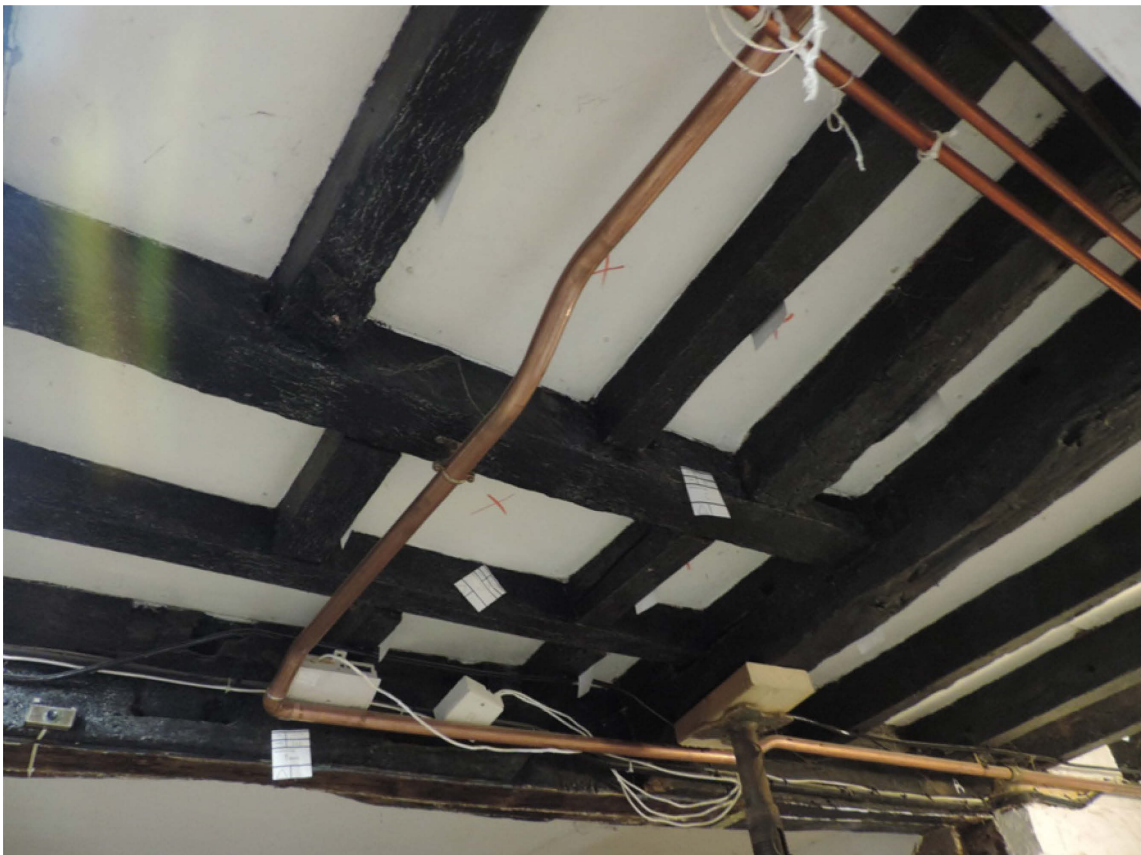
- 2.3.3 Some areas with later timbers appear to have been altered as part of a planned reconstruction. This can be seen in areas C, G, E and F. It is possible that these areas were reworked due to a large area of rot/ borer damage, or put in place to cover over a previously open area such as a trap door (Area K). These are a mix of older and newer timbers.

Fig 9 Area C arranged in a different pattern to the rest of the floor, likely to strengthen a weak area.

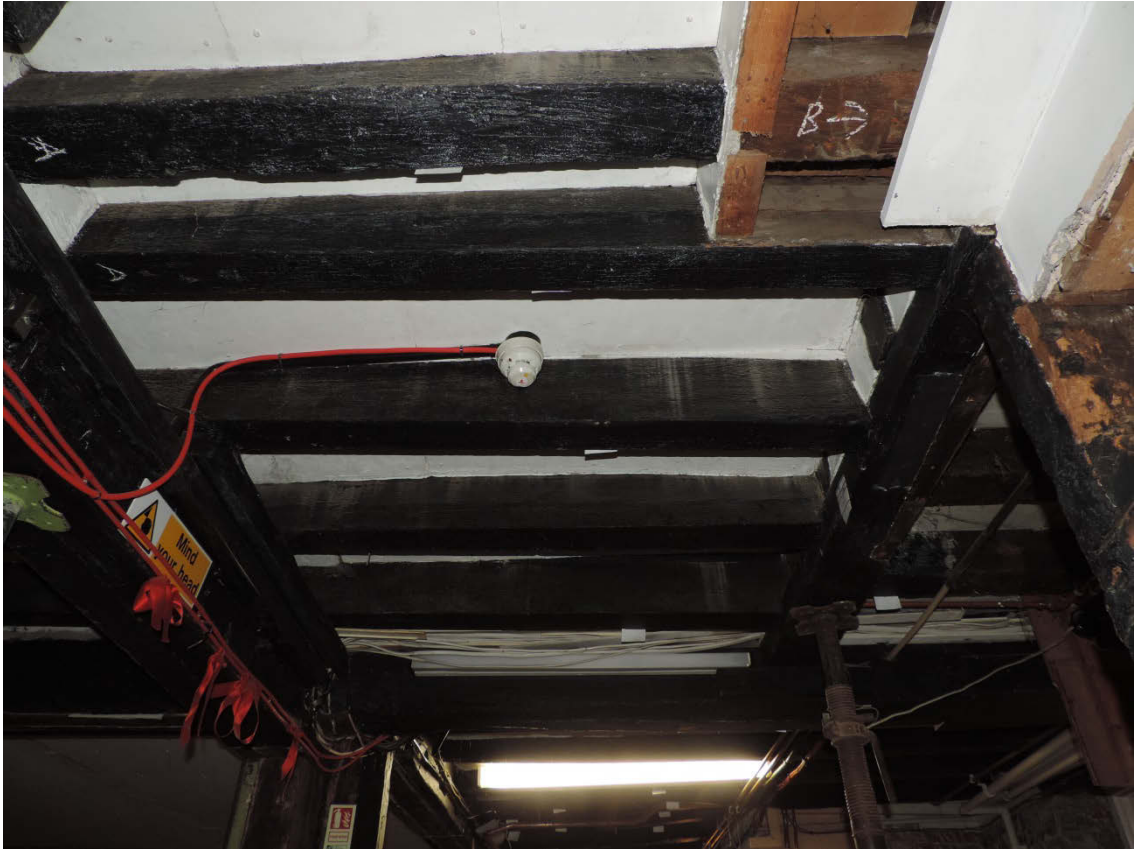
- 2.3.4 A few of the later timbers were brought in to act as doubling beams for timbers that have suffered heavy borer damage and appear weak. These have generally been attached using nails or bolts. See Fig 10.

Fig 10 Recently added joists in area G, supported by modern bridging beam [103] and [104] to the left and right respectively.

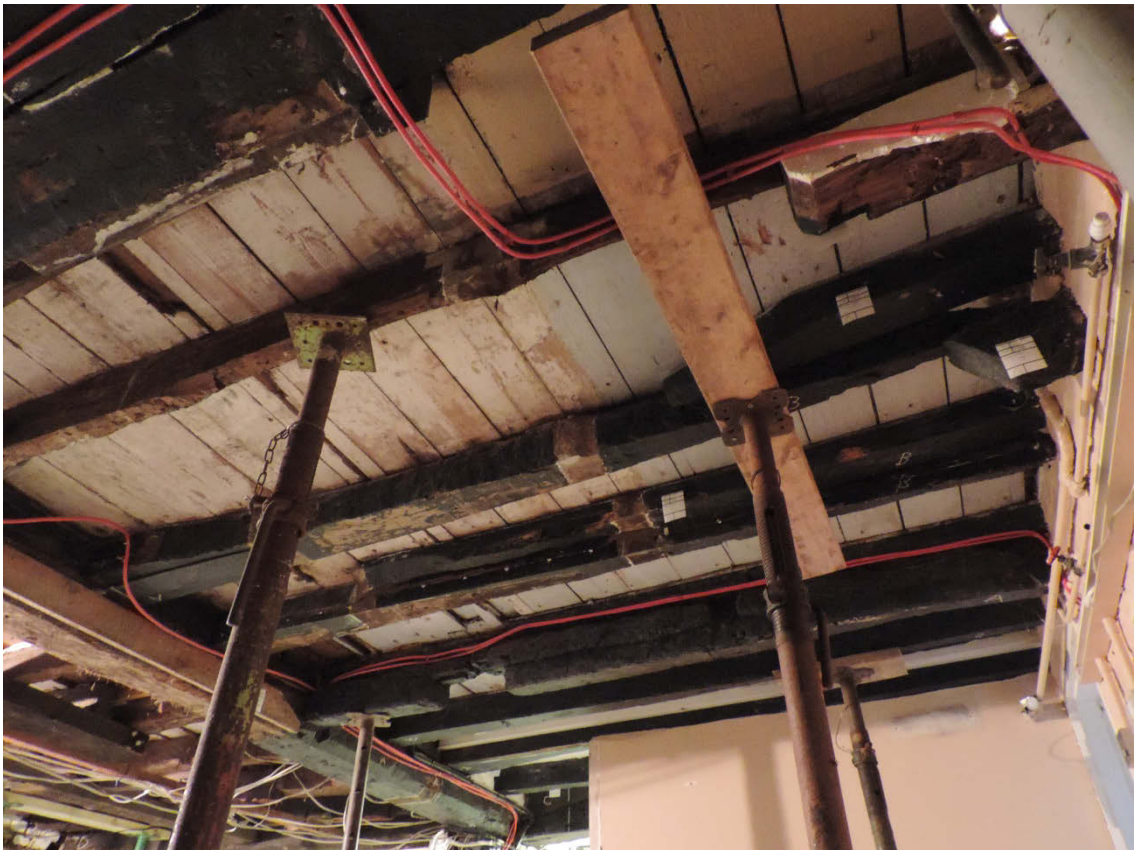
- 2.3.2 Several are standard replacement timbers, where a joist or beam was likely too rotten or had too much borer damage to adequately support the floor. These have been replaced by new oak timbers. See Fig 11 third joist from the right.

Fig 11 Timber doubling beam [47], looking north-east. Third joist from the top.

47	Joist	Added doubling beam, supports timber joist (46) along its western edge, likely due to borer damage or decay. Later addition. Inserts into the south brick wall. Full length of timber unseen. Minor borer damage. Thick black paint obscures much of the finer detail.	Length: 0.78m Width: 0.10m Height: 0.10m	J
48	Joist	Timber corbel supports timber joist (44). Protrudes from southern brick wall. Full length of timber unseen. Minor borer damage. Thick black paint obscures much of the finer detail.	Length: 0.23m Width: 0.09m Height: 0.13m	J

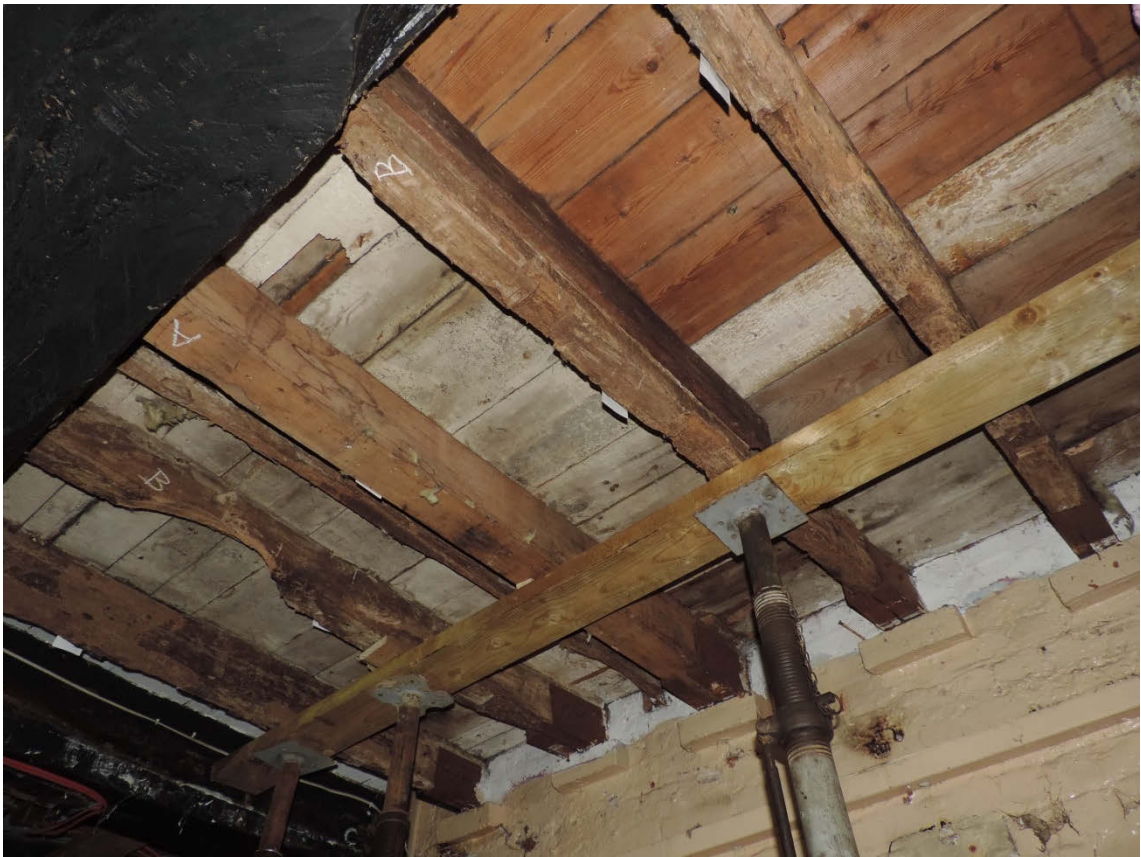
- 2.1.18 Area L was composed of N-S aligned joists running from the brick wall to the south into a bridging beam to the north. There are a few modern replacement joists within the area and all joists sit in iron cradles resting on brick corbels along the south wall. Here the bays change from having one central bridging beam to having two bridging beams and three areas per bay.

Fig 12 Area L, showing later added timbers and iron cradles supported by brick corbels.

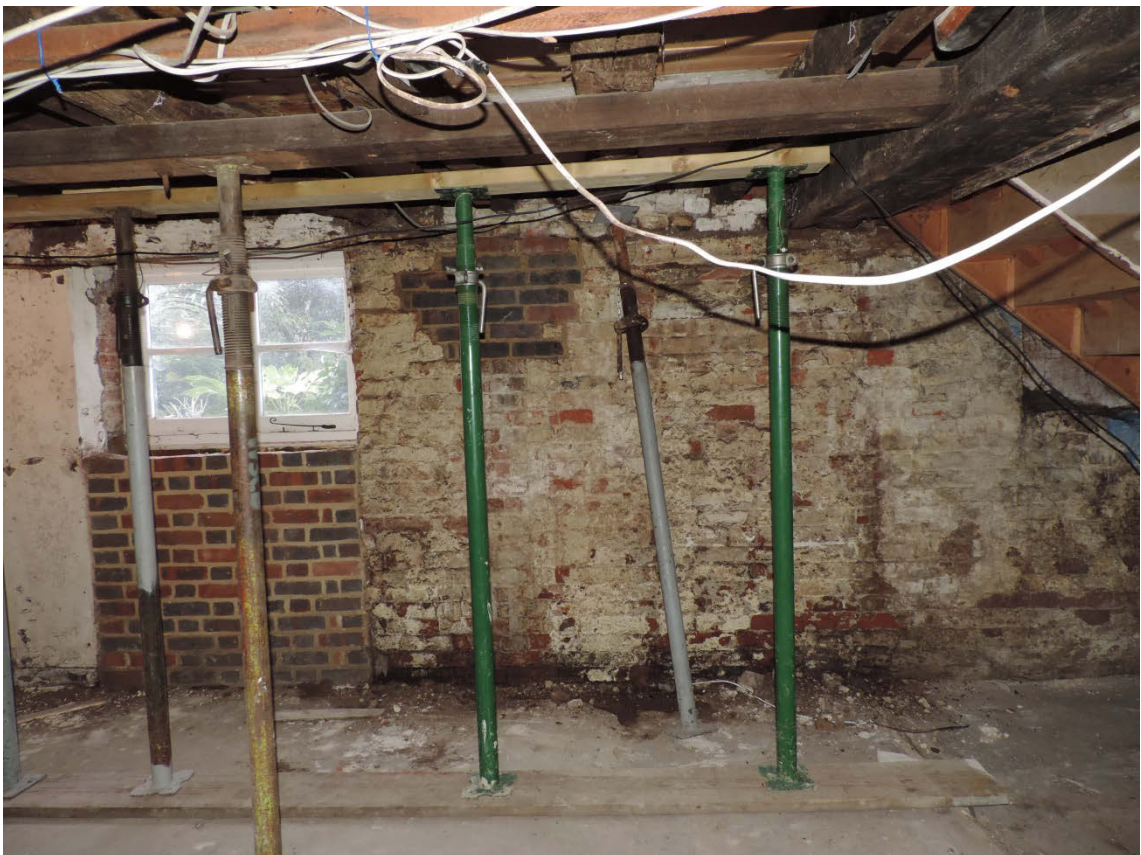
- 2.4.9 Along the northern wall in area K the wall appears to be original brick work with a number of recent repair patches (*Fig 12*). The brickwork around the timbers is very poor and appears to be altered but not properly repaired. This may have been done to assess the timber ends and perhaps attempt to repair some of them. Where the ends of the timbers are visible they are heavily decayed. A former door opening had been partially bricked-up to form a window.

Fig 13 Showing the northern wall in Area K with several repairs and poor brickwork surrounding the timbers, facing north

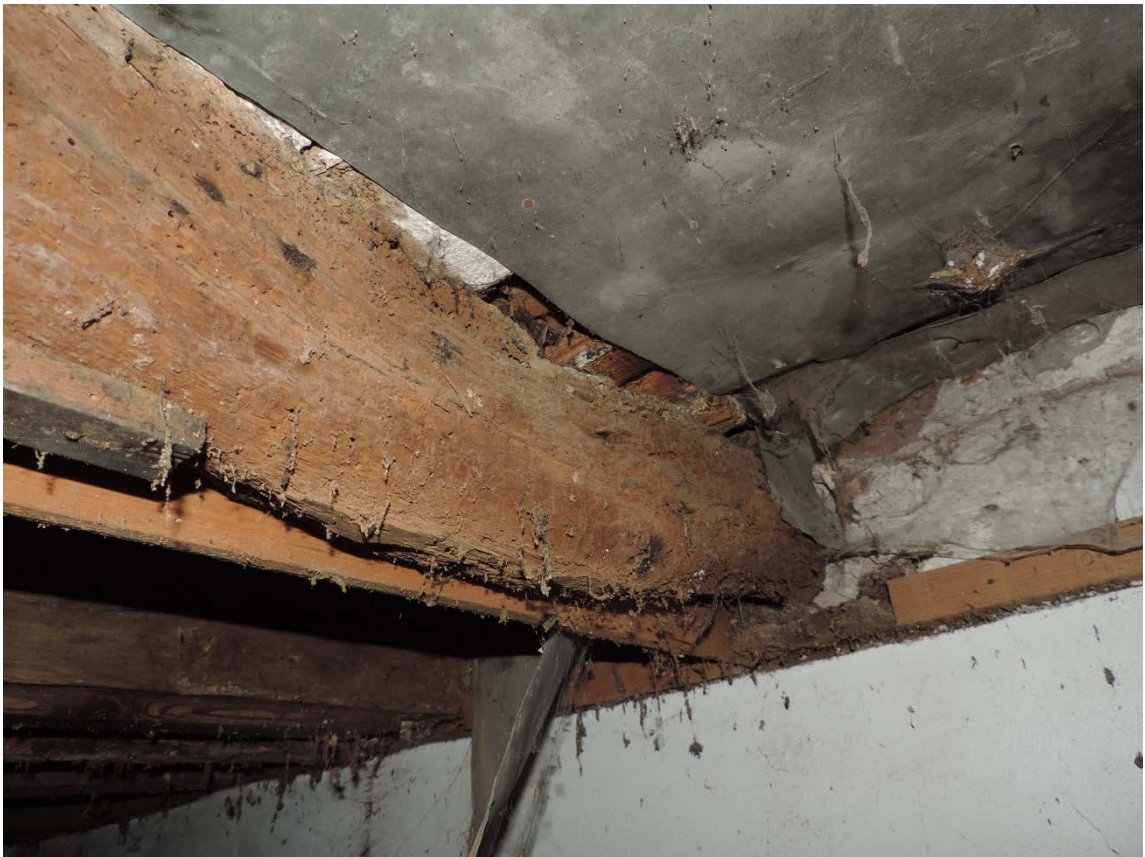
- 2.4.3 The majority of the timber joists and all of the crossbeams were inserted into the brick walls. Where the timbers were observed inserted into the walls there appeared to be a mixture of tenons and whole timbers making that connection. In both cases the timbers had undergone extensive decay where the tenons inserted into the wall, likely due to moisture.

Fig 14 Showing typical decay where the timber joist inserts into the brick wall, facing north-west. Timber [70]

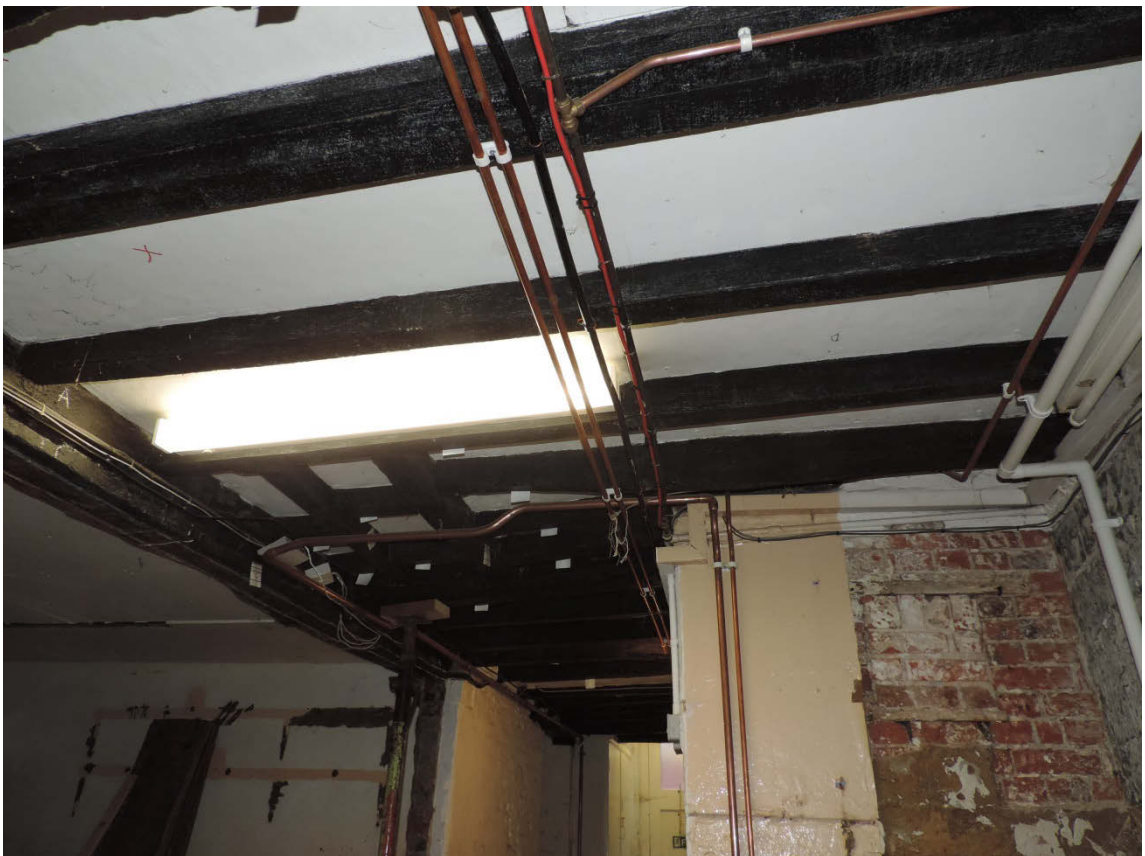
Fig 15 Showing the blocked opening along the southern wall in Area C, bottom corner of photo, facing east.

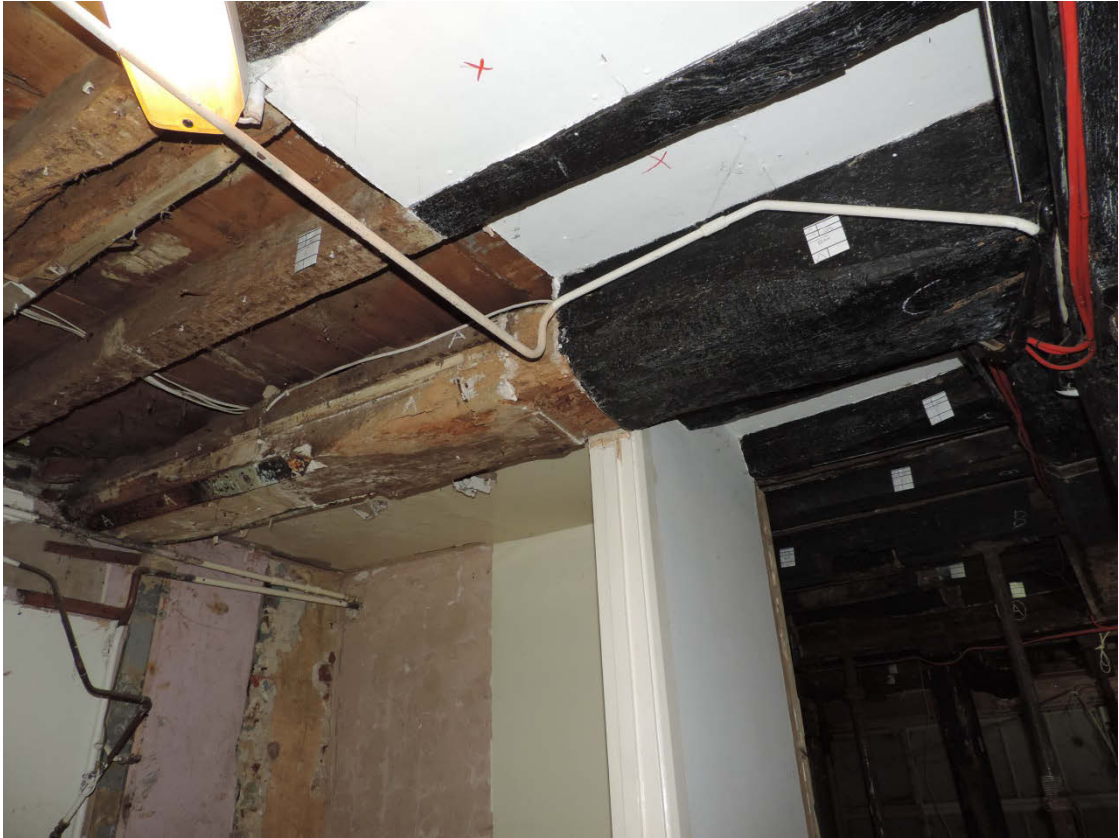
- 2.6.1 As has been recognised for some time and further documented in this survey, most of the framing timbers of the floor are reused timbers with many lacking well preserved sapwood. Therefore finding several timbers with sufficient annual rings (50 +) and sapwood for tight tree-ring ('Dendro') dating is very unlikely. One possible candidate is N-S timber bridging beam Timber [105]. This was clearly younger than the other oak timbers with relatively unweathered faces bearing traces of pitsawing. It was made from a whole oak of medium to largish dimensions of apparently medium growth rate and included several areas of sapwood to the waney or 'bark edge'. Thus, it is likely to have at least 60-70 annual rings and could be potentially datable. However, the sapwood has been much attacked by furniture beetle, larger boring insects and rodent gnawing and is very fragile. If two core samples were taken from near each end and an area of sapwood consolidated prior to sampling it might just be possible to obtain a close felling date. The advice of an experienced tree-ring specialist is essential here.

Fig 16 Timber [105], looking south-west, the timber with the most potential for a successful dendrochronology date. Sap wood can be observed near where the unpainted and painted portions of the timber meet.
