**Northey Island  
River Blackwater  
Maldon  
Essex**

**ARCHAEOLOGICAL SURVEY REPORT**

Site Code MDNI 15  
NGR 587770 206530

Archaeological survey report

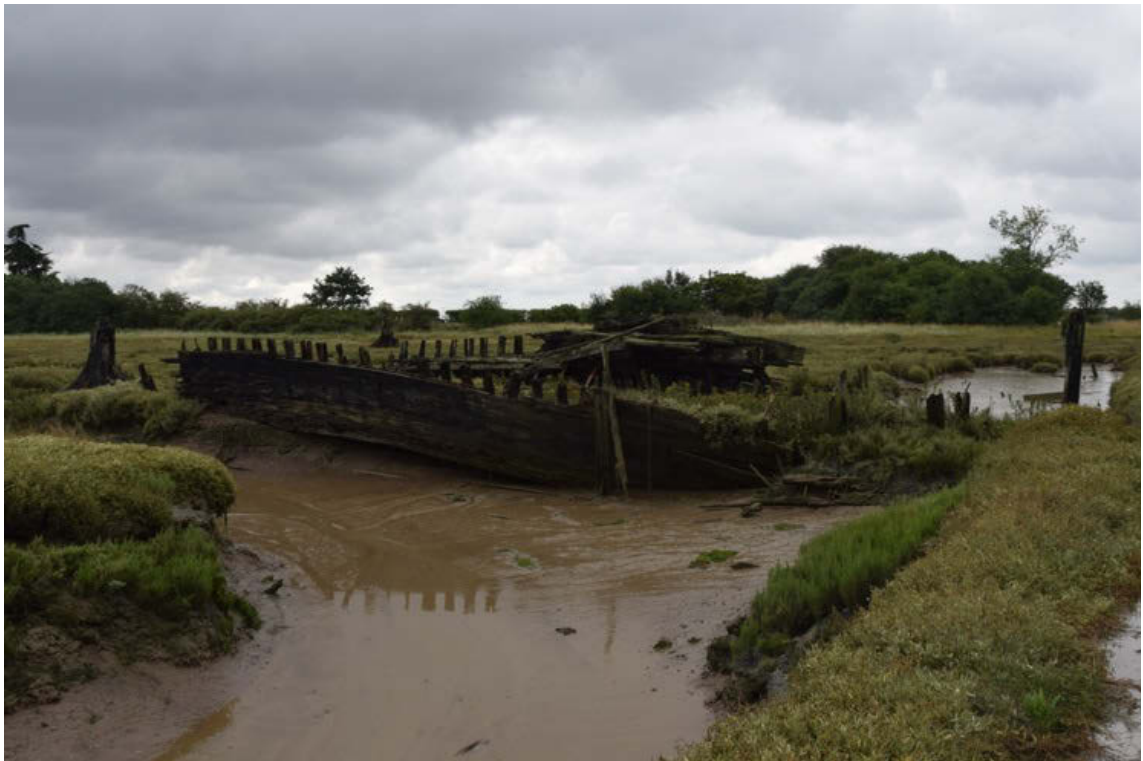
*Vessel 1 Starboard side, looking south*

4.2.2 It was in a very degraded condition but the stempost, sternpost and rudder were substantially intact, some of the vessel sides were intact to deck level but the majority had collapsed to some degree or other. The stempost was molded at the head 0.28m and sided at the head 0.23m, while the sternpost was molded at the head 0.23m and sided at the head 0.20m while being sided at the foot 0.28m. One piece of rising deadwood was noted, while the salt marsh was partially removed to reveal a softwood keelson sided 0.42m. The frames were molded 0.14m and sided 0.17m and were spaced, centre to centre, at 0.56m. There were two layers of overlapping external planking, the outer planks being 0.25m wide and 0.06m thick ,

- 5.1.1 Vessel 1 had been previously been identified as the *Mistley*, launched in 1891 at Harwich, by the NAS survey undertaken in 1997. That survey demonstrated that the hull was largely intact except for considerable damage at the bow, and that the deck was largely still *in situ*. It also demonstrated that the vessel had two openings to the hold (Clarke *et al*, 1997). The vessel has now deteriorated to such an extent that this was not discernible, although it explains the presence of the athwartship beam recorded above the area of the hold. It seems highly likely that this beam was one of the deck beams of the forward hold opening. Vessel Fragment 3 is almost certainly part of the *Mistley's* deck, possibly from either forward or aft of the after hold opening. It is highly likely, once the deck had collapsed inboard, that the rate of degradation and disintegration increased, and that this increased rate of destruction will continue.

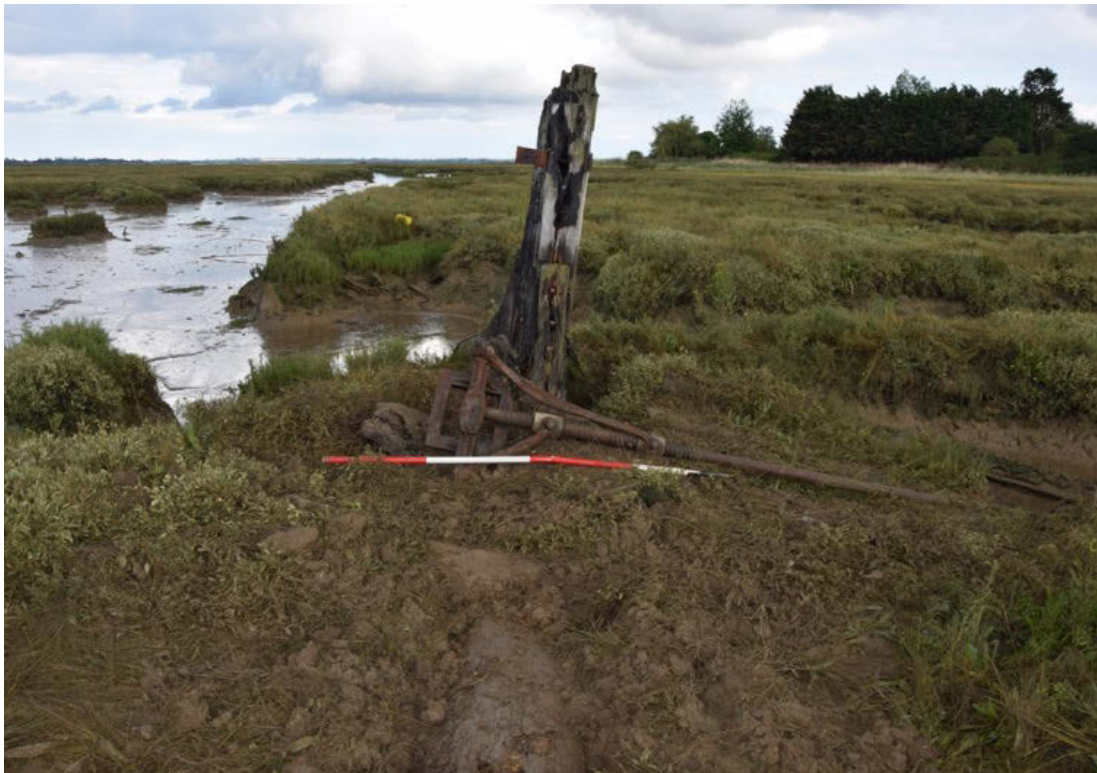
- 4.2.4 The screw steering gear was observed although it had fallen from the rudder head. It had a name plate inscribed 'Taylor-Neath Rochester', presumably the manufacturer. Three chain plates for standing rigging were observed midships on the upper port strakes. Two iron bilge pump tubes were observed forward of the hold, the starboard one appeared to still be *in situ* and had an 0.18m external diameter and 0.12m internal diameter. Observed closer to the bow and considerably obscured by the saltmarsh was the anchor windlass.

*Vessel 1 Screw steering gear and sternpost*

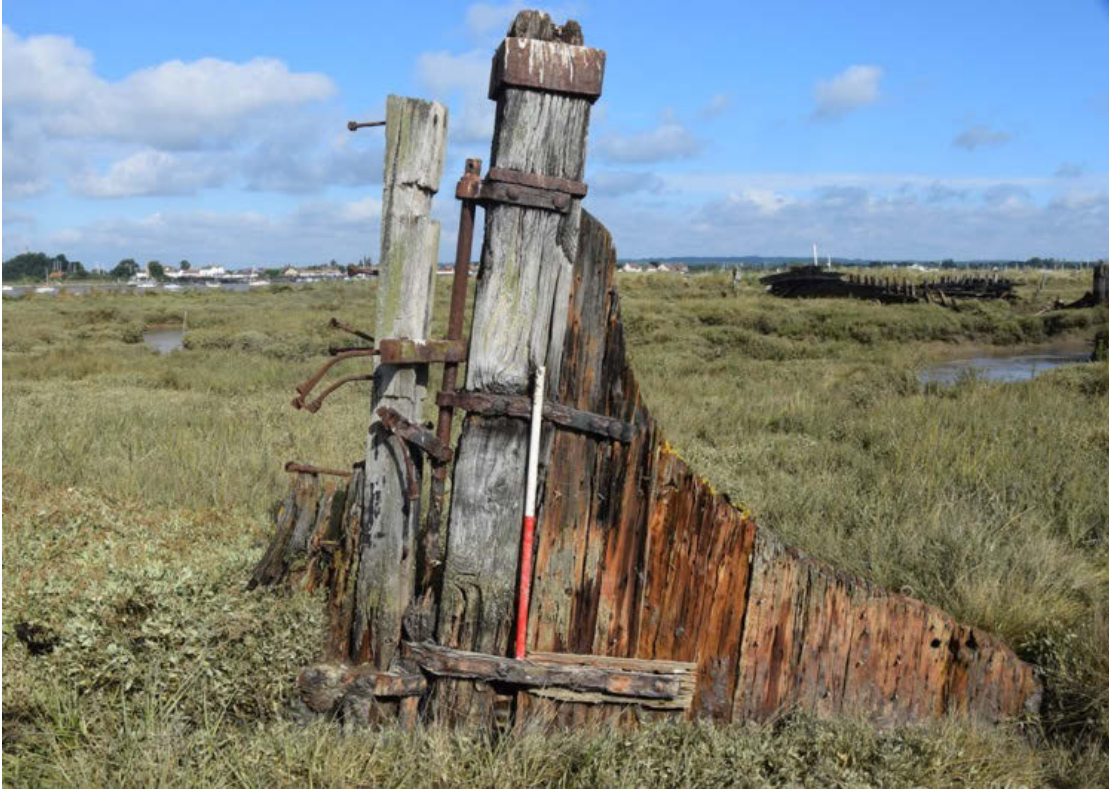
- 4.3.1 This vessel was almost entirely covered by salt marsh, only the rudder, sternpost and two extremely degraded frames being visible. The observed length was 2.85m and observed height 2.60m. The rudder and sternpost are located at NGR 587578 206439.
- 4.3.2 The sternpost was molded at the head 0.23m and sided at the head 0.15m. The rudder fan was studded with iron nails and a square iron collar measuring 0.34m by 0.33m was recorded on the rudder head. The rudder was not attached to the

sternpost by the usual gudgeon and pintle system but by straps from both sternpost and rudder around a vertical iron post. The two observed frames were too degraded to make any accurate measurements of their original dimensions but appeared to be spaced, centre to centre, 0.40m.

*Vessel 2 Rudder and sternpost looking starboard*

- 5.1.2 Likewise, Vessel 2 had been previously identified as the *Gillman*, launched in 1865 at Lambeth. This vessel was recorded as in considerably worse condition than the *Mistley*, only the floor timbers and some outer planking, along with the sternpost and rudder being visible (Clarke *et al*, 1997). Only the sternpost, rudder and ends of two extremely degraded floor timbers were observed during this survey. It is, however, likely that more of the bottom of the vessel survives under the salt marsh. Again, this vessel is likely to continue to disintegrate.

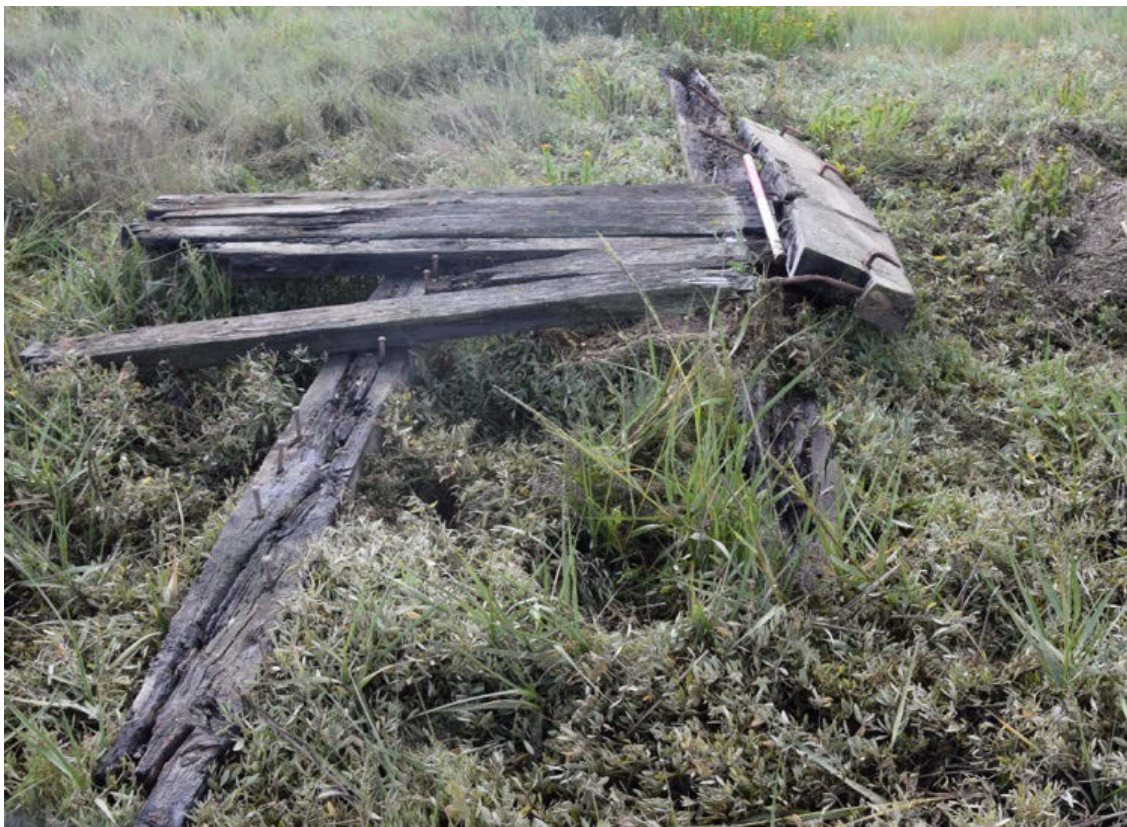
- 4.4.1 This vessel fragment comprised six planks fastened to a deck beam with hold coaming attached above. The fragment was located at NGR 587565 206437.
- 4.4.2 The planks were 0.10-0.20m wide and 0.08m to 0.10m thick, the deck beam was molded 0.18m and sided 0.20m, while the coaming comprised two planks, the lower one being 0.30m wide and 0.10m thick, the upper being 0.10m wide and 0.10m thick. The lower part of the coaming was studded with copper nails.
- 4.4.3 The dimensions of the planks, deck beam and coaming are consistent with those recorded in Vessel 1; it is, therefore, considered that this is part of the deck of that vessel which has come adrift.

*Vessel fragment 3, planks, deck beam, hold*

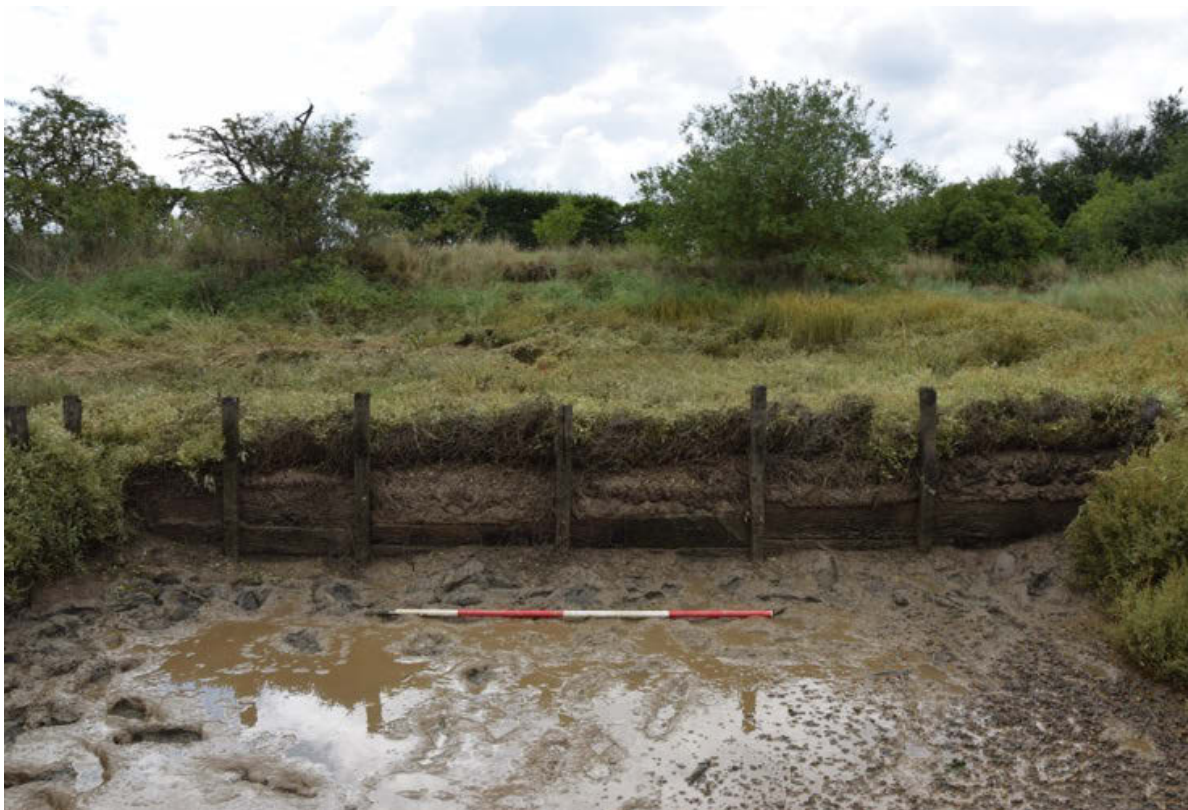
*Southern end of north-eastern oyster pit showing timber revetments*

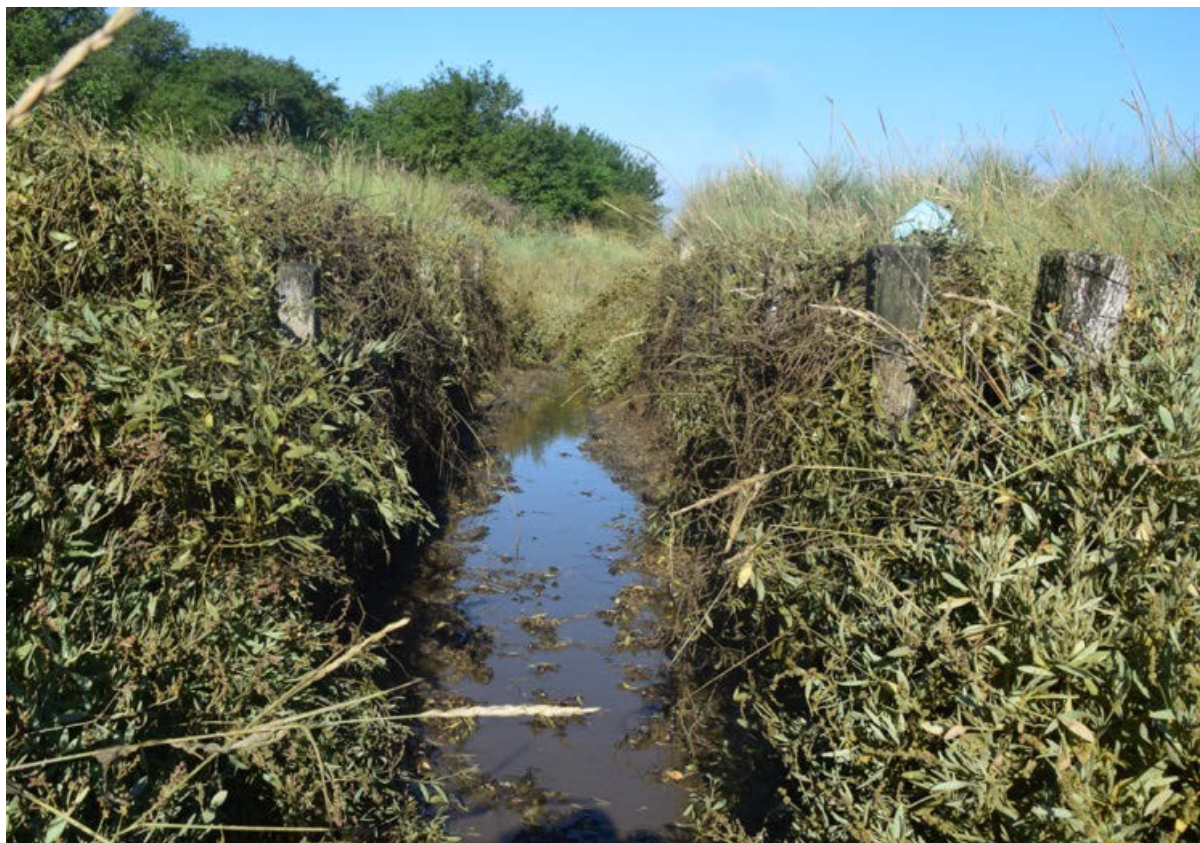
*Drainage channel on southern side of oyster pits*

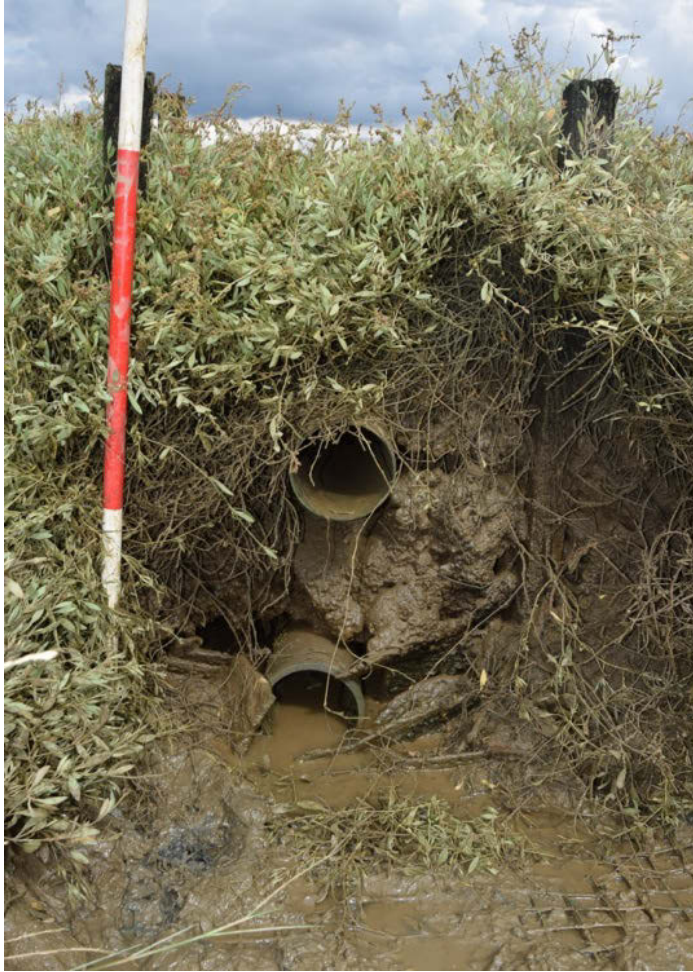
*Plastic drainage pipes in northern end of north-eastern oyster pit*

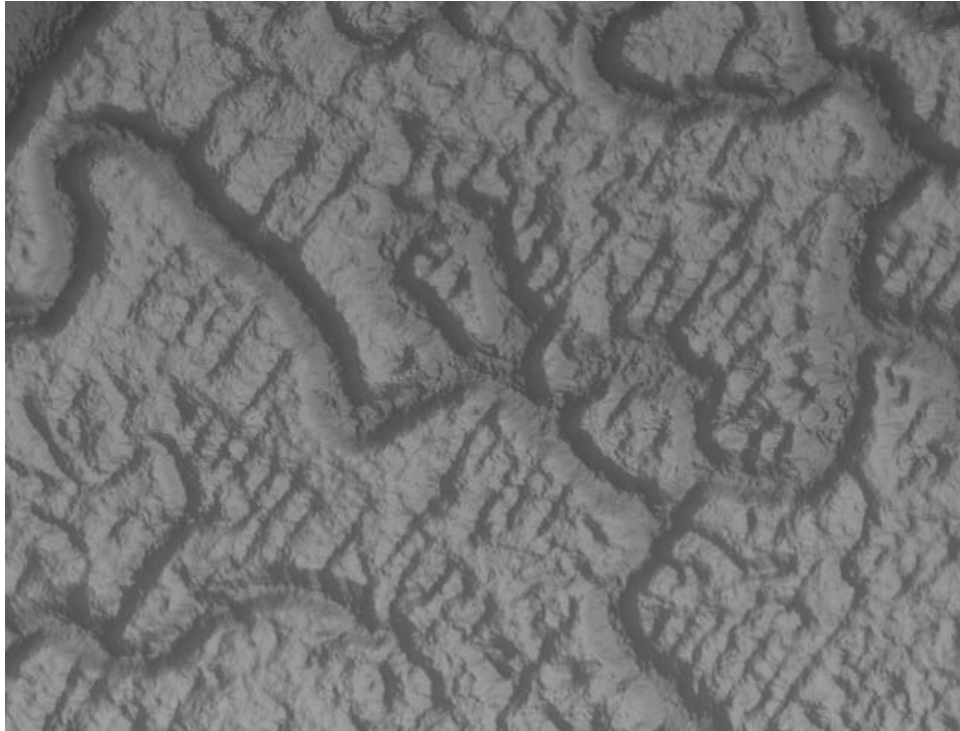
- 4.7.1 The aerial photo of the site clearly shows the presence of parallel lines orientated north-south across the majority of the site, which are the remnants of cultivation marks. These were not obviously visible on the ground, and have been recorded from the orthomosaic photo and digital elevation model. The distance between the lines is largely similar, between 2m and 3m.

*Cultivation marks visible on the digital elevation model (DEM) of the site*

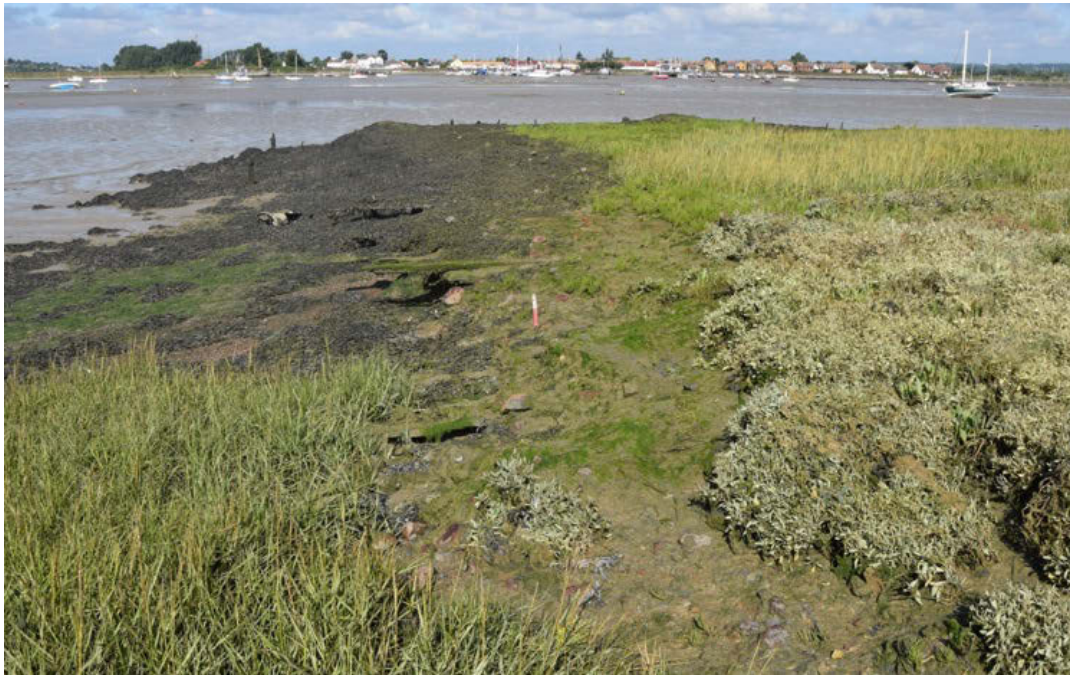
*Timber raft of the wharf, overlying ferrous slag, looking north-west*

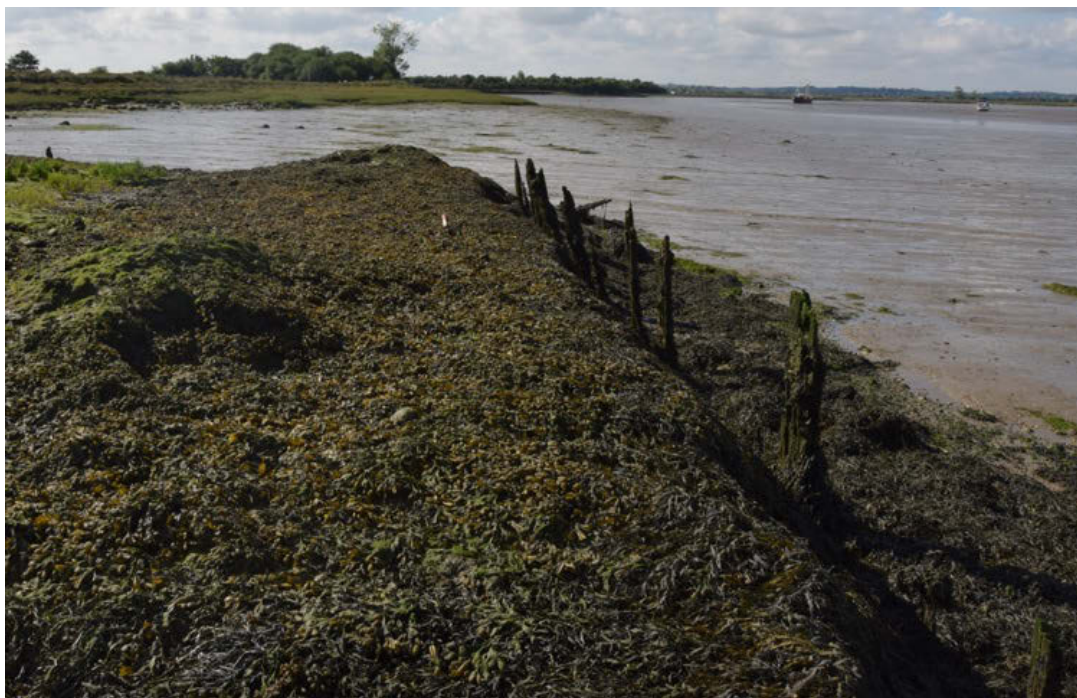
*Wharf looking south-west showing timber revetments along western side*

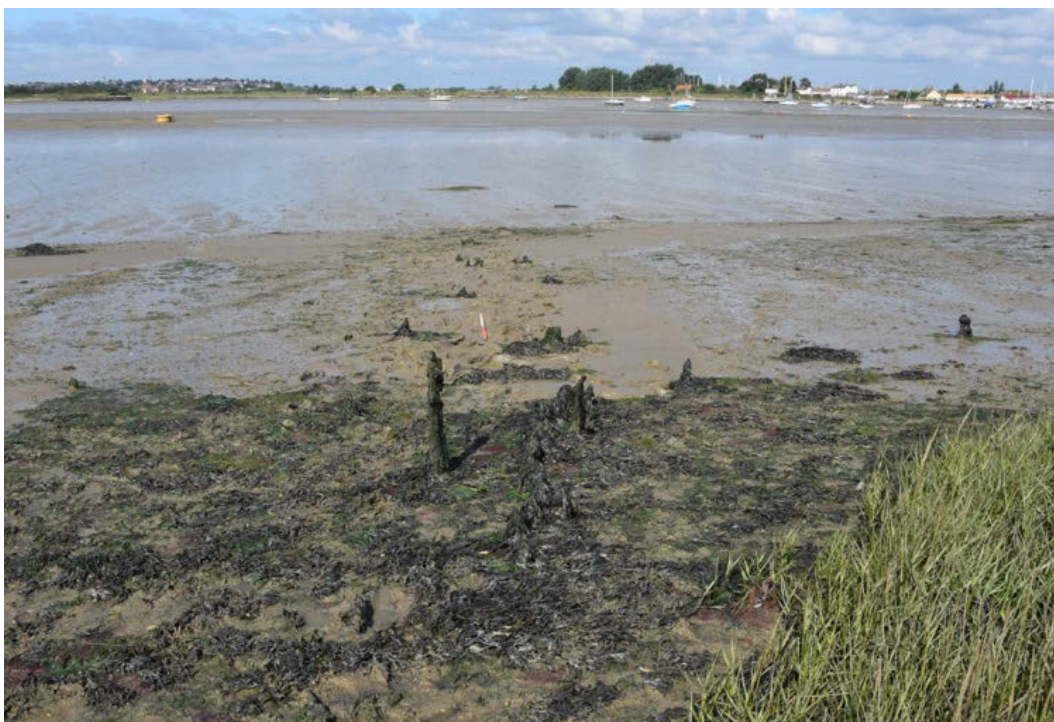
- 4.9.1 In the south-west of the site a linear structure was observed comprising thirty three posts and planks driven into the foreshore. The structure was 17.40m long and up to 1.40m wide and was interpreted as the remains of a possible landing stage. The central grid reference of the landing stage was NGR 587497 206463.

*View of landing stage looking west*

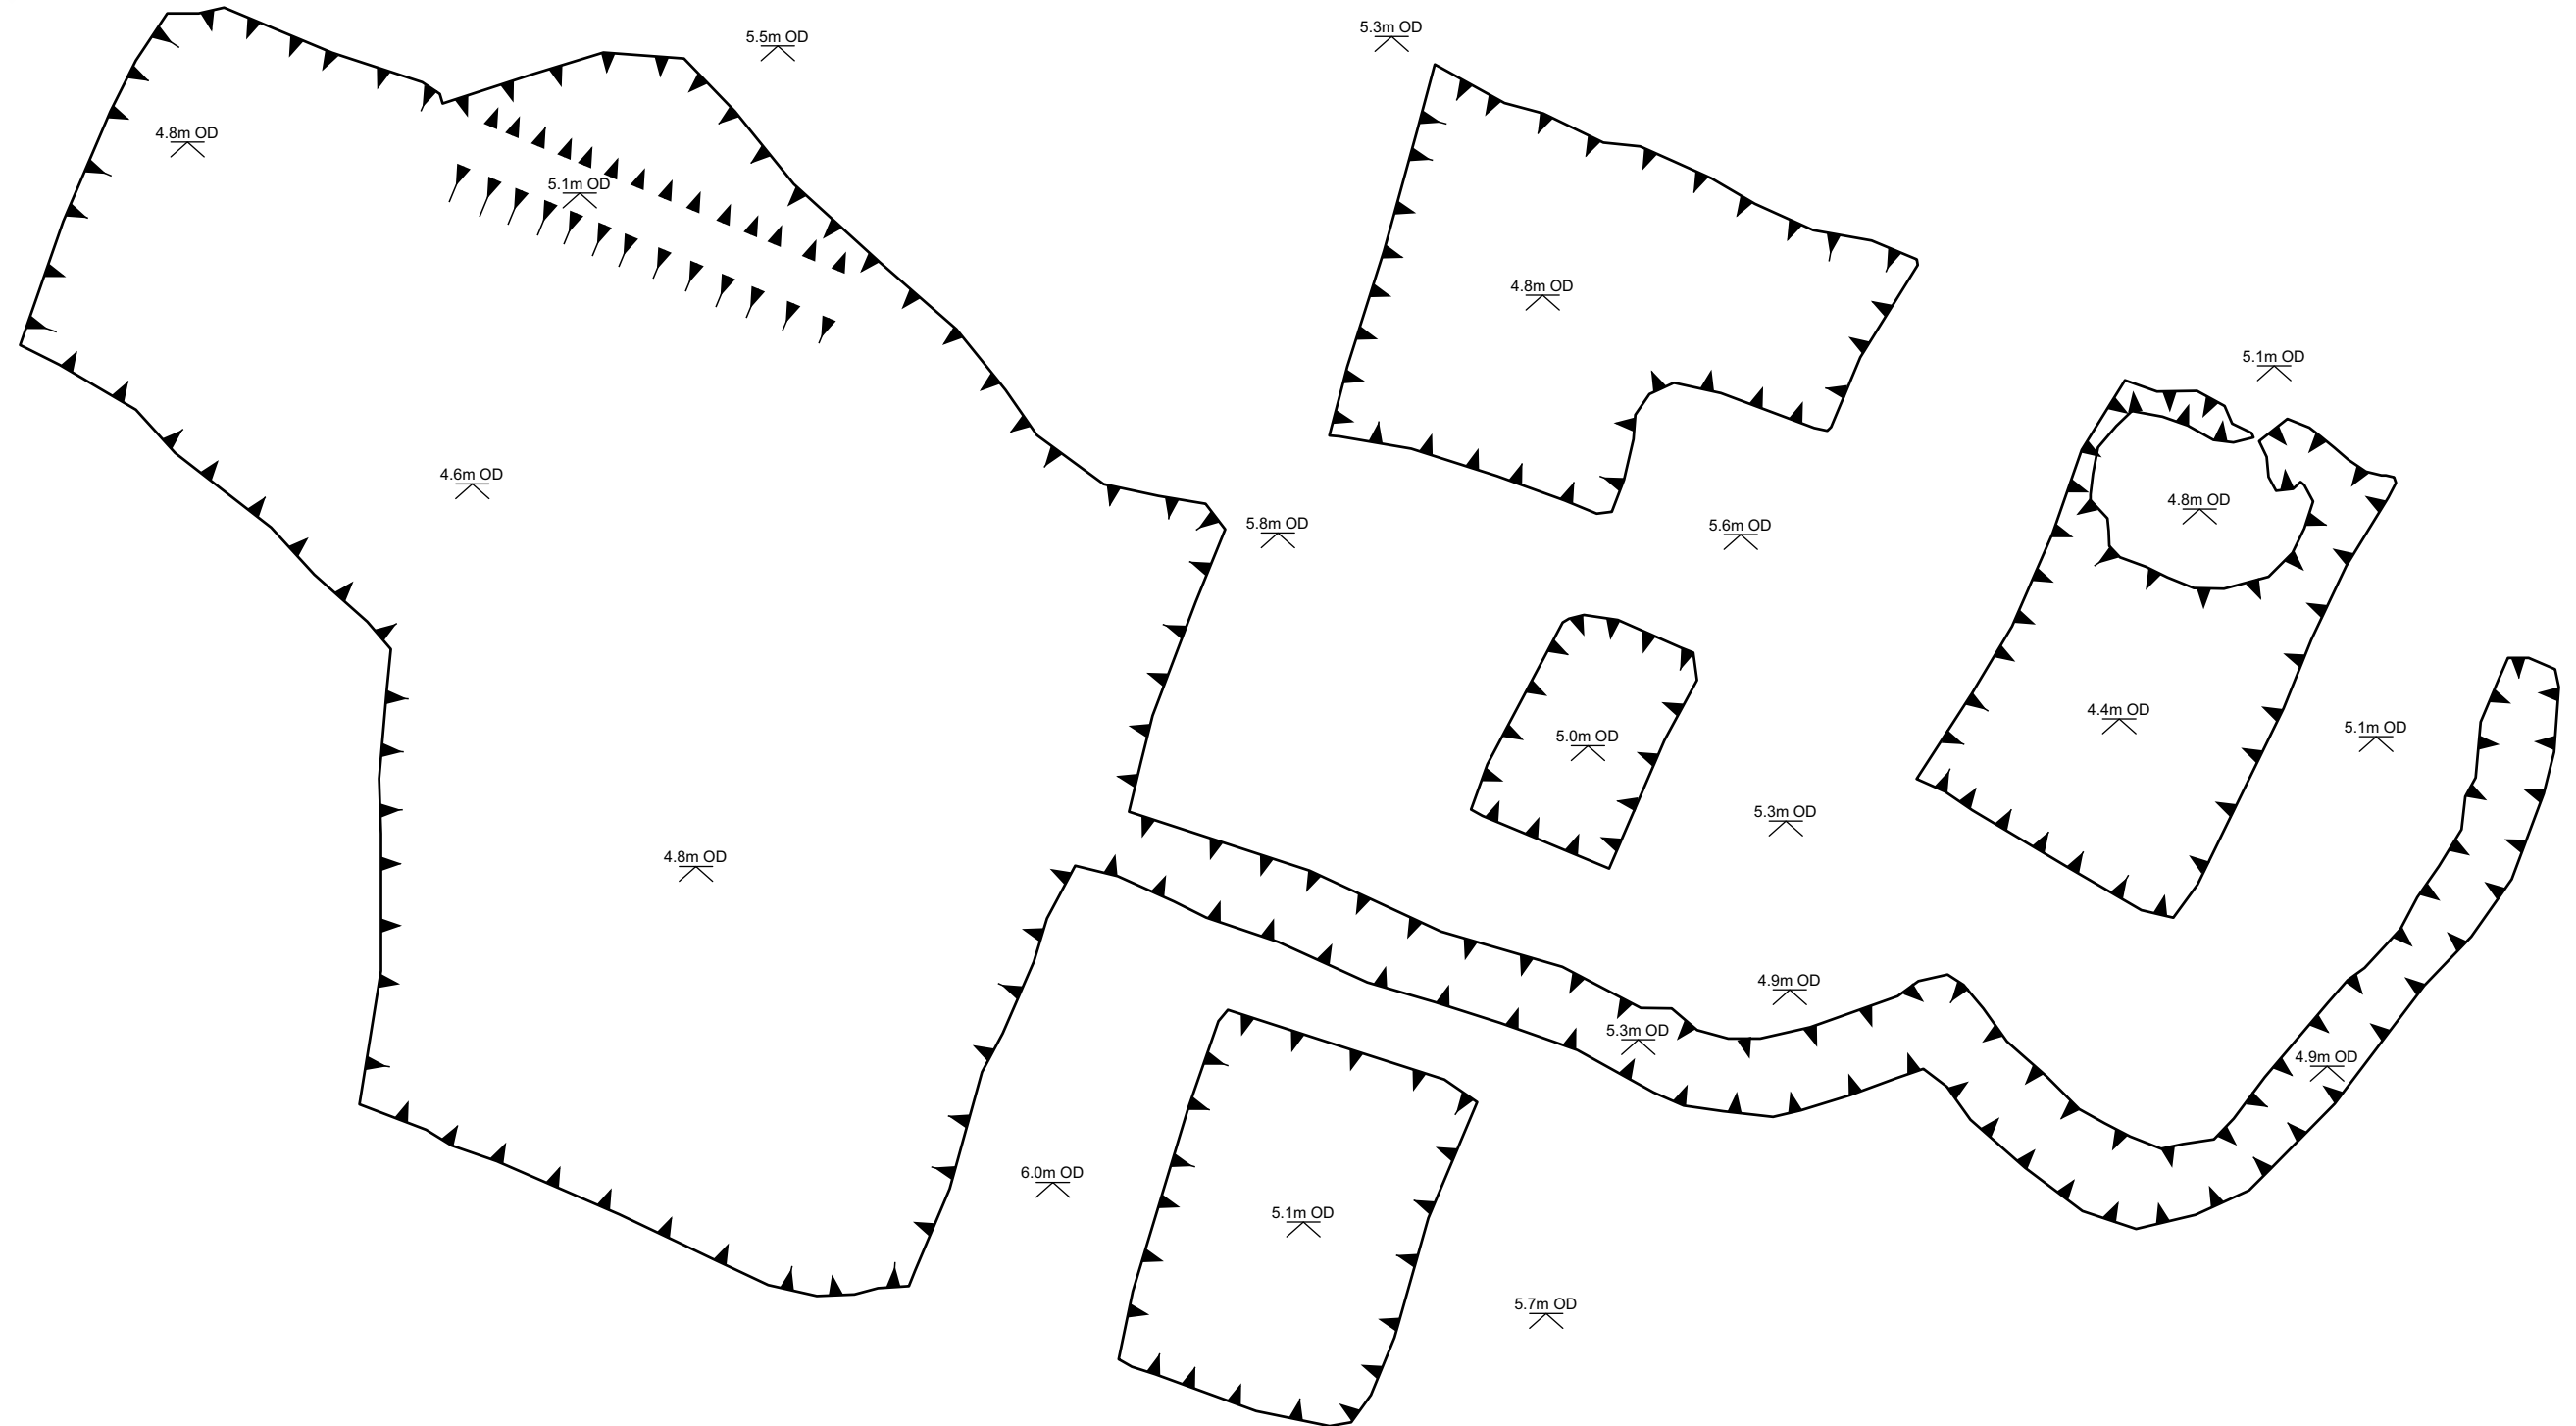
Fig 4 Oyster pits

- 4.5.1 Four former oyster pits were recorded in the south of the site, connected to each other by a drainage channel on the south and east sides, and by a number of pipes, most of which were ceramic but two of which were plastic. The central national grid reference for the group of oyster pits was 587580 206410.
- 4.5.2 The oyster pits ranged in size from 4.2m x 5.8m to 16m x 20m, were generally steep sided and c 0.8m deep. Some showed evidence of being revetted with small timber piles and planking. Most were square/rectilinear but some had irregular edges which may have been the result of subsequent flooding and silting. Where visible the bottoms of the pits contained gravel, some gravel also being recorded in the connecting drainage channel.
- 4.5.3 The oyster pits were recorded by measured archaeological survey and photography, and can be seen on Figure 4.

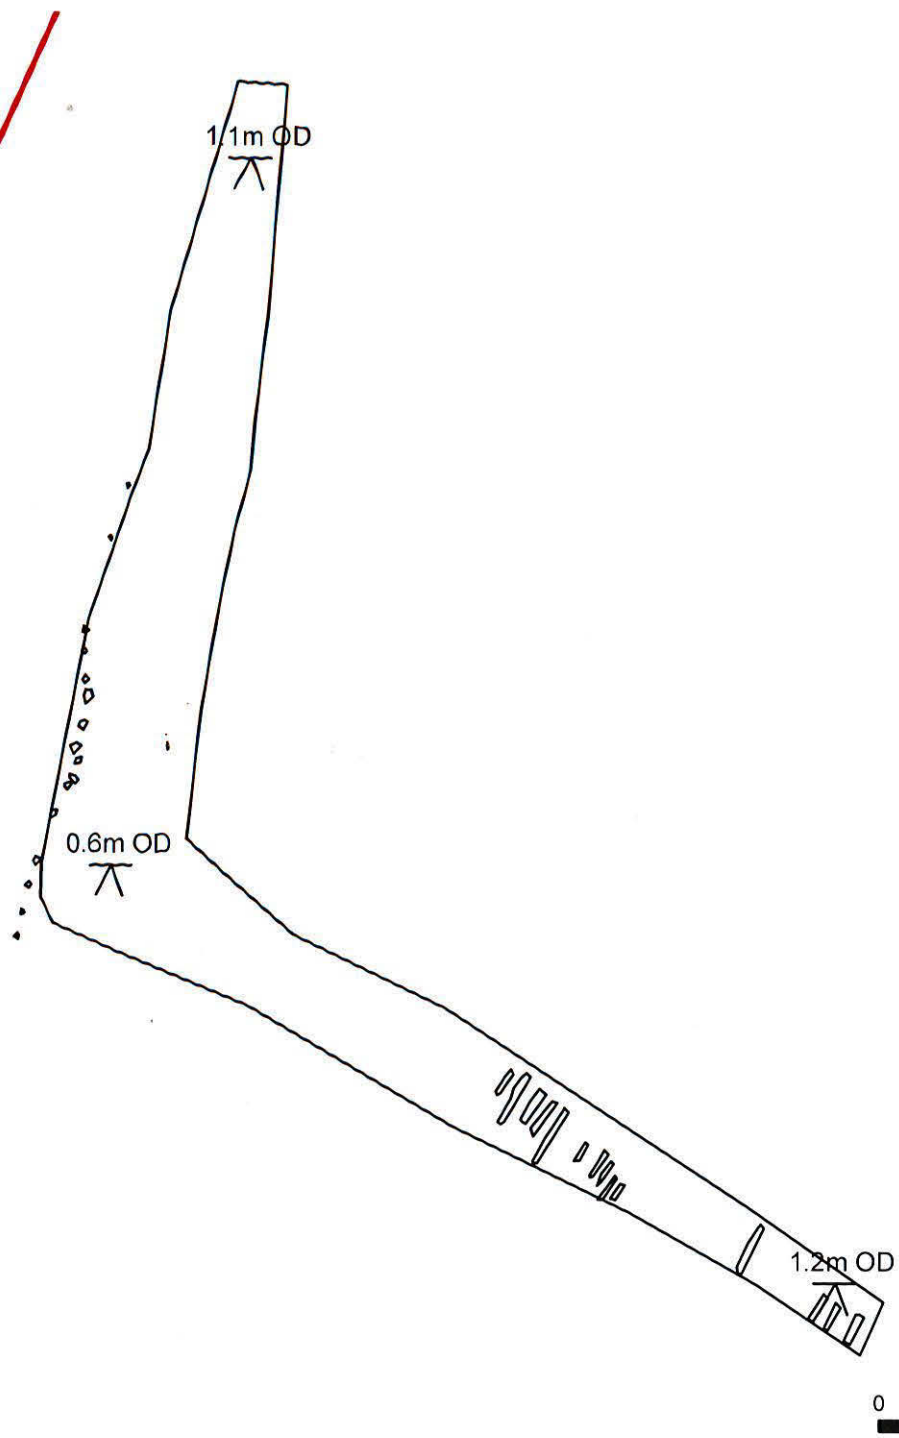
Fig 5 The wharf

- 4.8.1 In the north-west of the site the remains of what appears to be an 'L' shaped wharf was recorded, measuring c 29m x 34m. The central grid reference of the wharf was NGR 587564 206623.
- 4.8.2 The wharf appears to have been constructed by dumping masonry and ferrous slag onto a raft of timber planks. The seaward side was revetted by a number of posts and planks driven into the foreshore, twenty four of these were observed during the survey.

- 5.1.6 An 'L' shaped wharf was recorded in the northwest of the site built of ferrous slag and masonry being dumped onto a timber raft. The wharf is first marked on 1924 Ordnance Survey map. It may have been used for moving agricultural products off the island or building materials on to it. The slag and masonry which were used to build up the wharf could have been brought to the island as ballast.
