ANKERWYCKE FARMHOUSE
Magna Carta Lane
Wraysbury

Archaeological standing building survey

July 2007

Site Code: BR-AKW06
National Grid Reference: 500520 173240

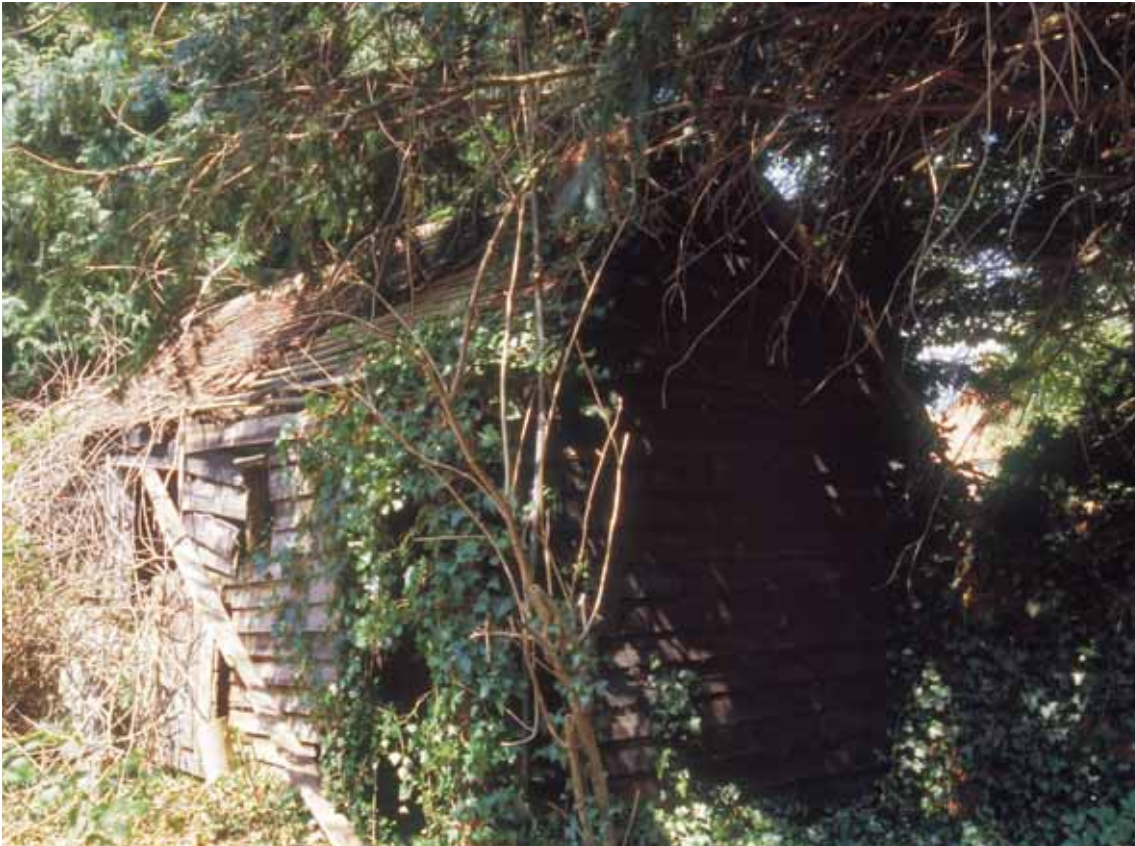
The outbuilding to the north-west of the farmhouse may have been constructed at about this time. This was a small, long, relatively narrow single-storey shed, timber-framed and boarded, under a tiled roof (Figs 22 and 23). This shed was divided into three spaces by transverse timber partitions, the two larger spaces to the east being paved with hard-wearing non-slip paviments and lined with smoothly-jointed boards, typical of stables. This outbuilding first appears on the 1932 map (Fig 15), and could have been added at any time between then and the date of the previous large-scale map, of 1869 (Fig 14), on which it seems not to appear. The paviments were of a type commonly used in the late 19th and early 20th centuries. There was no space in this outbuilding, nor doors large enough, for a pony trap or similar vehicle, although the existence of stabling sufficient for a pair of horses suggests they were intended to pull a vehicle. Possibly, if a vehicle were needed by the residents of the farmhouse they took it from Ankerwycke Farm or the stables of Ankerwycke House. Perhaps the other outbuilding shown to the west on the 1932 map, and not otherwise known, was intended to house a horse-drawn vehicle; later it may have been a garage; later still, it must have been demolished. A single cast-iron gate post survived in the south-west corner of the site, suggesting that the main approach to the house was from the road there, near the outbuildings.

Fig 22 Exterior of the stable shed, looking west

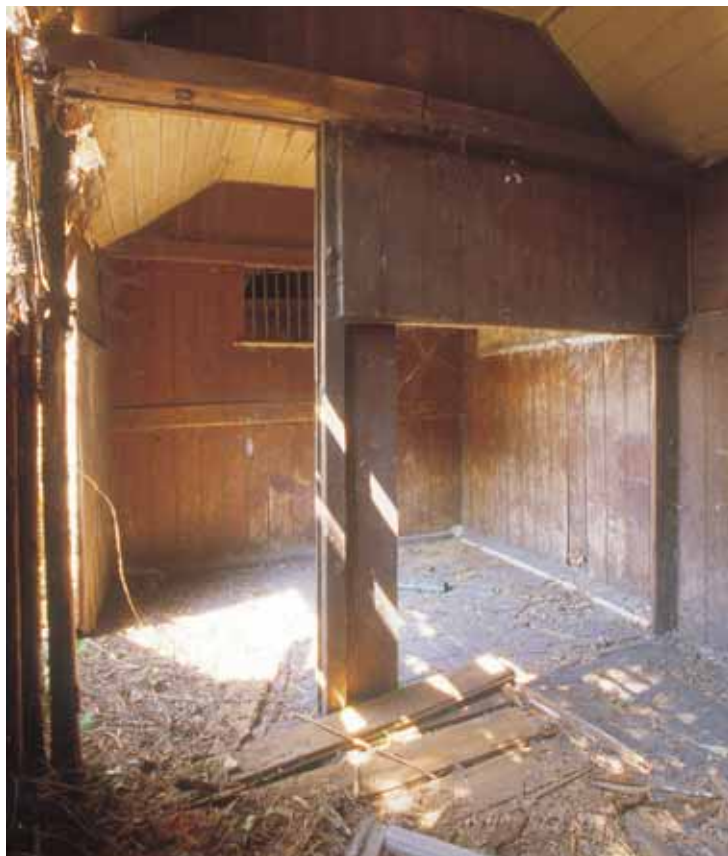
Fig 23 Interior of the stable shed, looking west

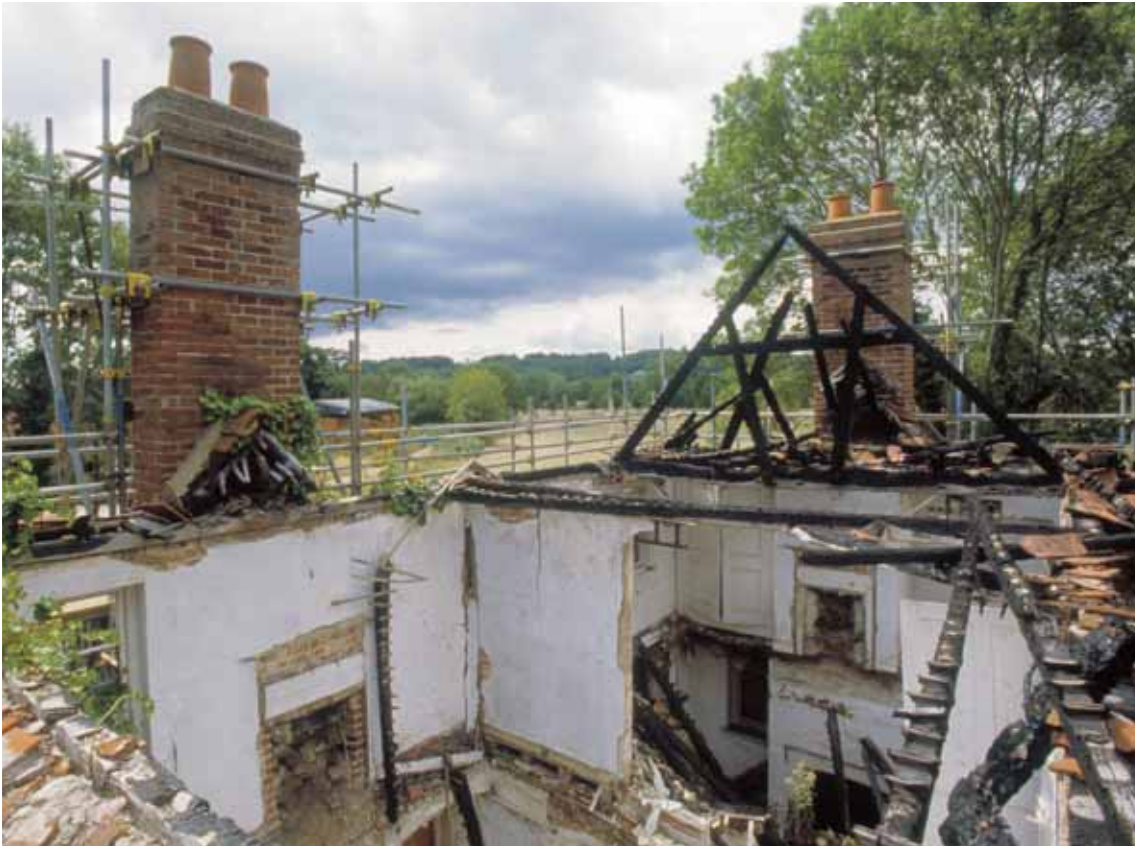
Fig 24 Looking south-west at eaves level into IF3 and IF4. The roof truss was the only major group of roof timbers still in situ

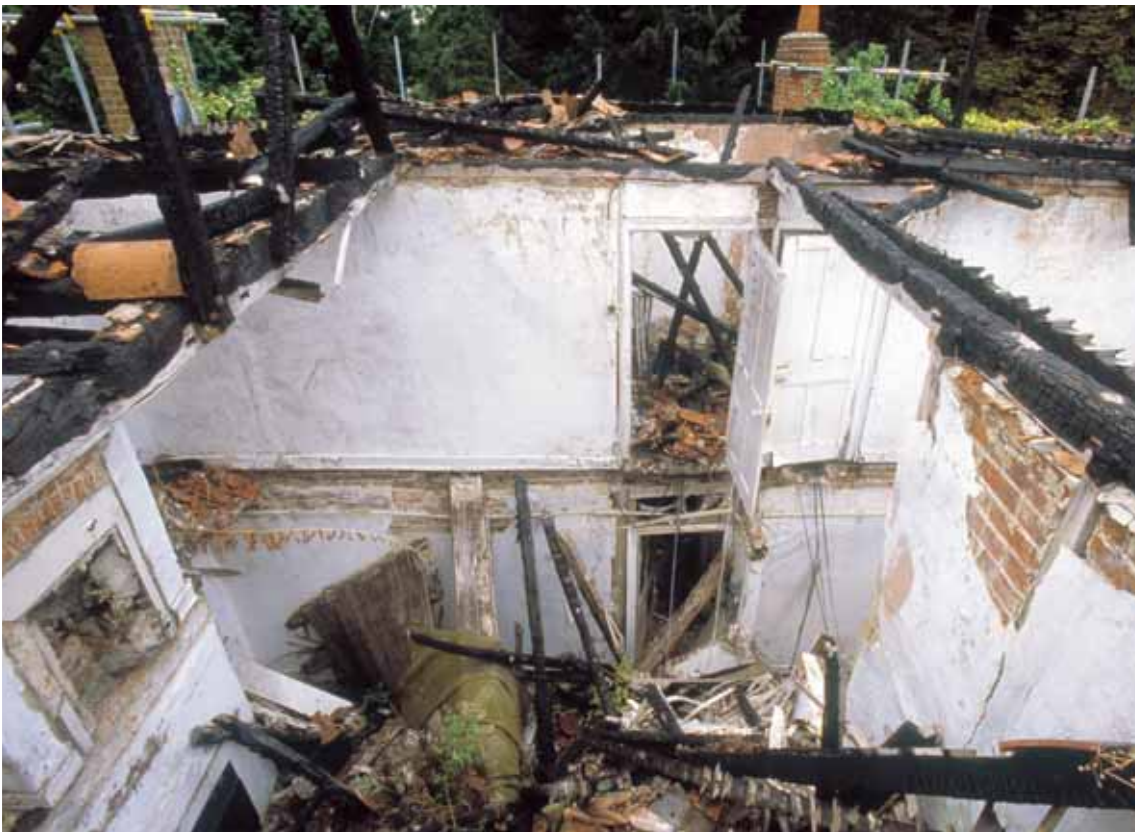
Fig 25 Looking north at eaves level into IF4 and G2. The stud and brick north-south partition wall had partially collapsed

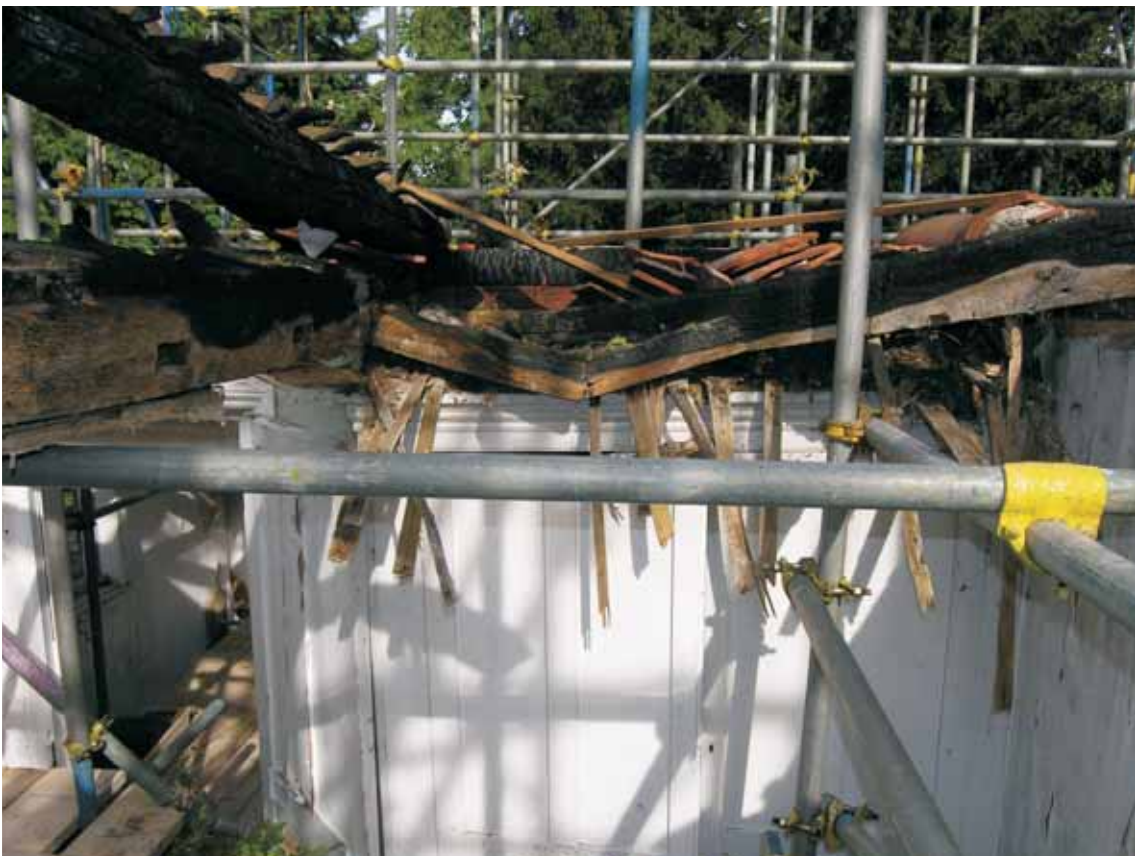
Fig 31 Partially collapsed roof remaining over IF5, looking north

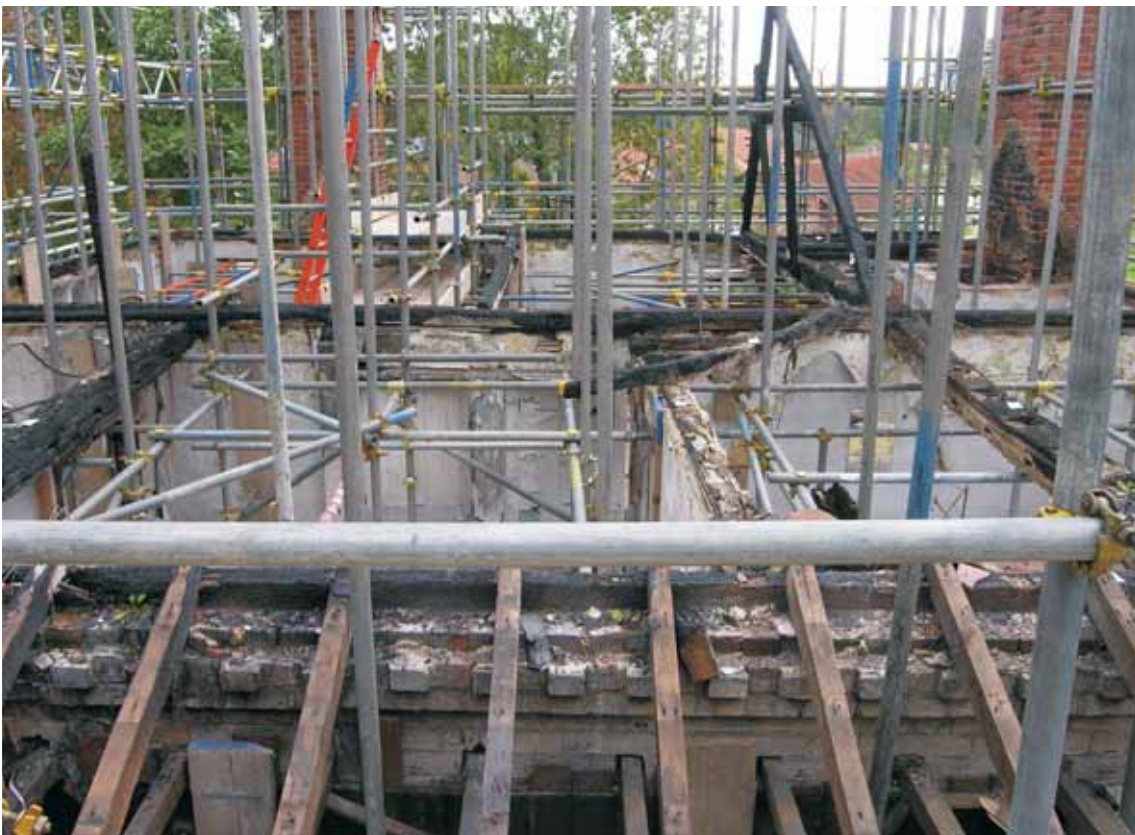
Fig 33 Dentilled brick eaves of the original external north wall of the cottage (foreground), to which a lean-to extension was later added, looking south

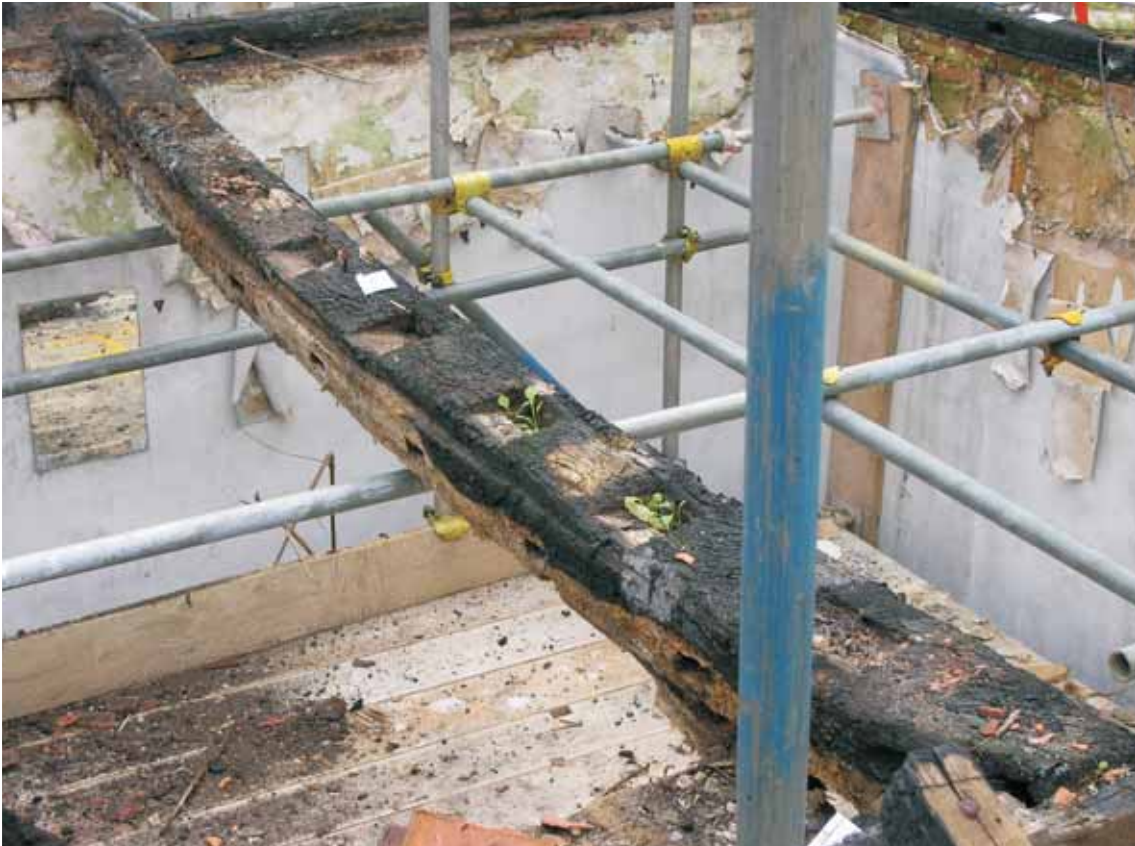
Fig 34 Detail of empty joints for seating rafters in a tie-beam over IF5, looking south-west

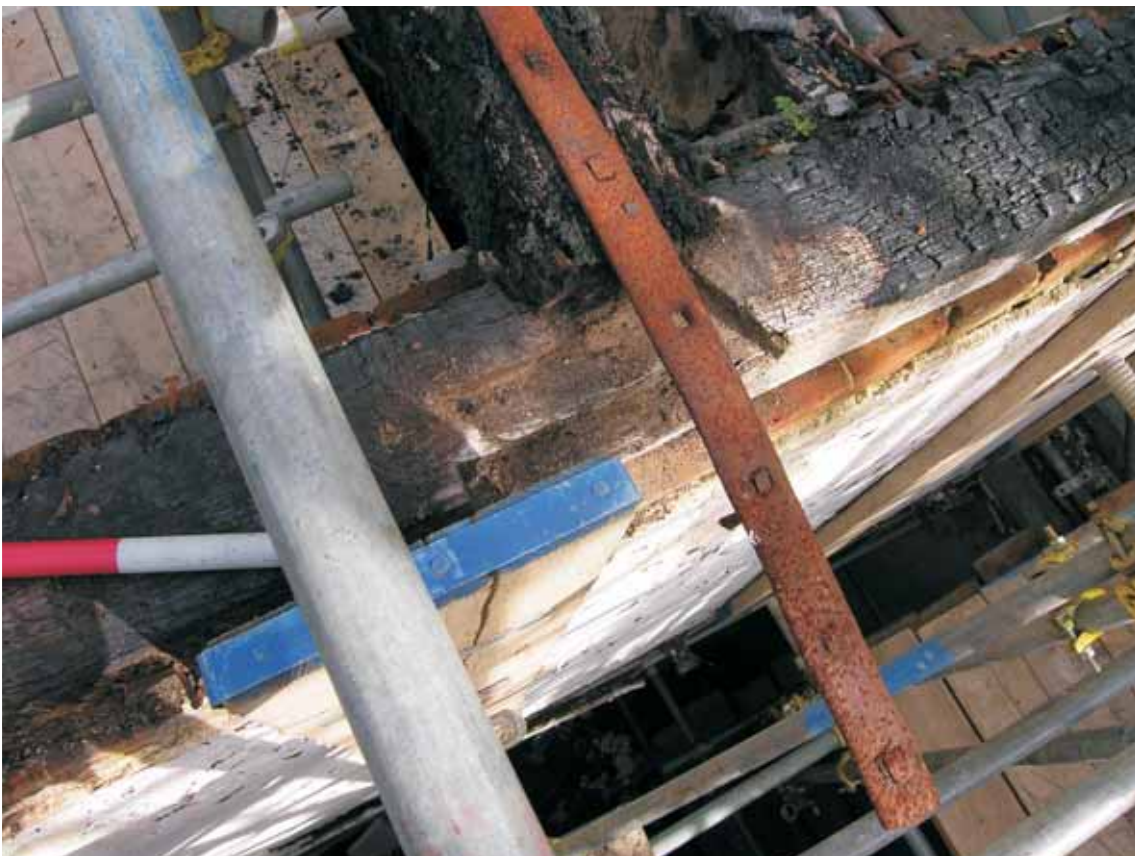
Fig 37 Iron strap across central wall plate, nailed to tie-beams to north and south (the latter burnt away), looking north-east

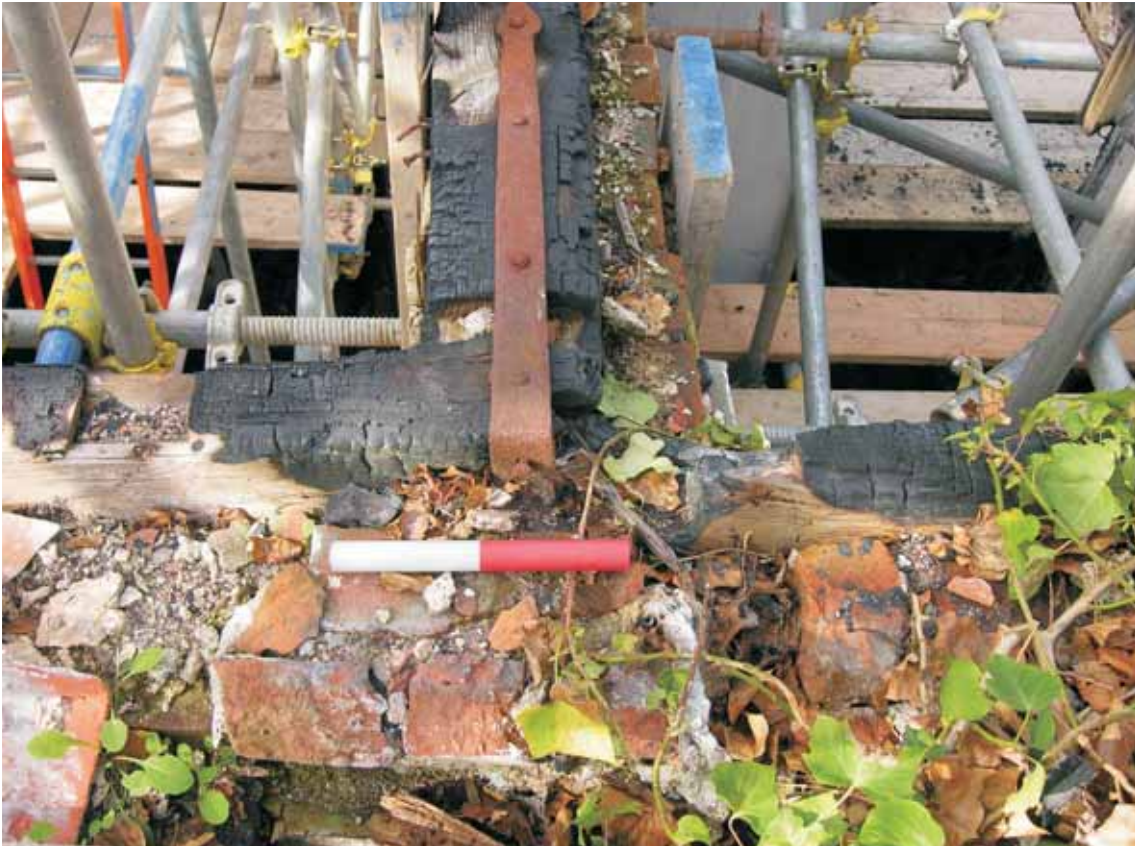
Fig 38 East end of central wall-plate, strapped to the plate on the external wall. The latter wall has moved outwards, breaking the wall plate on it immediately to the north of this joint

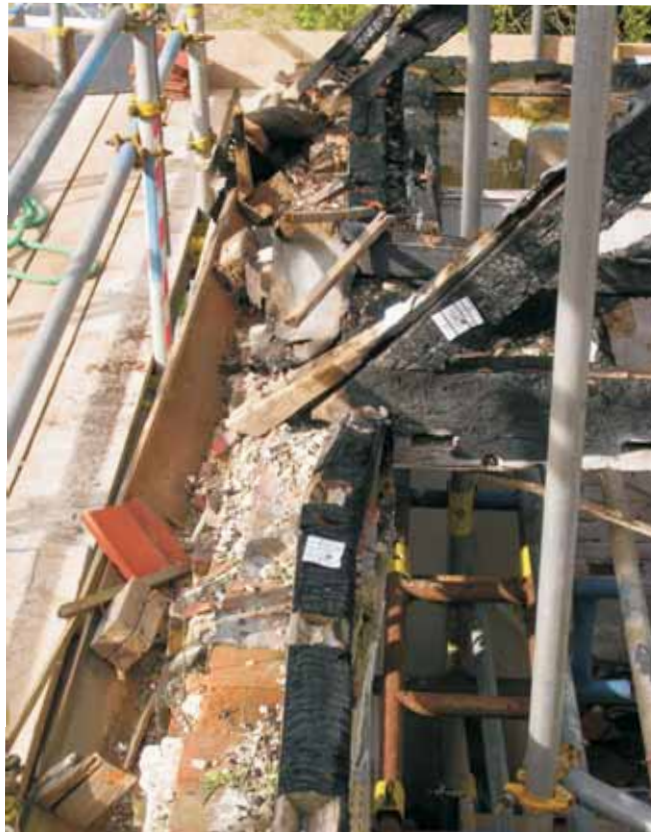
Fig 39 Wall plate on south external wall, broken where it has been pulled north by a tie-beam over IF4, looking west
