**VALENCE HOUSE**  
**Becontree Avenue**  
**London RM8**

London Borough of Barking and Dagenham

Watching Brief Report

February 2010

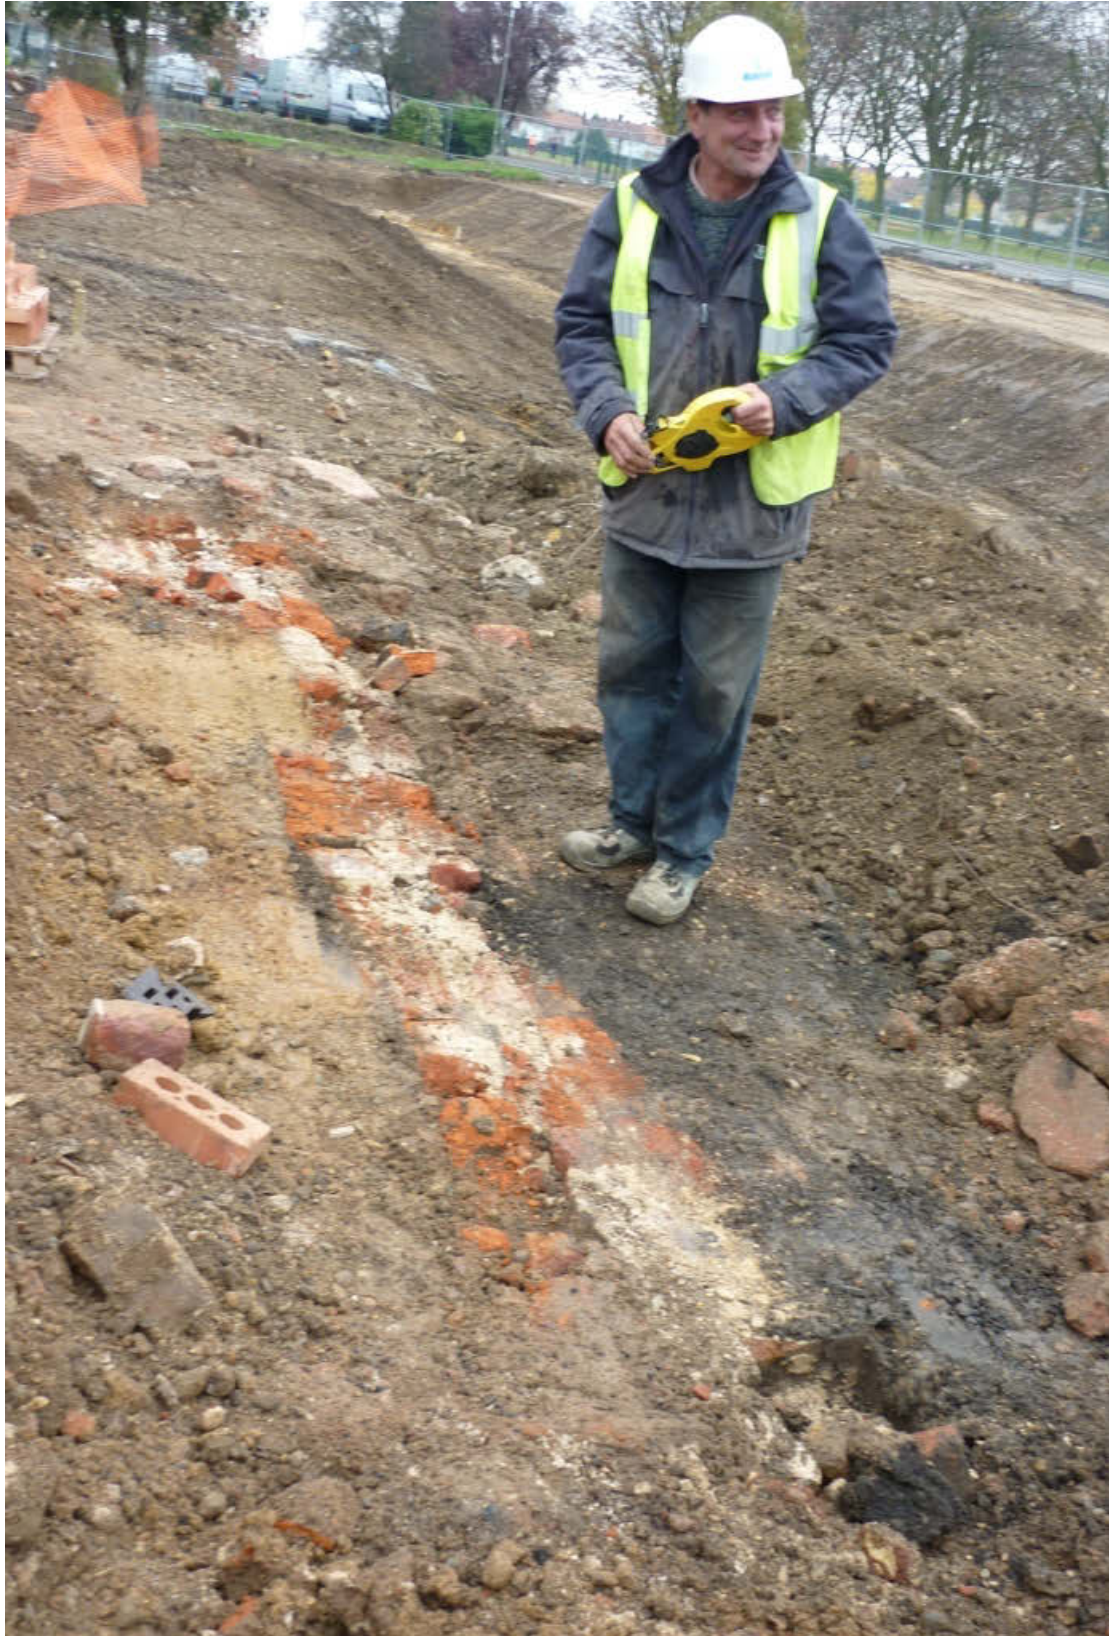
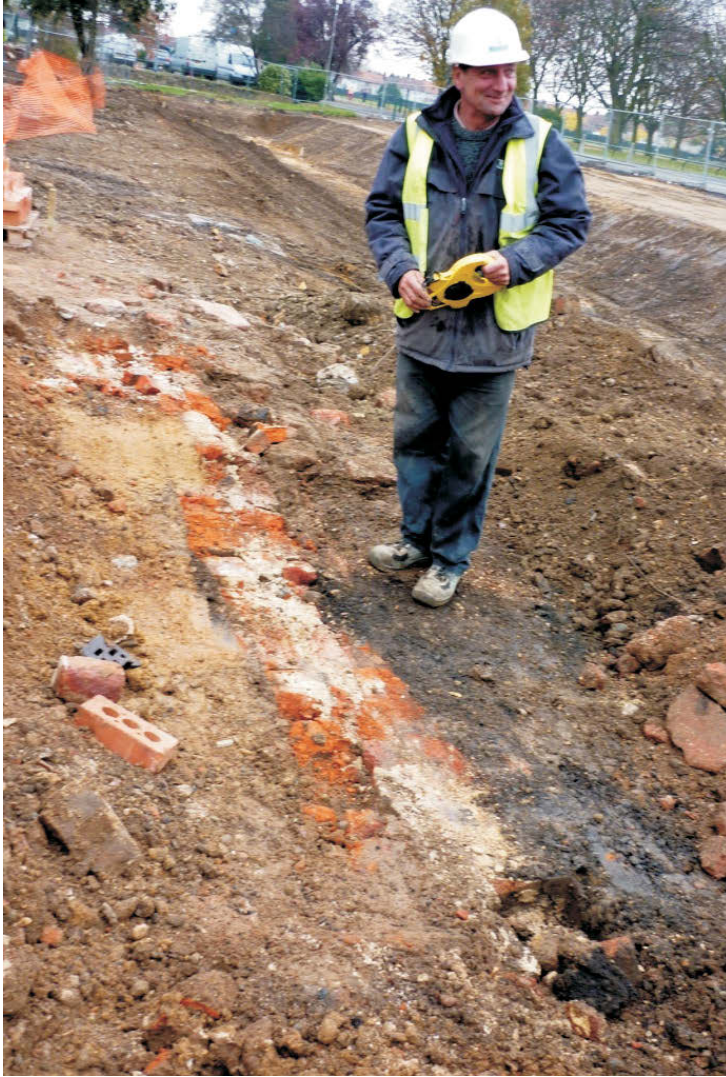
Fig 4 Foundations of old barn exposed in landscaping near to new moat

The wall foundation is located where the old barn is depicted on historic OS maps and was presumably its foundation. A single brick was examined by MOLA building materials specialist Dr Ian Betts. He suggested that the bricks are consistent with late 17th- or 18th-century technique. The fine moulding is indicative of an 18th-century date (Dr I Betts pers. comm.). The brick was not retained.

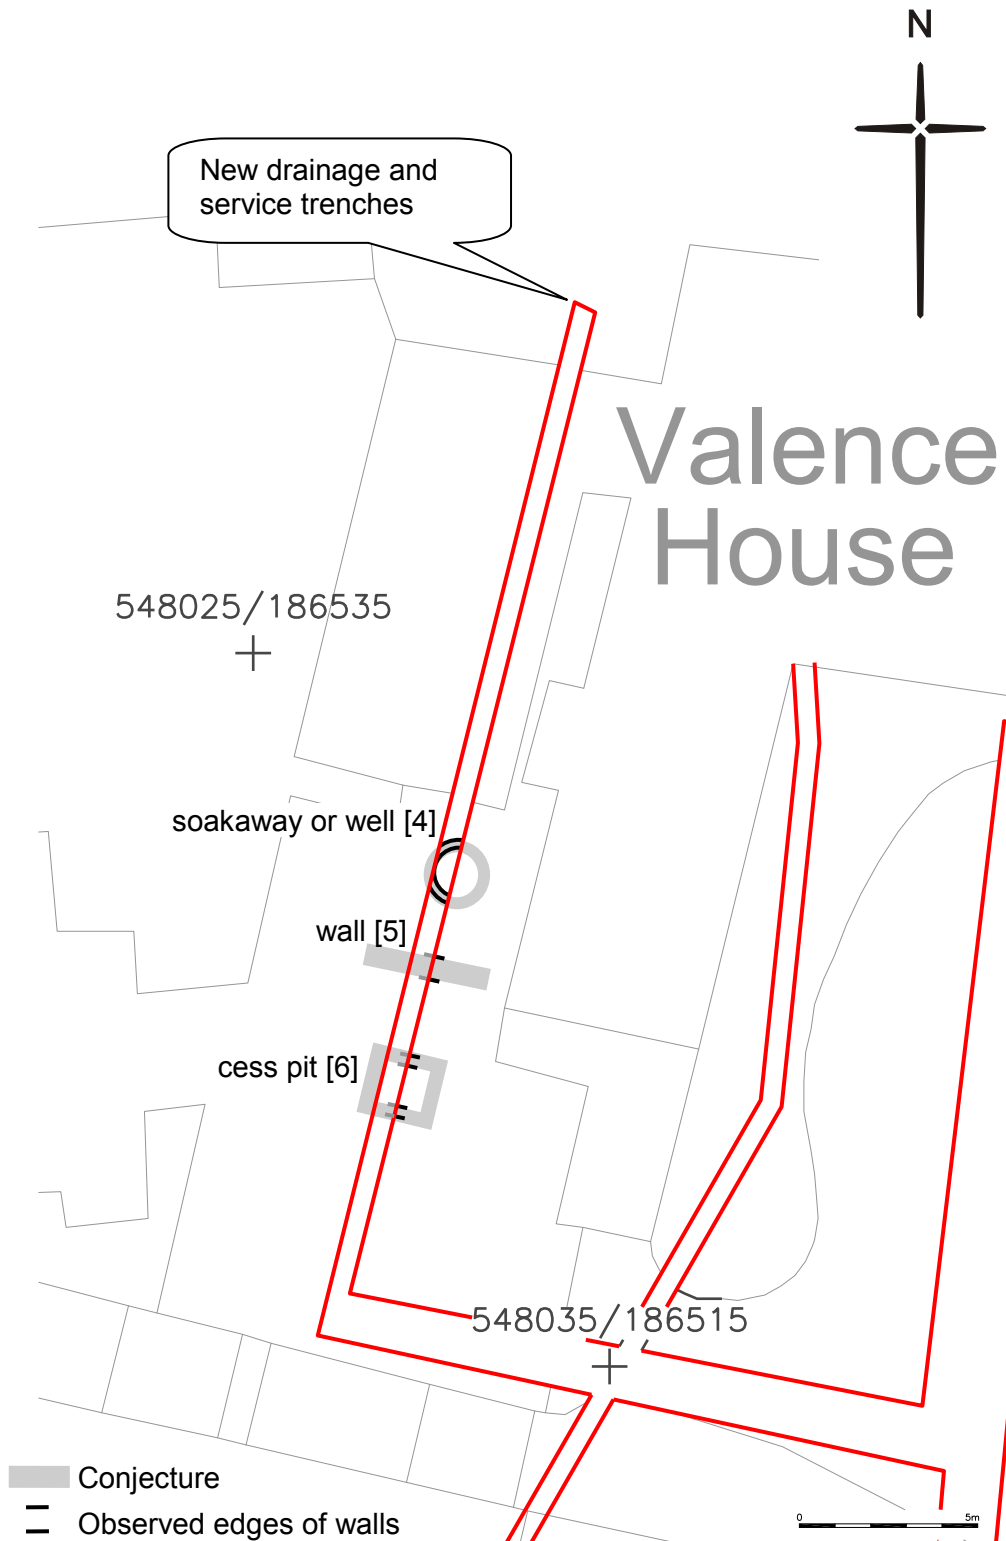
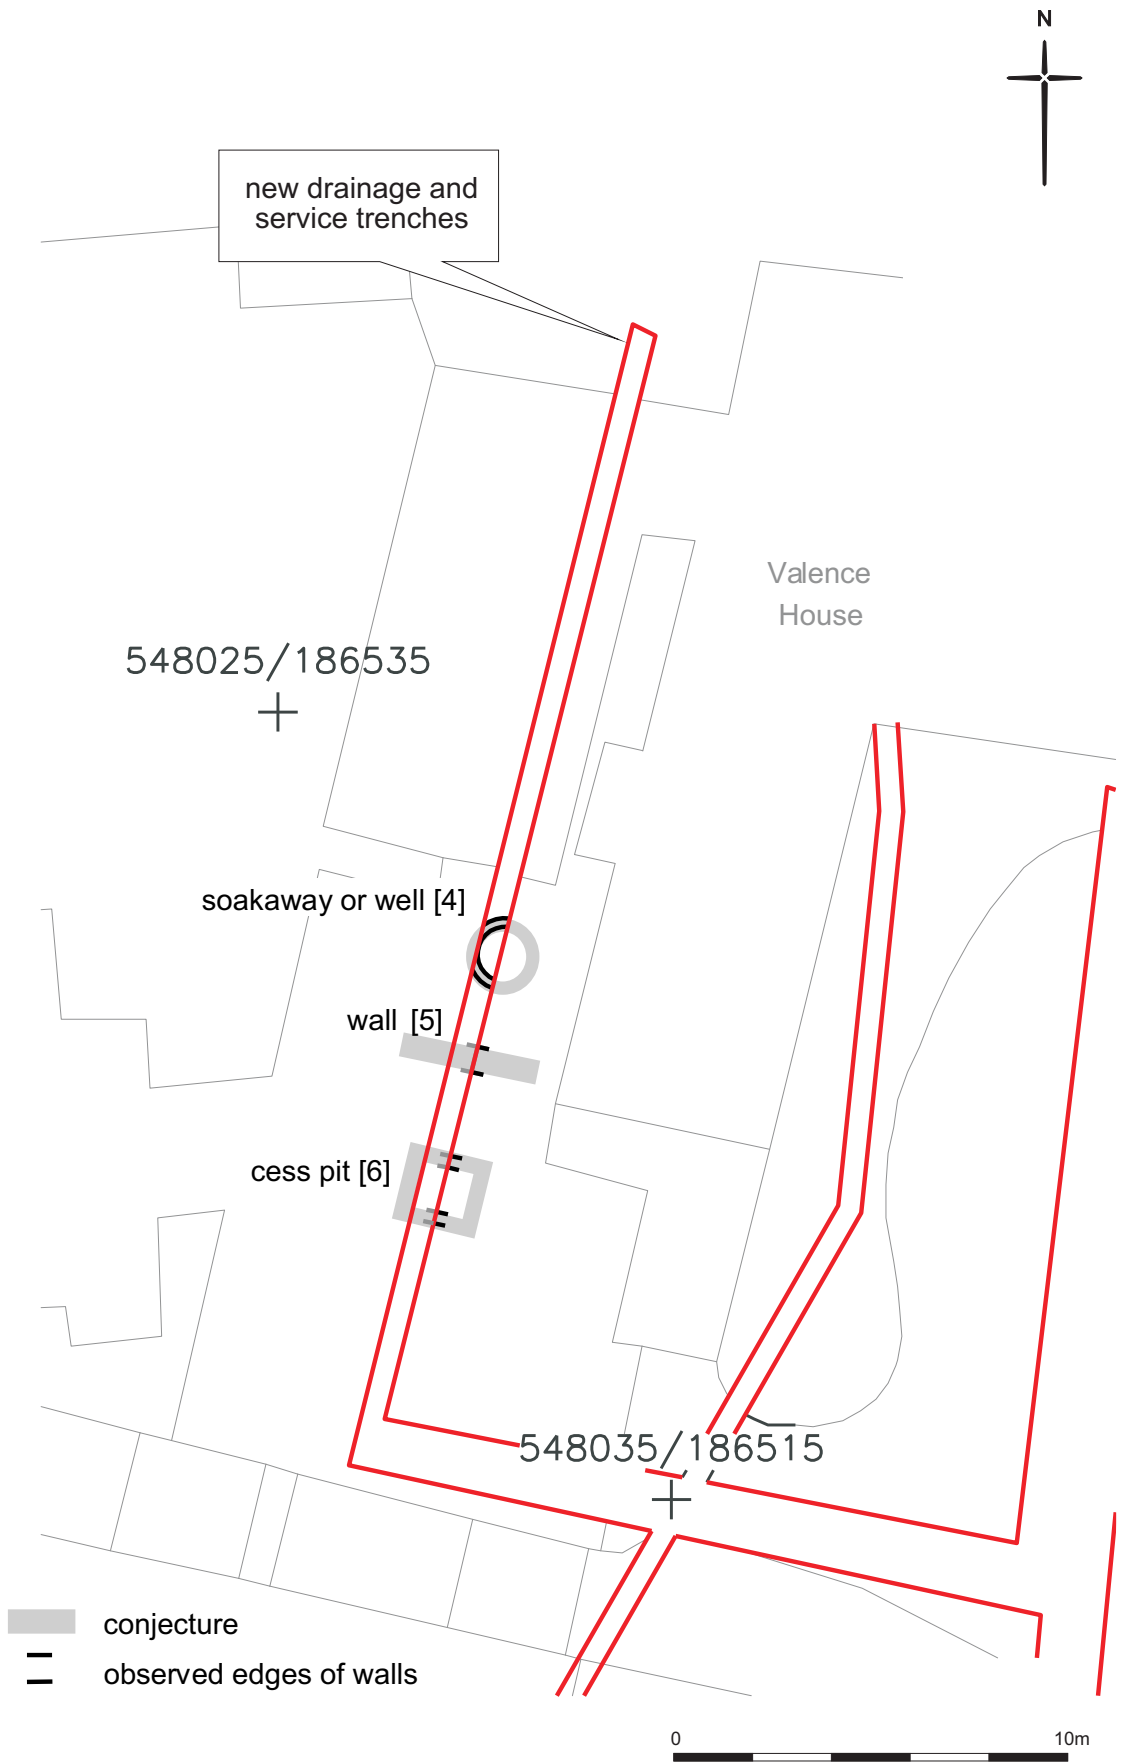
Fig 5 Archaeological remains west of Valence House

- a domed circular brick structure [4], just to the south of the external chimney of Valence House, constructed in yellow stock brick. Its walls were 0.22m thick and its internal diameter was 1.4m and it was at least 3.00m deep.
- 1.8m south of this in east side of the trench, a short length (0.66m) of wall built in red brick [5], was recorded.
- 2.20m south of this was a possible cesspit [6], constructed in chalk and red brick, whose walls were 0.3m thick with an internal dimension of 1.46m. This was seen to be aligned perpendicular to the trench and had been backfilled with brick rubble.

The features near to the house are considered typical of their setting. The domed structure [4], originally interpreted as a soakaway, was reinterpreted as a well as it is typical of wells using a pump to draw water. The end of a wall foundation [5] did not cross the width of the trench (600mm) and may have been a local foundation to a very slight structure – possibly an outside toilet connected to cess pit [6]. The proximity of possible cesspit and well need not preclude these interpretations as it is a relatively common occurrence on archaeological sites of all periods, and was the source of countless typhoid and cholera outbreaks in the 19th century.

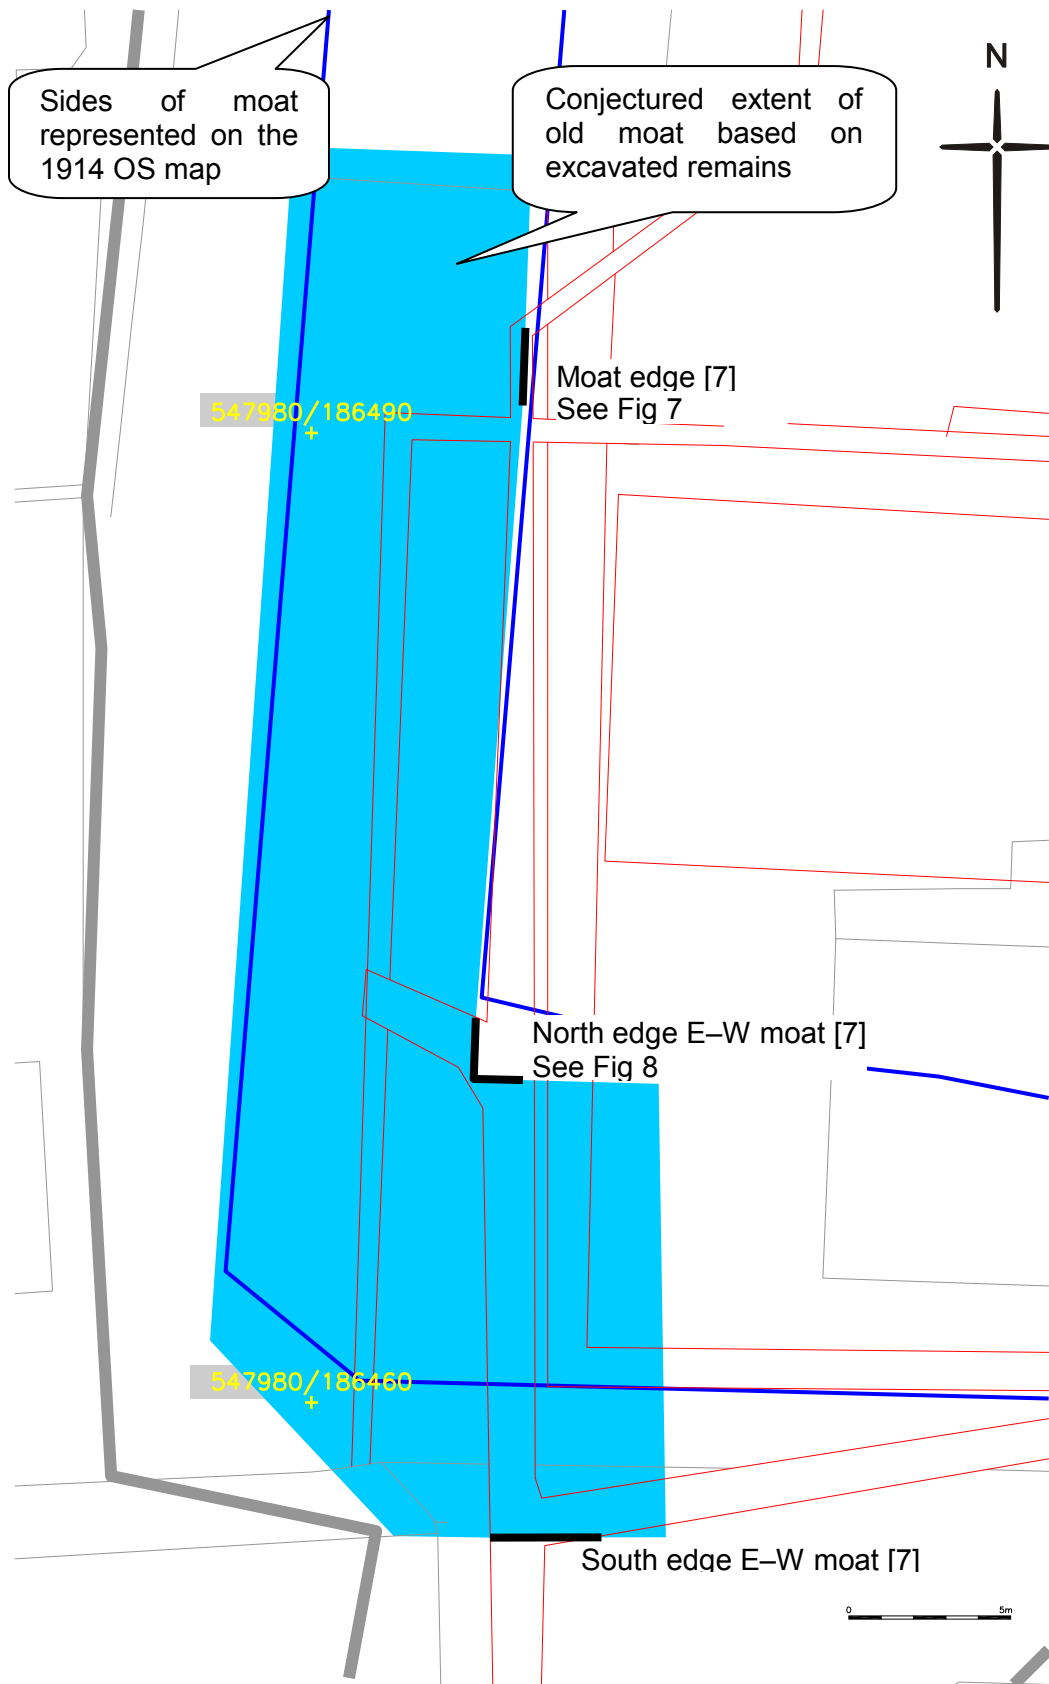
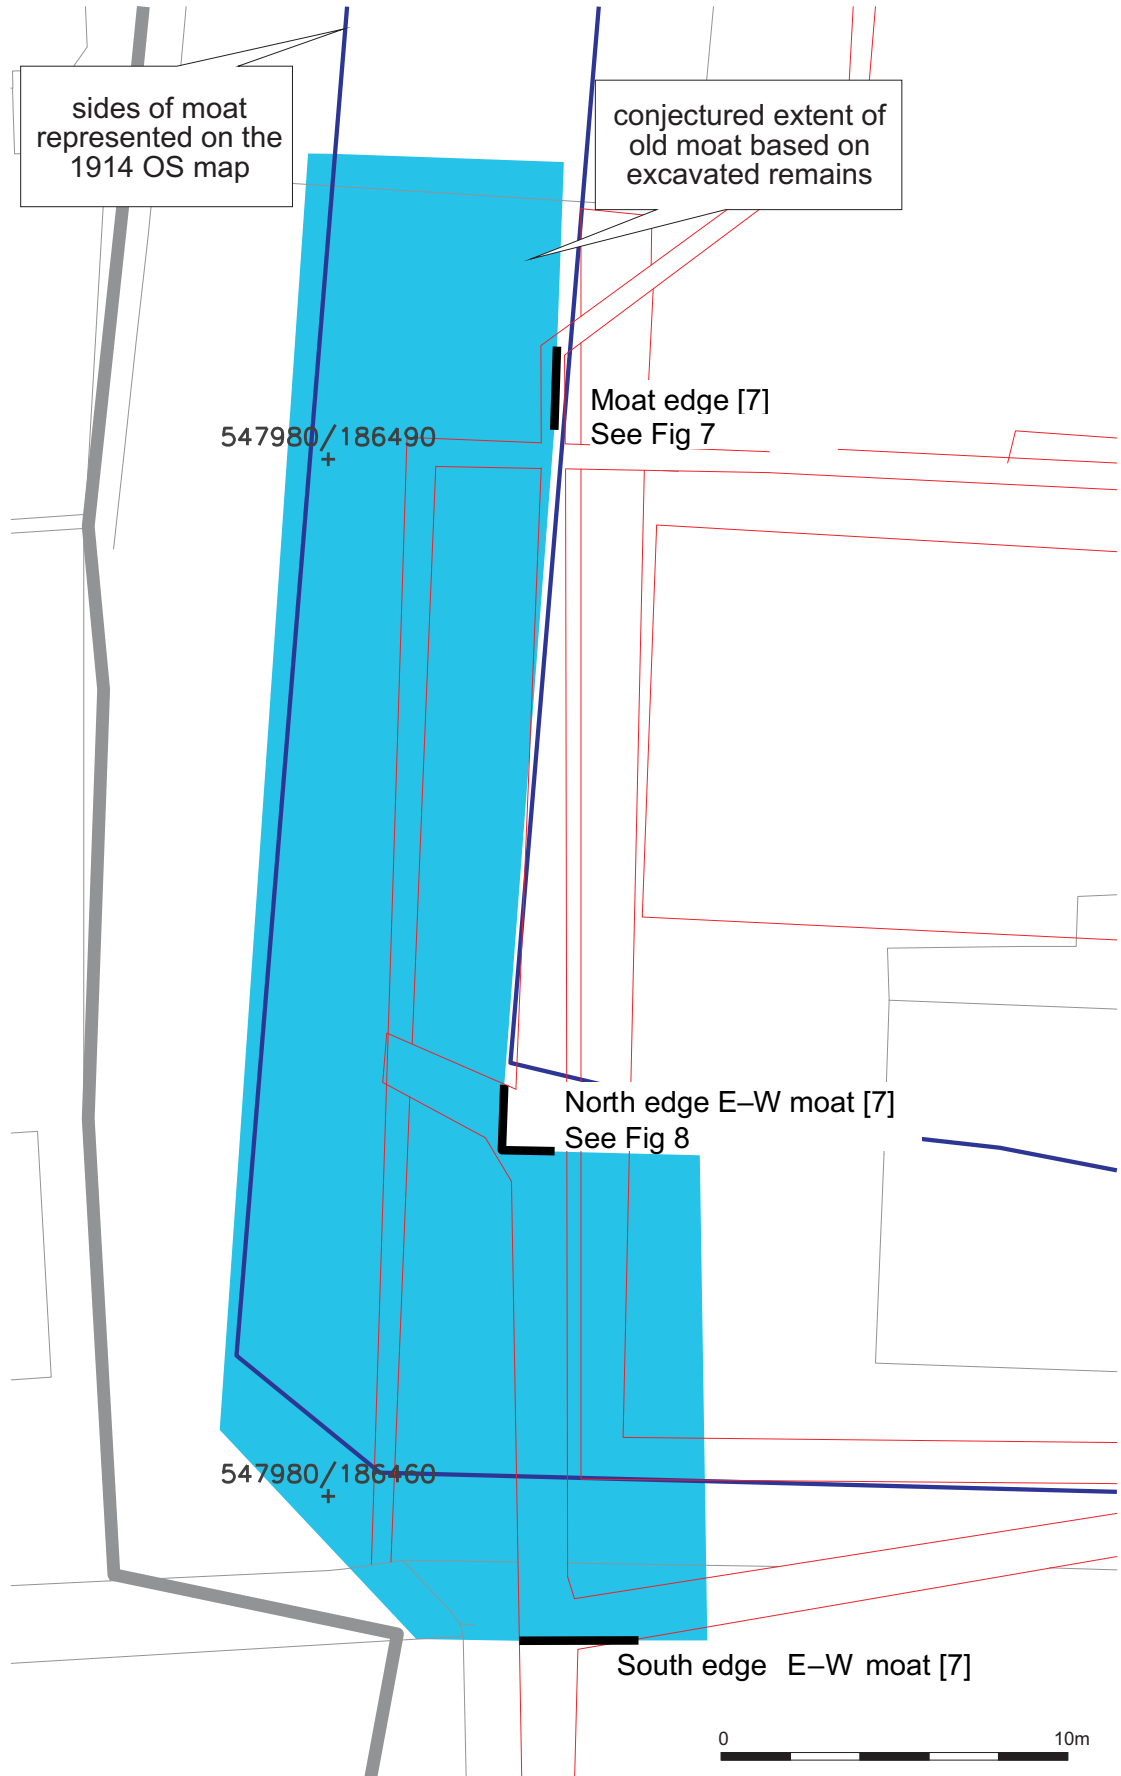
Fig 6 Remains of moat exposed in new drainage trenches

The edges of the historic moat were exposed in and around newly excavated manholes of drainage trenches east of the recently constructed Visitors Centre and south of the museum store (south-west corner of the site). It took the form of a shallowly concave cut [7] through natural brickearth sediments (here capping terrace gravels). The moat extending eastwards from the south-west corner was 14.17m wide. The width northwards of the corner could not be determined as only the east side of the moat was exposed. The cut was filled with a series of modern backfill deposits of gravel. Natural deposits near to the moat cut were stained darker but there was no distinct layer of silt at the base of the moat.

The moat edges were quite distinct and visible but were only revealed in a few places. Natural deposits near to the moat were stained darker through the action of water, either as a result of transporting clays and organics through the underlying sediment, the transport of metal salts in the earth, or through the root action of plants in the moat. The total width of the moat (14.17m) was wider than that recorded in the 1918 OS map (11.75m).

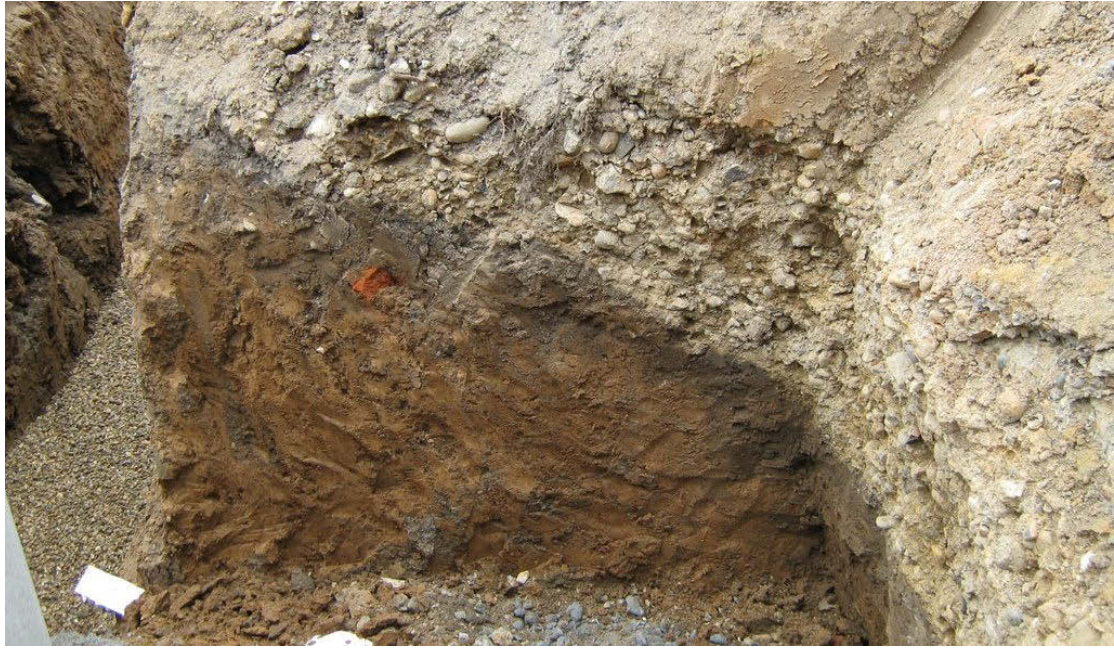
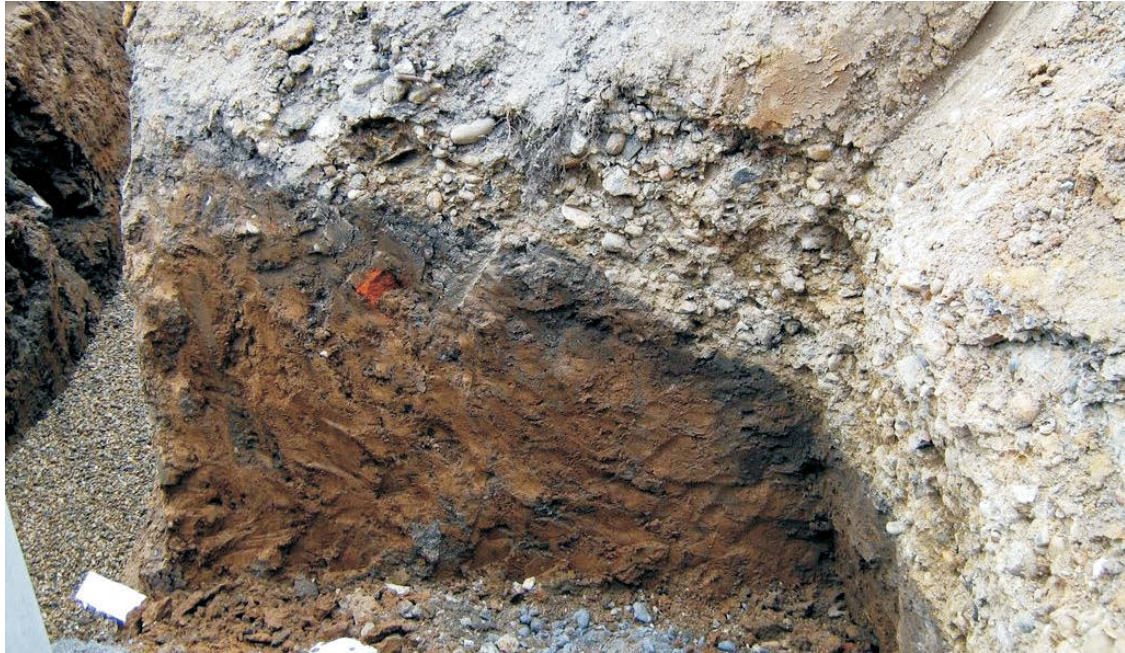
Fig 7 East edge of moat [7]  
Observed “around the northernmost manhole south of the green shed” ( Museum Store) See Fig 6 for location

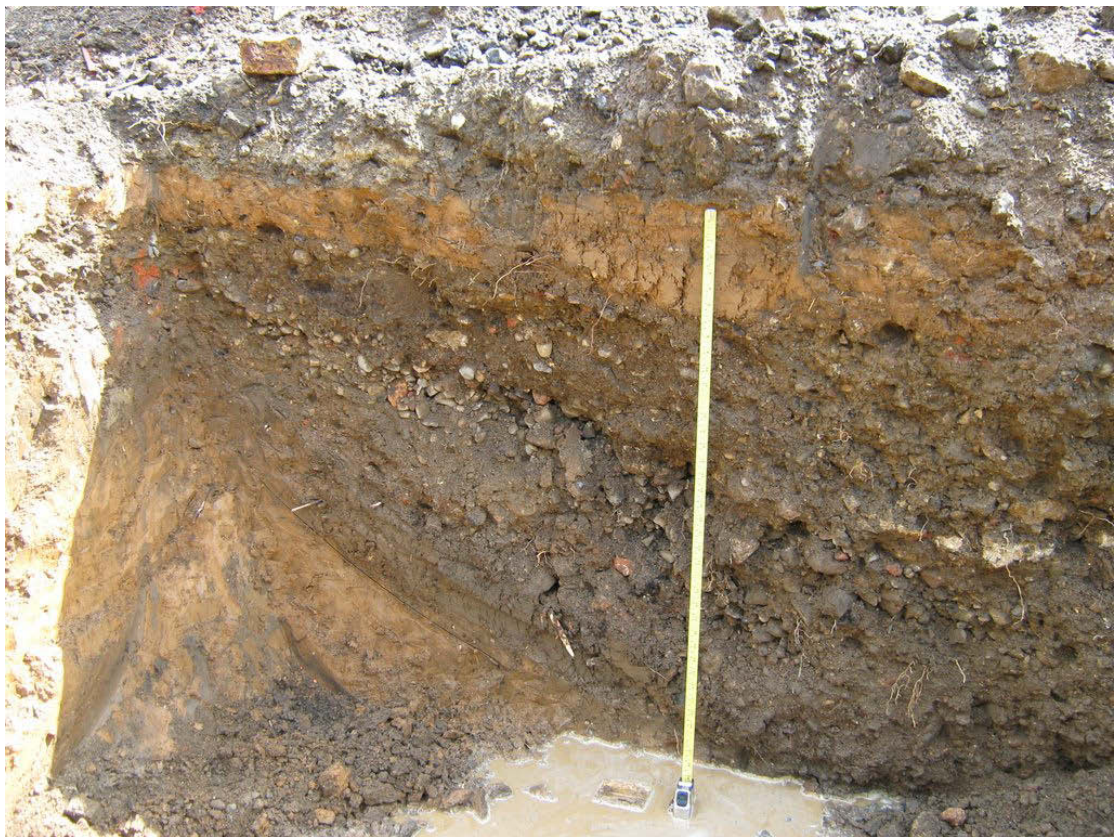
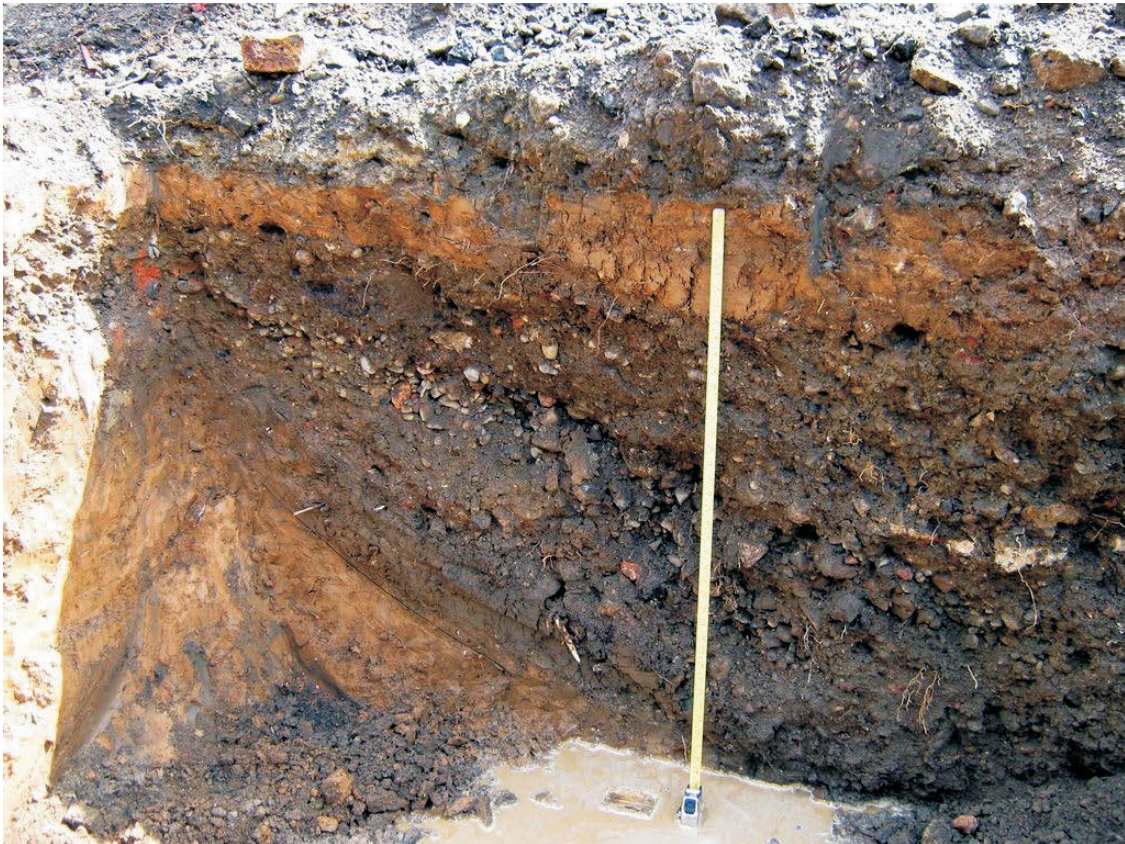
Fig 8 North edge of moat [7]  
Tape is 1m long, see Fig 6 for location

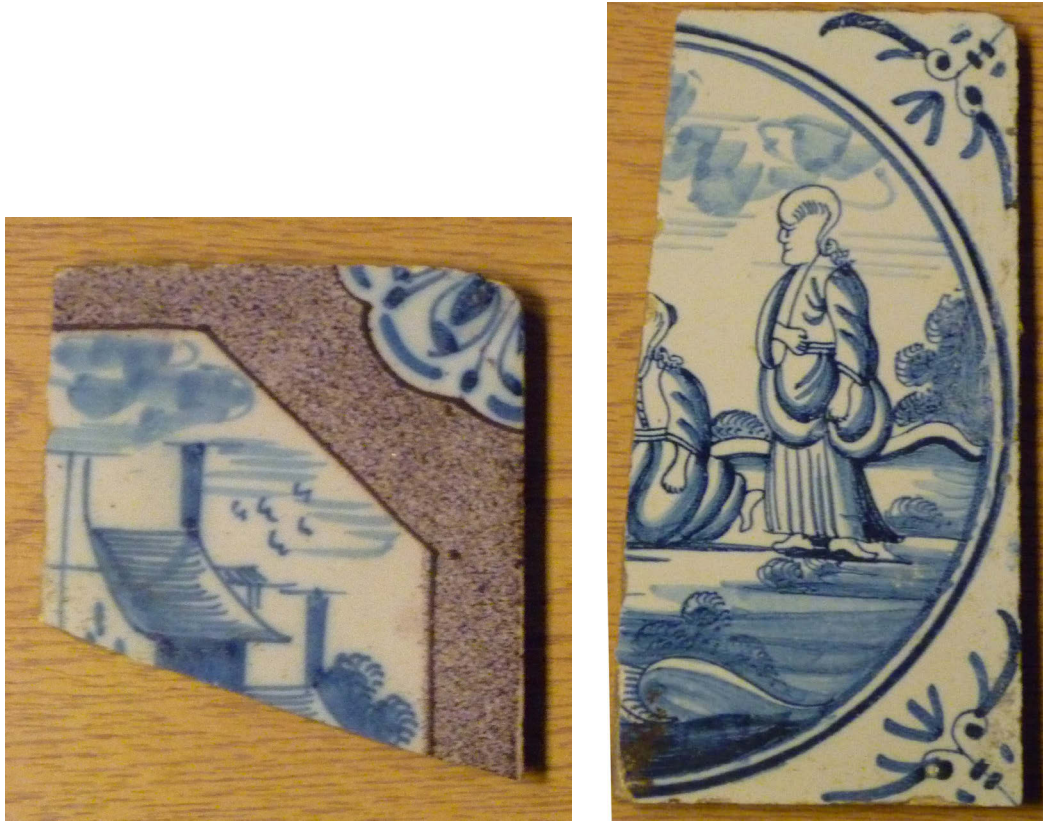
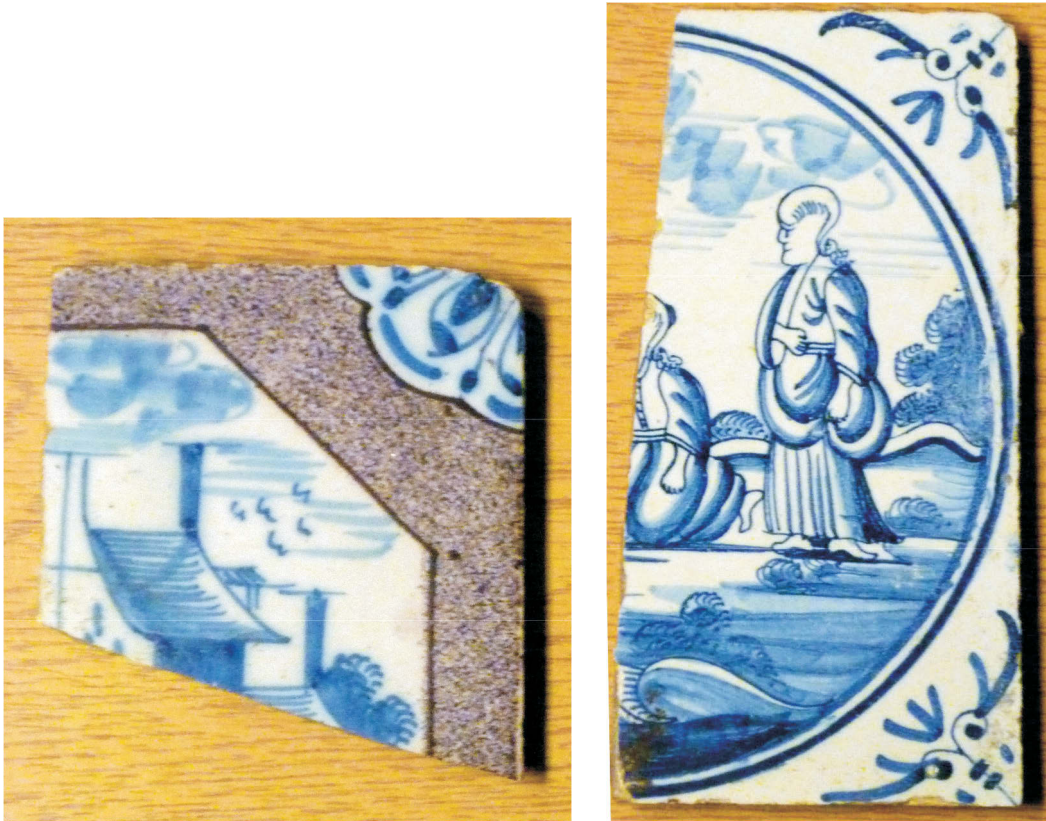
Fig 9 Tiles found in the void beneath the first floor and ground floor ceiling  
Dutch or London-made 18th-century tin-glazed tile (left) and Dutch 17th- or 18th-century tile (right)

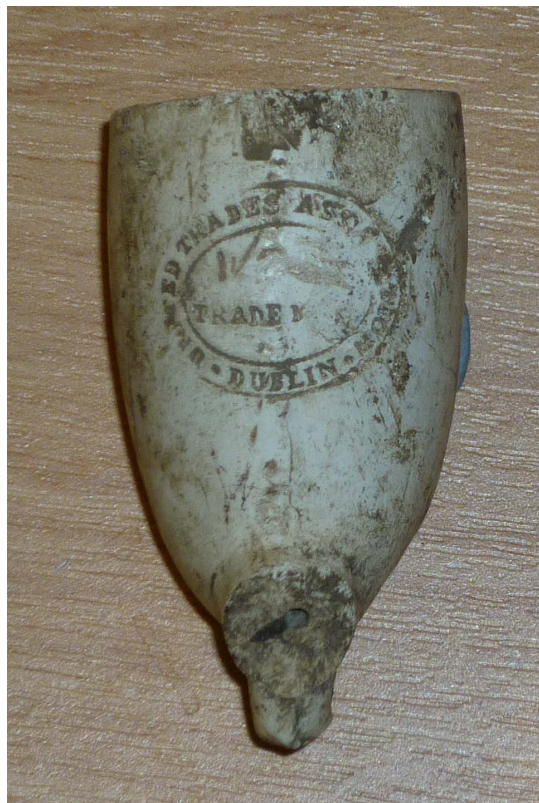
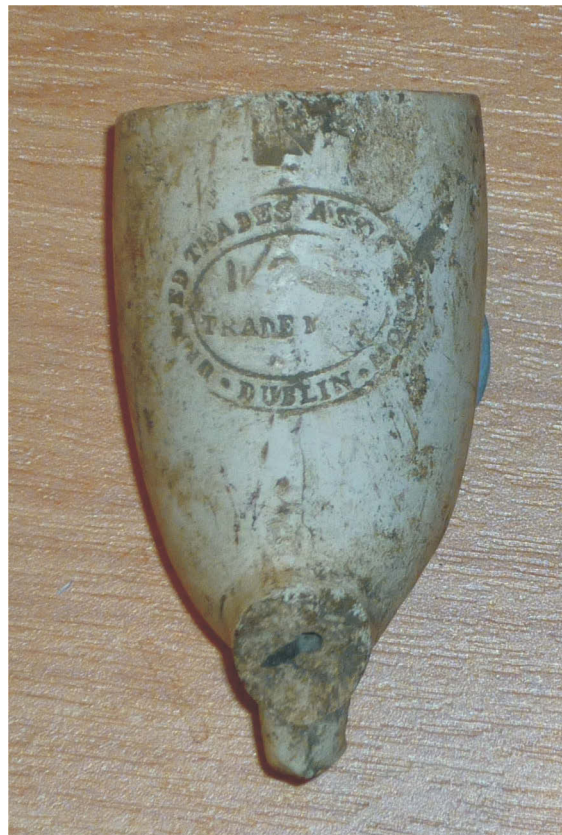
There were no Palaeolithic remains in the top of natural substrata in any of the exposures. An unstratified find of a clay tobacco pipe, inscribed with the United Dublin Trades Association (founded in the 1860s) indicated the 19th-century immigration of Irish “navvies”. It was returned to Valence House Museum.

Fig 10 United Dublin Trades Association tobacco pipe  
Unstratified find by workmen during general landscaping.
