Archaeological buildings assessment of the barns at Home Farm, Lyddington, Rutland

Report 10/106

July 2010

**ARCHAEOLOGICAL BUILDINGS ASSESSMENT OF THE BARN
HOME FARM, LYDDINGTON, RUTLAND
JUNE 2010**

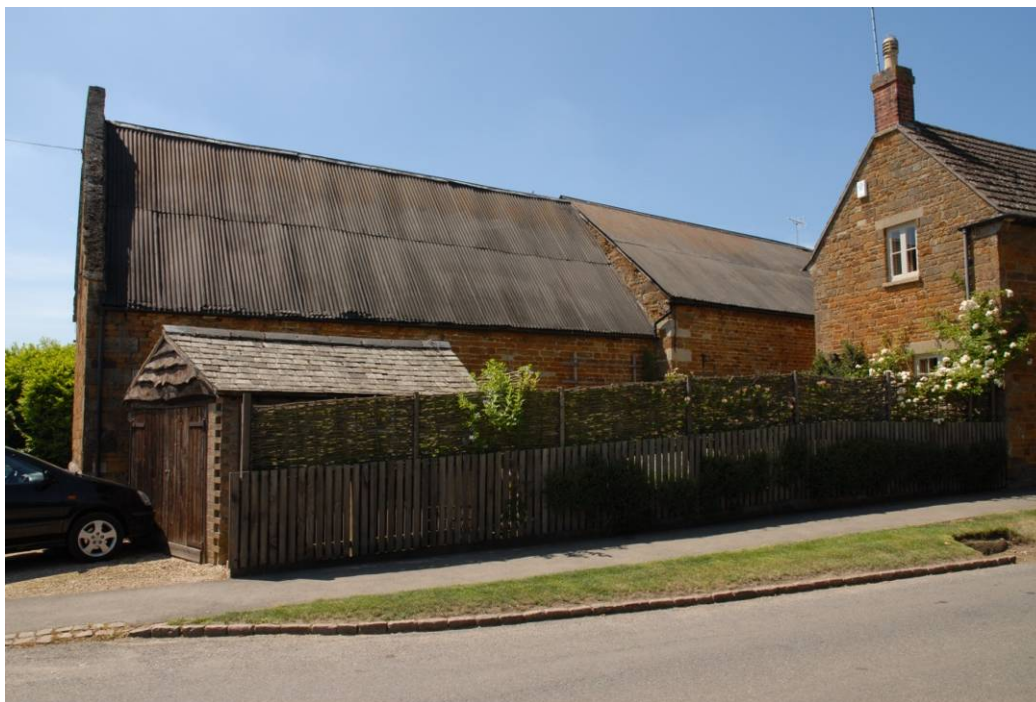
Barns 1 and 2 obscured by 39 Main Street

The buildings front onto the farmyard, more recently a parking area. Although the building line is not flush, the buildings are of a fairly uniform height and style. The rear view of the buildings from the road is obscured by the house, garage and garden of number 39 Main Street (Fig 6).

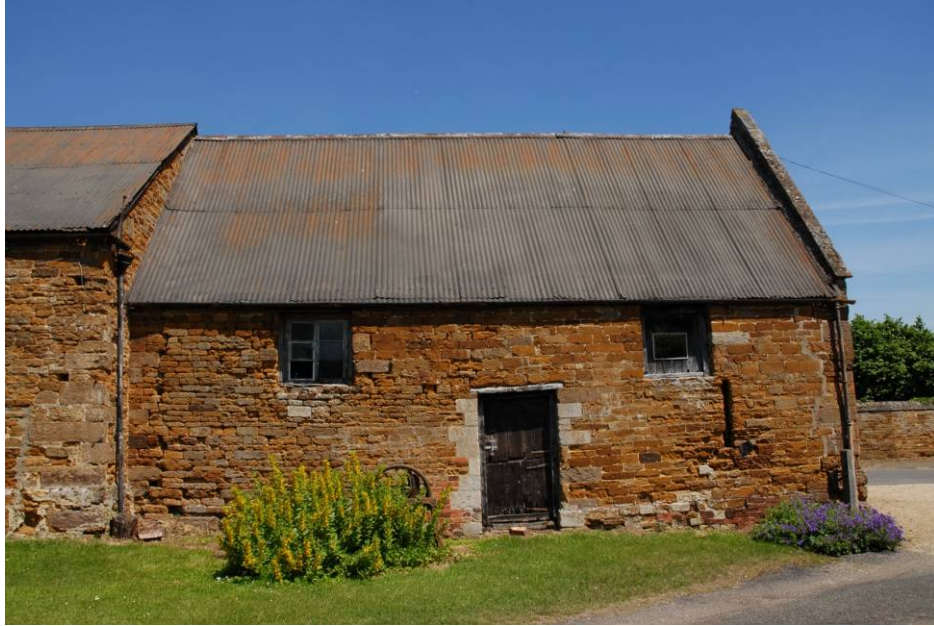
Barn 1, west elevation Fig 7

The walls are of roughly coursed, dressed ironstone rubble bonded with lime mortar. Quoins have been used in each corner, although not in every course where the building joins Barn 2. There is a chamfered plinth on the gable wall, but repair work has erased evidence of this to the western elevation. External repairs have been carried out using limestone, bricks and cement mortar. Structural repairs have also been carried out: a buttress has been built using ironstone in the south-east internal corner of the room and an iron reinforcing bar runs from the top of the ventilation slit in the gable along the length of the room; the external appearance is of rough crossed bars.

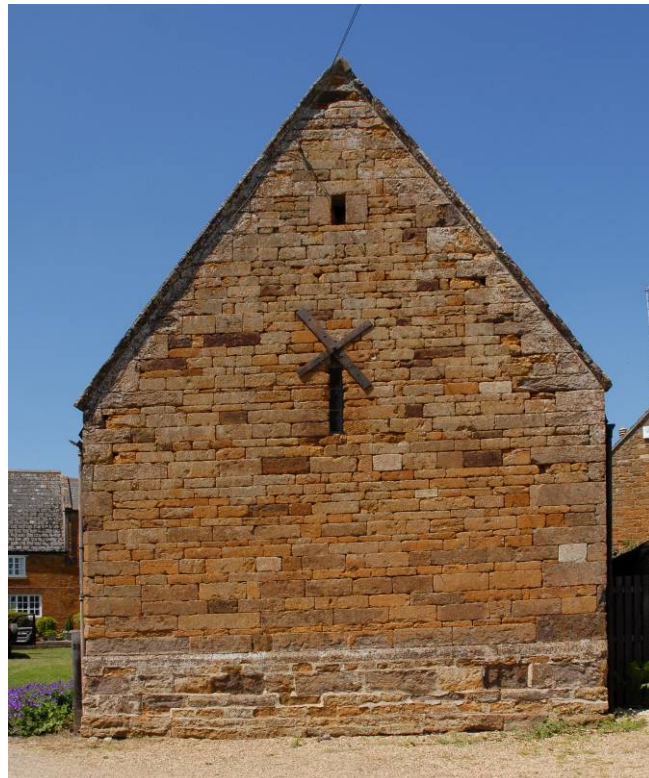
The gable wall of Barn 1 Fig 8

An owl hole in the gable wall (Fig 8) has been obscured internally by hessian draping (Fig 9).

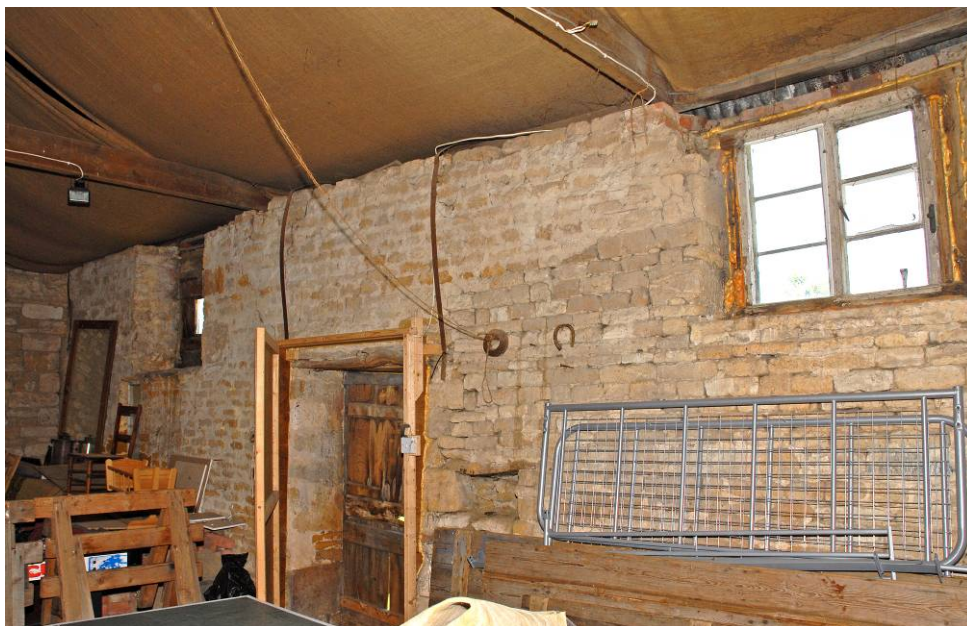
The west wall of Barn 1 Fig 9

This building is roofed with corrugated iron; the internal roof structure is mostly obscured by the aforementioned hessian, but enough can be seen to show that the roof timbers are modern. This is also indicated by the identical corrugated iron roof covering. The three-bay layout probably replicates the original roof structure.

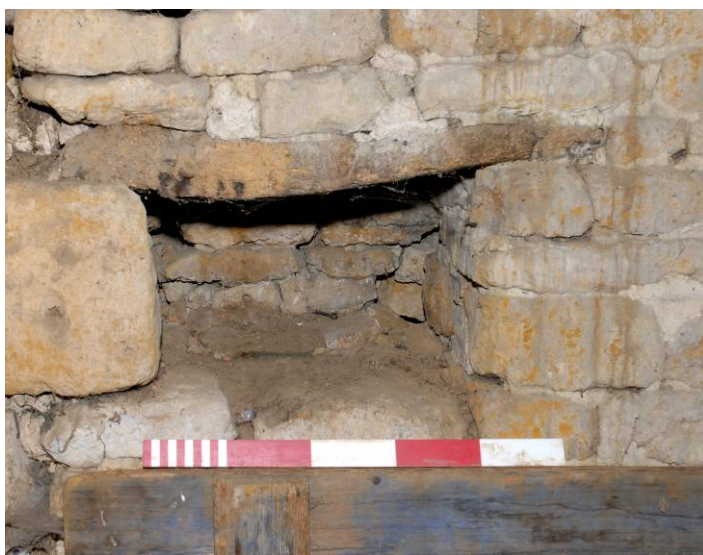
Niche next to the door in Barn 1 Fig 10

Apart from the roof, this southernmost barn has had little alteration. There is nothing to suggest the phasing of the windows, ventilation slit and doors, although the layout in the south-west corner of the room suggests that all the features being contemporary is unlikely. A niche (Fig 10) has also been cut into the internal wall to the north of the external door; this was probably used for storing a lamp.

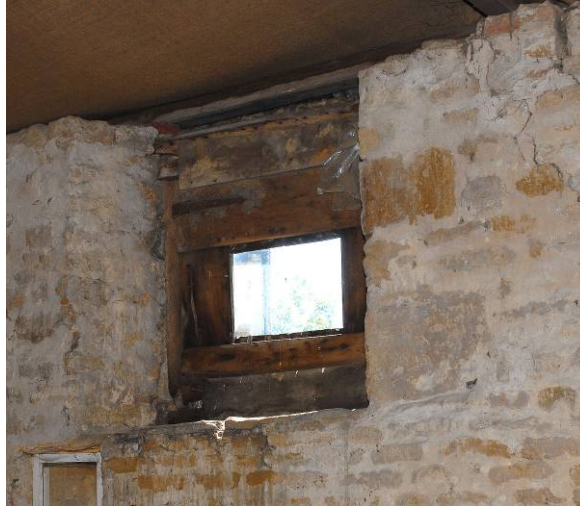
The partially boarded window, west wall of Barn 1 Fig 11

The ventilation slit in the gable has been glazed internally using a timber frame with no window furniture; the low ventilation slit in the southern end of the west wall has been glazed in a similar fashion. The two windows are of a similar size; the southernmost of which has been largely boarded with a small glazed light in the centre (Fig 11); the northernmost window contains a timber-framed casement window with two casements each containing three lights. One casement can be opened, with iron furniture (visible in Fig 9). The internal door leading to Barn 2 is of timber with iron furniture and appears original (Fig 12).

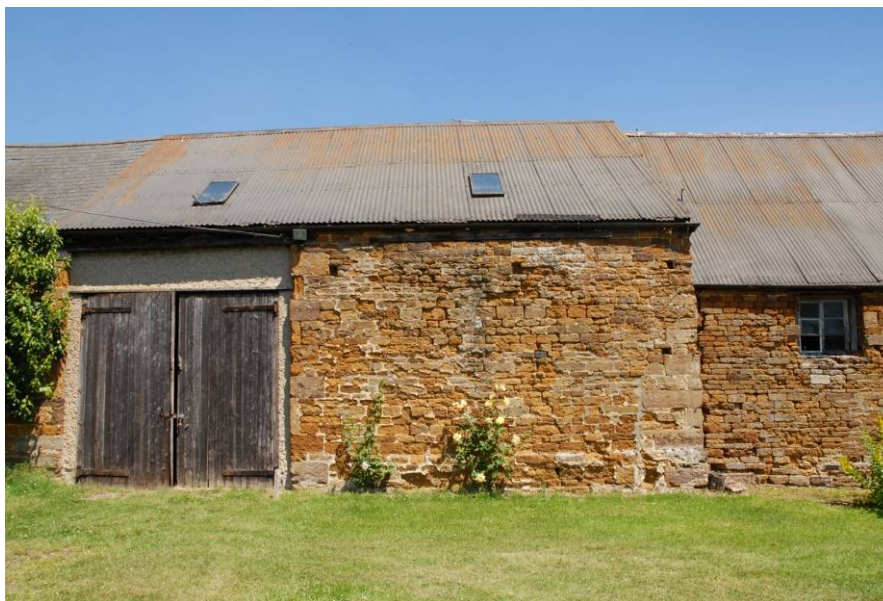
Barn 2, west elevation Fig 13

The walls are of roughly coursed, dressed ironstone rubble bonded with lime mortar; quoins are present in most courses. There is a chamfered plinth to the south wall, but this is not present in the other walls (Fig 13).

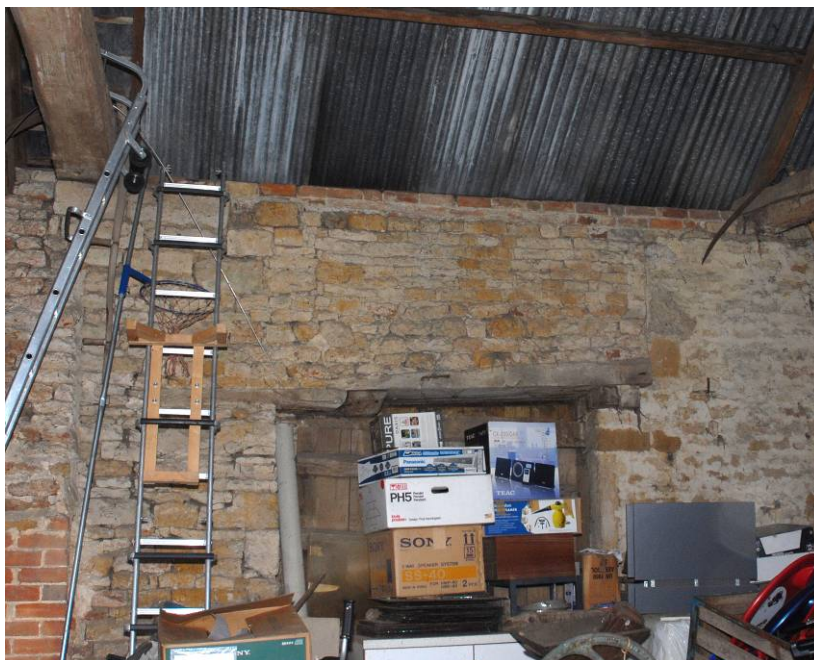
The blocked door in the east wall of Barn 2 Fig 14

Internally, the area of stonework surrounding the blocked door on the east wall is not flush with the surrounding walls and contains areas of brick repairs; reused timbers act as a lintel (Fig 14). These, and a change in the stonework above the door, indicate that a full height door has been replaced by a smaller access door which was in turn blocked. However, the external wall is obscured by the neighbouring buildings and so this alteration cannot be further appraised.

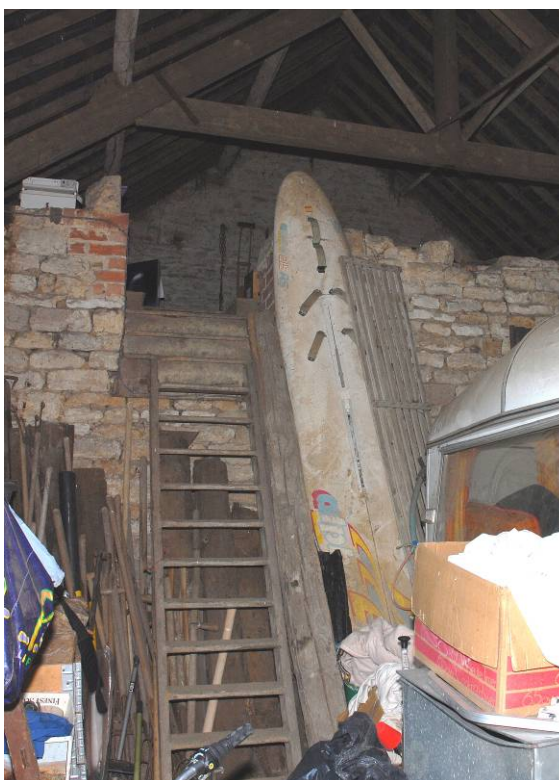
The steps to the mezzanine Fig 15

Wooden steps lead from Barn 2 to the Mezzanine, the last three steps being wooden stairs within the partition wall; the partition wall itself is of similar construction to the external walls (Fig 15). A straight joint between the partition wall and the external walls at either end indicates its later construction.

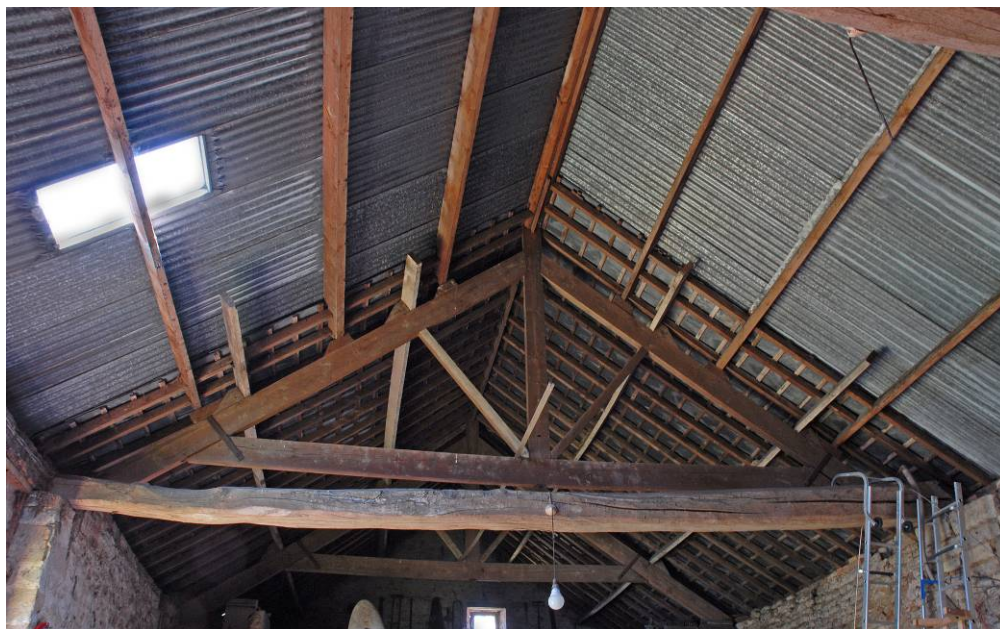
The two southernmost bays are roofed with corrugated iron as Barn 1; the northernmost bay, and that of the Mezzanine, is roofed with slate. The two tie beams within Barn 2 are original, although all other roof timbers are modern and probably contemporary with the roof structure of Barn 1 (Fig 16). The sawn timber truss

supports the roof independently of the original tie beam in the second bay, but incorporates the original tie beam in the third bay.

Roof timbers between bays 1 and 2 of Barn 2. This also shows the corrugated iron and slate roofs
Fig 16

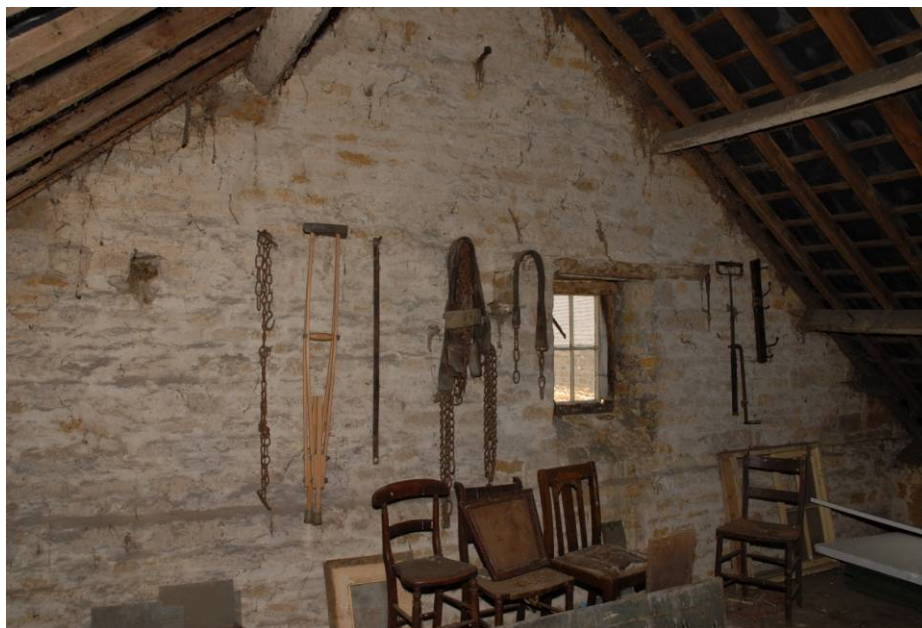
The north wall of the Mezzanine Fig 17

One small glazed window is in the gable (Fig 17); it is not central and so may have been cut to suit the mezzanine, although the whitewash obscures evidence of this theory and the external wall is not visible from the Home Farm property. It is also noted the lintel is also considerably longer than the window and may indicate blocking of a larger opening which is no longer visible.

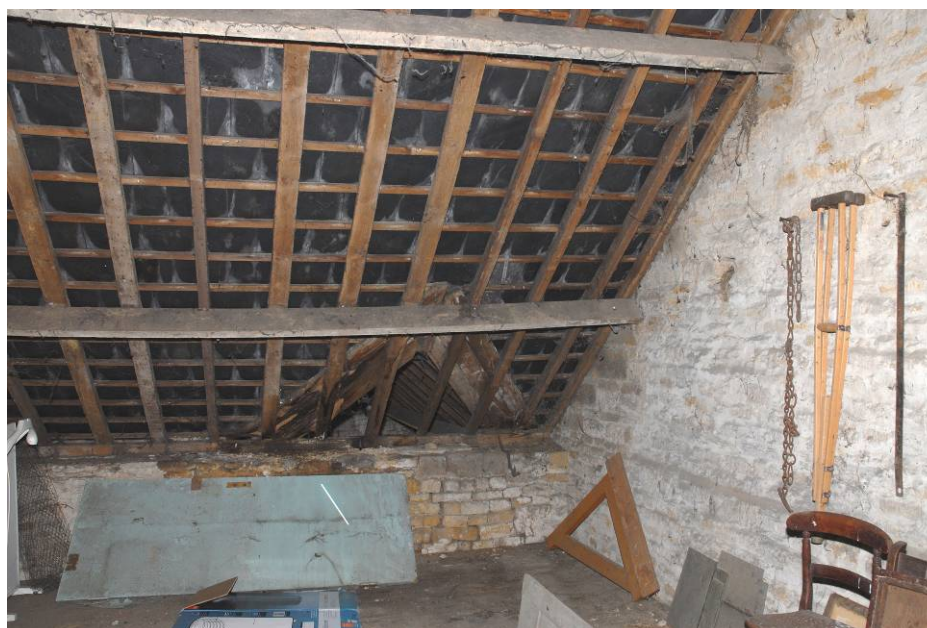
The join of the roofs of the Mezzanine and the Store Fig 18

The apex of the roof of the Store is built into the pitch and is left open (Fig 18).

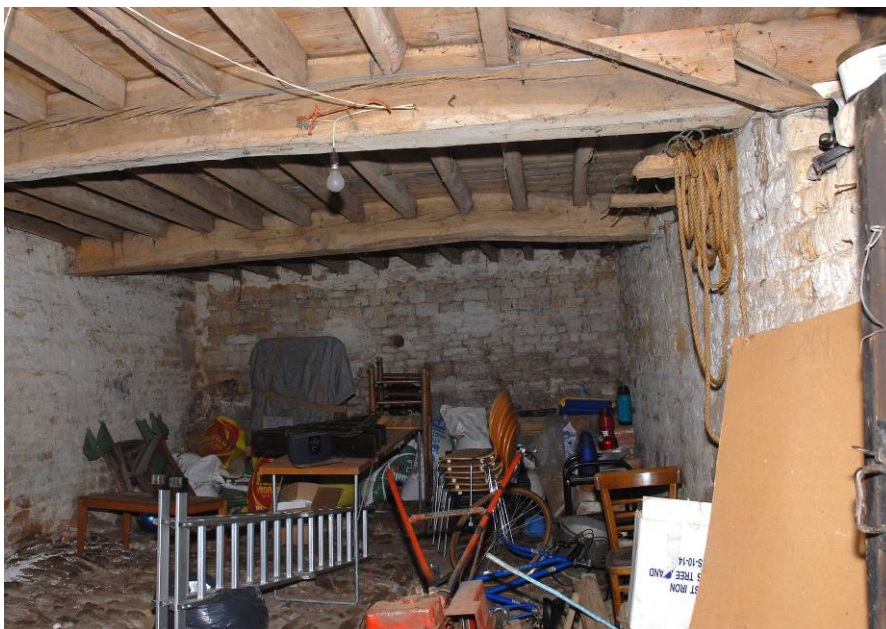
The east wall of the Stable Fig 19

The room is partitioned off from Barn 2, with the Mezzanine over. The external walls and partition wall are therefore as Barn 2. The ceiling consists of the floor structure to the Mezzanine; two beams run across the width of the room with joists being built into the wall at either end (Fig 19).

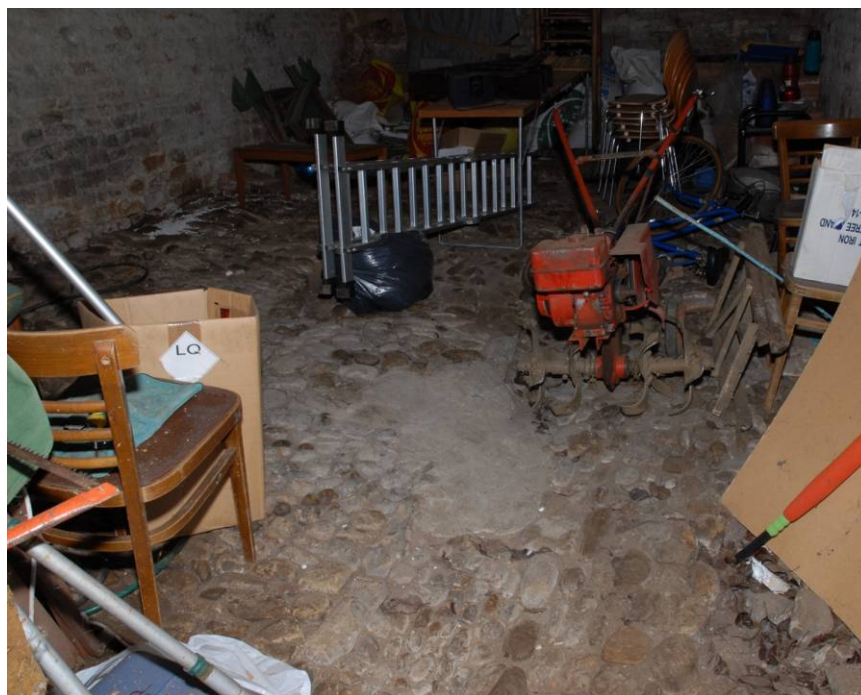
The floor of the Stable Fig 20

Although heavily obscured by stored items, the floor is cobbled and features gullies and level areas in a pattern which could indicate locations of earlier stalls (Fig 20); a

timber manger runs along the east wall (the 'back' of the room) indicating the room could have been used for stabling. There are remains of whitewash which would also indicate a use requiring the basic cleanliness this provides.

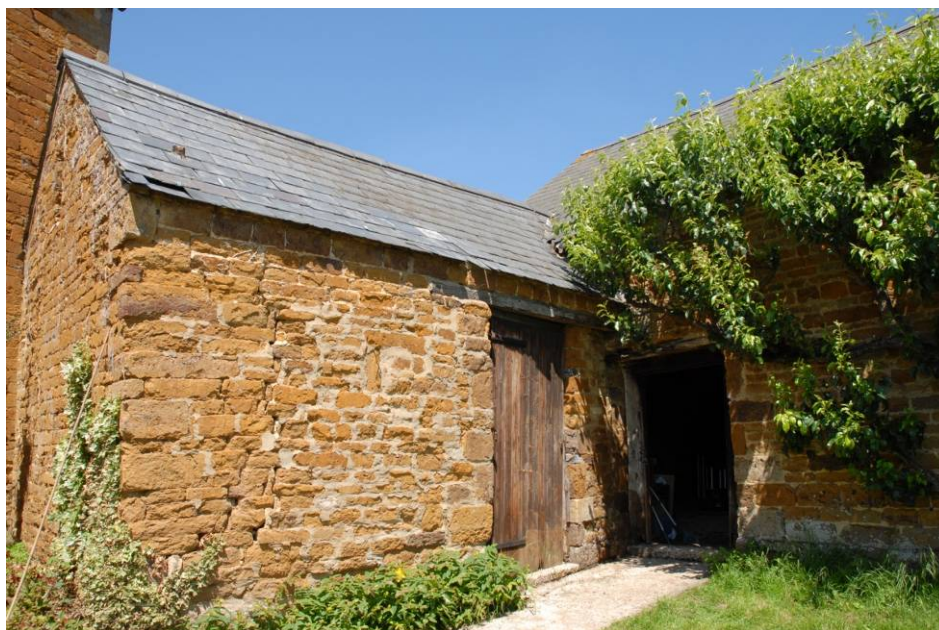
The Store, south and west walls Fig 21

The small storage building built onto the north-west corner of the Stable, and butting up to the farmhouse, has walls of similar construction to the rest of the outbuildings (Fig 21).

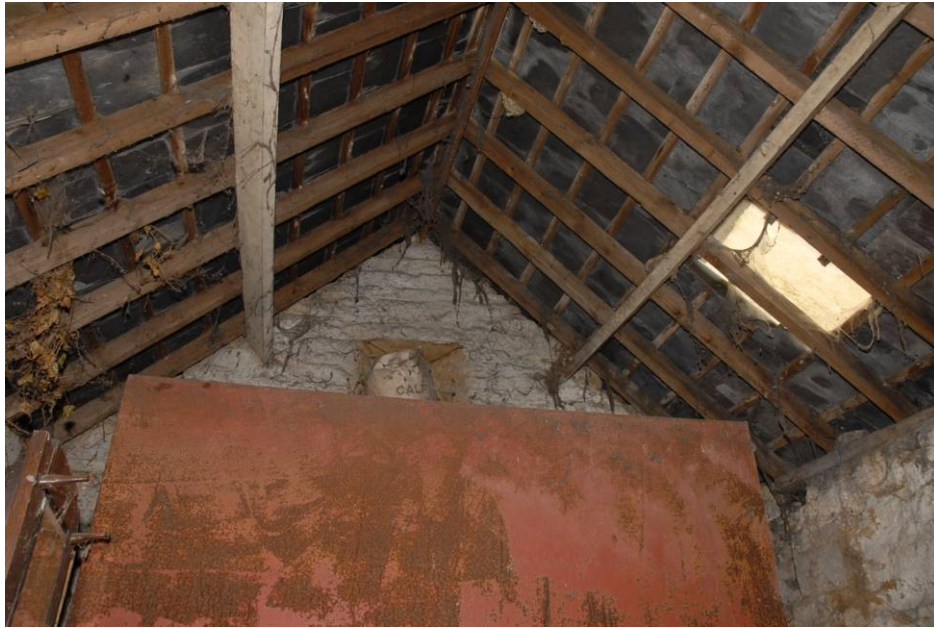
The slit in the west wall of the Store Fig 22

The doorway is original; the door and jamb have been replaced with modern timber. A rooflight is in the pitch of the roof and a slit is in the top of the gable wall (Fig 22). A small blocked opening is visible in the south wall near to the door (Fig 23); the infill is flush with the surrounding stonework and it has been obscured by shelving and the oil tank in the internal wall. The internal face of the walls has been whitewashed.
