Northamptonshire Archaeology

Archaeological Buildings Assessment at Stratford House and Ousebank Cottage Mill Lane, Stony Stratford, Milton Keynes

ARCHAEOLOGICAL BUILDINGS ASSESSMENT AT STRATFORD HOUSE AND OUSEBANK COTTAGE MILL LANE, STONY STRATFORD MILTON KEYNES DECEMBER 2009-JANUARY 2010

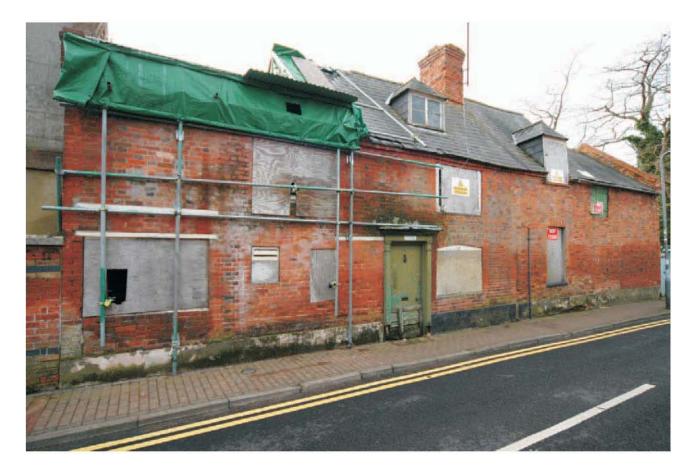
During 2008 a substantial portion of the roof of Ousebank Cottage collapsed, wrecking the interiors below and threatening the stability of the remainder. The remnants of the interior are scaffolded and propped, and it is now temporarily covered with tarpaulins for a roof (Fig 4).

3023 View of front of Ousebank Cottage in 2010 Fig 4

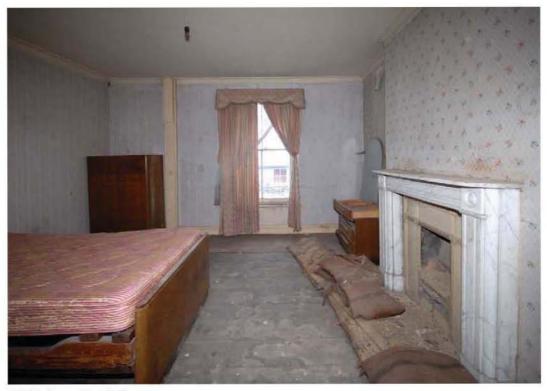
There are no original stairs surviving for this earliest block, but a structural failure in the back wall of bedroom F2 may denote where the first stairs wound tightly up from the interior of G2.

Bedroom F2 contains a substantial grey marble fireplace with tiled inner face. It is otherwise unremarkable, having a simple small skirting (Fig 14). Bedroom F4 has a skirting but no cornice, but has a walk-in wardrobe with cupboards above (Fig 15). Its fireplace has been removed, replaced with a 1930s-1950s wall-mounted electric fire. Both bedrooms have bars on the windows to prevent occupants falling out, which suggests they may once have been for children.

0049 Bedroom F2 Fig 14

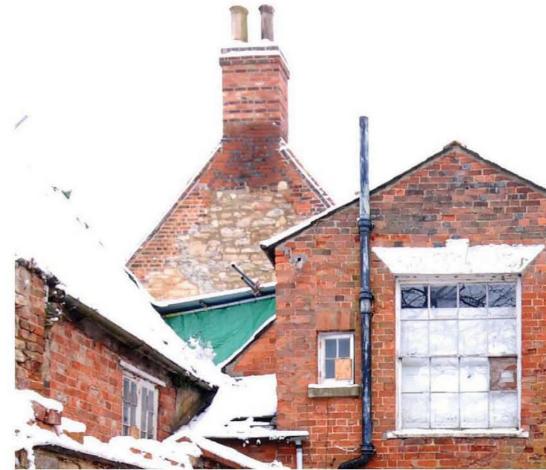
0089 Altered gable on main house (zoom in) Fig 16

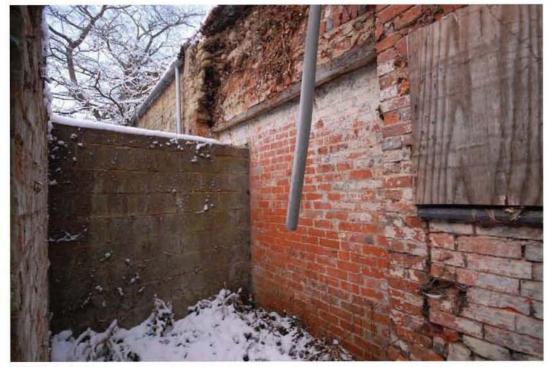
0098 Blocked-in former carriage entrance Fig 21

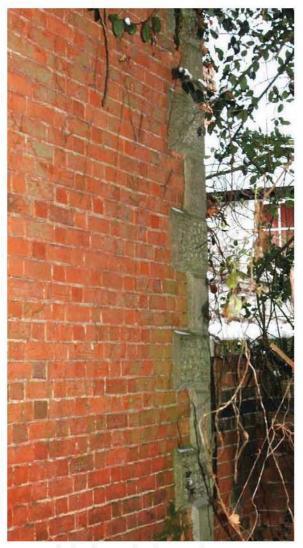
which lay above F6 and the floorless room, were less desirable, so these were given a matching gable to hide them, freestanding and entirely false. Both gables and the chapel (for which, see below) have central, blind windows high up, as does the east gable of the main house, which at the same time received a new brick skin and vermiculated quoins visible from the street (Fig 44).

3011 Vermiculated stressed quoins at north-east corner o...

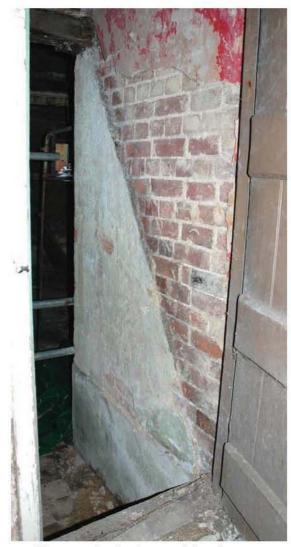
2996 Plaster scar denoting former stair from G15 to F13 ...

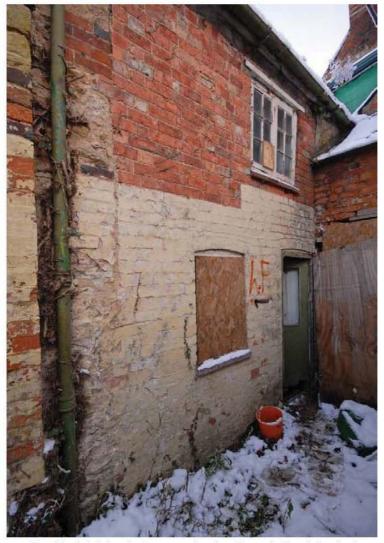
0097 Butt joint in brickwork of converted carriage house (left) and Ousebank...

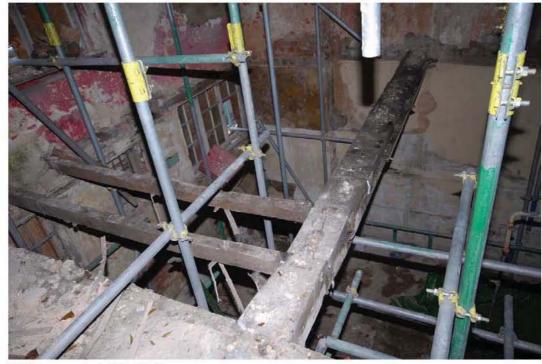
The remains of the first floor are only partial, the roof collapse having removed the interior of F13 and part of F10. Only an axial beam and a small number of joists are *in situ* in the former floor (Fig 54).

0106 Floor remains in F13 Fig 54

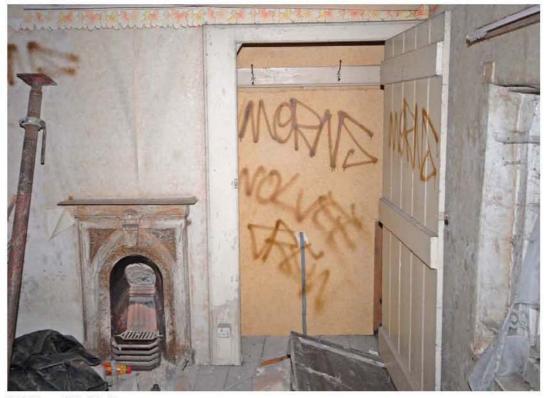
Bedroom F10 is a larger room (unhindered by stairs) and is accessed by stepping down slightly, perhaps suggesting that the lowering of the floors in G12 and G13 may have also been due to insufficient headroom or storage room. F10 is missing its east wall and an almost uninterrupted view can be seen straight through to the outside of the self-contained stair of Stratford House which links its first and second floors (F9a: Fig 47 above). It contains a small Victorian fireplace in the central stack and a built-in cupboard adjacent (Fig 56). It is lit by windows to north and south. Like F11 it contains the cheek-pieces of the roof.

0107 Room F10 Fig 56

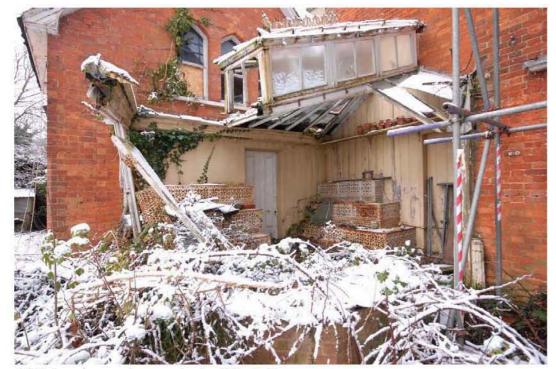
Later additions have been minor but notable, such as the now-dilapidated conservatory of perhaps just prior to 1900, with its tiled floor, the only part of it still in comparatively good condition.

0081 Collapsed conservatory superstructure G18 Fig 61
