Archaeological building assessment at Old Bunsty Farmhouse Milton Keynes

Report 10/53

March 2010

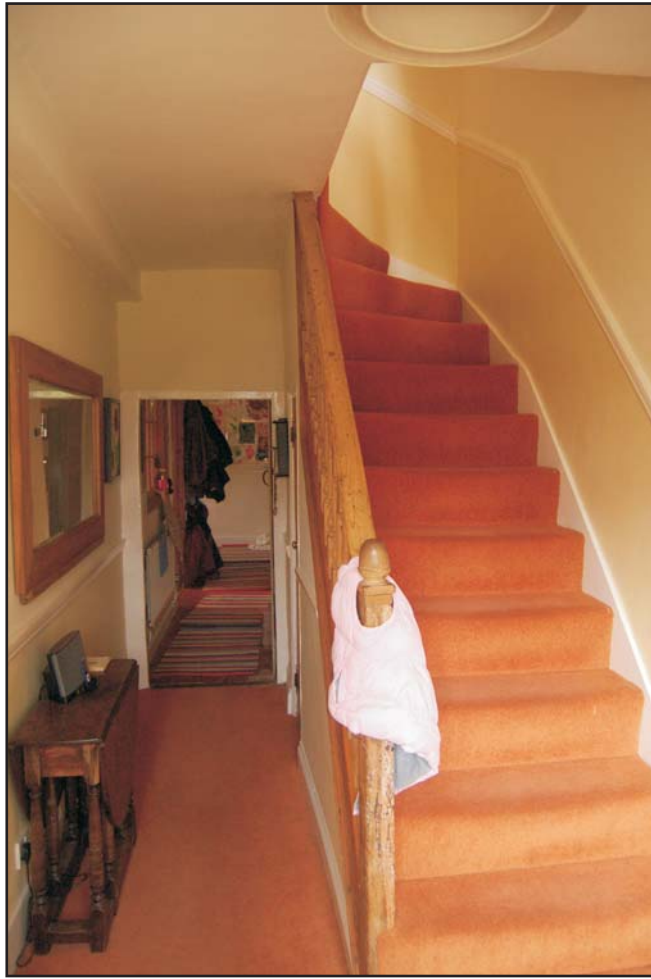
The house is entered via its centrally-placed front door, leading onto a hallway from which the staircase rises next to a Victorian pine banister rail with machine-made balusters (G1; Front cover and Fig 5). This, like most of the doors, has been stripped back to the bare wood in the fashion of the 1970s and 80s. There is an understairs cupboard which may incorporate a cellar access. This may have been blocked in brick so the evidence for a cellar is equivocal. If one exists it probably only lies under one half of the frontage and may have been filled with rubble.

View of the entrance lobby and stairs from the front entrance Fig 5

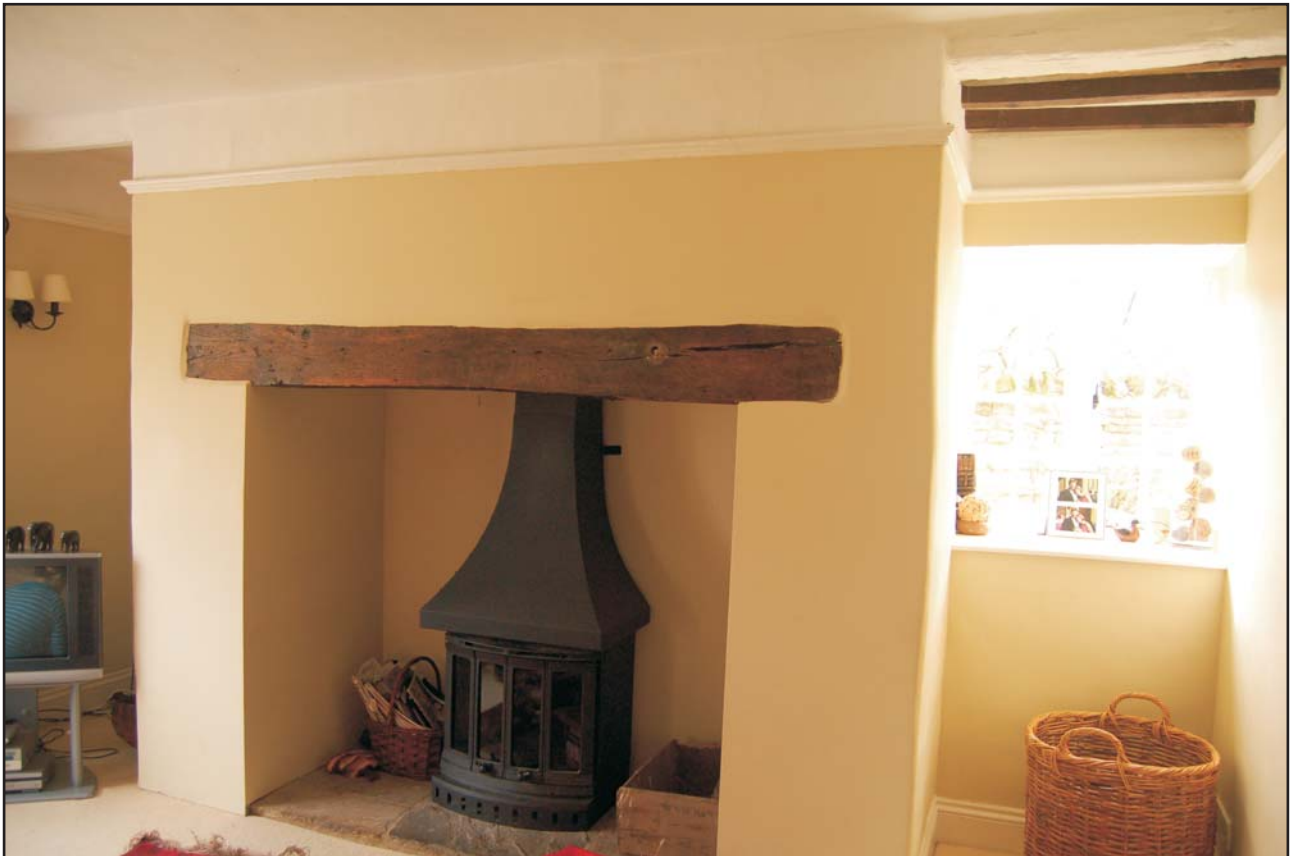
Through a doorway in a stud wall to the left of the entrance lies the Living Room (G2), formerly the farmhouse parlour, dominated by an inglenook fireplace which has probably

been largely rebuilt in recent times (Fig 6). The front window to this room may be original (although most of its glass is not; it is flanked by shutters folding back into shutter boxes in the splay (Fig 7). The side window appears to be a modern insertion since as an inglenook window it is both very large and derives no heat from the fire, from which it is separated. The exceptionally flat finish to the walls suggests that here, as in the rest of the house, early plaster has been taken off and replaced with modern. In room G2 that means that the picture rail has probably been re-set, if not imported.

The rebuilt inglenook fireplace in G2 Fig 6

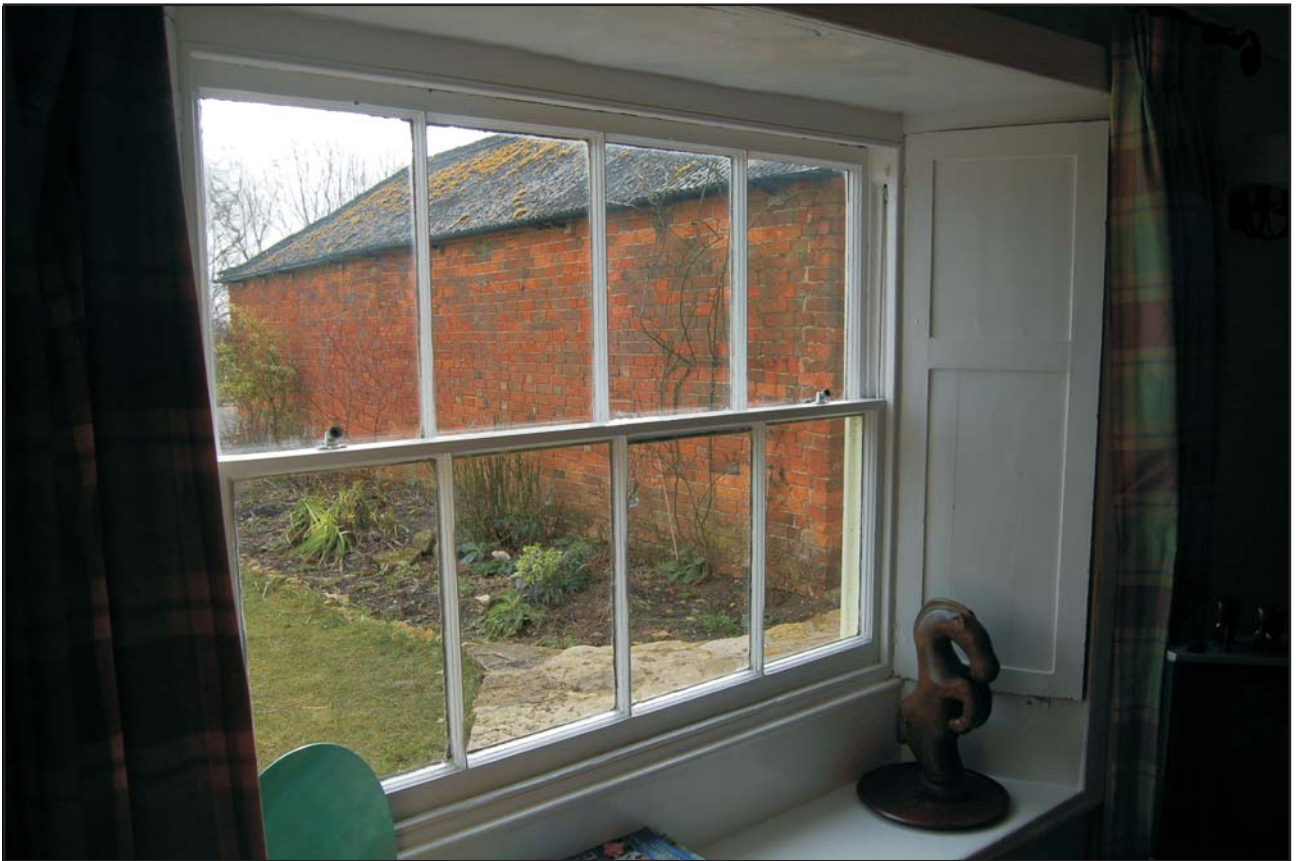
The early sash window and shutter/boxes in G2 Fig 7

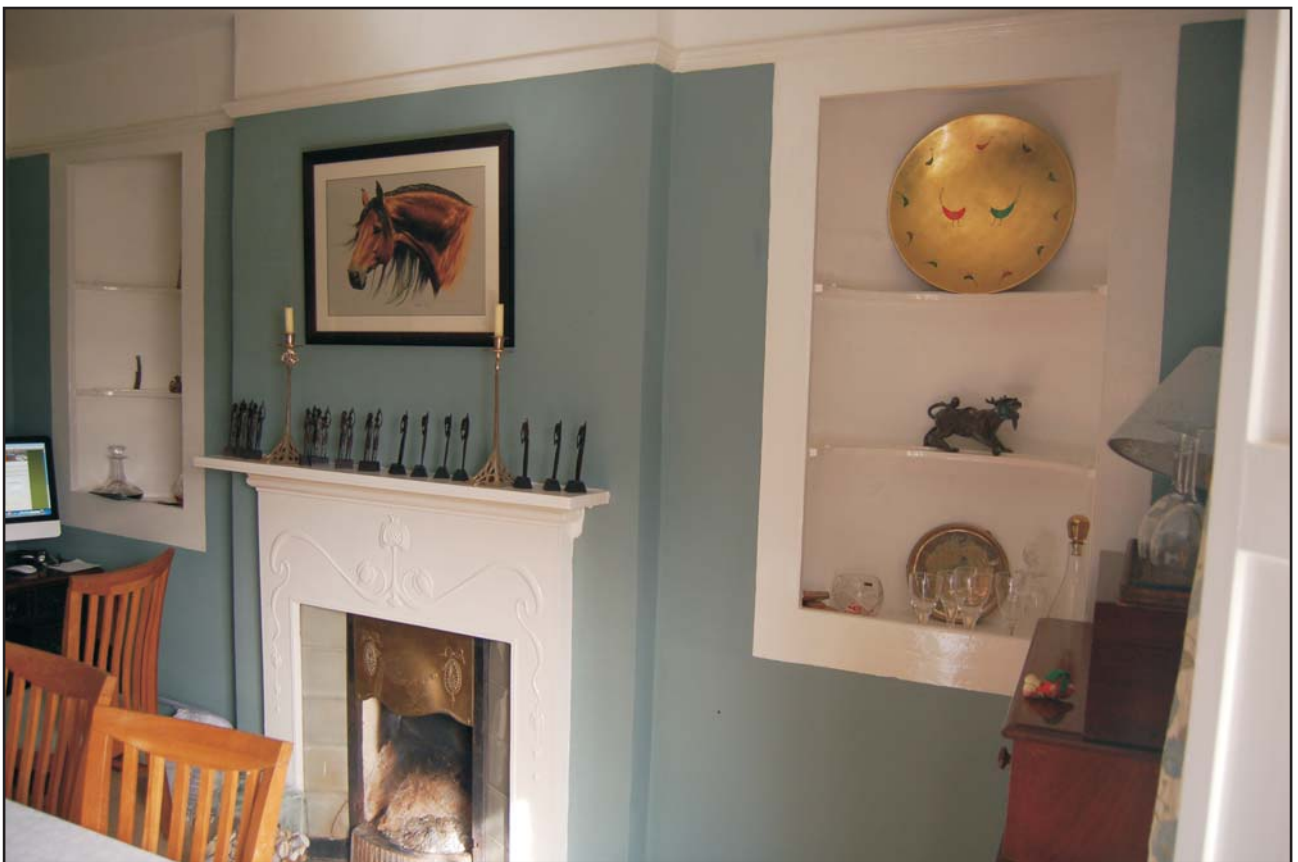
Room G3, today a dining room, has a fine Art Nouveau fireplace of c1900 in the gable wall, flanked by convex-backed display niches with shaped shelves (Fig 8). These niches, although for display, may be original, despite (seemingly strangely to modern eyes) having the vestiges of hinges and a catch for a cupboard door across each of them. This is not uncommon in 18th-century display cupboards and these fit the accepted pattern perfectly (Hall 2005, 197-8). There is a picture rail and as in G2, the window has a pair of folding shutters in splay-mounted shutter boxes. This room was once the 'best room' of the house.

Dining room G3; note convex display niches Fig 8

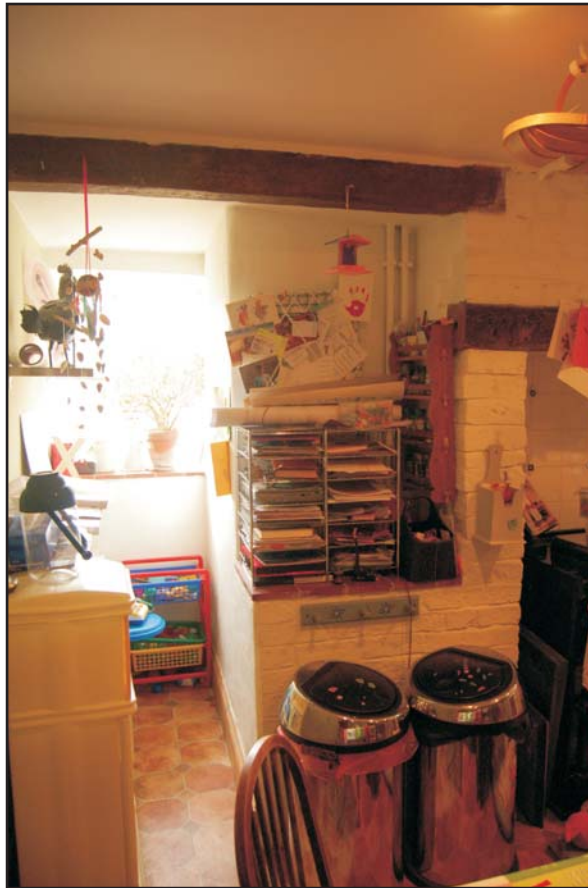
It may have been at this time that the brick-built cooking range was inserted into the kitchen (G5). It probably replaced an earlier fireplace (Fig 9). This new one would have been plastered (not bare brick) and would have incorporated a cast-iron range.

Kitchen G6; the range to the right, Fig 9
former doorway to the left

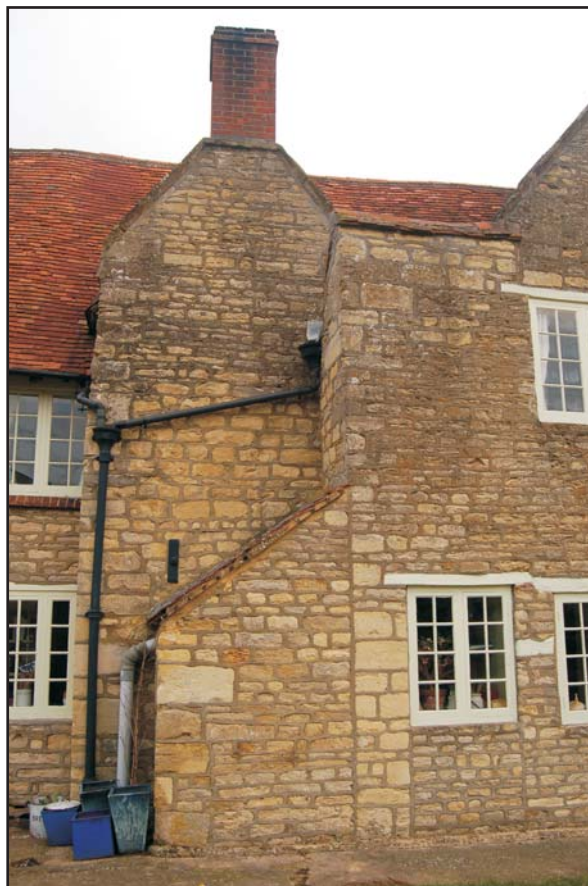
The rear wing chimney stack, when viewed from the exterior, sits amidst an agglomeration of stonework which looks awkward, is suggestive of numerous structural alterations, but which does not readily conform to any obvious developmental model without some form of intrusive inquiry. From the inside there is no clue as to the mass of stone which sits above and adjacent.

Agglomeration of stonework at the Fig 10
junction of the wings

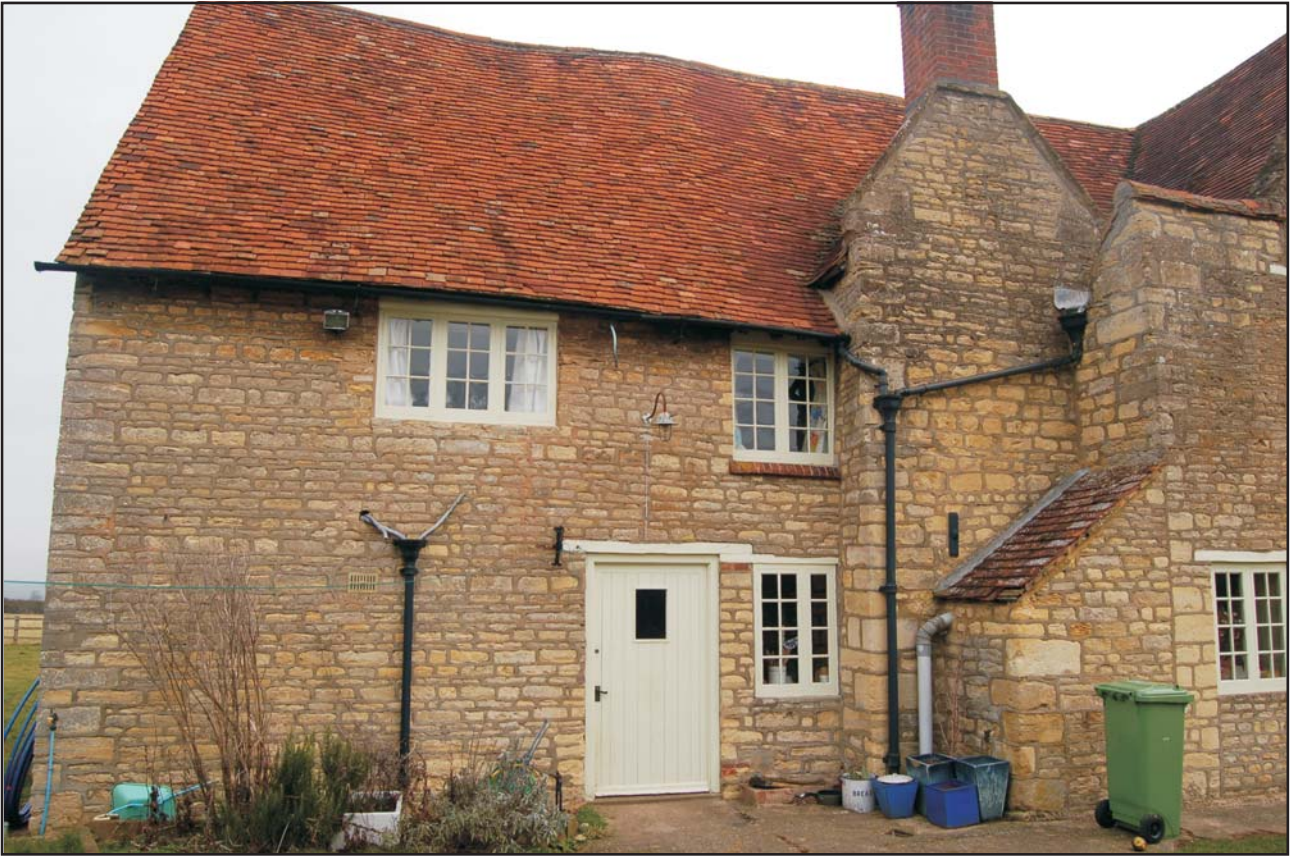
The rear service wing originally comprised a single room, or possibly two at most. It is today divided into a corridor (G4), off which lead two main rooms (G5 and G6). G5, today a kitchen, contains a heating boiler in what was the location of a Victorian cooking range, possibly with an integral tub for boiling up mash. Adjacent to this was the former back door from the farm (Fig 9 and Fig 10, bottom right). This is now a window and the rear pedestrian access has been transferred to the end of the corridor (Fig 11).

In order for the new, smaller kitchen to keep its heat in and be separated from the grime of the farmyard, the former doorway in the south wall was moved from its location directly adjacent to the cooking range to a new position at the far end of the corridor, again with an integral light panel (Fig 11). A small window was inserted adjacent to this but actually lay on the other side of the corridor wall, and allowed additional light into the kitchen, which was otherwise darkened by the loss of the large window it had once used in the far gable wall of G6.

South face of the rear service wing Fig 11

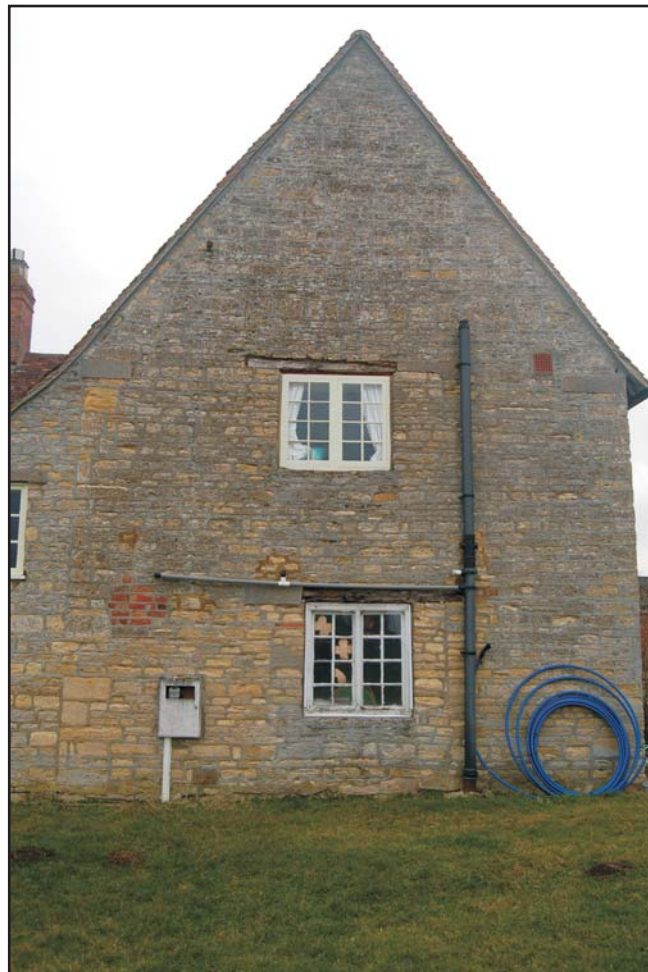
Room G6 was once part of the larger kitchen or main room of the service wing. Its one remaining ceiling beam (made exactly for this span as it fits perfectly) is simply but deeply chamfered with a simple run-out stop, and its position marks it to have been one of three formerly across the service wing. The other two seem to have been lost, one replaced by the corridor wall. The west window to G6 is an old window in poor condition but scars on the outside of the building and a much longer lintel beam show that the embrasure once held a much wider window with no interior splay (Fig 12). This would have been commensurate with the bigger room size.

Rear gable of the service wing; reduced window width at ground floor Fig 12

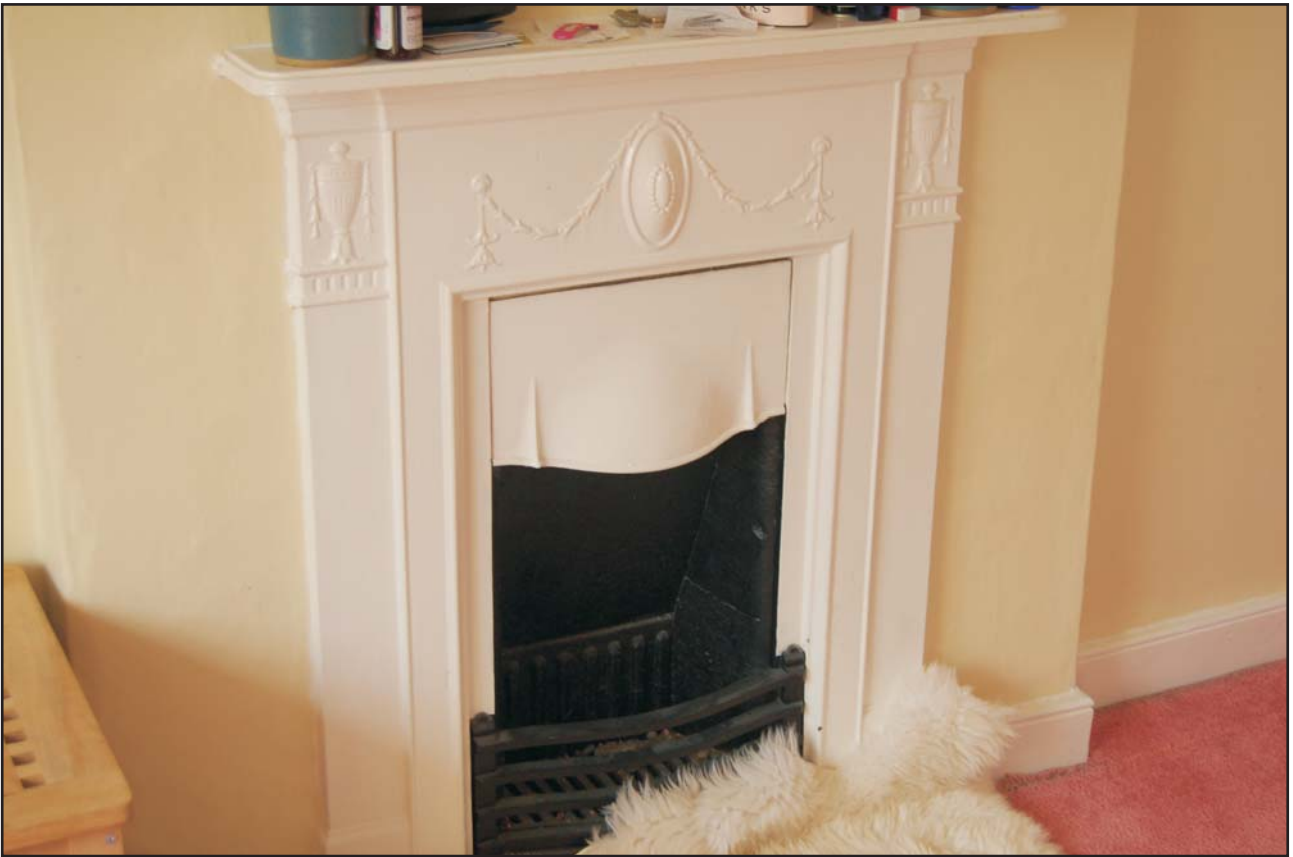
At first floor level the original layout is mirrored by a suite of four bedrooms (F2-3-F5-6), either flanking a landing or opening off the corridor (F1). There are also two modern bathrooms (F4 and F7). Three boxed-in axial beams tie the roof trusses of the front range, while none are visible in the service wing. The front bedrooms contain matching Victorian cast-iron fireplaces with classical vase and swag/foliate motifs in the style of Robert Adam (Fig 13).

Cast iron fireplace in bedroom F2 Fig 13

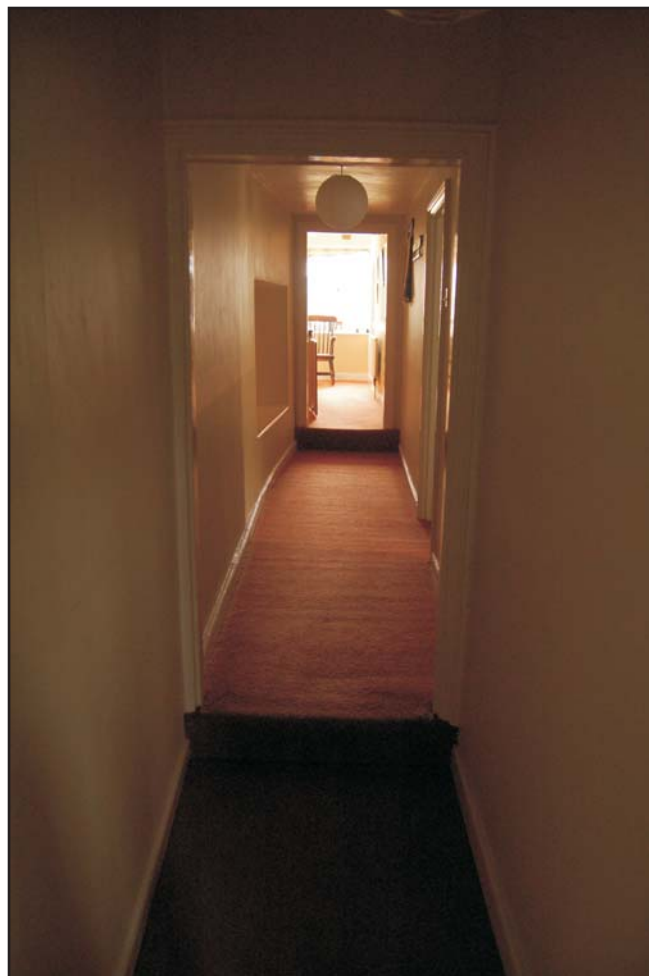
The bedrooms of the service wing, all apparently divided by stud walls, are probably 19th-century creations, as is the smaller of the two south-facing windows, which has a sill of chamfered bricks on edge, a layout not repeated anywhere else in the house. A single window faces north, lighting the corridor (Fig 14). The corridor incorporates two steps down in its entire length, which may denote a change in status as one progressed further from the centre of the house along the service wing. What bedroom space pertained to the early house may have been designated for servants.

View along corridor F1 from F7 Fig 14

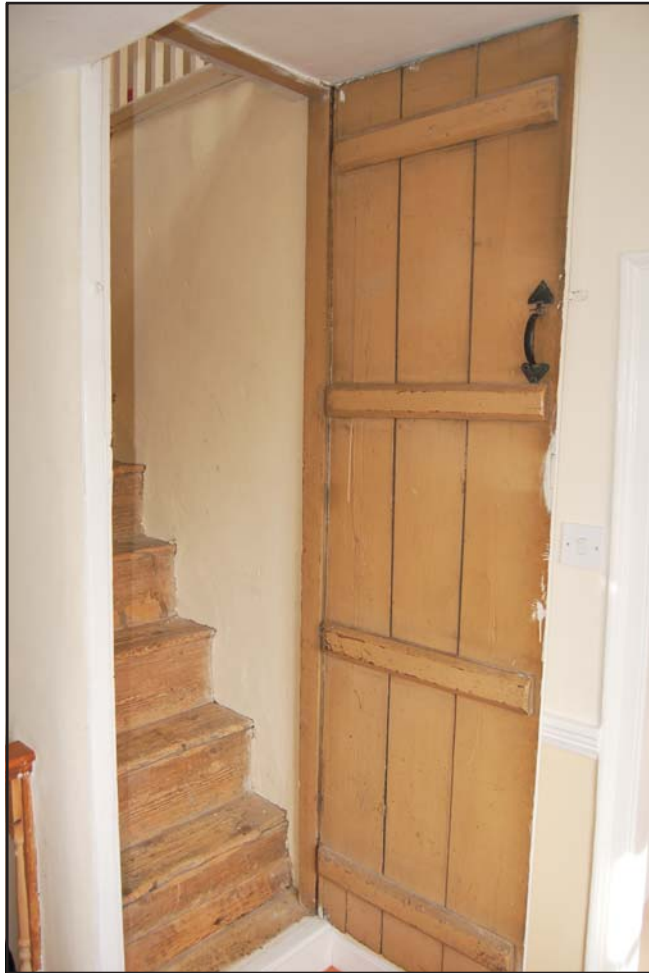
From the landing (F1) a narrow stair leads up to the attic spaces. Its age is unclear but the rear face of the simple planked and ledged door bears an ochre paint scheme beloved of the early 19th century (Fig 15).

View of stairs and door to second floor attic Fig 15

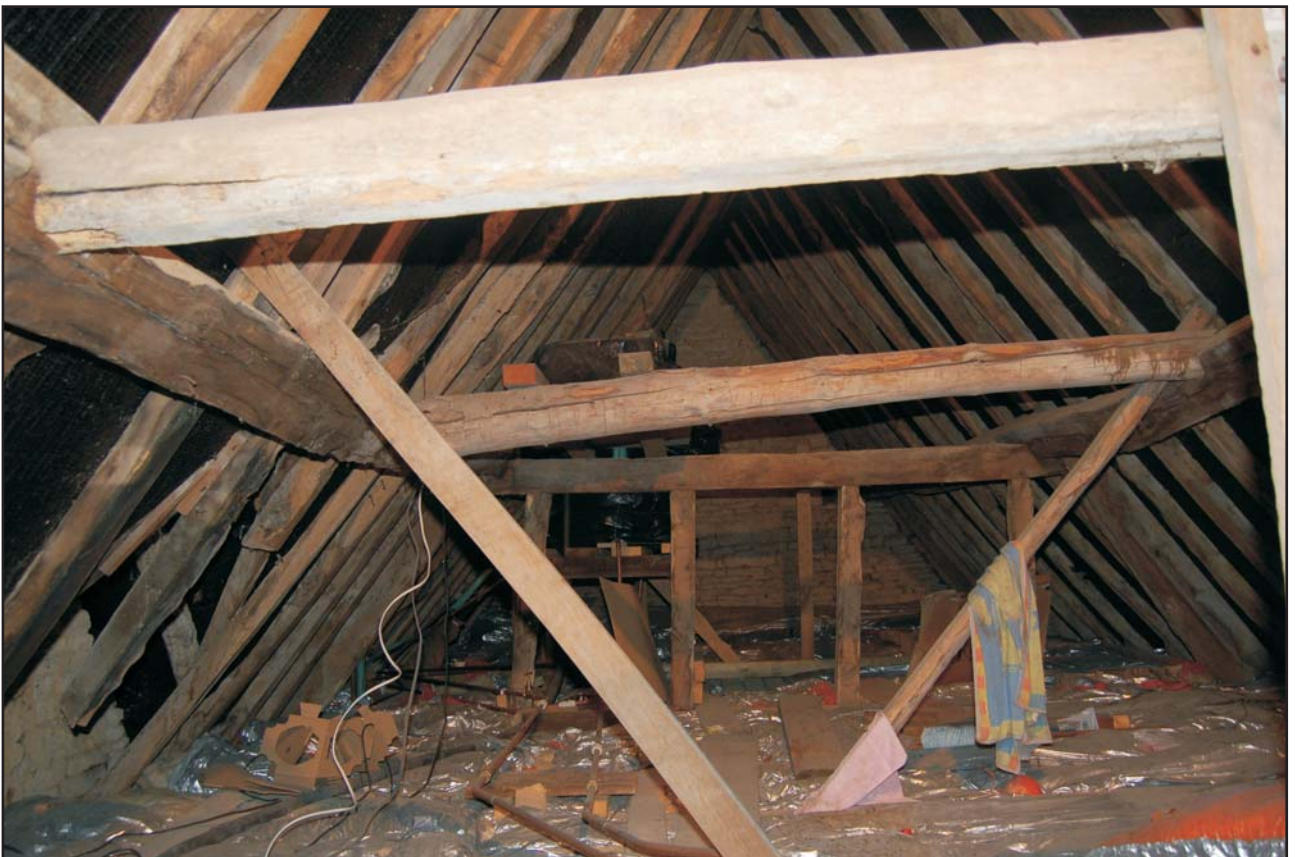
The roof space over the rear service wing (S4) has never been converted for occupation, nor is there apparent access for a storage use (Fig 16). The common rafters are halved and pegged at the apex and there is no ridge plank or pole. At the junction of the rear wing and the front range, the purlins here have unpegged and unfixed ends, indicating that at least the rear face of the front range roof has been completely rebuilt or re-configured. This aspect is perhaps the origin of the Listing-based assertion that the rear wing is older. Structurally these ends stand out in mid-air, un-linked to anything, although the weight at their ends is supported in each case by an upright prop standing up from the front-range wall-plate (Figs 17 and 18).

View along service wing roof Fig 16

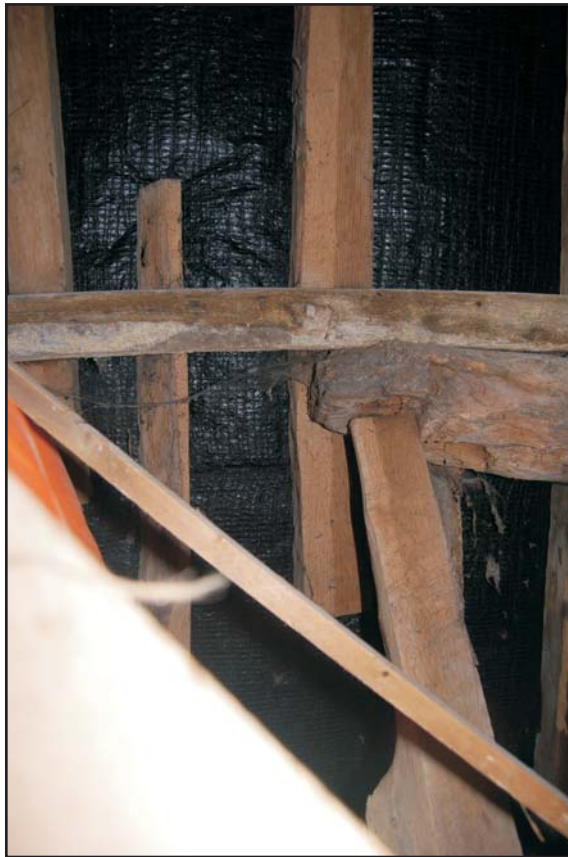
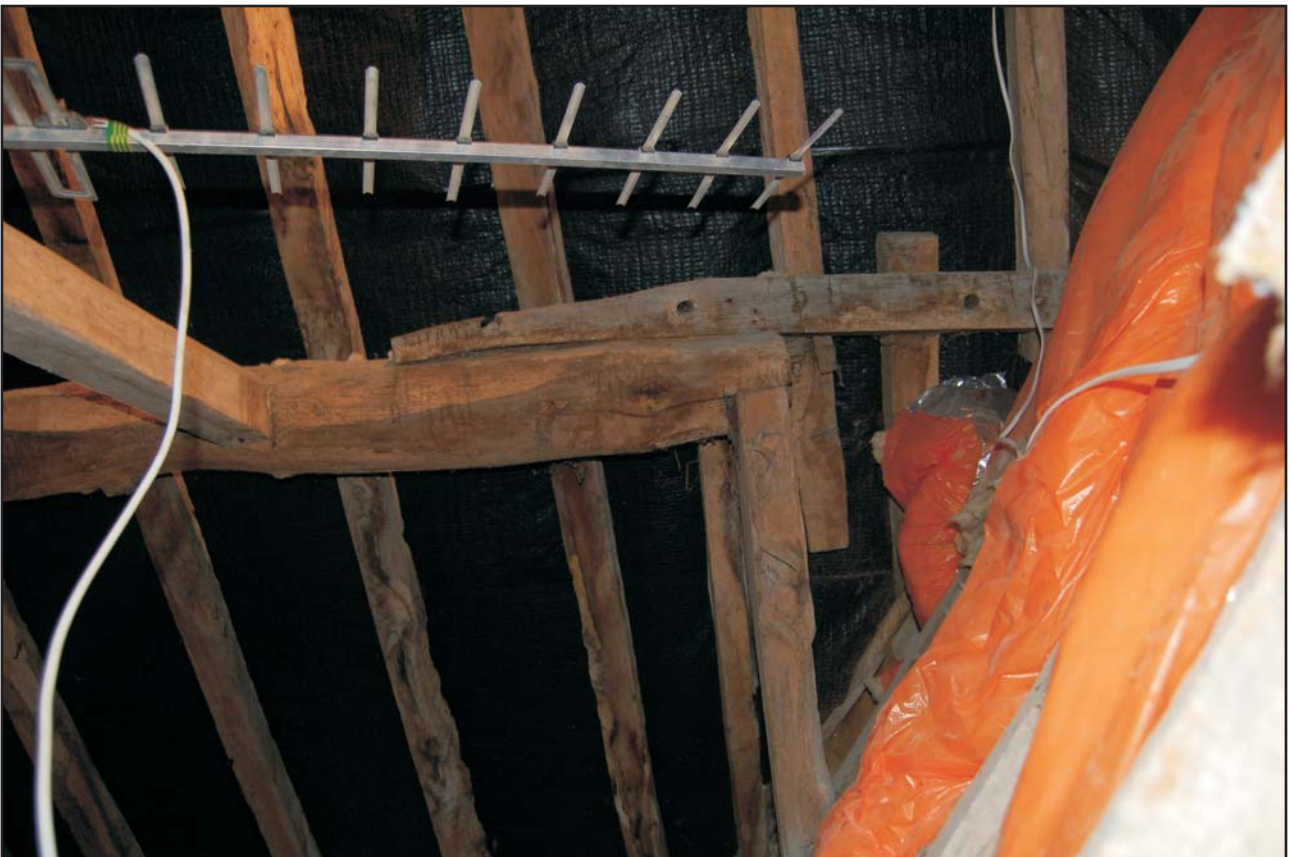
Propped south purlin of service wing roof Fig 17

Propped north purlin of service wing roof Fig 18

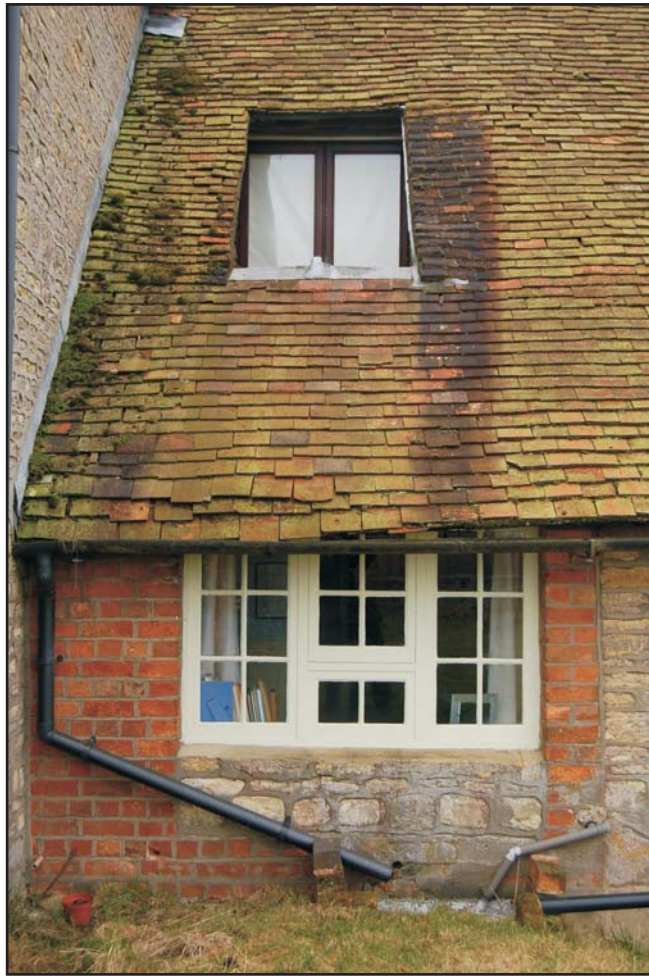
A need for separate room uses led to the interior of the extended service range being extended once more, by a simple process of infill to create room G9 (Fig 19). At about the same time the whole interior was divided up to create a smaller kitchen and add separate functions around the edge. This phase is characterised by the widespread use of brick as the principal material.

Former yard-space, enclosed and blocked to create G9 Fig 19

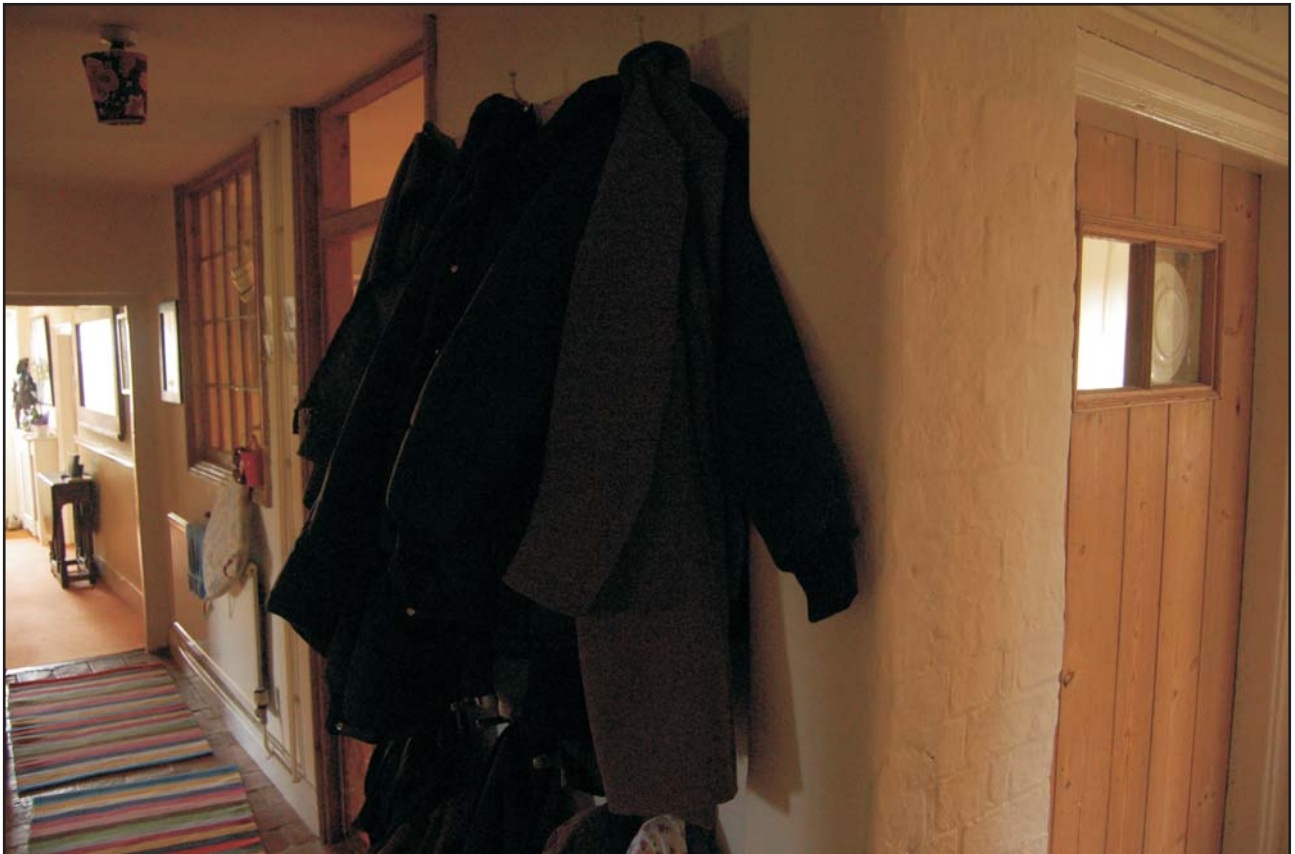
View along corridor G4 at its corner; front of the house to the left Fig 20

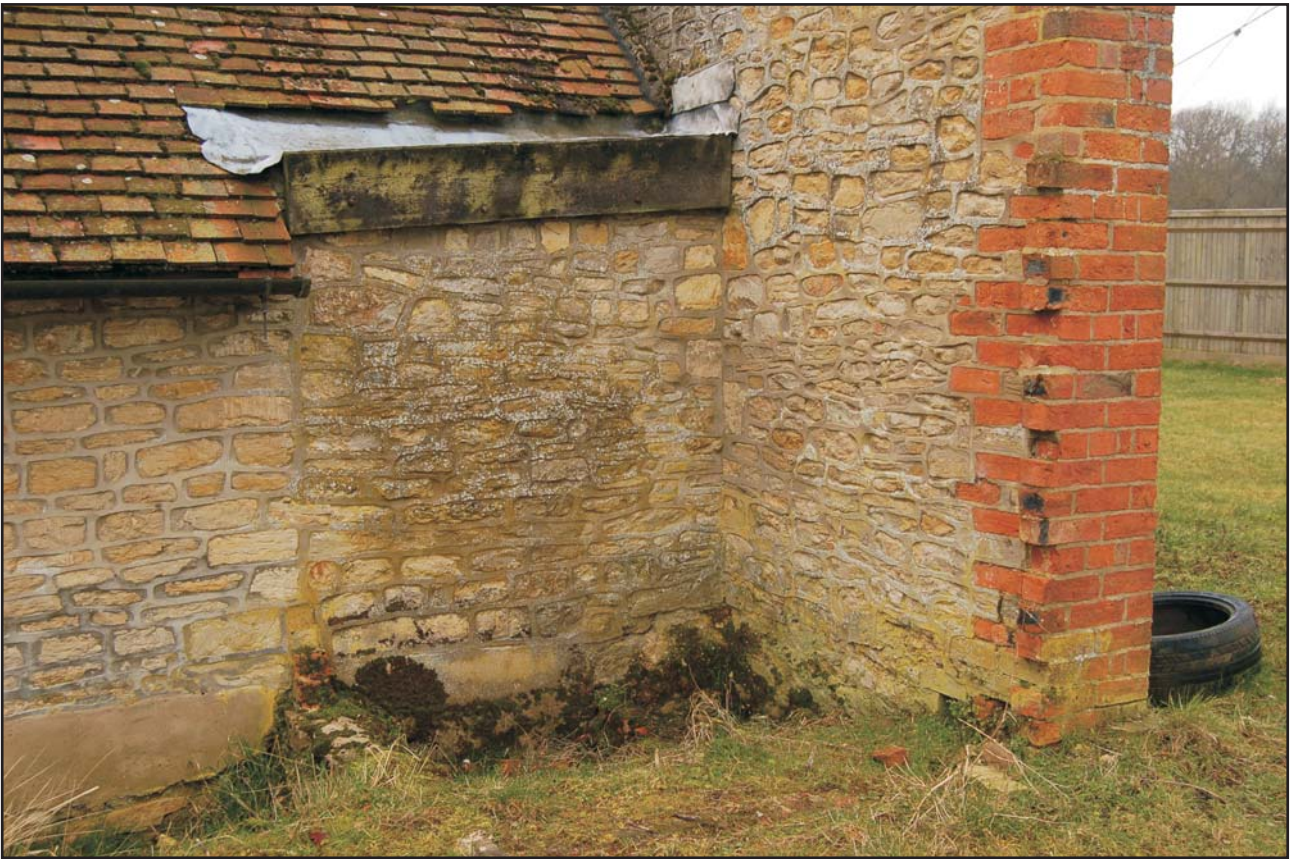
An outside WC may have been constructed against the north wall of G7 but this has been demolished and its form is now unclear (Fig 21).

Location of possible former outside WC Fig 21

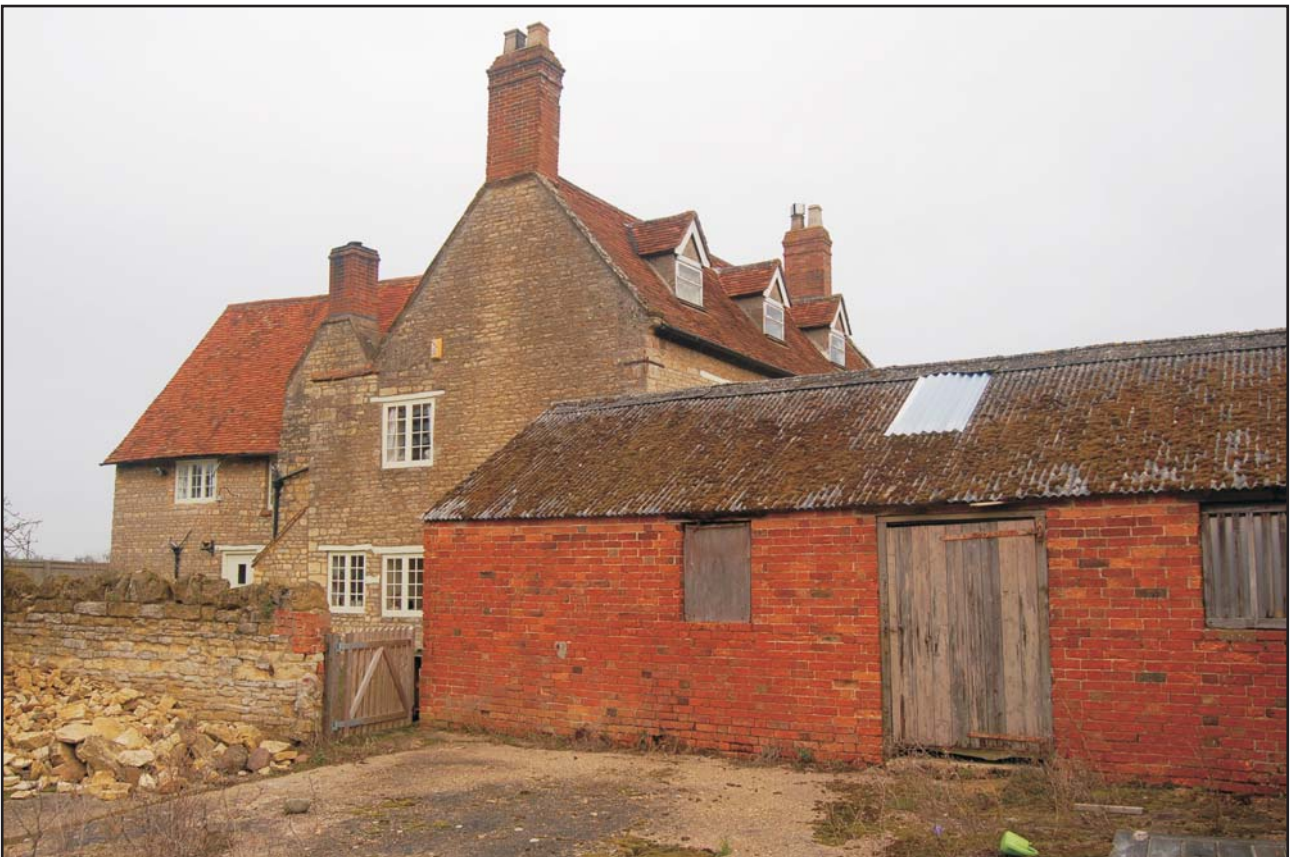
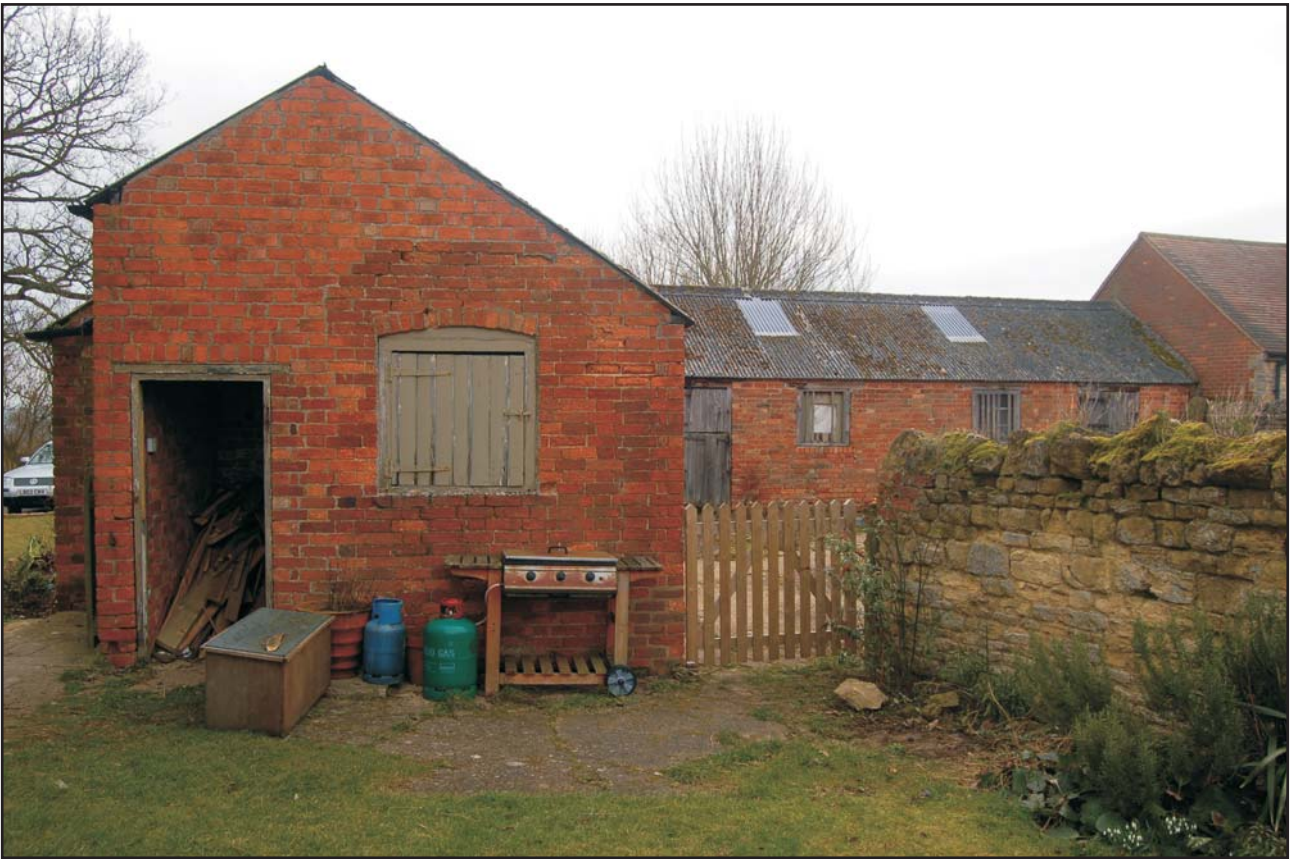
by 1885 but may not date to much earlier than this. There was no indication of them in 1810 and their bricks are standard machine-made Victorian examples. The range is divided up as cow-byre and cart hovel, with wood-shed closest to the service range (Figs 22 and 23). The face closest to the farmhouse is blind so as to maintain the family's privacy from the less savoury aspects of farming life. The roof, which was once probably either ceramic tile or Welsh slate, has been replaced in corrugated asbestos. The trusses inside are original to the range. It remains the only part of the complex not converted to modern uses or structurally upgraded.

Victorian farm buildings and the farmhouse in the background Fig 22

Victorian farm buildings, looking from the farmhouse Fig 23

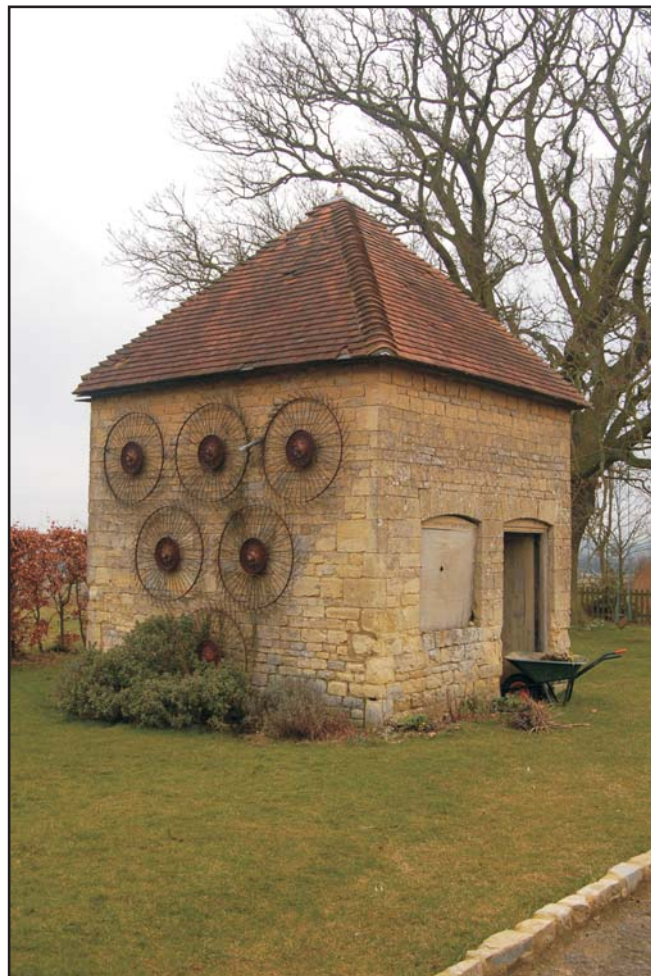
A square, stone-built well-house under a ceramic tile pyramidal roof stands in front of the farmhouse on the same property (Grade II listed, number 350948; Fig 24). It may post-date 1810 as it is not depicted on the map of that year. It is derelict and is now ideally used as a garden store, since it is believed that the well no longer functions.

Listed well-house (Grade II) Fig 24
